DEPARTMENT OF ENERGY

Subject: Biennial Inspection and Maintenance Report on Erosion Controls Associated with Solid Waste Management Unit 16-003(o) within Fishladder Canyon

Figures for the Biennial Inspection and Maintenance Report on Erosion Controls Associated with Solid Waste Management Unit 16-003(o) within Fishladder Canyon

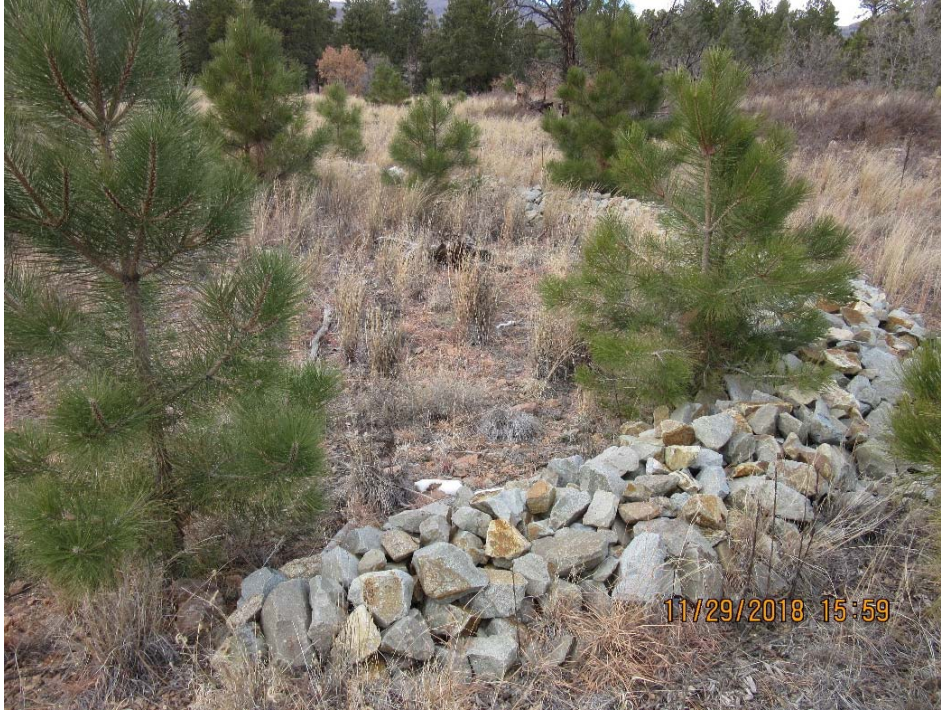
Figure 2 Rock berm (V00703120026, center of photo) at the top of drainage leading into Fishladder Canyon (December 2018). Note established vegetation. Condition of control: excellent.

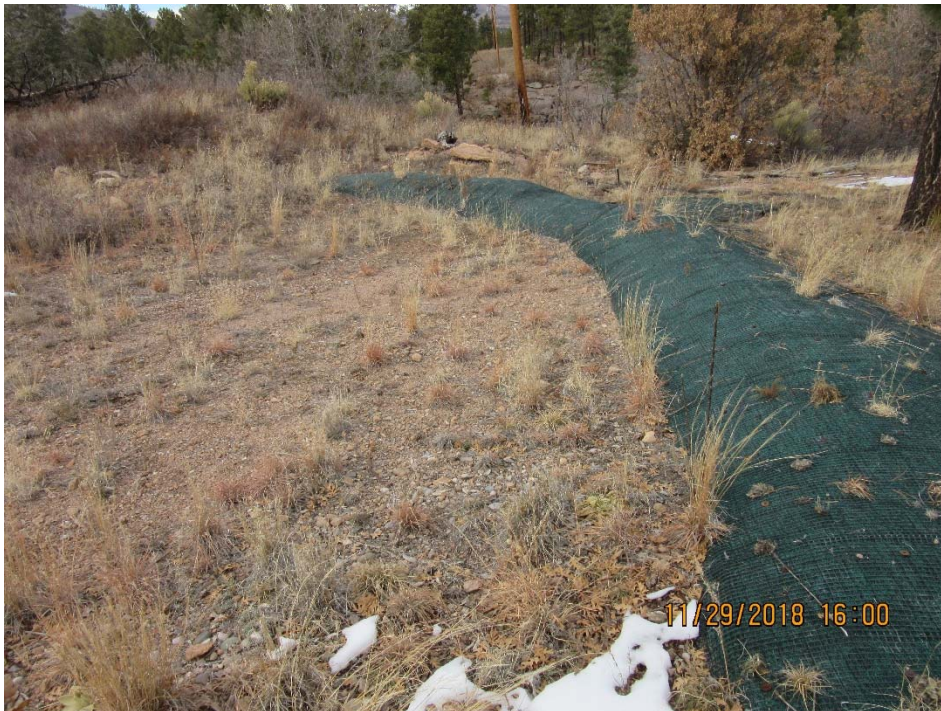
Figure 3 Earthen berm (V00703010027, center of photo) at the top of drainage leading into Fishladder Canyon (December 2018). Note established vegetation. Condition of control: excellent.

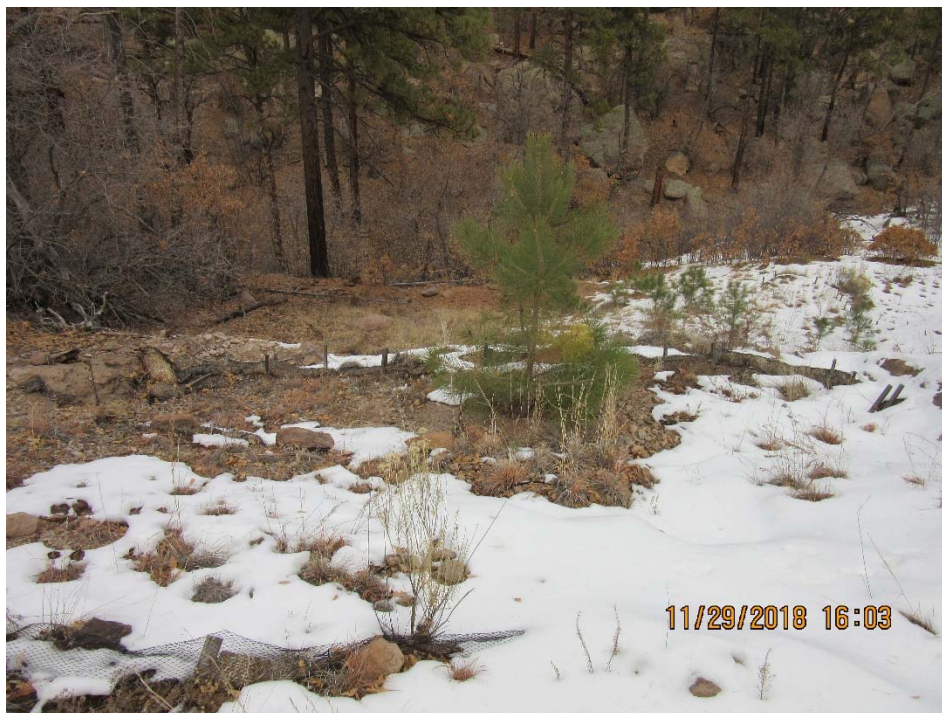
Figure 4 View downslope of the former fishladder location (December 2018). Note established vegetation above and below straw wattle (V007030600028, center of photo). Condition of control: good.

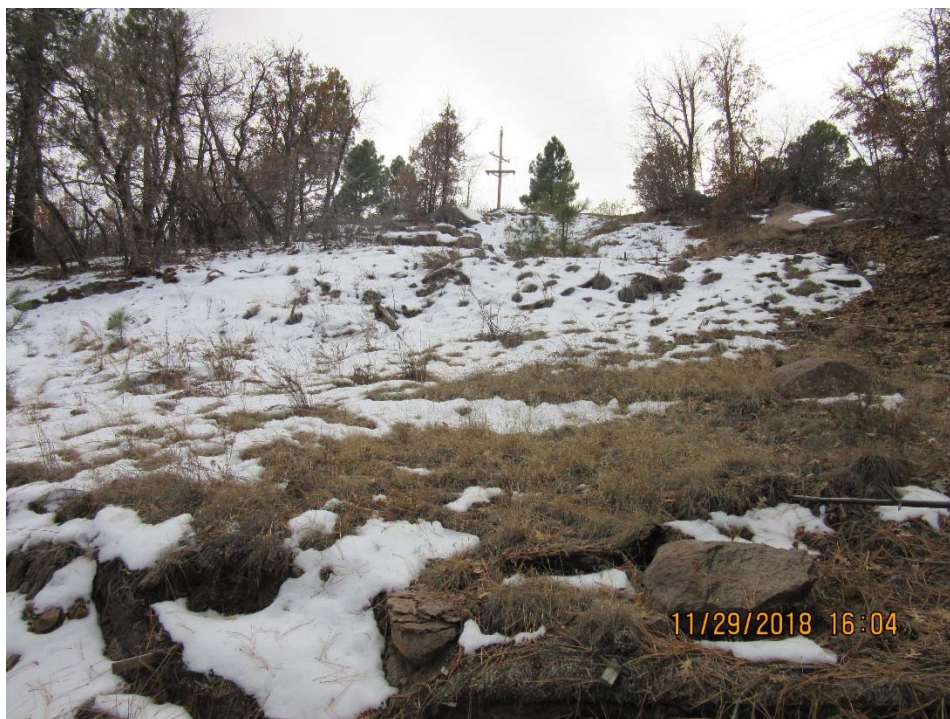
Figure 5 View upslope of the former fishladder location from the canyon bottom (December 2018). Note established vegetative cover and lack of erosional features. Control not visible in photo.

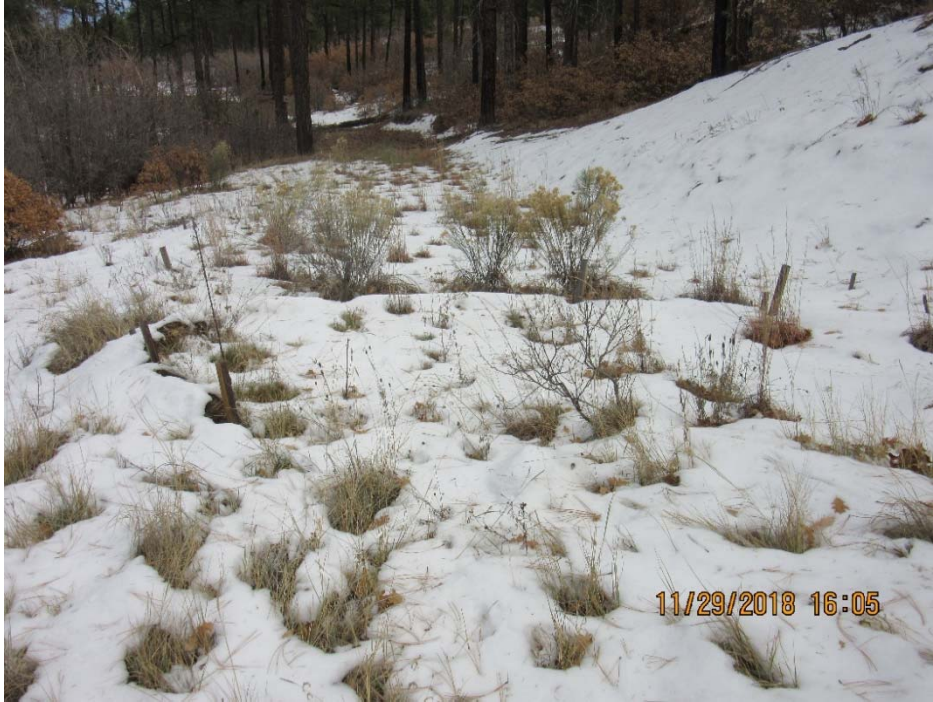
Figure 6 View east of former access road and straw wattle (V007030600028, center of photo, obscured by snow) (December 2018). Note established vegetation. Condition of control: very good.

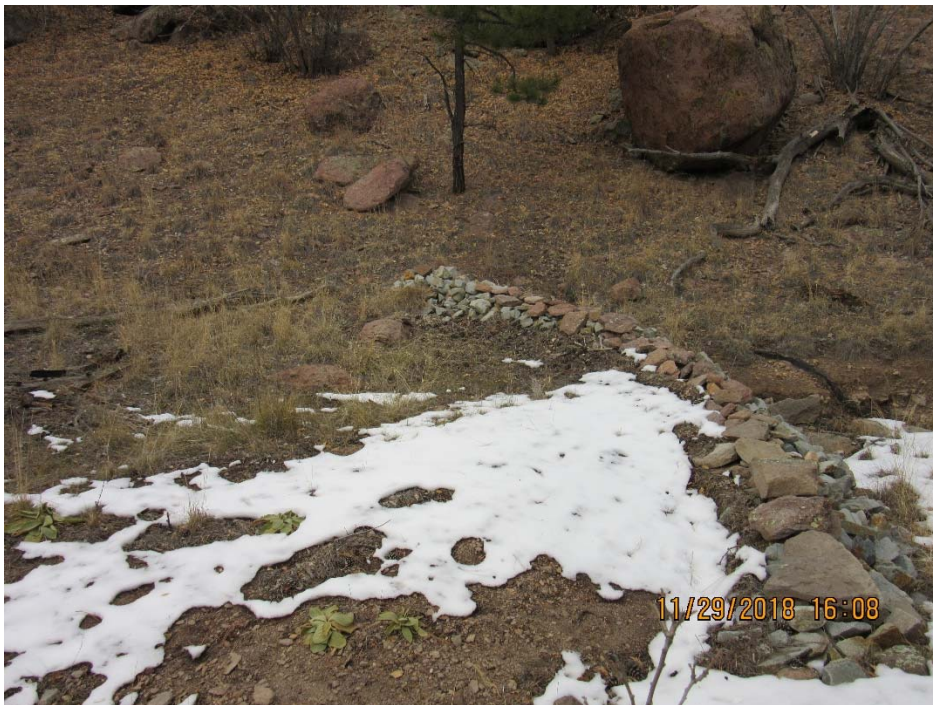
Figure 7 Rock check dam (V00706010024, center of photo) in Fishladder Canyon primary drainage (December 2018). Condition of control: very good.

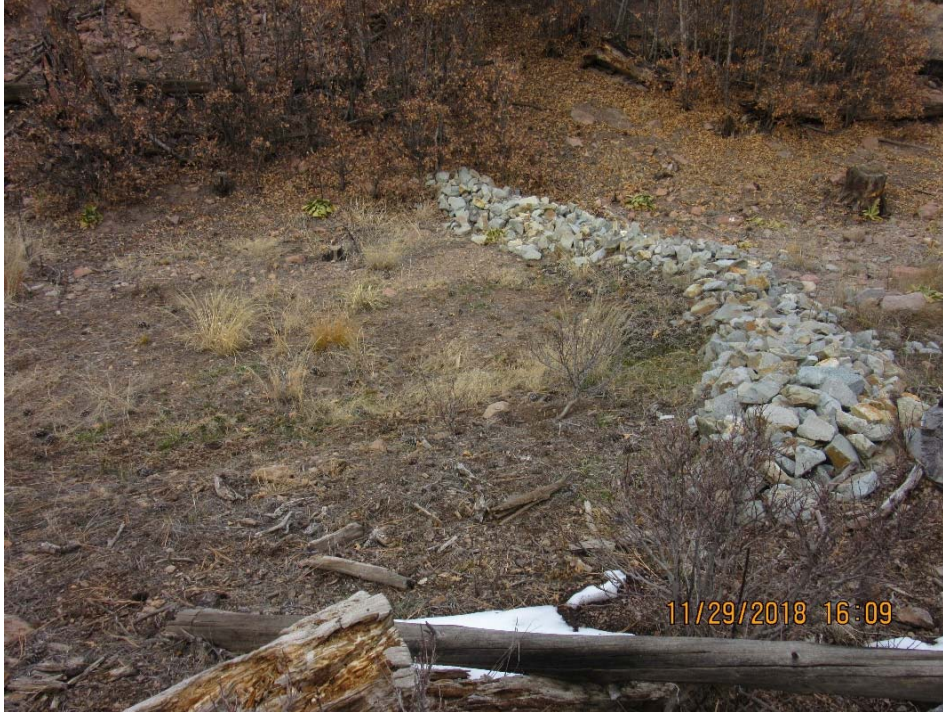
Figure 8 Rock check dam (V00706010025, center of photo) in primary drainage (December 2018). Note established vegetation in channel. Condition of control: excellent.

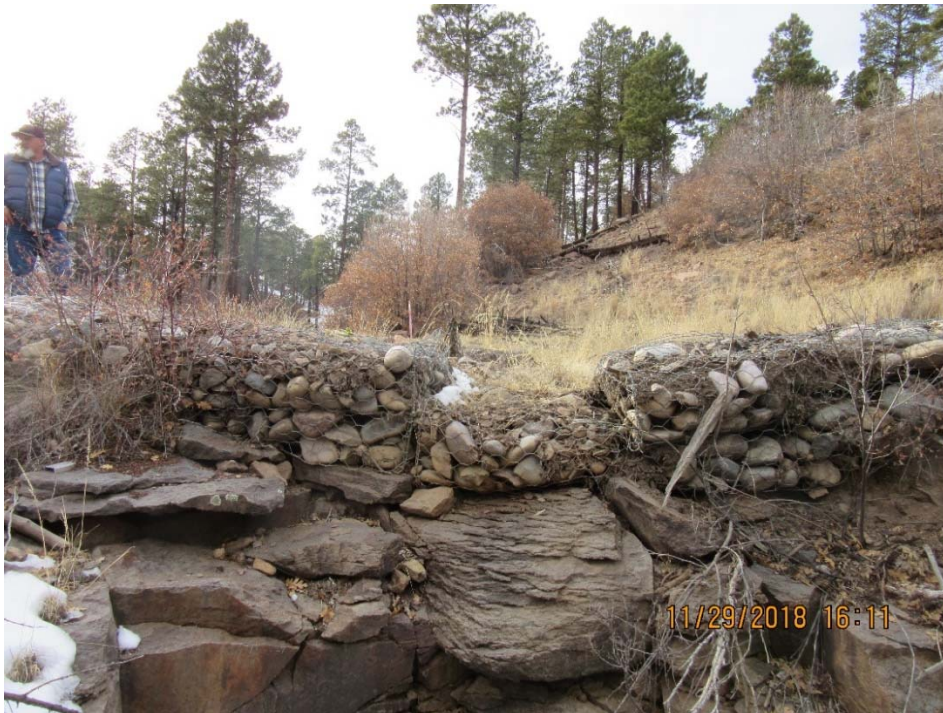
Figure 9 Gabion (V00707010002, center of photo) at access road crossing in Fishladder Canyon (December 2018). Note vegetation in channel upstream of control. Condition of control: good.

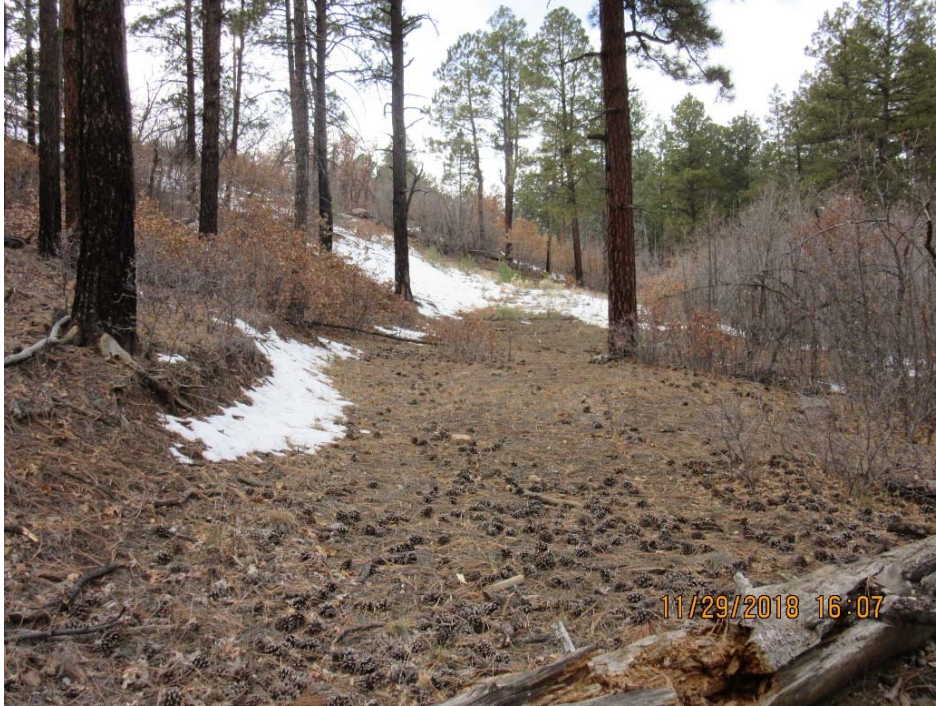
Figure 10 View west of former access road in Fishladder Canyon (December 2018). Note vegetative cover, needle cast, and downed trees along the former access road.
