Date: **MAR 05 2019**
Refer To: N3B-19-0065

**Subject: Response to Request for Information Regarding Damage to Technical Area 54
Domes 229 and 230 and Compliance with Los Alamos National Laboratory
Hazardous Waste Facility Permit, EPA ID No. NM0890010515**

Event Summary:

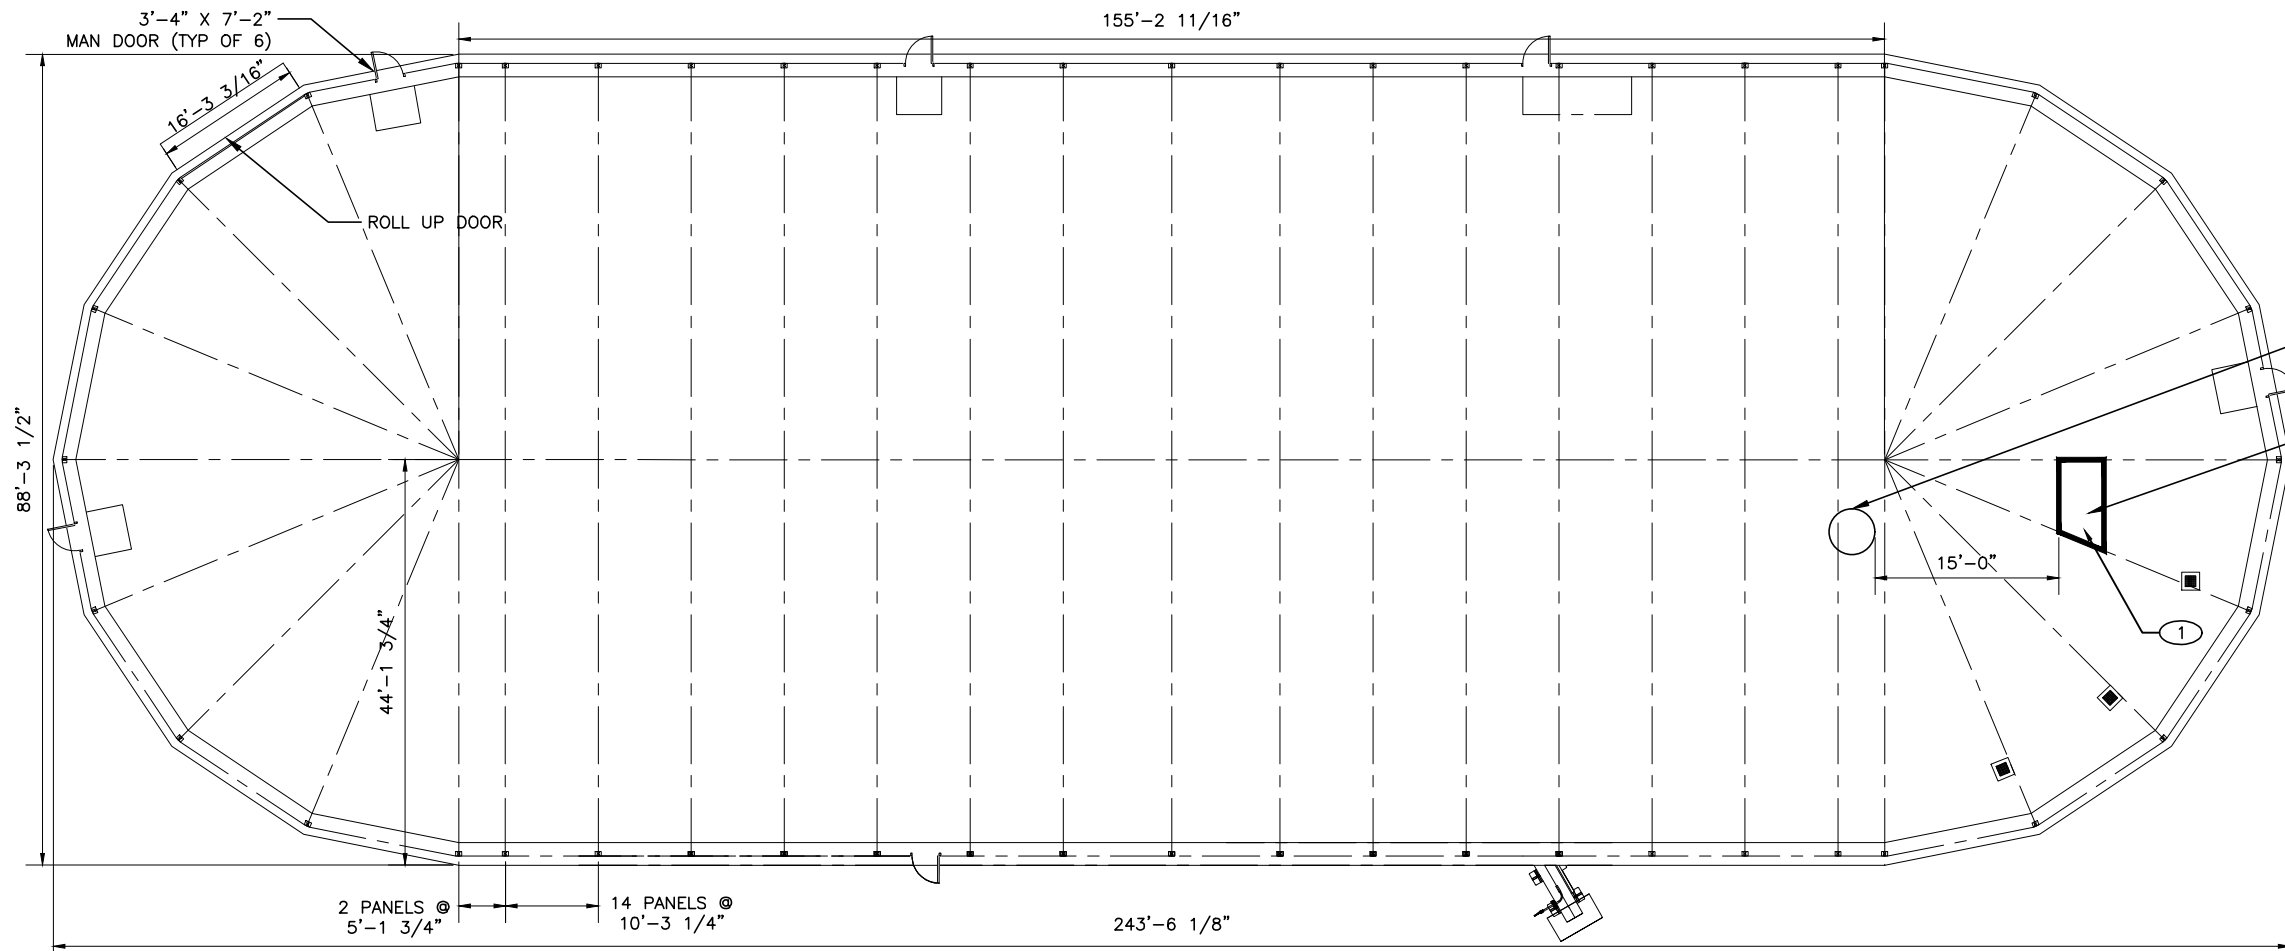
DOME 230 FLOOR PLAN
SCALE: NONE

2. Enclosure 1 provides photos of Dome 229 and Enclosure 2 provides photos of Dome 230. The engineering diagram provided at the end of each enclosure illustrates the location of the damage to each dome and the relative distance between the snow and the closest waste containers. Distance from the snow to containers is approximately 25 ft in Dome 229 and approximately 15 ft in Dome 230.

NEAREST DRUM LOCATION
APPROXIMATELY 15' AWAY

APPROXIMATELY 45
SQUARE FEET

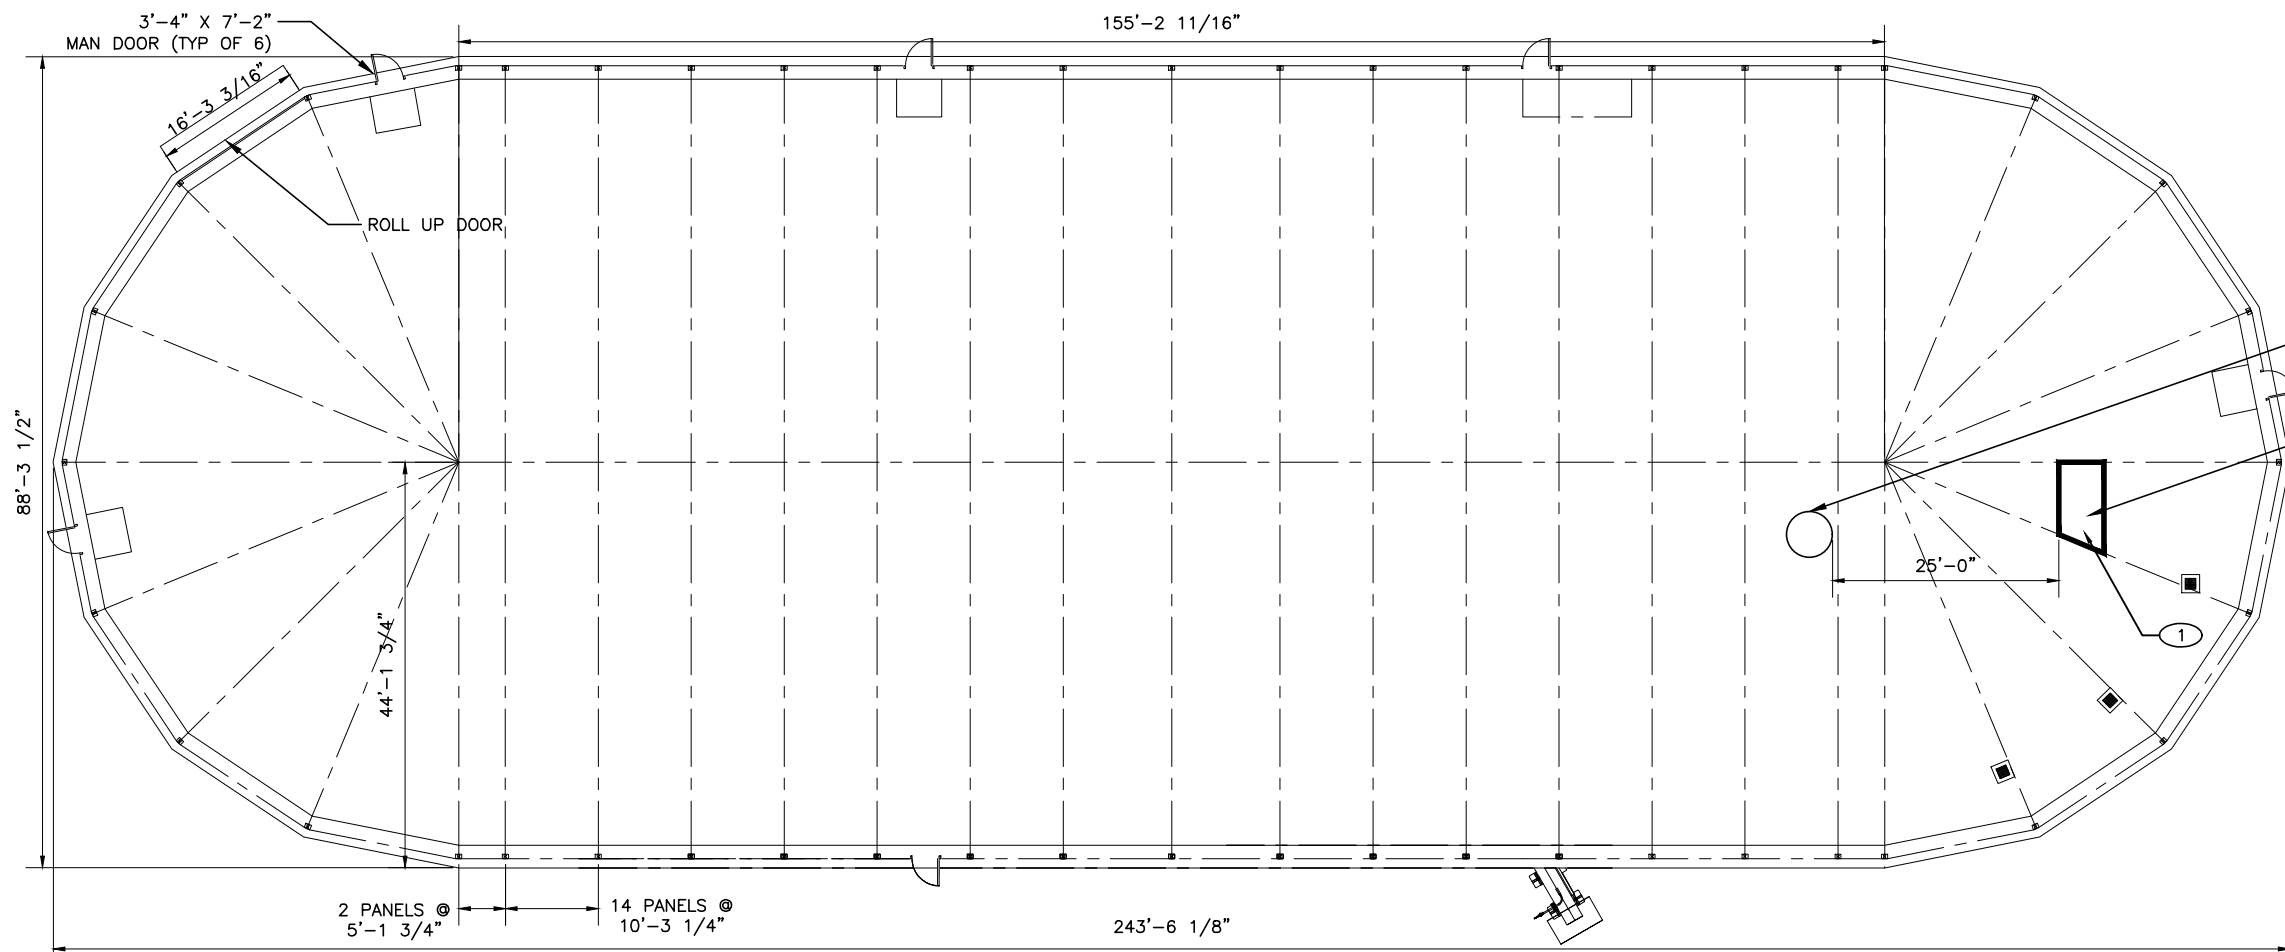
DOME 229 FLOOR PLAN
SCALE: NONE

NEAREST DRUM LOCATION
APPROXIMATELY 25' AWAY

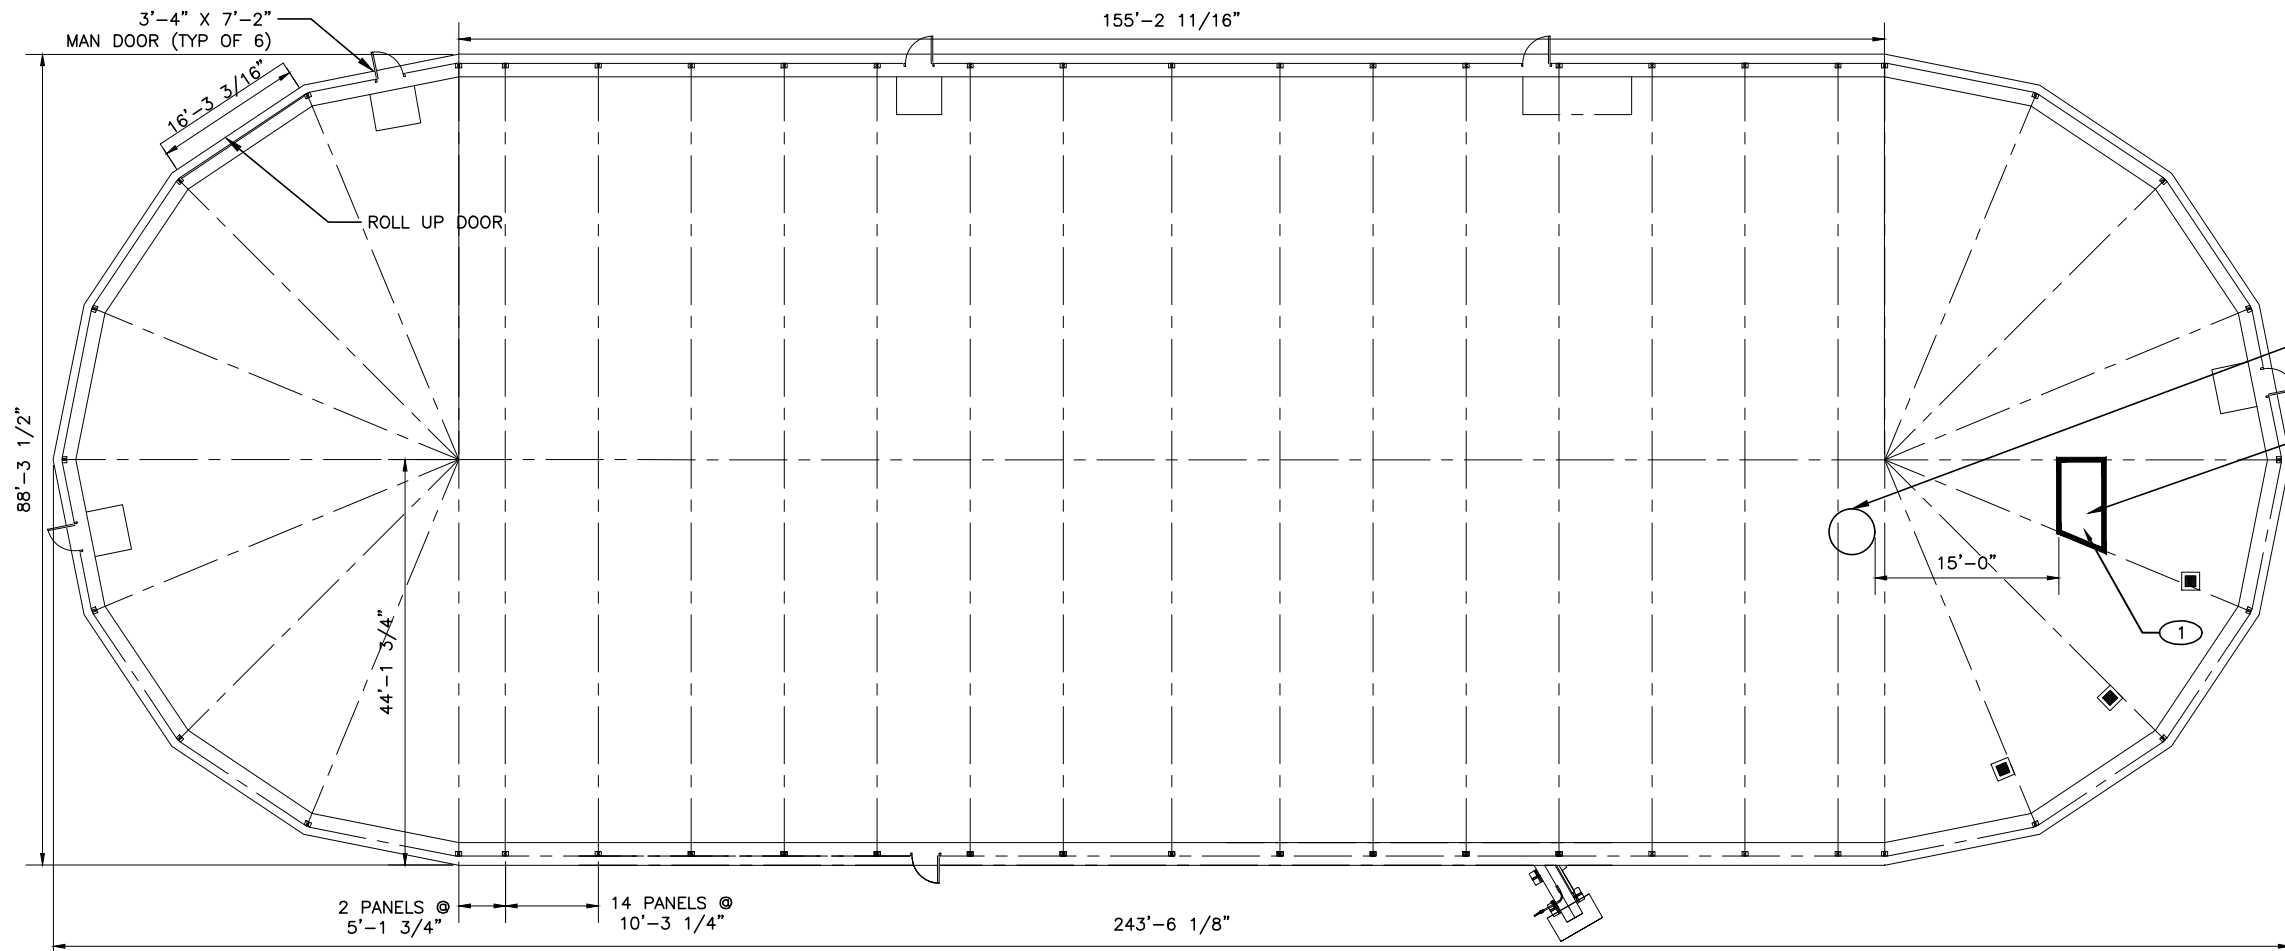
DOME 230 FLOOR PLAN
SCALE: NONE

NEAREST DRUM LOCATION
APPROXIMATELY 15' AWAY

APPROXIMATELY 45
SQUARE FEET

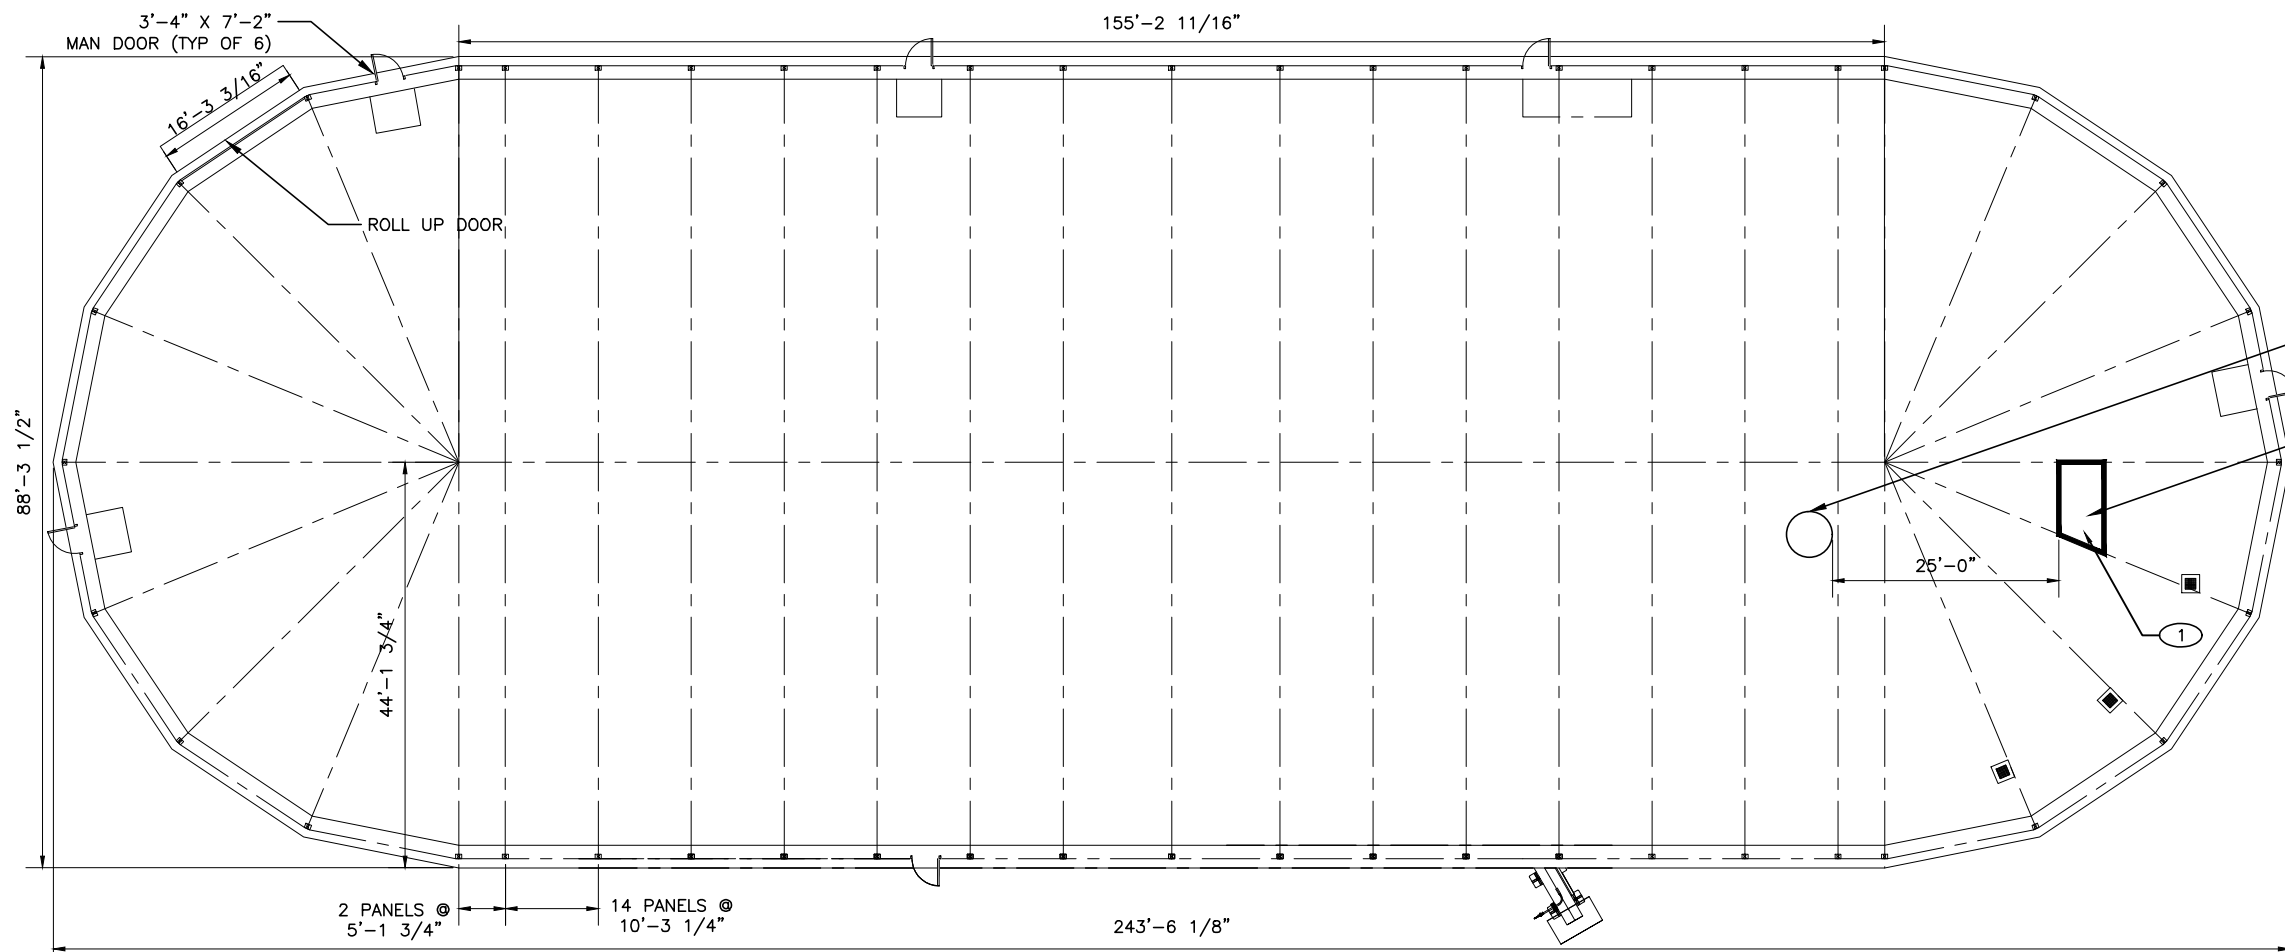
DOME 229 FLOOR PLAN
SCALE: NONE

NEAREST DRUM LOCATION
APPROXIMATELY 25' AWAY
