Subject: Submittal of the 2018/2019 Annual Long-Term Monitoring Status Report (July 2018 through June 2019) for Los Alamos County Airport Landfill Cover System Replacement, Solid Waste Management Units 73-001(a,d), Technical Area 73

### **LOS ALAMOS COUNTY AIRPORT LANDFILL COVER SYSTEM REPLACEMENT SOLID WASTE MANAGEMENT UNITS 73-001(a,d) TECHNICAL AREA 73**

<b>Site Name: Los Alamos County Airport Landfill Cover Replacement</b>	<b>Date of Inspection: October 1, 2018</b>
<b>City: Los Alamos</b>	<b>Weather: warm, partly cloudy, breezy</b>
<b>State: New Mexico</b>	<b>Temperature: 70s</b>
<b>Agency: Department of Energy</b>	<b>Inspector: Stephen F Dwyer, PhD, PE</b>
<b>Site Element</b>	<b>Remarks</b>
1. Construction of the new LA County Airport Hangar continues. This is west of the footprint of the landfill. The seeded areas adjacent to this work in the waste removal areas have been disturbed. This area is scheduled to be reseeded by the Los Alamos County upon completion of the hangar and utility work (Pictures 3, 7 and 8).	1. This work is west of the landfill and does not affect the performance of the cover or related facilities.

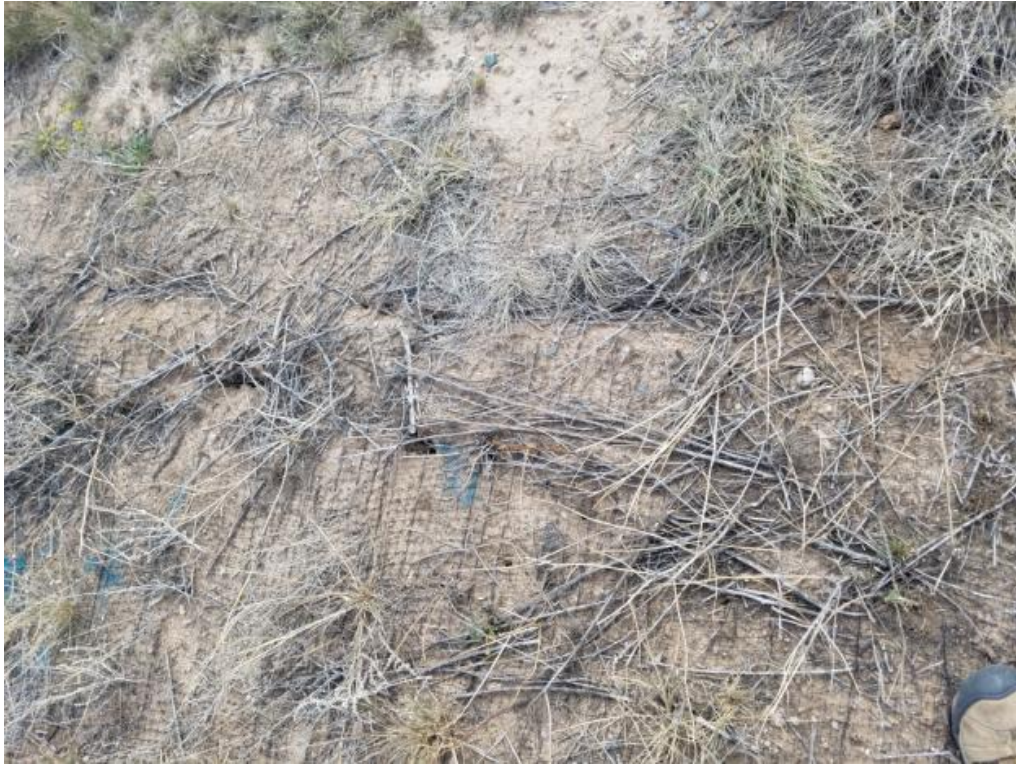
**Picture 28. Tension Cracking near Top of Side Slope of Older Landfill Cover, North of ET Cover**

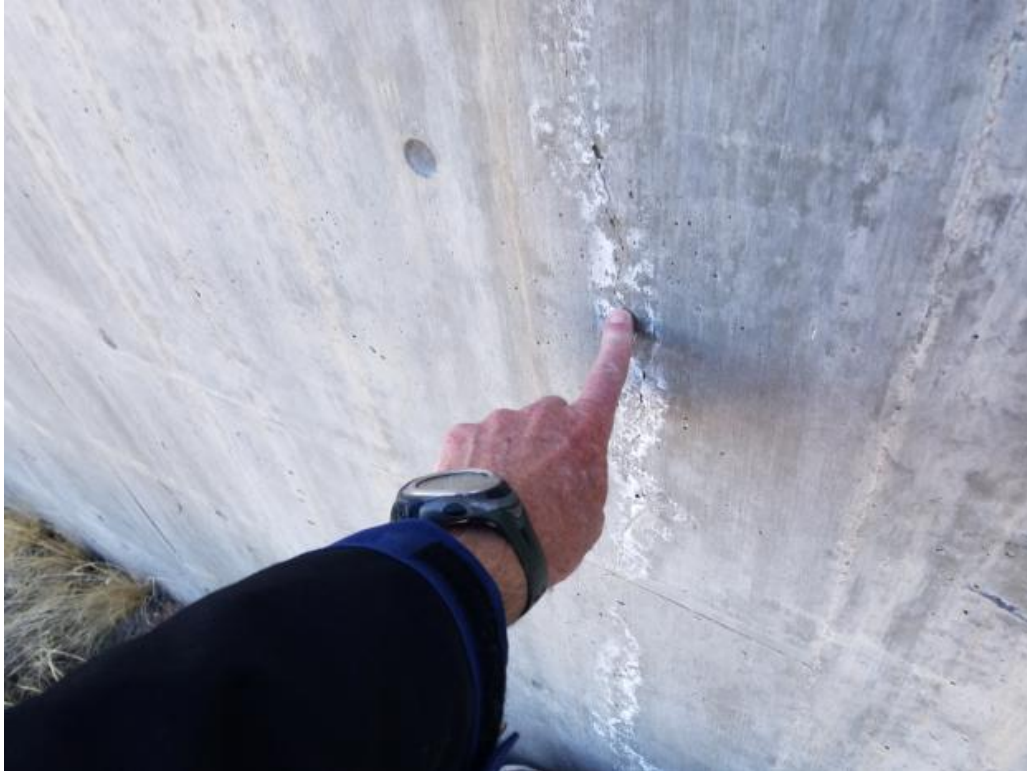
**Picture 24. Small Crack in Concrete Retaining Wall - East End of Landfill**

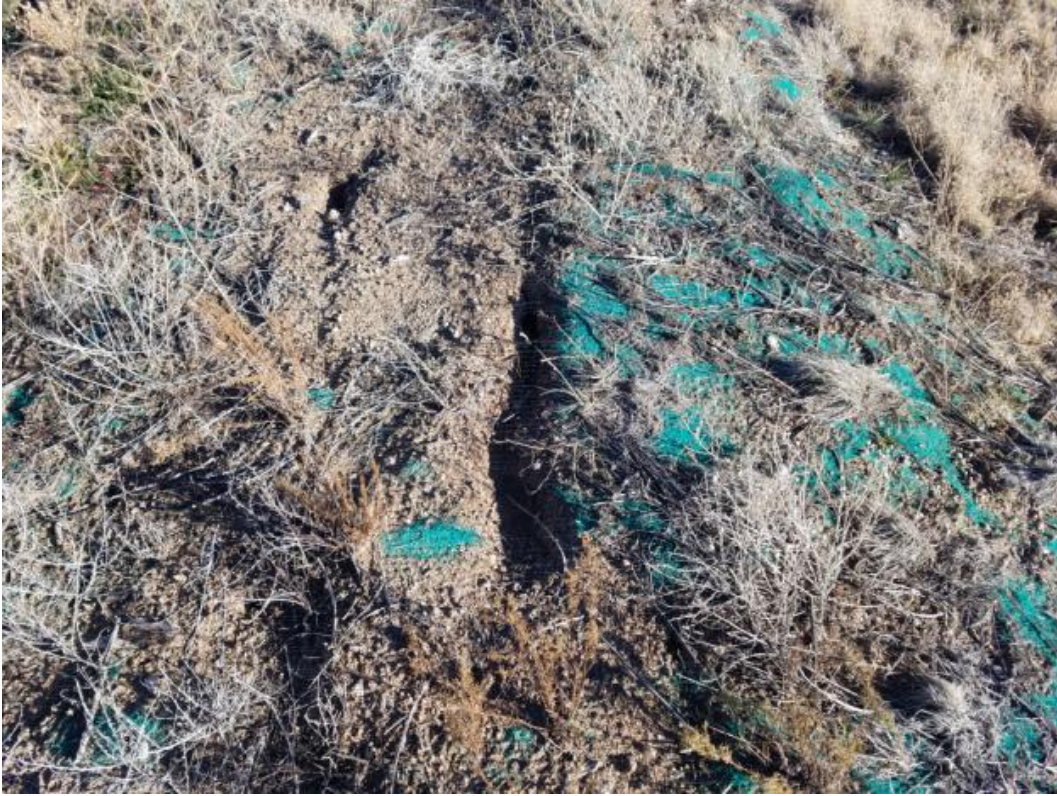
**Picture 29. Tension Cracking near Top of Side Slope of Older Landfill Cover, North of ET Cover**

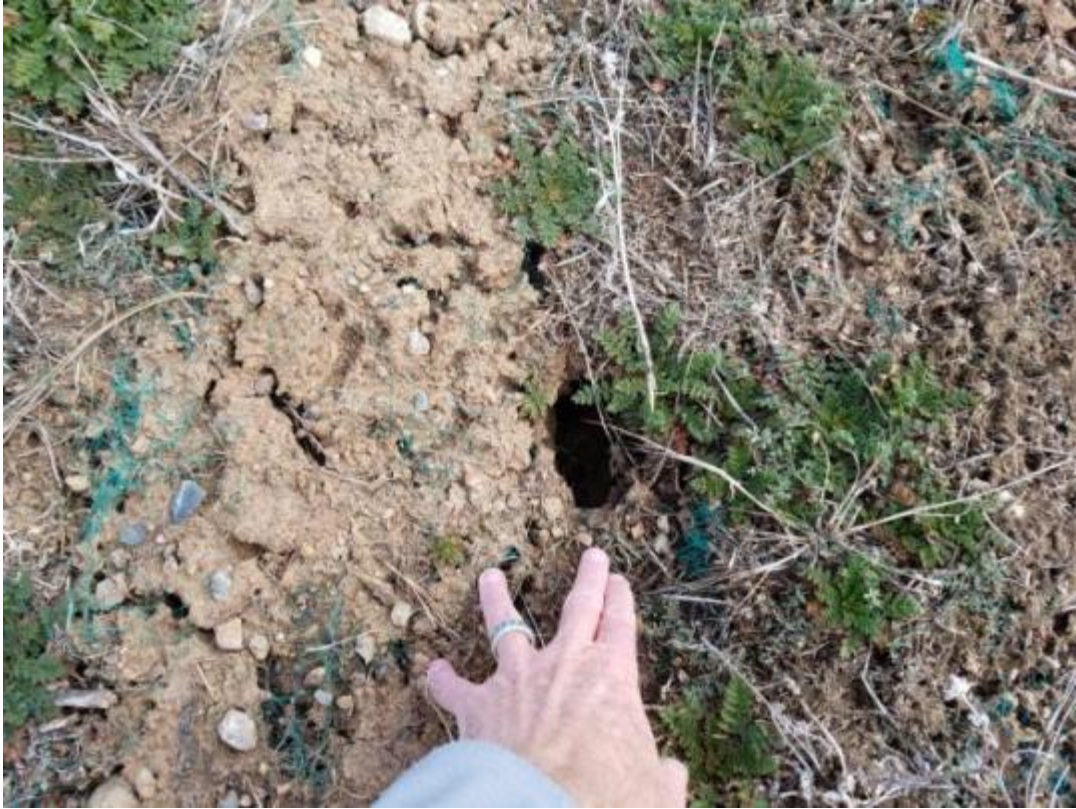
Picture 19. Biointrusion in Older Landfill Side Slope, North of ET Cover

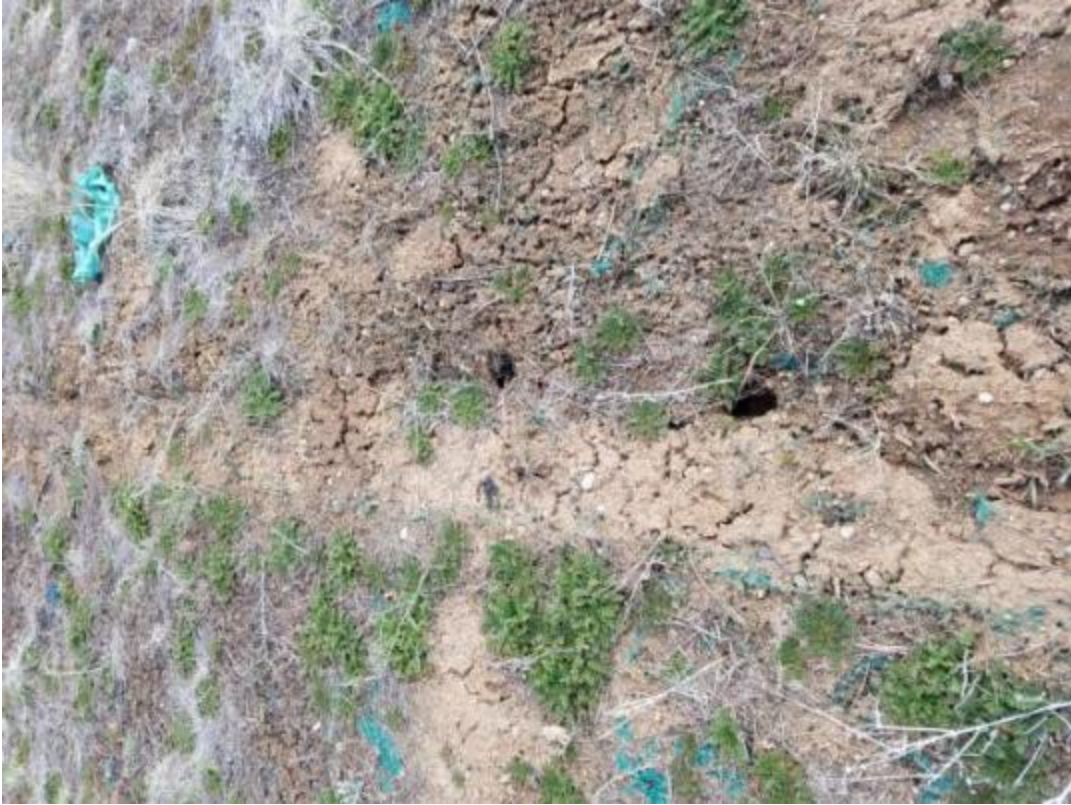
Picture 29. Crack near Top of Side Slope of Older Landfill Cover, North of ET Cover

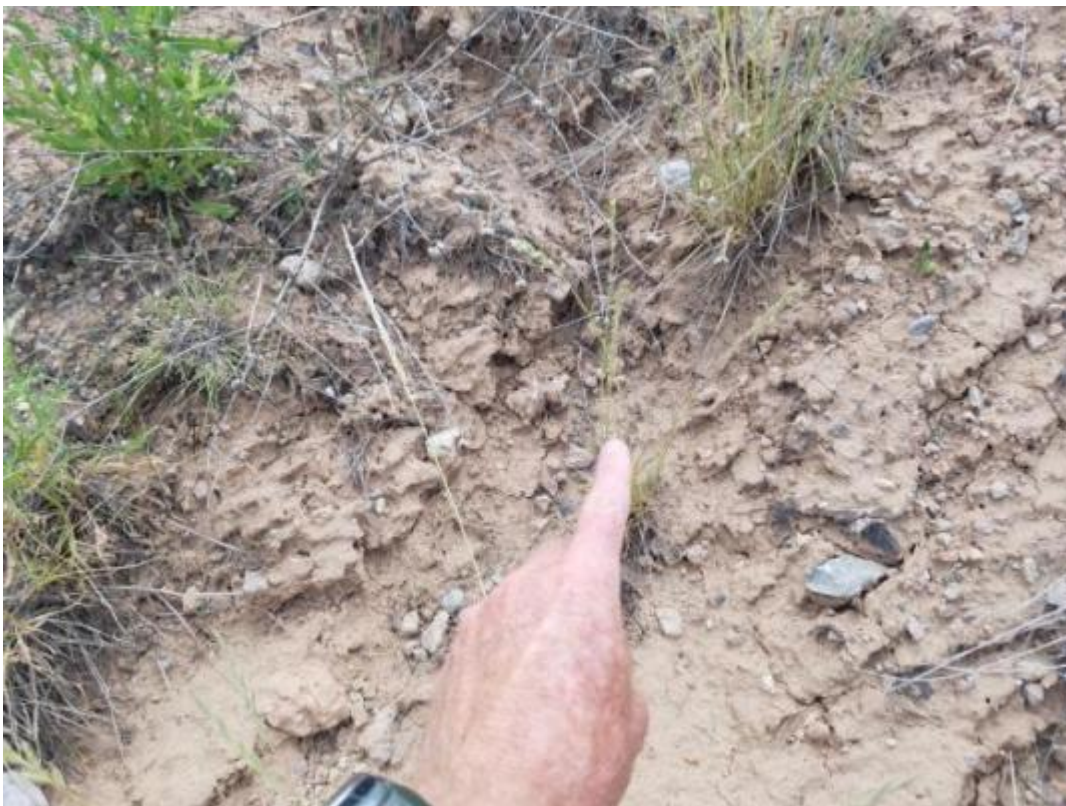
The cover systems are currently in good condition and working as designed. There was some minor rill erosion noted at the base of the eastern side slope of the landfill. It is recommended that measures be taken to limit the continuance of erosion in this localized area (Attachment A – Inspection Reports 11 and 12). Measures taken will be reported on in the next Annual Report due to NMED July 30, 2020.

**Picture 26. Rill Erosion, Base of East Slope @ End of Landfill**

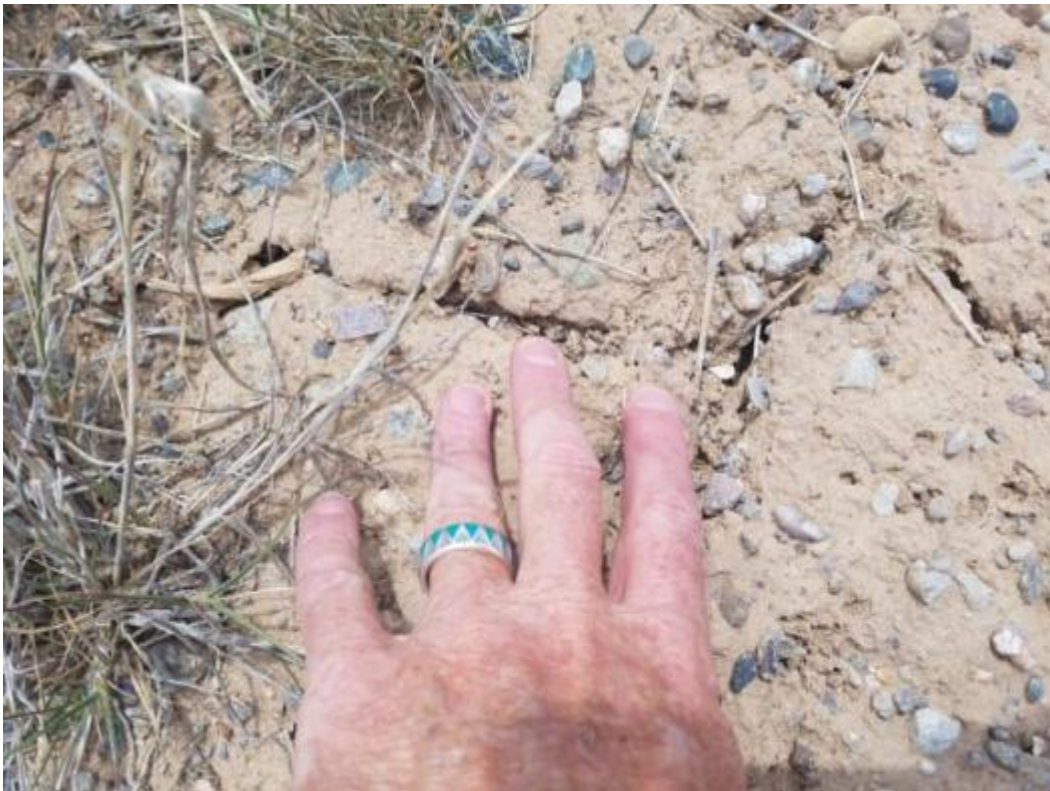
**Picture 28. Tension Cracking in Surface of ET Cover**

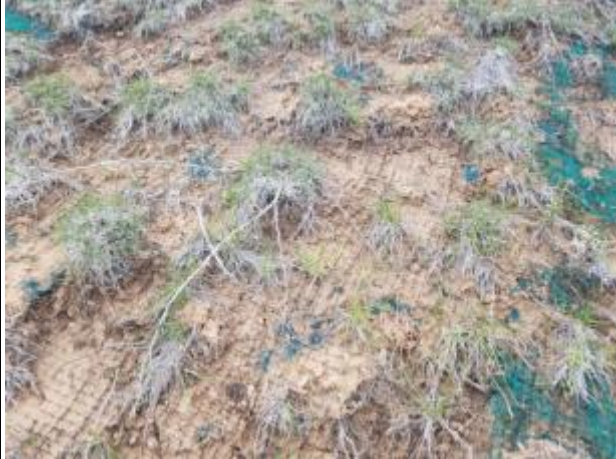
<p><b>Picture 5.</b> Evidence of Soil Loss on Eastern Landfill Side Slope</p>

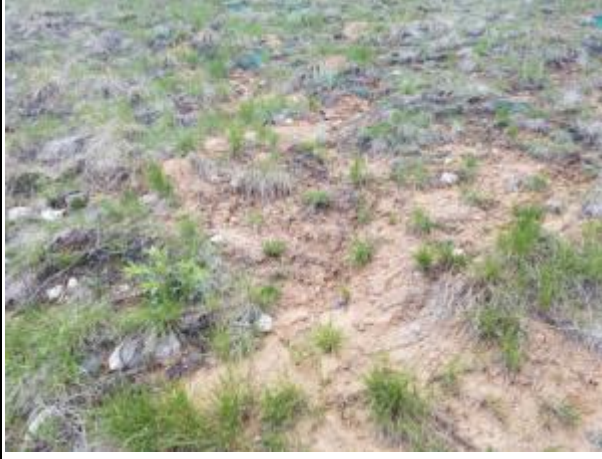
<p><b>Picture 6.</b> Small Rill Forming at Base of Eastern Landfill Side Slope</p>

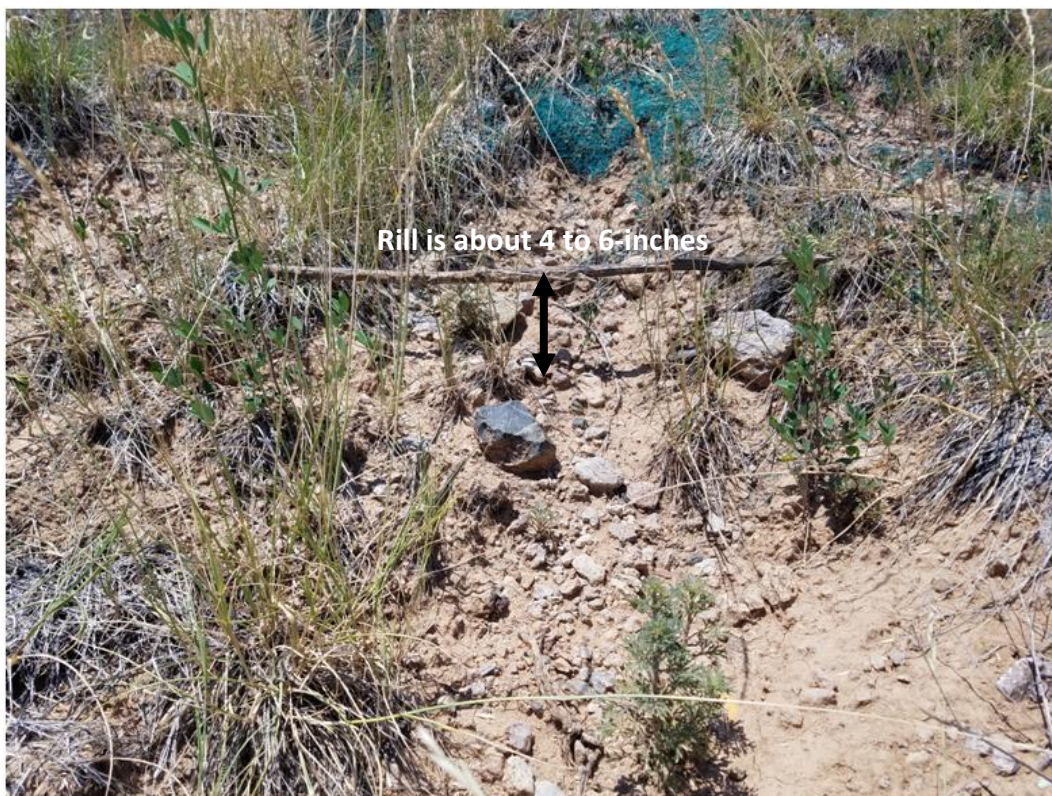
Picture 1. New Rill Erosion noted at Base of Eastern Landfill Slope

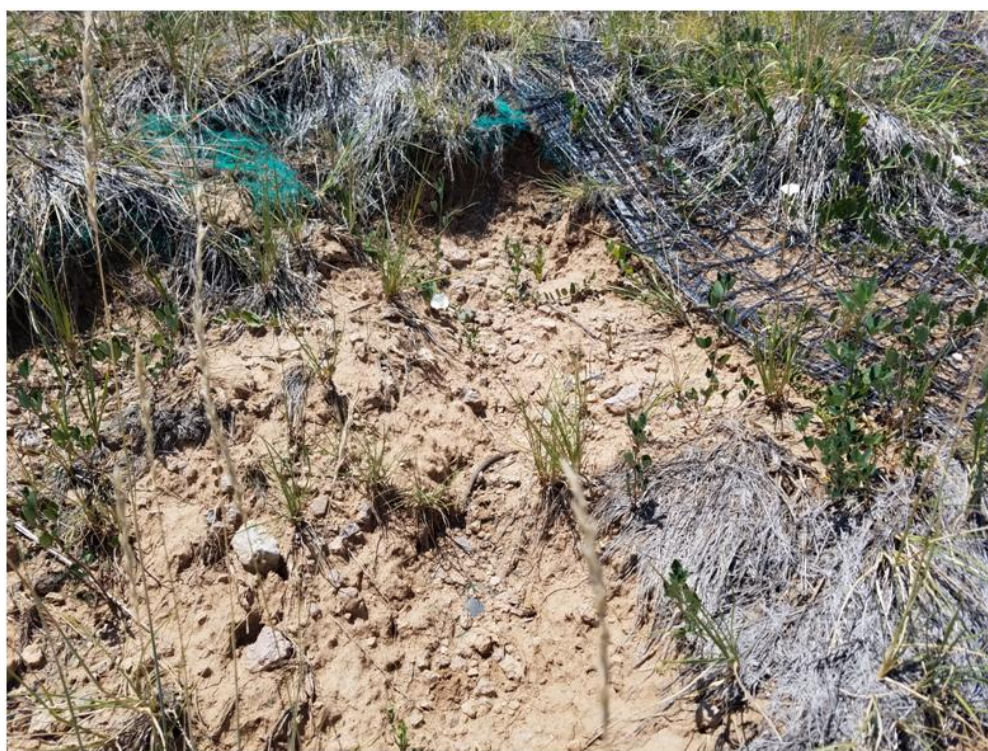
Picture 2. Close-up of Rill Erosion

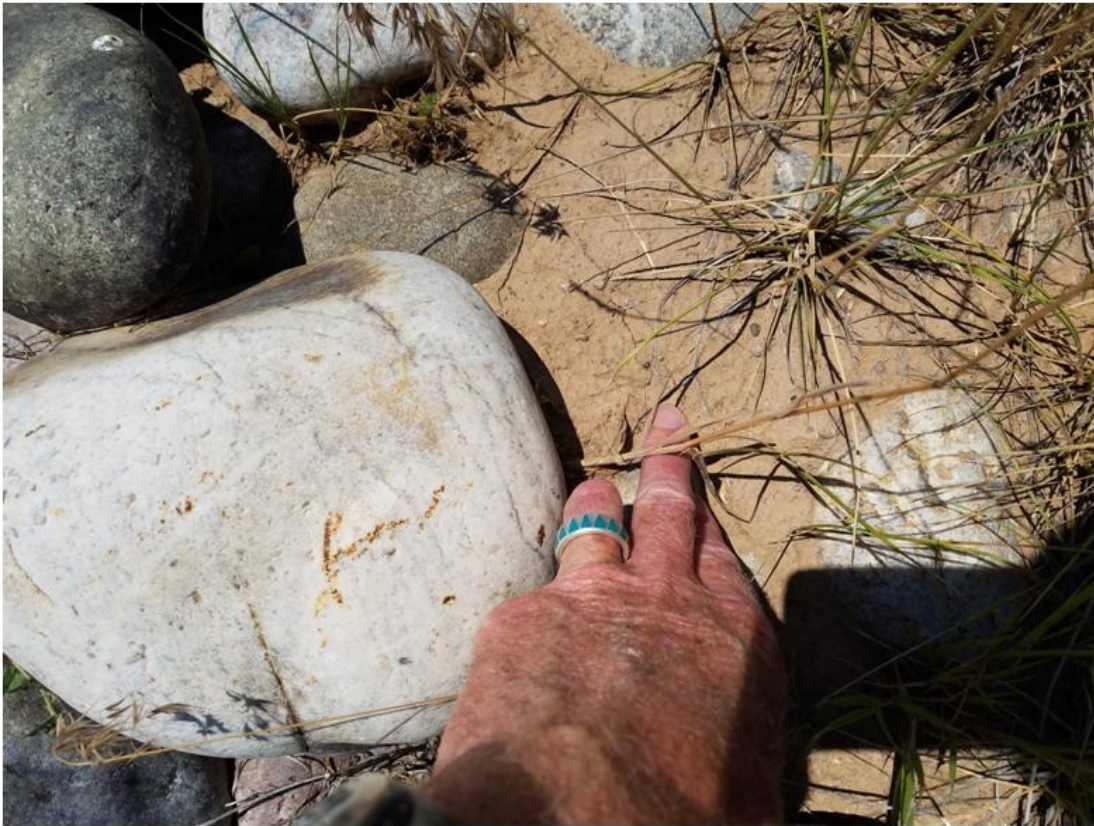
Picture 3. Sediment in Riprap at Base of Slope
