EMLA-2020-1602-02-001

Subject: Submittal of the Delta Prime Site Aggregate Area Progress Report

Delta Prime Site Aggregate Area Progress Report for Fiscal Year 2020

September 2020

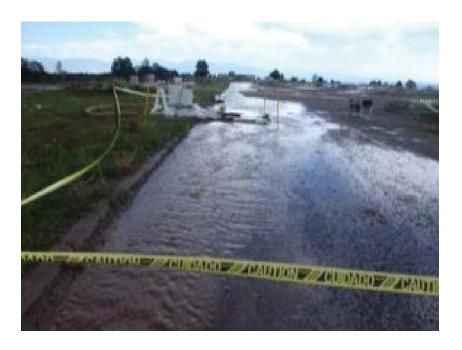
- Date: August 7, 2019
- Direction: East
- Description: Rain event involving pothole from August 05, 2019

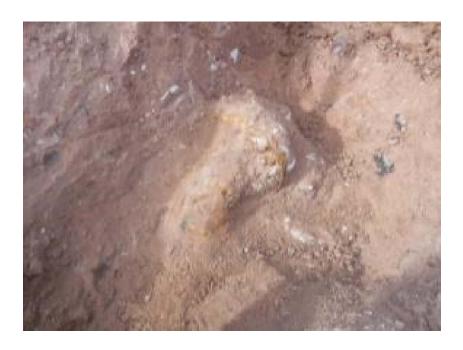
- Date: January 30, 2020
- Direction: Northwest
- Description: Location 1,4Cl plugged and abandoned at flanage.

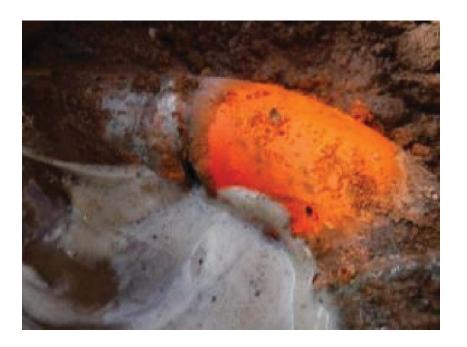
- Date: February 12, 2020
- Direction: West
- Description: Location 2, 1.5SS from Building 3 is cracked at elbow weld.

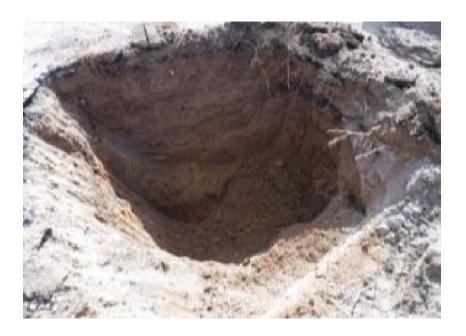
- Date: March 9, 2020
- Direction: Southeast
- Description: Location 45, no utility found

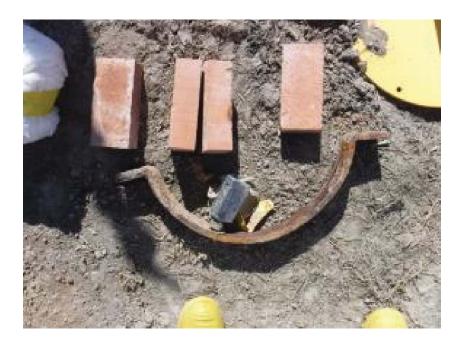
- Date: March 11, 2020
- Direction: Top view
- Description: Location 48, debris found during mechanical potholing

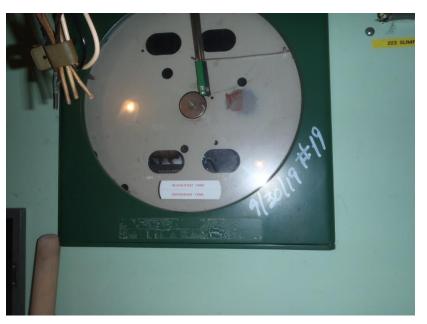
Dark green paint on a Honeywell south metal graph door cover XRF location #19 and coupon sample ID WST21-20-188178. This location failed for TCLP lead in the dark green paint. Packaged as mixed waste.

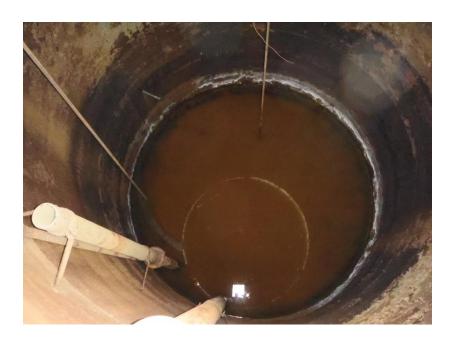
Interior of water level inside tank 21-110, water level ≅ 4 ft, water level in both tanks was the same. Volume ≅ 3,400 G in each tank
