EMLA-23-BF43-2-1

December 13, 2022

Subject: Biennial Inspection and Maintenance Report on Erosion Controls in Drainages to the 90s Line Pond at Technical Area 16

*Figures for the Biennial Inspection and Maintenance Report on
Erosion Controls in Drainages to the 90s Line Pond at
Technical Area 16*

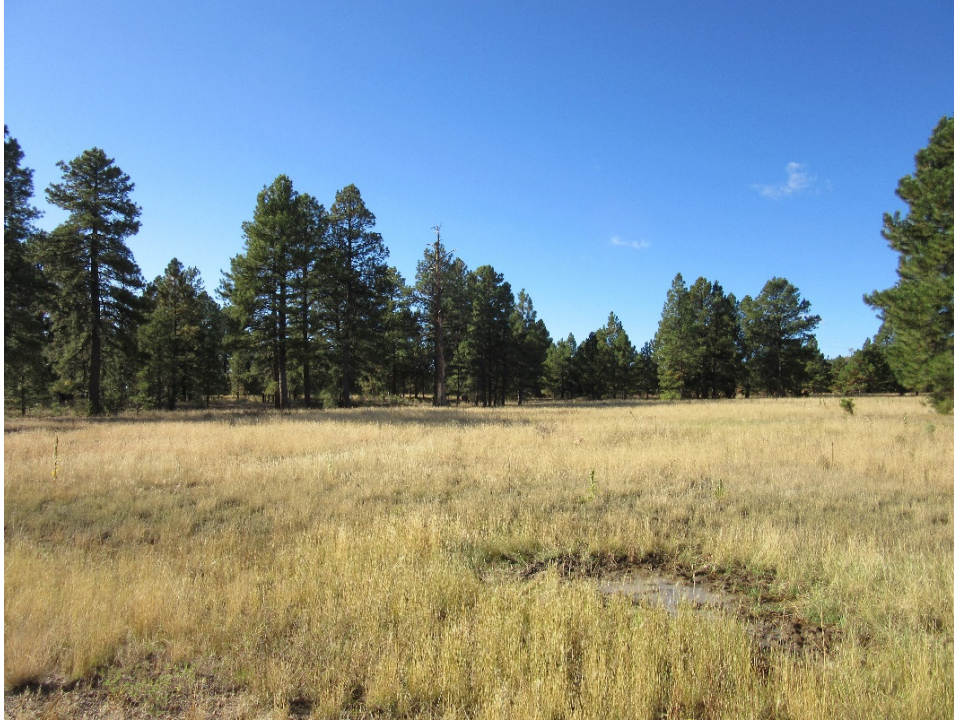
Figure 1 Vegetated Consolidated Unit 16-008(a)-99 draining to 90s Line Pond, October 2021

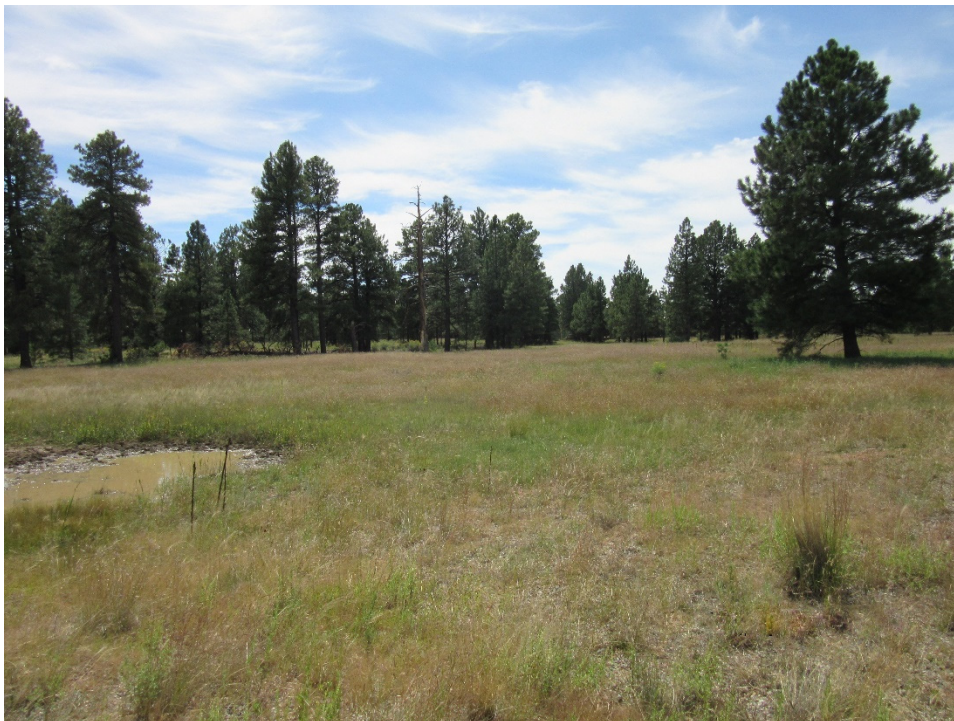
Figure 2 Vegetated Consolidated Unit 16-008(a)-99 draining to 90s Line Pond, September 2022

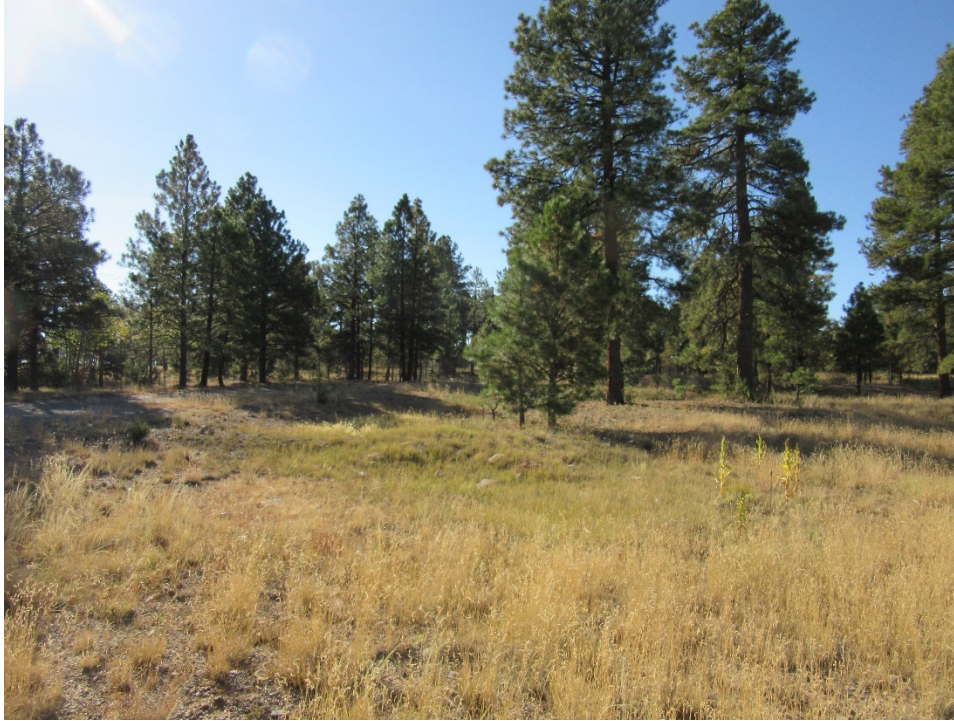
Best management practices were installed in 2008 in the drainages to the 90s Line Pond, consisting of five juniper bale controls designed to block sediment transport down the drainages into the pond. Controls were inspected annually on October 22, 2021, and September 13, 2022. A photograph of the run-on earthen berm control was not taken at the September 2022 inspection but was taken on November 8, 2022, for inclusion in this submittal (Enclosure 1, Figure 4). The results indicate all controls are currently in good operating condition with no evidence of erosion in the drainages, as shown in Enclosure 1.

Figure 3 Run-on control earthen berm in the vegetated area draining to 90s Line Pond, October 2021

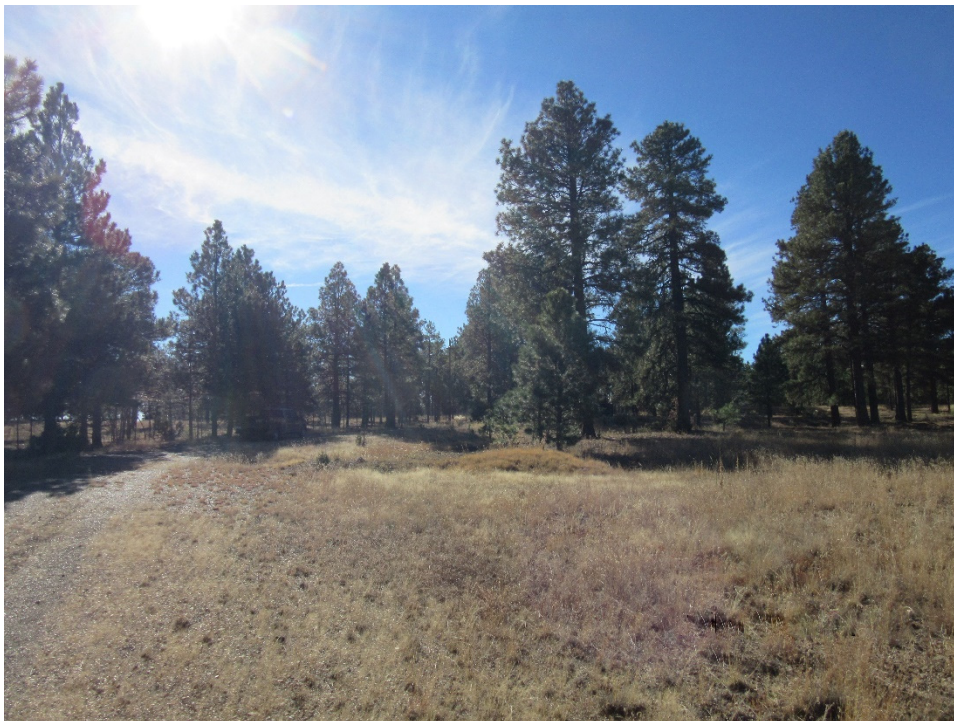
Figure 4 Run-on control earthen berm in the vegetated area draining to 90s Line Pond, November 2022

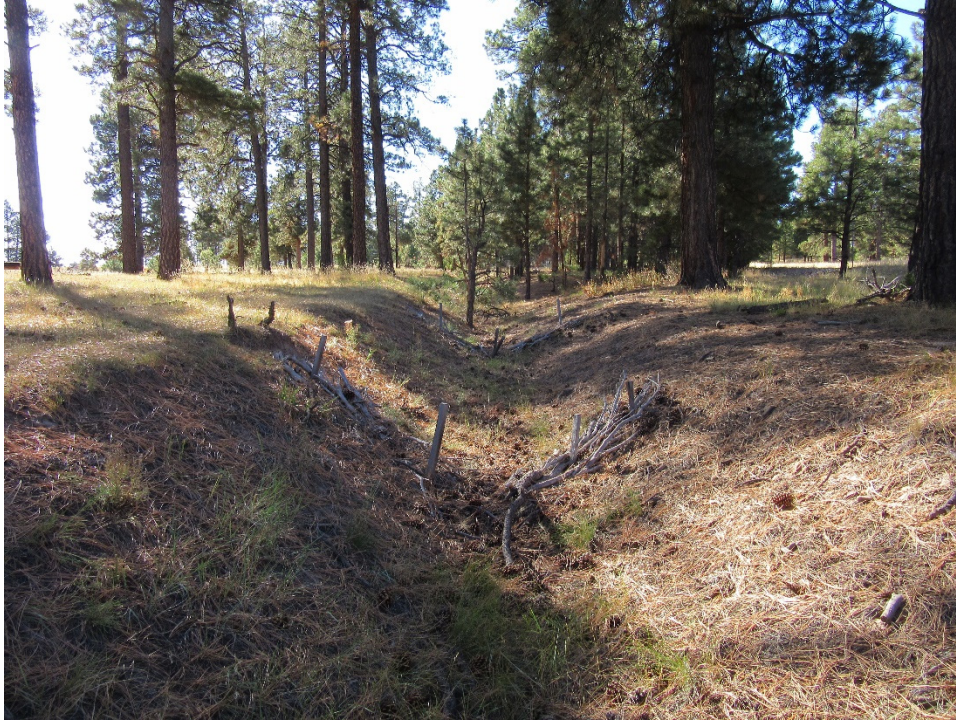
Figure 5 Juniper bale check dams located in drainage channel to 90s Line Pond, October 2021. Note vegetation in channel.

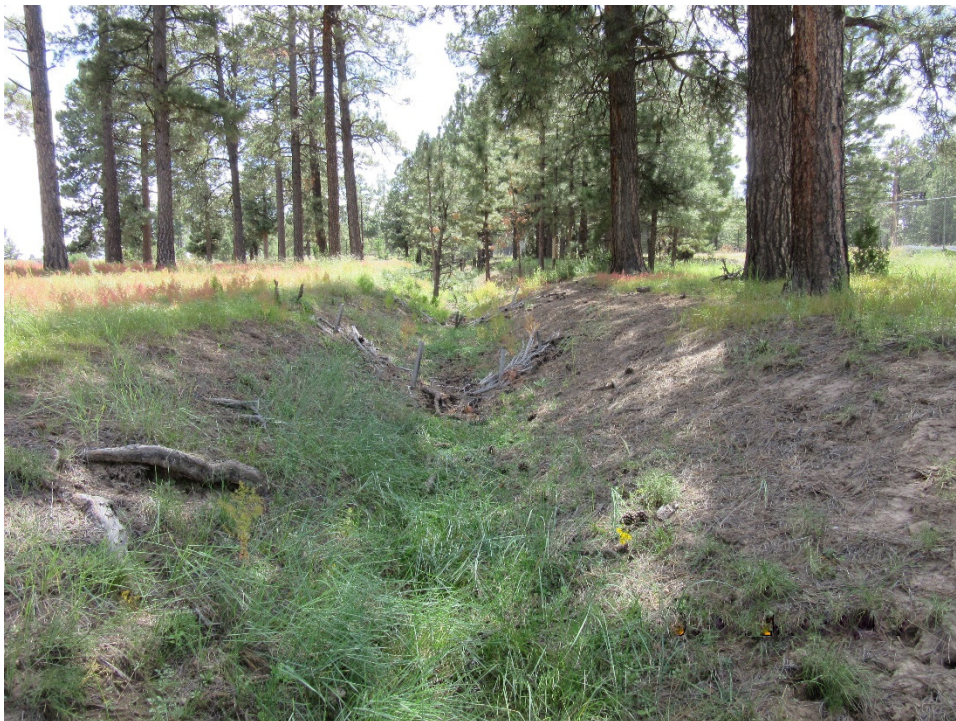
Figure 6 Juniper bale check dams located in drainage channel to 90s Line Pond, September 2022. Note vegetation in channel.

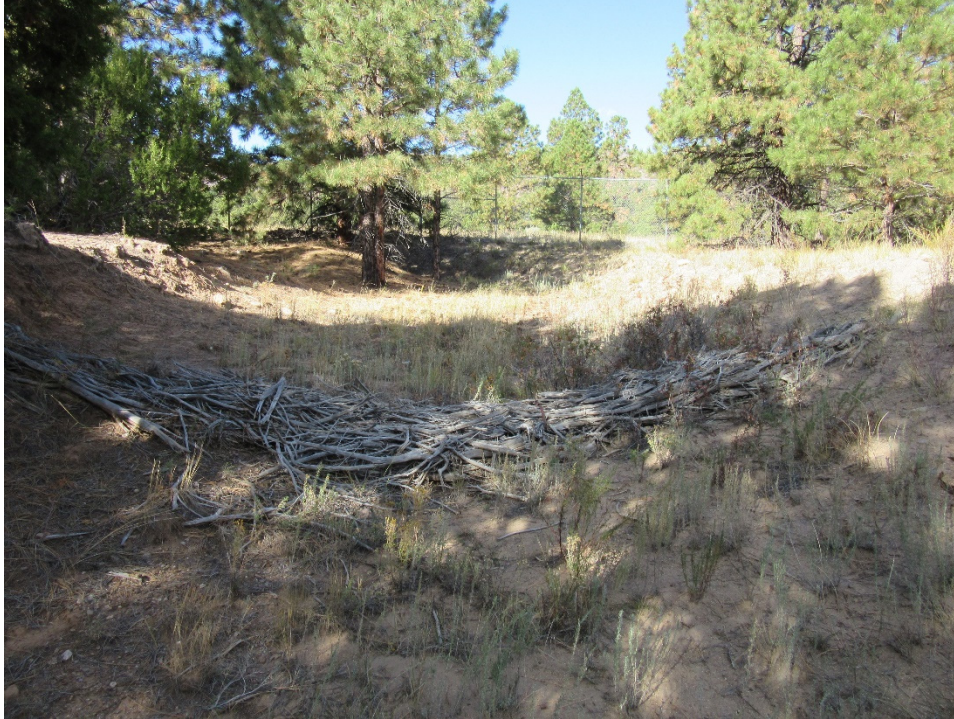
Figure 7 Juniper bale check dam located in drainage channel to 90s Line Pond, October 2021. Note vegetation in channel.

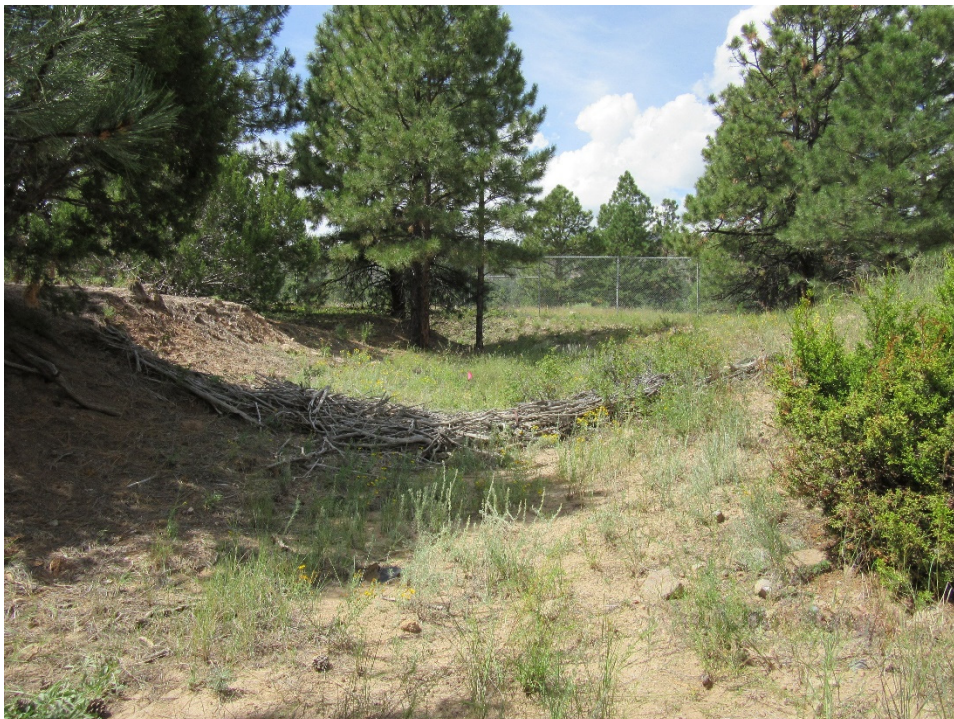
Figure 8 Juniper bale check dam located in drainage channel to 90s Line Pond, September 2022. Note vegetation in channel.

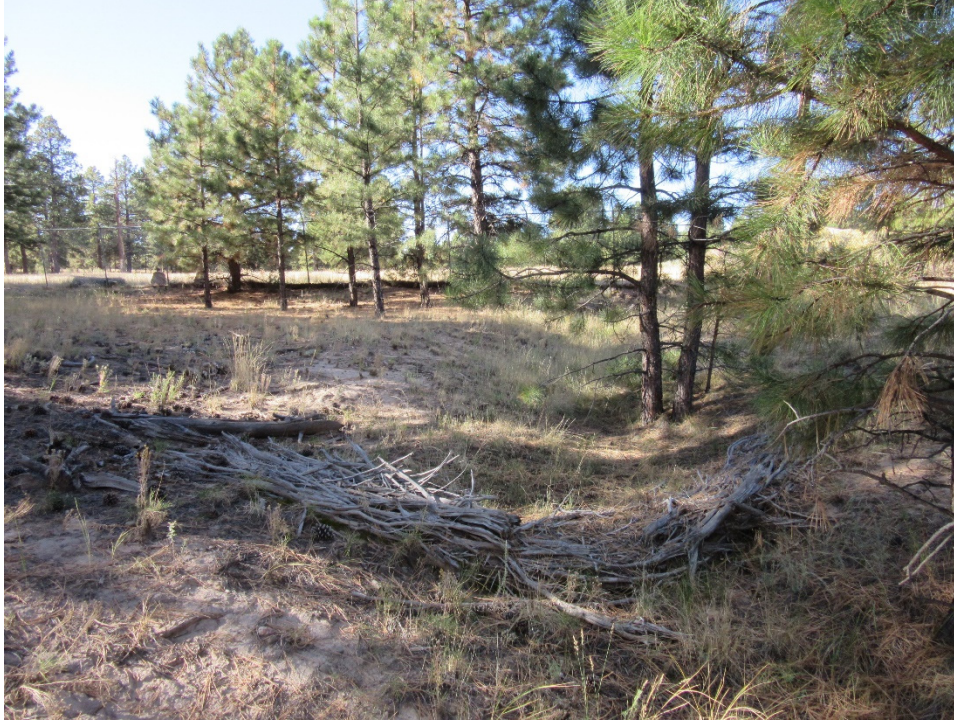
Figure 9 Juniper bale check dam located in drainage channel to 90s Line Pond, October 2021. Note vegetation in channel.

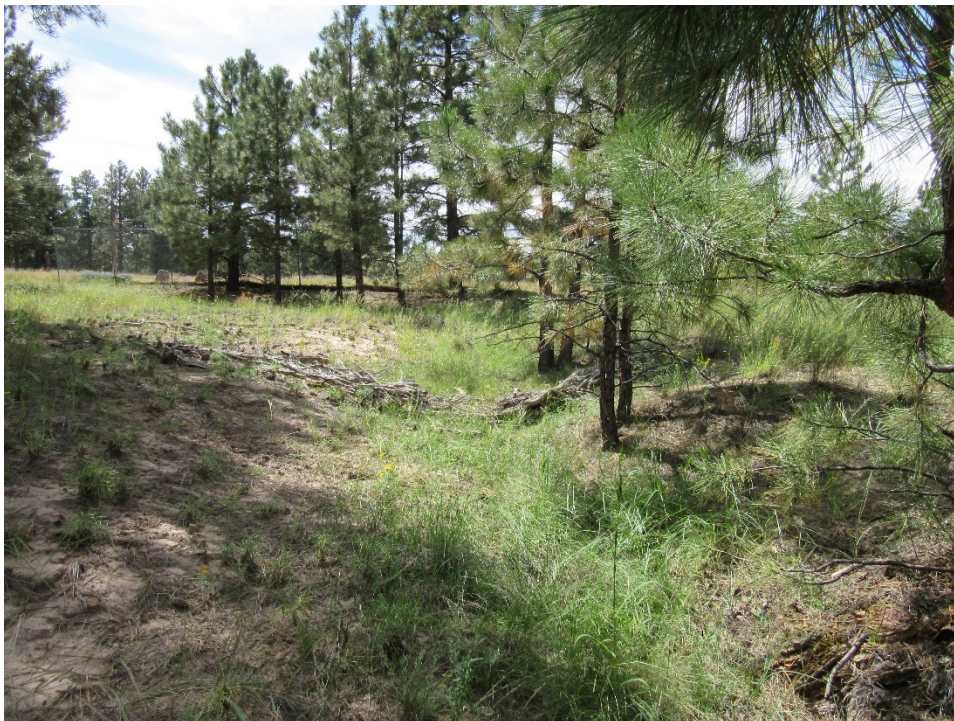
Figure 10 Juniper bale check dam located in drainage channel to 90s Line Pond, September 2022. Note vegetation in channel.

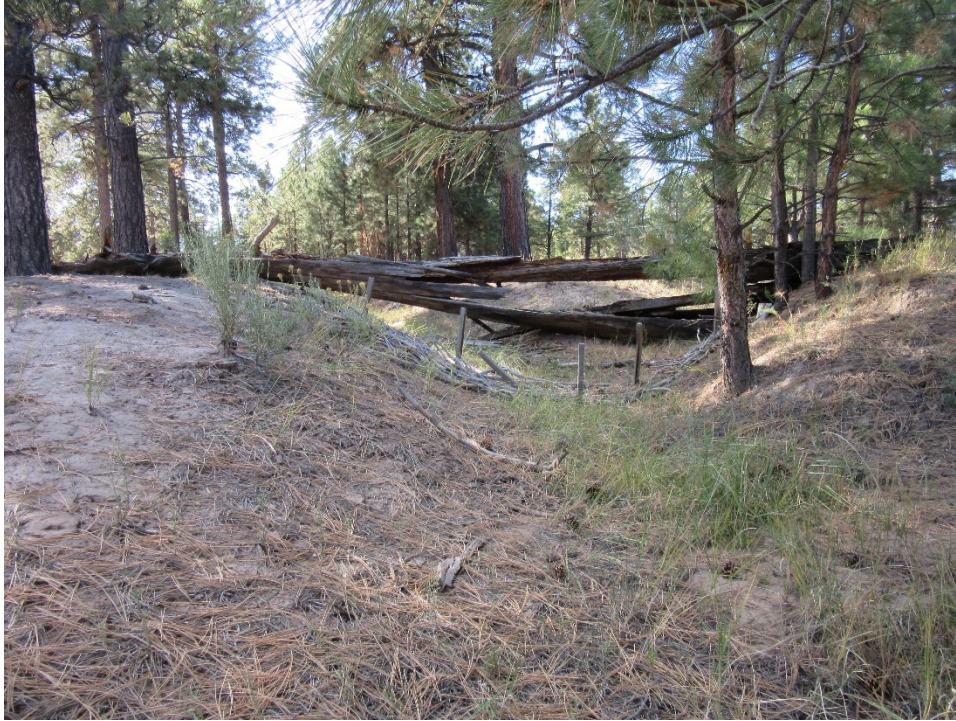
Figure 11 Juniper bale check dam located in drainage channel to 90s Line Pond, October 2021. Note vegetation in channel.

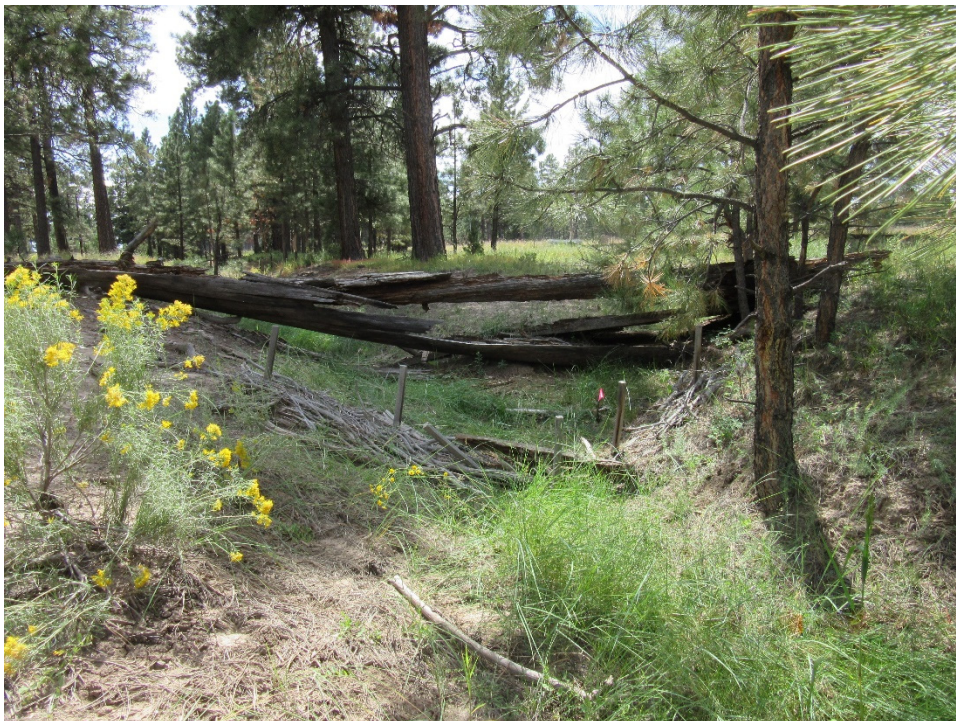
Figure 12 Juniper bale check dam located in drainage channel to 90s Line Pond, September 2022. Note vegetation in channel.

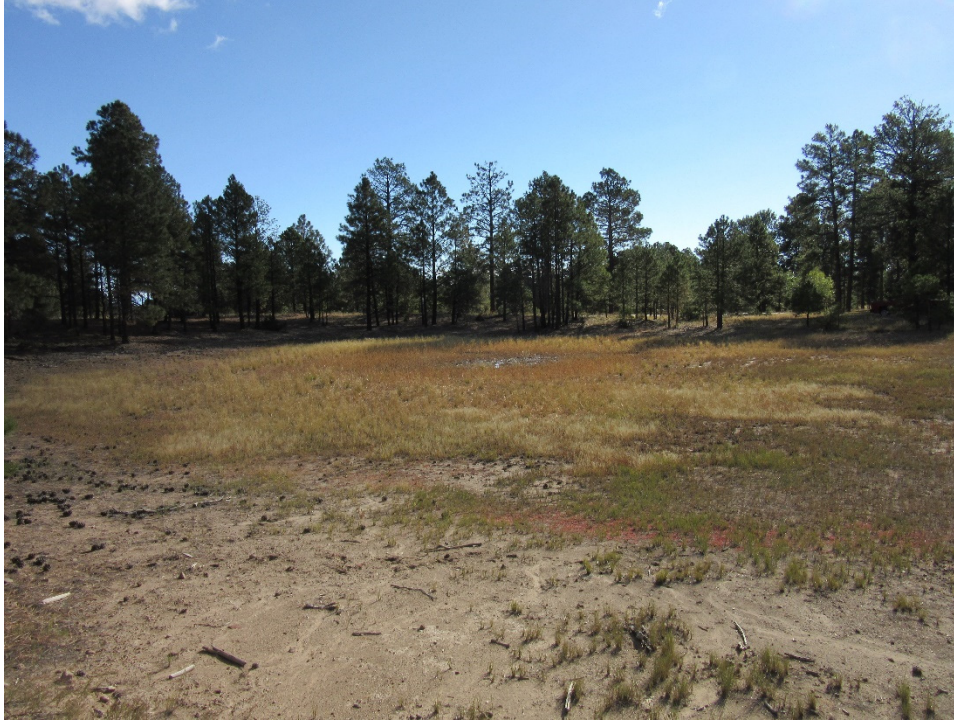
Figure 13 90s Line Pond, October 2021

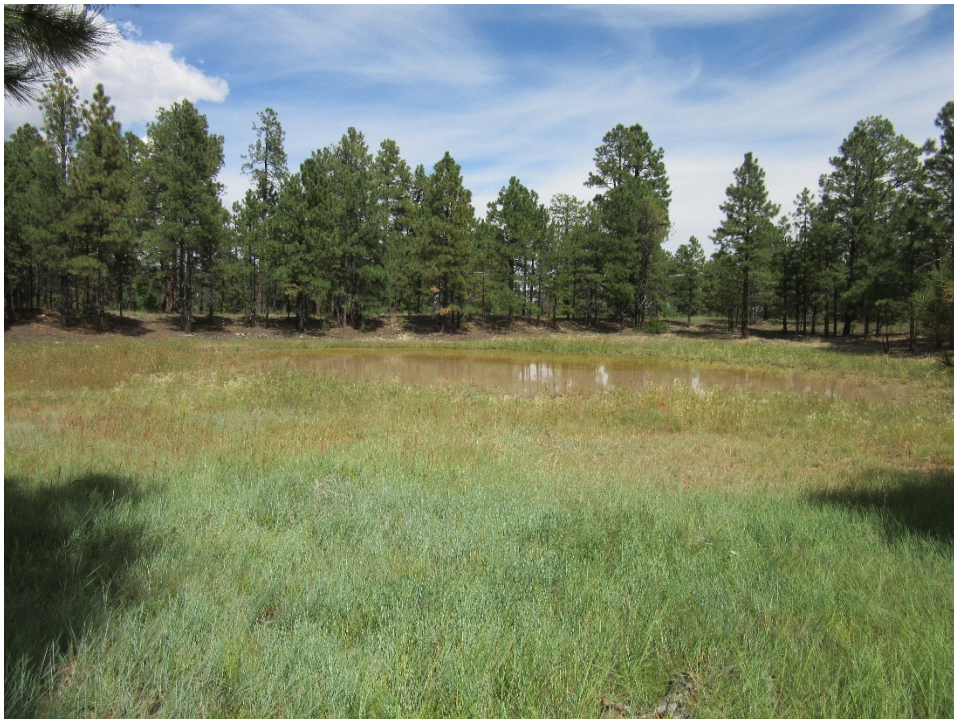
Figure 14 90s Line Pond, September 2022
