**DEPARTMENT OF ENERGY**

December 15, 2022

Subject: Biennial Inspection and Maintenance Report on Erosion Controls Associated with
Solid Waste Management Unit 16-003(o) within Fishladder Canyon

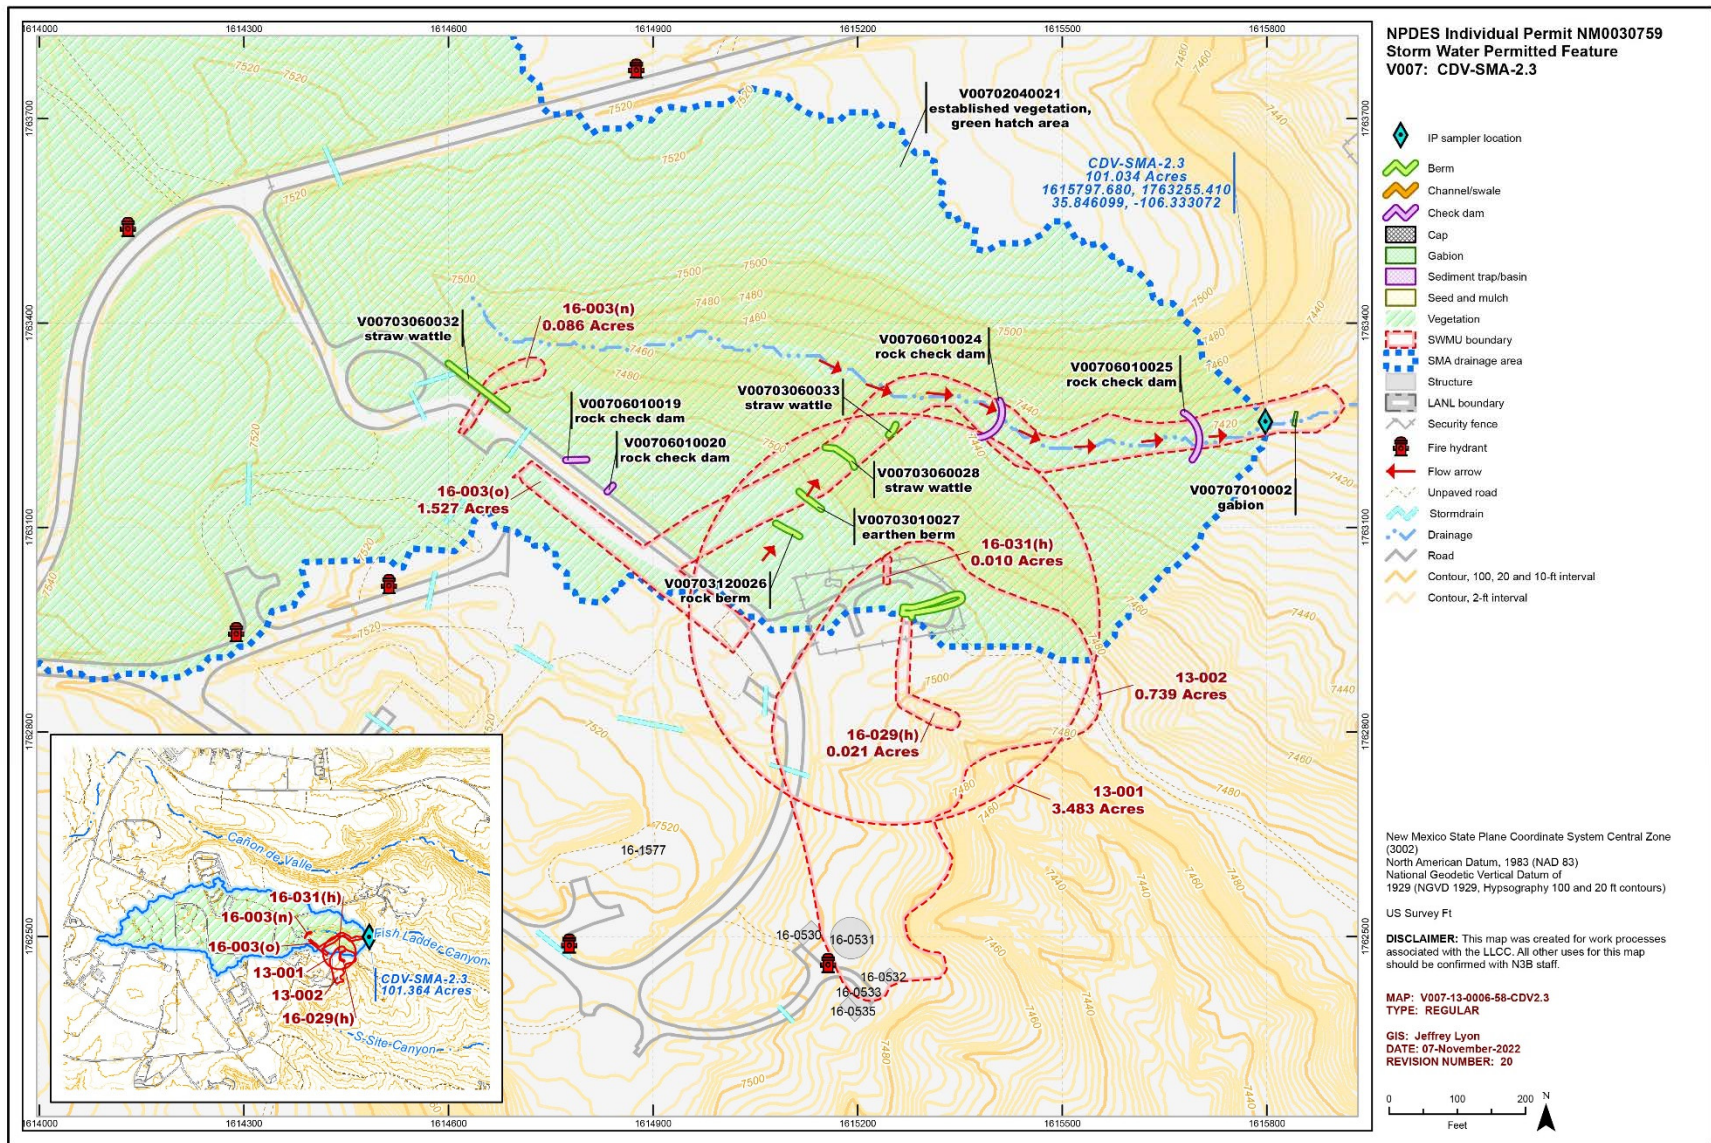
- The first inspection was completed on July 7, 2022, for the June 25, 2022, and July 4, 2022, rain events (maximum intensity of 0.47 in. and 0.33 in. within 30 min, respectively). Straw wattle V00703060030 was recommended for replacement as the sediment retention capacity was almost full. The BMP was replaced with straw wattle V00703060033 on July 29, 2022 (Enclosure 1, Figure 1).

Figure 1 Individual Permit sample locations and stormwater controls as well as solid waste mangement units (SWMUs) associated with CDV-SMA-2.3

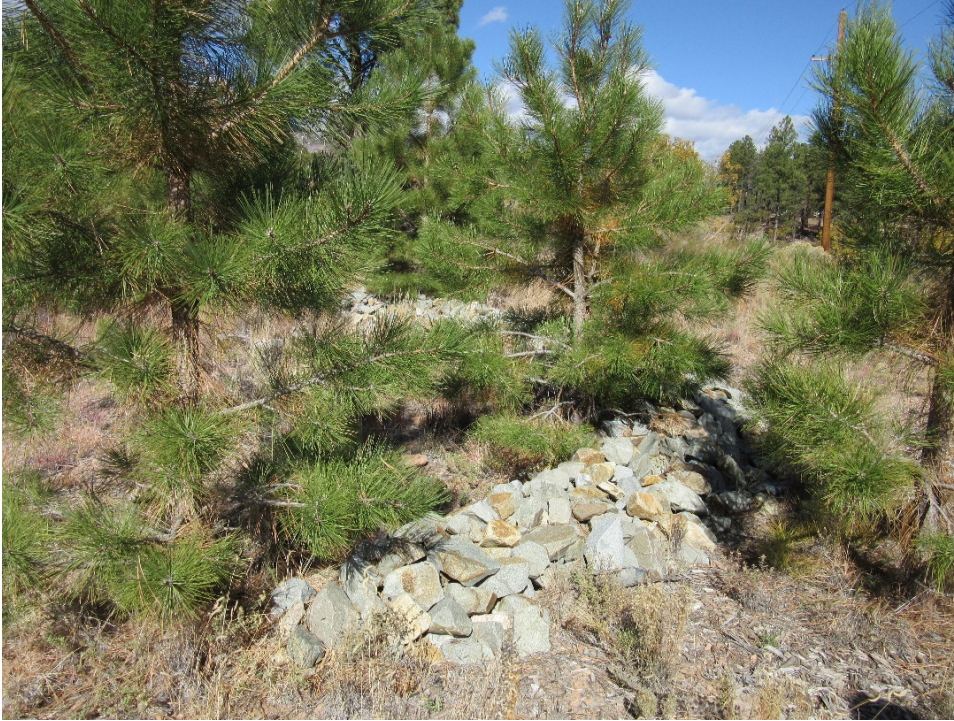
Figure 2 Rock berm (V00703120026, center of photo) at the top of drainage leading into Fishladder Canyon (October 2021). Note established vegetation. Condition of control: excellent.

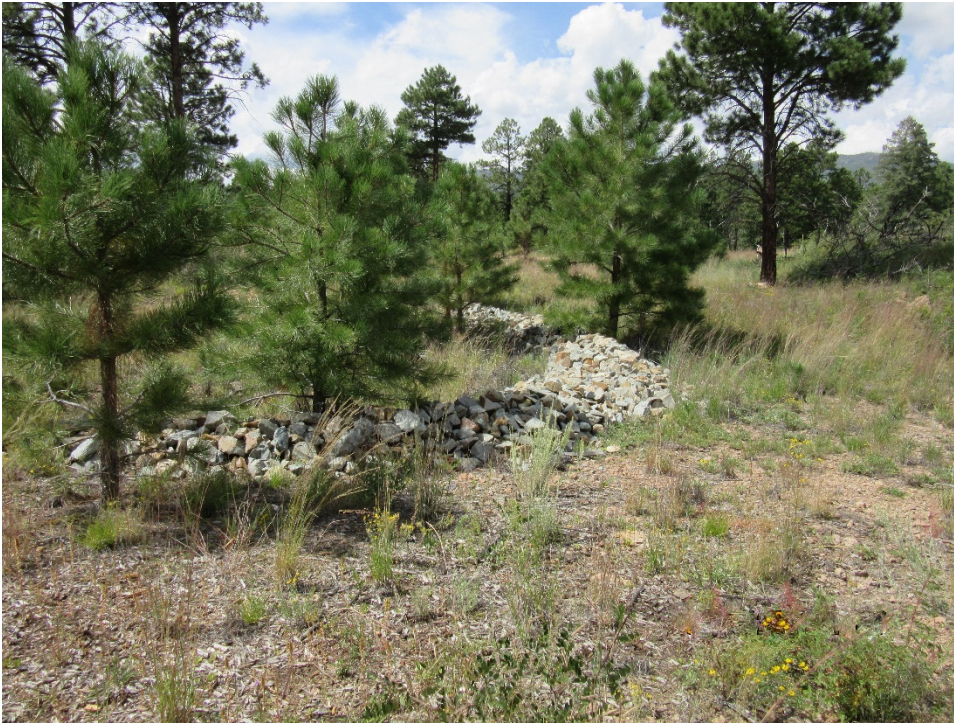
Figure 3 Rock berm (V00703120026, center of photo) at the top of drainage leading into Fishladder Canyon (September 2022). Note established vegetation. Condition of control: excellent.

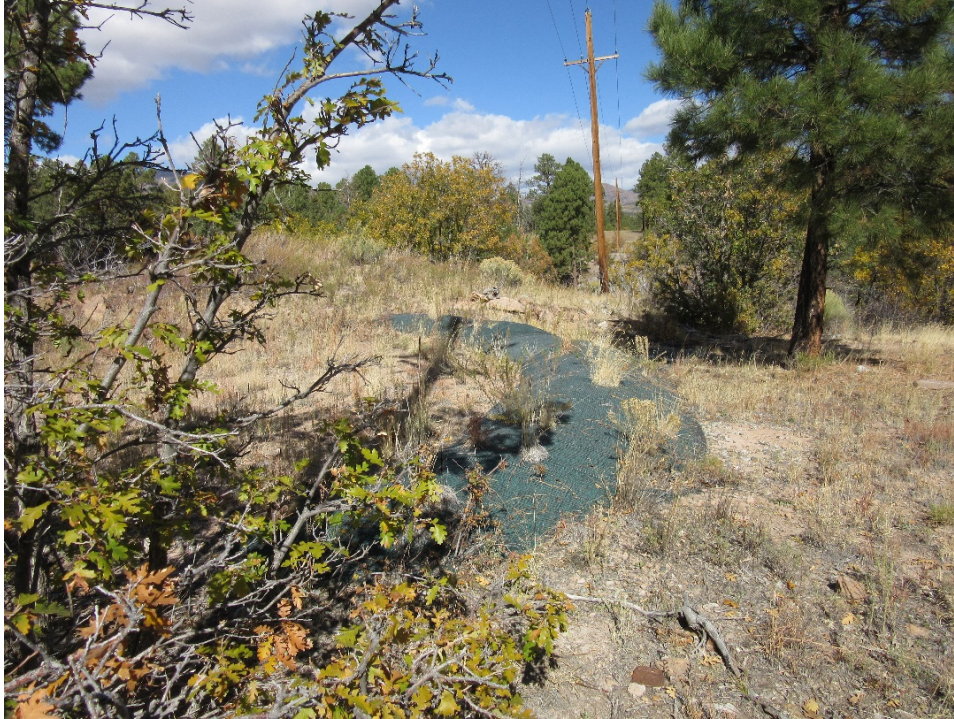
Figure 4 Earthen berm (V00703010027, center of photo) at the top of drainage leading into Fishladder Canyon (October 2021). Note established vegetation. Condition of control: excellent.

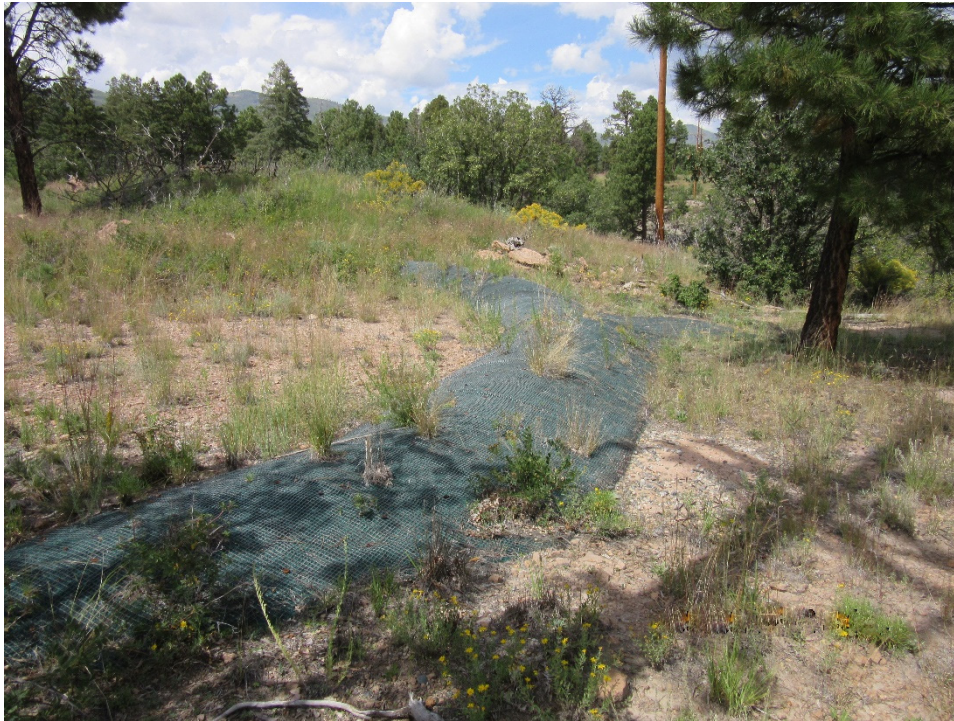
Figure 5 Earthen berm (V00703010027, center of photo) at the top of drainage leading into Fishladder Canyon (September 2022). Note established vegetation. Condition of control: excellent.

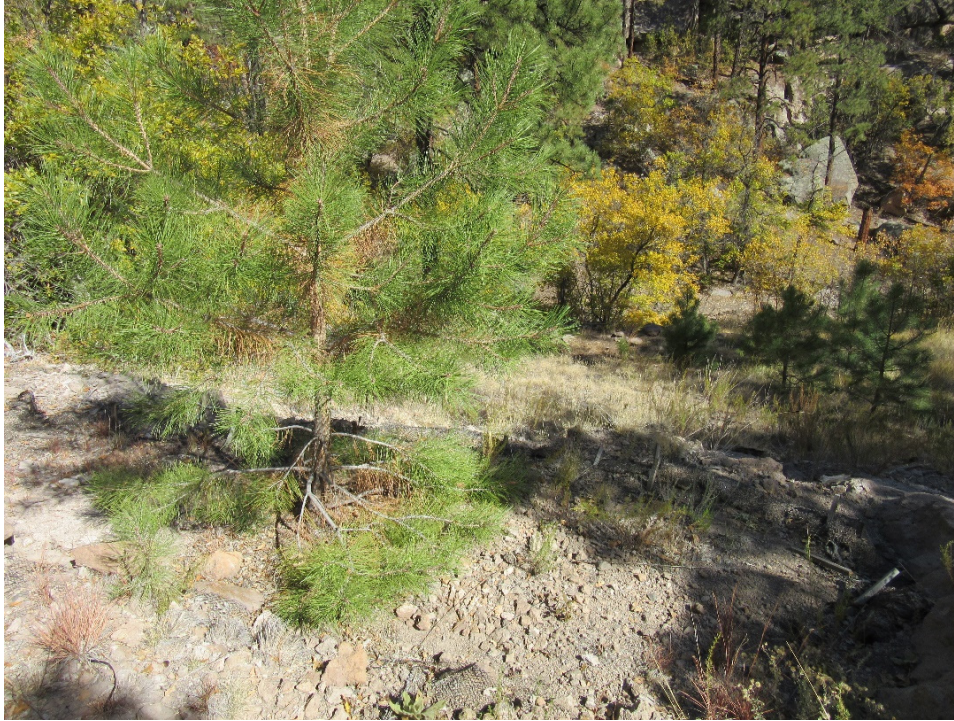
Figure 6 View downslope of the former fishladder location (October 2021). Note established vegetation above and below retired straw wattle. No active controls are visible in photo.

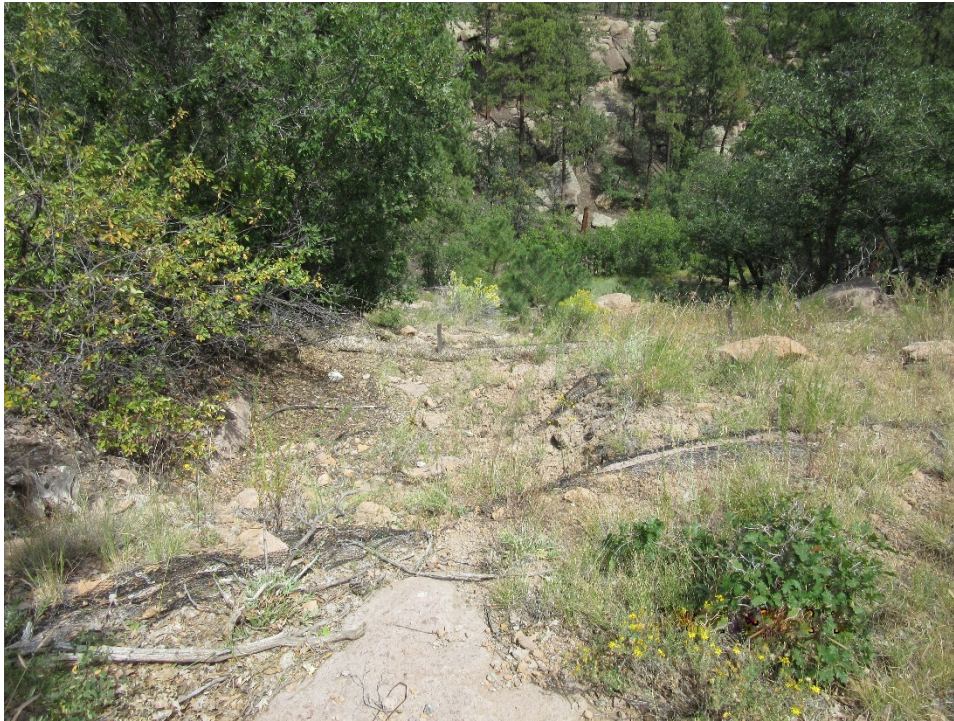
Figure 7 View downslope of the former fishladder location (September 2022). Note established vegetation above and below retired straw wattle. No active controls are visible in photo.

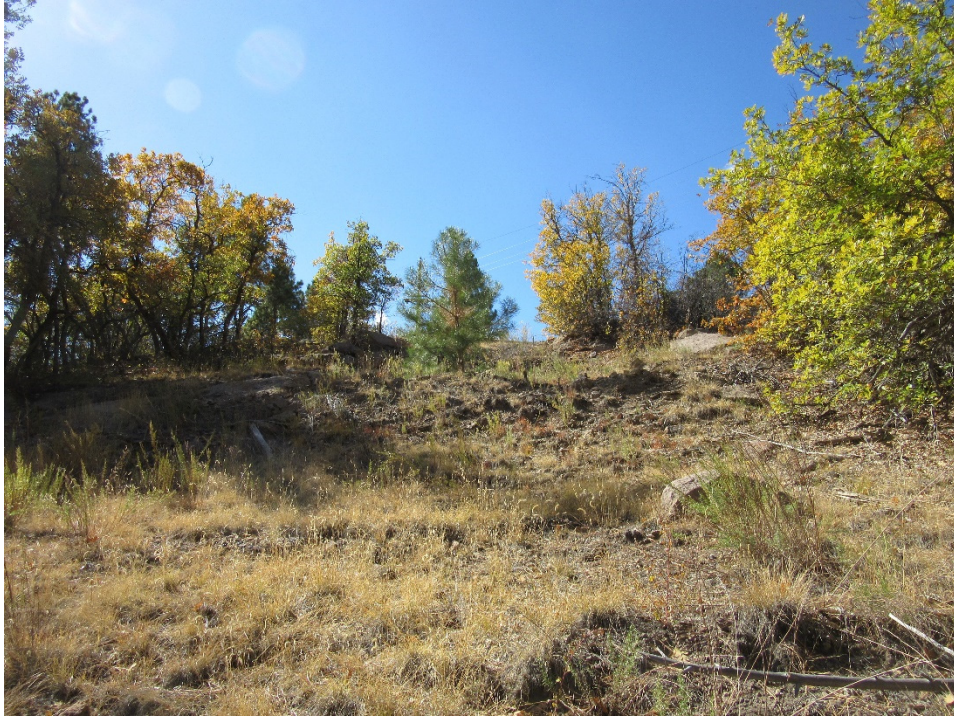
Figure 8 View upslope of the former fishladder location from the canyon bottom (October 2021). Note established vegetative cover and lack of erosional features. Control is not visible in photo.

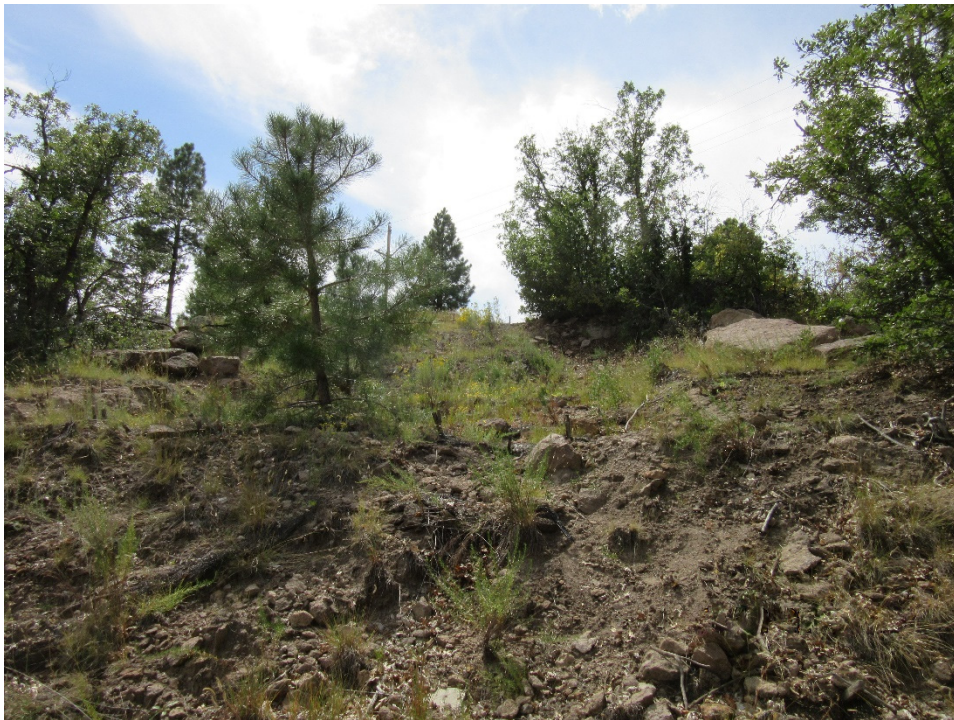
Figure 9 View upslope of the former fishladder location from the canyon bottom (September 2022). Note established vegetative cover and lack of erosional features. Control is not visible in photo.

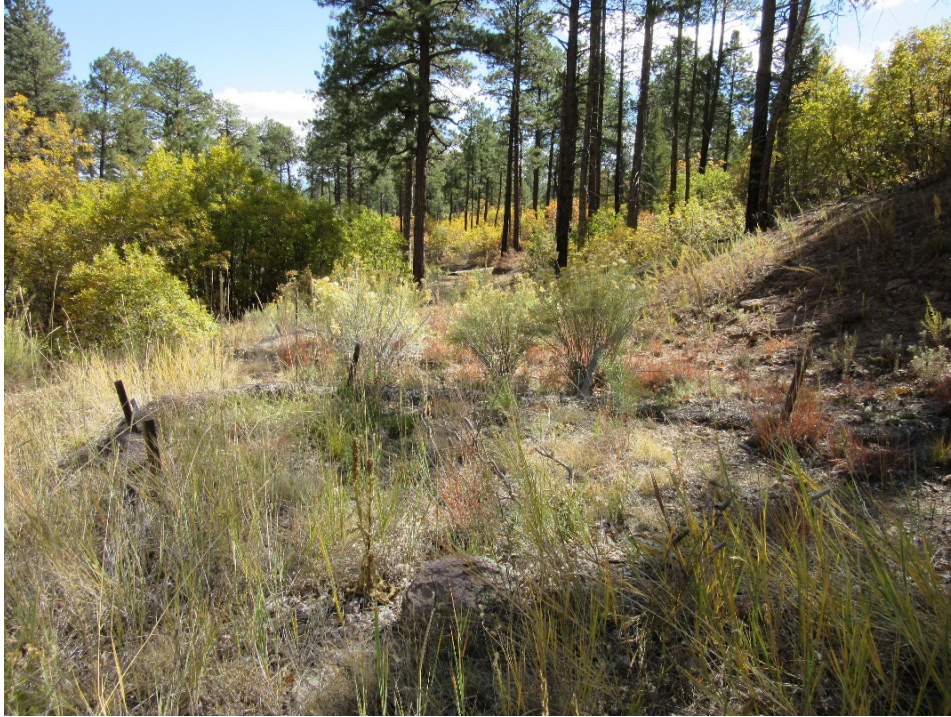
Figure 10 View east of former access road and straw wattle (V00703060028, center-left of photo, October 2021).
Note established vegetation.

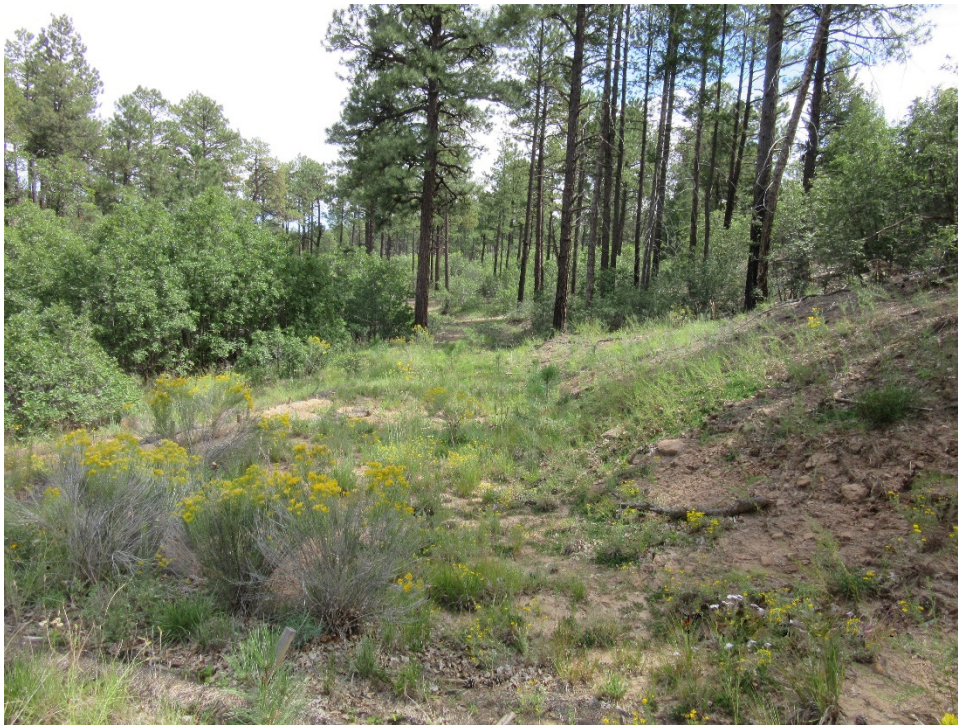
Figure 11 View east of former access road and straw wattle (V00703060028, center-left of photo, September 2022).
Note established vegetation. Condition of control: very good.

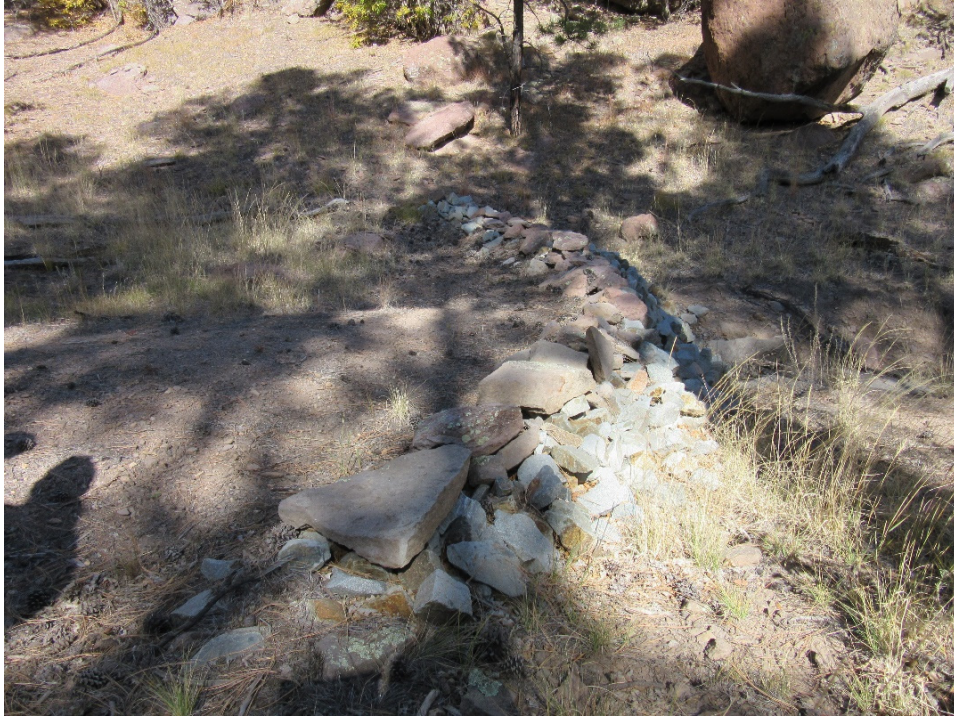
Figure 12 Rock check dam (V00706010024, center of photo) in Fishladder Canyon primary drainage (October 2021).
Condition of control: good.

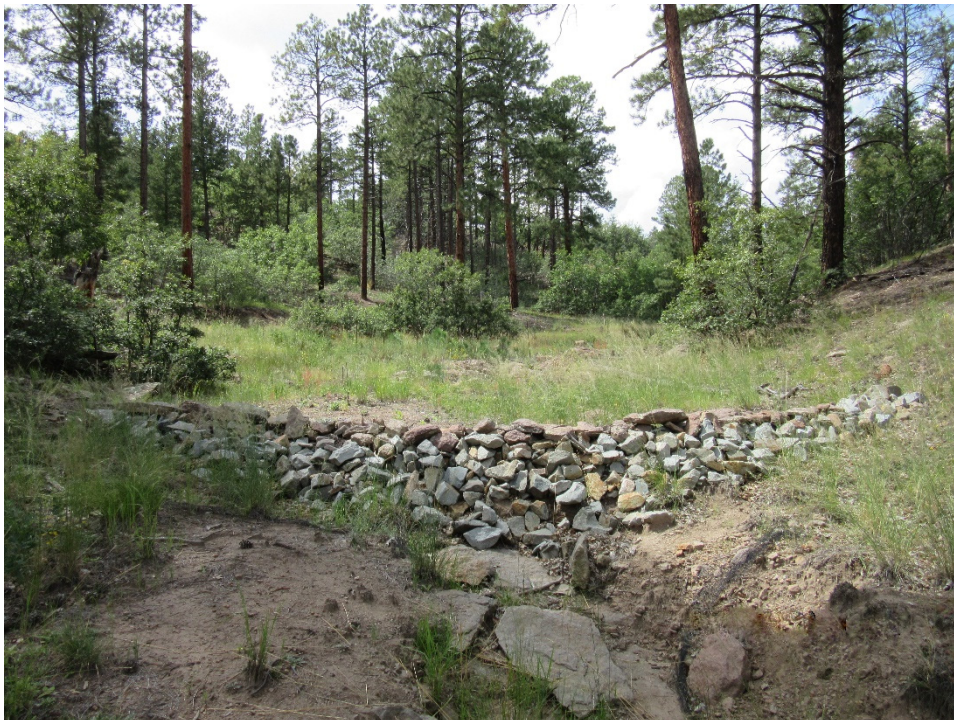
Figure 13 Rock check dam (V00706010024, center of photo) in Fishladder Canyon primary drainage (September 2022).
Condition of control: good.

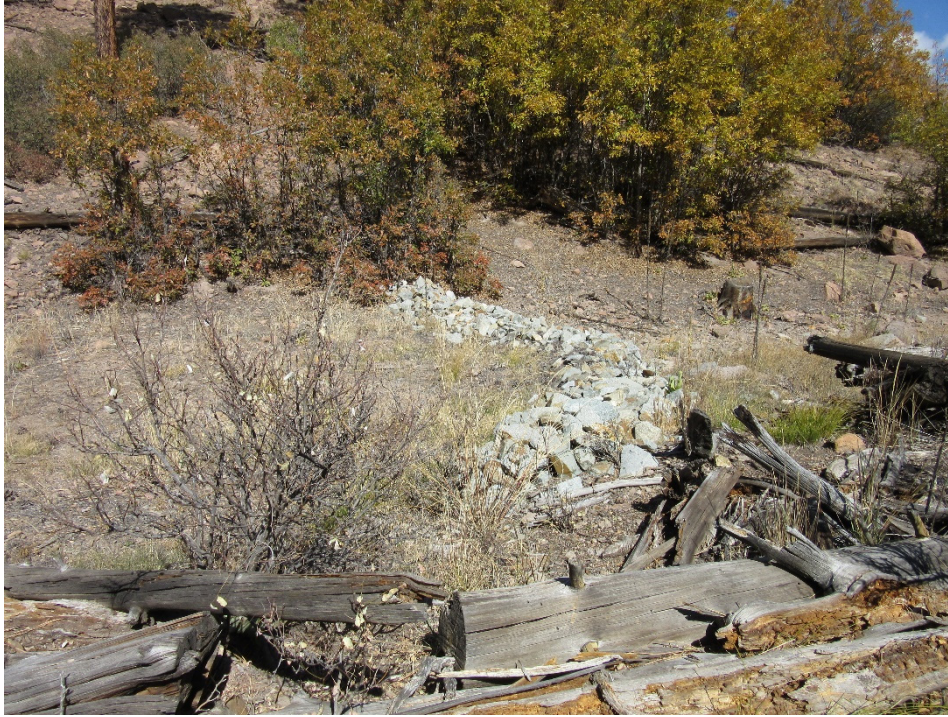
Figure 14 Rock check dam (V00706010025, center of photo) in primary drainage (October 2021). Note established vegetation in channel. Condition of control: excellent.

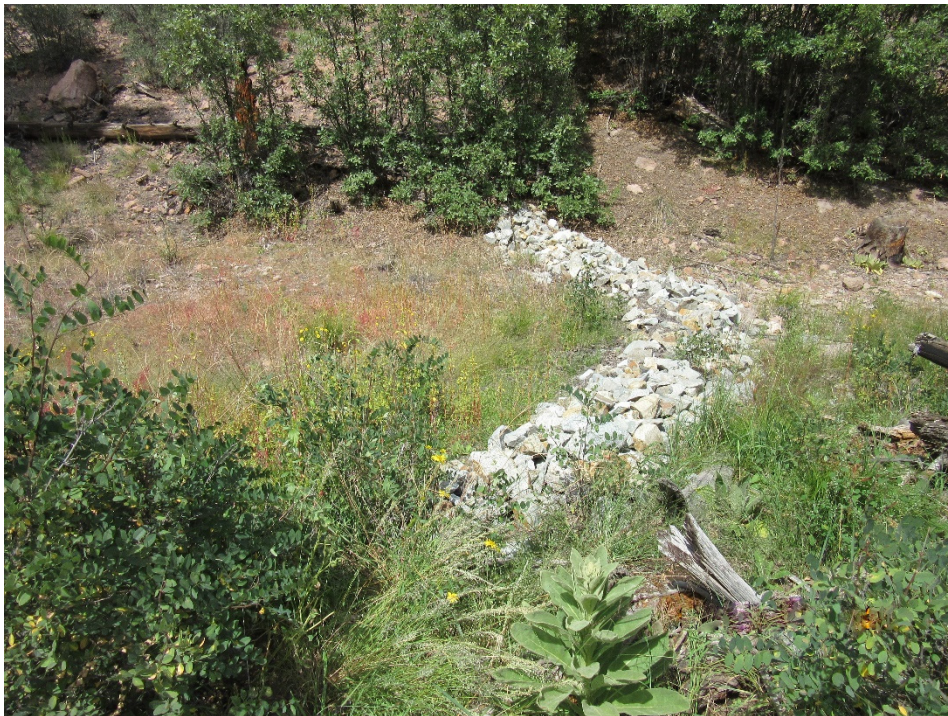
Figure 15 Rock check dam (V00706010025, center of photo) in primary drainage (September 2022). Note established vegetation in channel. Condition of control: excellent.

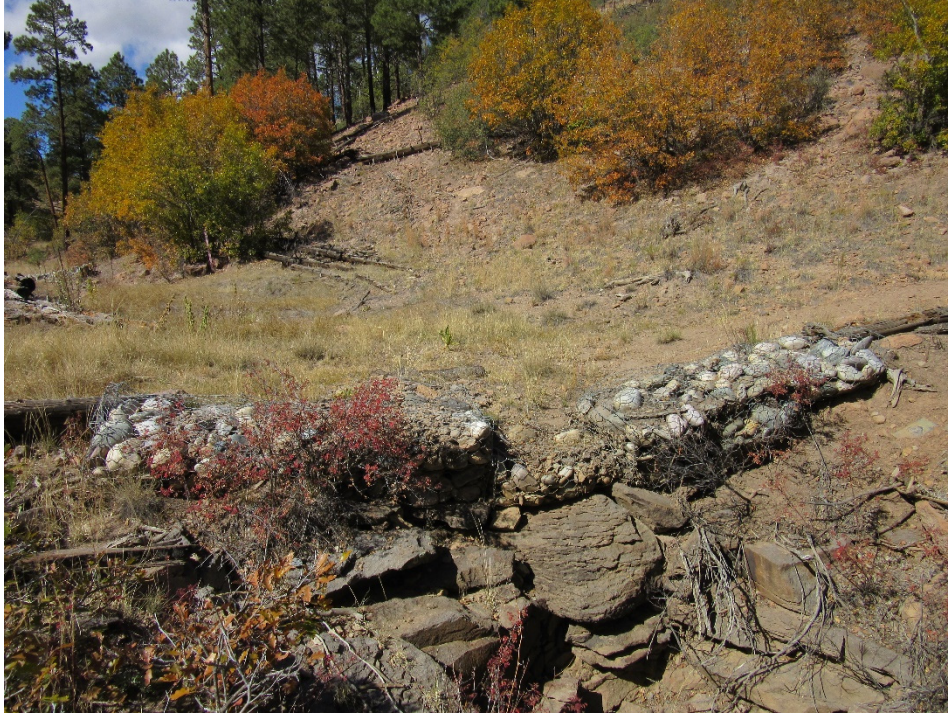
Figure 16 Gabion (V00707010002, center of photo) at access road crossing in Fishladder Canyon (October 2021). Note vegetation in channel upstream of control. Condition of control: good.

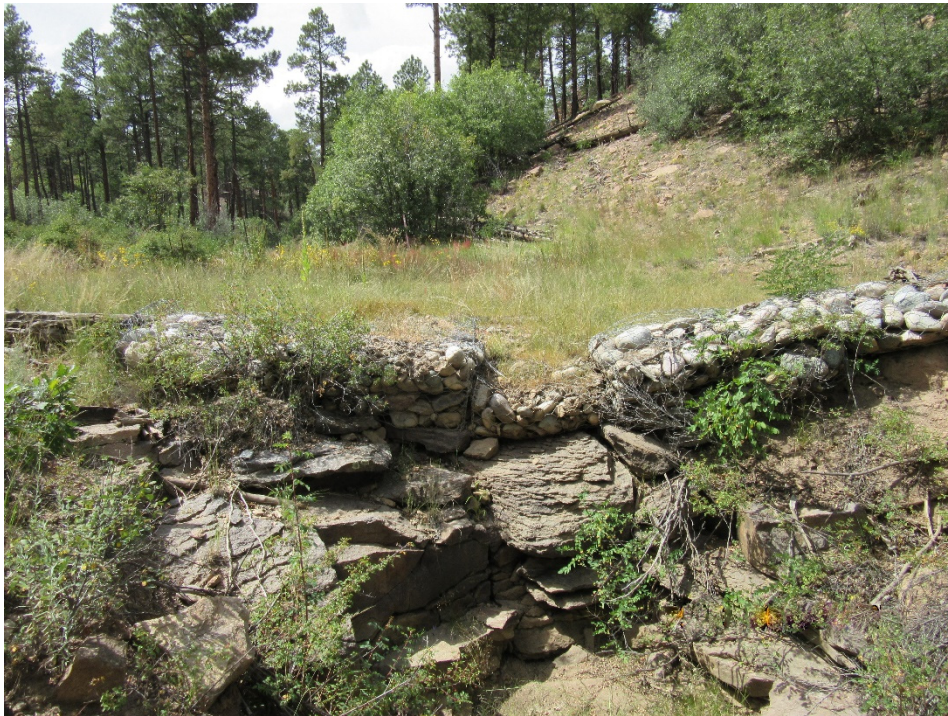
Figure 17 Gabion (V00707010002, center of photo) at access road crossing in Fishladder Canyon (September 2022). Note vegetation in channel upstream of control. Condition of control: good.

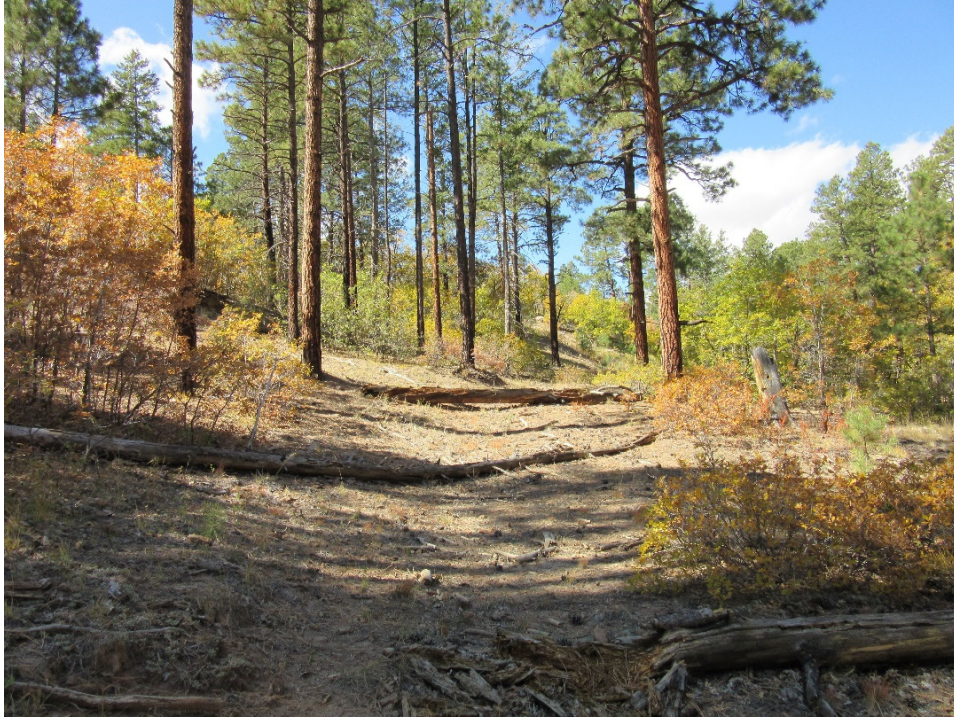
Figure 18 View west of former access road in Fishladder Canyon (October 2021). Note vegetative cover, needlecast, and downed trees along the former access road.

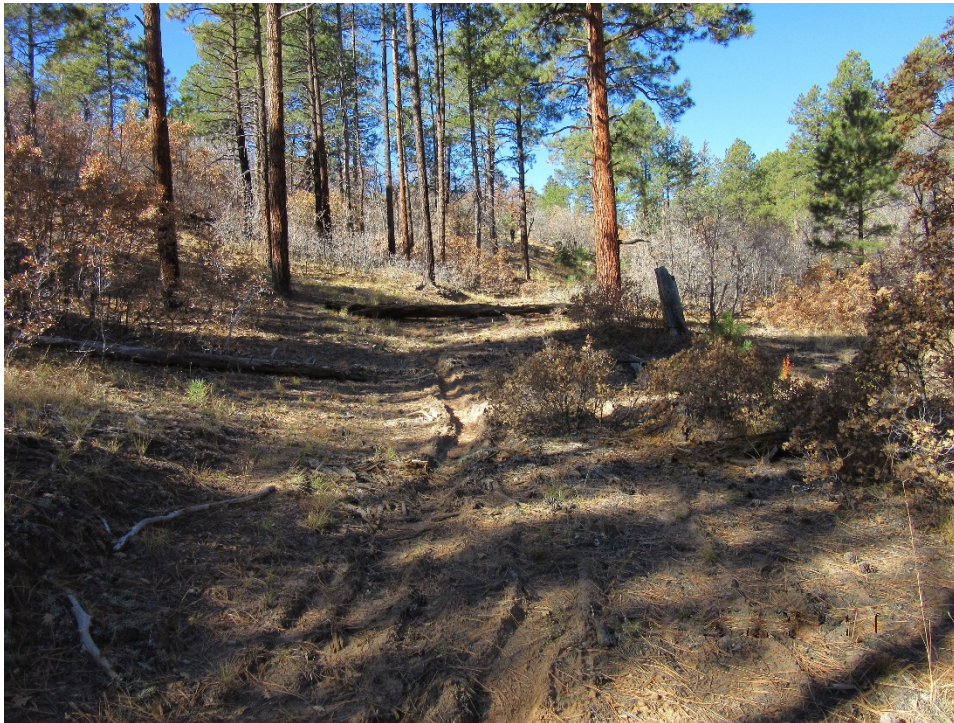
- The fourth inspection was completed on September 13, 2022, for the required annual inspection. There were no findings or maintenance items. A photograph of the view west of the former access road into Fishladder Canyon was not taken at that inspection. A photograph was obtained on November 8, 2022, for inclusion for this submittal (Enclosure 1, Figure 19).

Figure 19 View west of former access road in Fishladder Canyon (November 2022). Note vegetative cover, needlecast, and downed trees along the former access road.
