EMLA-23-BF315-2-1

Subject: Submittal of the 2023 Annual Long-Term Monitoring and Maintenance Report for the
Corrective Measures Implementation at Former 260 Outfall Area

September 2023
EM2023-0581

2023 Annual Long-Term Monitoring and Maintenance Report for the Corrective Measures Implementation at Former 260 Outfall Area

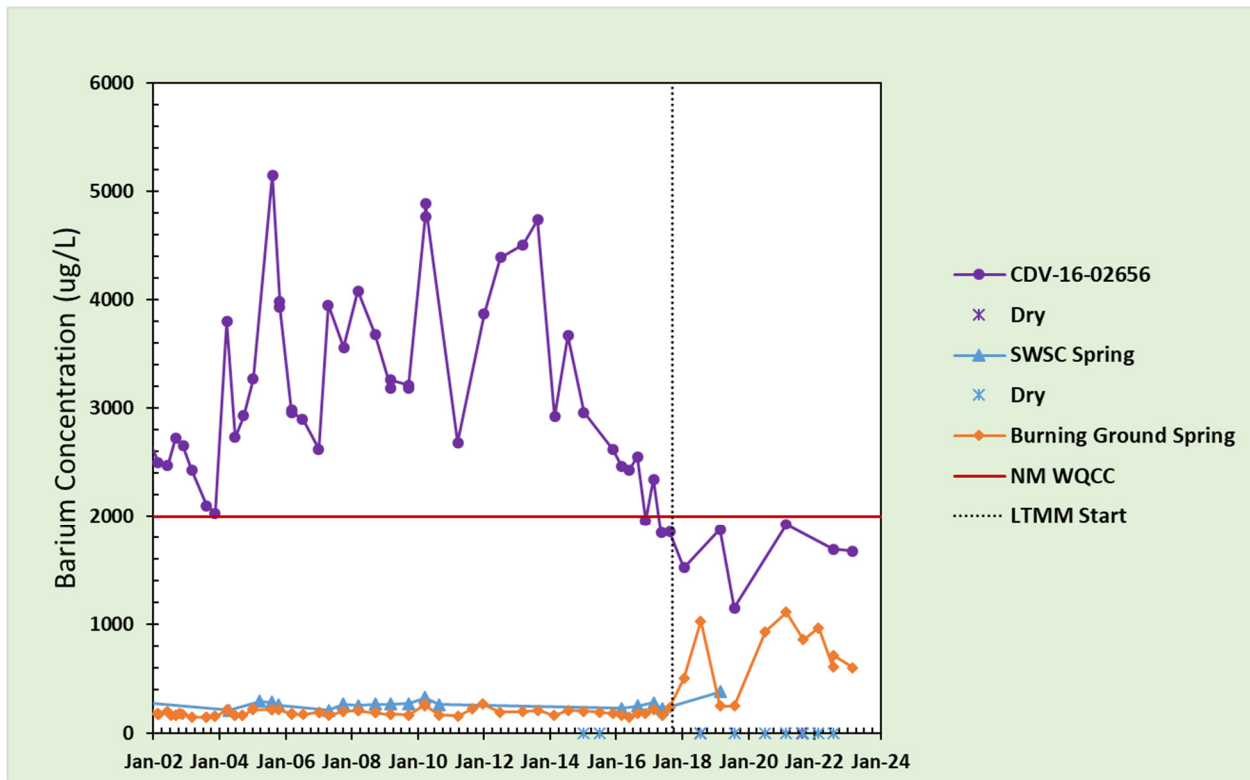
Figure 4.2-1 Cañon de Valle segment 1 barium data record

Barium concentration data for filtered samples collected in the Cañon de Valle segments 1 and 2 are presented in Figures 4.2-1 and 4.2-2, respectively. A review of these data indicate that the temporal and spatial trends, and conditions in the surface water, alluvial groundwater, and springs, are consistent with conditions described in the CMI remedy report (LANL 2017, 602597). The alluvial wells show barium concentration spikes after the Las Conchas wildfire and subsequent flooding in 2011, and associated declines more recently. The concentration spikes are consistent with flooding leading to barium desorption and witherite dissolution causing temporary increases in barium.
