# Individual Permit Corrective Actions Update

March 5, 2025

# Individual Permit NM0030759 Corrective Actions

Individual Permit (IP) effective date: August 1, 2022

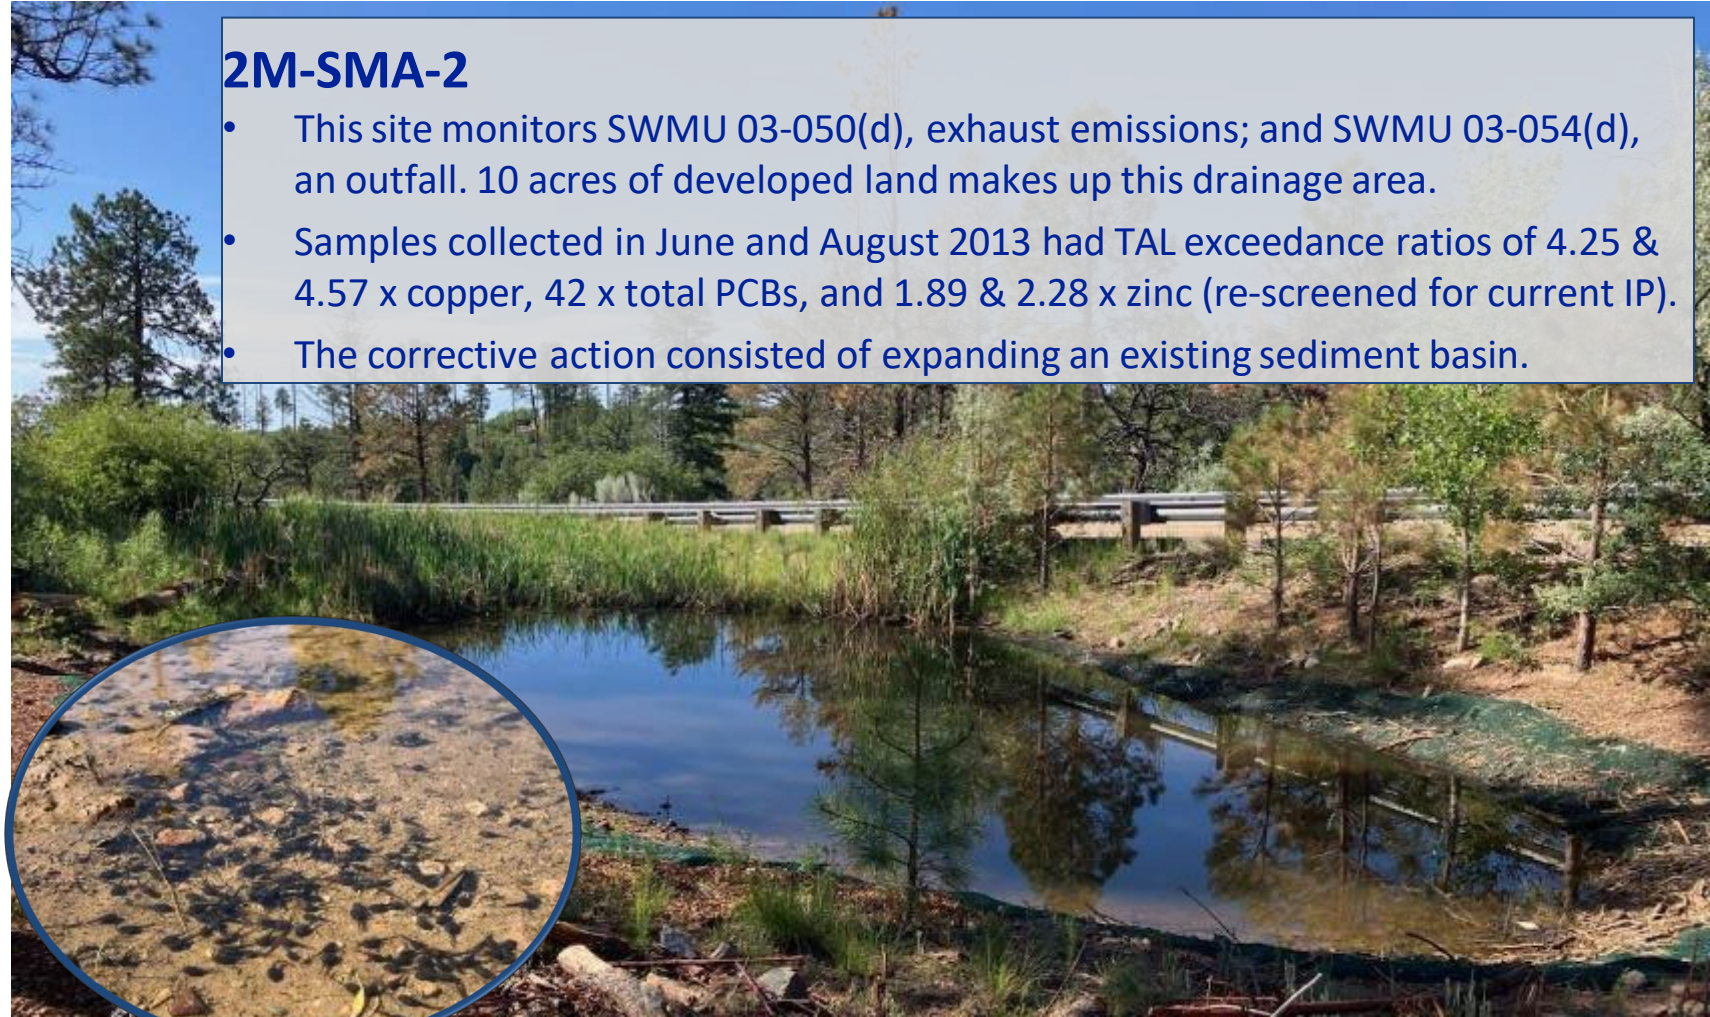
## 2M-SMA-2

- This site monitors SWMU 03-050(d), exhaust emissions; and SWMU 03-054(d), an outfall. 10 acres of developed land makes up this drainage area.
- Samples collected in June and August 2013 had TAL exceedance ratios of 4.25 & 4.57 x copper, 42 x total PCBs, and 1.89 & 2.28 x zinc (re-screened for current IP).
- The corrective action consisted of expanding an existing sediment basin.

Sediment basin E01205020016 at 2M-SMA-2. Tadpoles in basin observed summer 2024 (inset).

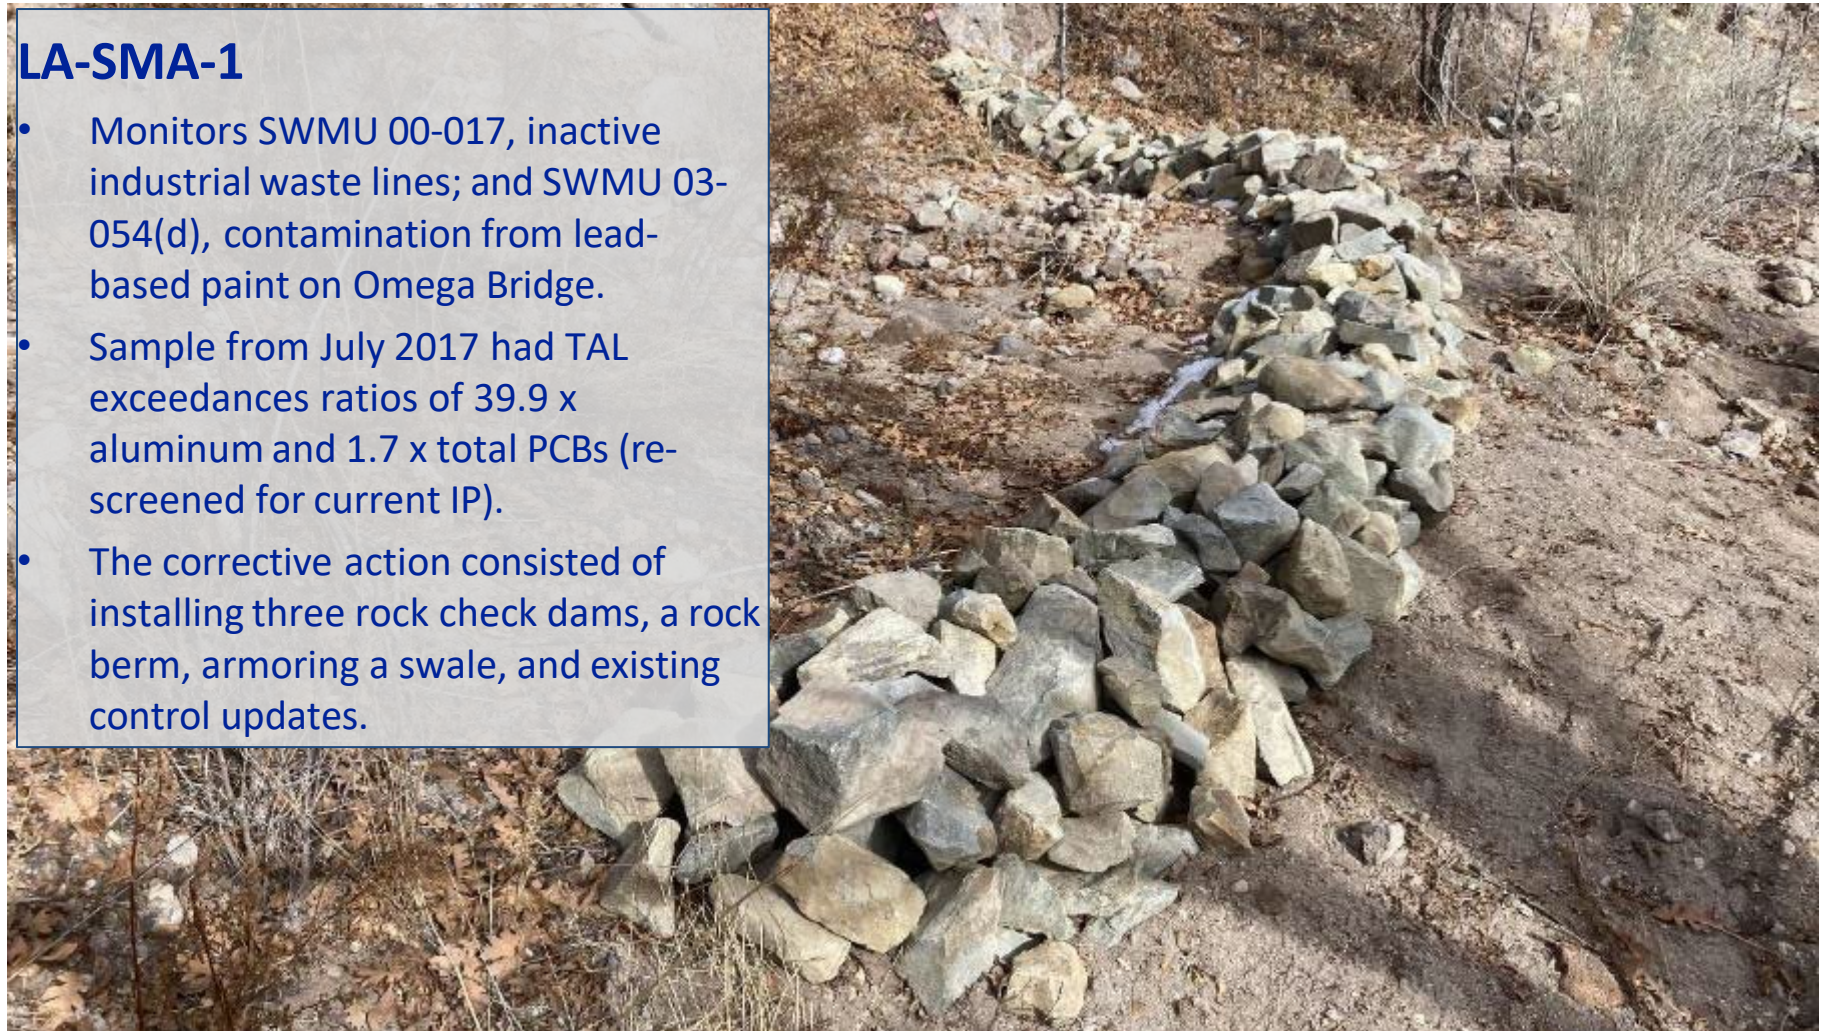
**LA-SMA-1**

- Monitors SWMU 00-017, inactive industrial waste lines; and SWMU 03-054(d), contamination from lead-based paint on Omega Bridge.
- Sample from July 2017 had TAL exceedances ratios of 39.9 x aluminum and 1.7 x total PCBs (re-screened for current IP).
- The corrective action consisted of installing three rock check dams, a rock berm, armoring a swale, and existing control updates.

Rock berm L00303120032 at LA-SMA-1.

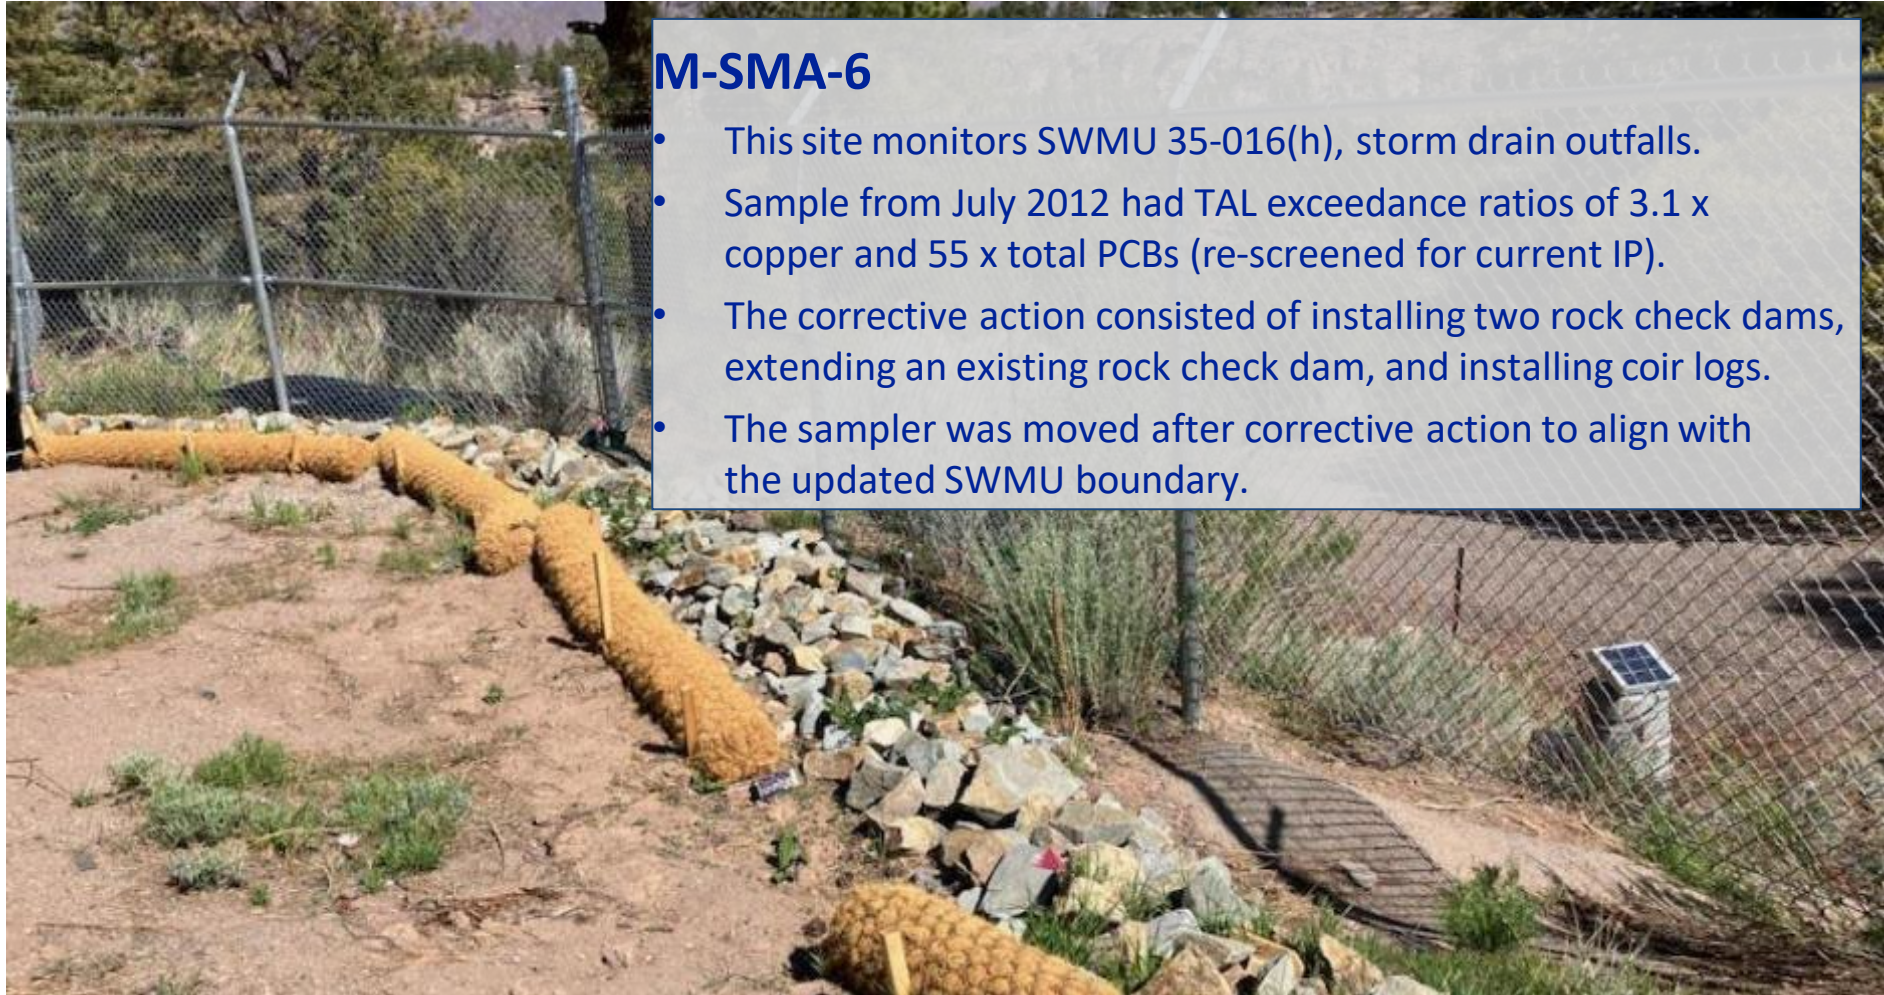
## M-SMA-6

- This site monitors SWMU 35-016(h), storm drain outfalls.
- Sample from July 2012 had TAL exceedance ratios of 3.1 x copper and 55 x total PCBs (re-screened for current IP).
- The corrective action consisted of installing two rock check dams, extending an existing rock check dam, and installing coir logs.
- The sampler was moved after corrective action to align with the updated SWMU boundary.

Coir logs M00803140051 and M00803140052, rock berm M00803140031, and sampler at M-SMA-6.

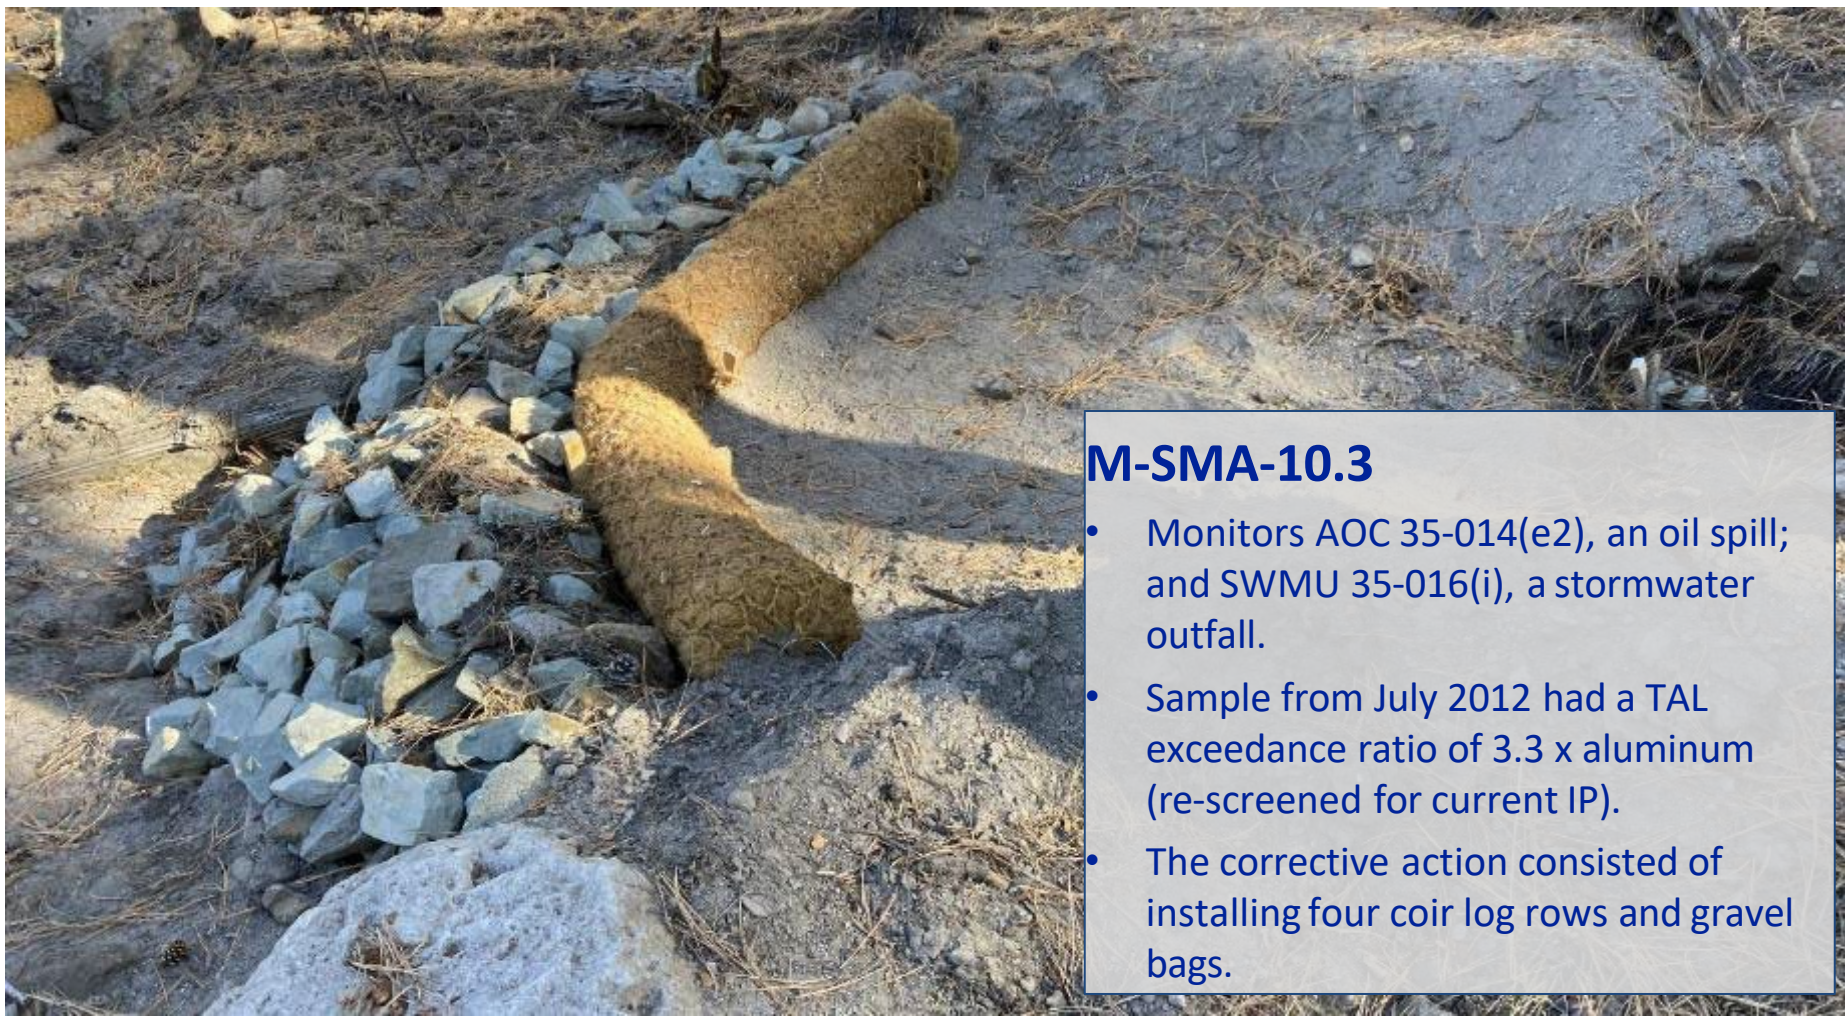
### M-SMA-10.3

- Monitors AOC 35-014(e2), an oil spill; and SWMU 35-016(i), a stormwater outfall.
- Sample from July 2012 had a TAL exceedance ratio of 3.3 x aluminum (re-screened for current IP).
- The corrective action consisted of installing four coir log rows and gravel bags.

Rock check dam M01306010017 and coir log M01306010023 at M-SMA-10.3.

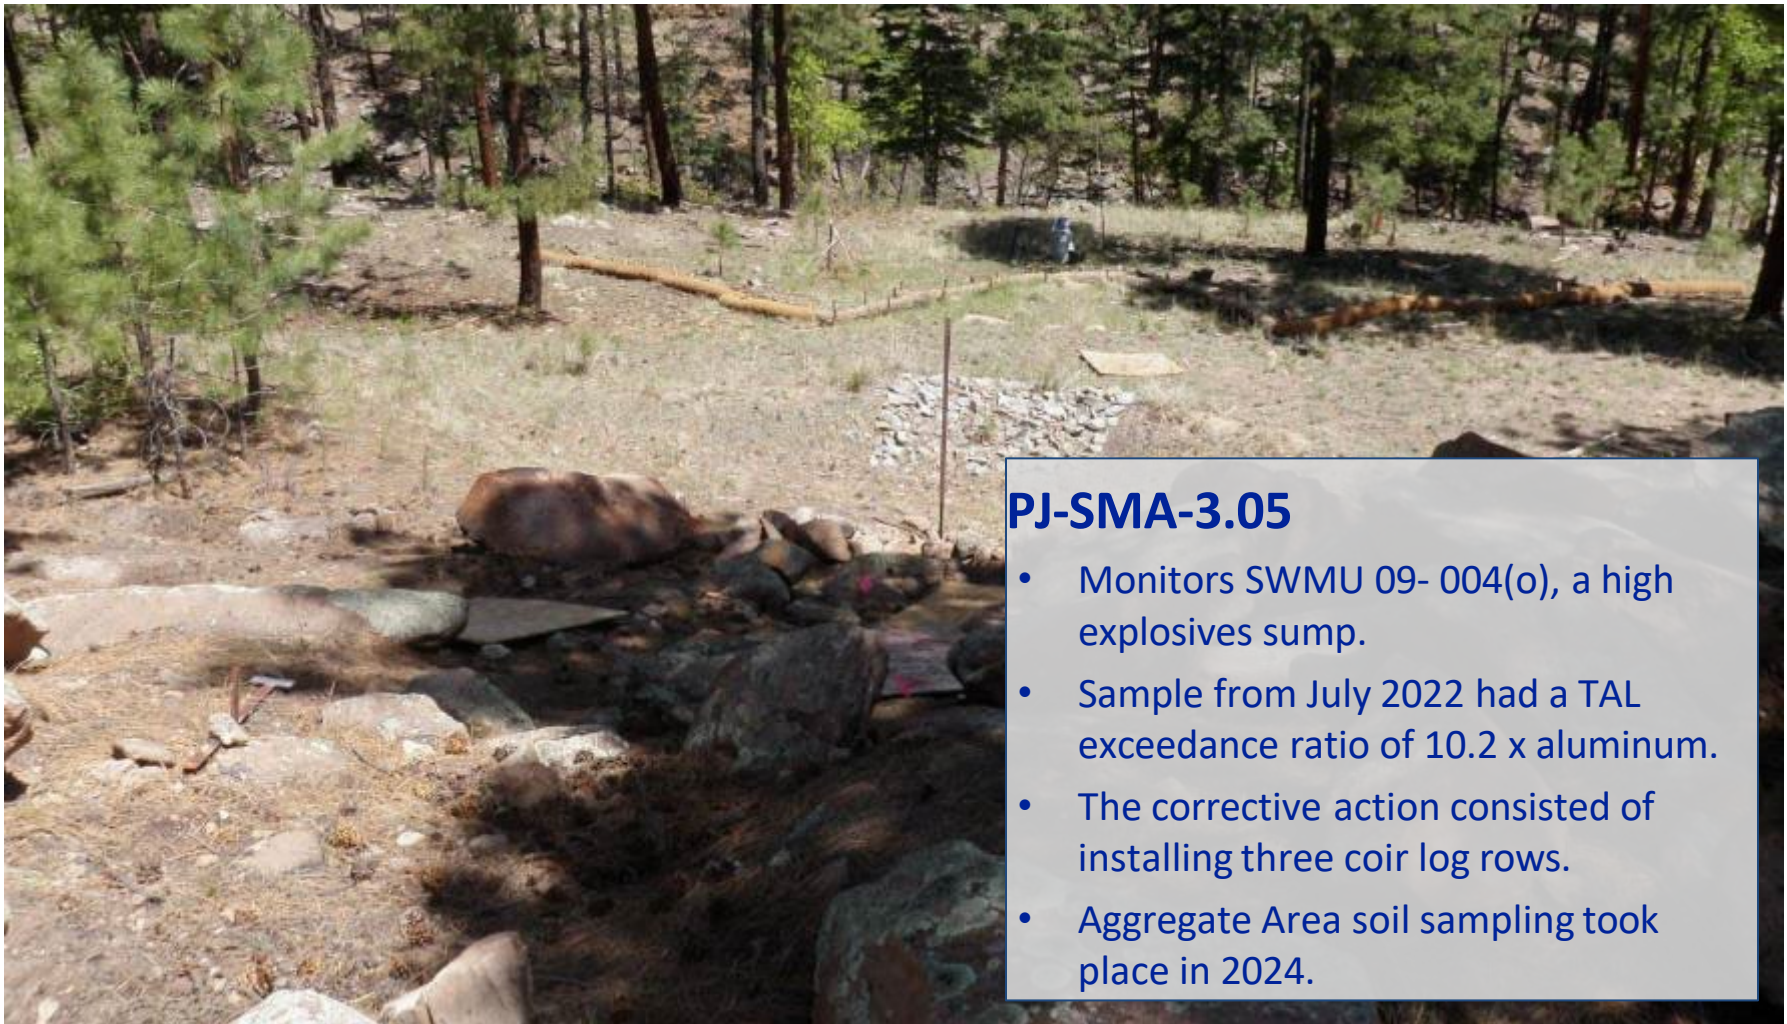
**PJ-SMA-3.05**

- Monitors SWMU 09- 004(o), a high explosives sump.
- Sample from July 2022 had a TAL exceedance ratio of 10.2 x aluminum.
- The corrective action consisted of installing three coir log rows.
- Aggregate Area soil sampling took place in 2024.

Earthen berm with riprap spillway J00303140011, and multiple coir and compost logs in background at PJ-SMA-3.05.

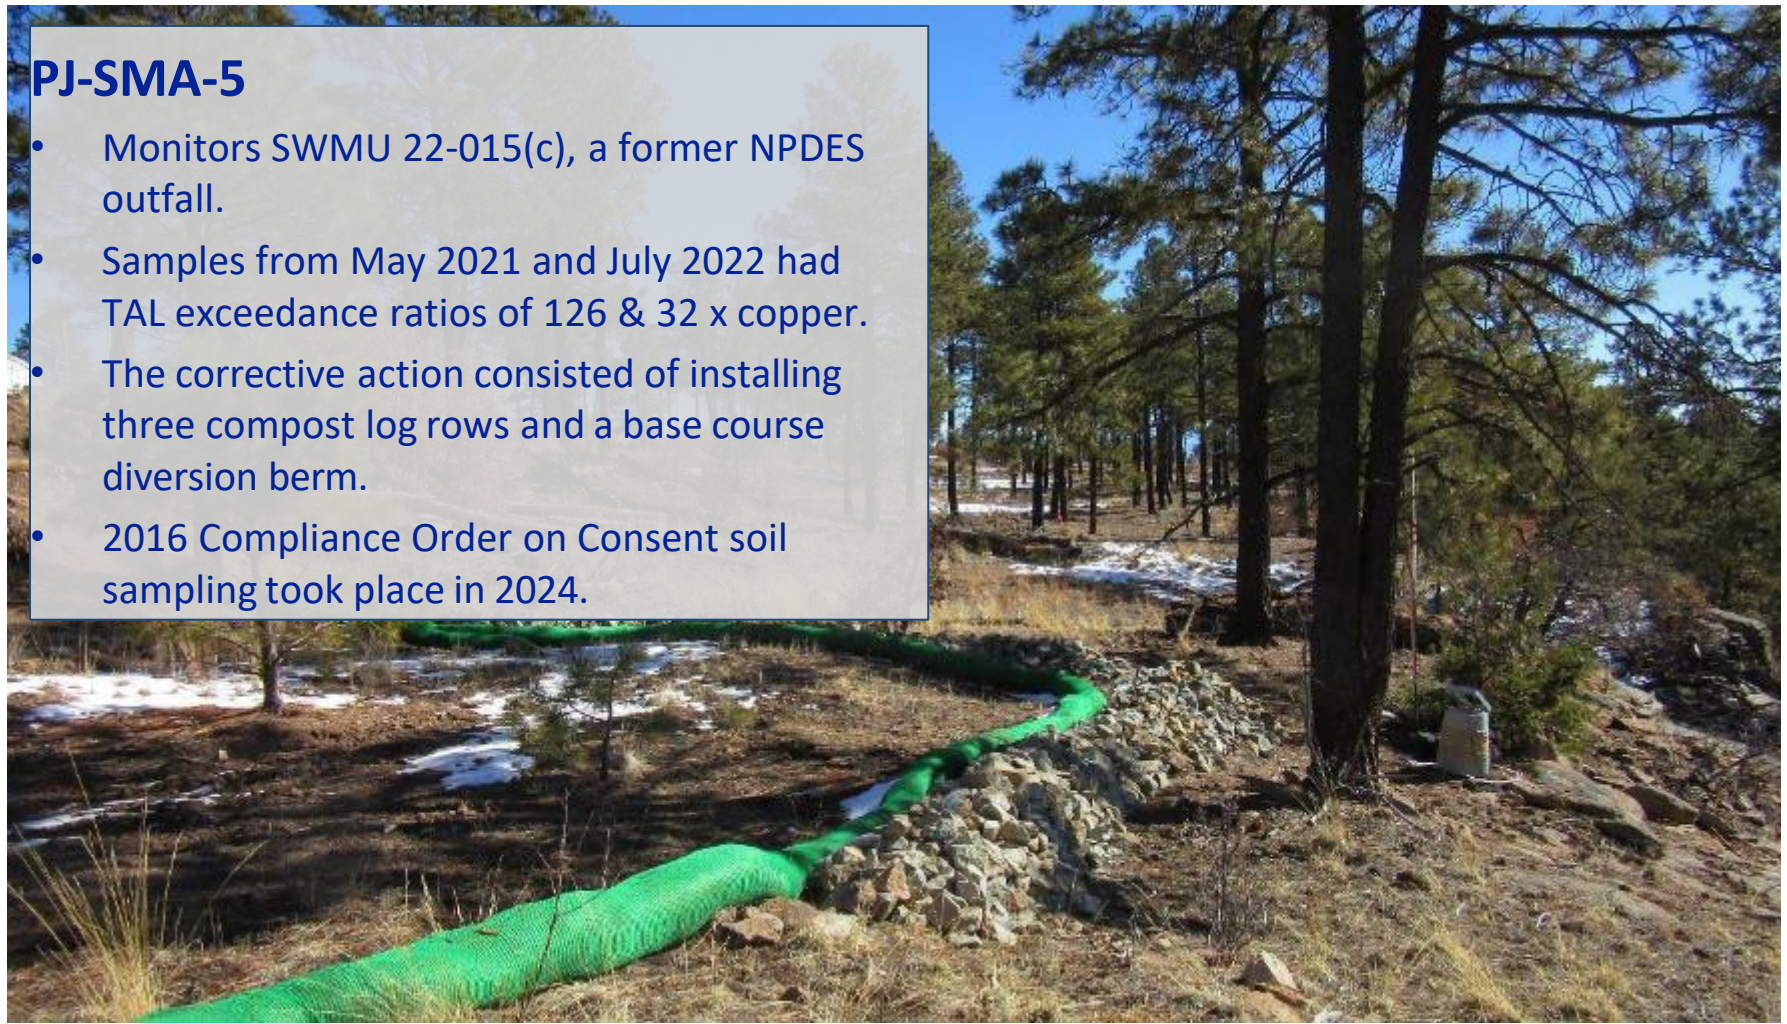
## PJ-SMA-5

- Monitors SWMU 22-015(c), a former NPDES outfall.
- Samples from May 2021 and July 2022 had TAL exceedance ratios of 126 & 32 x copper.
- The corrective action consisted of installing three compost log rows and a base course diversion berm.
- 2016 Compliance Order on Consent soil sampling took place in 2024.

Rock check dam J00506010024, compost log J00506010028, and sampler at PJ-SMA-5.

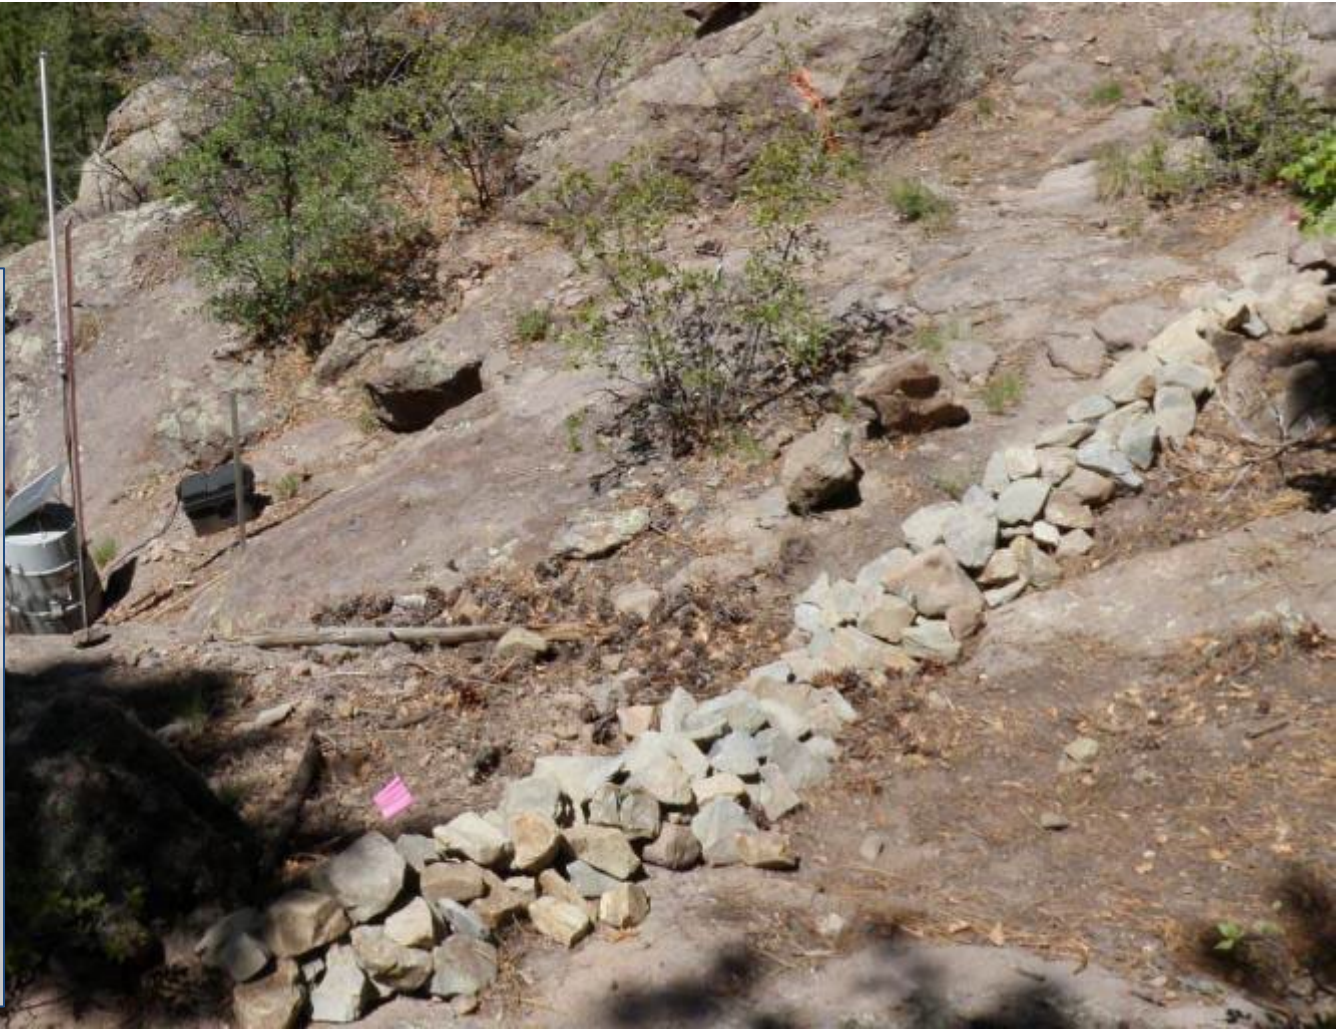
## PJ-SMA-9

- Monitors SWMU 40-009, a surface disposal area.
- Samples from July 2021 and July 2022 had TAL exceedance ratios of 8.5 & 11.0 x copper.
- The corrective action consisted of installing one row of coir logs, two rows of compost logs, and two rock check dams.

Rock check dam J01006010027 and sampler at PJ-SMA-9.02.

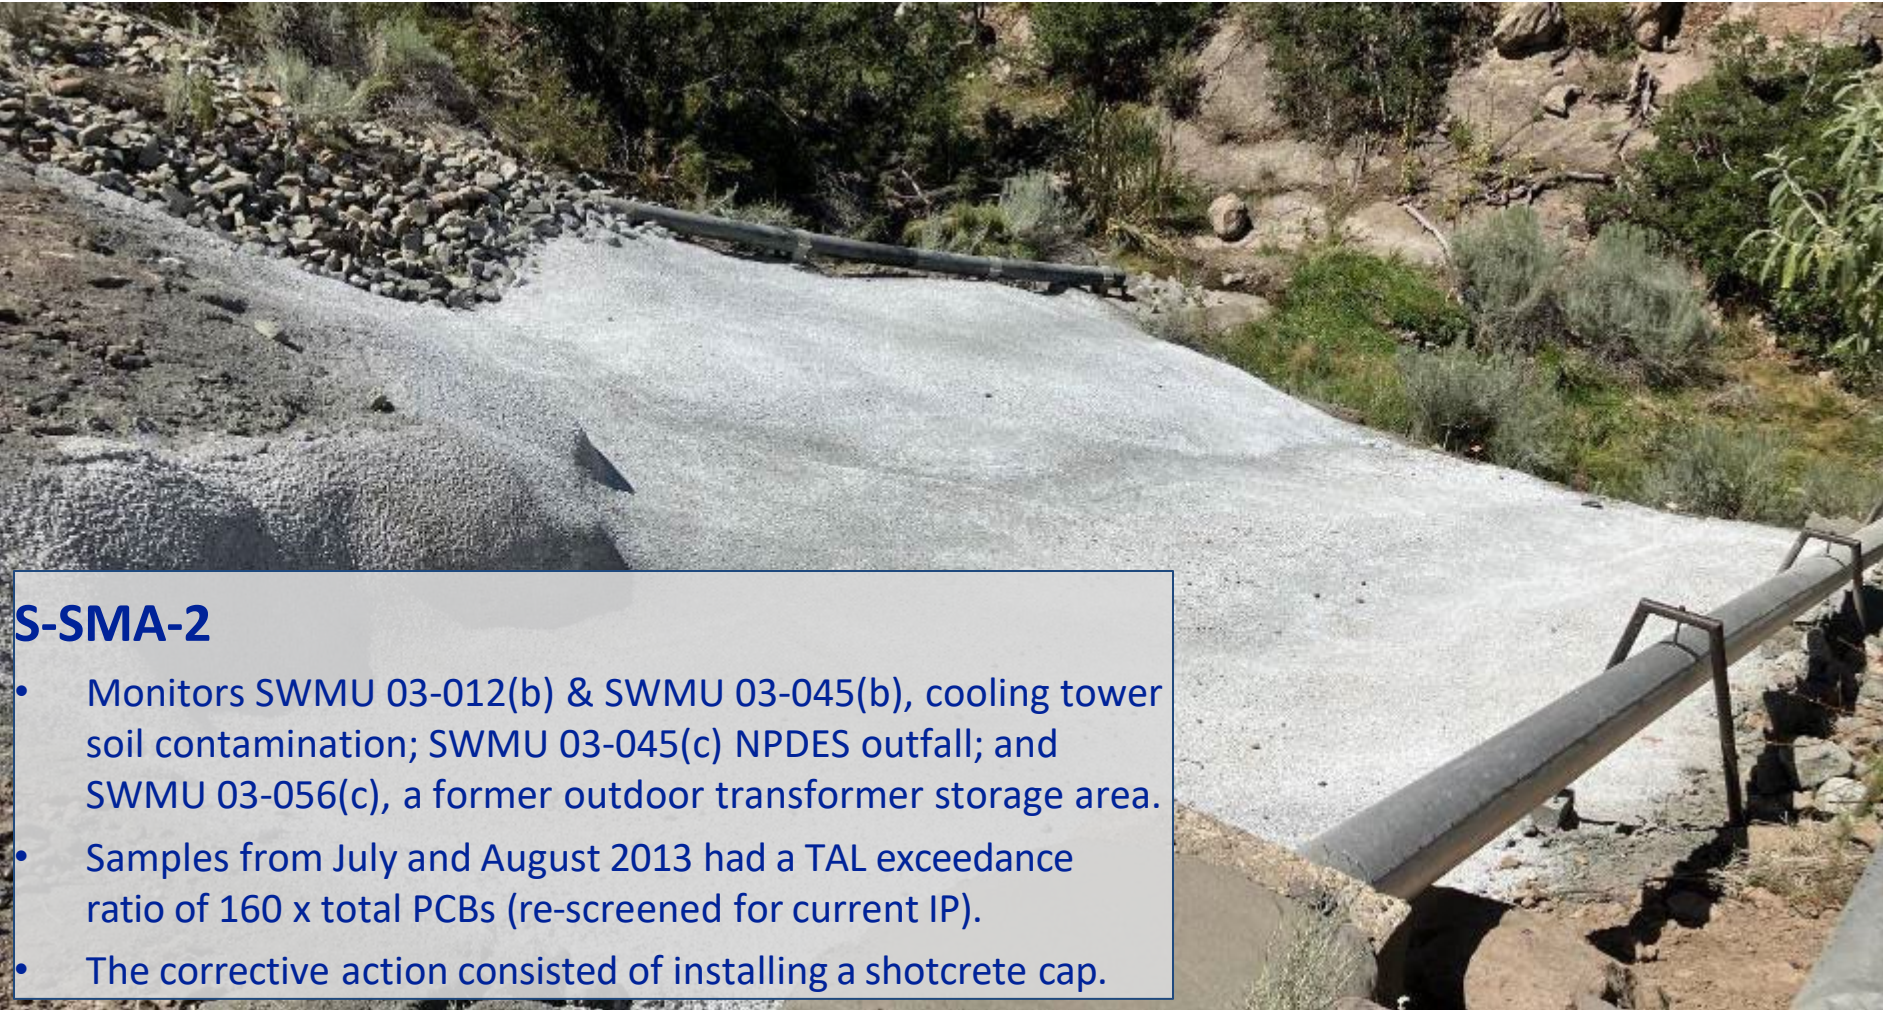
**S-SMA-2**

- Monitors SWMU 03-012(b) & SWMU 03-045(b), cooling tower soil contamination; SWMU 03-045(c) NPDES outfall; and SWMU 03-056(c), a former outdoor transformer storage area.
- Samples from July and August 2013 had a TAL exceedance ratio of 160 x total PCBs (re-screened for current IP).
- The corrective action consisted of installing a shotcrete cap.

Shotcrete cap S00308060028 at S-SMA-2.

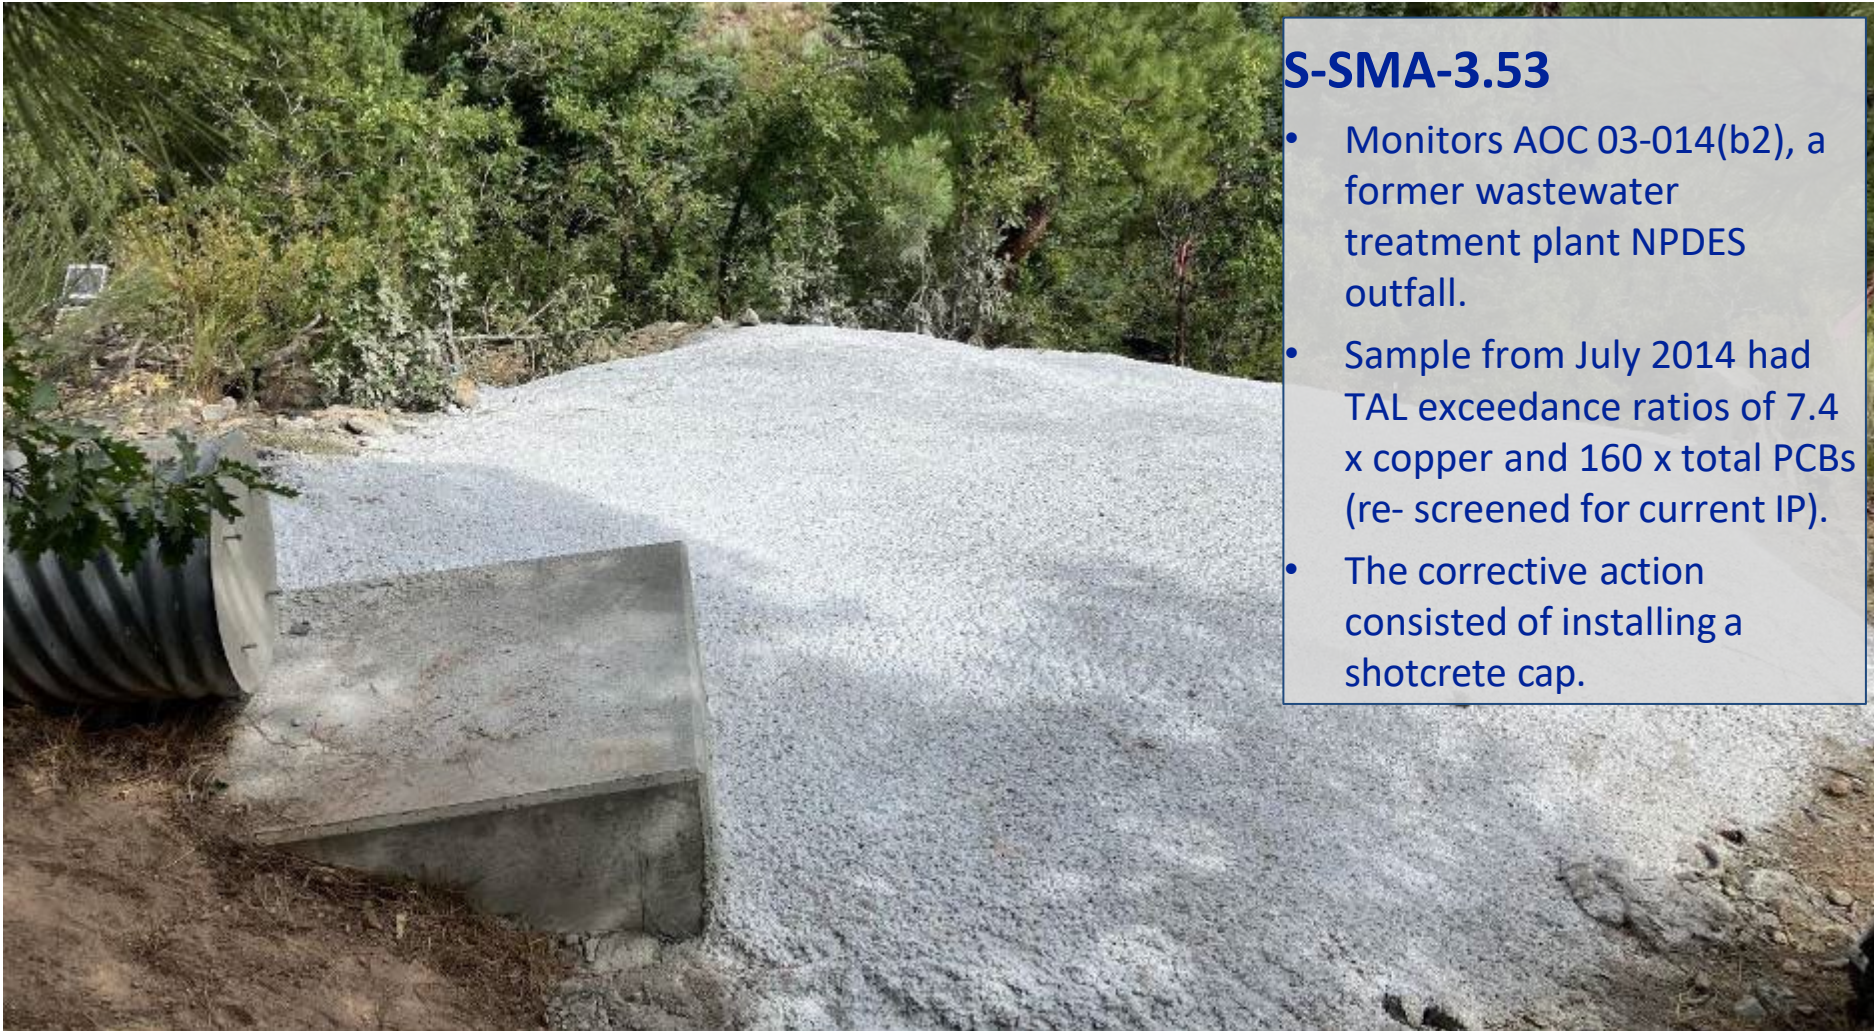
**S-SMA-3.53**

- Monitors AOC 03-014(b2), a former wastewater treatment plant NPDES outfall.
- Sample from July 2014 had TAL exceedance ratios of 7.4 x copper and 160 x total PCBs (re- screened for current IP).
- The corrective action consisted of installing a shotcrete cap.

Shotcrete cap S005B08030008 at S-SMA-3.53.

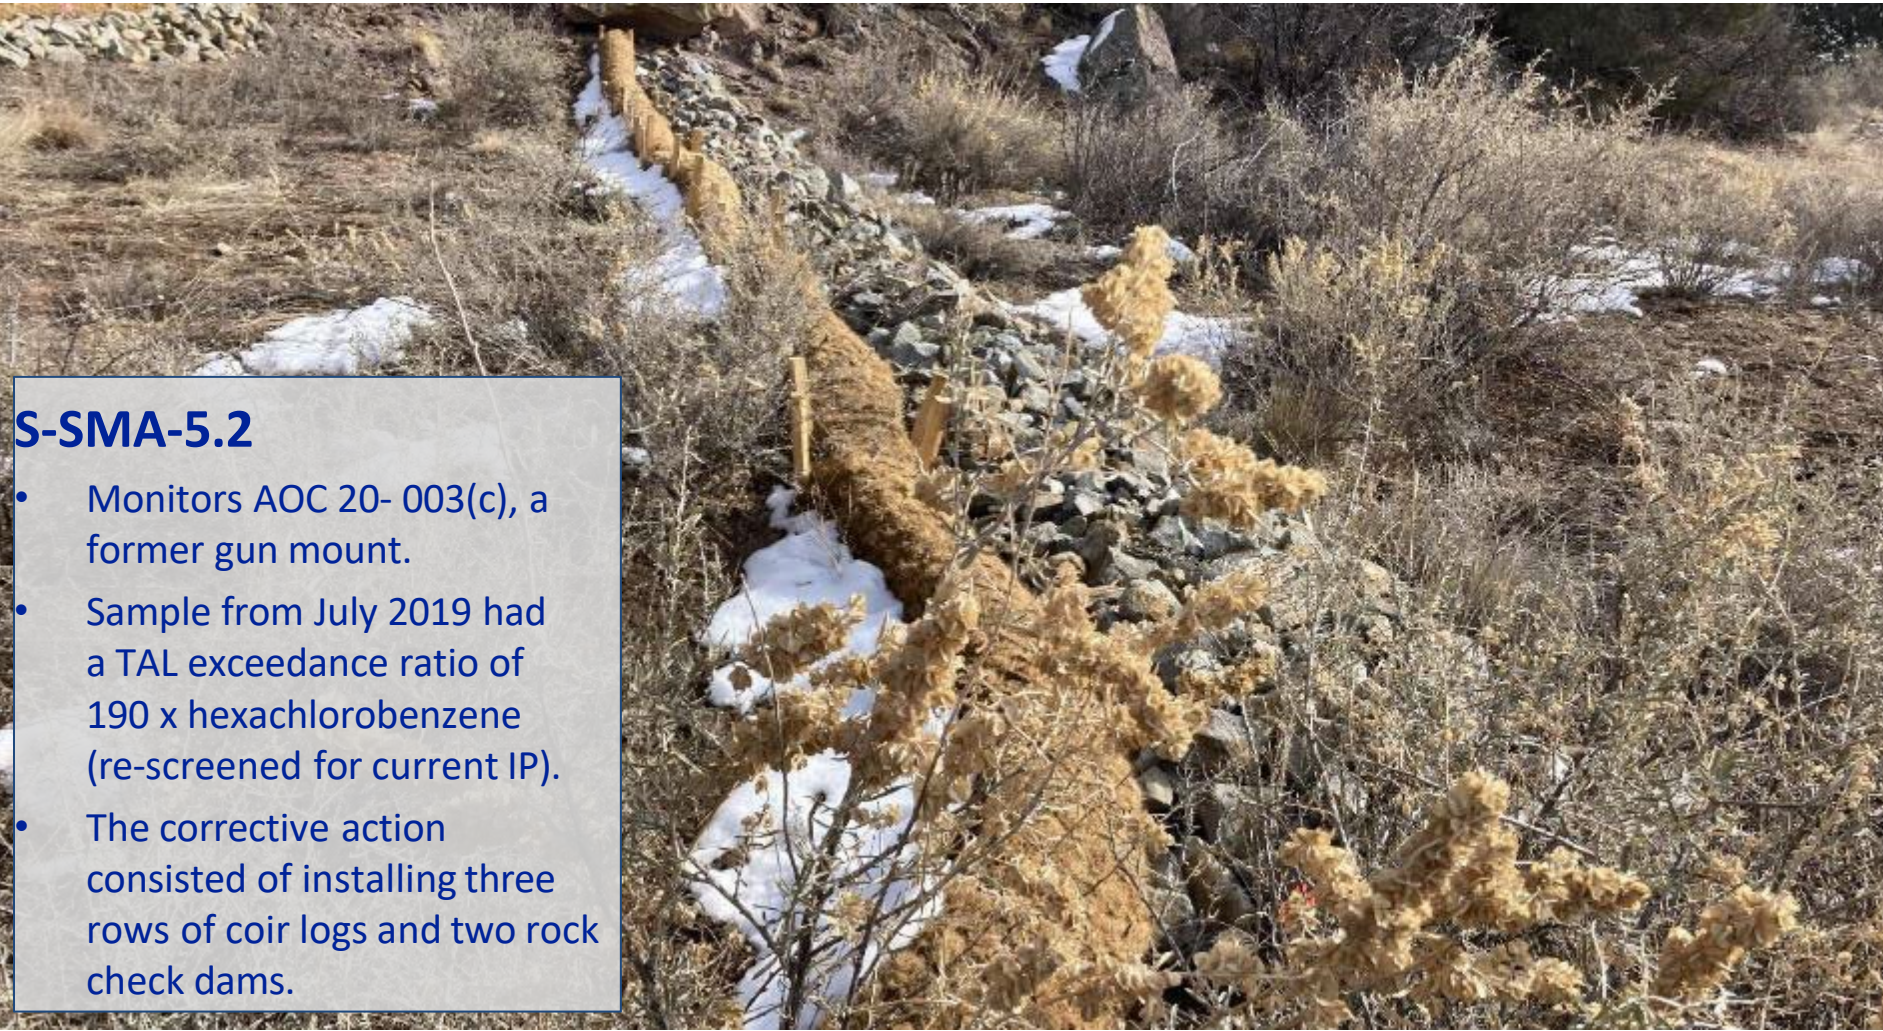
**S-SMA-5.2**

- Monitors AOC 20- 003(c), a former gun mount.
- Sample from July 2019 had a TAL exceedance ratio of 190 x hexachlorobenzene (re-screened for current IP).
- The corrective action consisted of installing three rows of coir logs and two rock check dams.

Coir log S01403140024 and rock berm S01403140017 at S-SMA-5.02.

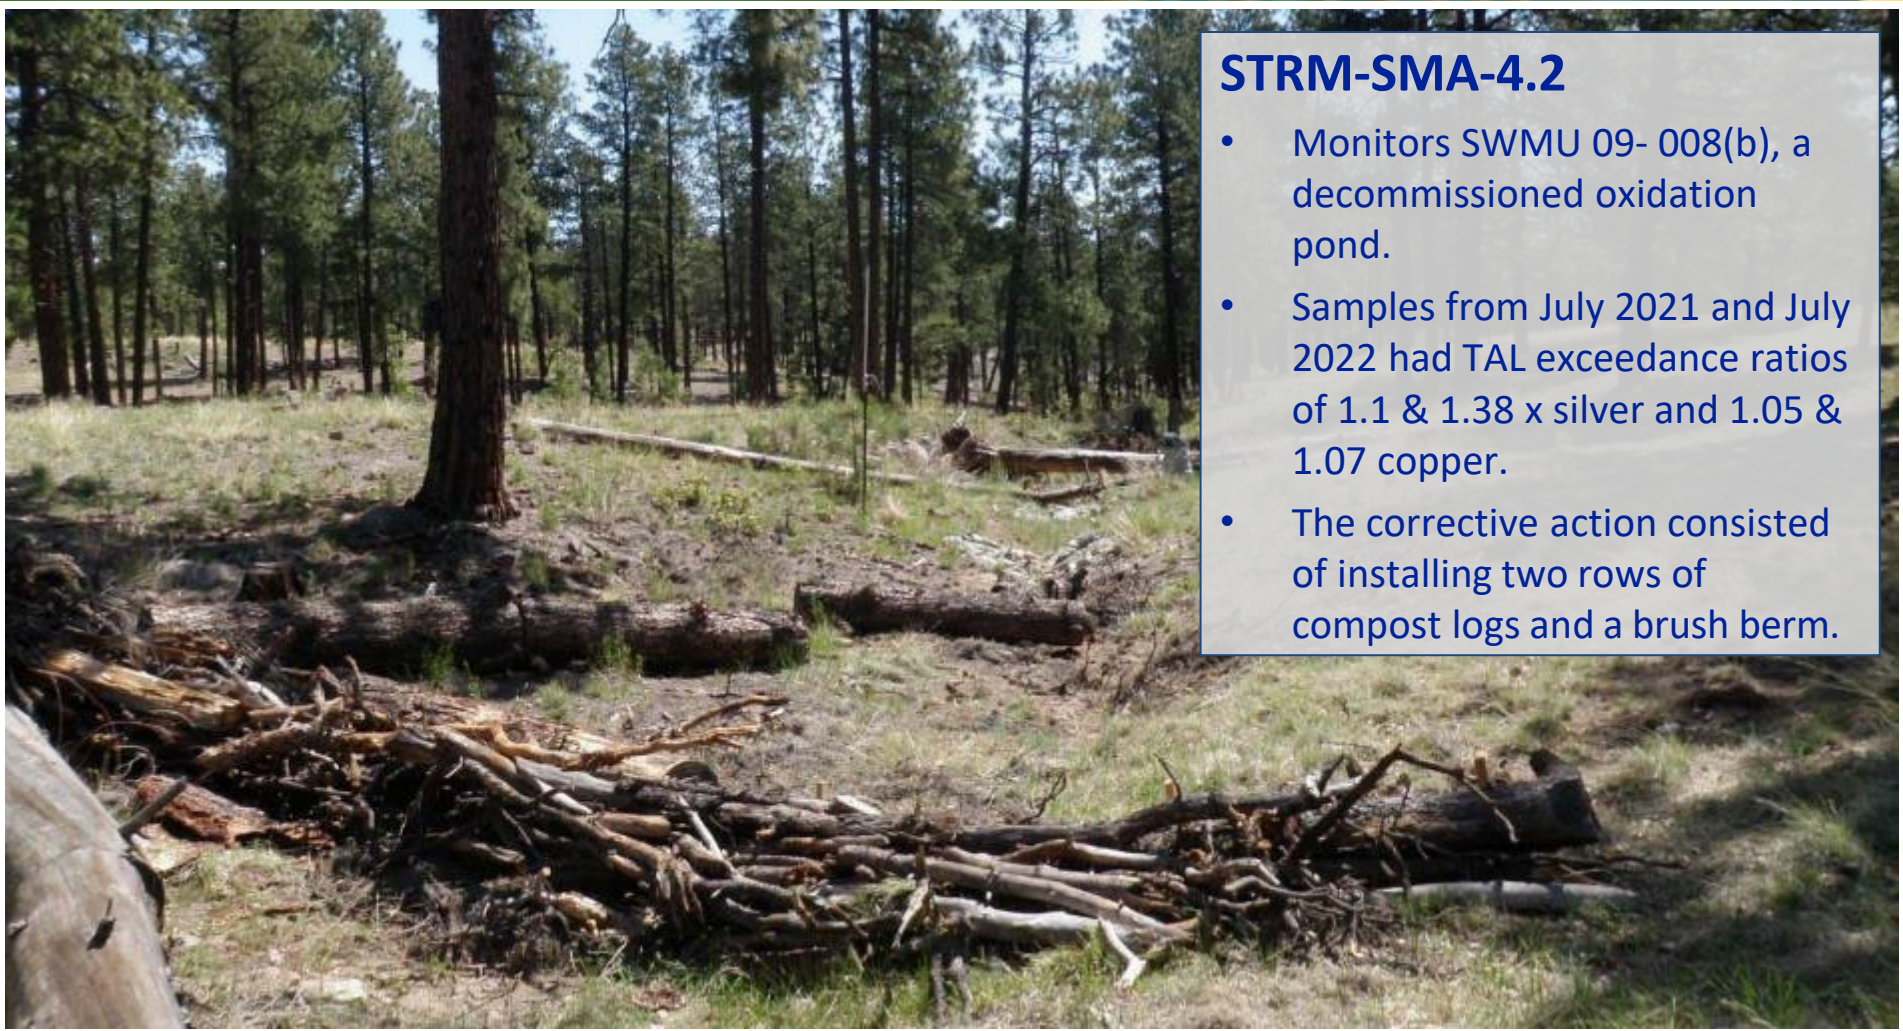
**STRM-SMA-4.2**

- Monitors SWMU 09- 008(b), a decommissioned oxidation pond.
- Samples from July 2021 and July 2022 had TAL exceedance ratios of 1.1 & 1.38 x silver and 1.05 & 1.07 copper.
- The corrective action consisted of installing two rows of compost logs and a brush berm.

Log berm J03003030015 at STRM-SMA-4.2.
