# Individual Permit Corrective Actions Update

March 5, 2025

# Individual Permit NM0030759 Corrective Actions

Individual Permit (IP) effective date: August 1, 2022

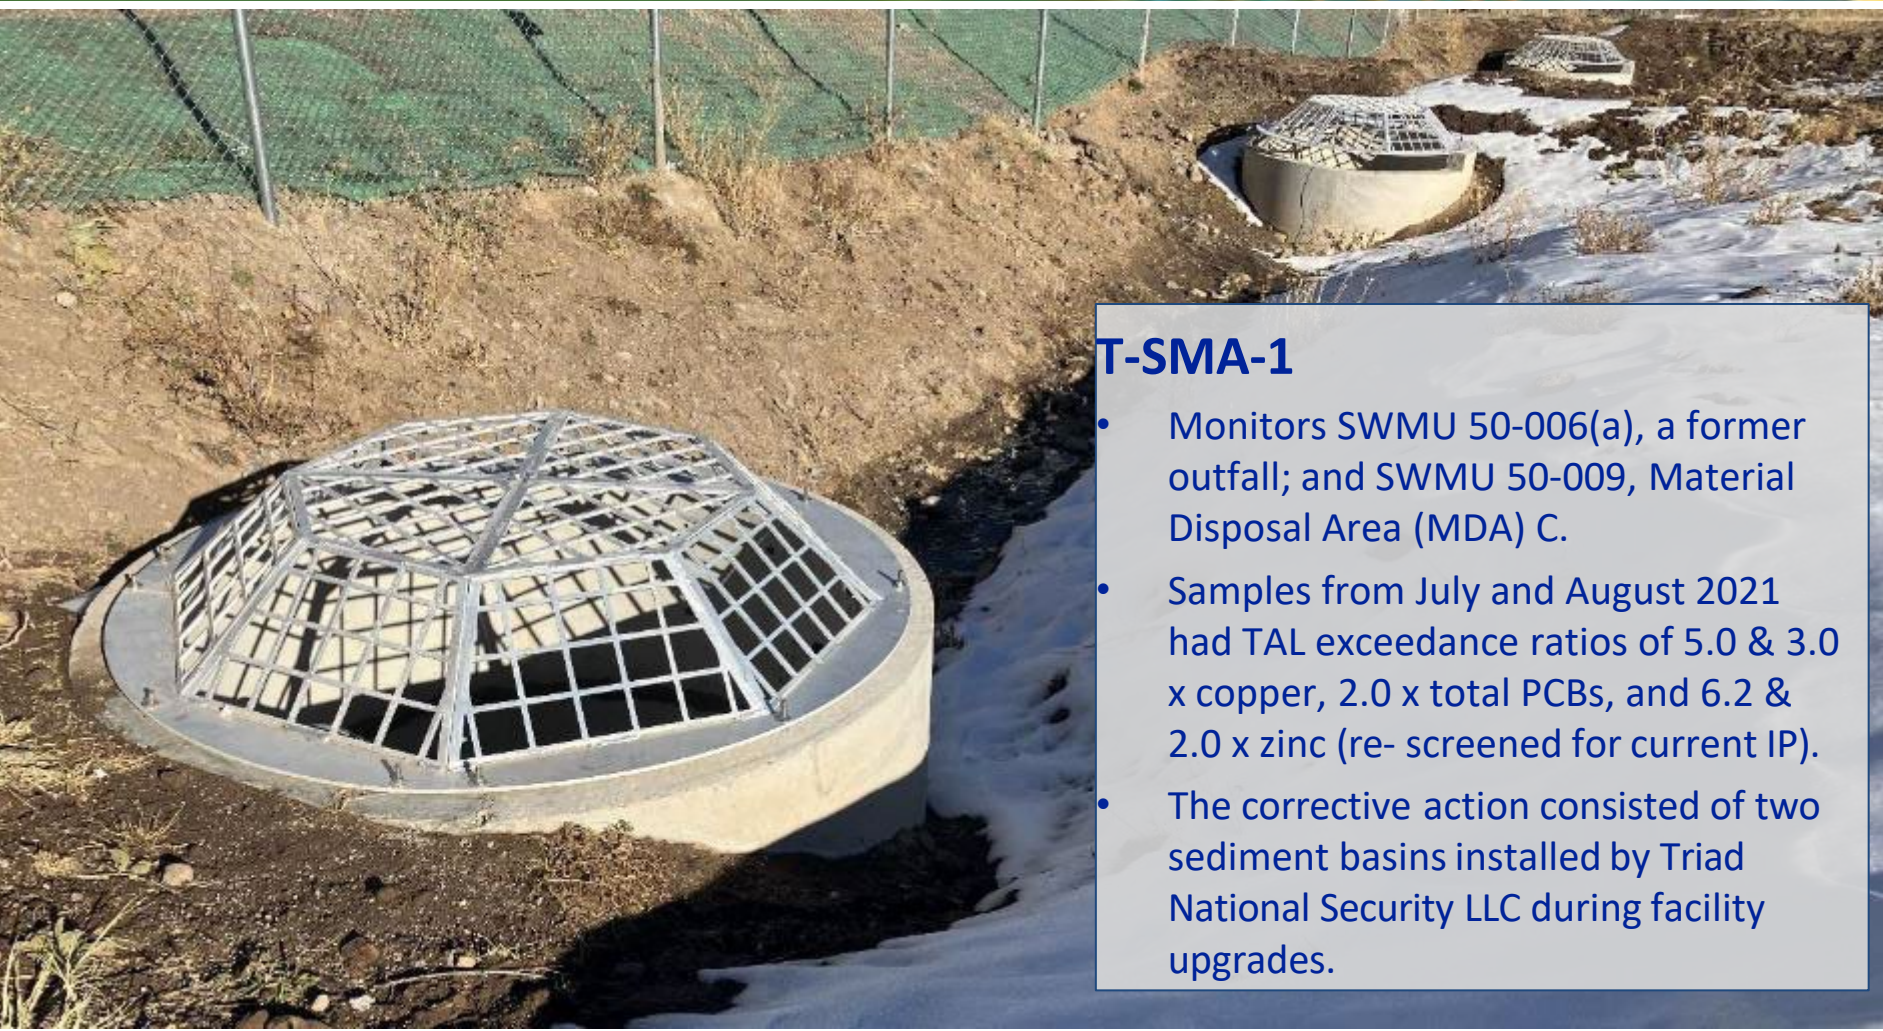
## T-SMA-1

- Monitors SWMU 50-006(a), a former outfall; and SWMU 50-009, Material Disposal Area (MDA) C.
- Samples from July and August 2021 had TAL exceedance ratios of 5.0 & 3.0 x copper, 2.0 x total PCBs, and 6.2 & 2.0 x zinc (re- screened for current IP).
- The corrective action consisted of two sediment basins installed by Triad National Security LLC during facility upgrades.

Sediment basins T00205020029 and T00205020030 at T-SMA-1.

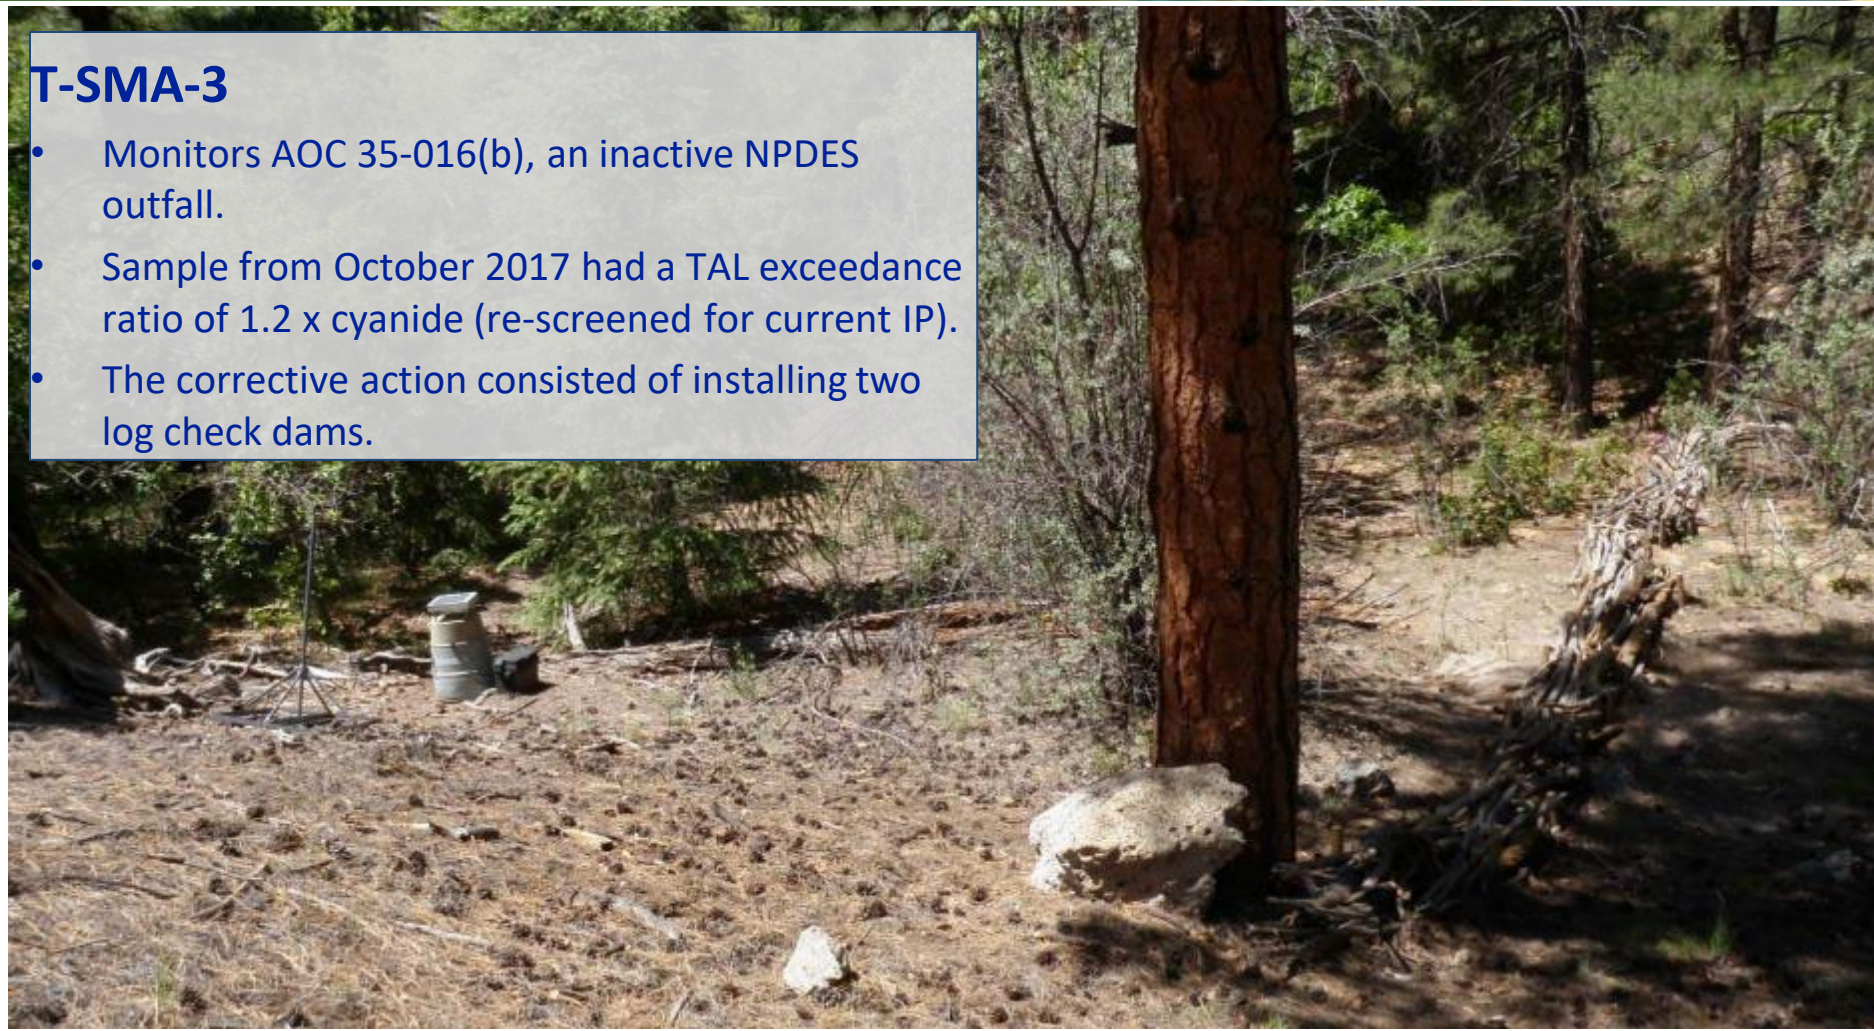
## T-SMA-3

- Monitors AOC 35-016(b), an inactive NPDES outfall.
- Sample from October 2017 had a TAL exceedance ratio of 1.2 x cyanide (re-screened for current IP).
- The corrective action consisted of installing two log check dams.

Sampler and log check dam T00506020015 at T-SMA-3.

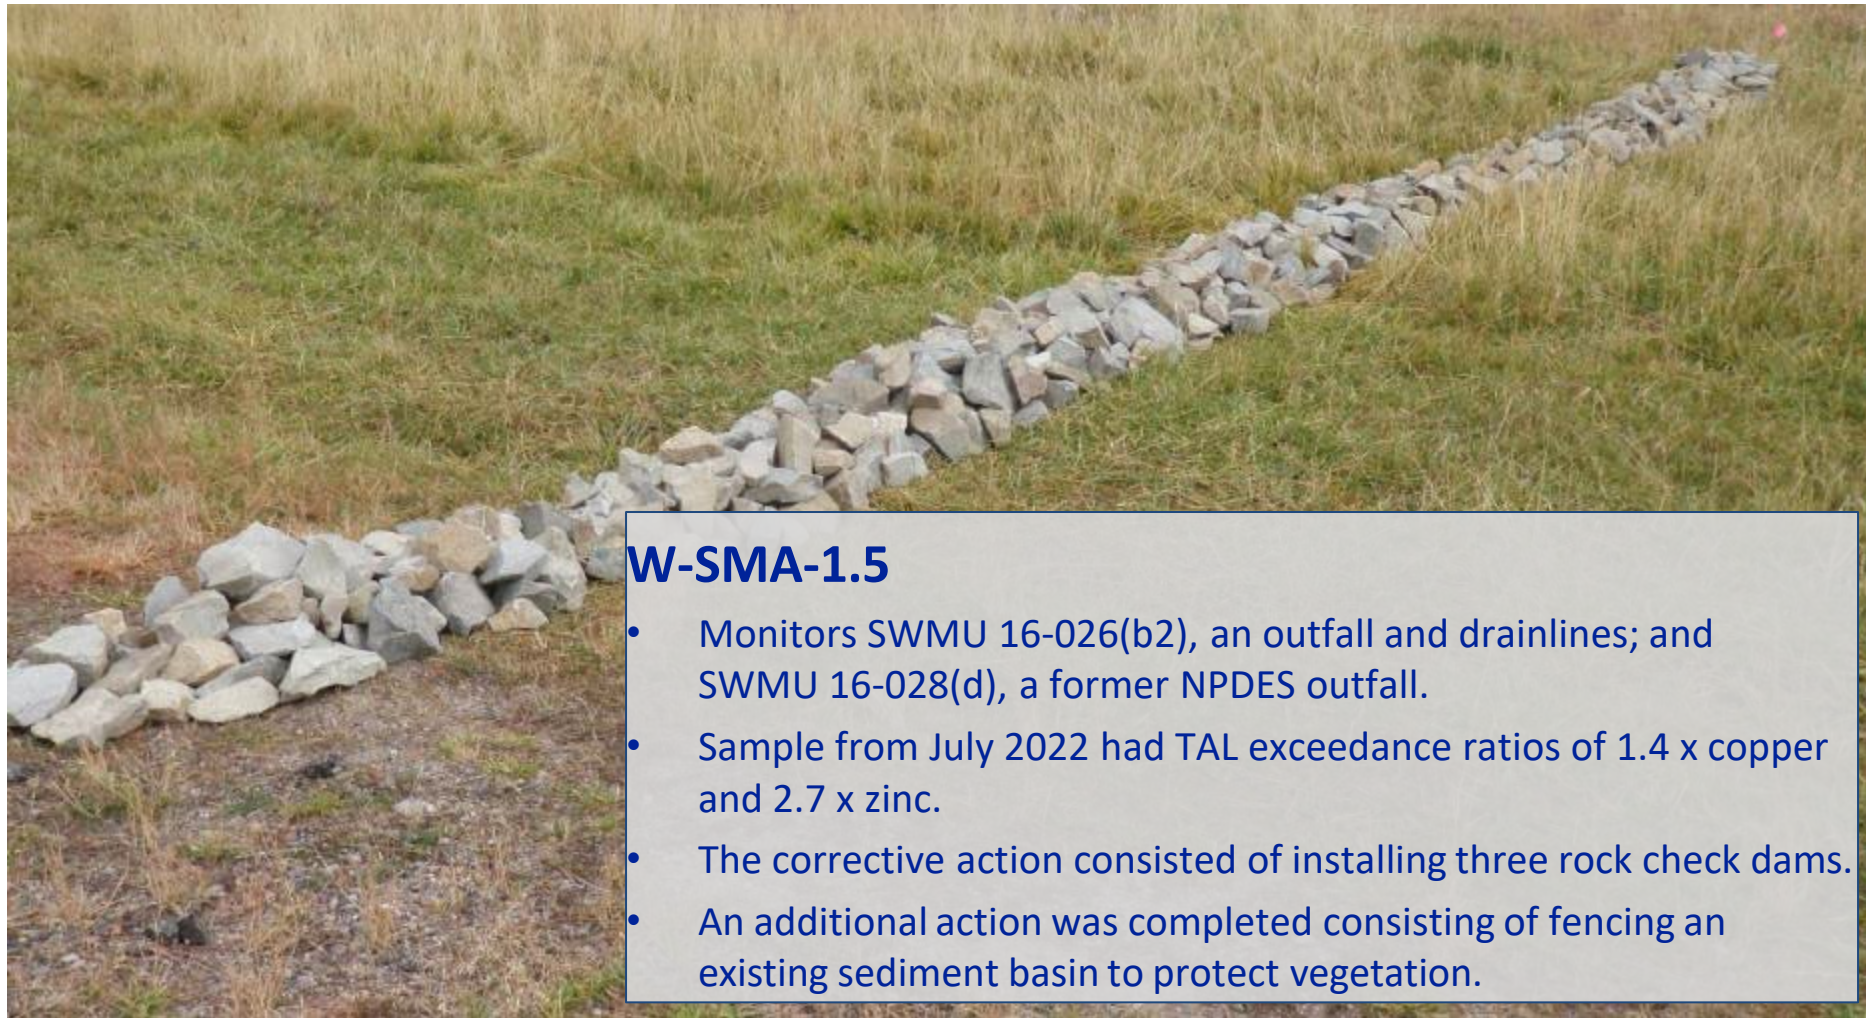
## W-SMA-1.5

- Monitors SWMU 16-026(b2), an outfall and drainlines; and SWMU 16-028(d), a former NPDES outfall.
- Sample from July 2022 had TAL exceedance ratios of 1.4 x copper and 2.7 x zinc.
- The corrective action consisted of installing three rock check dams.
- An additional action was completed consisting of fencing an existing sediment basin to protect vegetation.

Rock check dam W00206010026 at W-SMA-1.5.

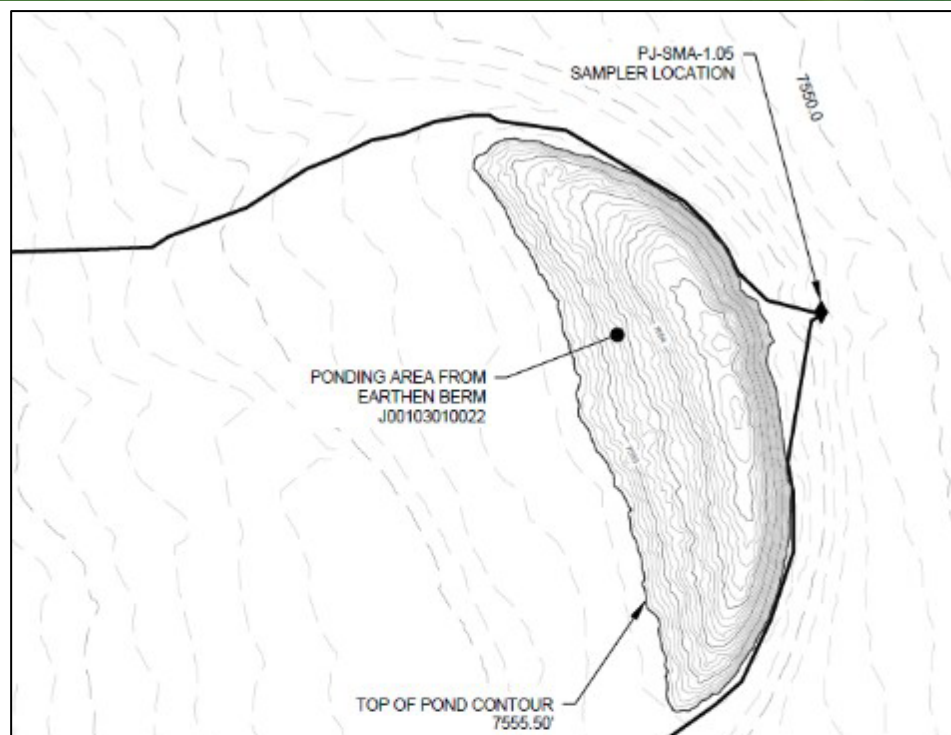
# 3-year, 24-hour Retention Certifications Scheduled for 2025 – PJ-SMA-1.05, S-SMA-3.51, and STRM-SMA-5.05

Earthen Berm	3-year, 24-hour Storm Runoff Volume (ft <sup>3</sup> )	Pond Retention Volume (ft <sup>3</sup> )	Volume Difference (ft <sup>3</sup> )	Maximum Allowable Sediment Accumulation Stage (ft)
J00103010022	450	2,717	2267	2.0
