Individual Permit Corrective Actions Update February 28, 2024

Grayson Vogel, PEWater Programs Engineering Manager N3B/T2S

New Individual Permit NM0030759

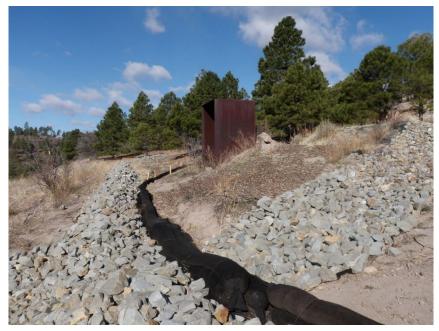
- This site monitors SWMU 40-003(a), a former detonation area.
- It had 8.2 & 10 x copper and 3.6 x gross alpha TAL exceedances from June 2021 and August 2021 samples.
- The corrective action consisted of installing compost logs and lining a swale with riprap.

New stormwater controls at PJ-SMA-11

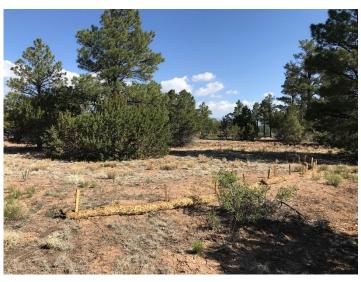
- This site monitors AOC 49-008(c), potentially contaminated soil from radiochemistry operations and containment experiments.
- It had 6.3 x aluminum and 3.0 x gross alpha TAL exceedances from September 2013 and August 2021 samples.
- The corrective action consisted of installing wood chip wattles.

New stormwater controls at W-SMA-11.7

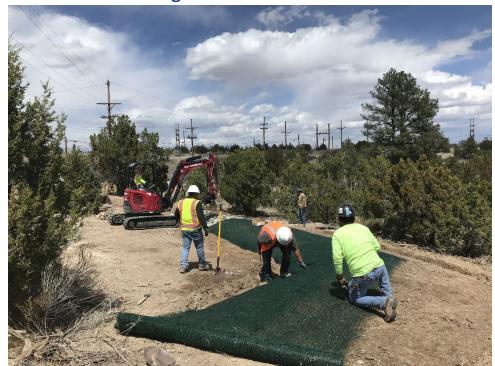
- This site monitors SWMU 33-004(h), a warehouse outfall; SWMU 33-011(d), a former storage area; SWMU 33-015, a former incinerator; and AOC 33-008(c), a former surface disposal area.
- It had 2.0 x copper and 2.4 x gross alpha TAL exceedances from May and August 2021 samples.
- The corrective action consisted of installing an earthen berm.

Earthen berm construction at CHQ-SMA-1.02

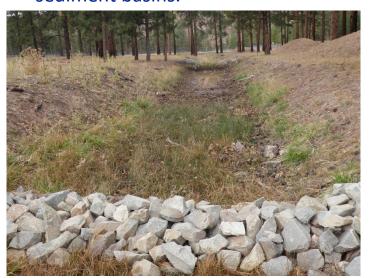
- BTV and 1.4 x copper TAL, and 2.7 x zinc exceedances from a July 2022 sample.
- The corrective action installation is complete and certification is in process. The corrective action consisted of installing rock berms.
- An additional action consisting of vegetation planting and fencing a sediment basin is planned for spring 2024.

Sediment basin at W-SMA-1.5

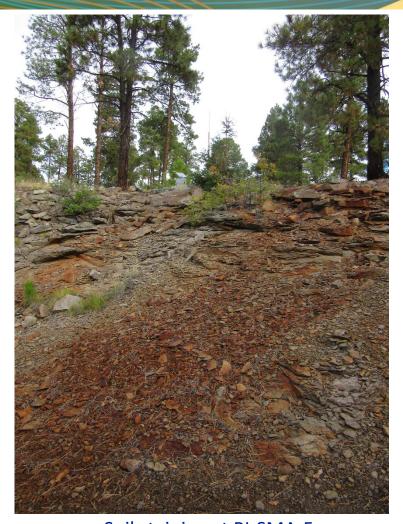
- This site monitors SWMU 22-015(c), a former NPDES outfall.
- It had BTV and 126.0 & 32.3 x copper TAL exceedances from May 2021 and July 2022 samples.
- The corrective action installation is scheduled for February 2024. The corrective action will consist of a diversion berm and large compost logs.

Soil staining at PJ-SMA-5

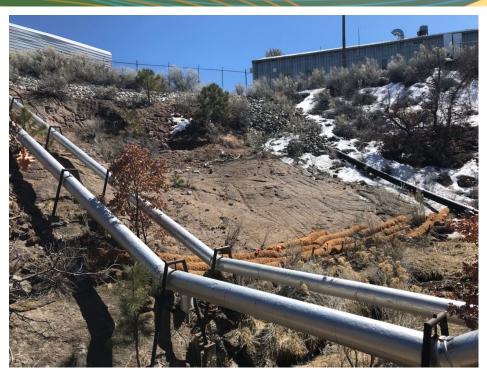
S-SMA-2

- This site monitors SWMU 03-012(b), 03-045(b), operational releases from cooling towers, 03-045(c), a cooling tower outfall, and 03-056(c), a former outdoor transformer storage area.
- It had BTV and 160 x PCB TAL exceedances from July and August 2013 samples.
- The corrective action installation is scheduled for May 2024. The corrective action will consist of a shotcrete cap.

Soil removal area at SWMU 03-056(c) with existing stormwater controls.
