EMID-700411

2018 Update to the Site Discharge Pollution Prevention Plan, Revision 1

NPDES Permit No. NM0030759

Volume 3

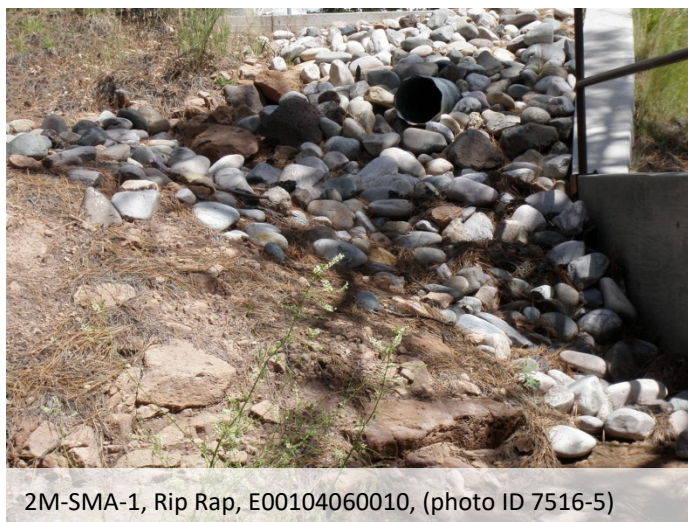
2M-SMA-1, Rip Rap, E00104060010, (photo ID 7516-5)

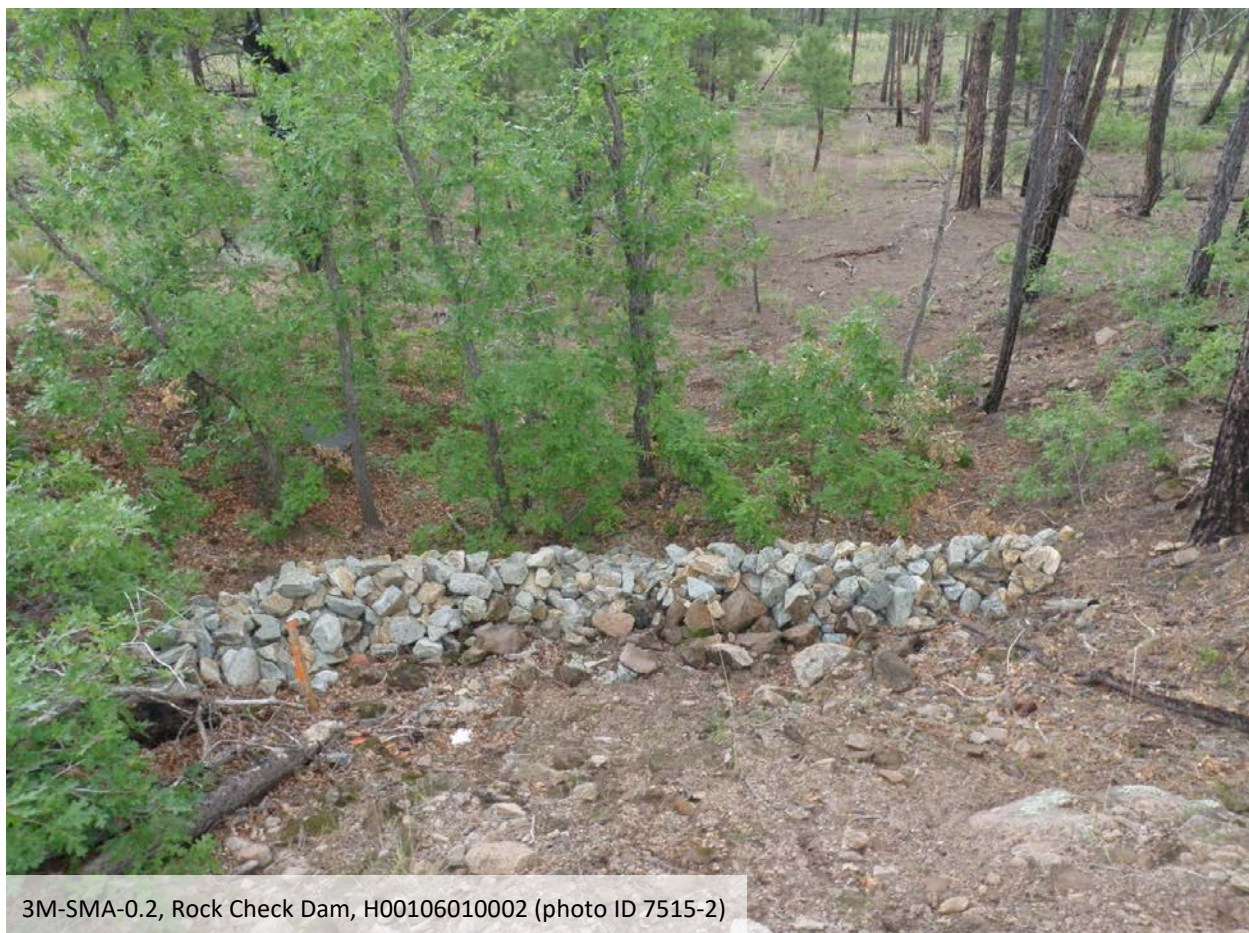
3M-SMA-0.2, Rock Check Dam, H00106010002 (photo ID 7515-2)
