EMLA-2021-0019-02-001

Subject:Biennial Inspection and Maintenance Report on Erosion Controls Associated with Solid
Waste Management Unit 16-003(o) within Fishladder Canyon

Figures for the Biennial Inspection and Maintenance Report on Erosion Controls Associated with Solid Waste Management Unit 16-003(o) within Fishladder Canyon

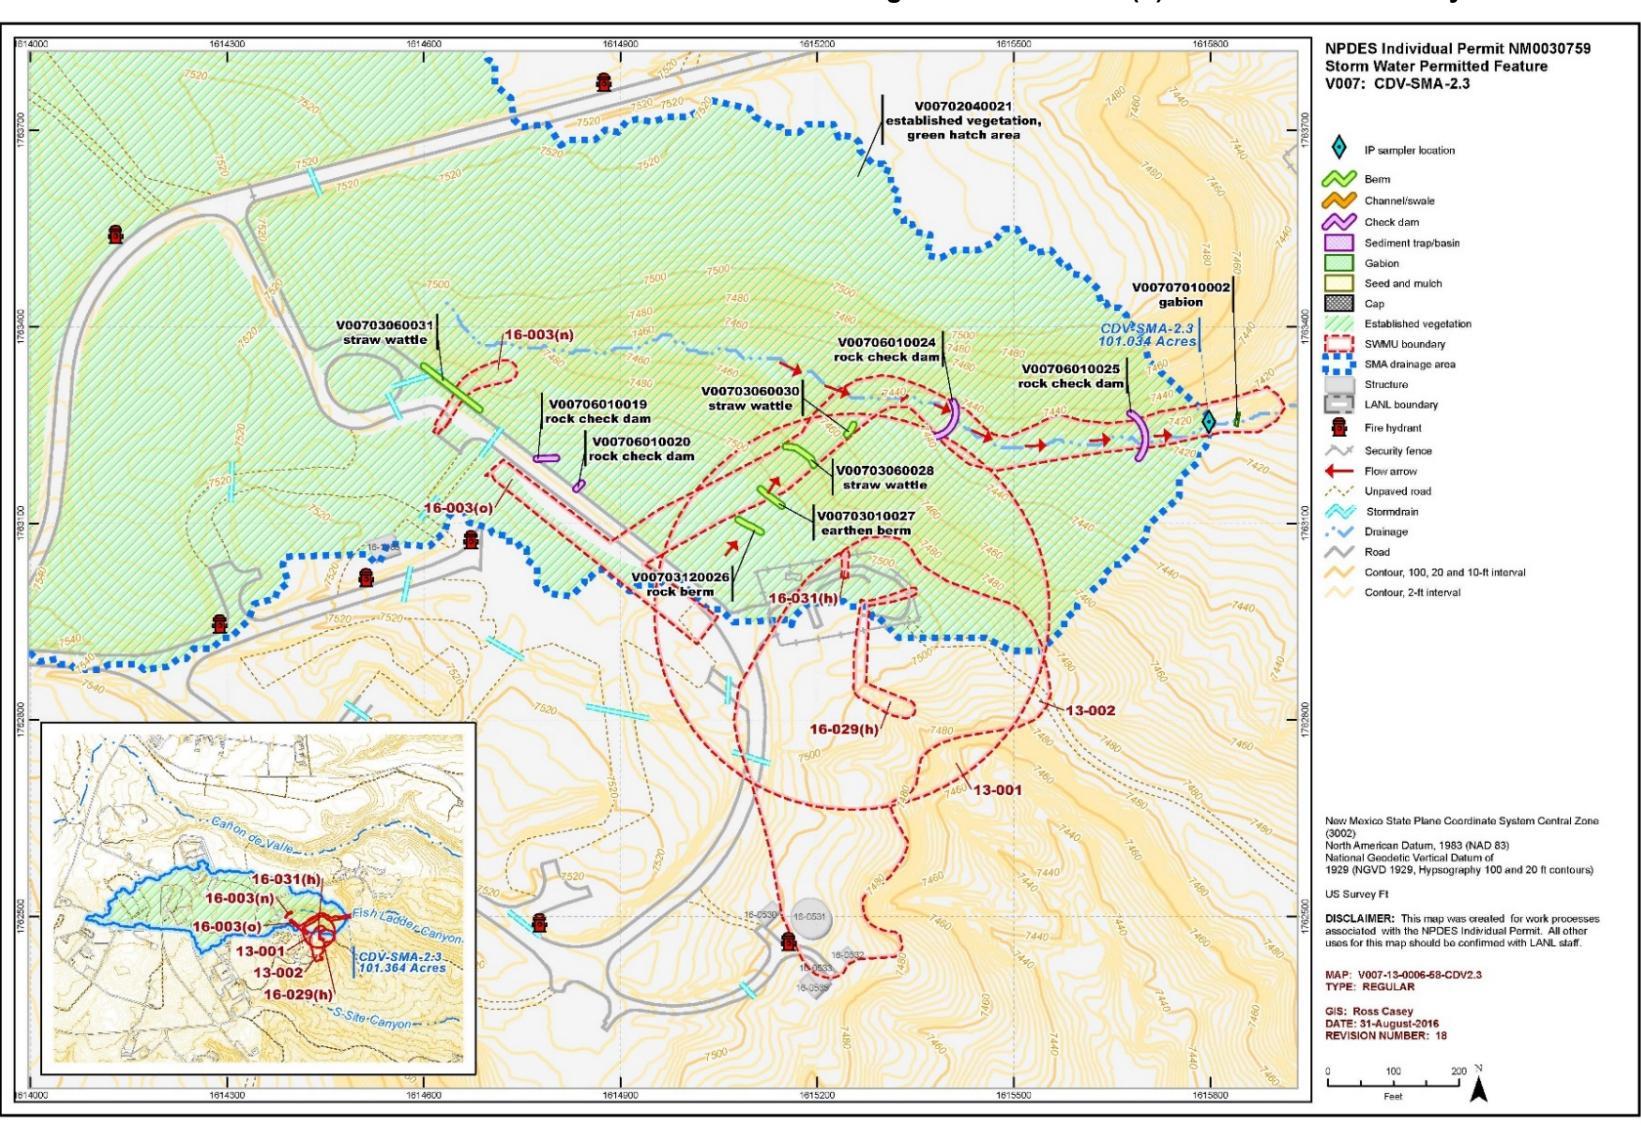
Figure 1 also shows the Individual Permit sampler location as well as erosion and sedimentation controls for other SWMUs associated with the SMA. Controls specifically associated with SWMU 16-003(o) consist of a rock berm (-0026), an earthen berm (-0027), straw wattles (-0028 and -0030), rock check dams (-0024 and -0025), and the small gabion structure (-0002) installed during the Phase II investigation. The photographs in Figures 2 through 19, taken in 2019 and 2020, show these controls as well as general site conditions. Other controls in this SMA are associated with SWMU 16-003(n) and are not evaluated as part of this submittal.

Figure 1 Individual Permit sample locations and storm water controls as well as SWMUs associated with CDV-SMA-2.3A

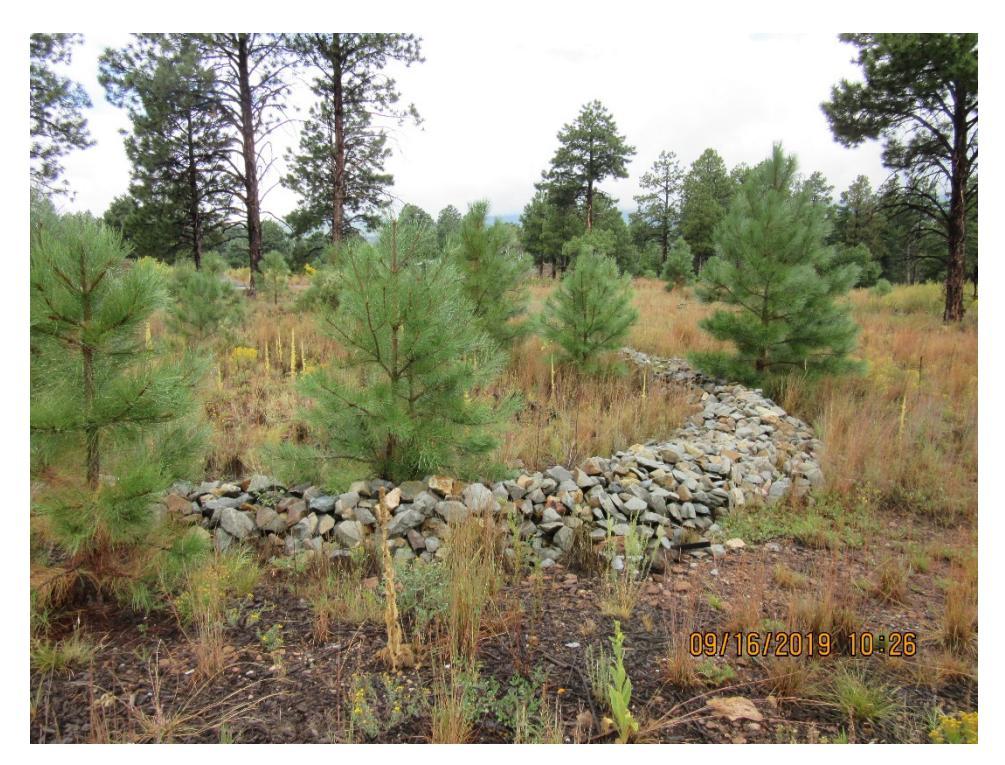
Figure 2 Rock berm (V00703120026, center of photo) at the top of drainage leading into Fishladder Canyon (September 2019). Note established vegetation. Condition of control: excellent.

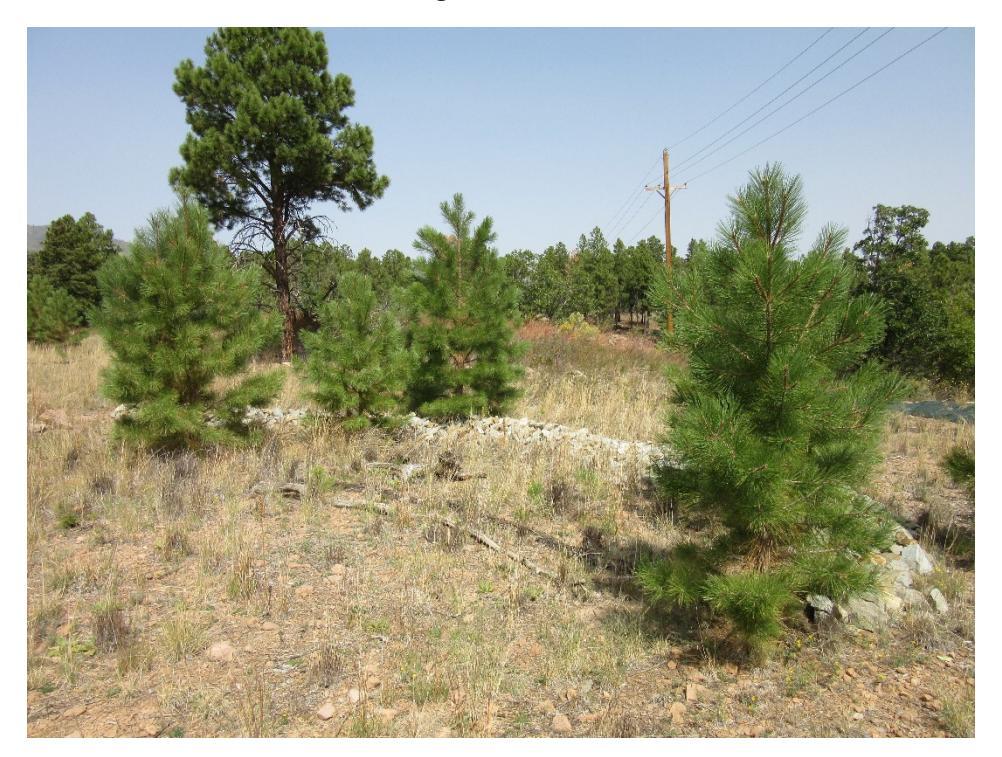
Figure 3 Rock berm (V00703120026, center of photo) at the top of drainage leading into Fishladder Canyon (September 2020). Note established vegetation. Condition of control: excellent.

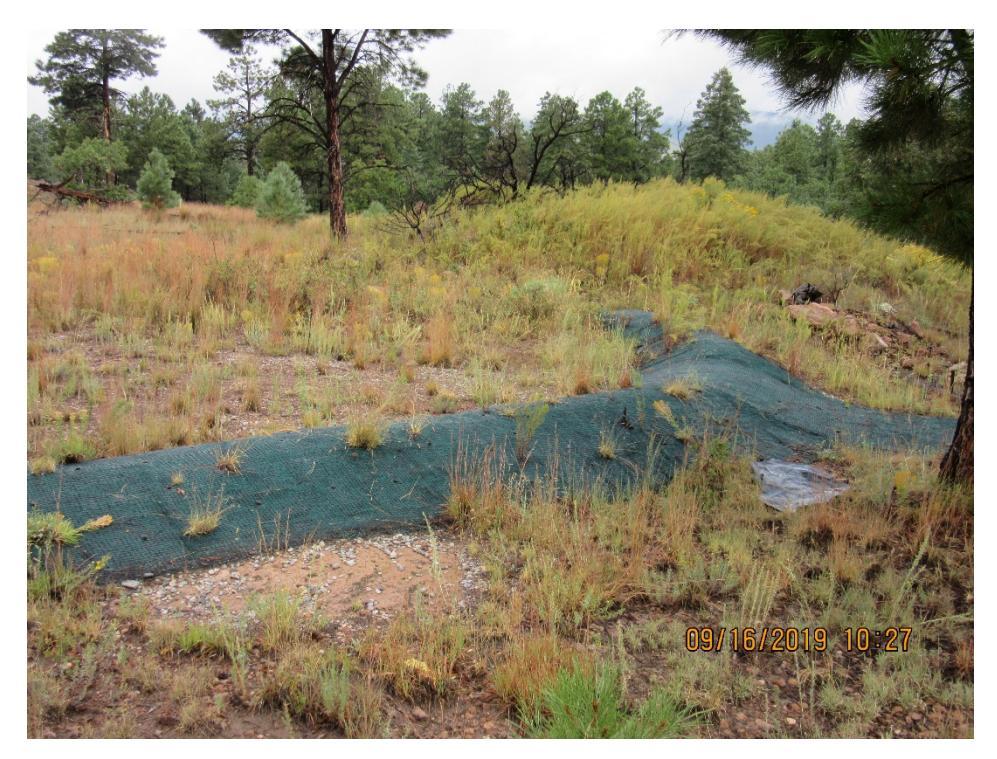
Figure 4 Earthen berm V00703010027, center of photo) at the top of drainage leading into Fishladder Canyon (September 2019). Note established vegetation. Condition of control: excellent.

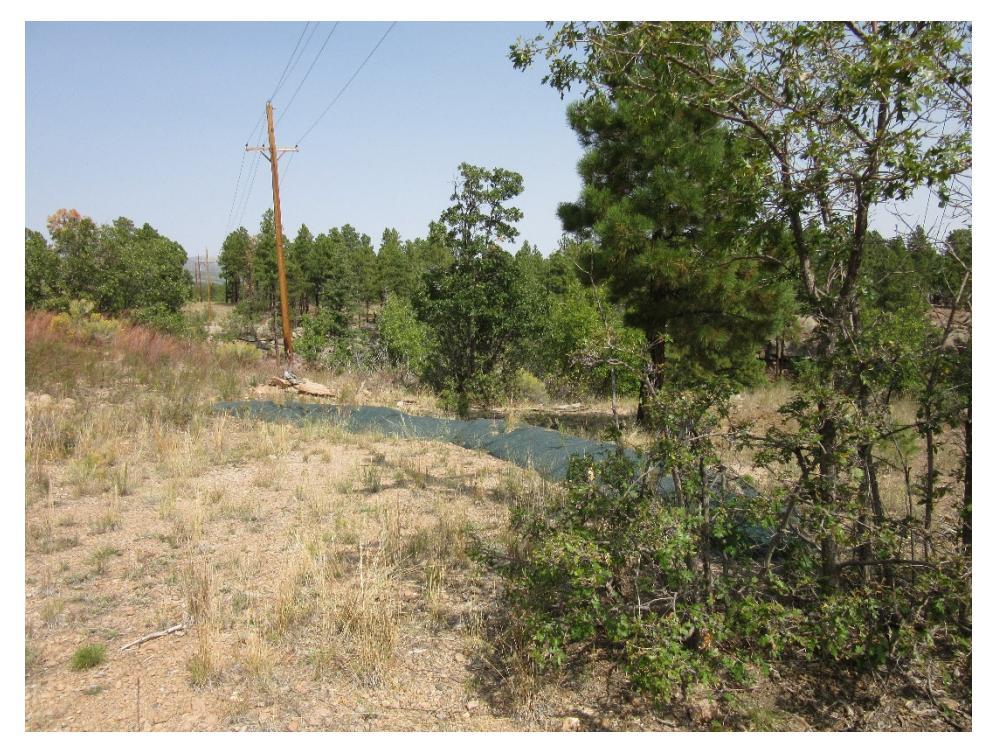
Figure 5 Earthen berm (V00703010027, center of photo) at the top of drainage leading into Fishladder Canyon (September 2020). Note established vegetation. Condition of control: excellent.

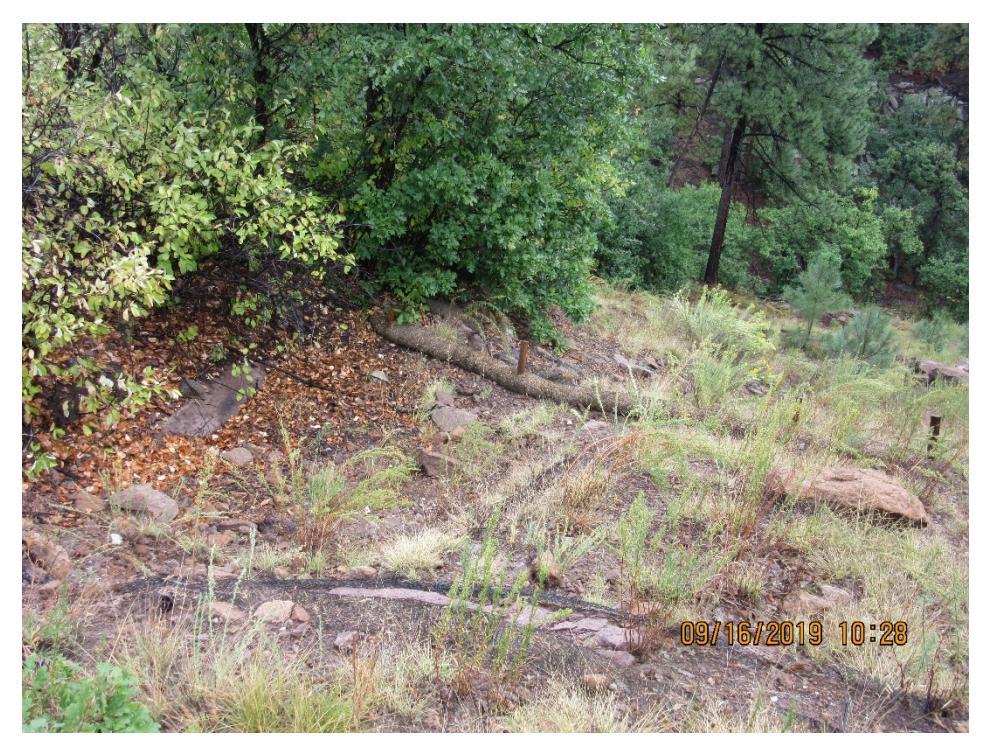
Figure 6 View downslope of the former fishladder location (September 2019). Note established vegetation above and below straw wattle (V00703060028, center of photo). Condition of control: good.

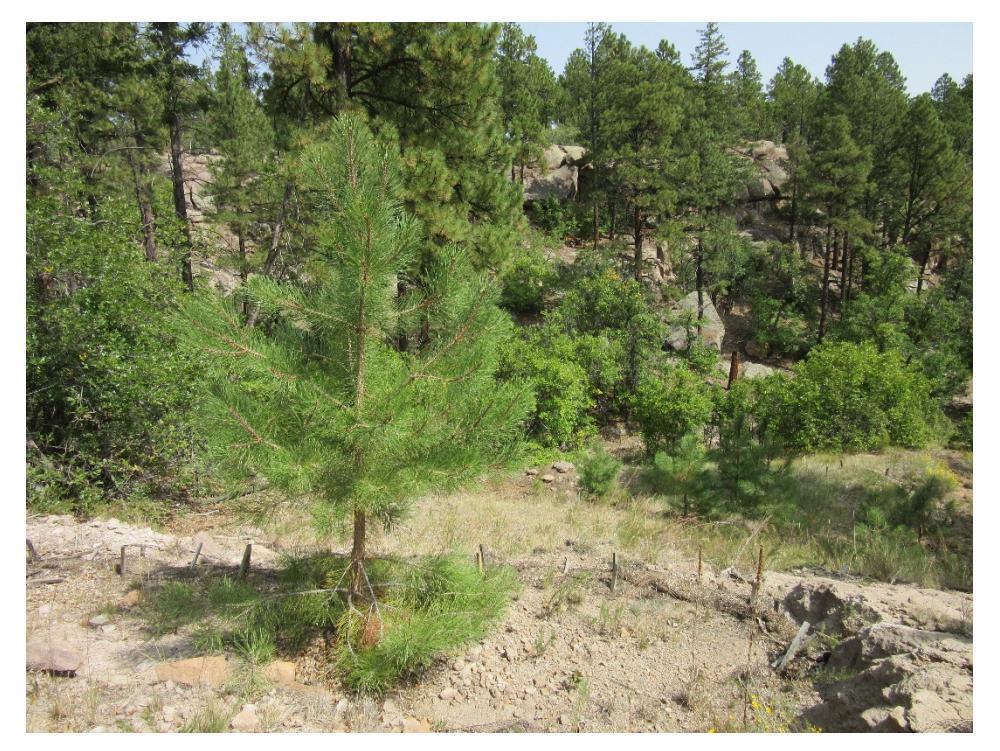
Figure 7 View downslope of the former fishladder location (September 2020). Note established vegetation above and below retired straw wattle. No active controls visible in photo.

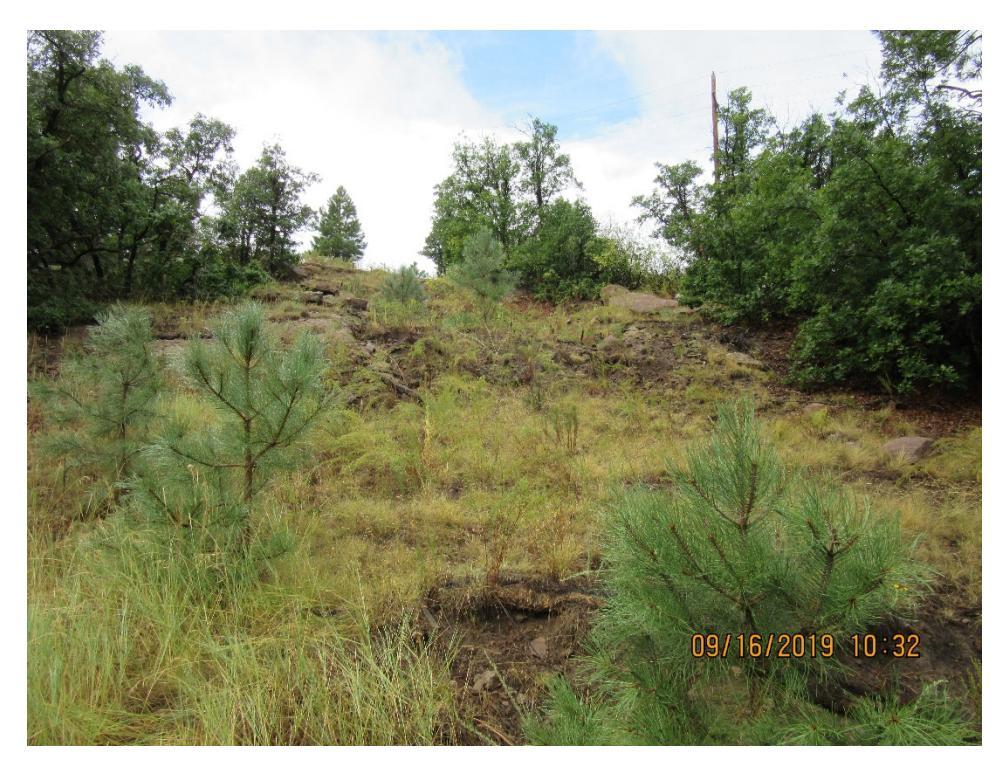
Figure 8 View upslope of the former fishladder location from the canyon bottom (September 2019). Note established vegetative cover and lack of erosional features. Control not visible in photo.

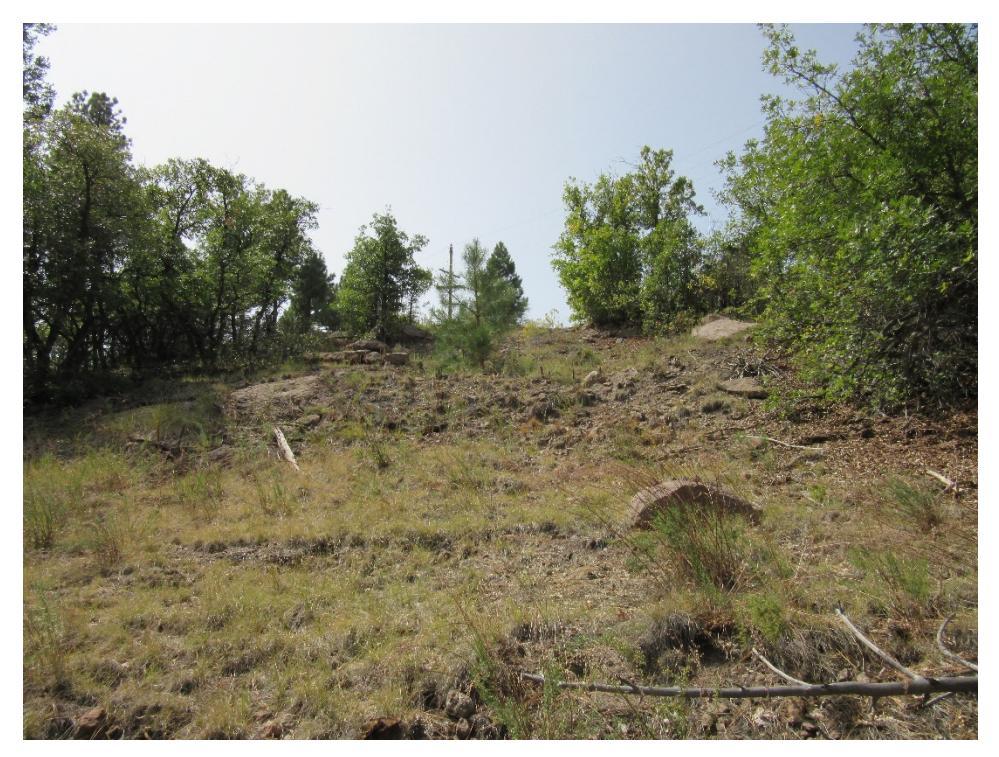
Figure 9 View upslope of the former fishladder location from the canyon bottom (September 2020). Note established vegetative cover and lack of erosional features. Control not visible in photo.

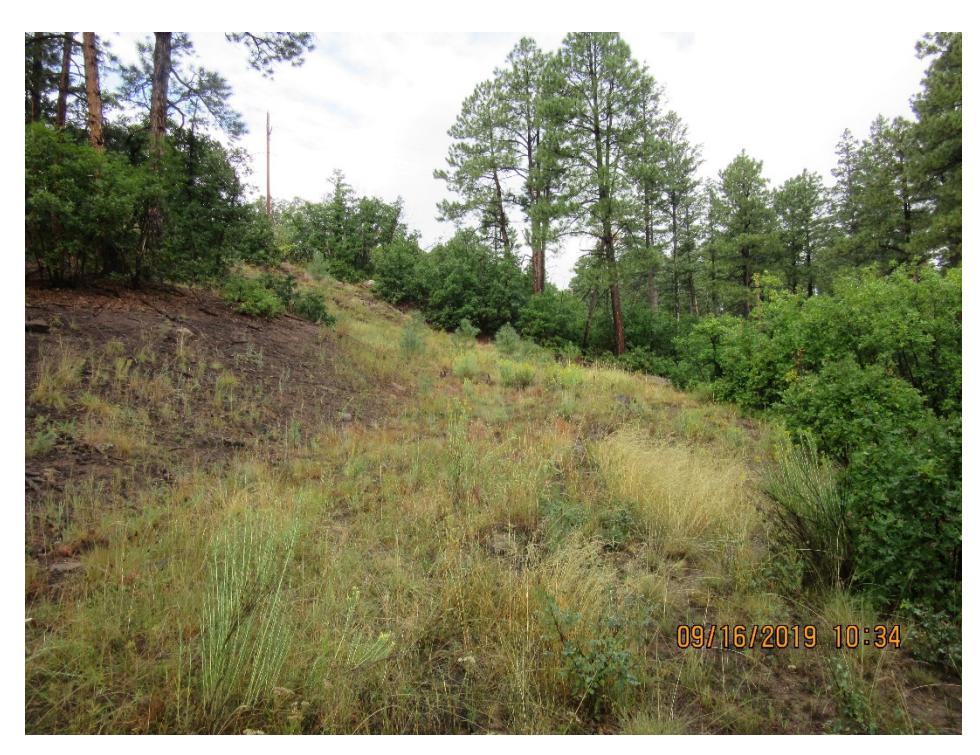
Figure 10 View west of former access road (photo taken at V00703060028, September 2019). Note established vegetation.

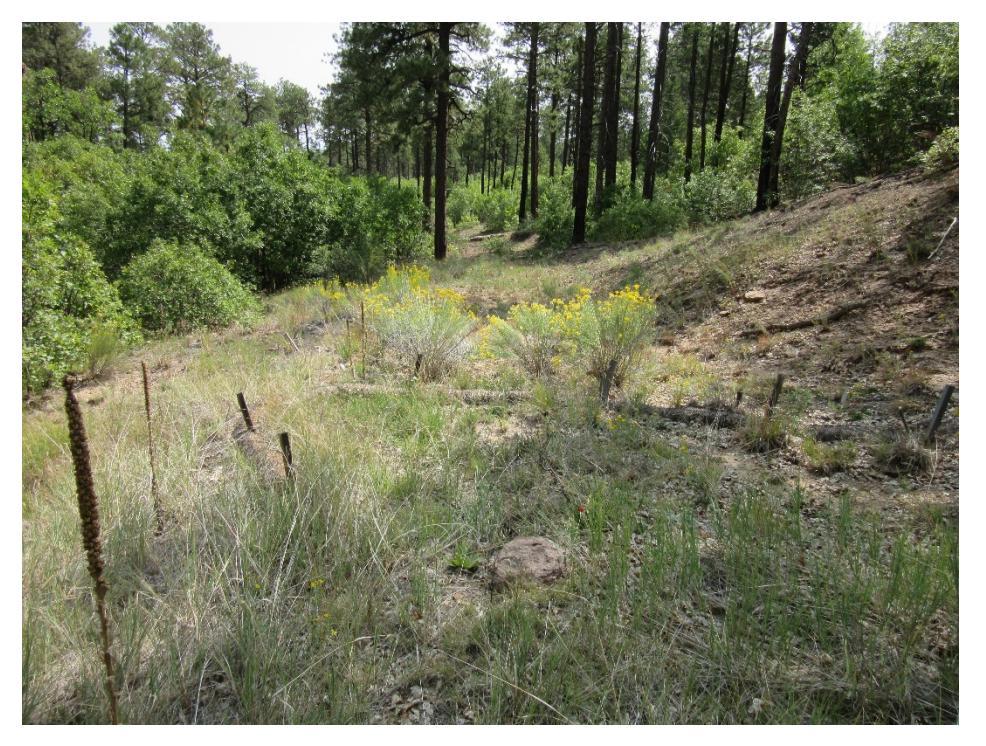
Figure 11 View east of former access road and straw wattle (V00703060028, center of photo, September 2020). Note established vegetation. Condition of control: very good.

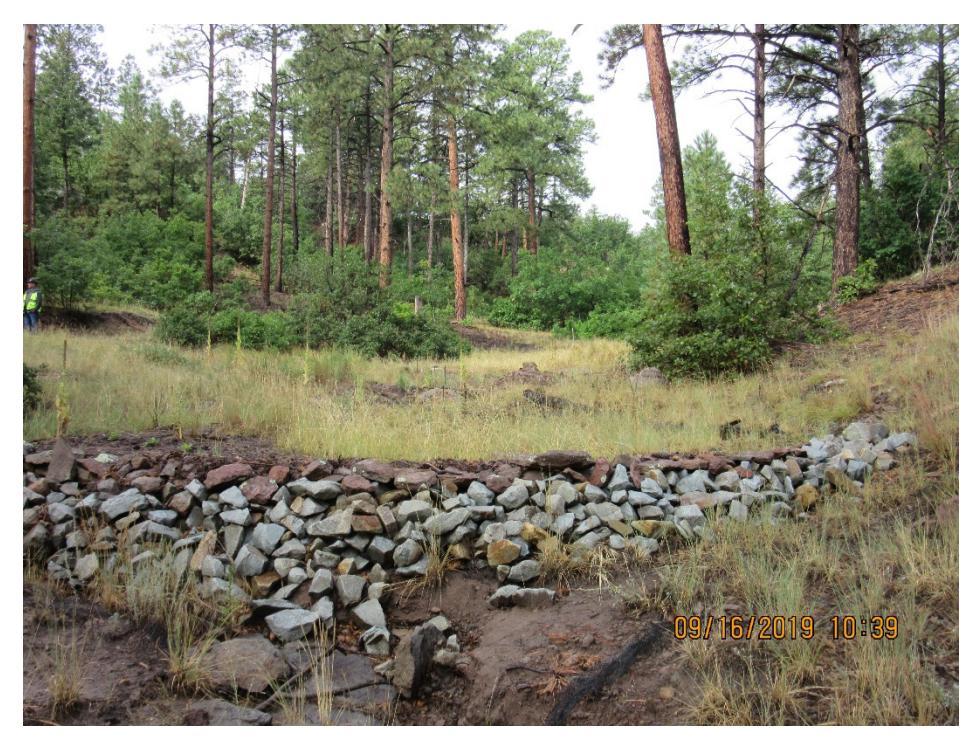
Figure 12 Rock check dam (V00706010024, center of photo) in Fishladder Canyon primary drainage (September 2019). Condition of control: very good.

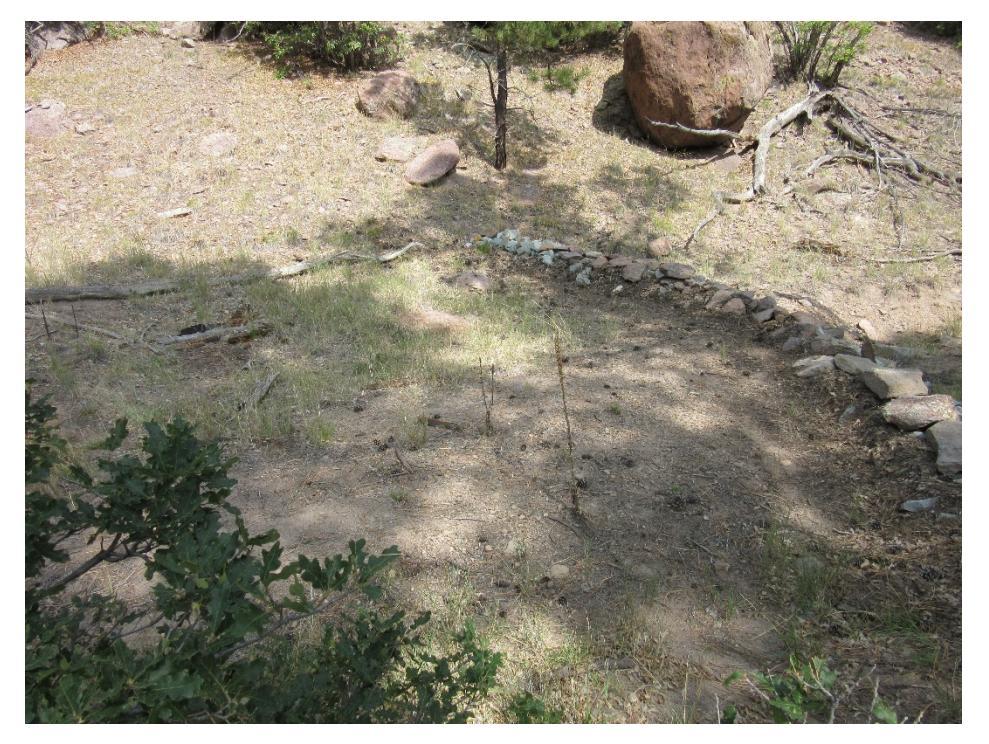
Figure 13 Rock check dam (V00706010024, center of photo) in Fishladder Canyon primary drainage (September 2020). Condition of control: very good.

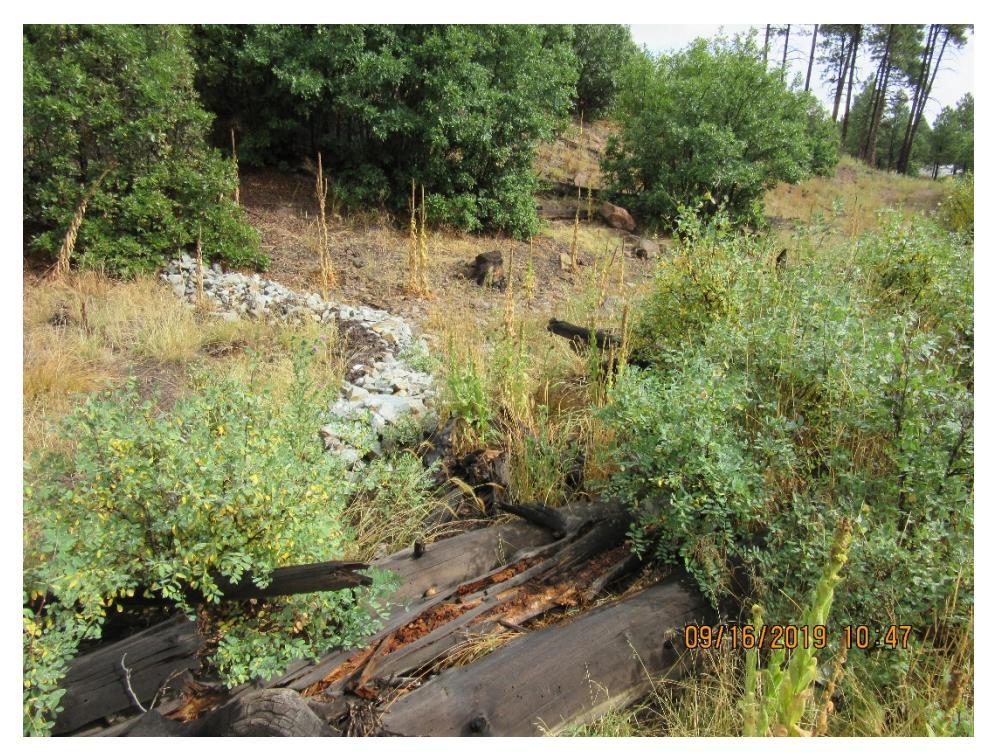
Figure 14 Rock check dam (V00706010025, center of photo) in primary drainage (September 2019). Note established vegetation in channel. Condition of control: excellent.

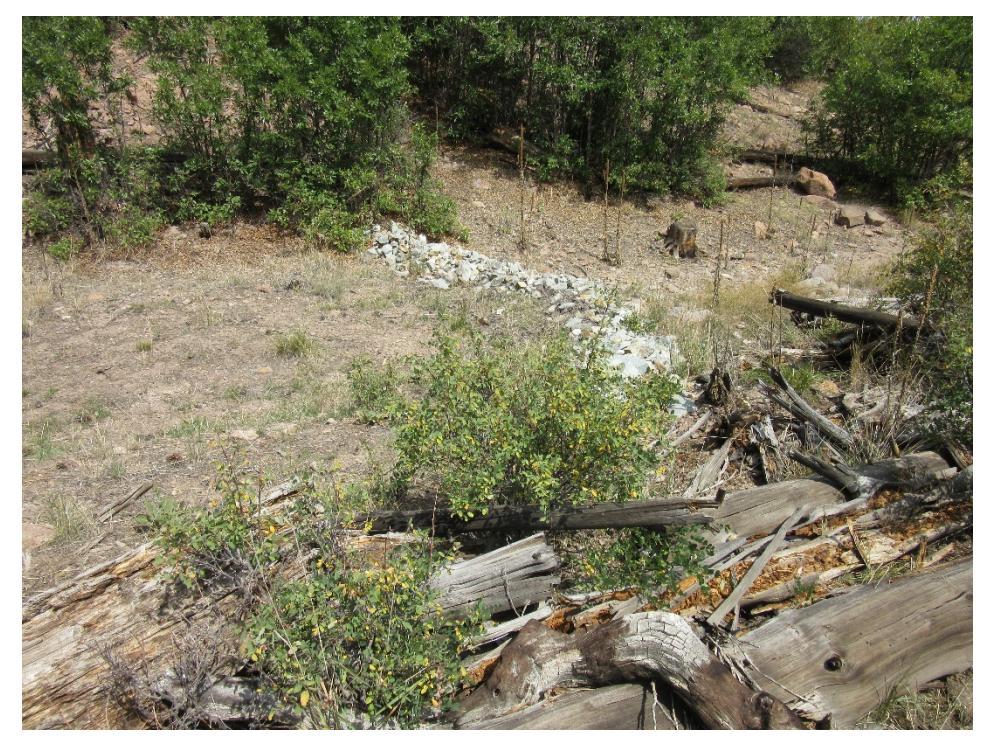
Figure 15 Rock check dam (V00706010025, center of photo) in primary drainage (September 2020). Note established vegetation in channel. Condition of control: excellent.

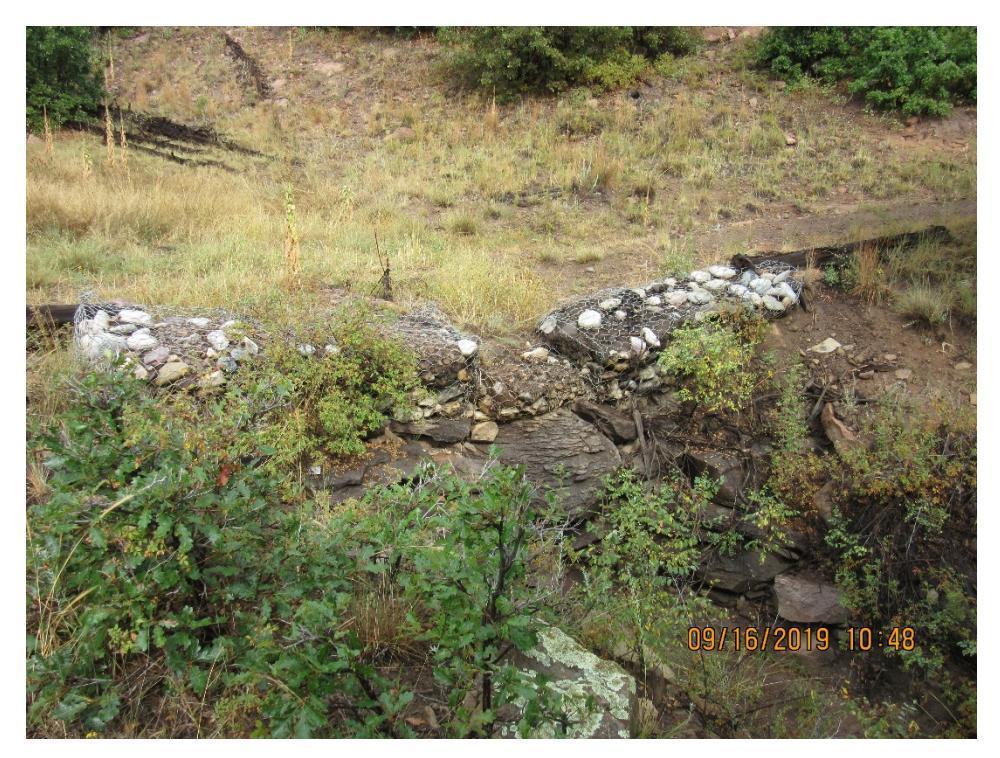
Figure 16 Gabion (V00707010002, center of photo) at access road crossing in Fishladder Canyon (September 2019). Note vegetation in channel upstream of control. Condition of control: good.

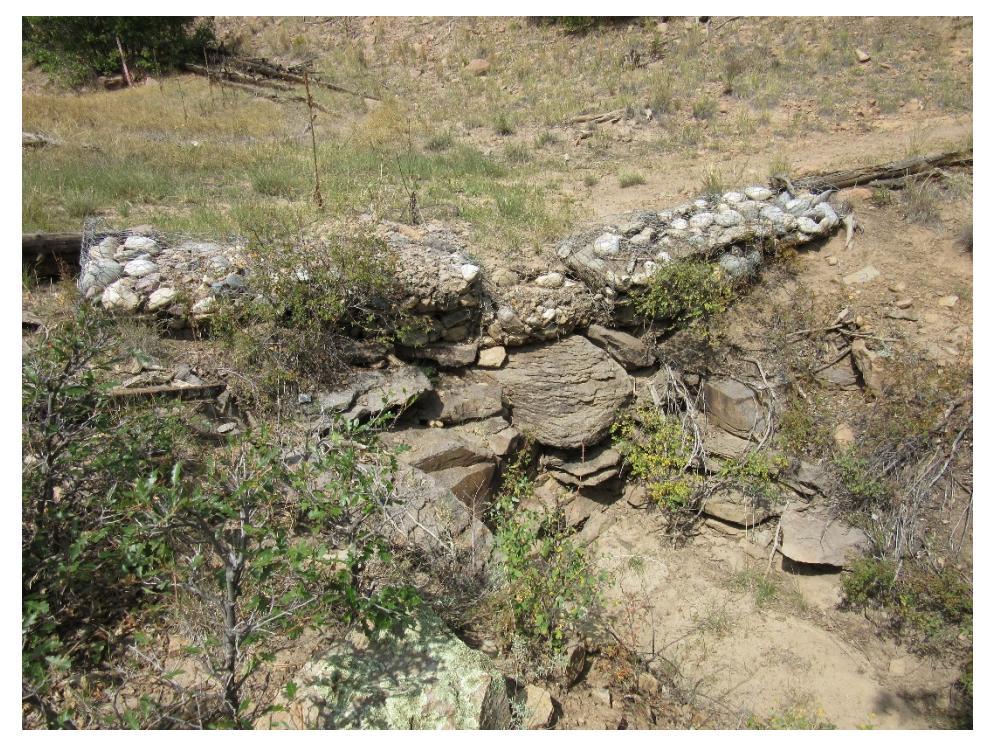
Figure 17 Gabion (V00707010002, center of photo) at access road crossing in Fishladder Canyon (September 2020). Note vegetation in channel upstream of control. Condition of control: good.

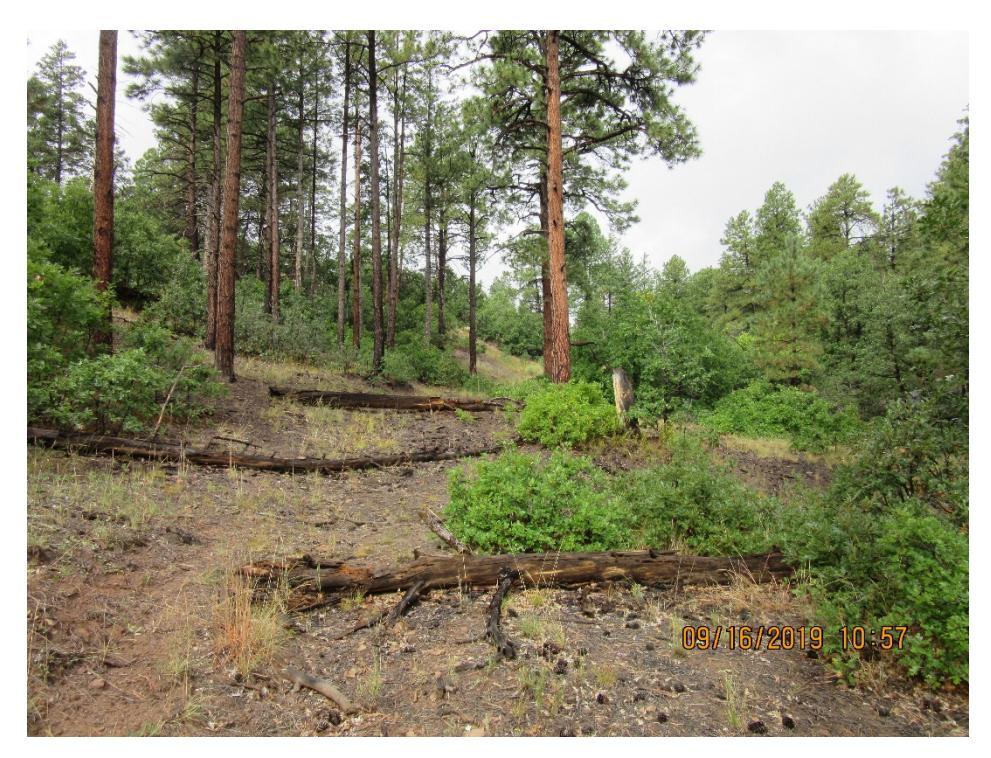
Figure 18 View west of former access road in Fishladder Canyon (September 2019). Note vegetative cover, needle cast, and downed trees along the former access road.

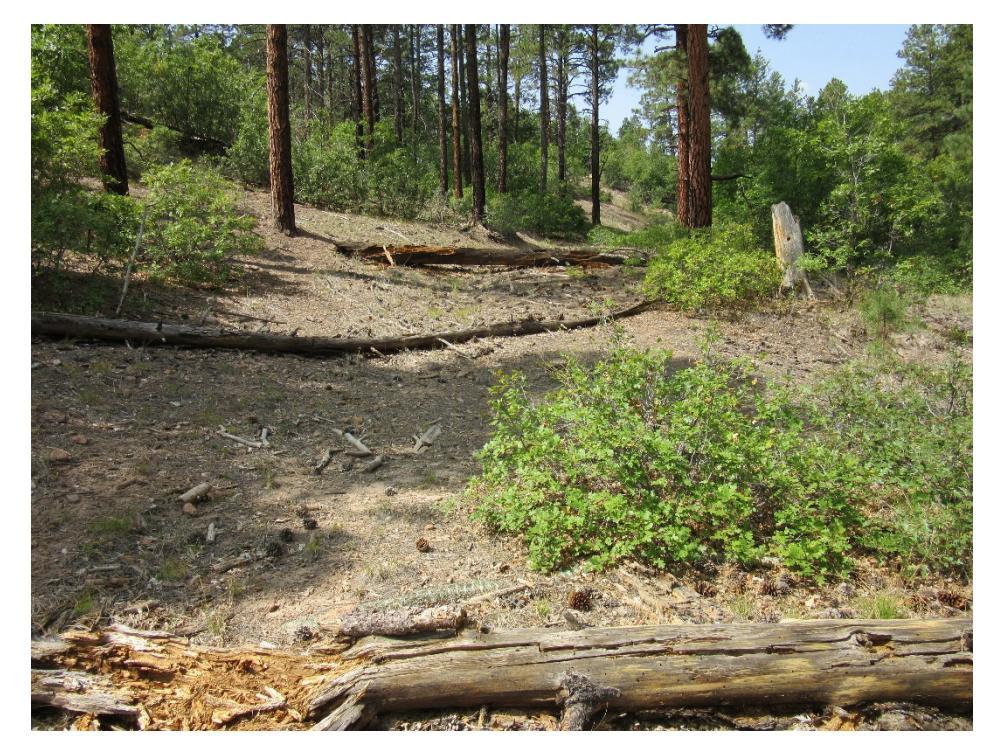
Figure 19 View west of former access road in Fishladder Canyon (September 2020). Note vegetative cover, needle cast, and downed trees along the former access road.
