2021 Update to the Site Discharge Pollution Prevention Plan, Revision 1

NPDES Permit No. NM0030759

May 1, 2022

Pajarito Watershed

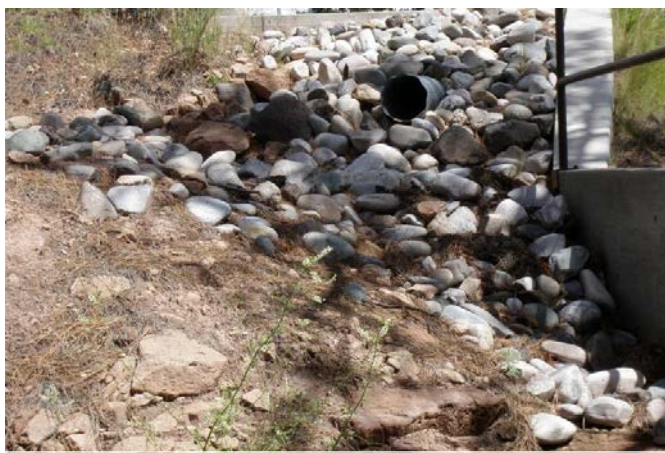
2M-SMA-1, Rip Rap, E00104060010, (photo ID 7516-5)
