Subject:Submittal of the 2022–2023 Annual Long-Term Monitoring Status Report (July 2022
through June 2023) for the Los Alamos County Airport Landfill Cover System
Replacement, Solid Waste Management Units 73-001(a,d) in Technical Area 73

July 2023 EM2023-0423

2022–2023 Annual Long-Term Monitoring Status Report (July 2022 through June 2023) for the Los Alamos County Airport Landfill Cover System Replacement, Solid Waste Management Units 73-001(a,d) in Technical Area 73

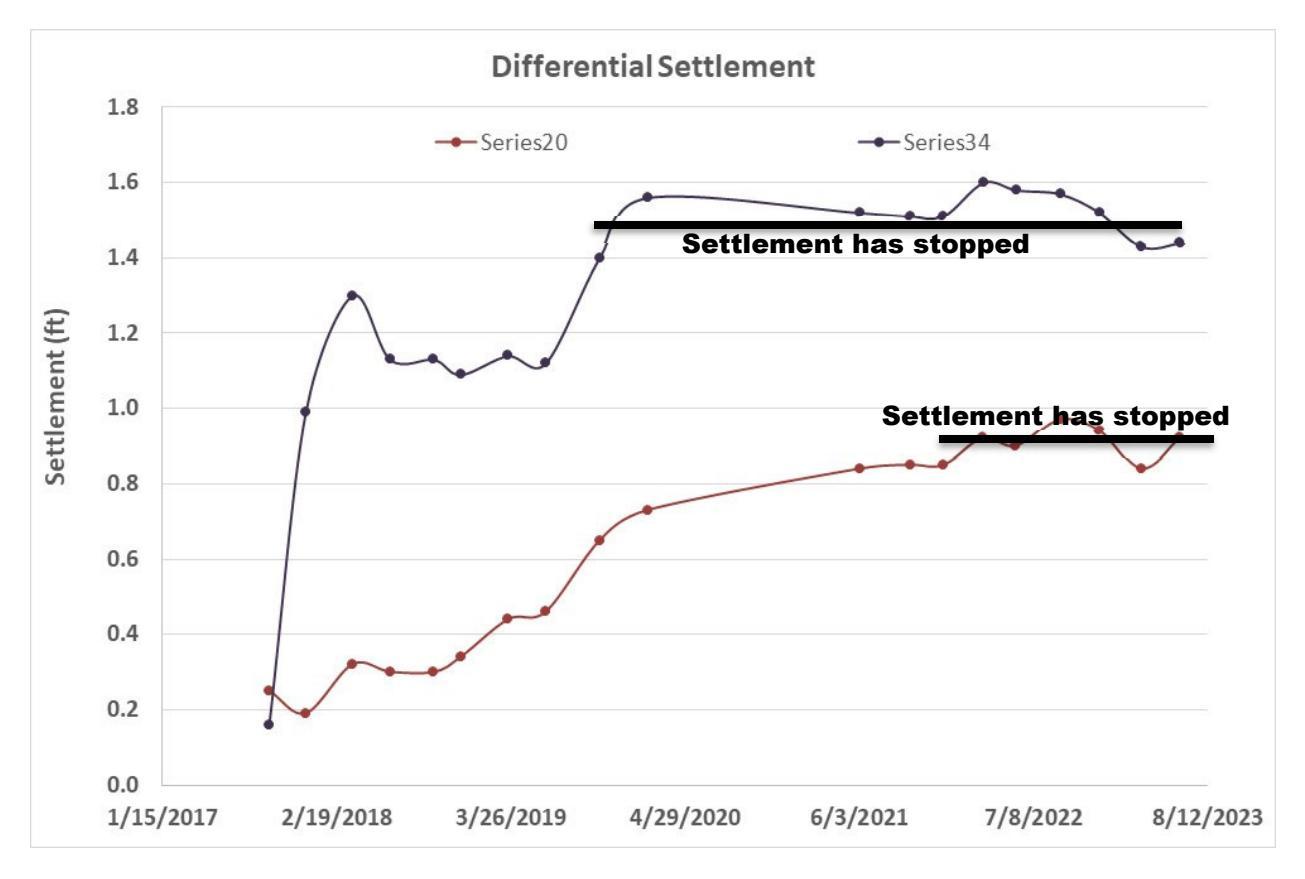
Figure 5 Measured settlement at points 20 and 34

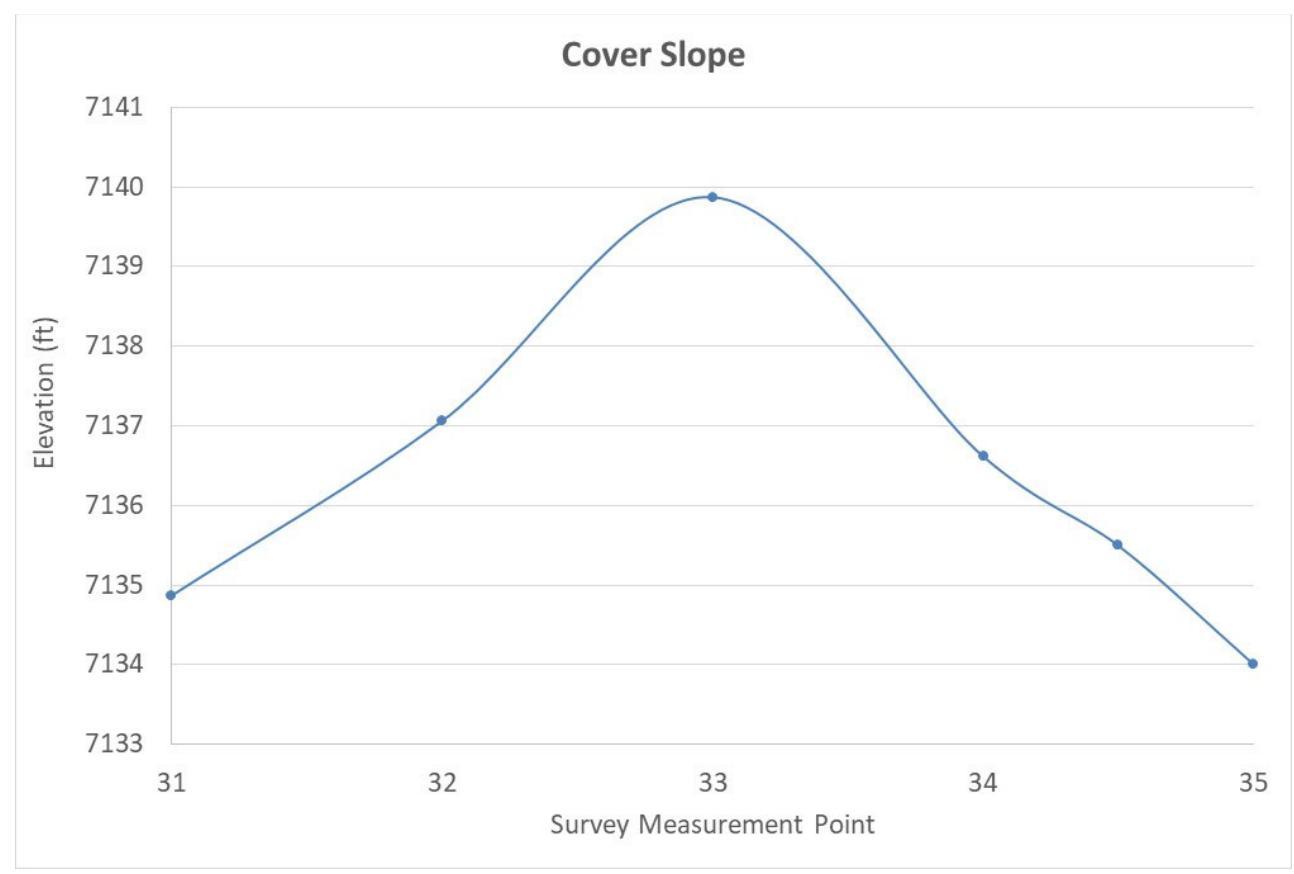
Note: Cross section through cover surface including point 34 where most settlement has been measured indicates there is positive drainage – no ponding.

Figure 6 Elevation cross-section through area with most settlement

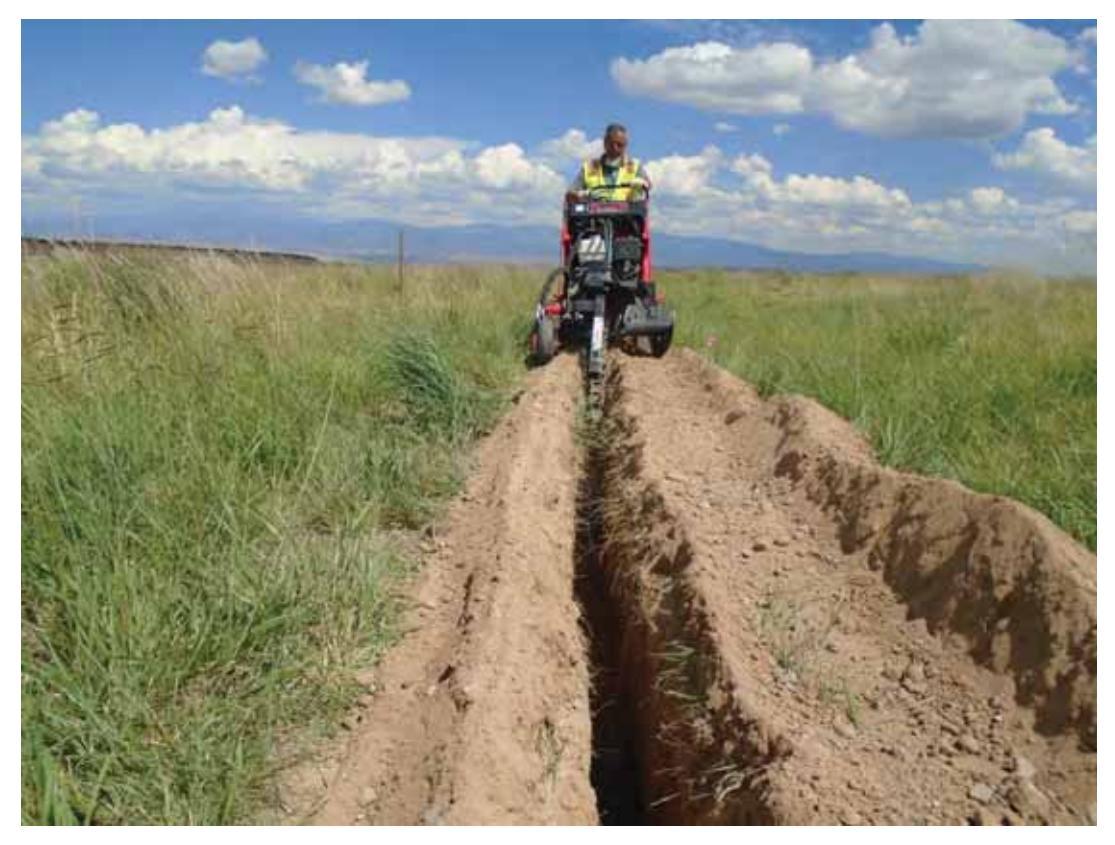
Photo 1 Trenching during landfill cover crack repair. Photo taken August 15, 2022.

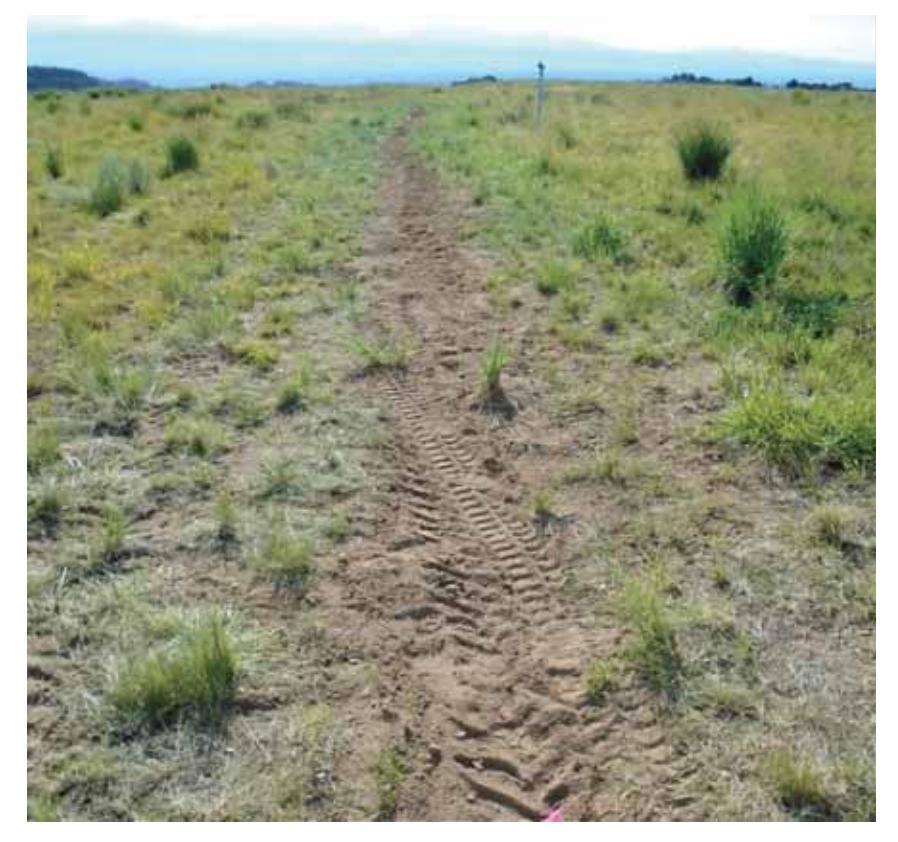
Photo 2 Repaired landfill cover tension crack. Photo taken August 16, 2022.

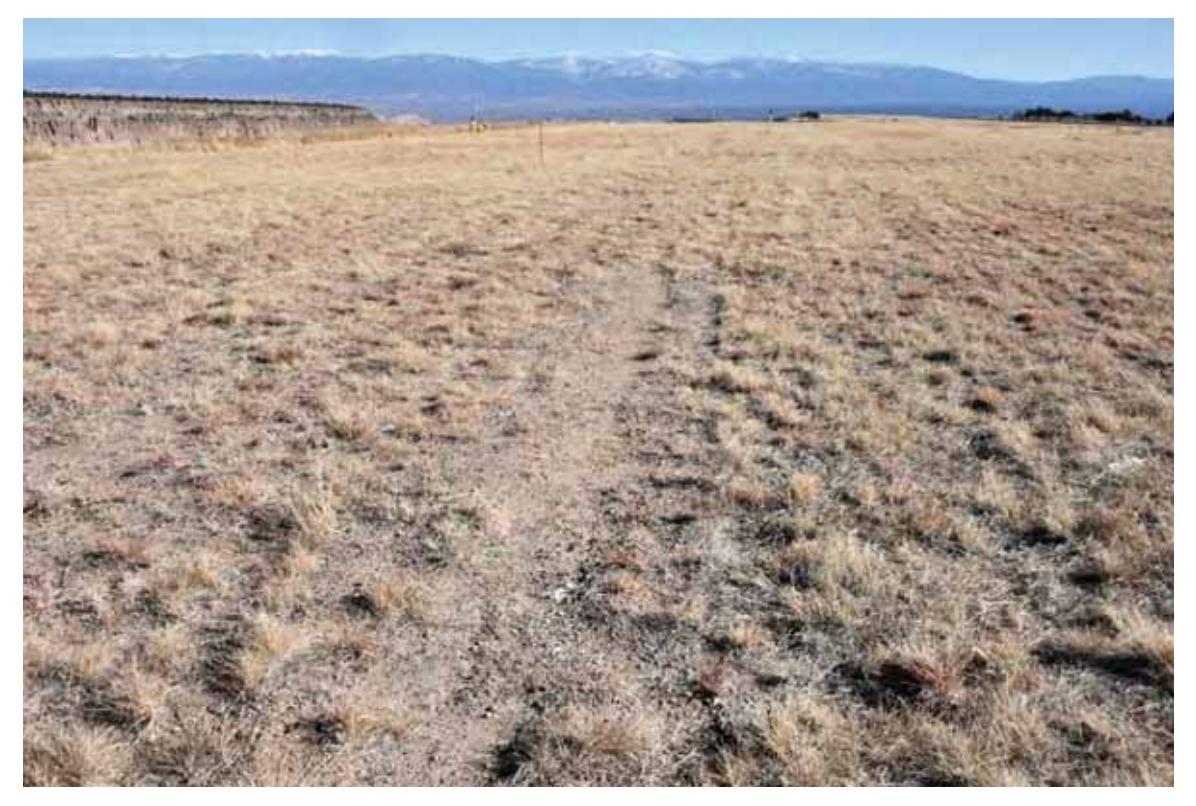
Photo 2 Repaired tension crack on the landfill cover near Survey Point 24, looking east

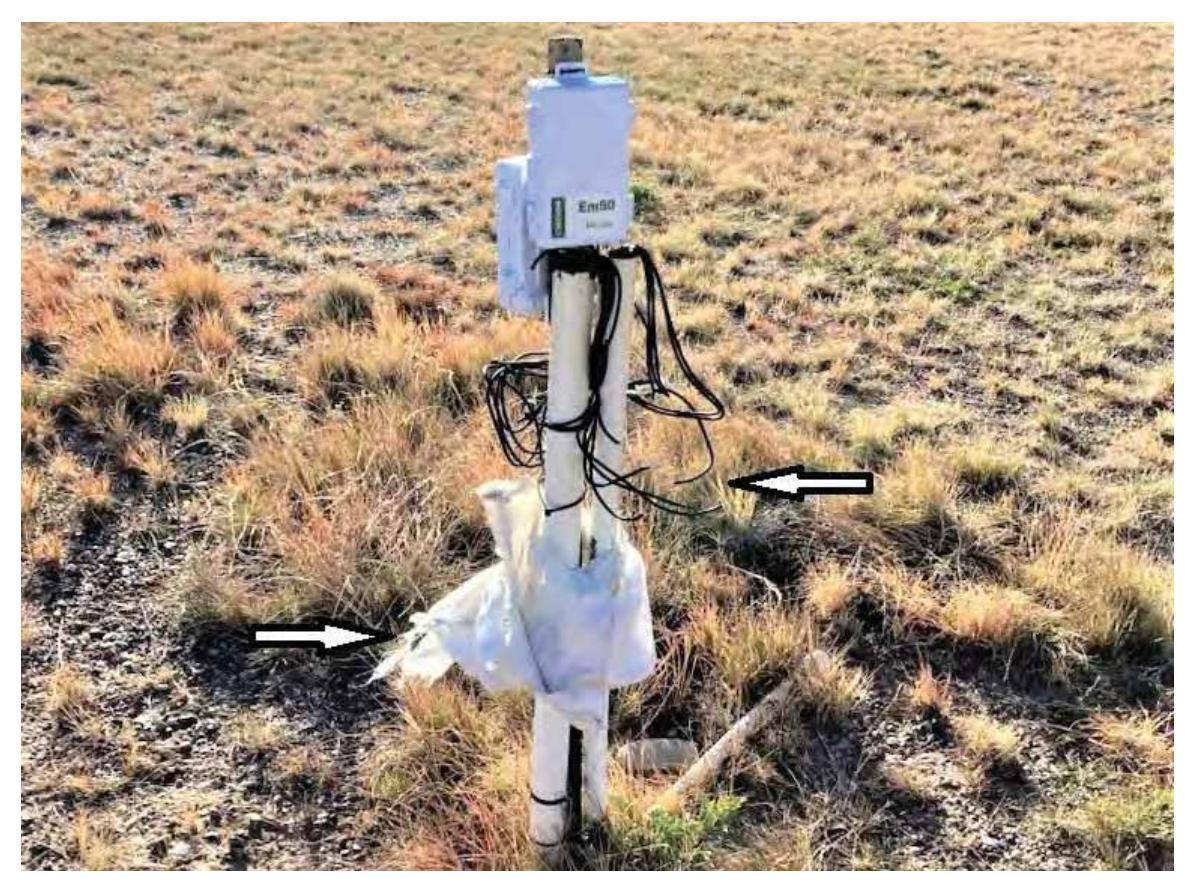
Photo 11 Damaged moisture monitoring station (note severed cables and damaged cover)

Summary of Recommended Maintenance and/or Repairs		
Maintenance/Repairs Necessary: ☑ Yes □ No If yes, explain: The southern moisture monitoring station is scheduled to be repaired, if possible. Other	Remarks: One moisture monitoring station was damaged by wildlife and has been offline since October 26, 2022.

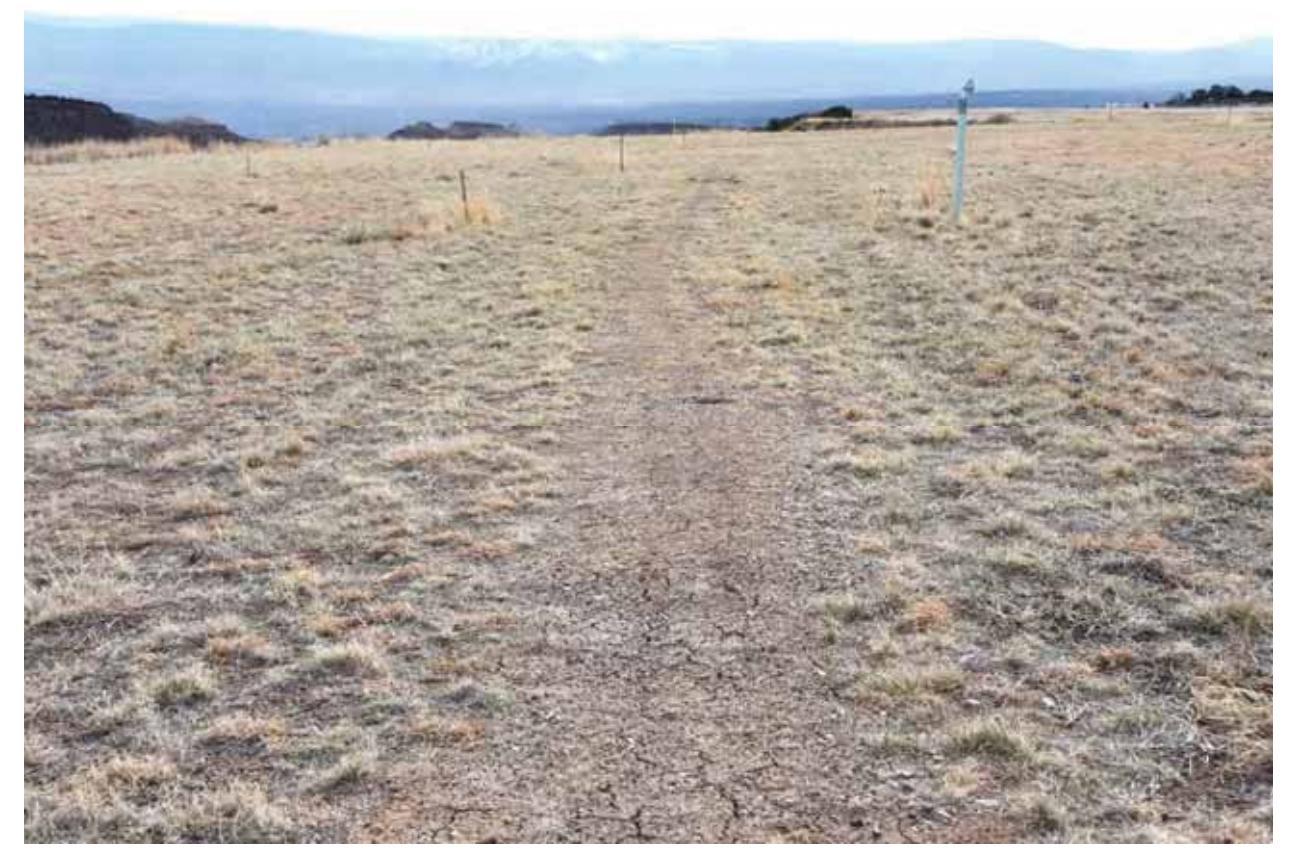
Photo 1 Repaired tension crack on the landfill cover near Survey Point 34, looking east (Note: surface scoring is due to winter free e-thaw cycles or desiccation and does not appear to be new tension cracking.)

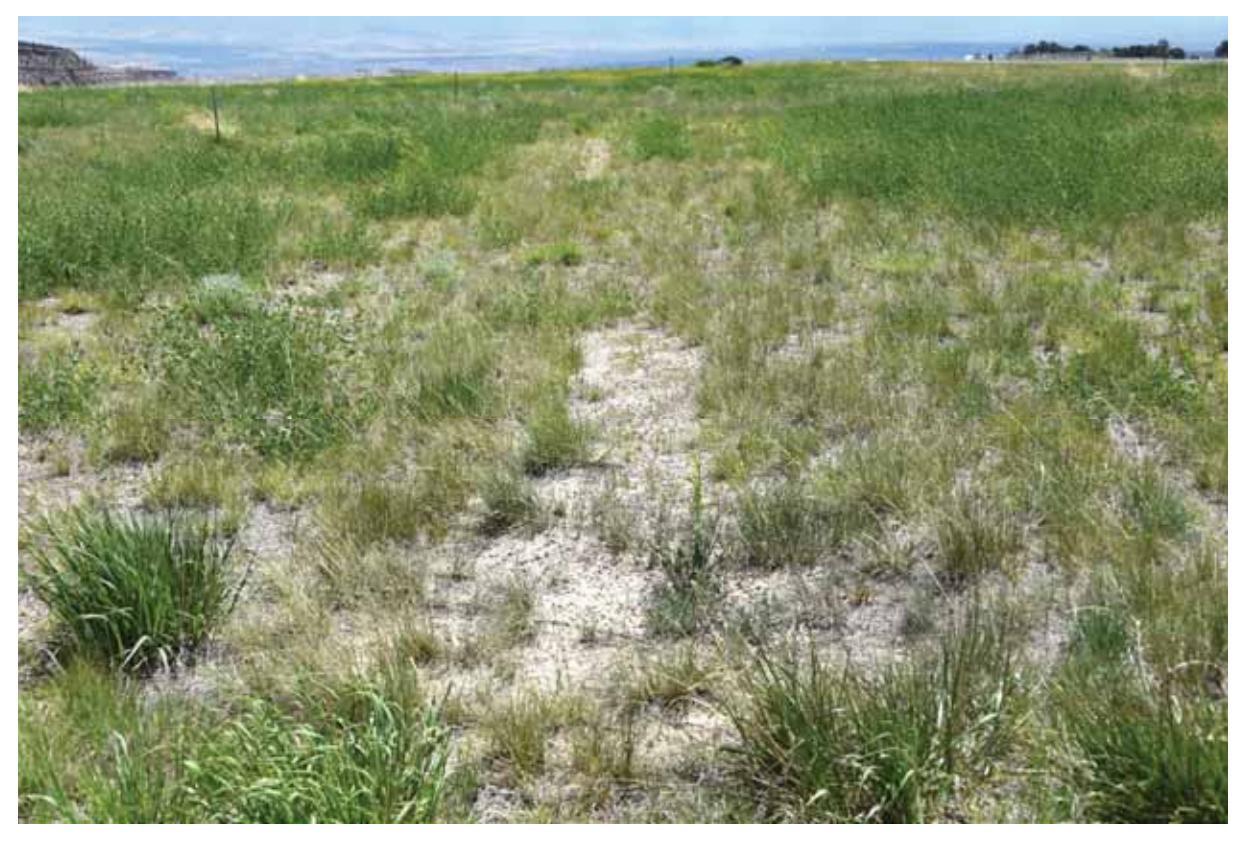
Photo 1 Repaired tension crack on the landfill cover near survey point 29, looking east

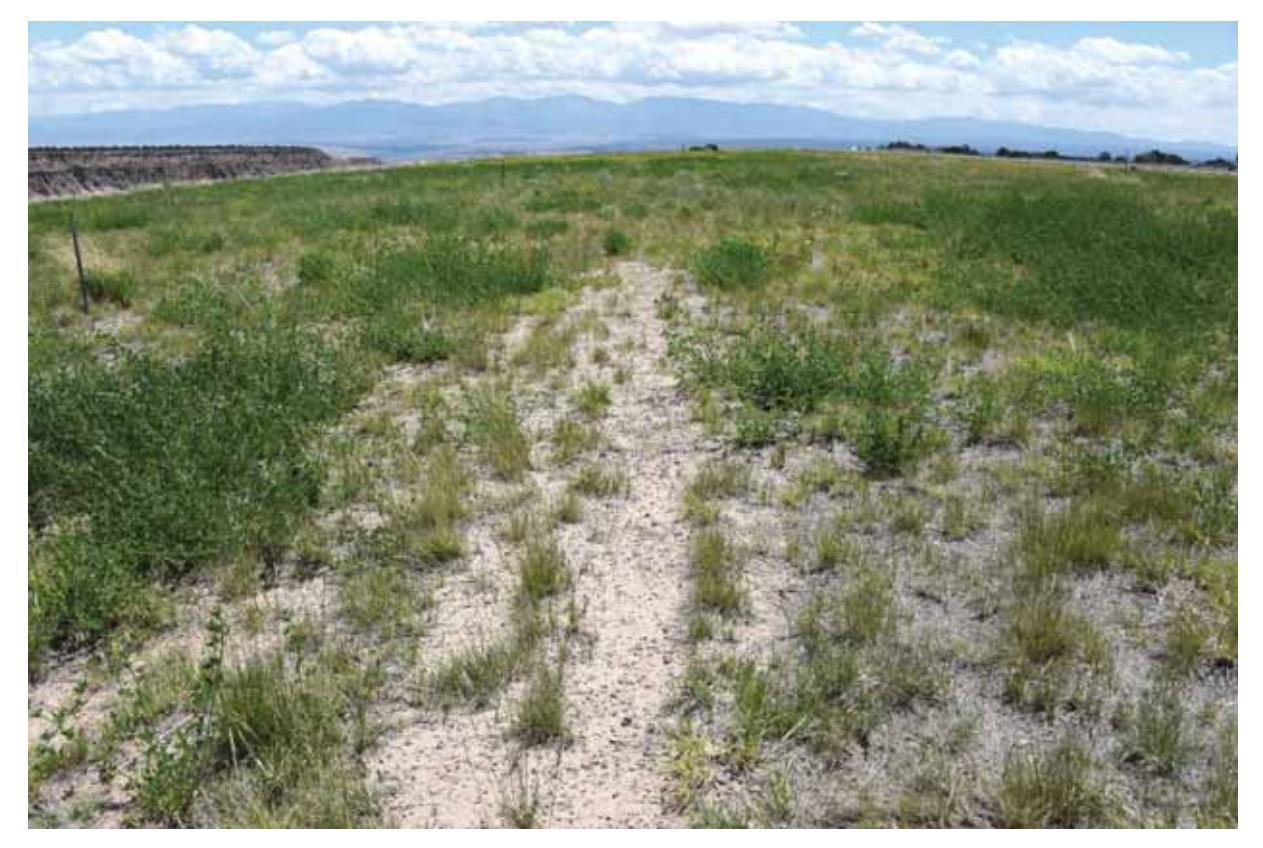
Photo 2 Repaired tension crack on the landfill cover near Survey Point 14, looking east

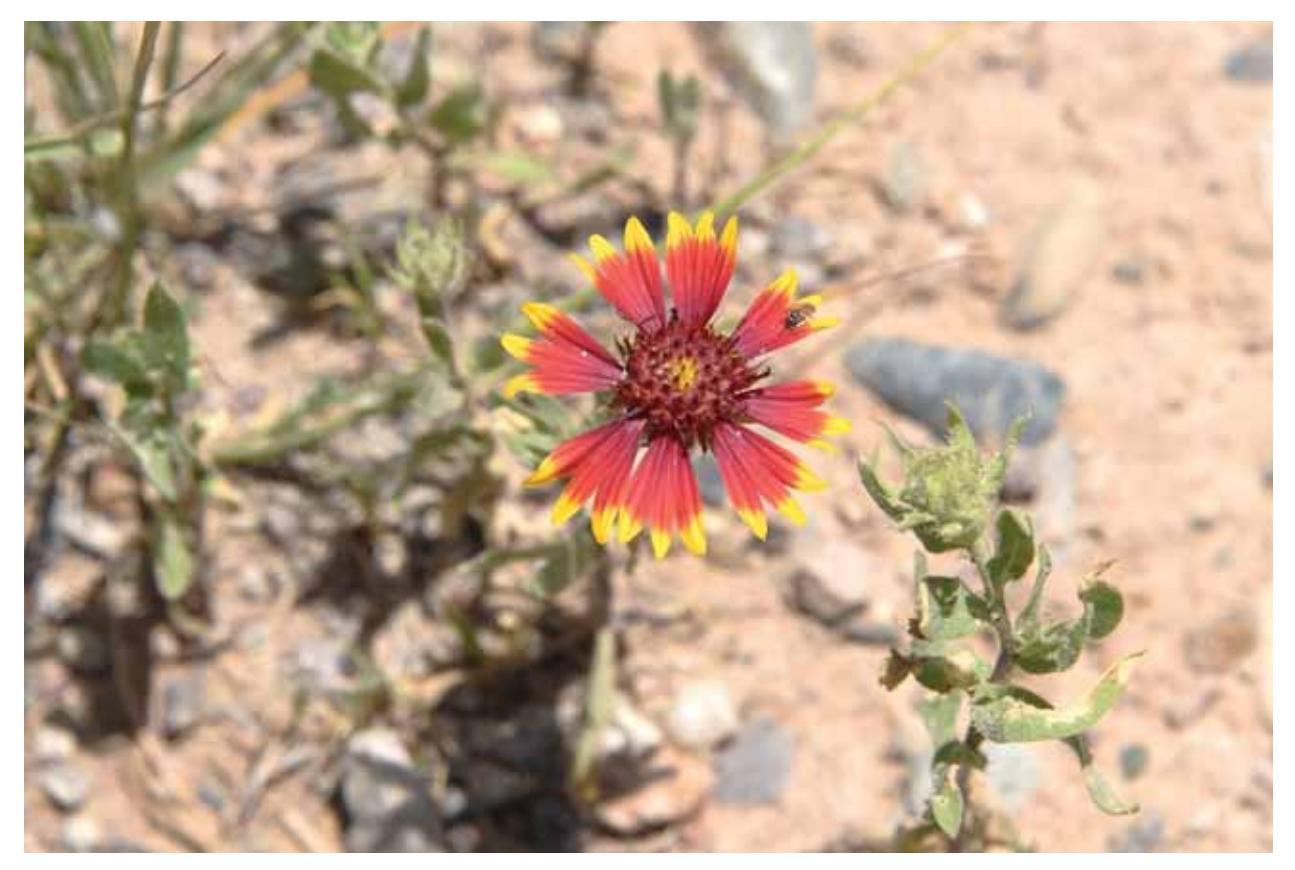
Photo 3 New vegetation growing along the repaired tension crack (Gaillardia pulchella - also known as firewheel, Indian blanket flower, or sundance)

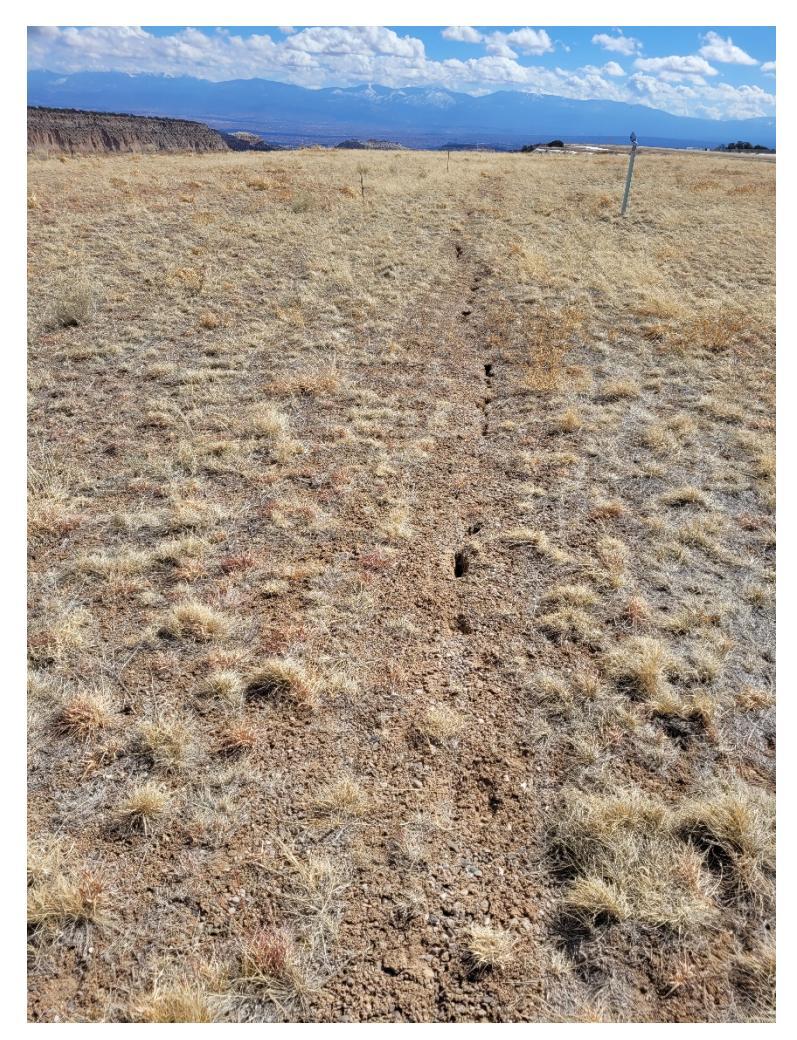
Figure 1. Picture of Surface Crack in Cover System

Based on observations of settlement prior to the cover placement and again after its placement, it is possible the waste was installed in trenches running east/west (Figure 3). The northern crack (Figure 1) appears to be running parallel with the estimated boundary of the northern waste trench (Figure 3). Thus, the continued settlement likely caused a tension crack along this boundary. There was significant infiltration of meteoric water into the waste prior to the installation of the initial asphalt/concrete cover and while it was in place. This moisture is still causing biodegradation in the waste although it is has slowed significantly. Thus, settlement continues – albeit much slower than when the asphalt/concrete cover was in place. The infiltration into the waste ceased after the Evapotranspiration (ET) Cover was installed based on ongoing monitoring documented in inspection reports.

b. After the soil toward the base of the crack has been compacted, fill and compact the remaining crack opening in approximate 6-inch lifts. That is, pour soil/rock admixture into the remaining opening filling about 6-inches deep in the crack and repeat tamping with the blunt side of the digging bar. A hand tamping tool may be used to perform compaction of the soil if the width of the crack permits. Repeat filling and compacting in 6-inch lifts until the crack is filled to the surface. A hand tamping tool shall be used to compact the surface of the crack. Make sure there are no depressions when compaction is complete at the surface of the crack.

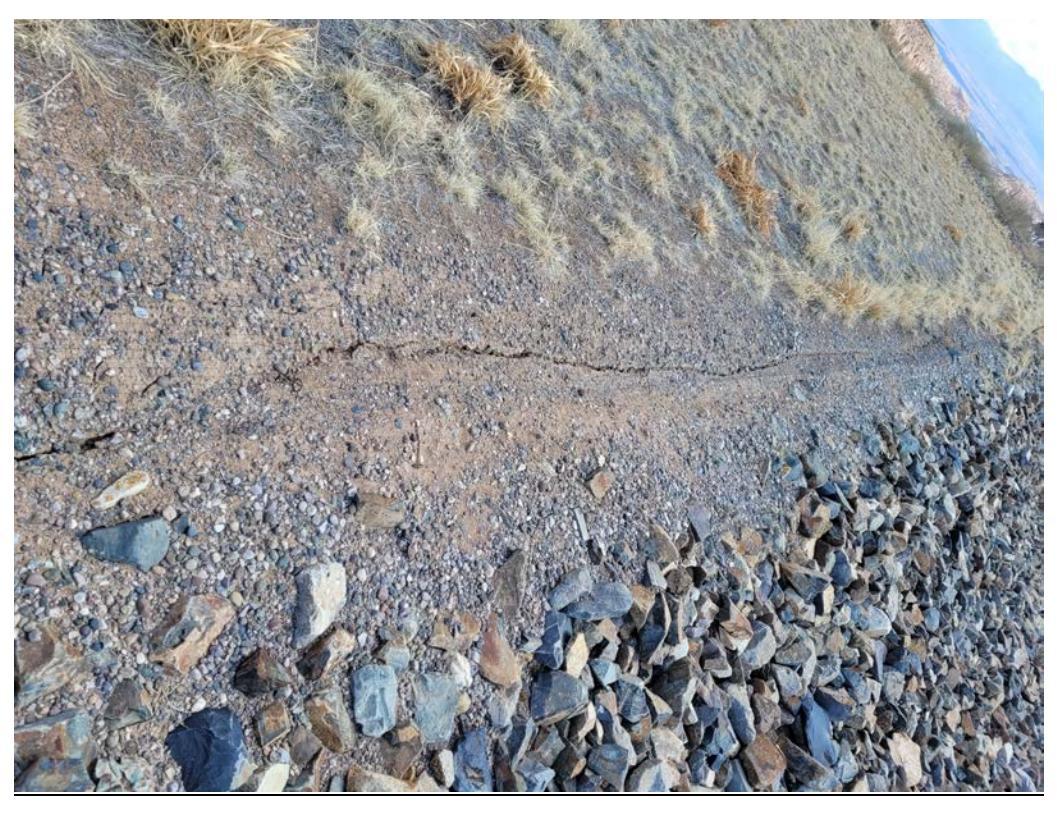
There was also a smaller crack identified during this site visit along the southern perimeter of the cover system between the cover and perimeter riprap drainage ditch (Figure 2).

Figure 2. Crack Along Southern Perimeter of Landfill

The southern edge crack appears to be a tension crack along the southern edge of the waste perimeter and is much smaller than the crack in the northern portion of the landfill. Settlement of the underlying waste in the landfill has likely also caused this tension crack.

Steps to repair the thin southern crack (Figure 2):

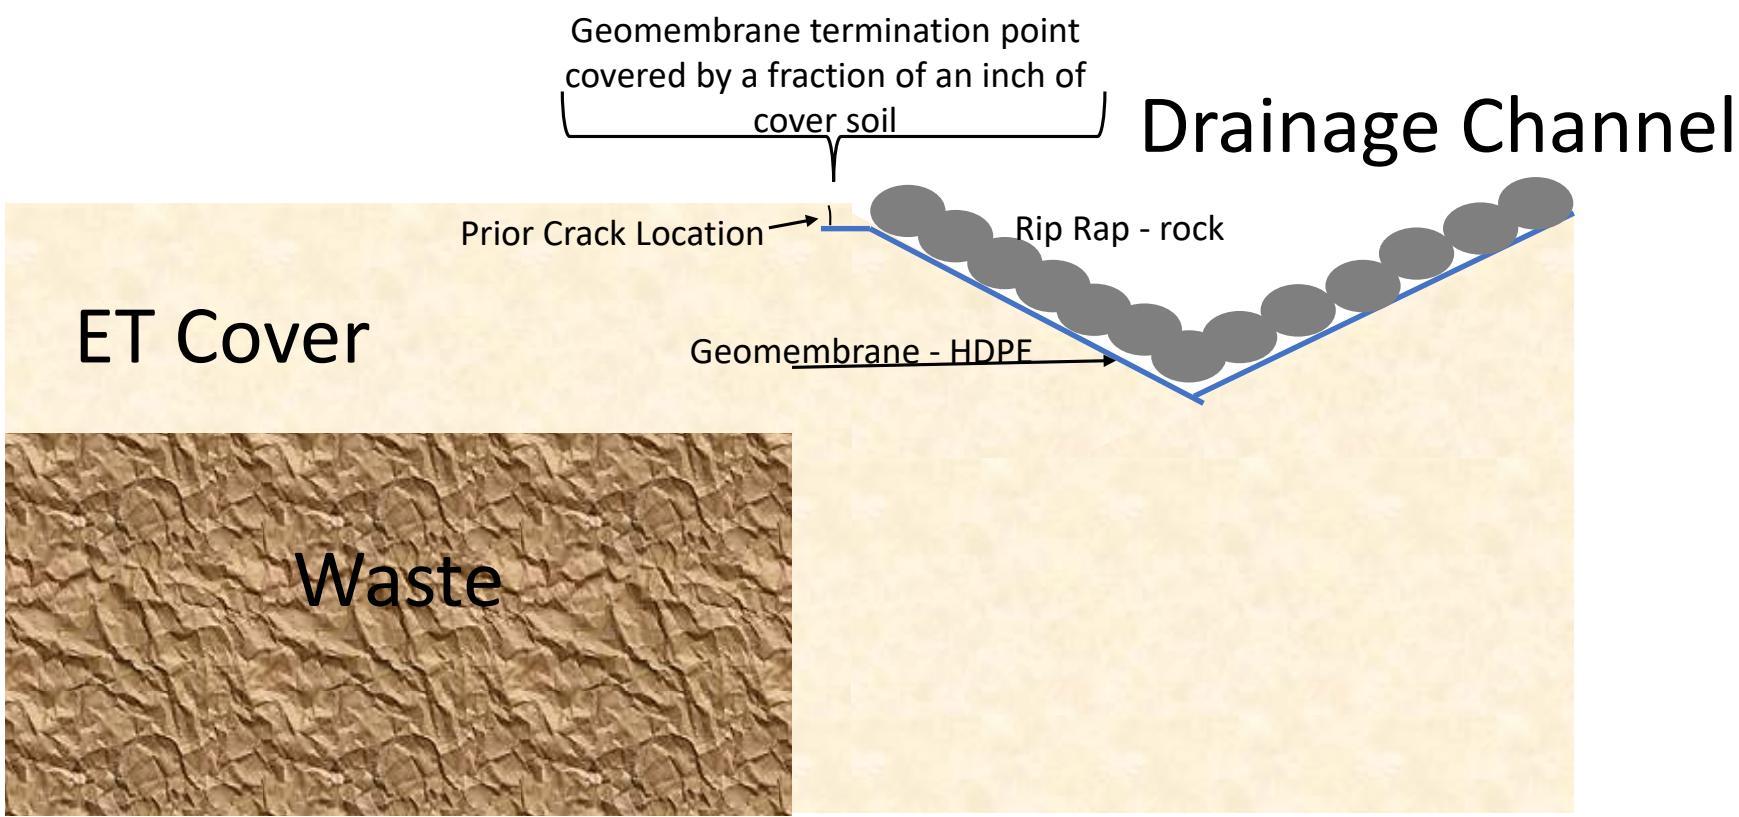
Figure 2. South Crack: Geomembrane Termination Point

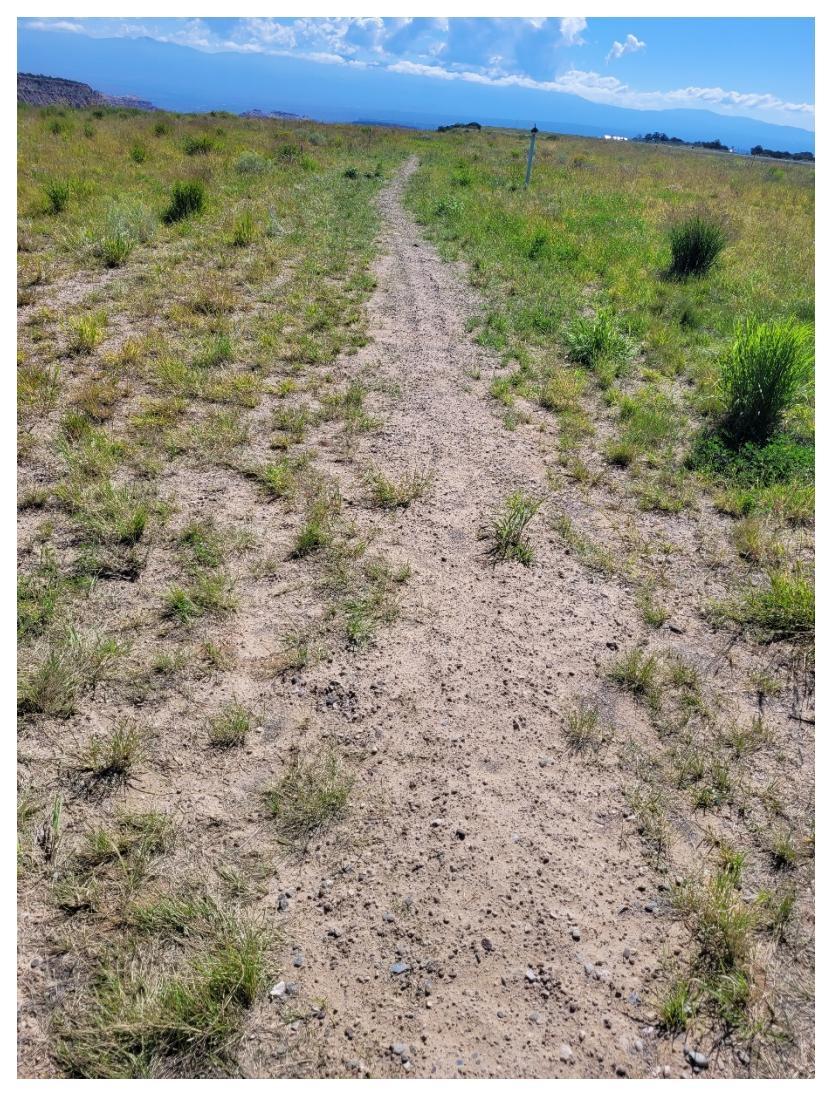
Figure 3. Northern Crack Repair

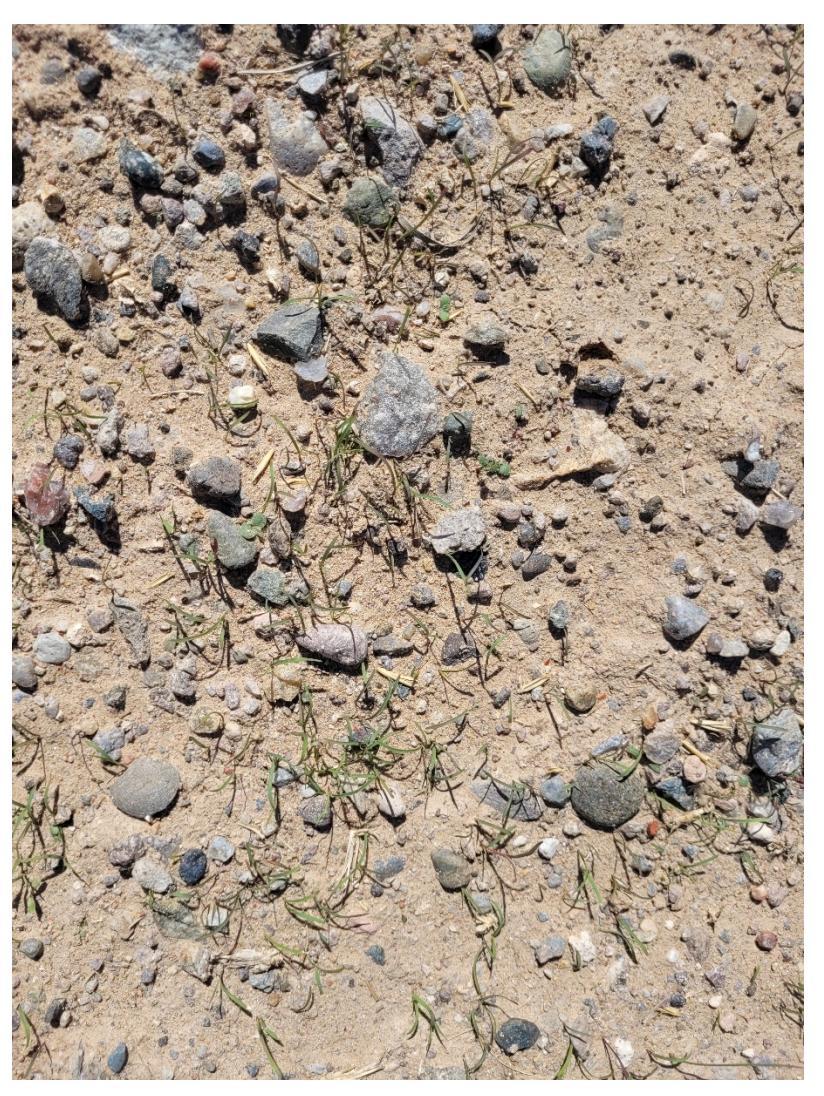
Figure 4. Seeded Grass Emerging in Northern Crack Repaired Area
