EMID-700154

Subject: Biennial Inspection and Maintenance Report on Erosion Controls in Drainages to the 90s Line Pond at Technical Area 16

**Figures for the Biennial Inspection and Maintenance Report on  
Erosion Controls in Drainages to the 90s Line Pond at Technical Area 16**

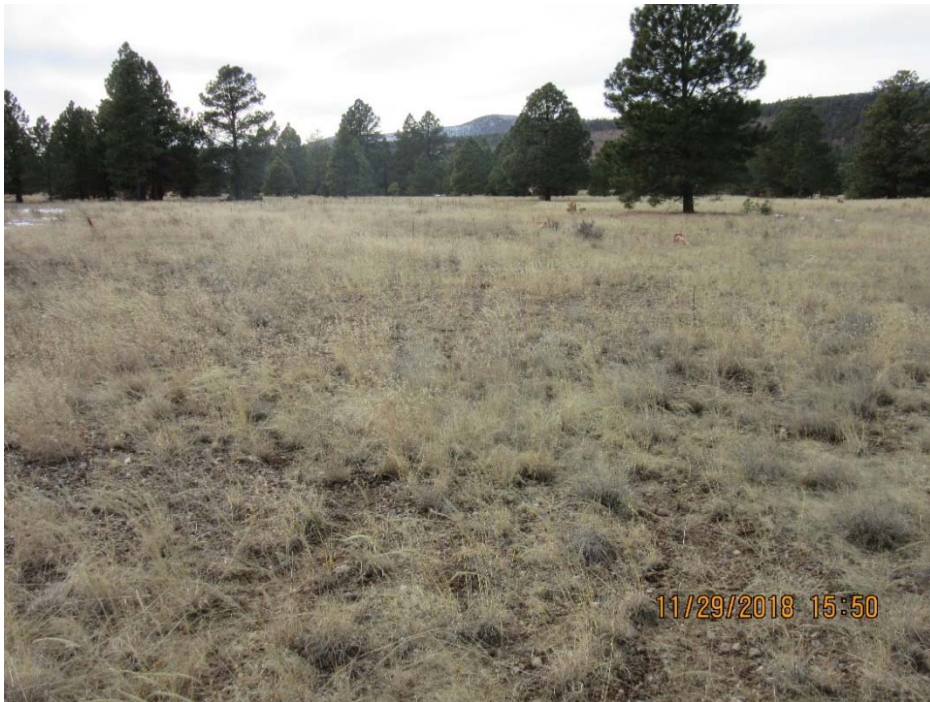
**Figure 1** Vegetated Consolidated Unit 16-008(a)-99 draining to 90s Line Pond, November 2018

Best management practices were installed in 2008 in the drainages to the 90s Line Pond and consist of five juniper bale controls designed to block sediment transport down the drainages into the pond. Controls were inspected annually on September 1, 2017, and November 29, 2018; the results indicate all controls are currently in good operating condition (Figures 1 to 7, enclosed) with no evidence of erosion in the drainages.

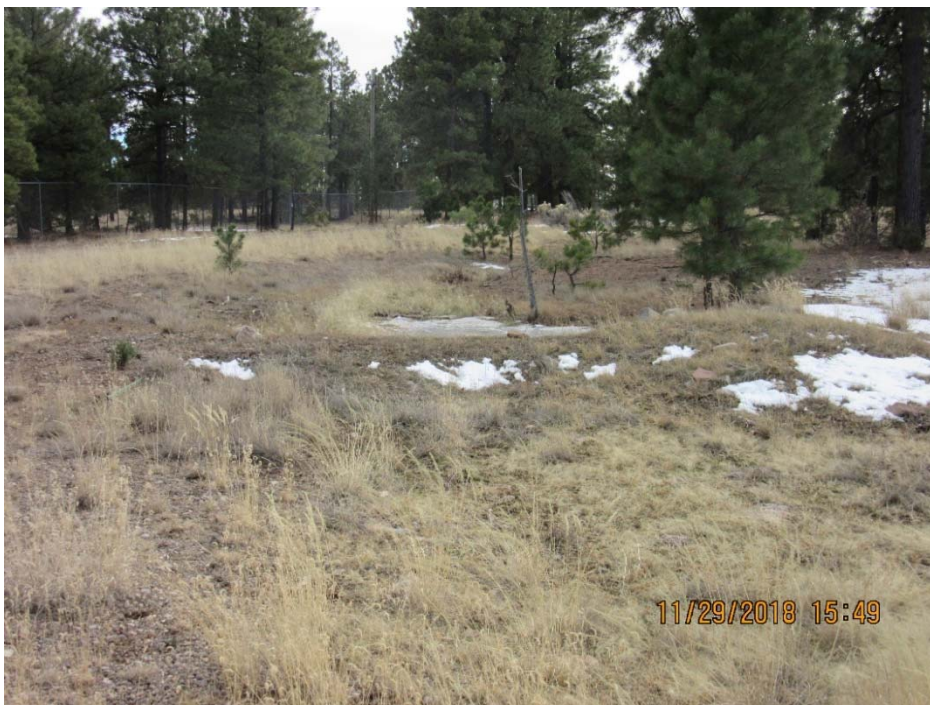
**Figure 2** Run-on control earthen berm in the vegetated area draining to 90s Line Pond, November 2018

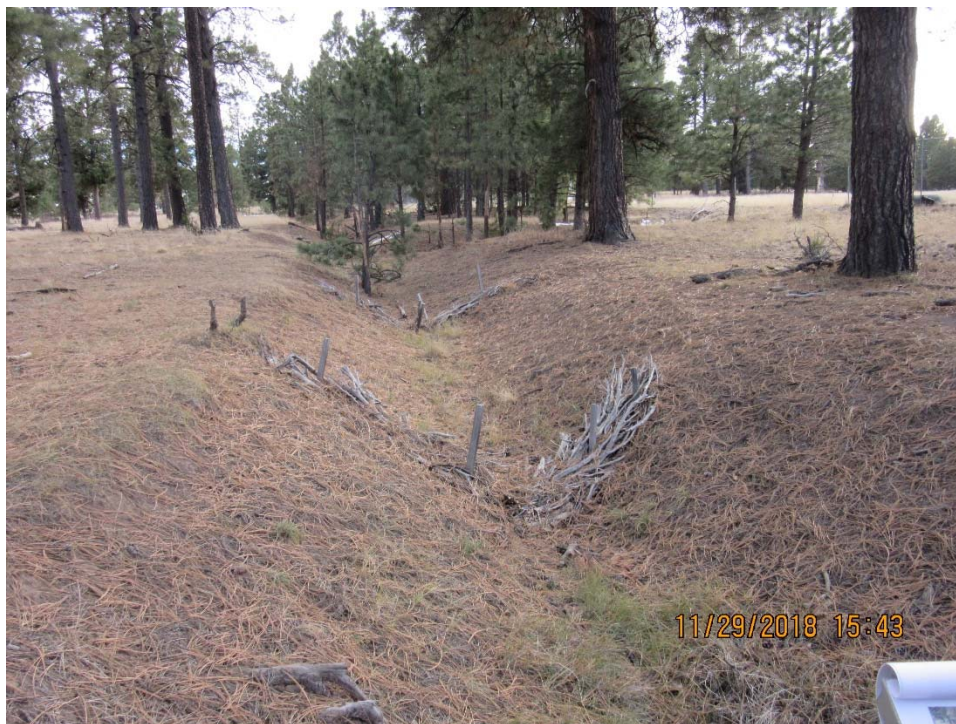
**Figure 3** Juniper bale check dams located in drainage channel to 90s Line Pond, November 2018. Note needle cast and vegetation in channel.

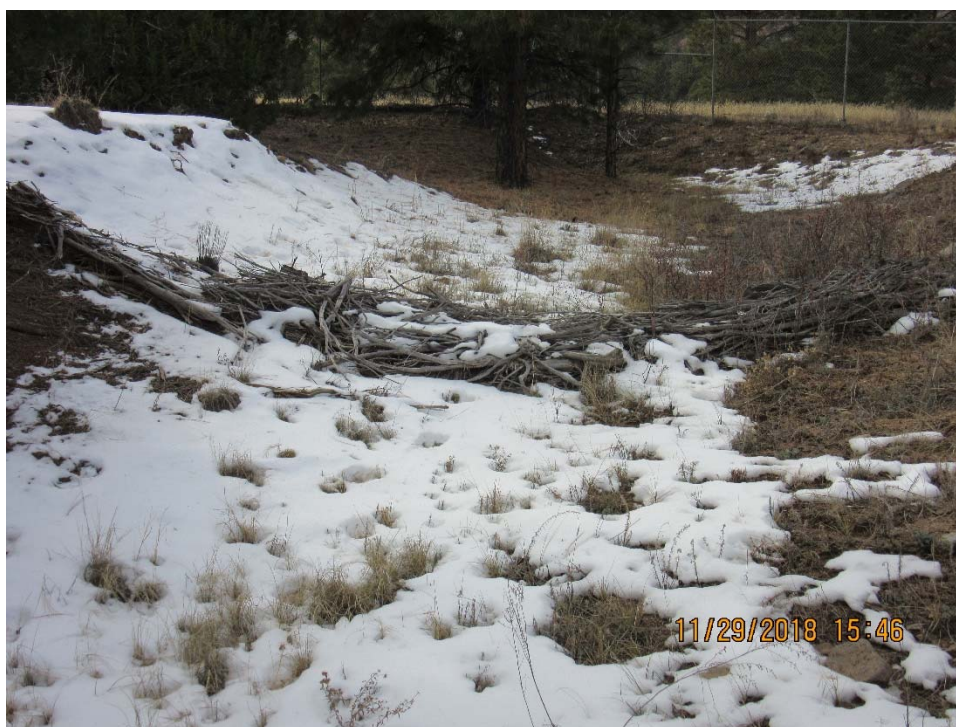
**Figure 4** Juniper bale check dam located in drainage channel to 90s Line Pond, November 2018. Note vegetation in channel.

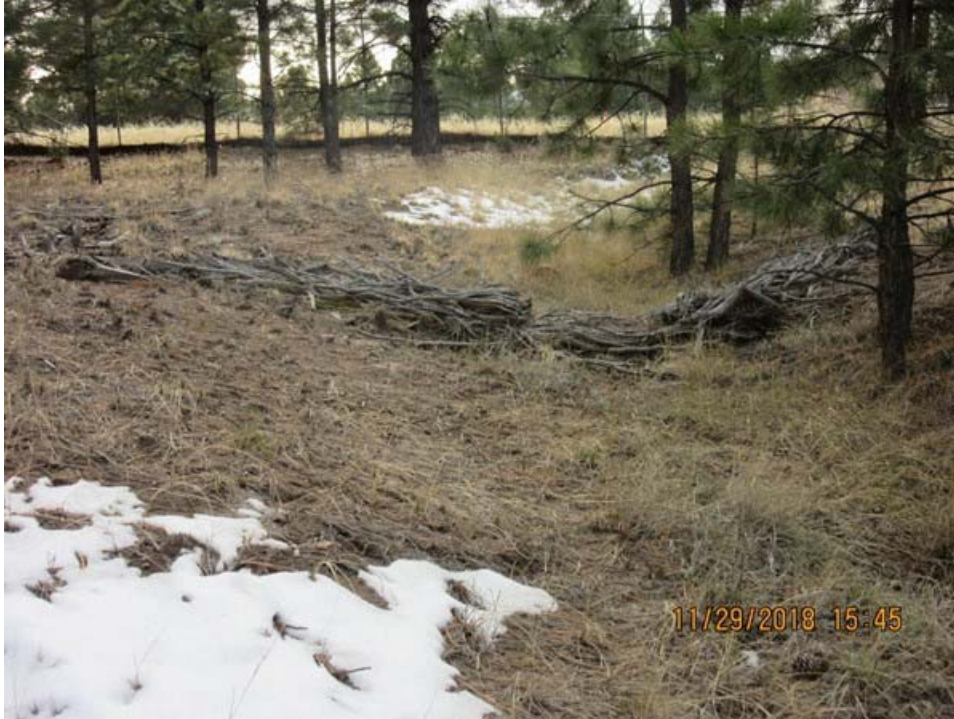
**Figure 5** Juniper bale check dam located in drainage channel to 90s Line Pond, November 2018. Note vegetation in channel.

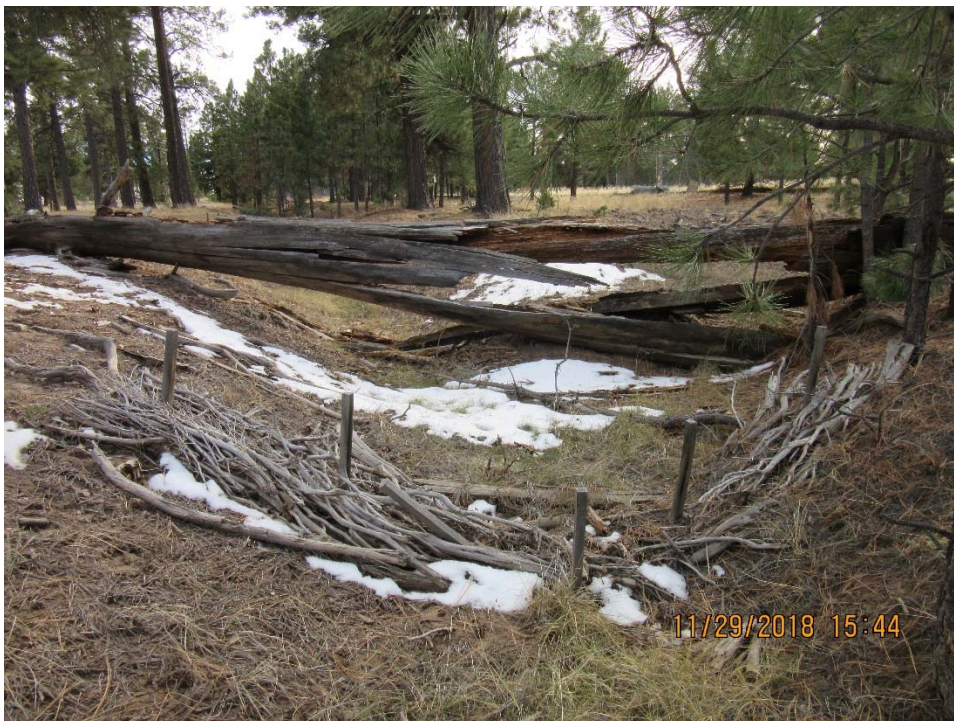
**Figure 6** Juniper bale check dam located in drainage channel to 90s Line Pond, November 2018. Note vegetation in channel.
