Subject: Submittal of the 2018 Sandia Wetland Performance Report

The 2018 Sandia wetland performance report is the fifth annual performance report following the 2012 to 2014 baseline that assessed the overall condition of the wetland at the head of Sandia Canyon. Canyon wetland monitoring was performed in the context of the wetland's ability to mitigate migration of contaminants of concern (i.e., chromium, polychlorinated biphenyls [PCBs], and polycyclic aromatic hydrocarbons) detected in wetland sediments as a result of historical releases at Los Alamos National Laboratory (LANL or the Laboratory). The geochemistry and physical stability of wetland sediments, along with the extent of wetland vegetation, are the key indicators of wetland conditions. The condition of the wetland is assessed to evaluate the effectiveness of the grade-control structure (GCS) completed in 2013 at the terminus of the wetland, and to monitor changes to the Laboratory's operational practices that have affected outfall volumes discharging to the wetland. This report presents the results of monitoring conducted for surface water, alluvial groundwater, vegetation, and geomorphology between January and Decem

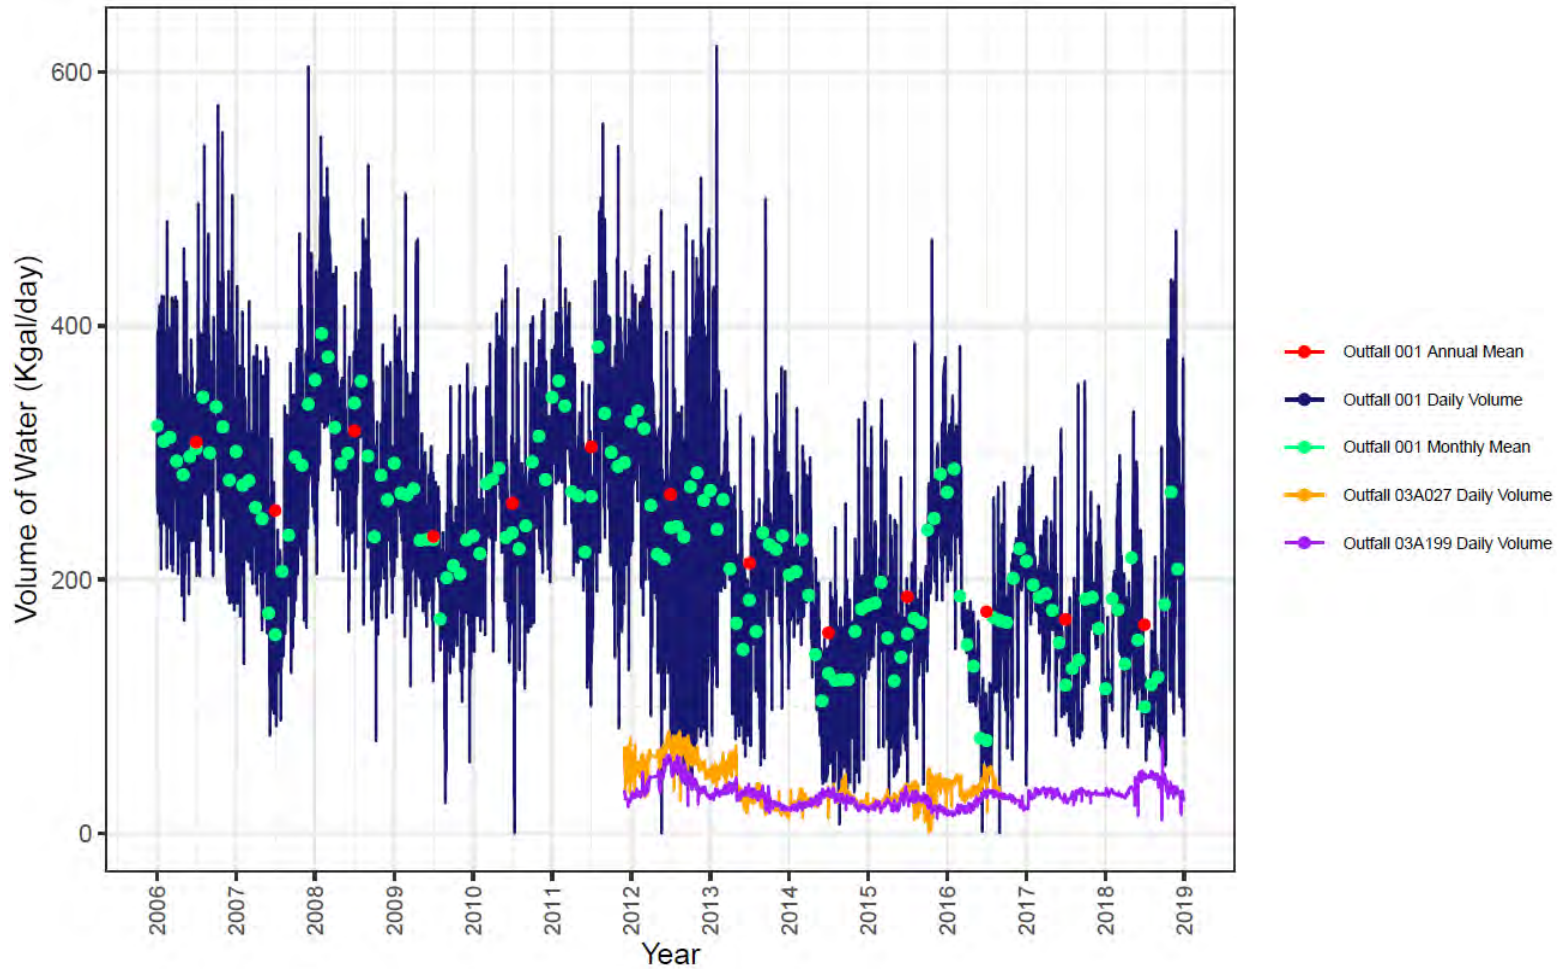
**Figure 1.3-1** Daily, monthly average, and yearly average effluent release volumes (expressed as Kgal./day) for Outfall 001 from 2006 to December 2018. Daily effluent releases for Outfall 03A027 is from November 2011 to September 2016. Outfall releases from 03A199 are plotted from August 2007 to January 2010 and from November 2012 to December 2018. No discharges to Outfall 03A027 have occurred since September 2016

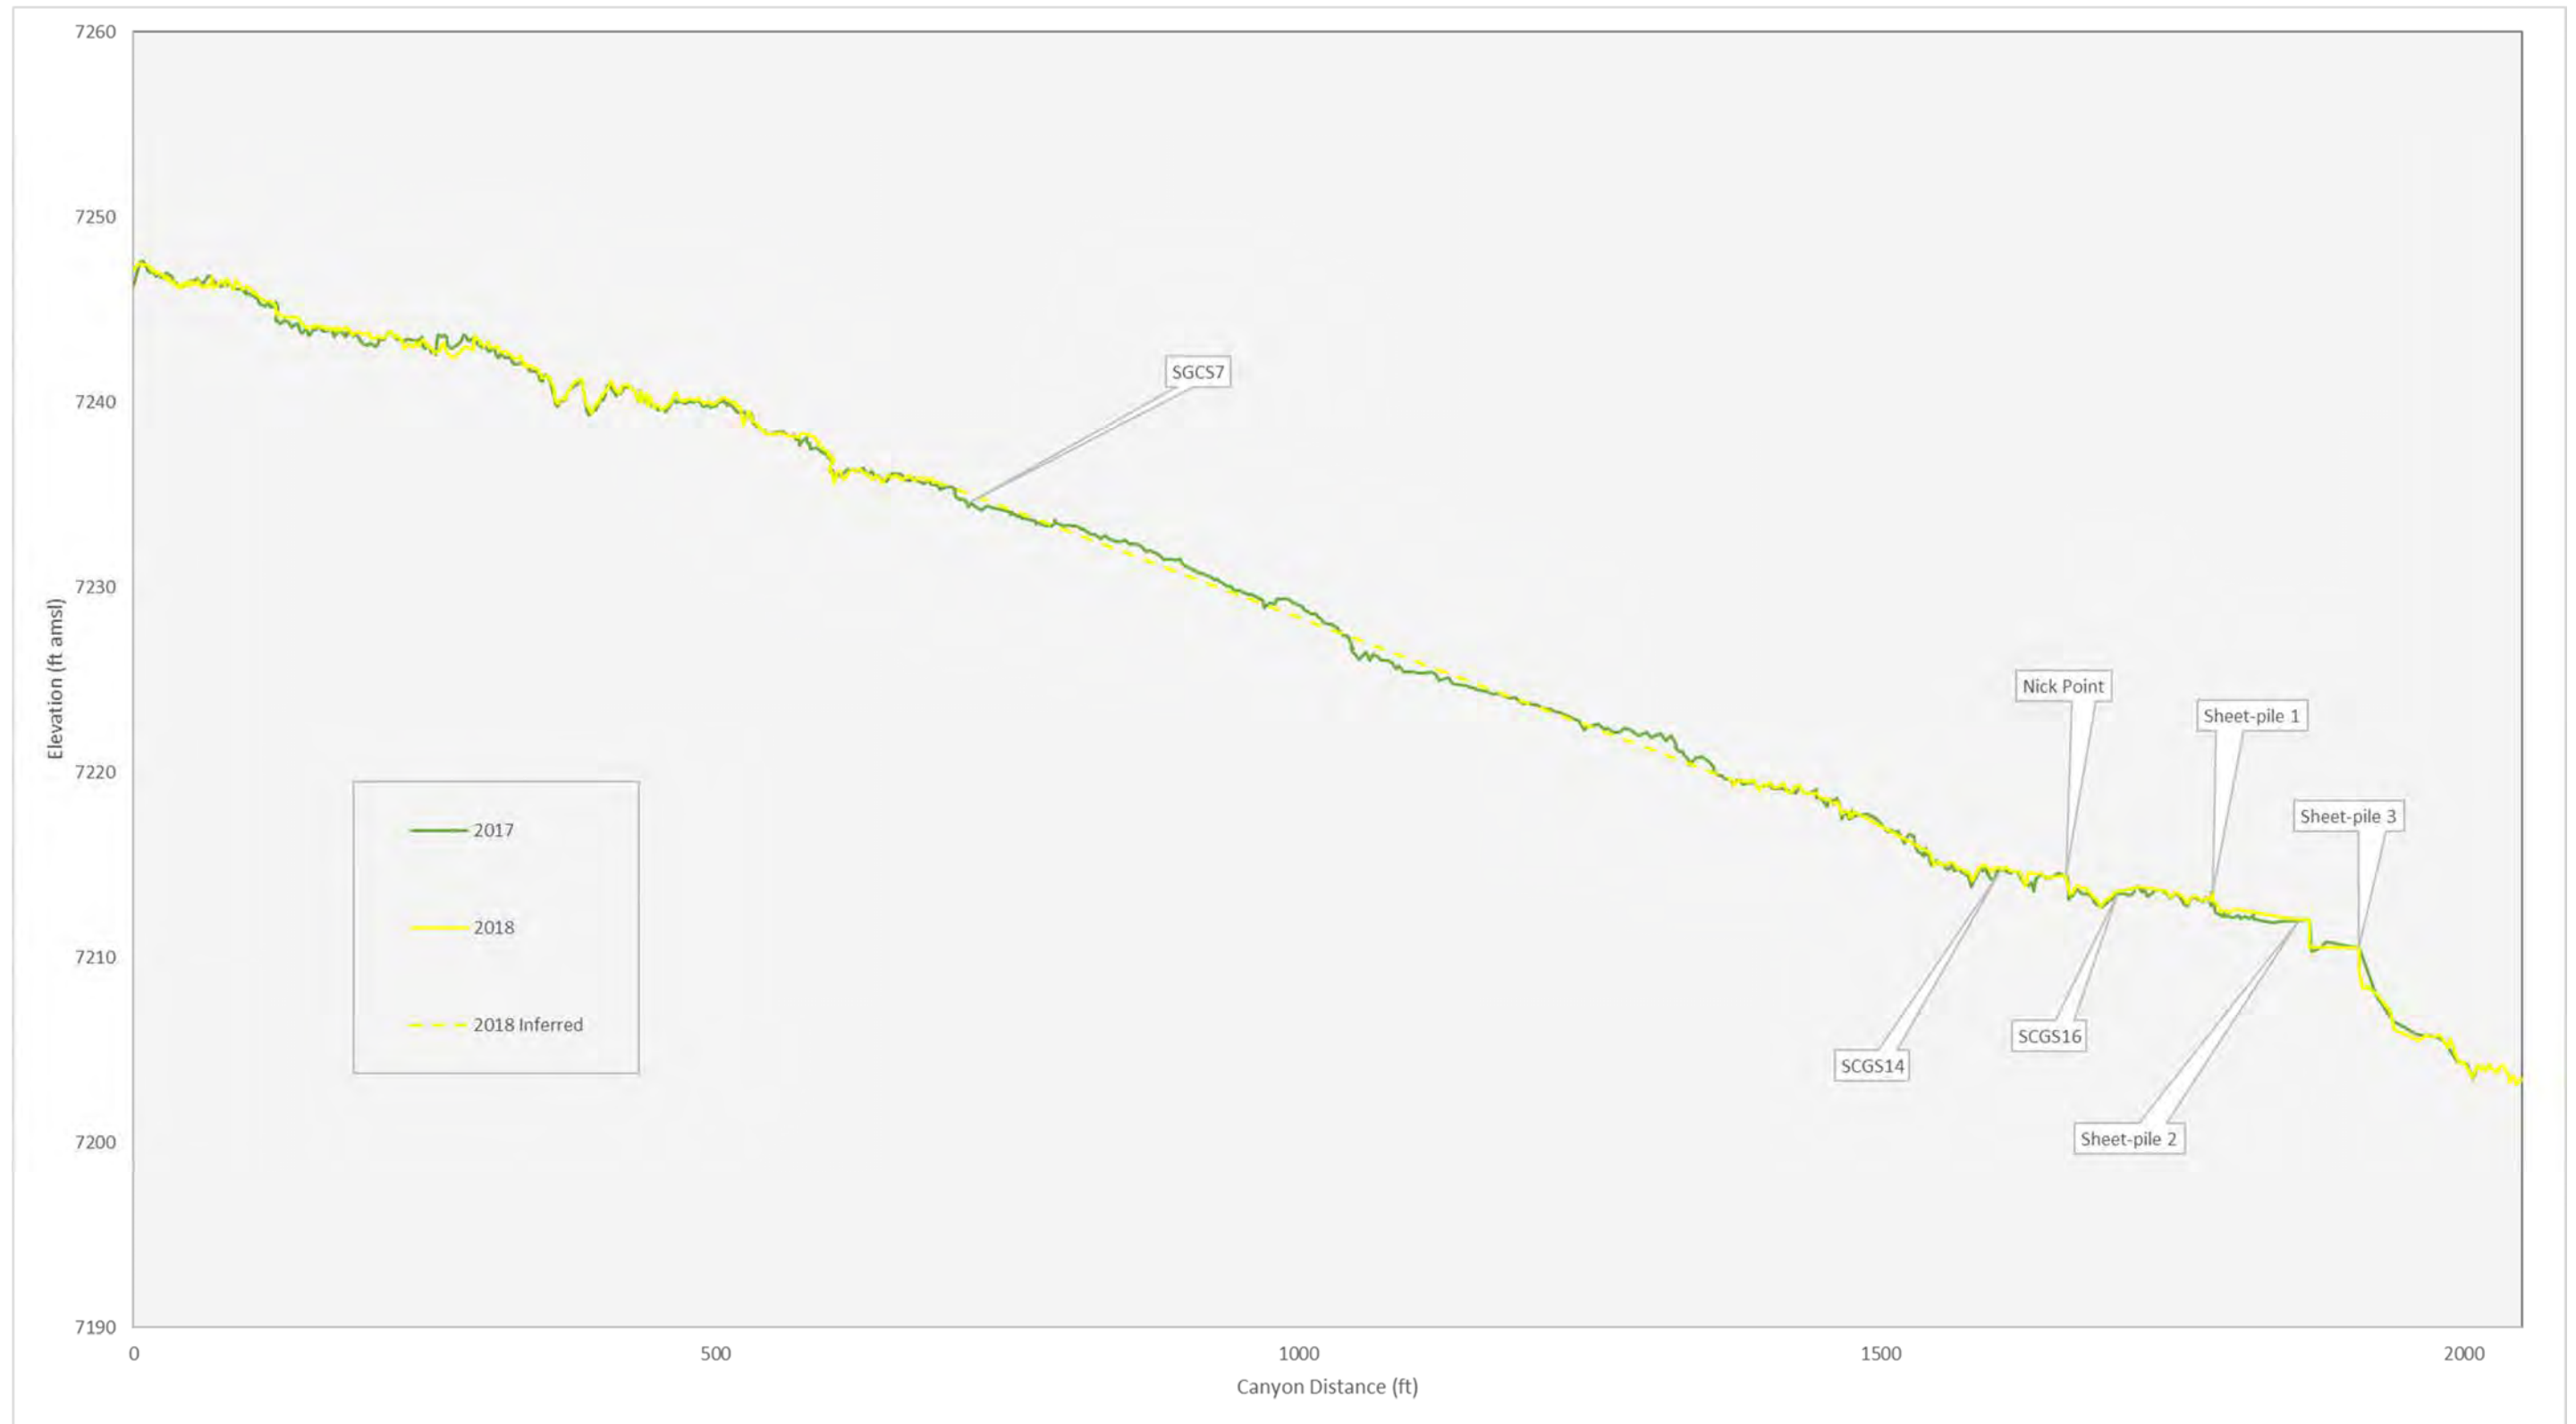
Figure B-4.1-1 1-yr thalweg profile comparison

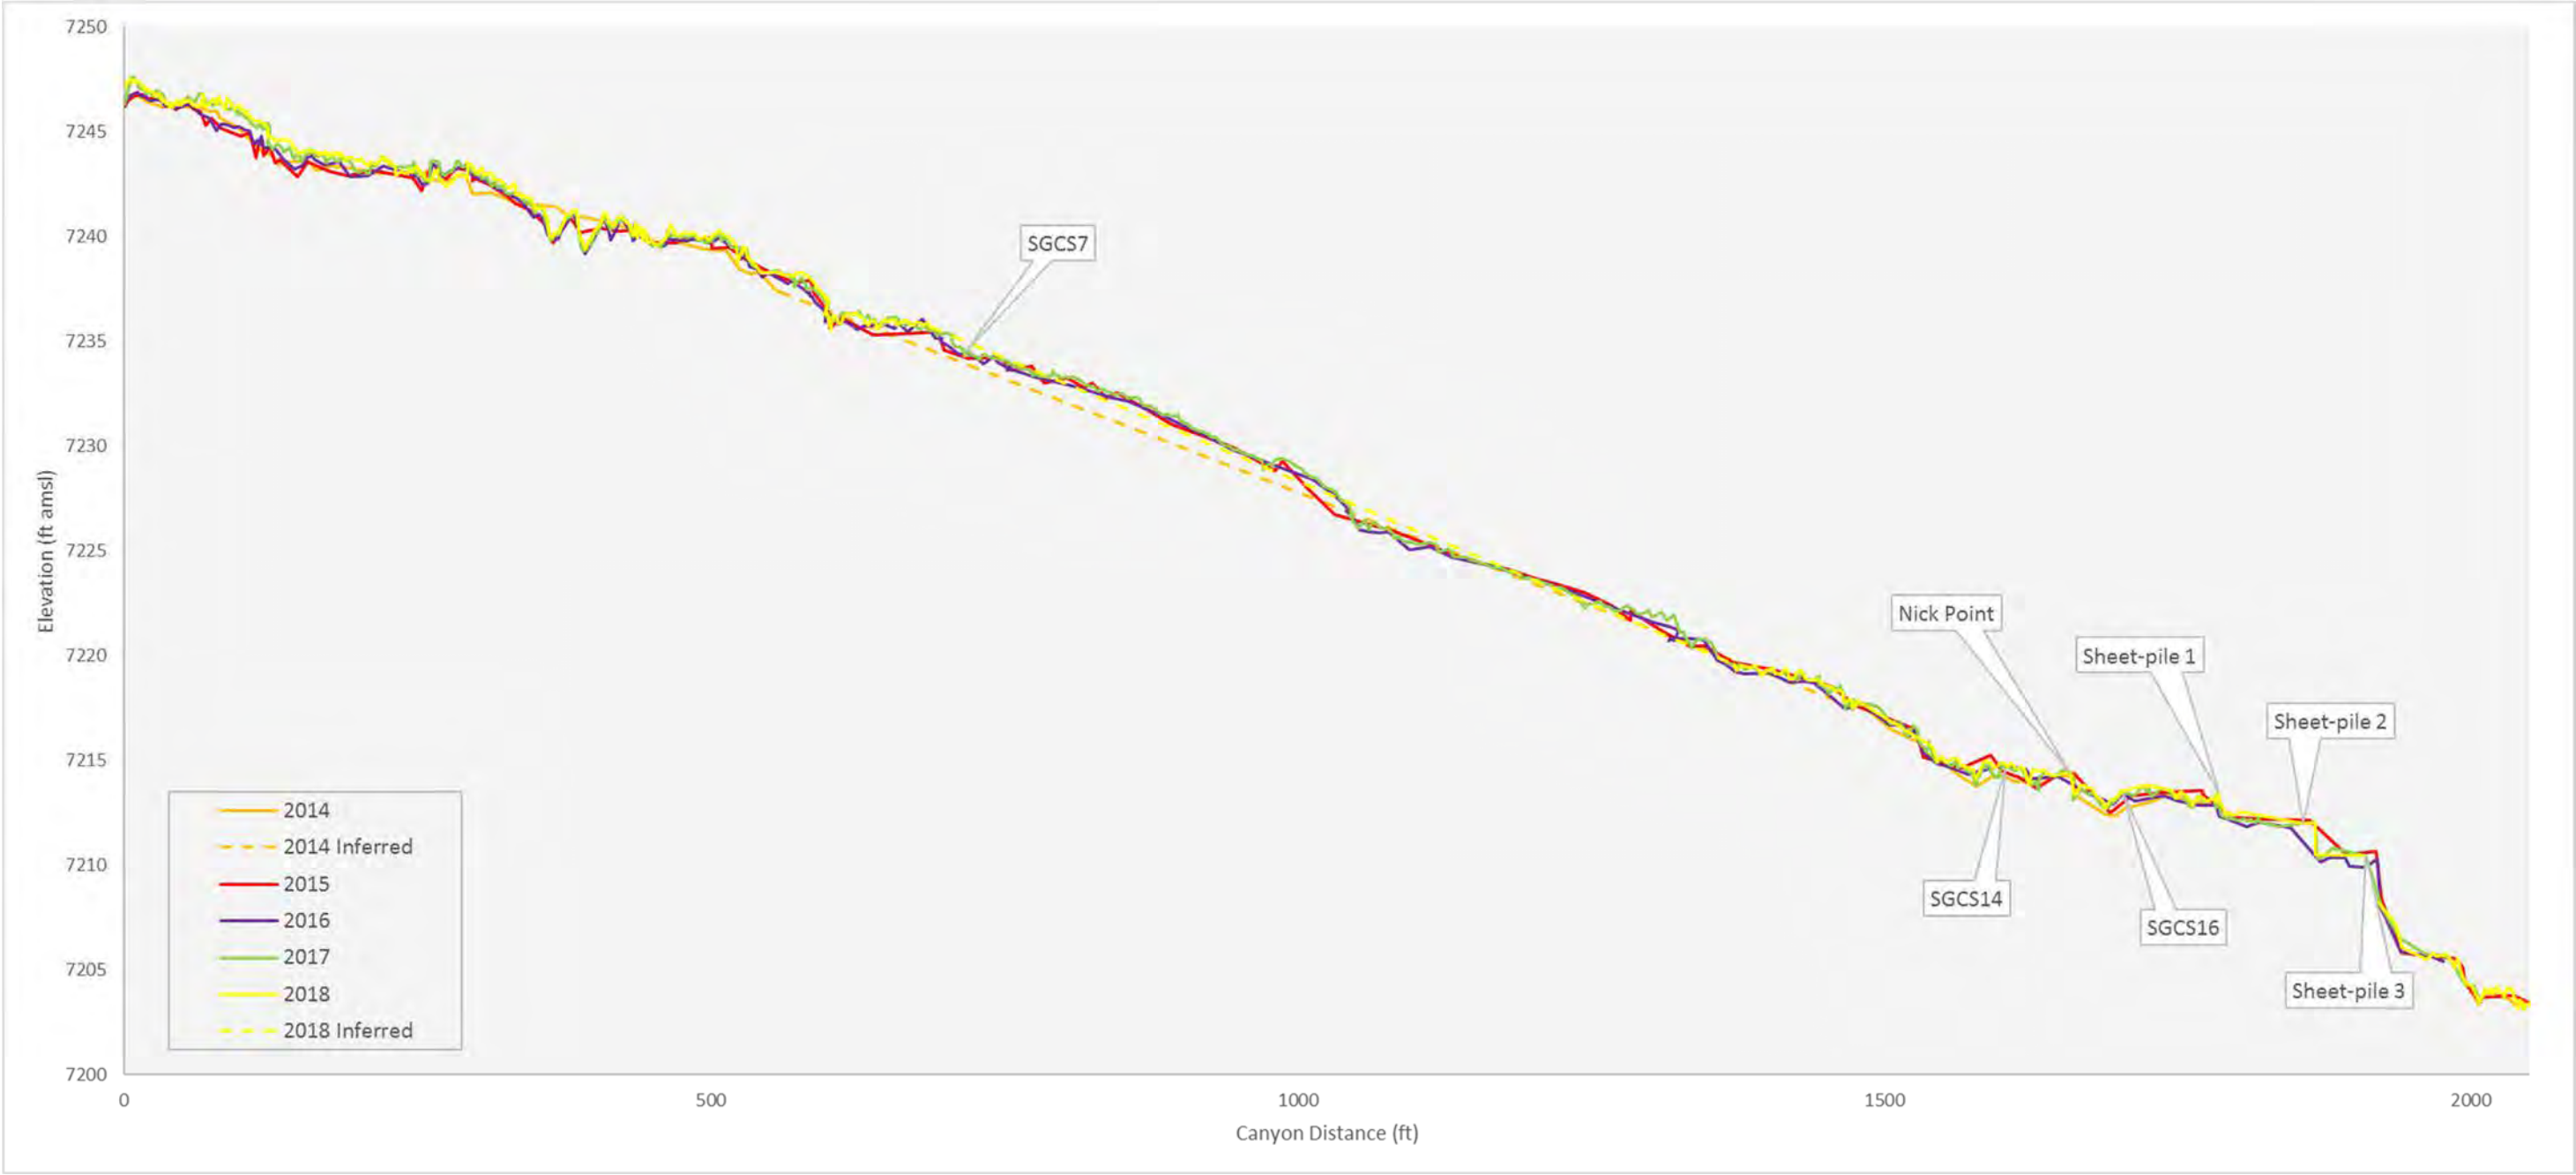
Figure B-4.1-2 5-yr thalweg profile comparison

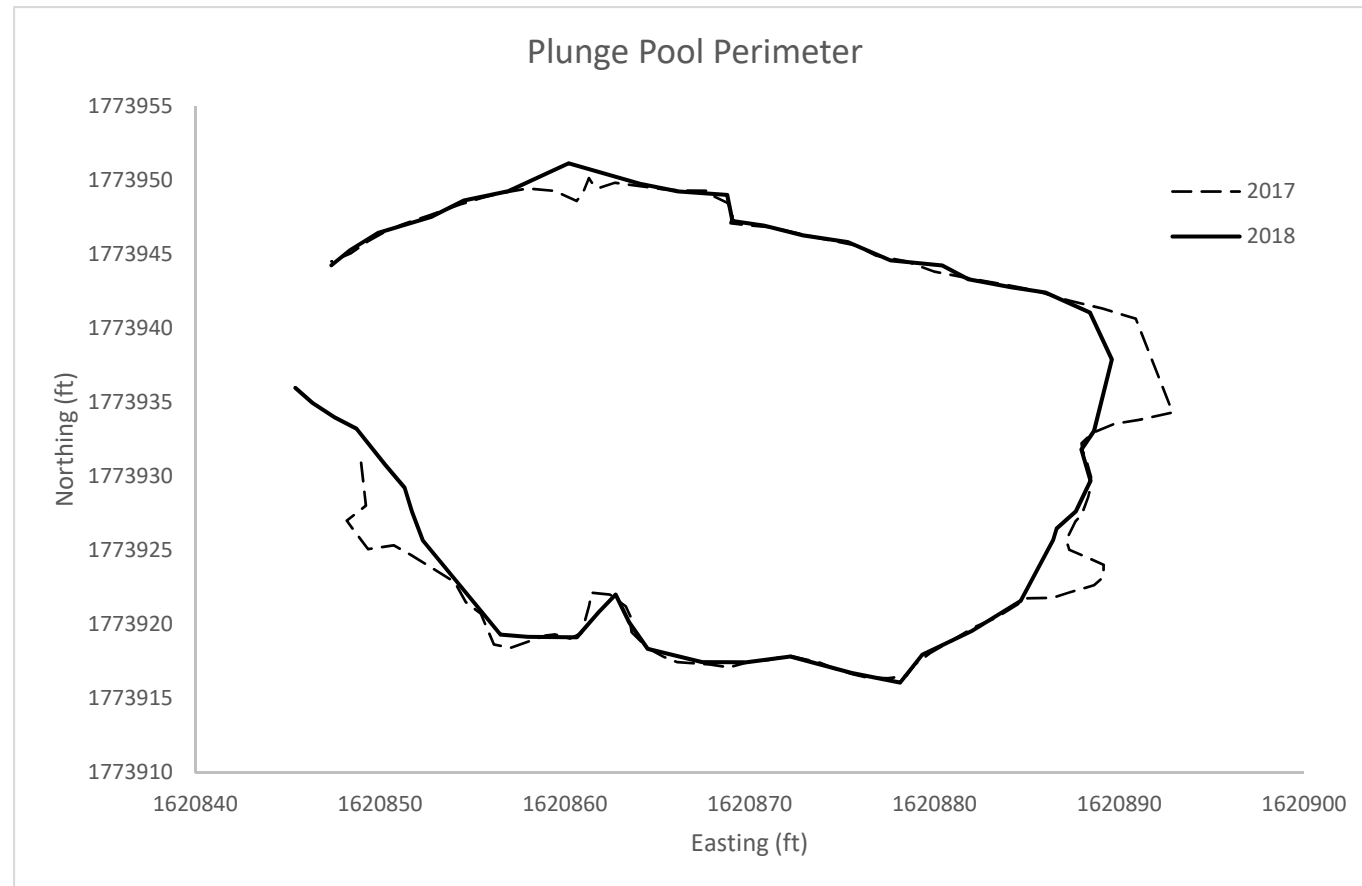
Figure B-4.2-1 1-yr plan view of plunge pool in Sandia Canyon reach S-2

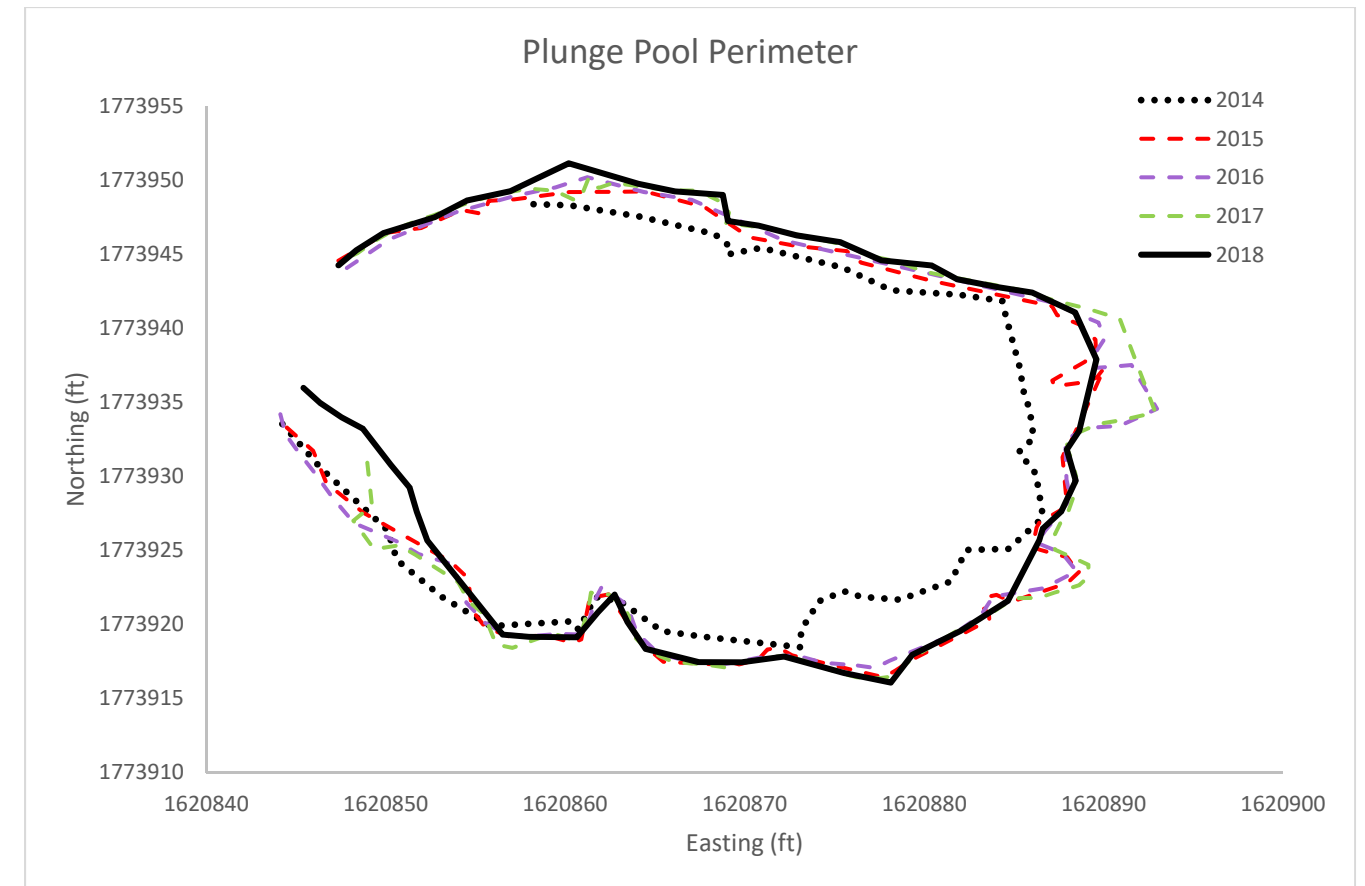
Figure B-4.2-2 5-yr plan view of plunge pool in Sandia Canyon reach S-2

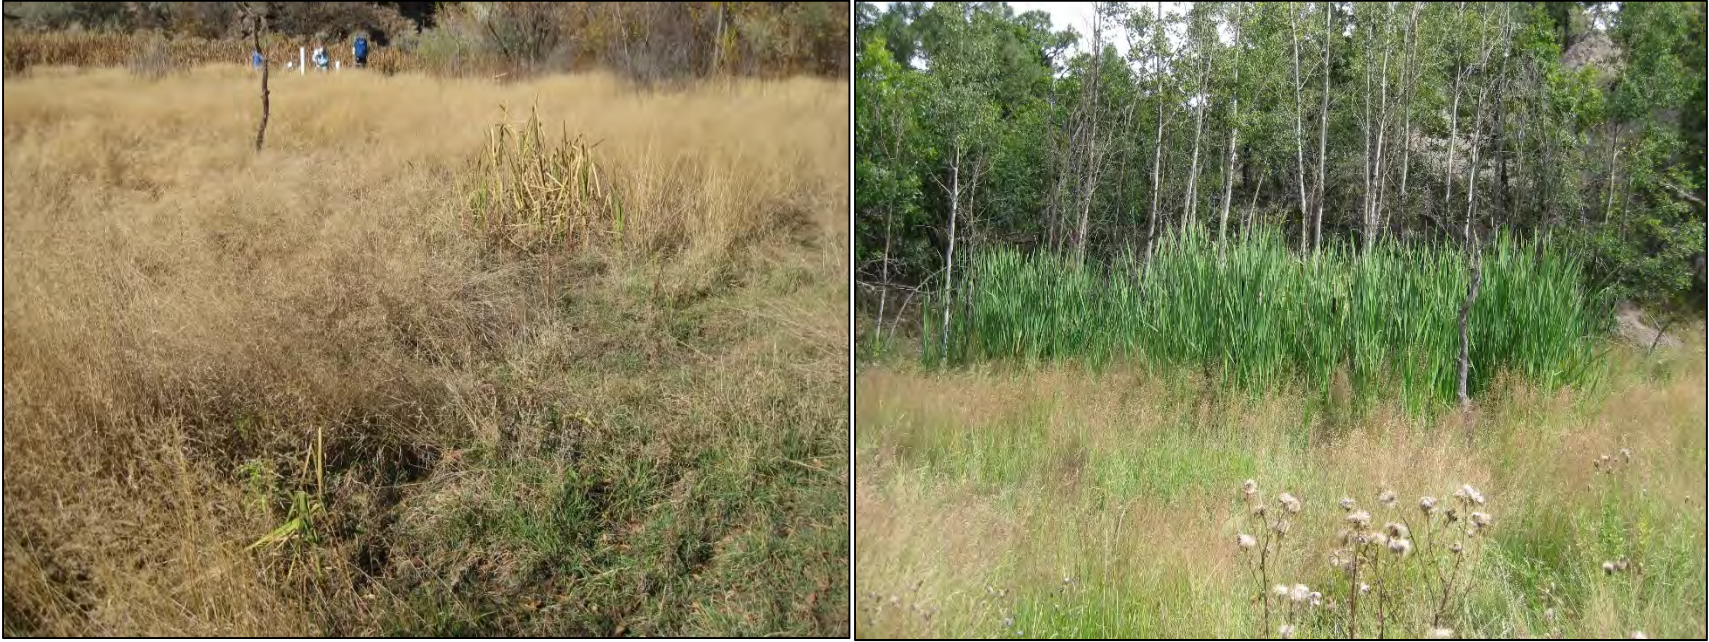
**Photo C1-27** New observed cattail populations from 2016 within grass meadow along southern end of SGCS-3A and 3B, looking northeast (left); same cattail population in August 2018, looking southeast (right)

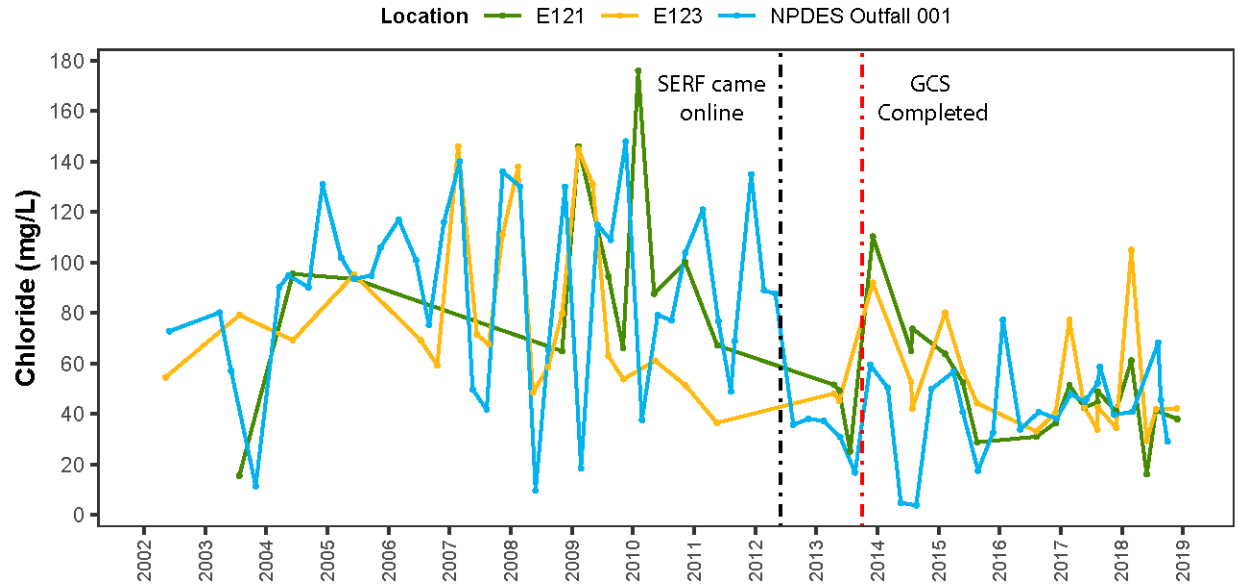
**Figure D-2.0-1 Time-series plot showing chloride concentrations at gaging stations E121 and E123 and National Pollutant Discharge Elimination System– (NPDES-) permitted Outfall 001**

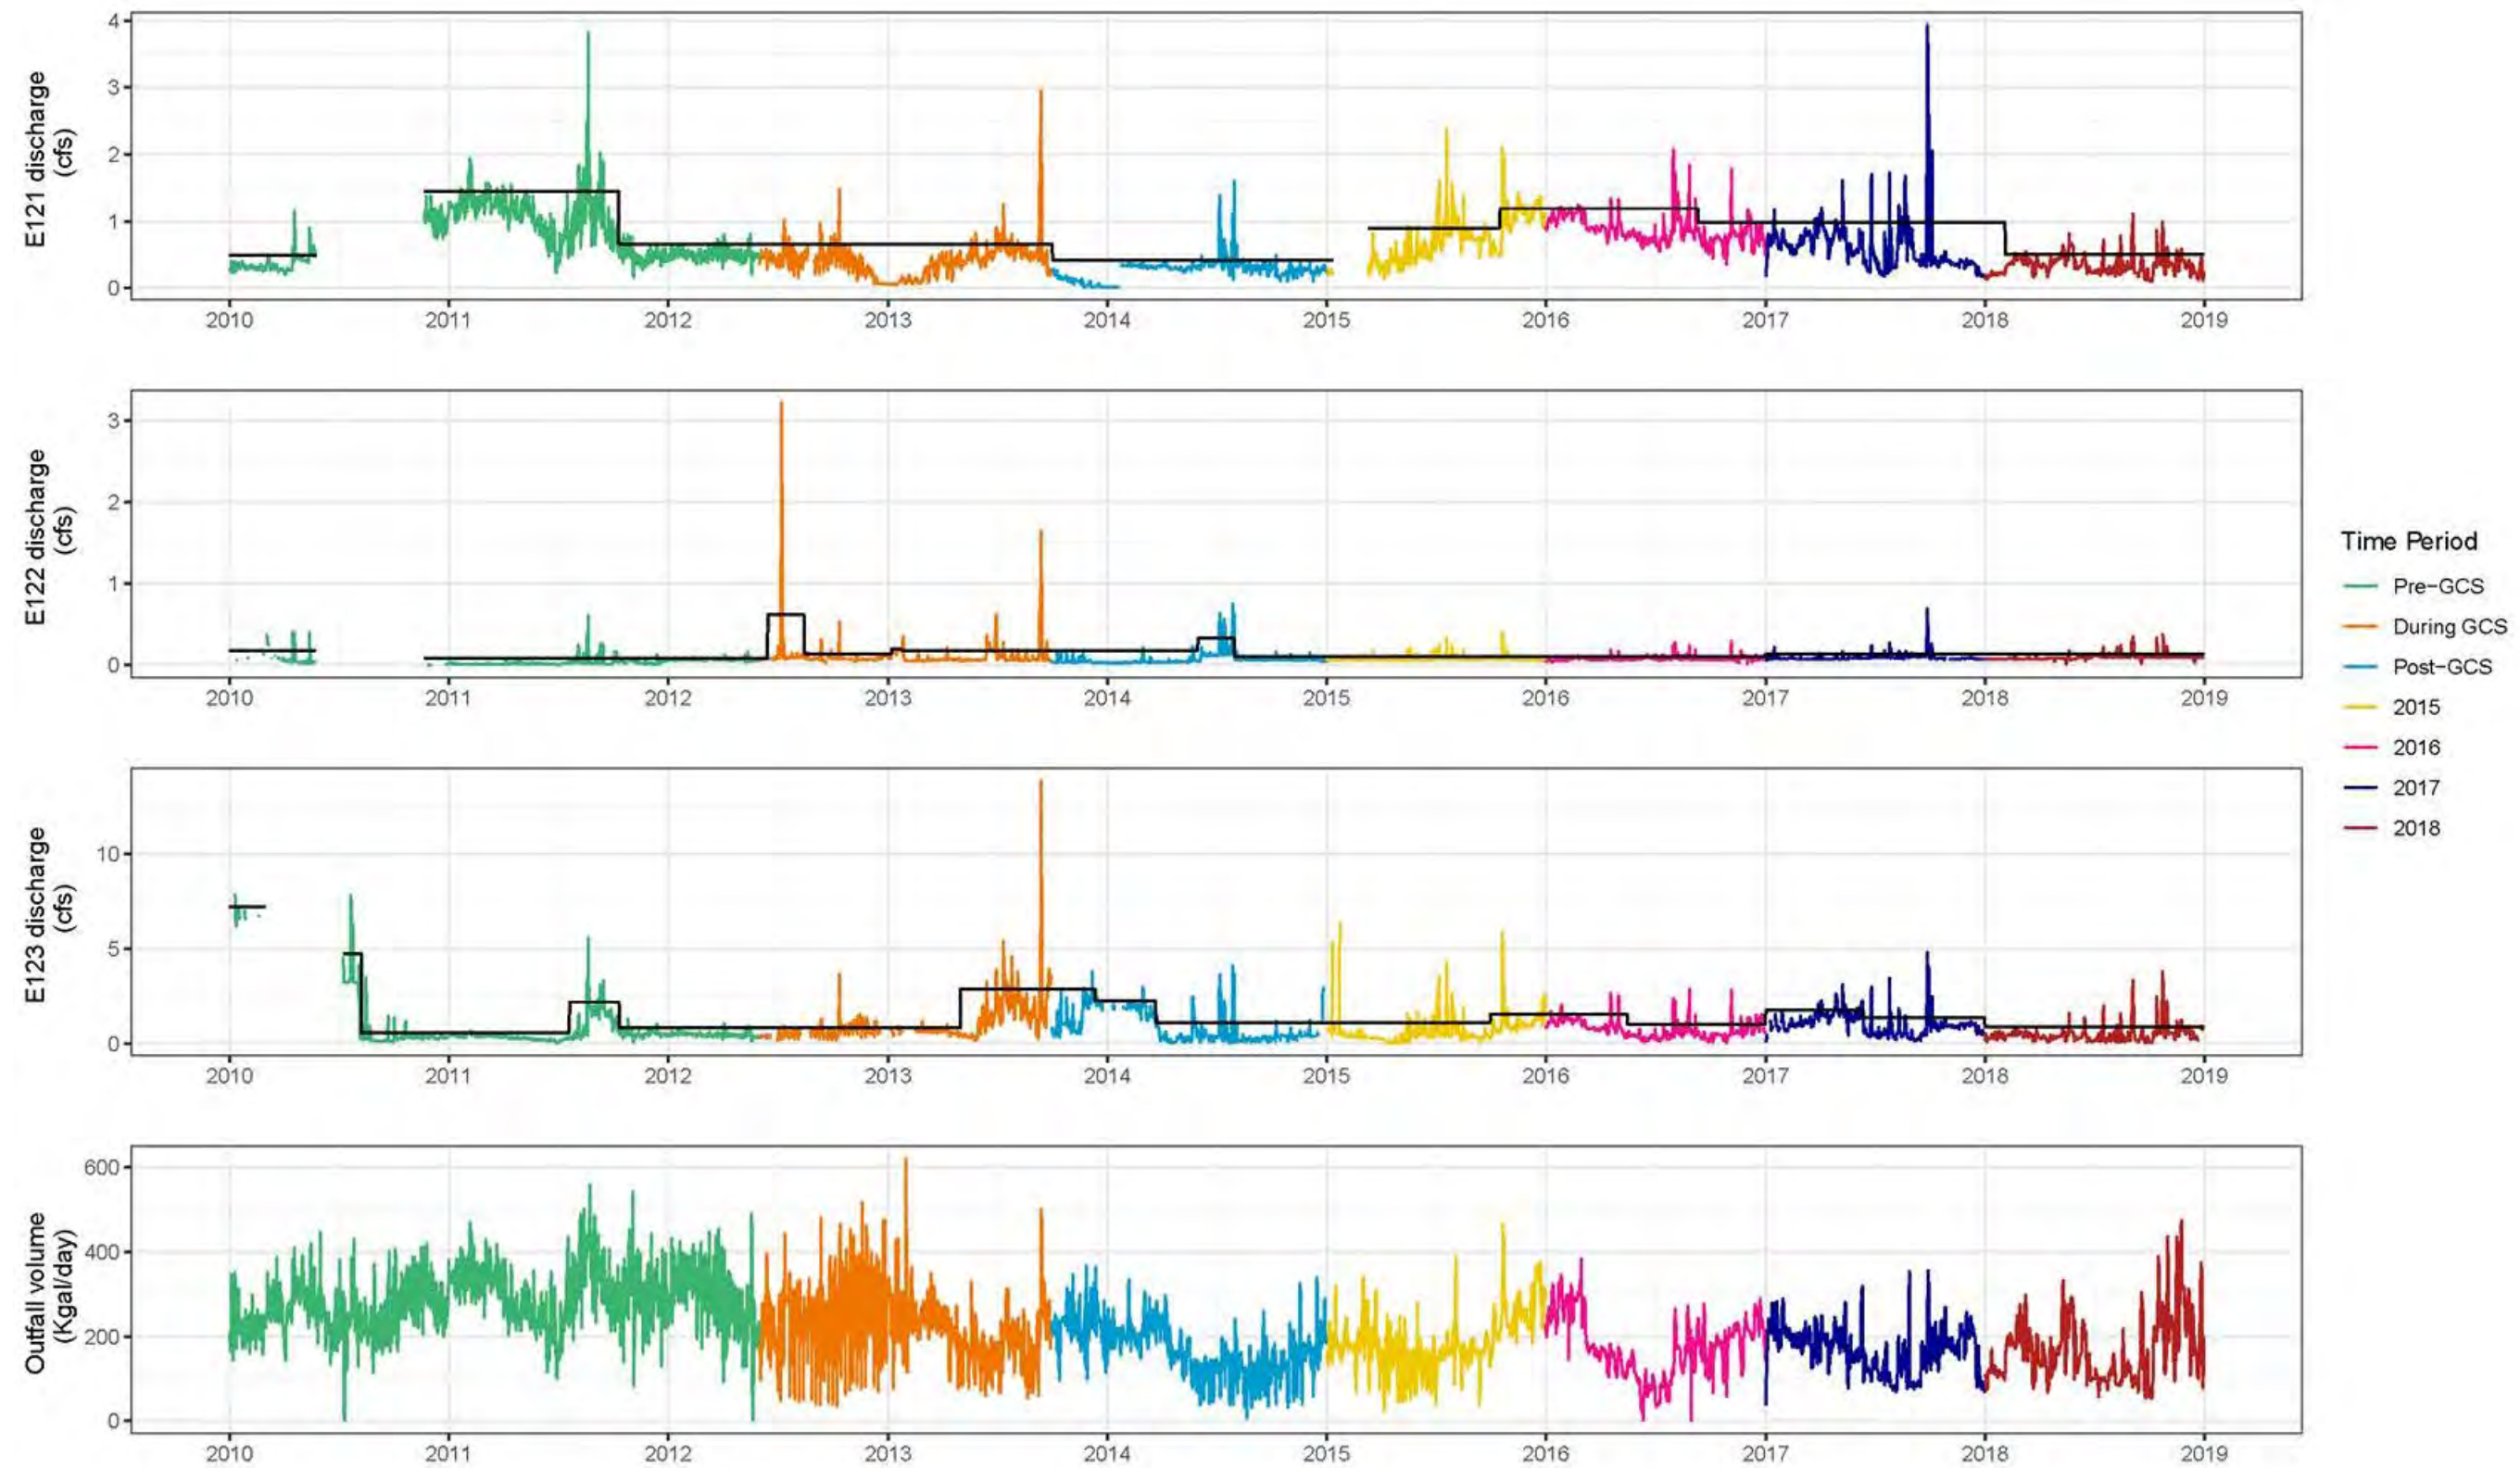
Figure D-2.0-6 Time-series plots from 2010 to 2018 showing discharge at E121, E122, and E123 and total discharge from Outfalls 001, 03A027, and 03A199. Black lines show approximate base flow, calculated as the mean daily discharge over the defined periods of stable base flow plus one standard deviation.

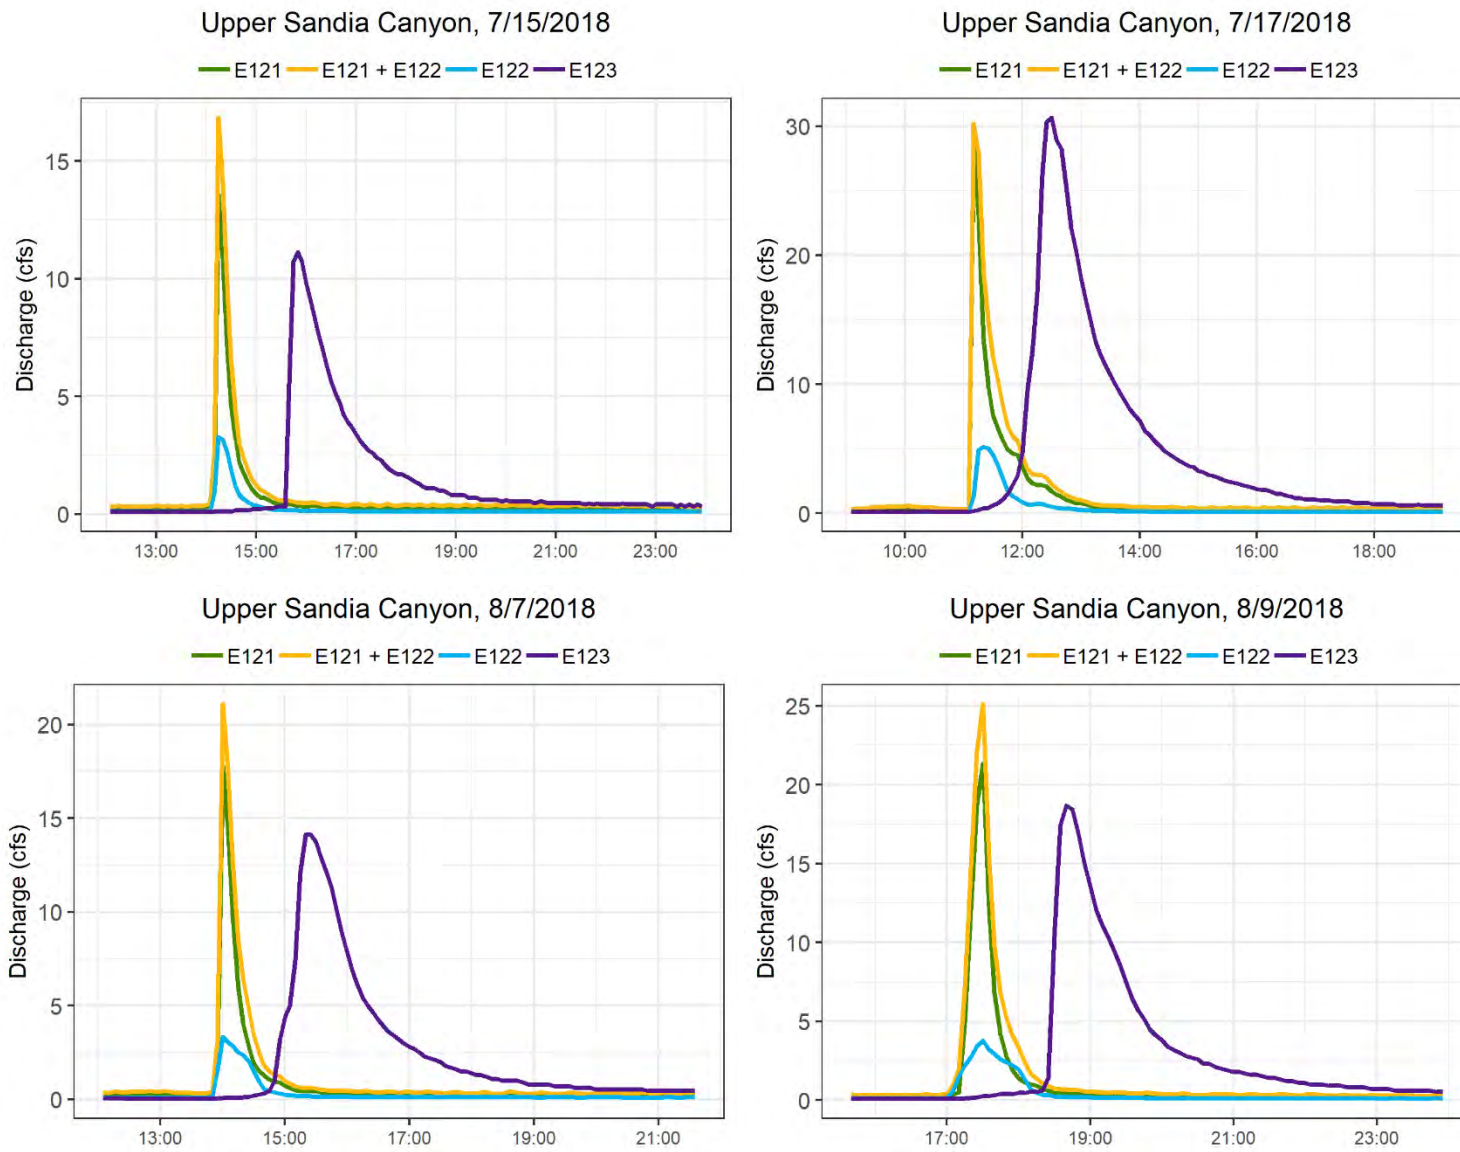
Figure D-2.0-8 Hydrographs of storm water discharge at E121, E122, and E123 during each sample-triggering storm event in 2018

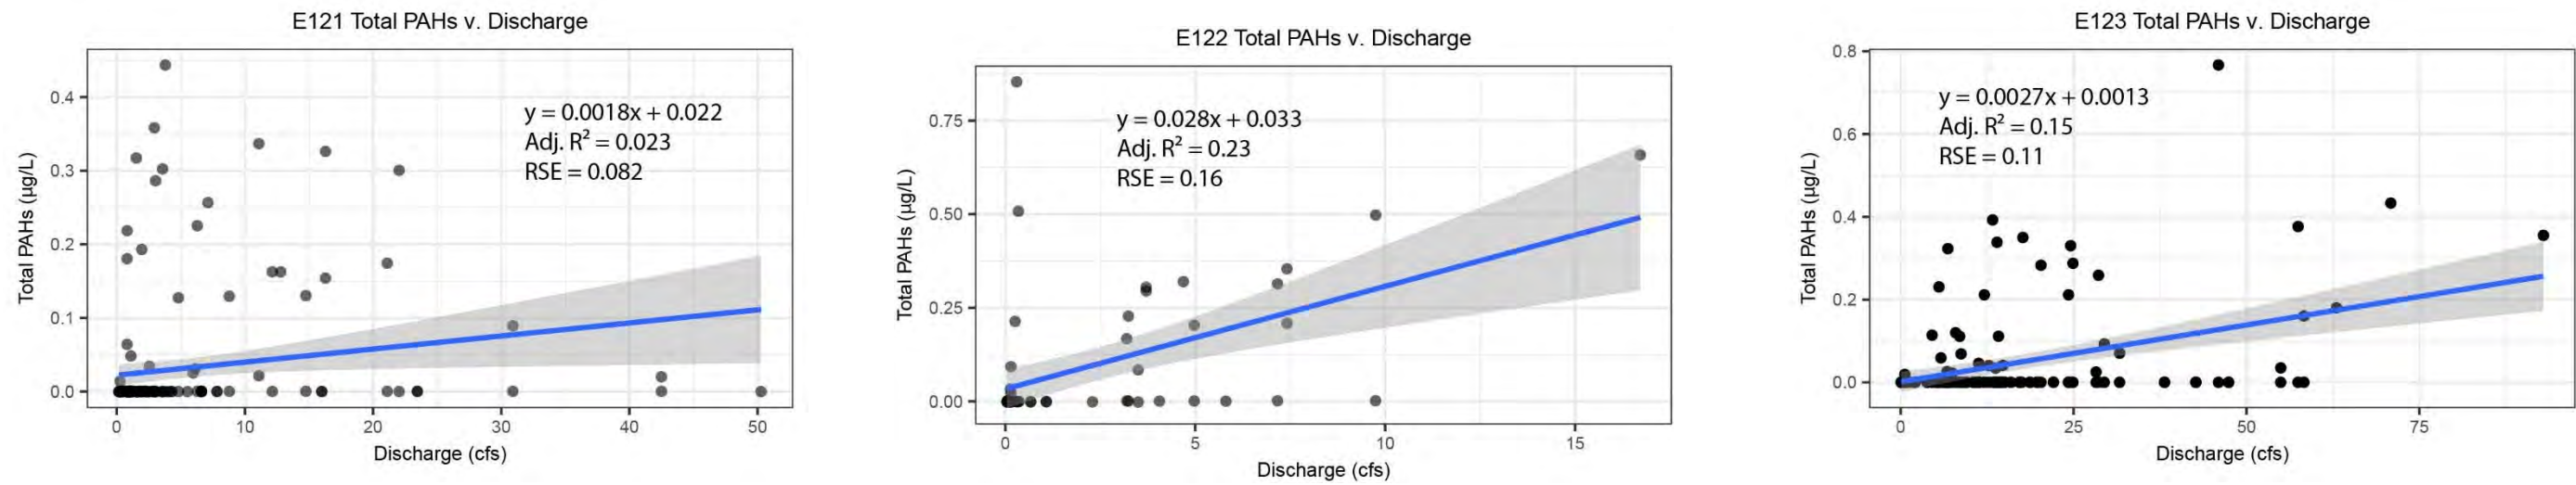
**Figure D-2.0-9** Storm- and base-flow discharge correlations with SSC, total PCBs, total chromium, and total PAHs from 2014 to 2018 at E121, E122, and E123 with standardized residual outliers removed; the shaded areas represent 95% confidence intervals. The linear model equation, adjusted R², and residual standard error are provided on each plot.

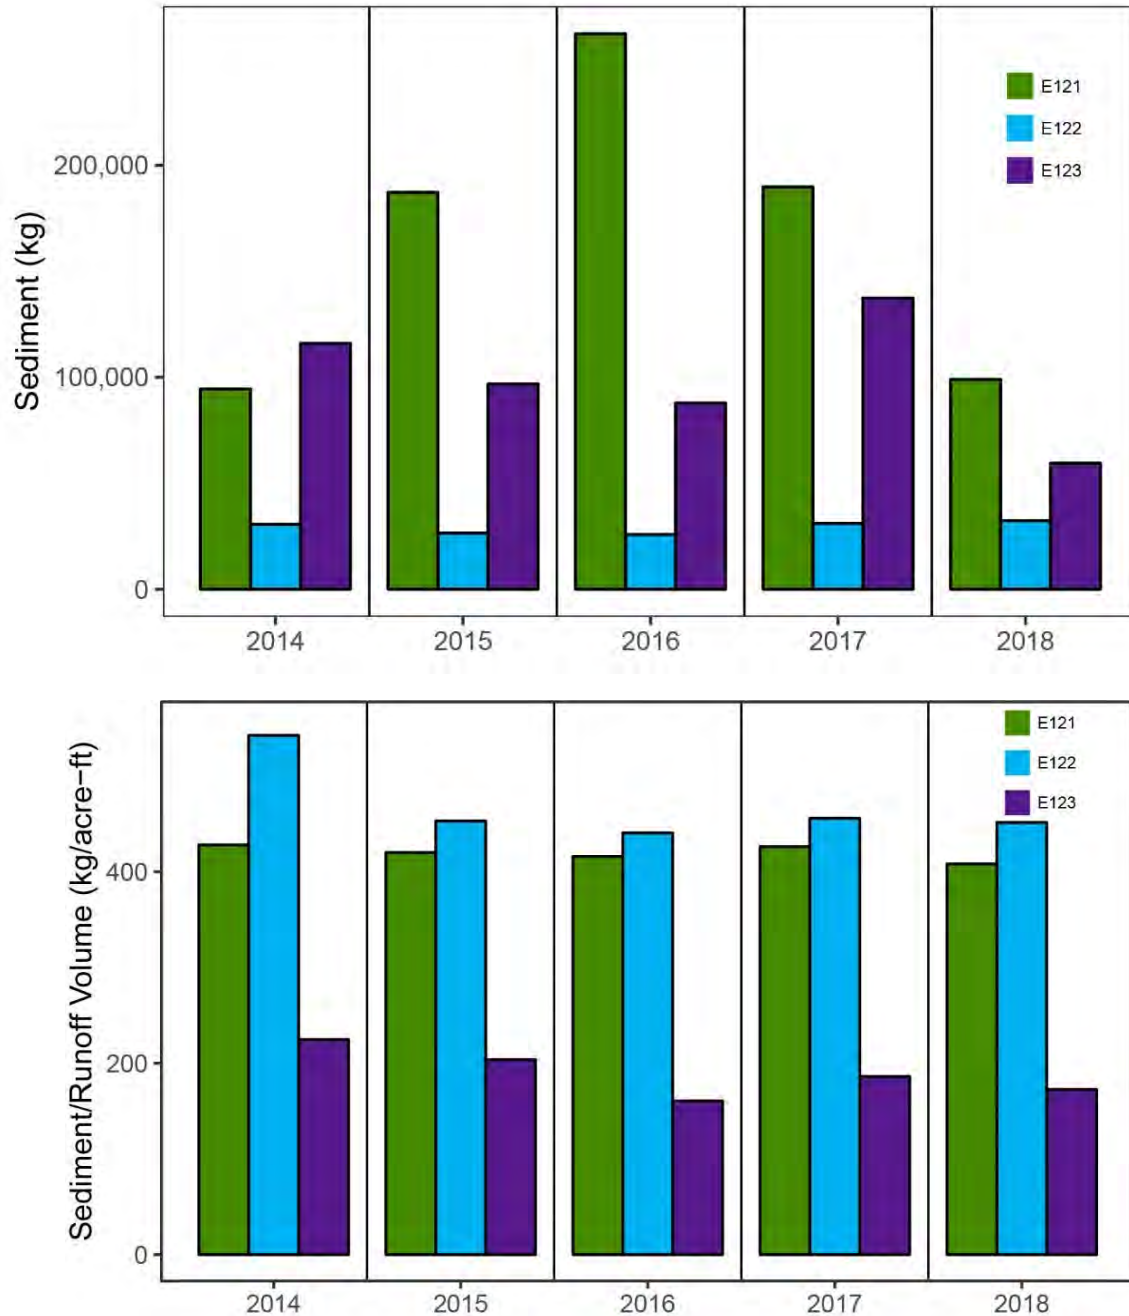
**Figure D-2.0-10 Annual mass flux (top) and annual mass flux normalized by runoff volume (bottom) for sediment at gaging stations E121 (green), E122 (blue), and E123 (purple) from 2014 to 2018. Gaging stations E121 and E122 represent inputs into the wetland, and E123 represents output from the wetland.**

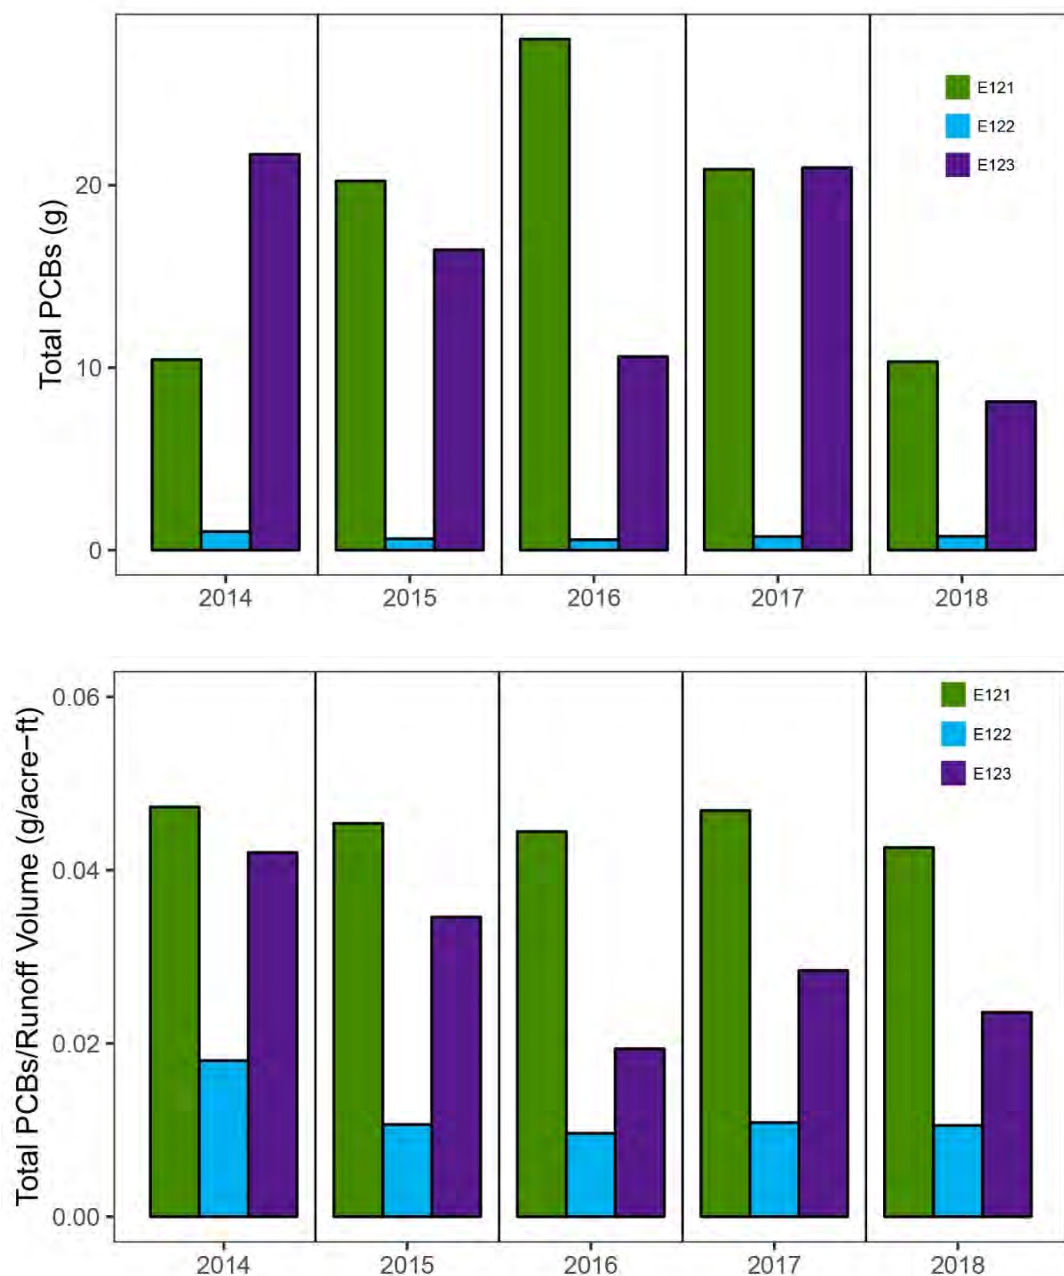
**Figure D-2.0-11** Annual mass flux (top) and annual mass flux normalized by runoff volume (bottom) for total PCBs at gaging stations E121 (green), E122 (blue), and E123 (purple) from 2014 to 2018. Gaging stations E121 and E122 represent inputs into the wetland, and E123 represents output from the wetland.
