Subject: Submittal of the 2018 Sandia Wetland Performance Report

The 2018 Sandia wetland performance report is the fifth annual performance report following the 2012 to 2014 baseline that assessed the overall condition of the wetland at the head of Sandia Canyon. Canyon wetland monitoring was performed in the context of the wetland's ability to mitigate migration of contaminants of concern (i.e., chromium, polychlorinated biphenyls [PCBs], and polycyclic aromatic hydrocarbons) detected in wetland sediments as a result of historical releases at Los Alamos National Laboratory (LANL or the Laboratory). The geochemistry and physical stability of wetland sediments, along with the extent of wetland vegetation, are the key indicators of wetland conditions. The condition of the wetland is assessed to evaluate the effectiveness of the grade-control structure (GCS) completed in 2013 at the terminus of the wetland, and to monitor changes to the Laboratory's operational practices that have affected outfall volumes discharging to the wetland. This report presents the results of monitoring conducted for surface water, alluvial groundwater, vegetation, and geomorphology between January and Decem

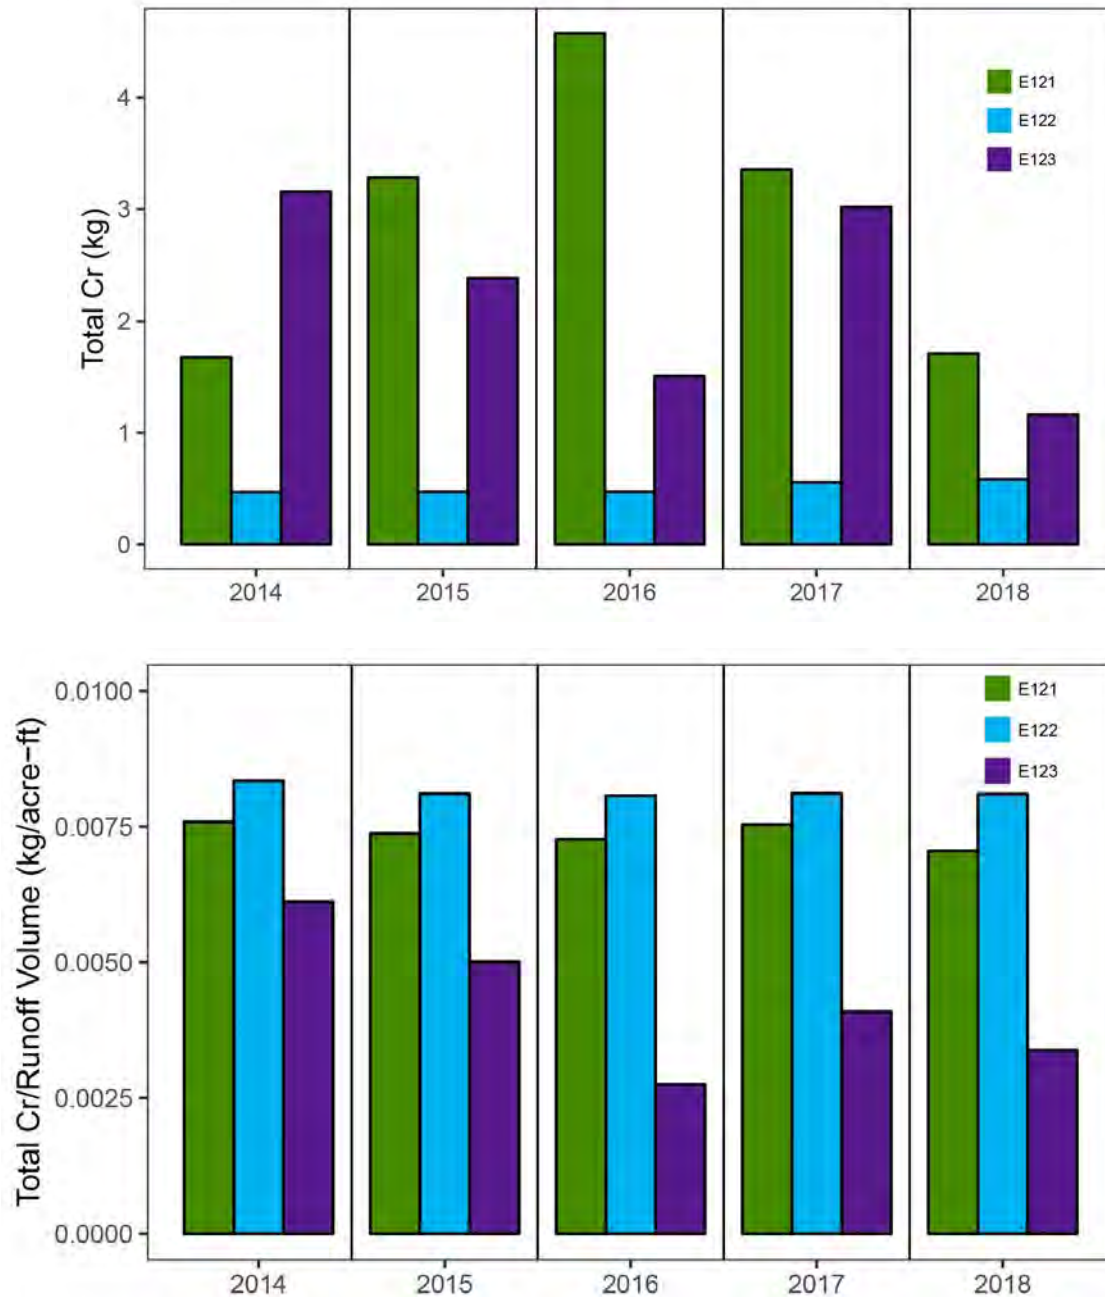
**Figure D-2.0-12** Annual mass flux (top) and annual mass flux normalized by runoff volume (bottom) for total chromium at gaging stations E121 (green), E122 (blue), and E123 (purple) from 2014 to 2018. Gaging stations E121 and E122 represent inputs into the wetland, and E123 represents output from the wetland.

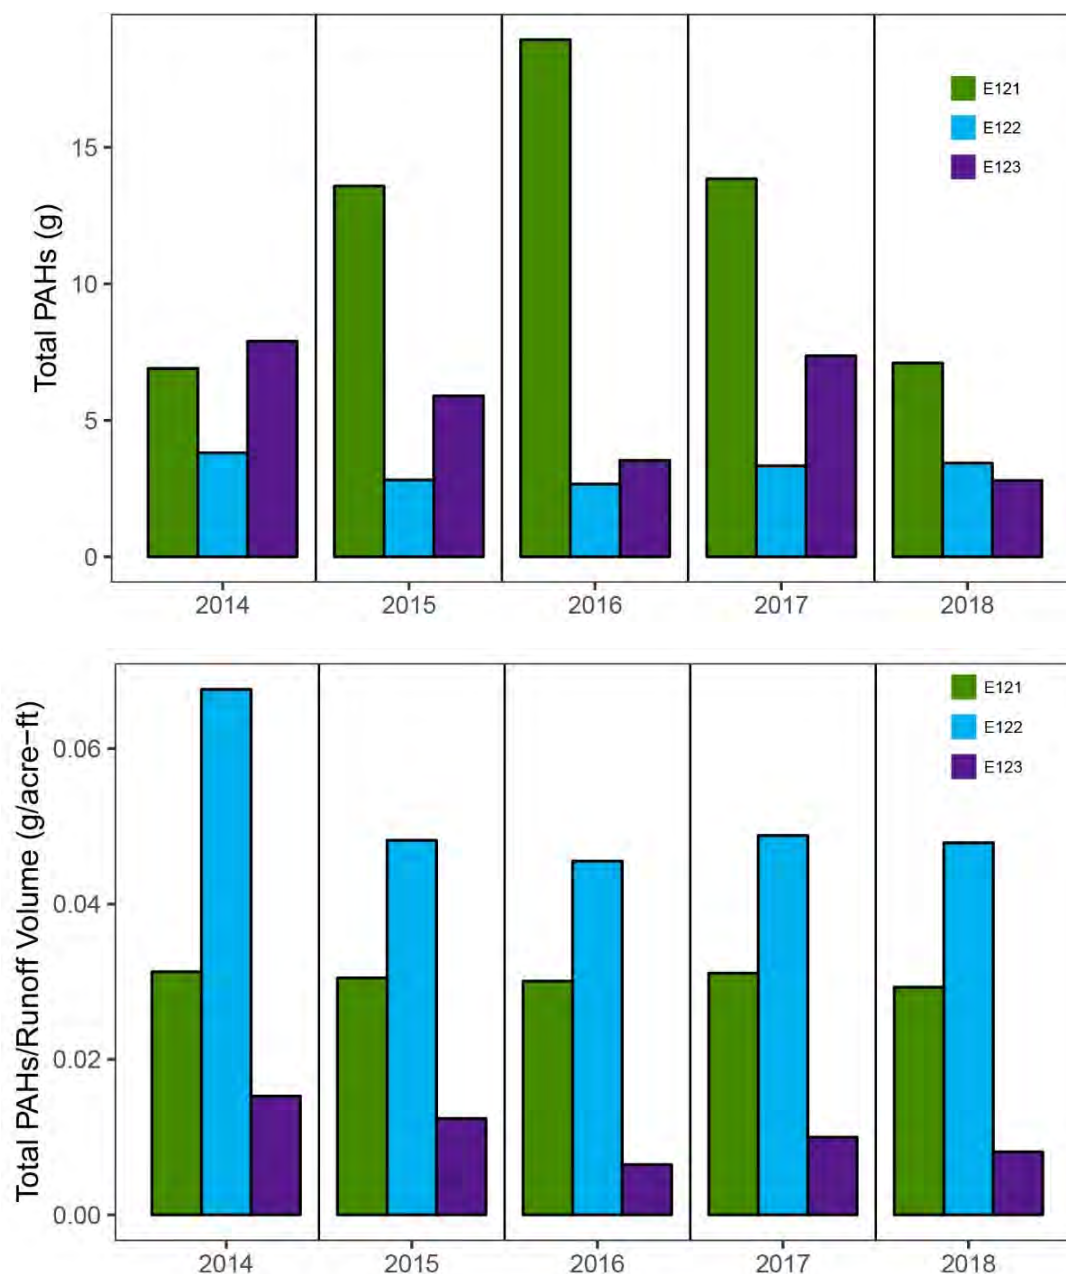
**Figure D-2.0-13** Annual mass flux (top) and annual mass flux normalized by runoff volume (bottom) for total PAHs at gaging stations E121 (green), E122 (blue), and E123 (purple) from 2014 to 2018. Gaging stations E121 and E122 represent inputs into the wetland, and E123 represents output from the wetland.

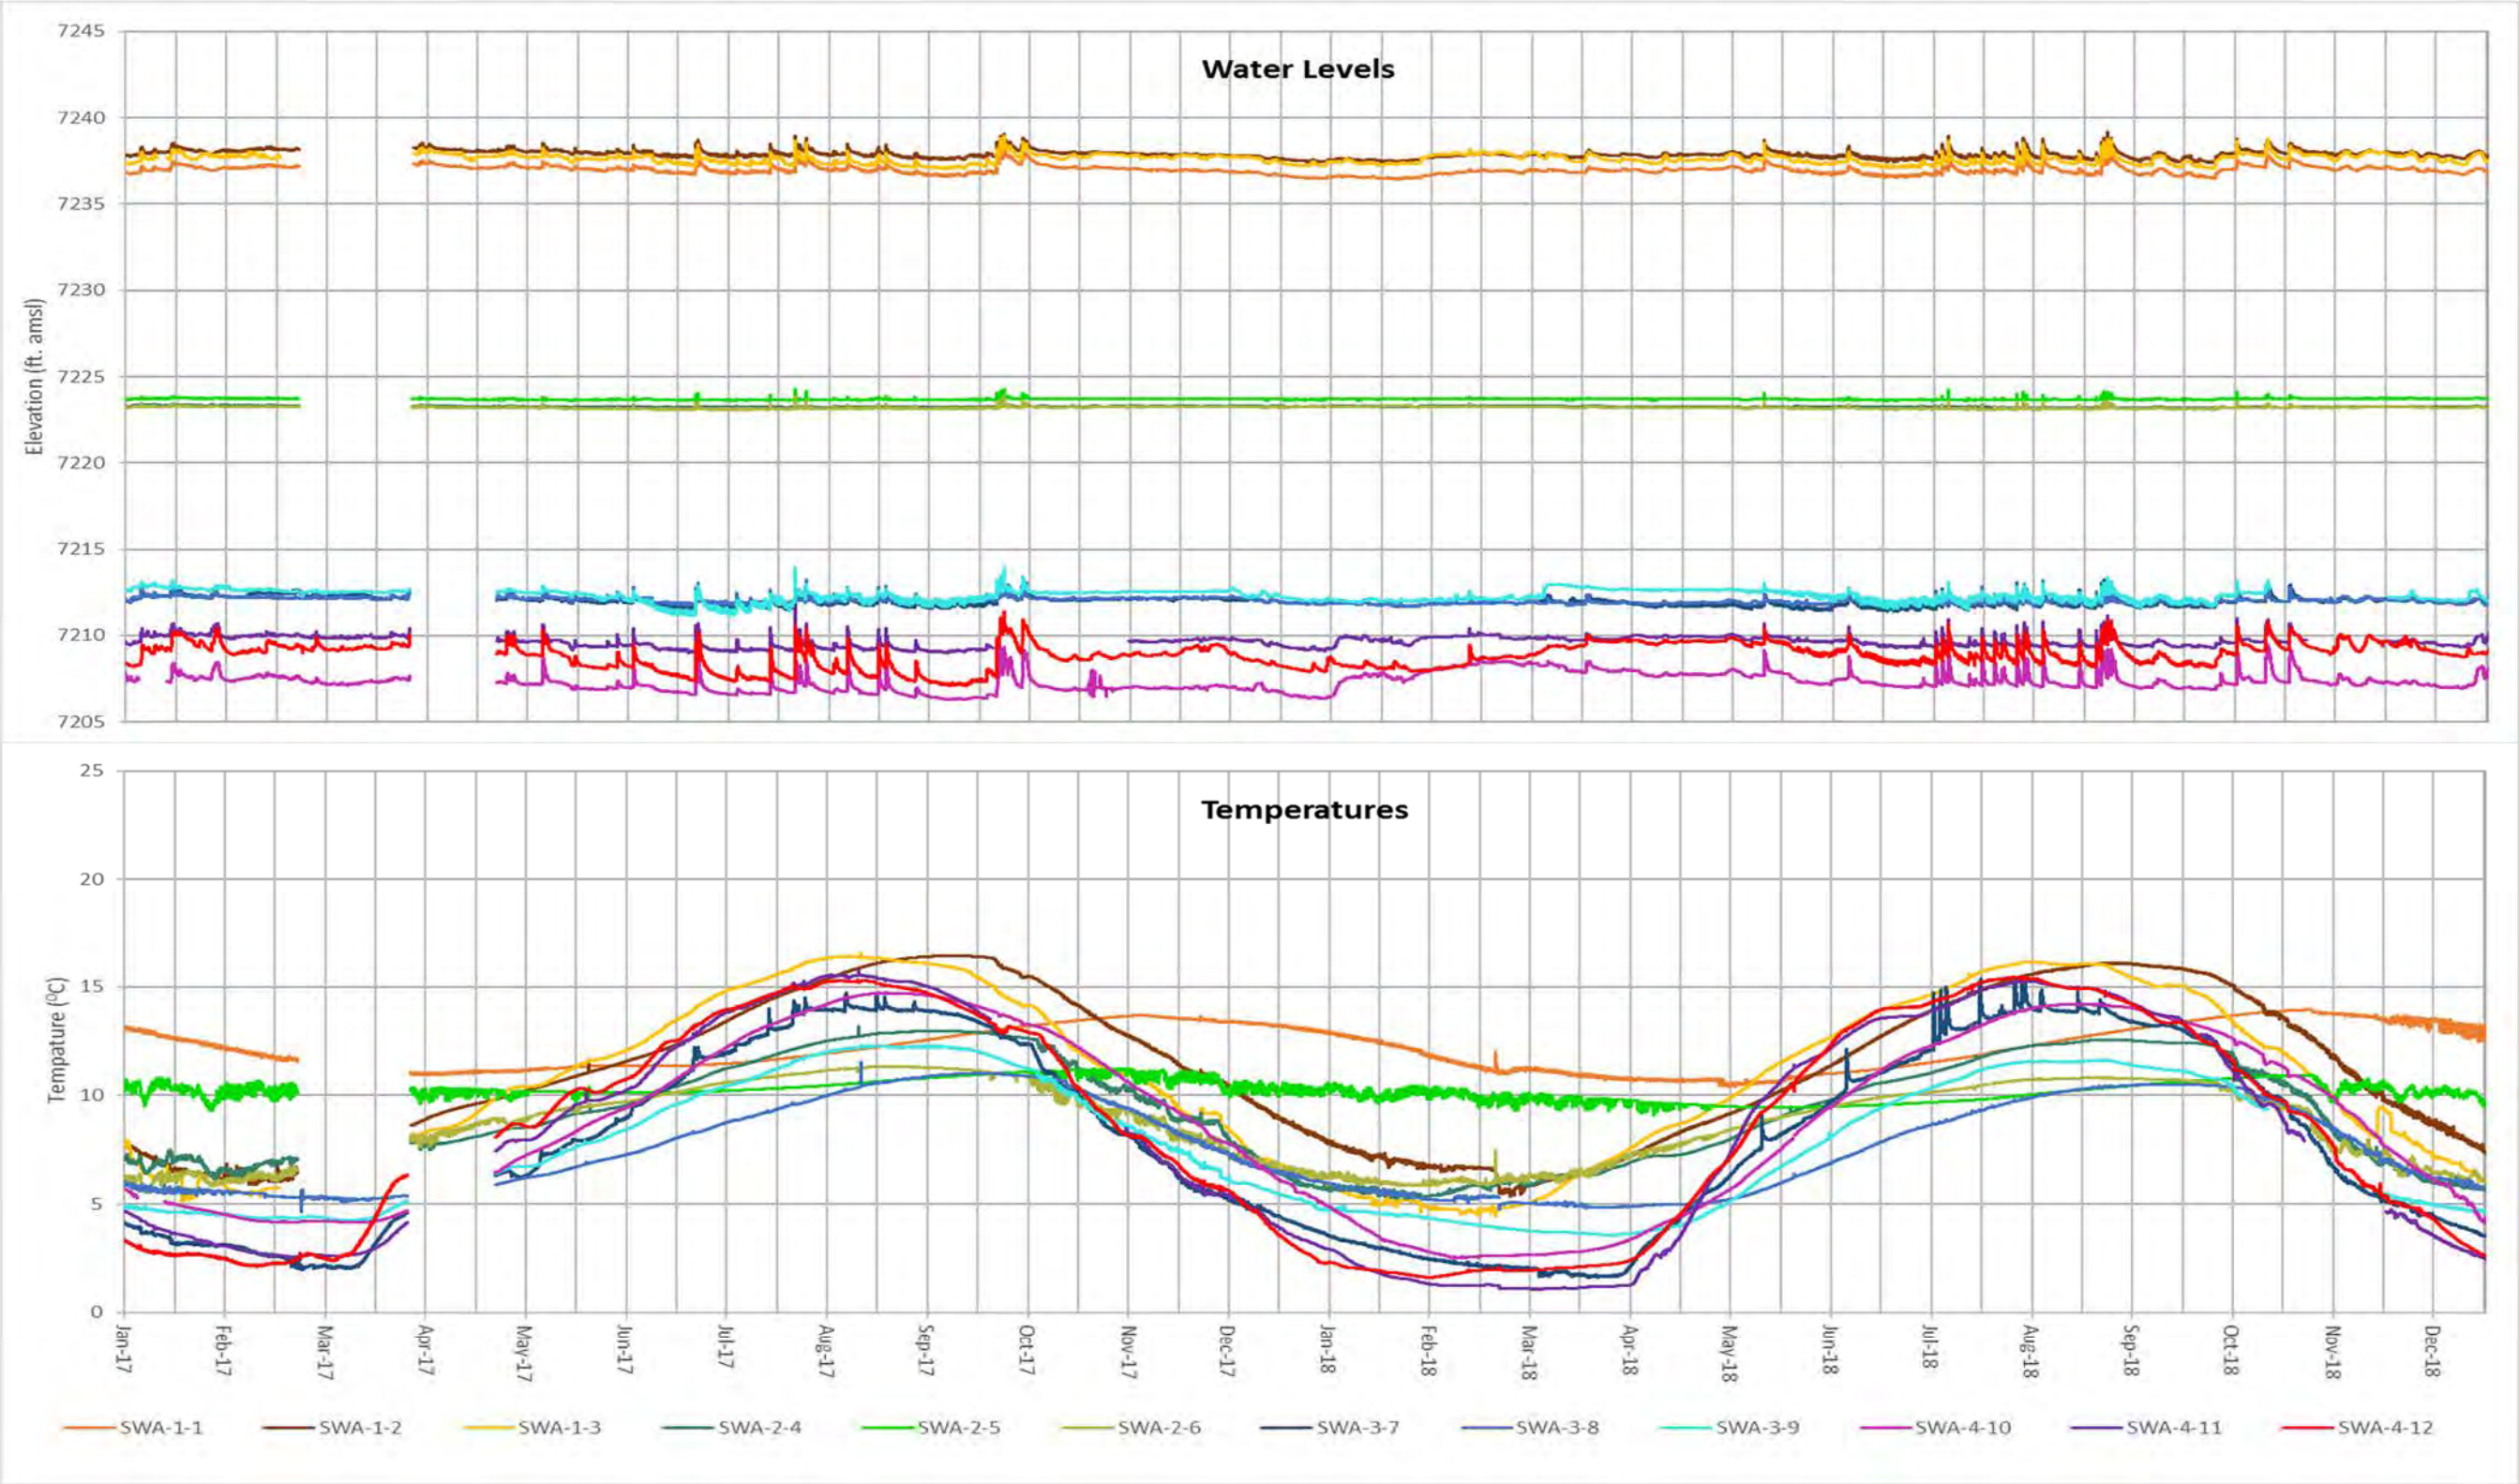
Figure D-4.0-2 Time series of water level and temperature in alluvial system in 2017 and 2018

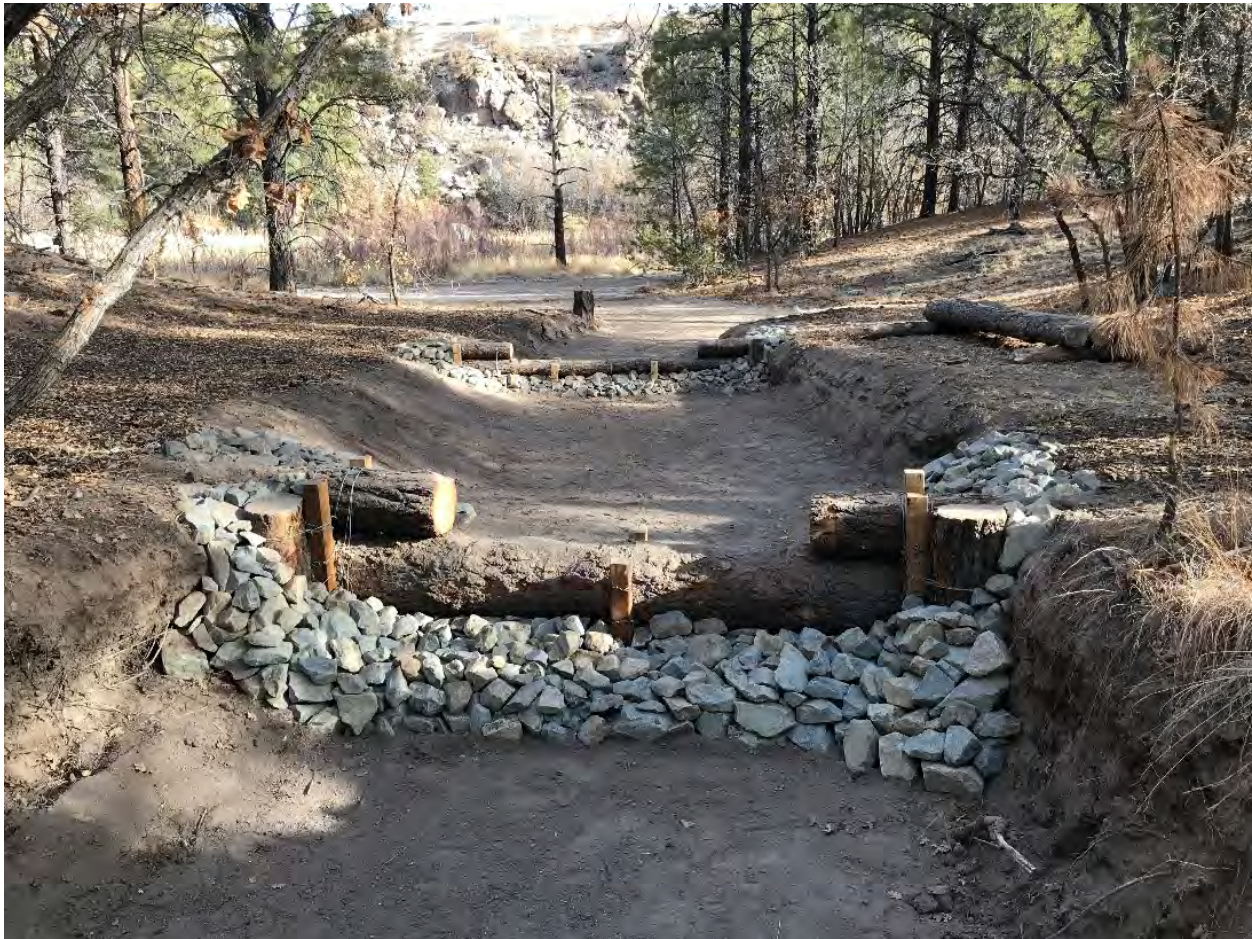
**Figure E-2.1-1** January 2018: View of repaired log check dams with additional riprap erosion protection (looking downstream)

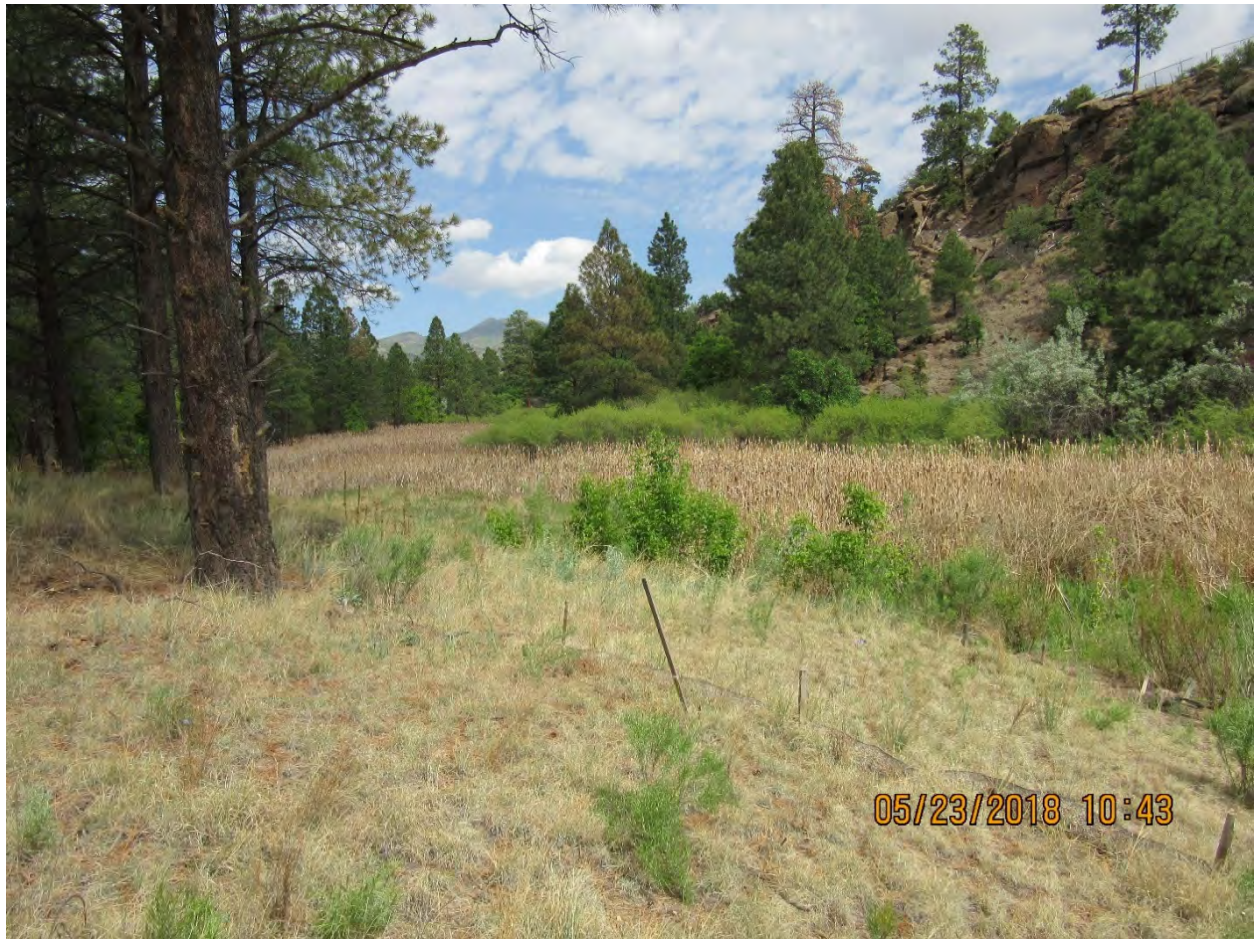
**Figure E-3.1-1** May 2018: South bank of vegetation looking upstream. Vegetation continuing to establish on south bank. No erosion is present.

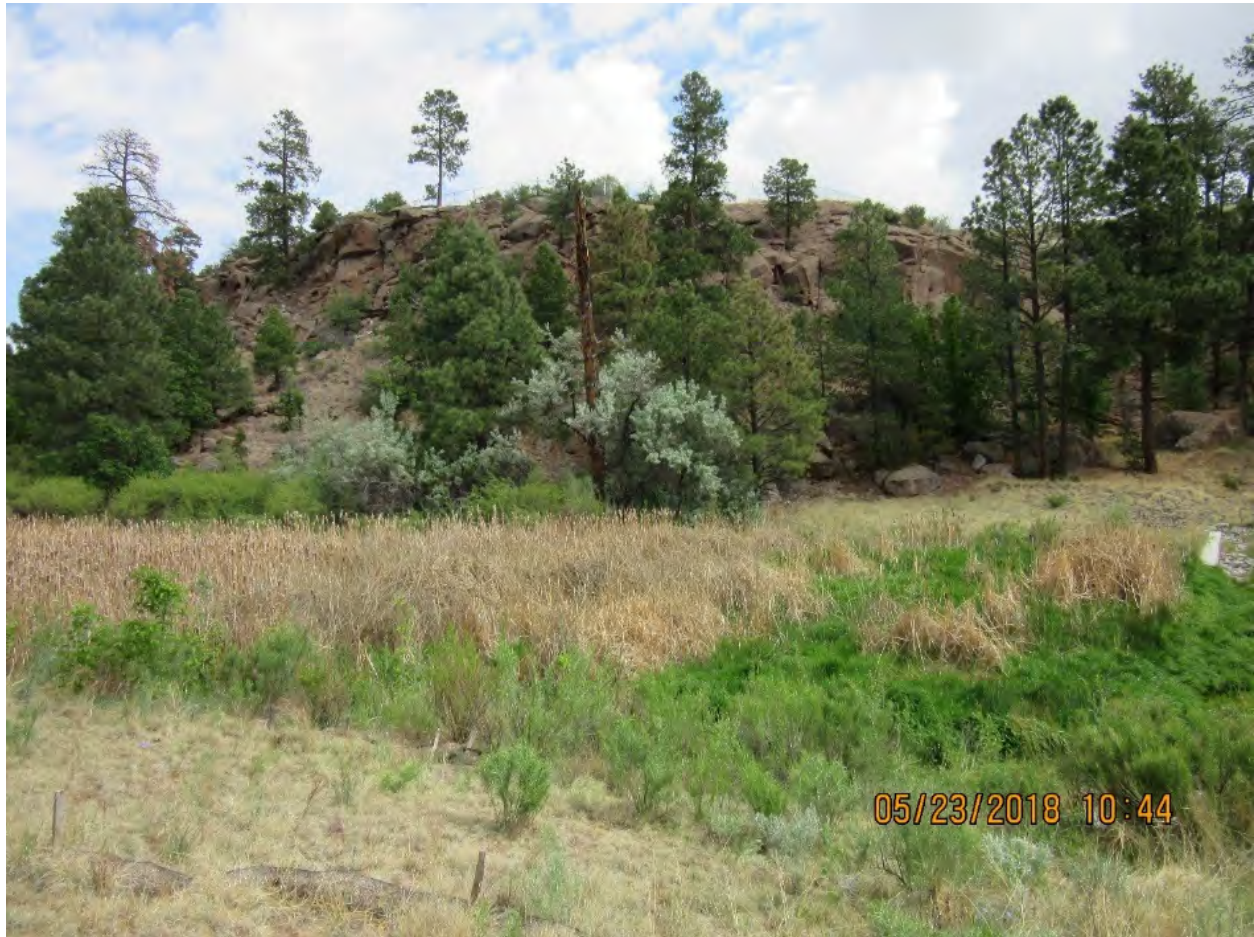
**Figure E-3.2-1** May 2018: North bank looking north. Established vegetation with no sign of erosion. Vegetation showing good stability and density.

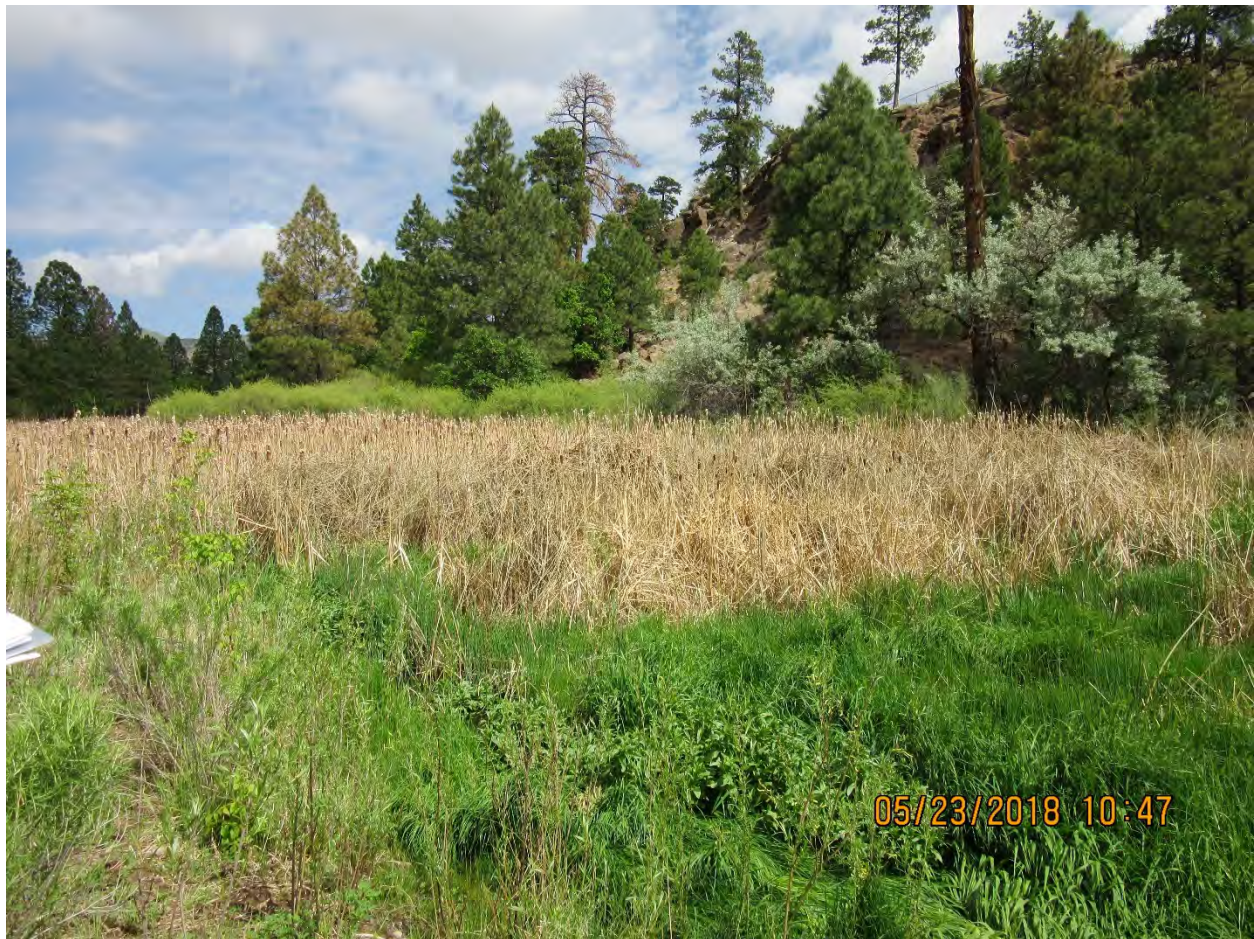
**Figure E-3.3-1** May 2018: Upper wetland looking upstream. There is some evidence of wetland channelization. Continue to monitor to preferential flow paths within wetland with slight channelization.

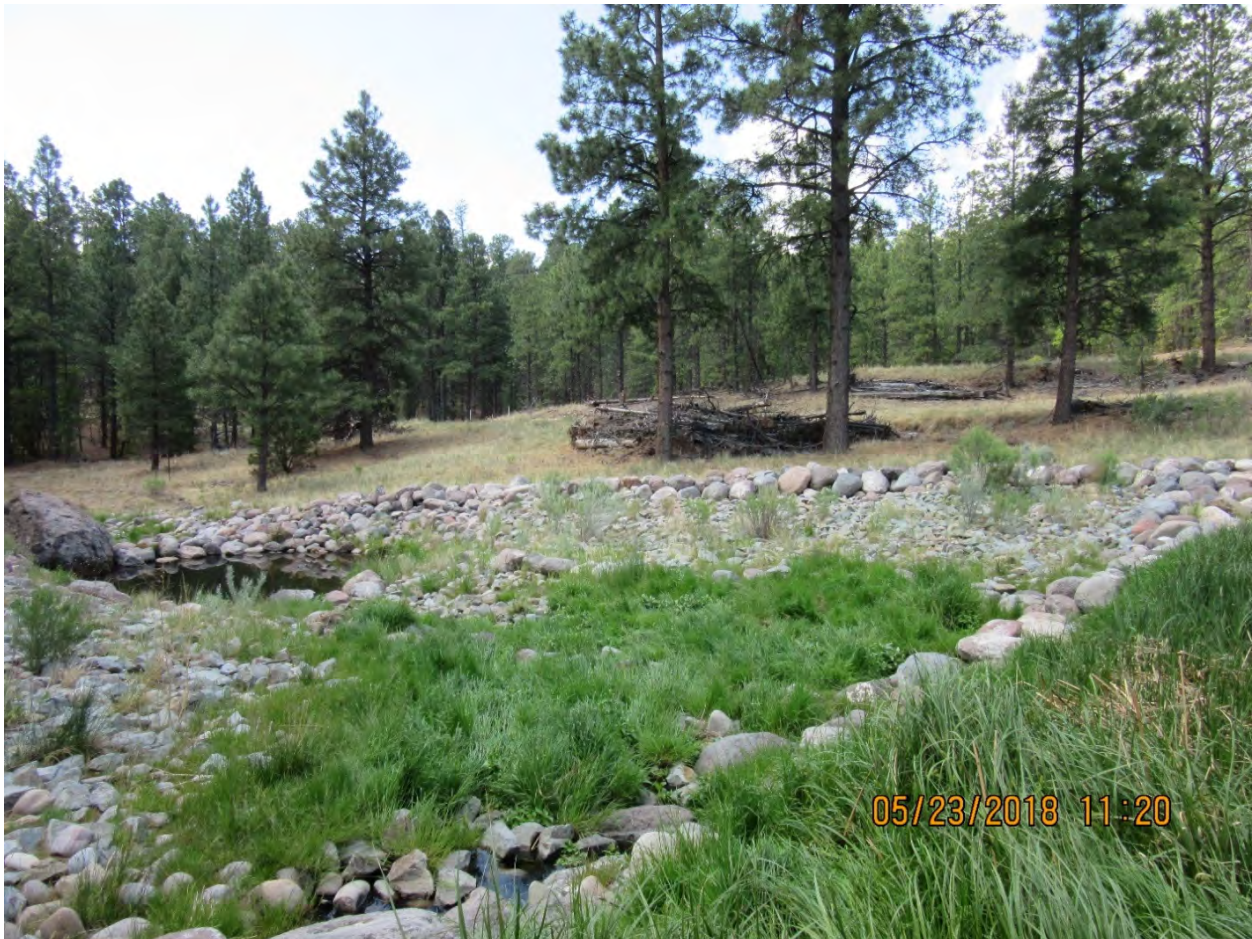
**Figure E-3.5-1** May 2018: Lower wetland looking downstream. There is slight vegetation establishment in riprap. The structure is working as designed with no evidence of channelization.

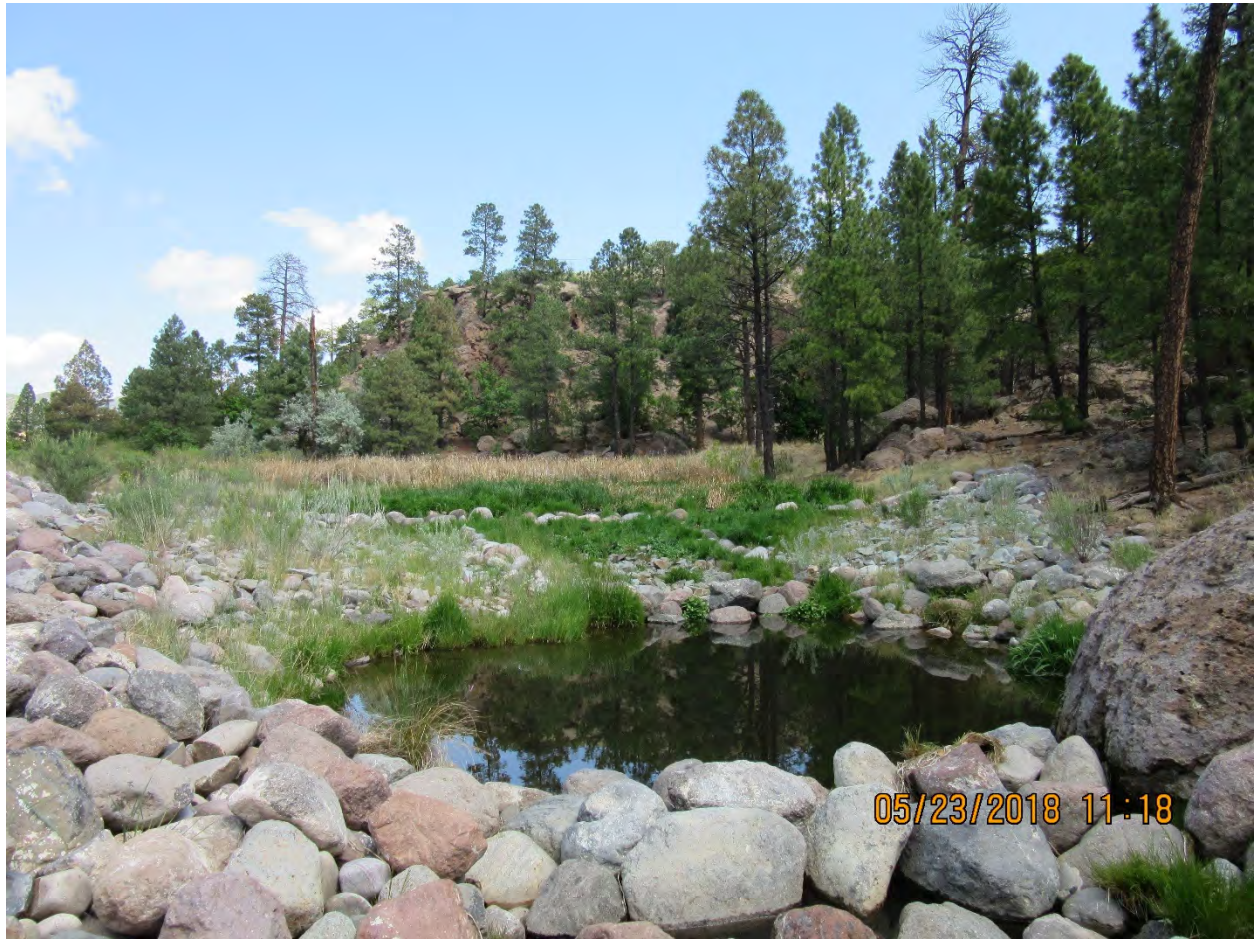
**Figure E-3.6-1** May 2018: Cascade structure (looking downstream) working as designed. There is no evidence of rock displacement. There is no evidence of erosion in/near cascade pool.

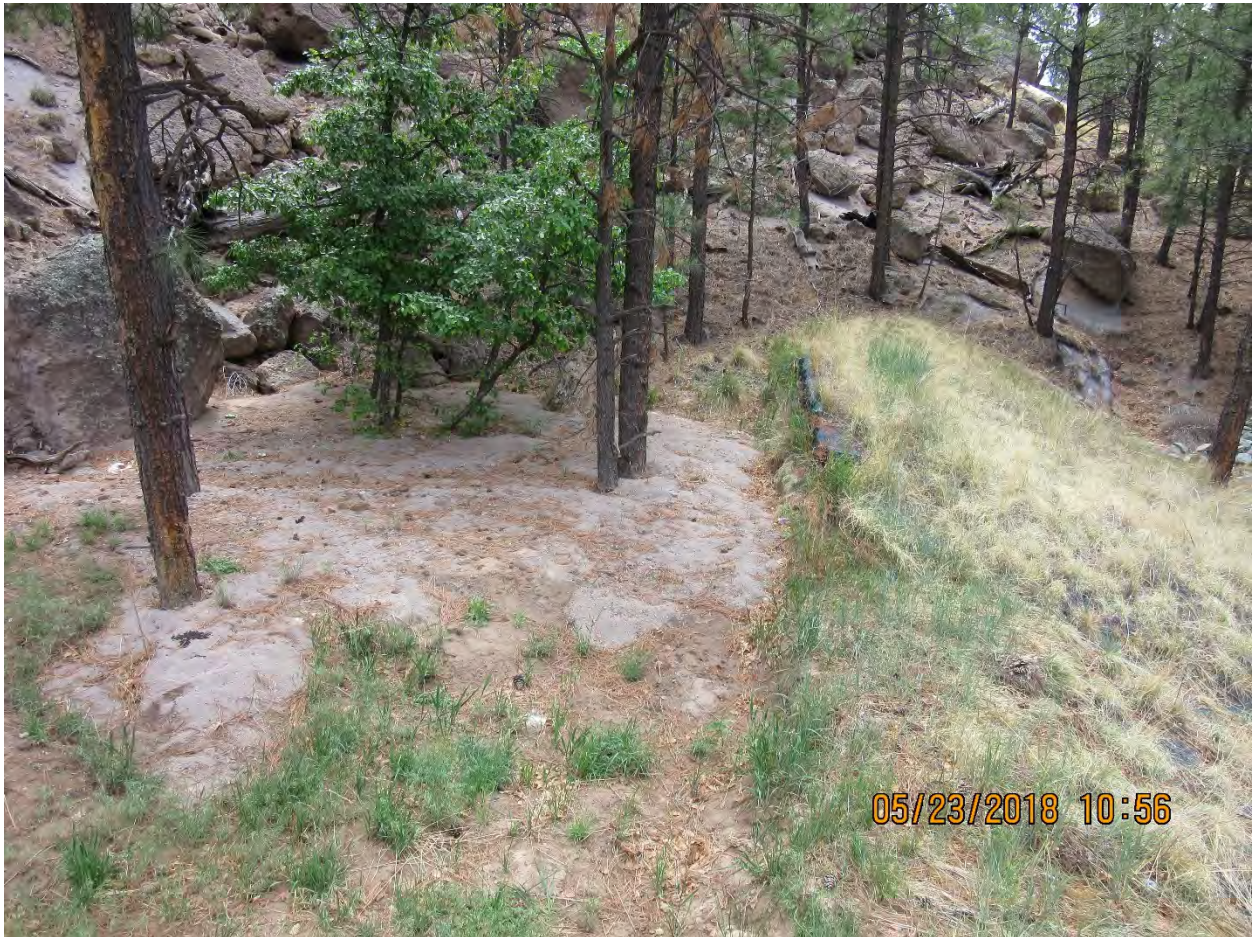
**Figure E-3.7-1** May 2018: Upper defense cell sediment migration has recently occurred. There is approximately 1 ft of capacity from the bottom of the pond to the spillway.

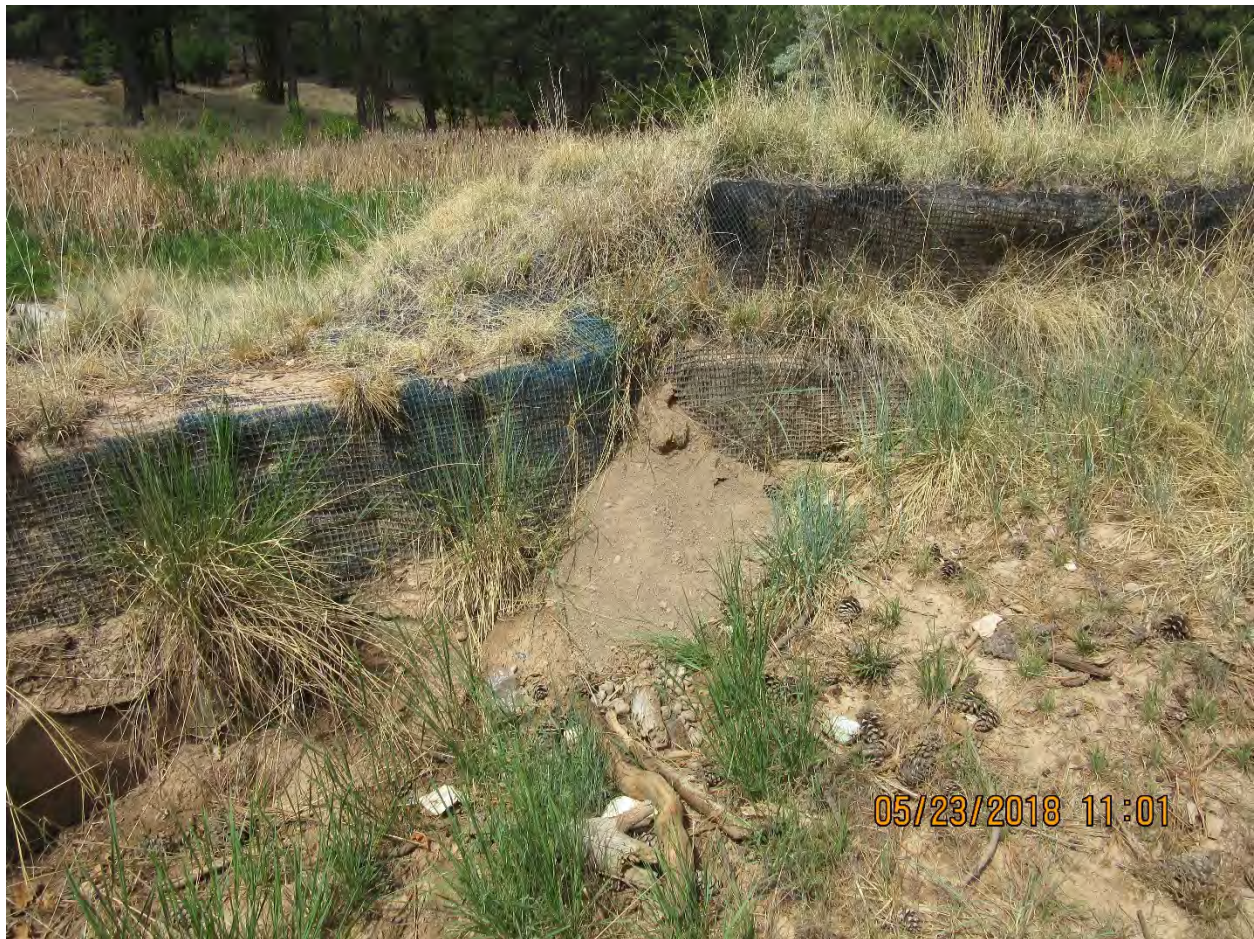
**Figure E-3.8-1 May 2018: Lower defense cell. Need to monitor erosion occurring at the west end of the spillway. Investigate need for possible maintenance to address erosion occurring under the turf-reinforcement mat on spillway rundowns.**

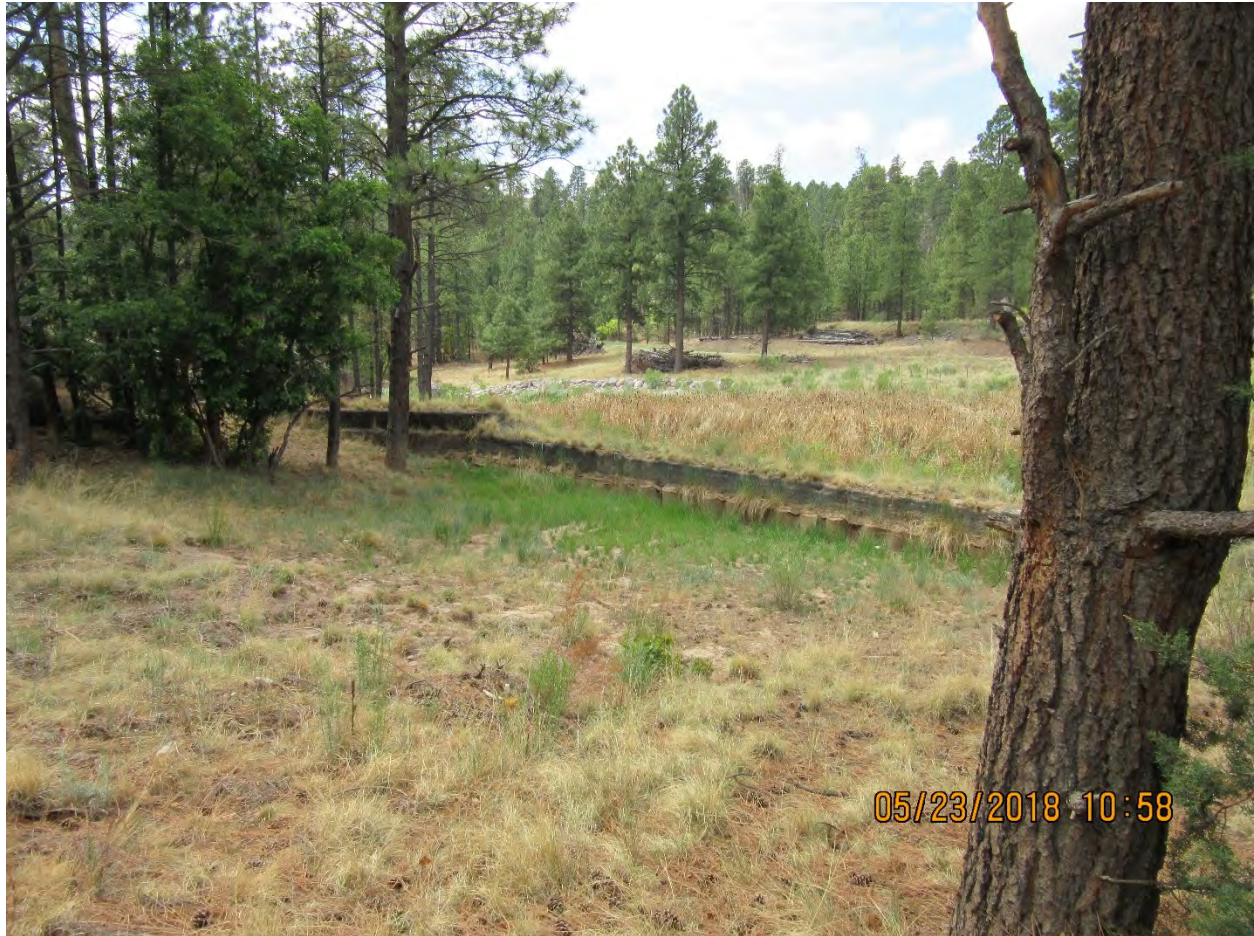
**Figure E-3.8-2 May 2018: Lower defense cell barrier with approximately 3.5 ft of capacity available from bottom of pond to spillway**
