Subject: Submittal of the 2019 Biennial Asphalt Monitoring and Removal Report for Area of Concern C-00-041, Guaje/Barrancas/Rendija Canyons Aggregate Area

December 2019  
EM2019-0409

# **2019 Biennial Asphalt Monitoring and Removal Report for Area of Concern C-00-041, Guaje/Barrancas/Rendija Canyons Aggregate Area**

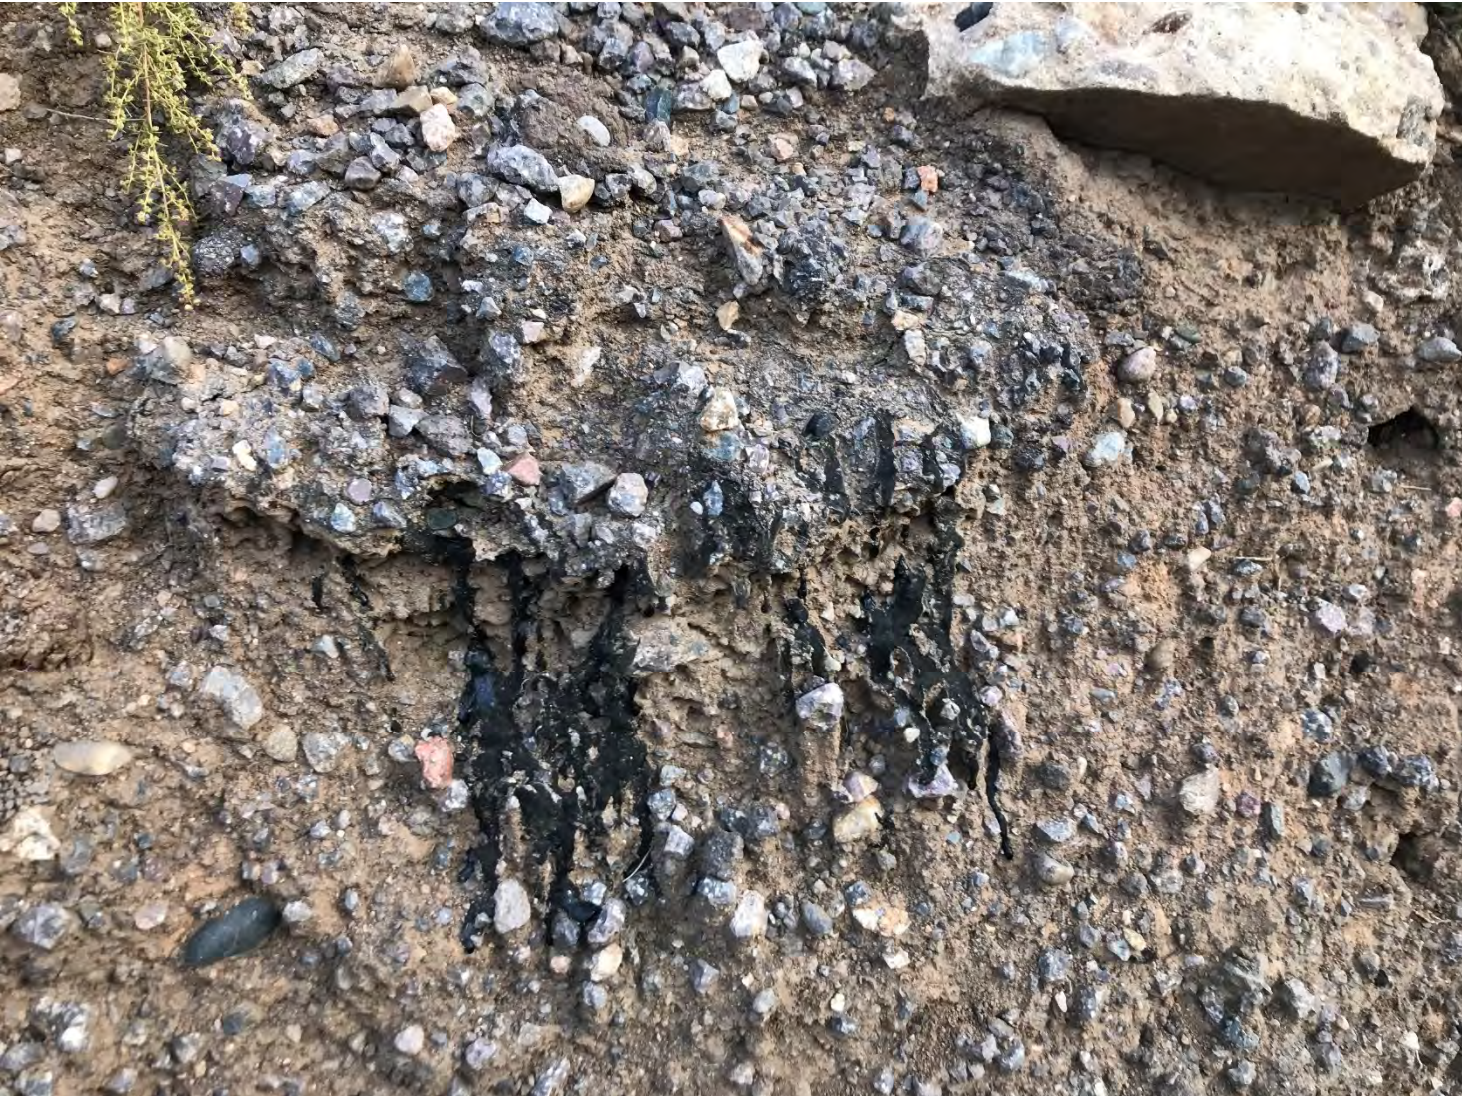
**Figure 4.2-2** Example of tar and asphalt in the banks of the drainage channel. The visual portion of the piece of asphalt is approximately 1 ft in height and width.

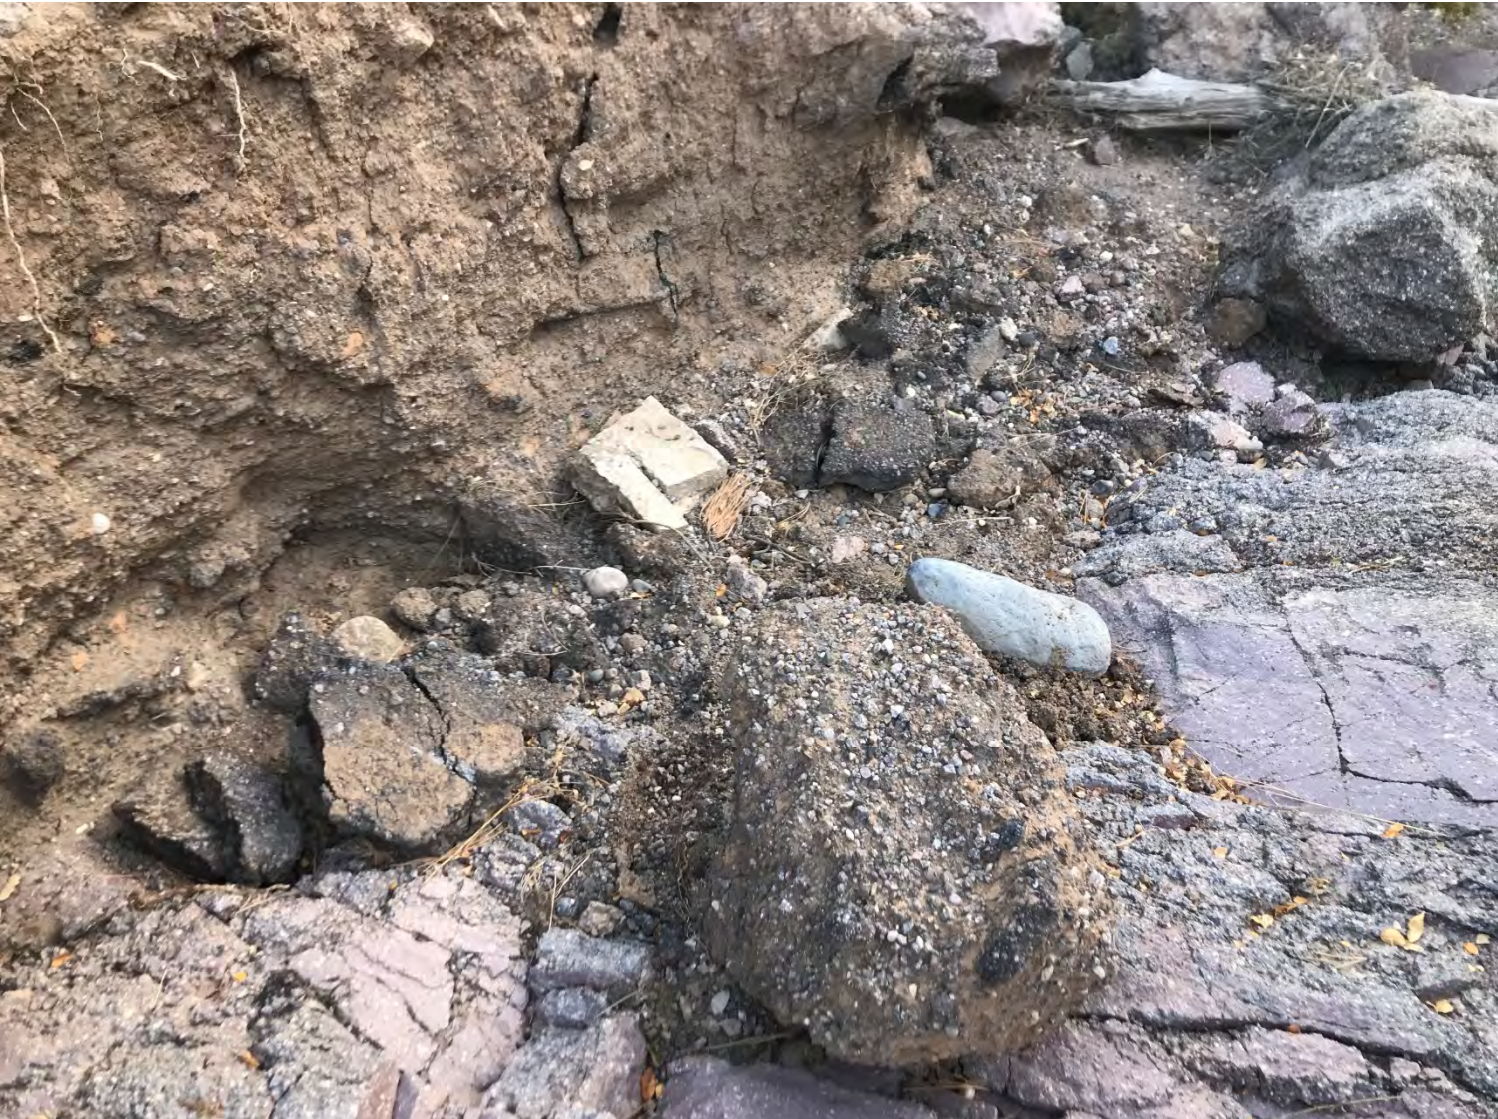
**Figure 4.2-4** Example of asphalt in the soil in the drainage channel before removal. Asphalt pieces ranged in size from 0.5 ft to several feet in diameter.

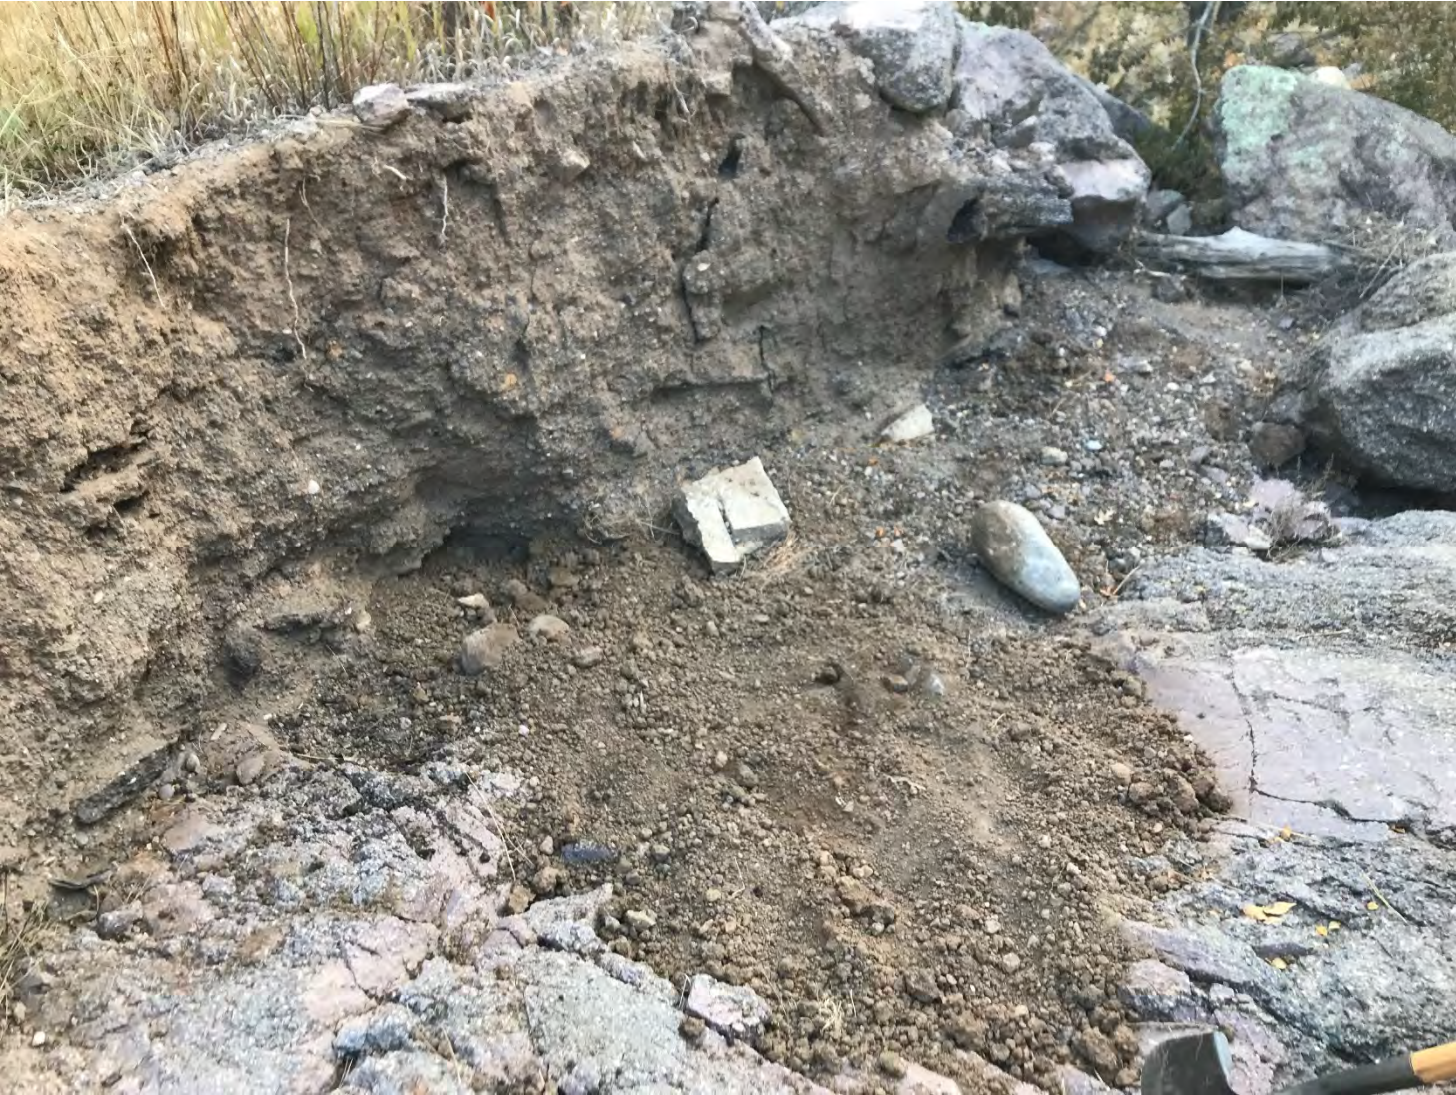
**Figure 4.2-5** The area shown in Figure 4.2-4 after asphalt removal from the drainage channel

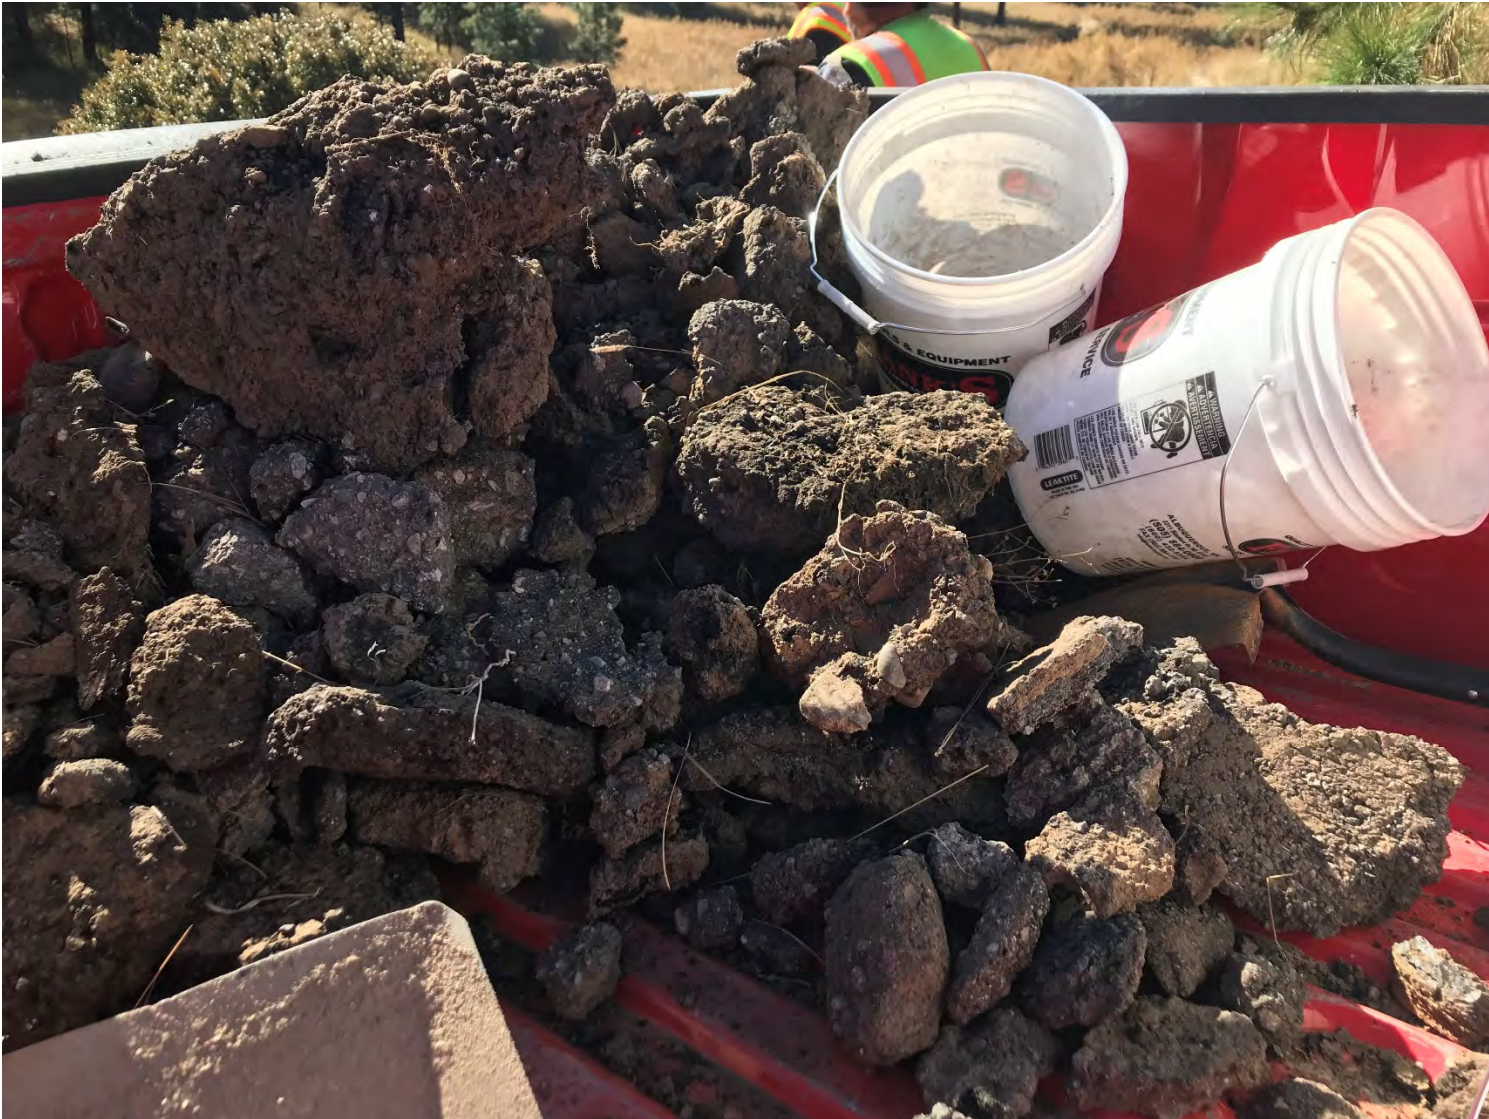
**Figure 4.2-6** Asphalt debris removed from AOC C-00-041; a total of 820 lb removed. The asphalt pieces were larger in size compared with the asphalt removed in 2017.
