Subject: Submittal of the 2019 Monitoring Report for Los Alamos/Pueblo Watershed Sediment Transport Mitigation Project

1. Two hard copies with electronic files – 2019 Monitoring Report for Los Alamos/Pueblo Watershed Sediment Transport Mitigation Project (EM2020-0019)

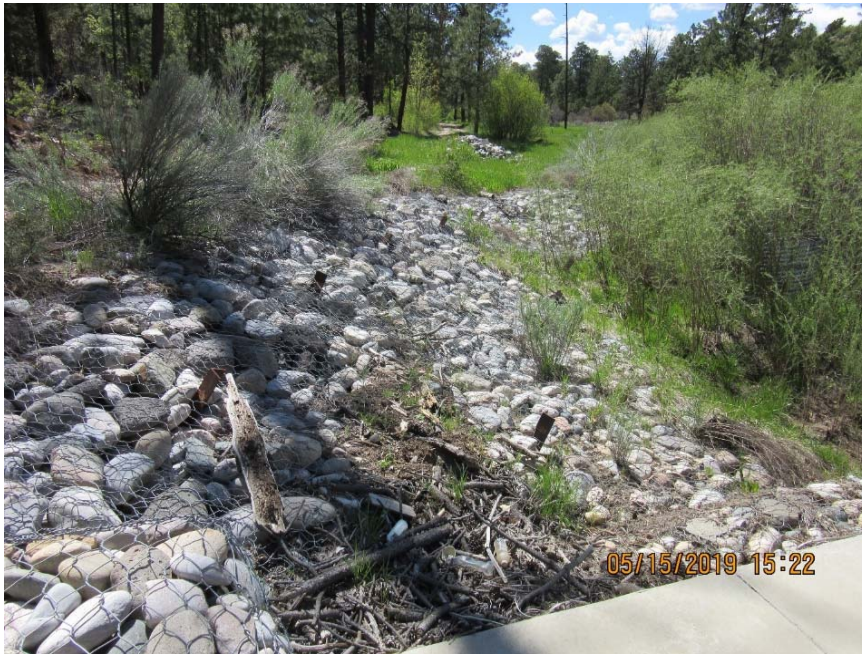
Photo C-2.1-1 May 2019—Embankment is stable and operating as designed. Well-established vegetation with no erosion occurring from hillslope. Some trash and debris present.

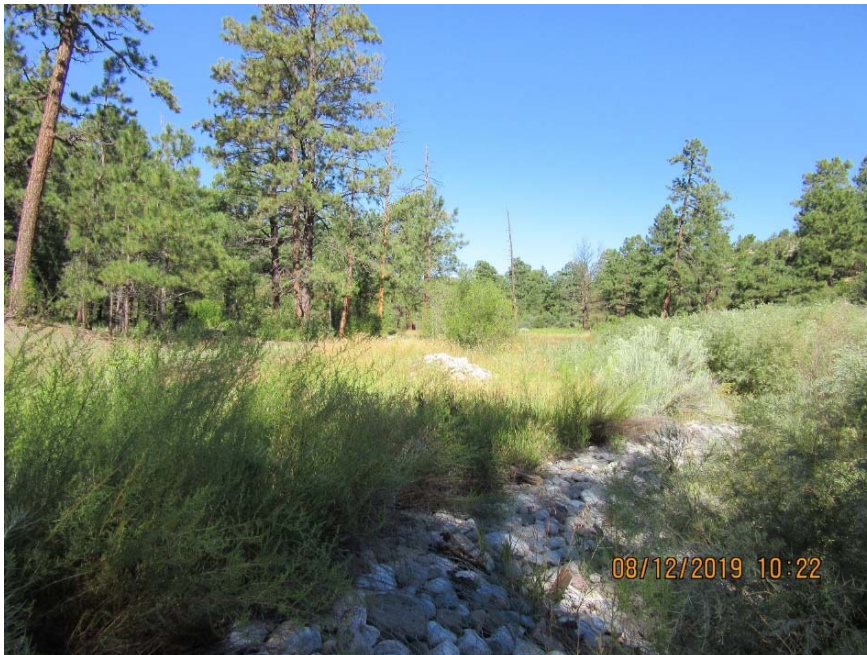
Photo C-2.1-2 Flow event inspection for August 7, 2019, storm event—embankment. Vegetation is well established.

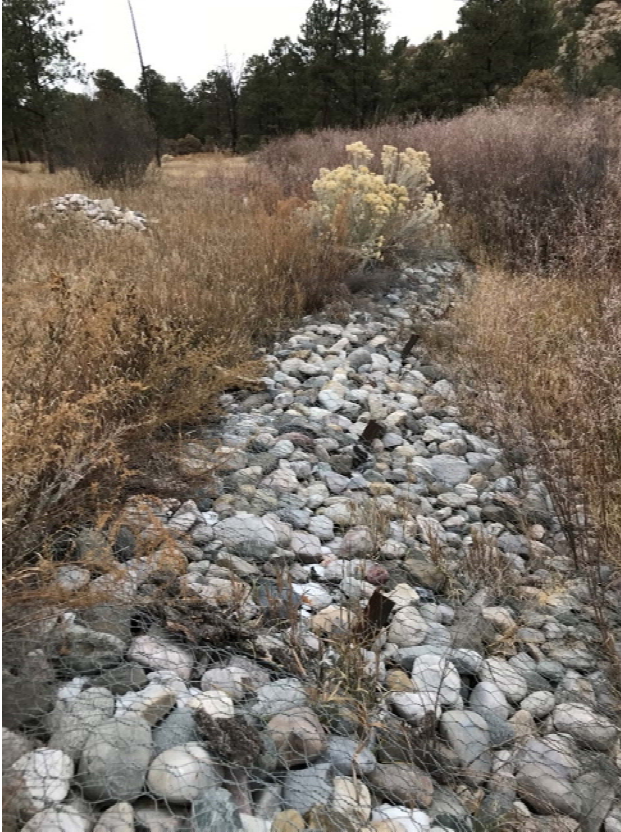
Photo C-2.1-3 November 2019—Embankment is stable and operating as designed. Well-established vegetation with no erosion occurring from hillslope. One rodent hole encountered. Recommend continued monitoring.

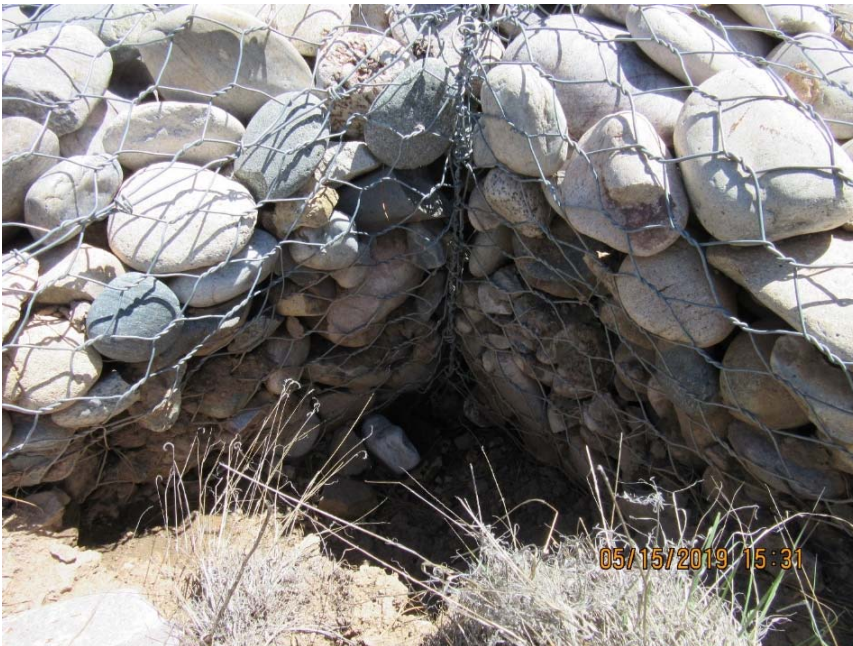
Photo C-2.1-4 May 2019—Erosion occurring at northeast corner of weir. Recommend filling hole with on-site round riprap.

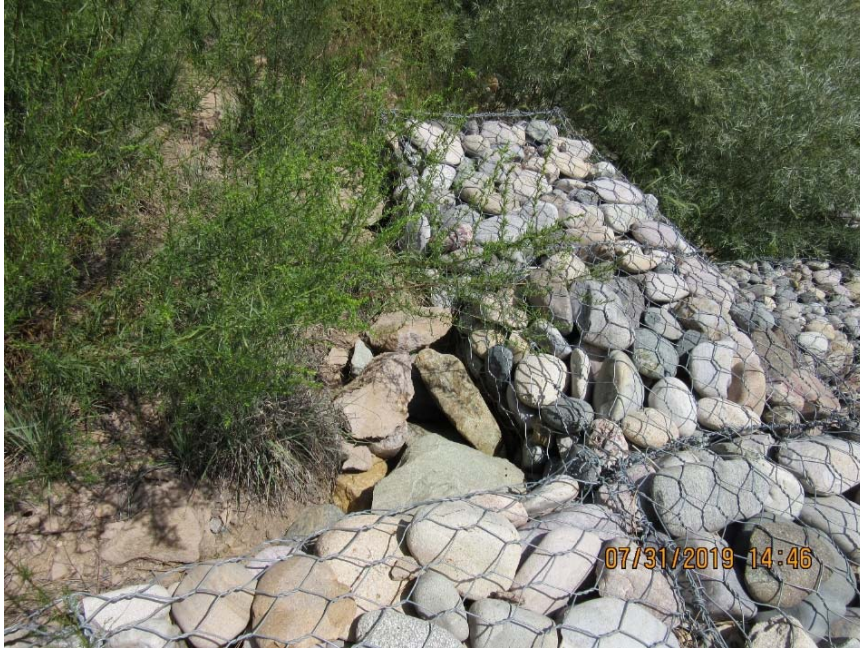
Photo C-2.1-5 Flow event inspection for July 25, 2019, storm event—Erosion occurring at northeast corner of weir was addressed. Area filled with on-site round riprap.

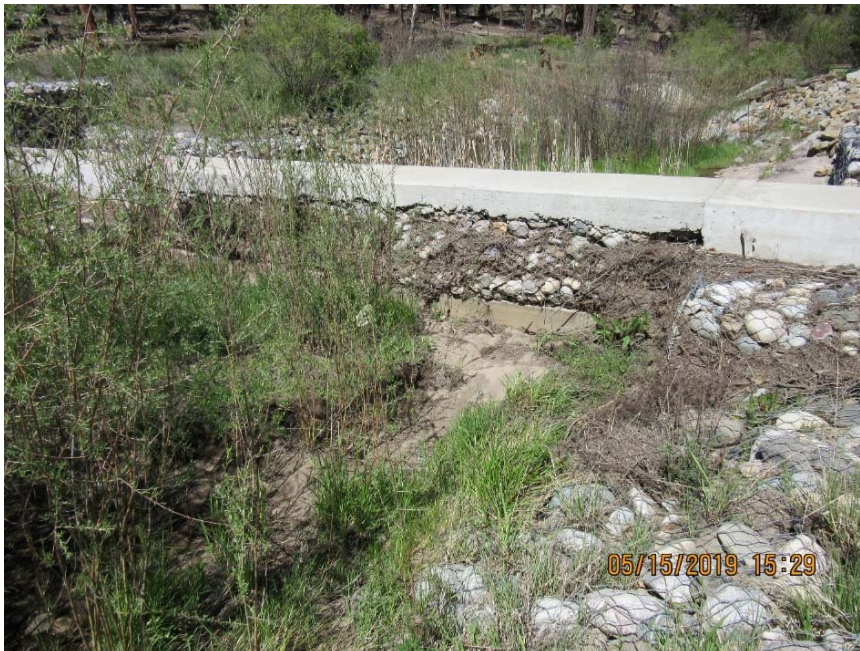
Photo C-2.2-1 May 2019—upslope face of weir, looking east. Weir is functioning; no deteriorating joints or bulging gabion baskets.

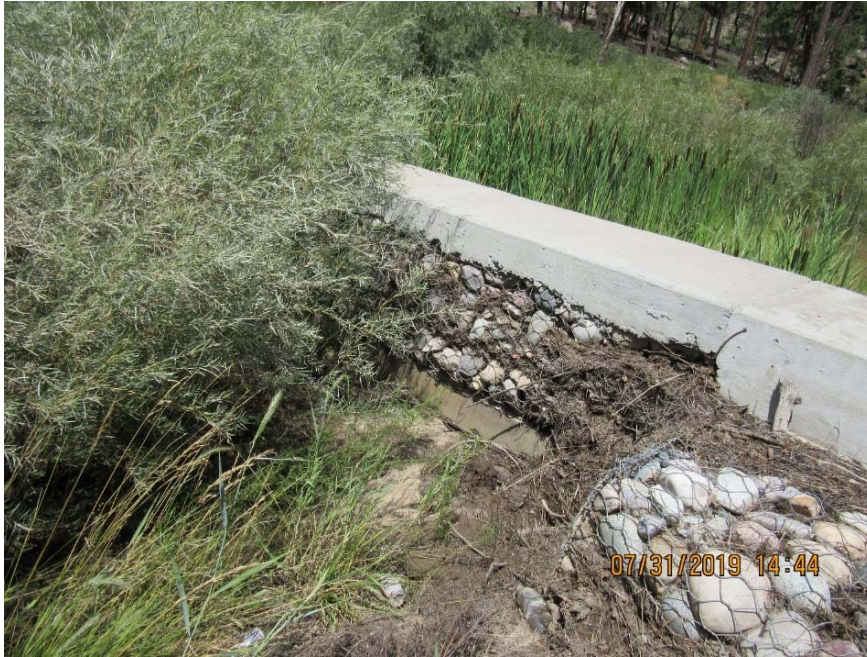
Photo C-2.2-2 Flow event inspection for July 25, 2019, storm event—upslope face of weir, looking east. Some trash/debris present.

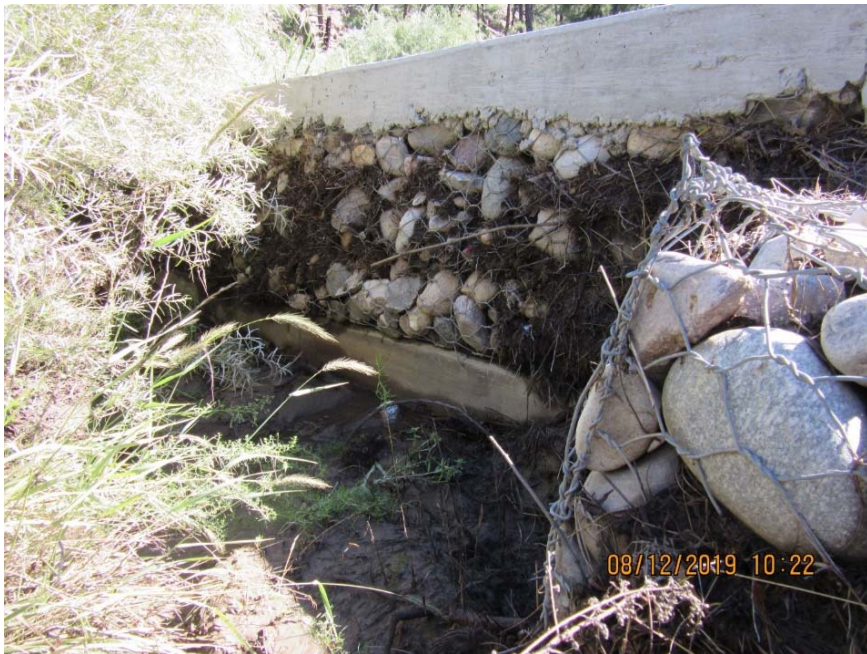
Photo C-2.2-3 Flow event inspection for August 7, 2019, storm event—upslope face of weir, looking east. Some trash/debris present.

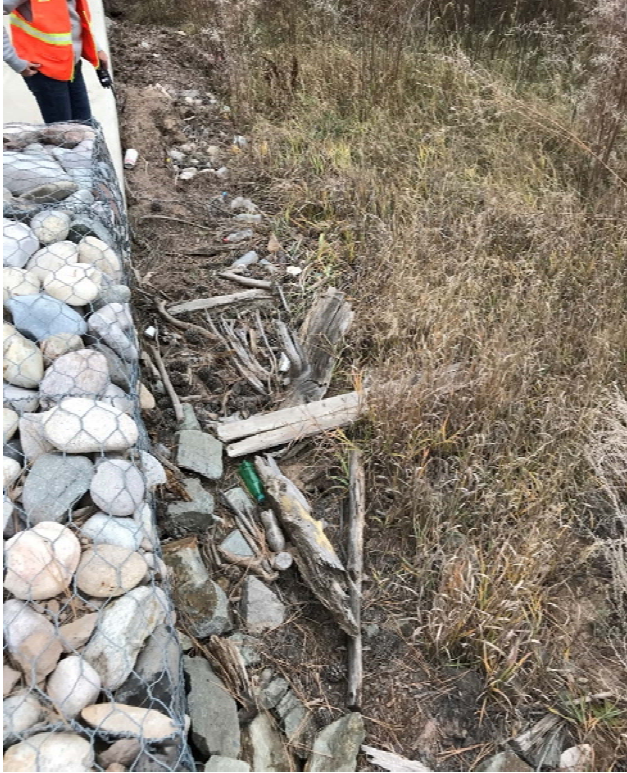
Photo C-2.2-4 November 2019—upstream face of weir. Floatable debris present. Recommend removal of debris.

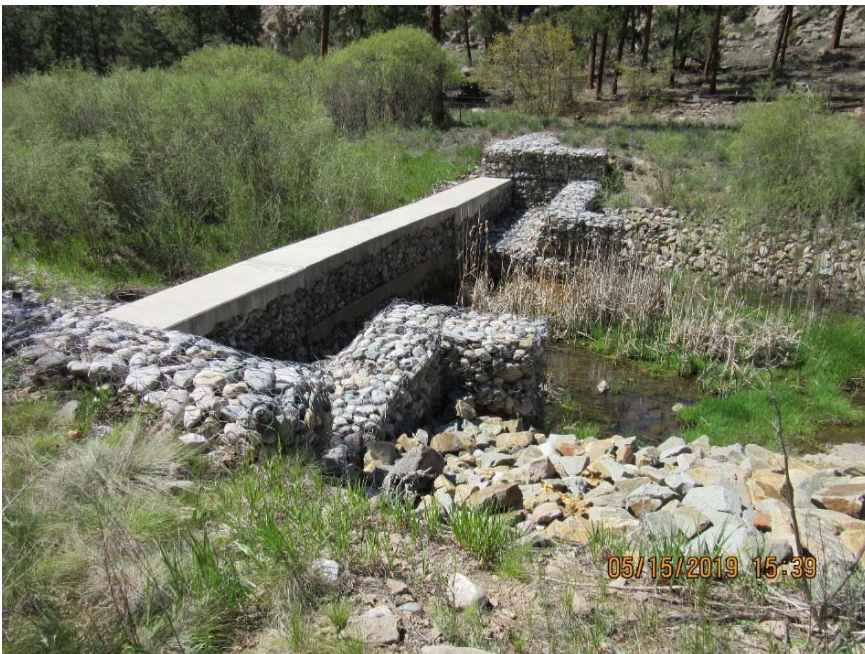
Photo C-2.3-1 May 2019—weir structure looking upstream. No deteriorated joints present on upslope side of weir. Gabion basket is structurally intact and in stable condition.

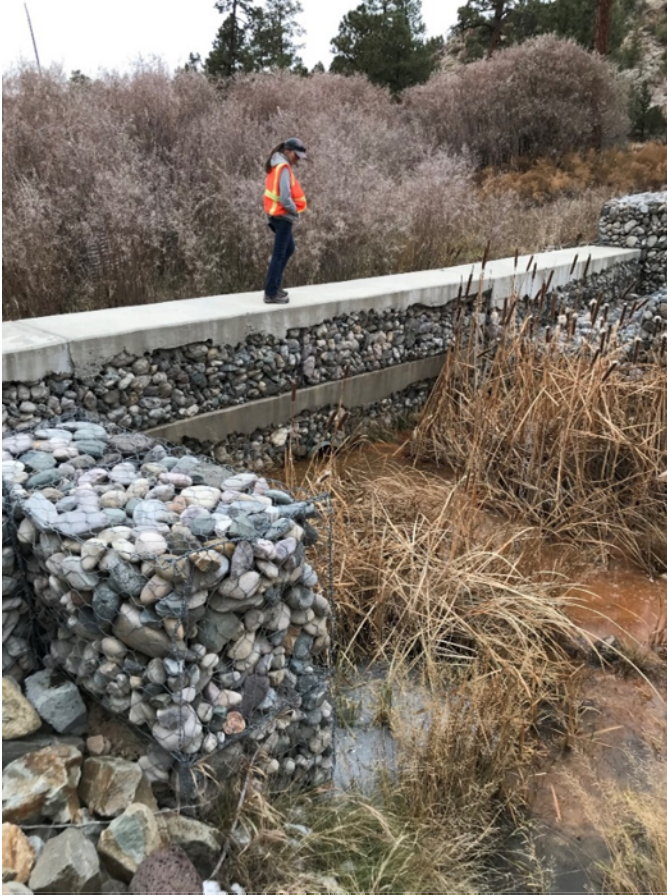
Photo C-2.3-2 **November 2019—weir structure looking upstream. No significant change since last inspection.**

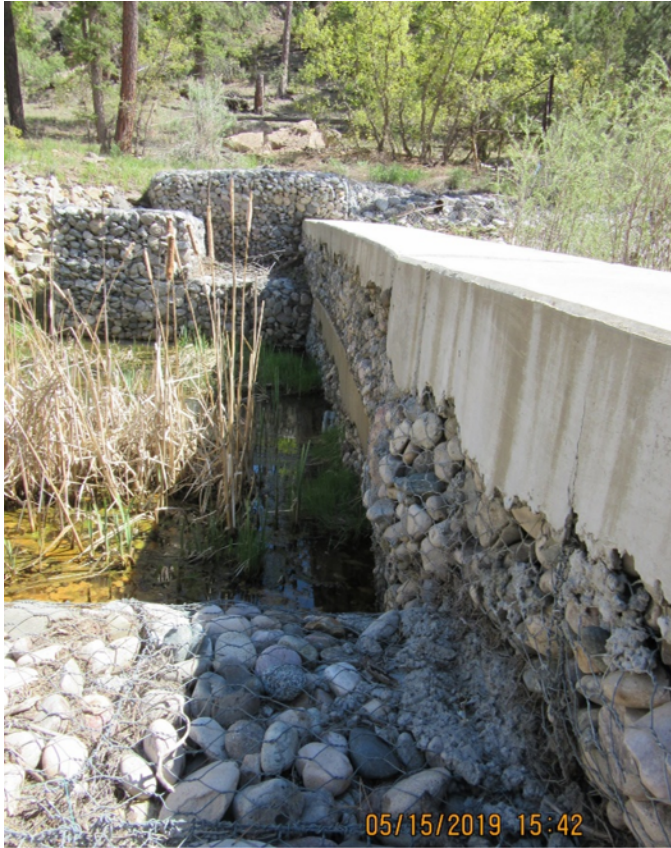
Photo C-2.4-1 May 2019—downstream face of weir. Continue to monitor bulging gabion baskets. No evidence of cracking/spalling; area is clear of debris.

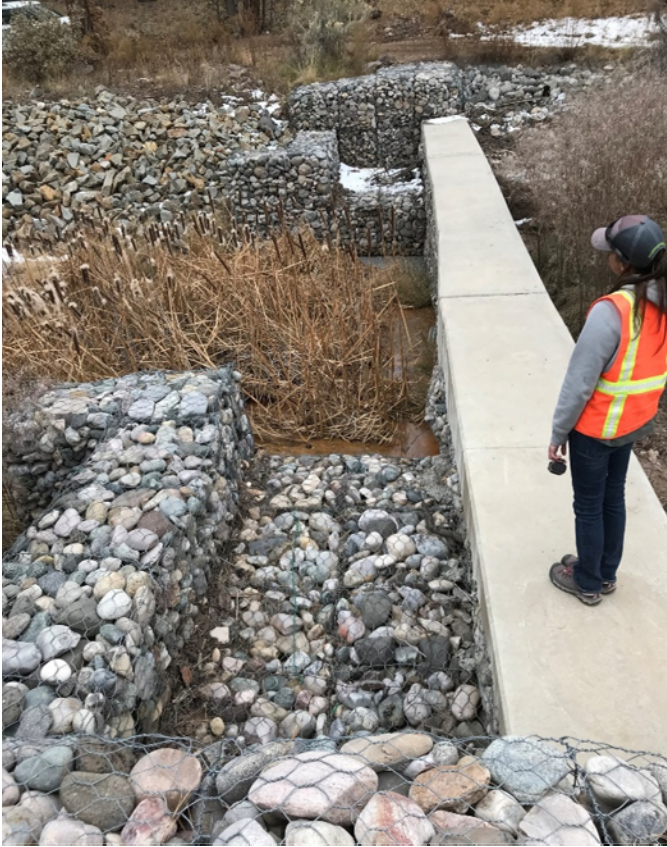
Photo C-2.4-2 November 2019—downstream face of weir. No significant change since last inspection.

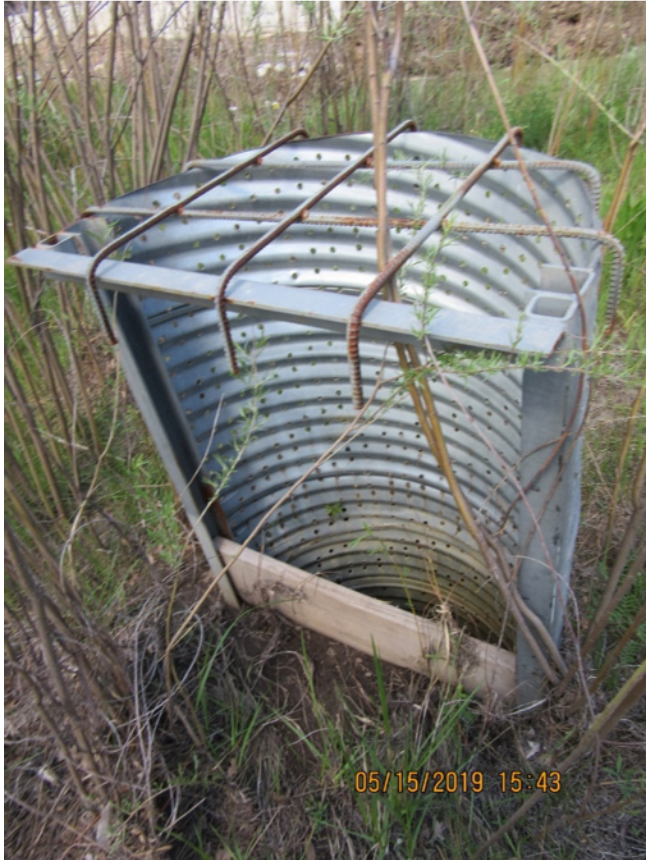
Photo C-2.5-1 May 2019—standpipe. Sediment level is approximately 1 ft below wood board stop. No significant change since last inspection. Will continue to monitor.

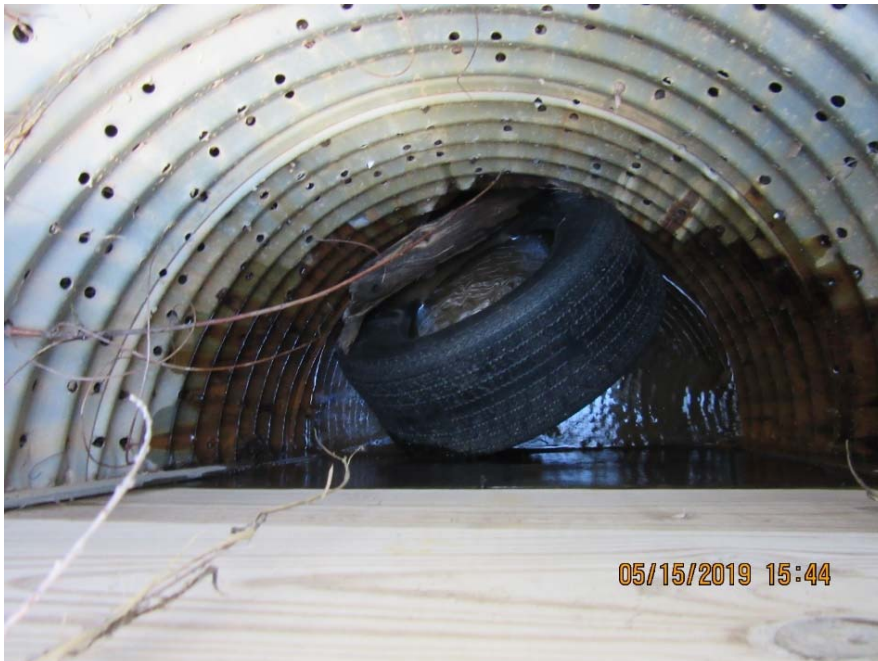
Photo C-2.5-2 May 2019—standpipe. Tire is present within standpipe. No action recommended.

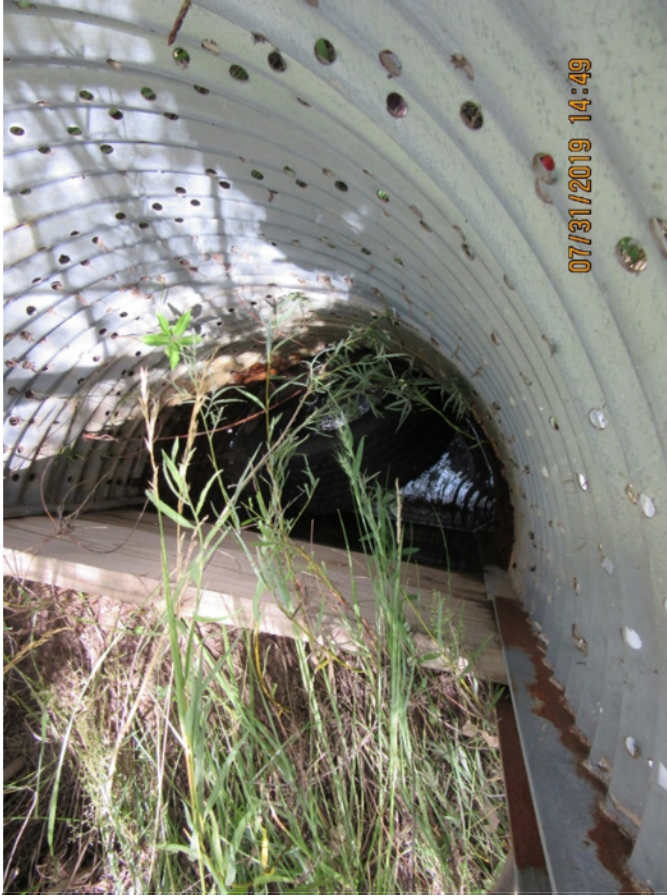
Photo C-2.5-3 Flow event inspection for July 25, 2019, storm event—standpipe. No change in sediment level since last inspection.

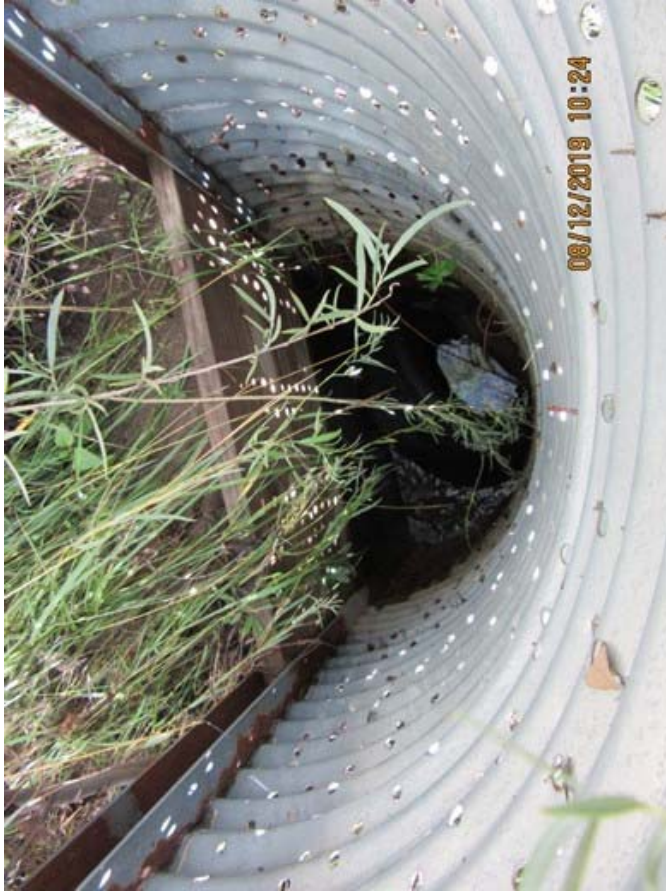
Photo C-2.5-4 Flow event inspection for August 7, 2019, storm event—standpipe. Sediment level at approximately 6 in. below top of wood board stop.

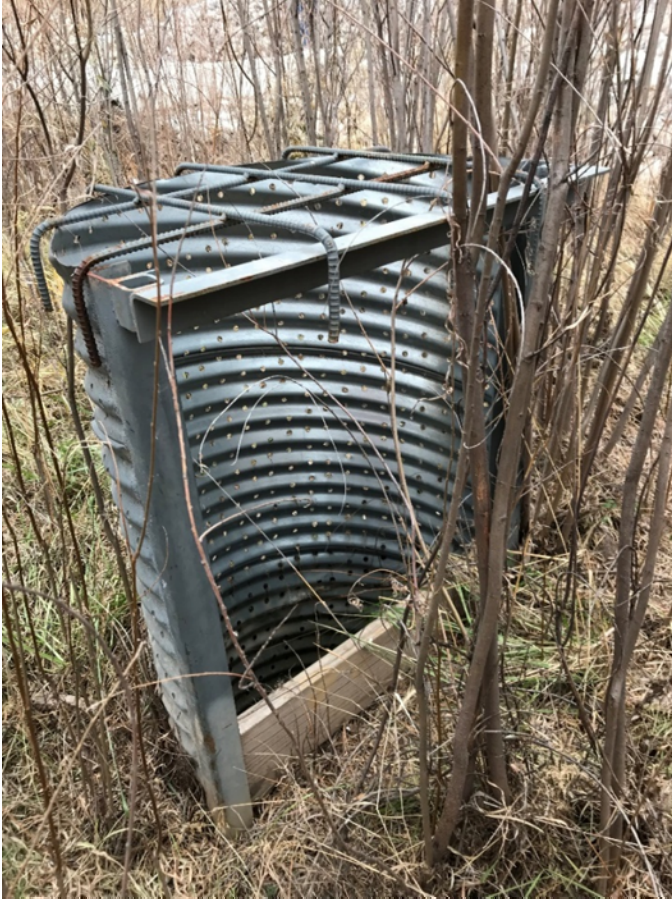
Photo C-2.5-5 **November 2019—standpipe. Sediment level is approximately 1 ft below wood board stop. Tire is present within standpipe. No action recommended.**

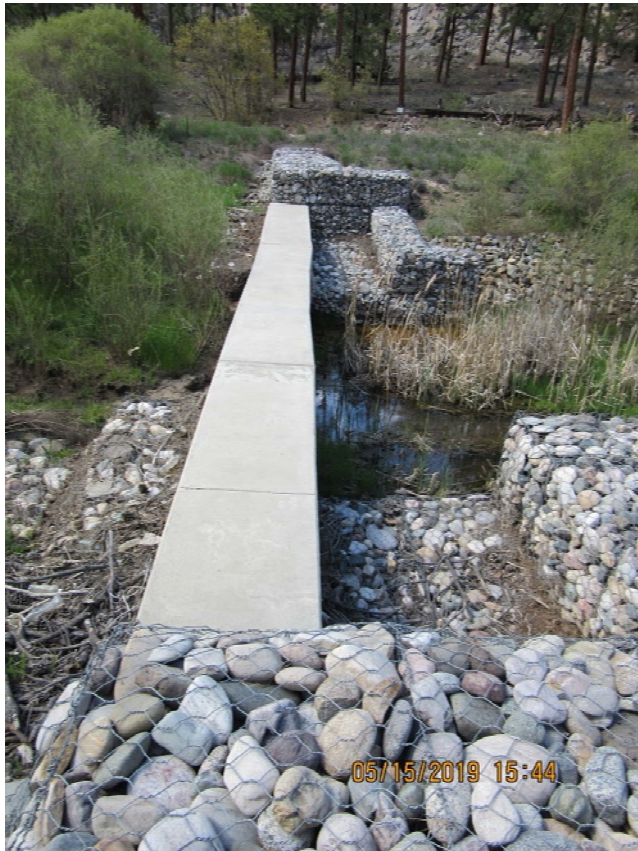
Photo C-2.6-1 May 2019—spillway alignment. Spillway operating as designed. No sign of improper alignment or deterioration. Recommend removal of trash encountered.

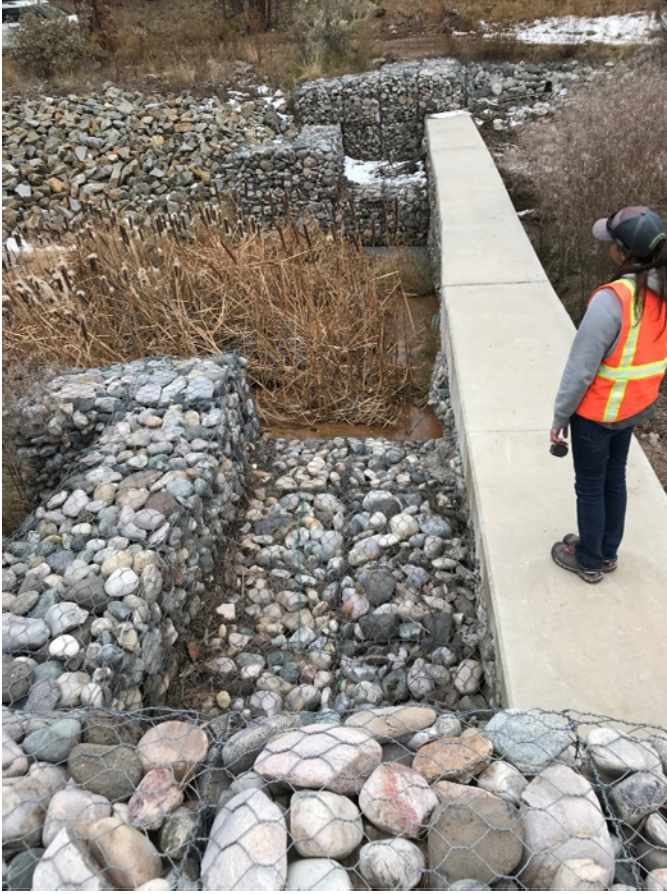
Photo C-2.6-3 **November 2019—spillway alignment. Spillway operating as designed. No sign of improper alignment, deterioration, or trash/debris.**

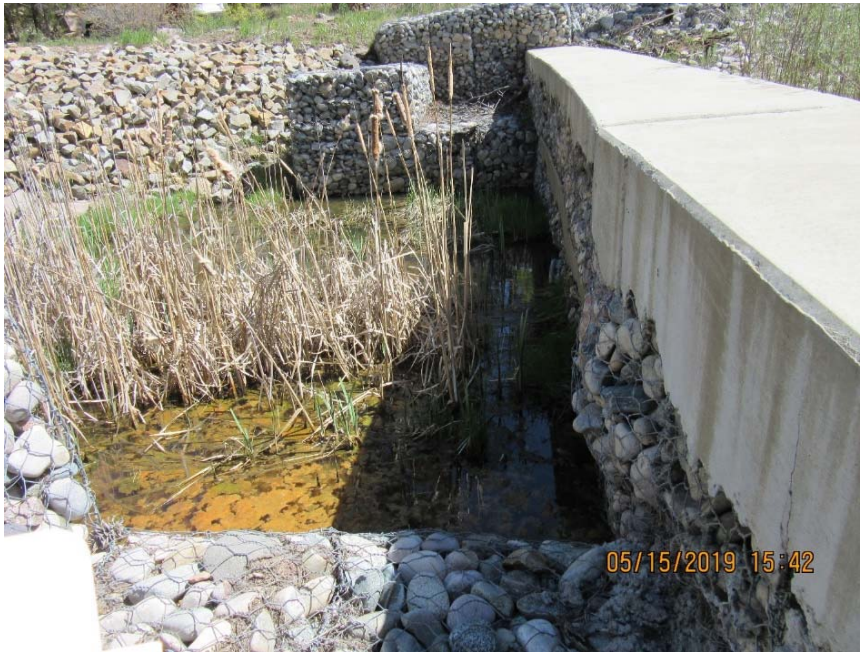
Photo C-2.7-1 May 2019—outlet. Evidence of corrosion noted in 2018. Pond level was at approximately 6 in. above the bottom of the outlet culvert at time of inspection. No evidence of undercutting, erosion, or excessive sediment deposition. Fallen trees are present downstream of GCS—one upstream of flow gage and one downstream of flow gage. Recommend removal of fallen trees. Sediment level to 6 in. above outlet culvert invert elevation. Will continue to monitor.

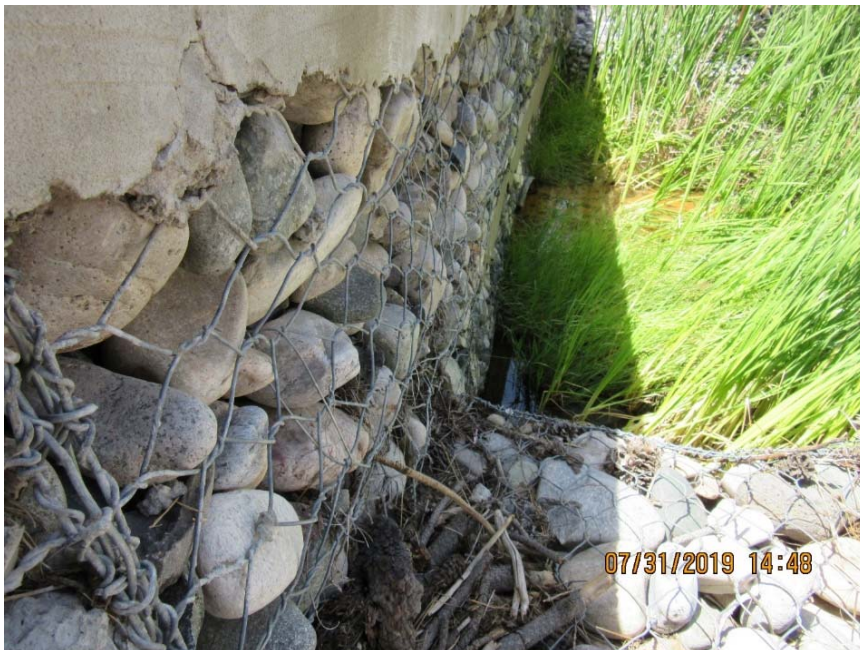
Photo C-2.7-2 Flow event inspection for July 25, 2019, storm event—outlet. Evidence of corrosion noted in 2018. Pond level was at approximately 6 in. above the bottom of the outlet culvert at time of inspection.

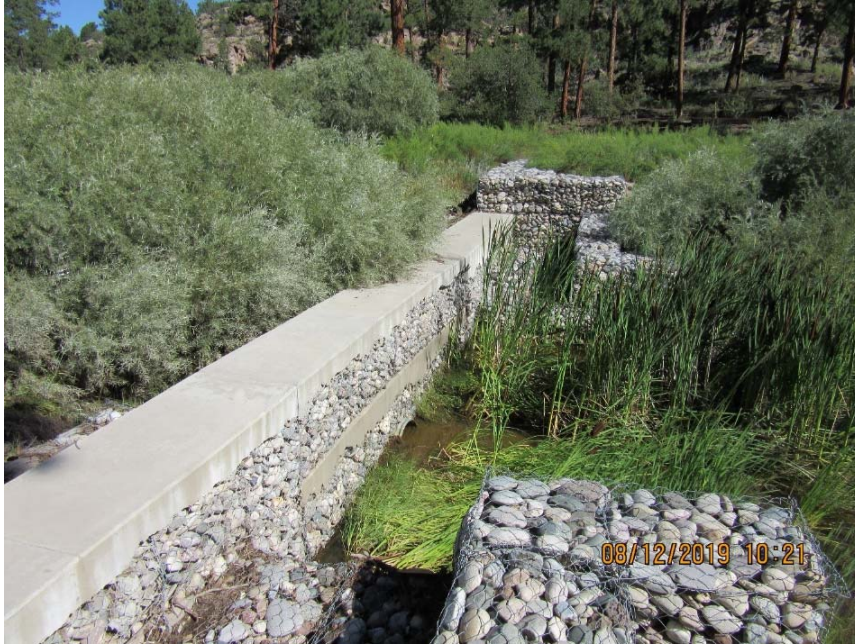
Photo C-2.7-3 Flow event inspection for August 7, 2019, storm event—outlet. Pond level was at approximately 6 in. above the bottom of the outlet culvert at time of inspection.

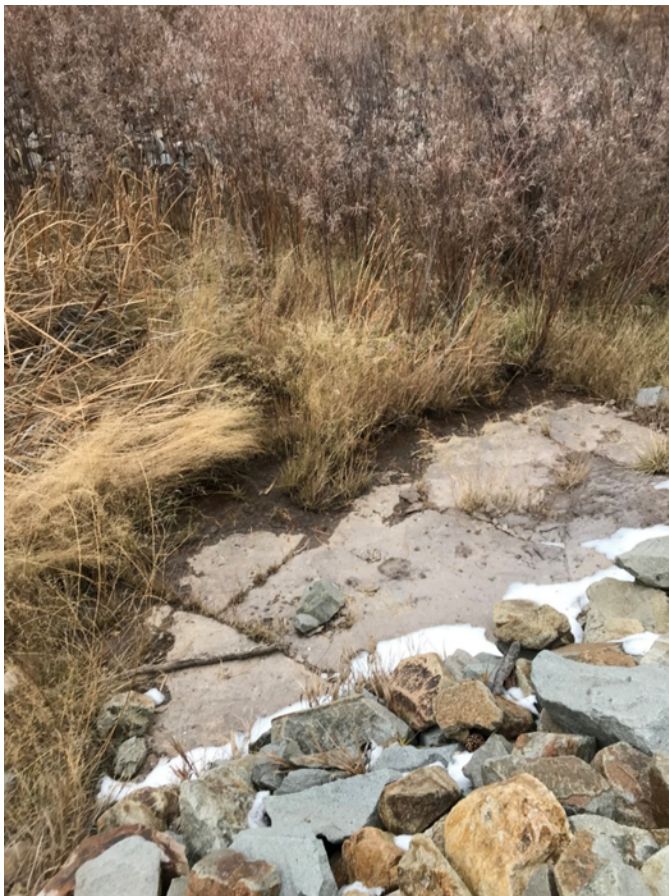
Photo C-2.7-4 November 2019—outlet. Channel downgradient of pool is dry.

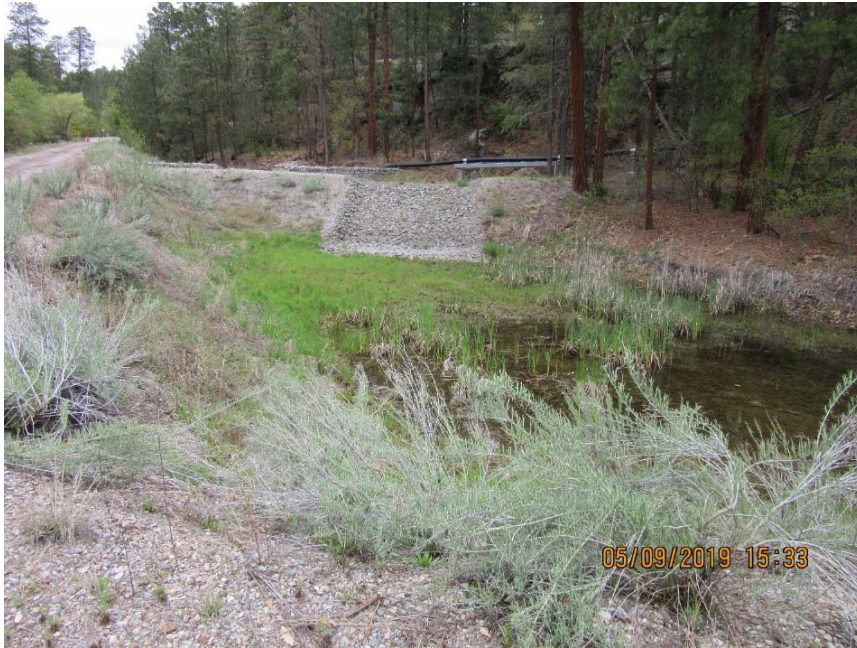
Photo C-3.1-1 May 2019—lower basin. No breaching/slides/cracks/sloughs present on embankment and pond. No erosion occurring on slope. No trash or debris present in control. Recommend pest control along south side of ponds for several rodent burrows.

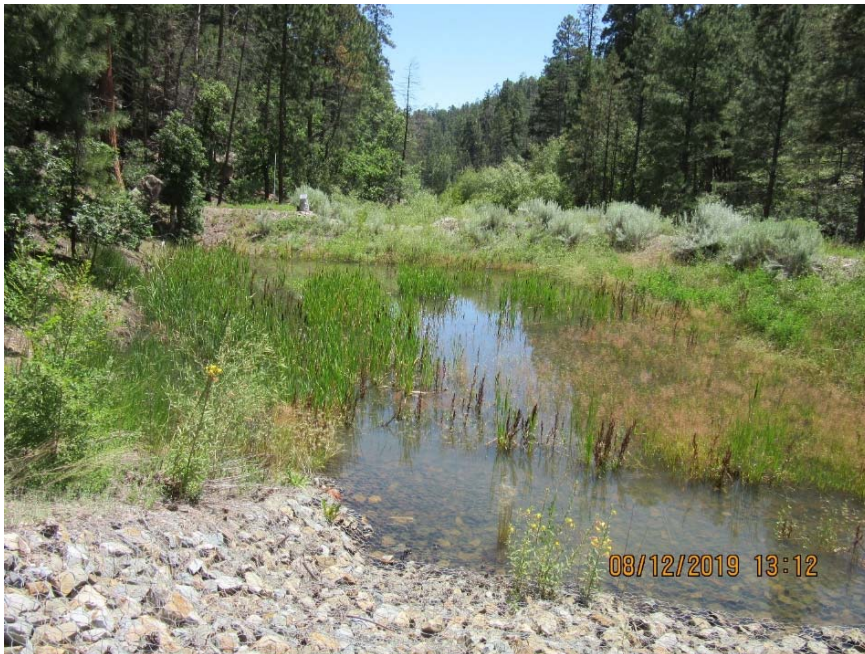
Photo C-3.1-2 Flow event inspection for August 7, 2019, storm event—lower basin

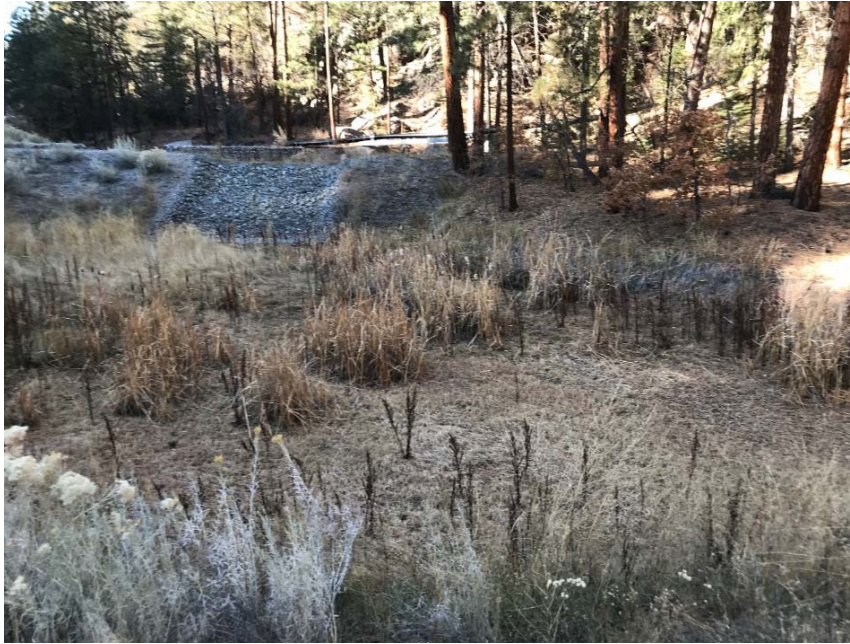
Photo C-3.1-3 November 2019—lower basin. Basin dry. Rodent burrows encountered on south side of basin. Will continue to monitor.

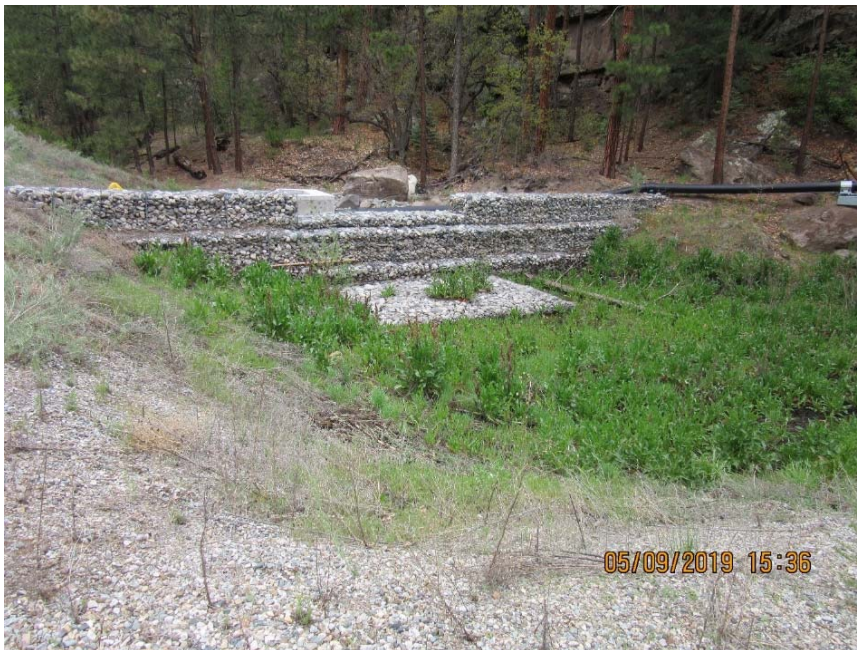
Photo C-3.2-1 May 2019—upper basin. No breaching, slides, cracks, or sloughs present on embankment and pond. No erosion occurring on slope. No trash or debris present in control. Recommend pest control along south side of ponds for several rodent burrows. Recommend removal of fallen tree in pond.

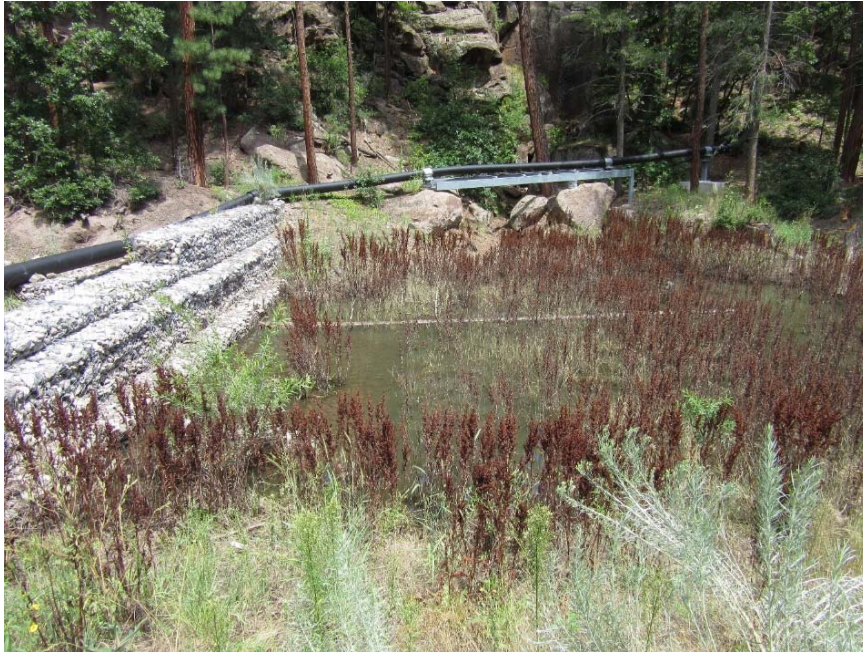
Photo C-3.2-2 Flow event inspection for August 7, 2019, storm event—upper basin. Sloughs due to wildlife tracts upgradient of turf-reinforcement mat (TRM). Fallen tree in pond. Vegetation growth noted on basin maintenance access. Recommend to clean up vegetation growth on the maintenance access paths.

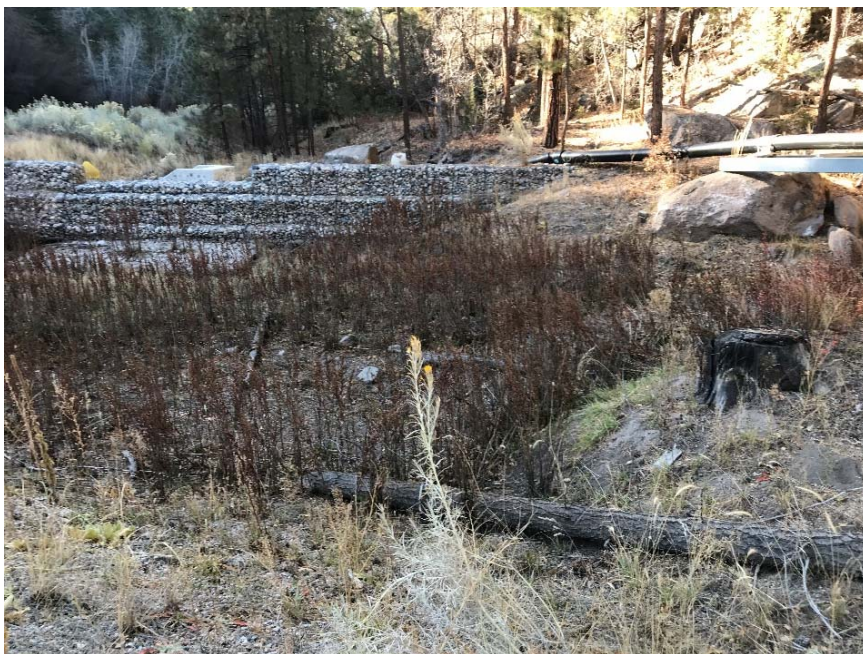
Photo C-3.2-3 November 2019—upper basin. Basin dry. No erosion occurring on slope. Sloughing on south side of basin, above where TRM was installed. Sides are retained by concrete jersey barrier at edge of road. Rodent burrows encountered on south side of basin, above where TRM was installed. Fallen tree in basin. Will continue to monitor.

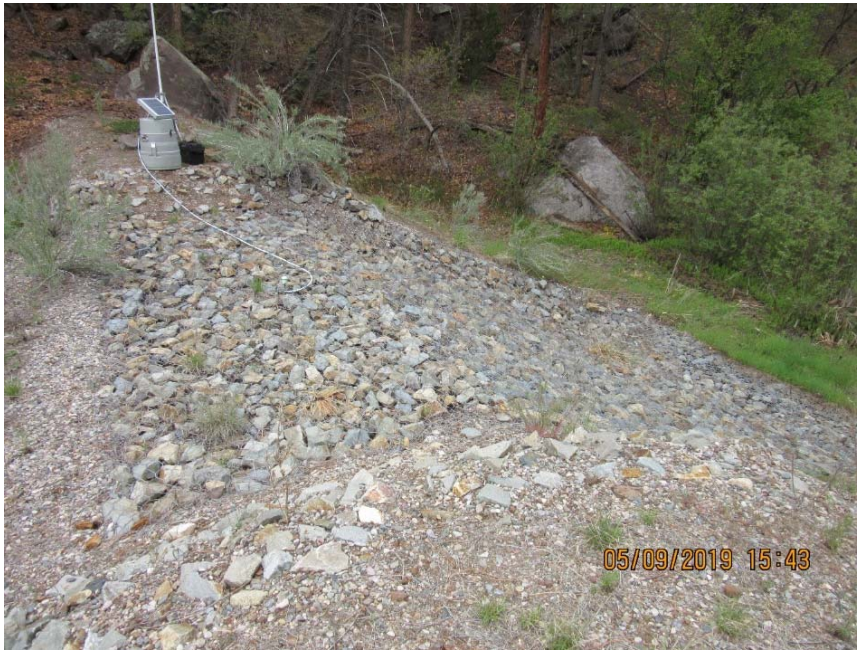
Photo C-3.3-1 May 2019—lower basin spillway. No signs of erosion occurring on or near spillway. Spillway is maintaining alignment and stability.

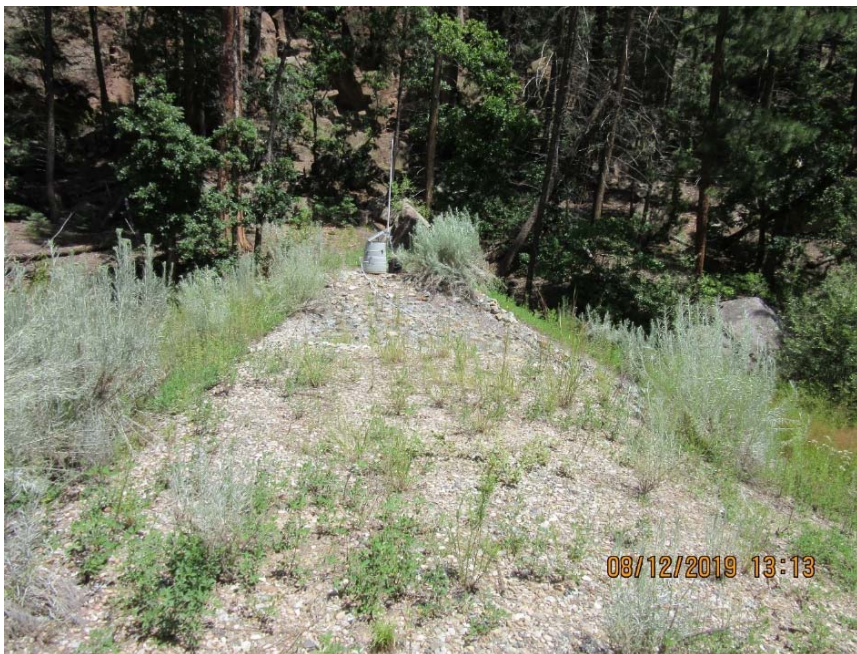
Photo C-3.3-2 Flow event inspection for August 7, 2019, storm event—lower basin spillway. Needlecast and taller vegetation noted. Recommend cleanup of vegetation growth on the spillway.

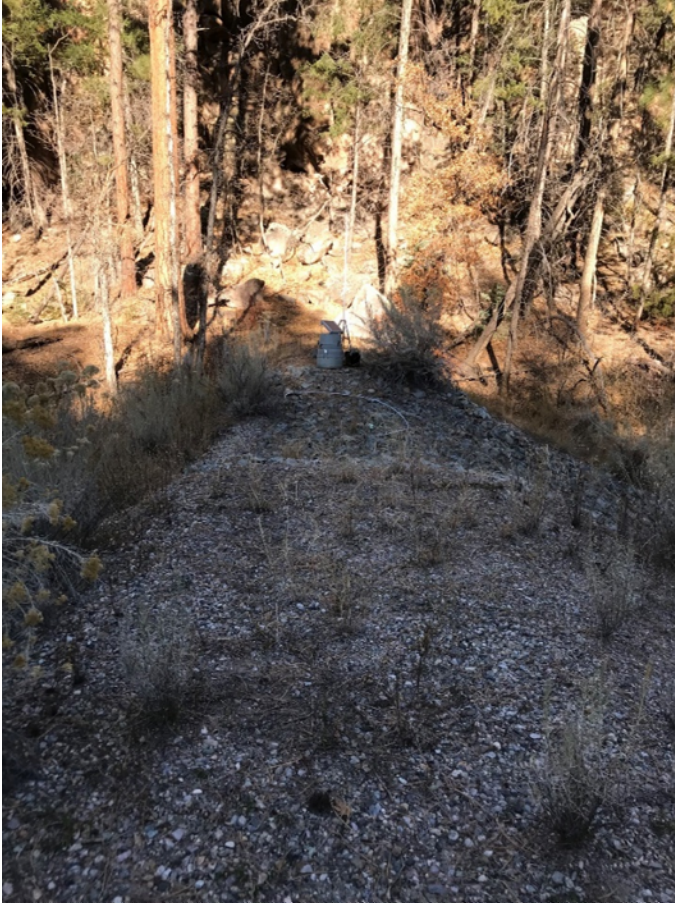
Photo C-3.3-3 **November 2019—lower basin spillway. No signs of erosion occurring on or near spillway. Spillway is maintaining alignment and stability. Rodent burrows encountered. Will continue to monitor.**

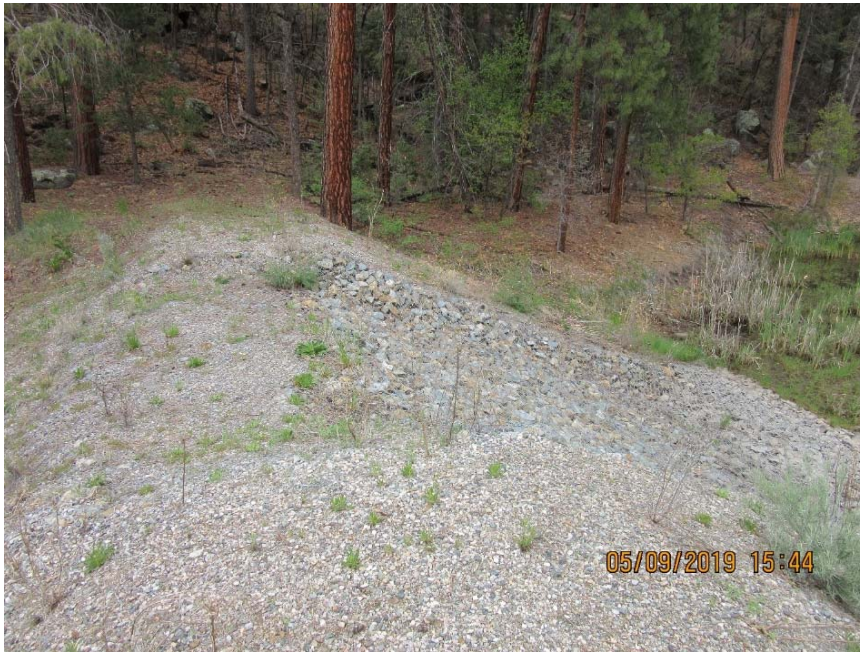
Photo C-3.4-1 May 2019—upper basin spillway. No signs of erosion occurring on or near spillway. Spillway is maintaining alignment and stability.

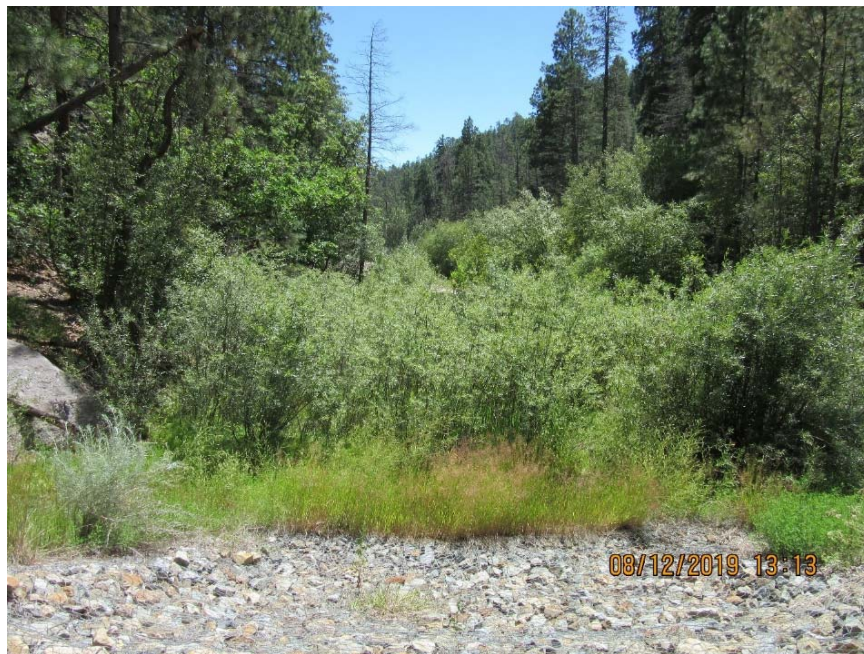
❖ **Photo C-3.4-2** Flow event inspection for August 7, 2019, storm event—upper basin spillway and wetland vegetation. Needlecast noted. Vegetation is well established.

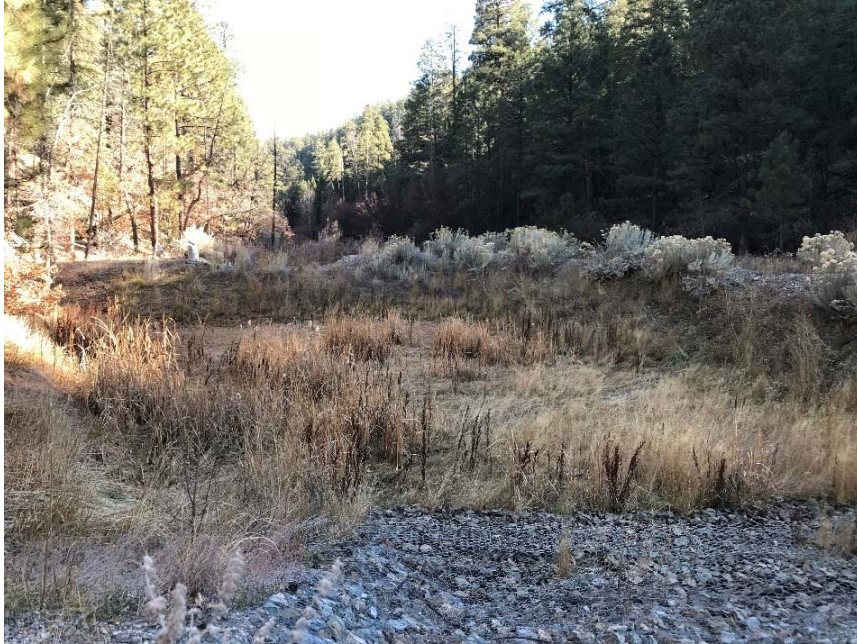
Photo C-3.4-3 November 2019—upper basin spillway and wetland vegetation. No change since last inspection.

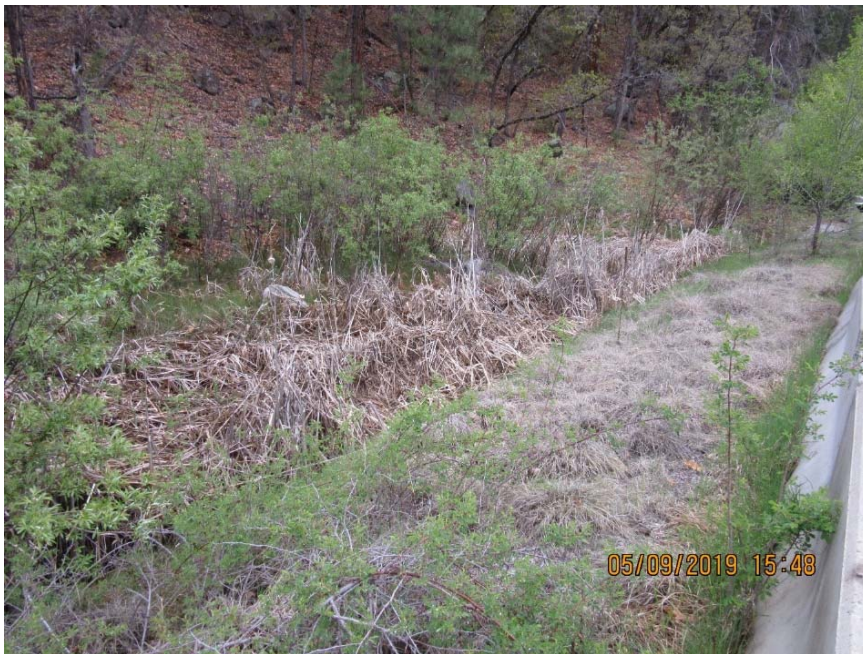
Photo C-3.5-1 May 2019—wetland vegetation. Willows and wetland vegetation well established, stable, and clear of trash/debris. No seepage or piping occurring.
