Subject: Submittal of the 2019 Monitoring Report for Los Alamos/Pueblo Watershed Sediment Transport Mitigation Project

1. Two hard copies with electronic files – 2019 Monitoring Report for Los Alamos/Pueblo Watershed Sediment Transport Mitigation Project (EM2020-0019)

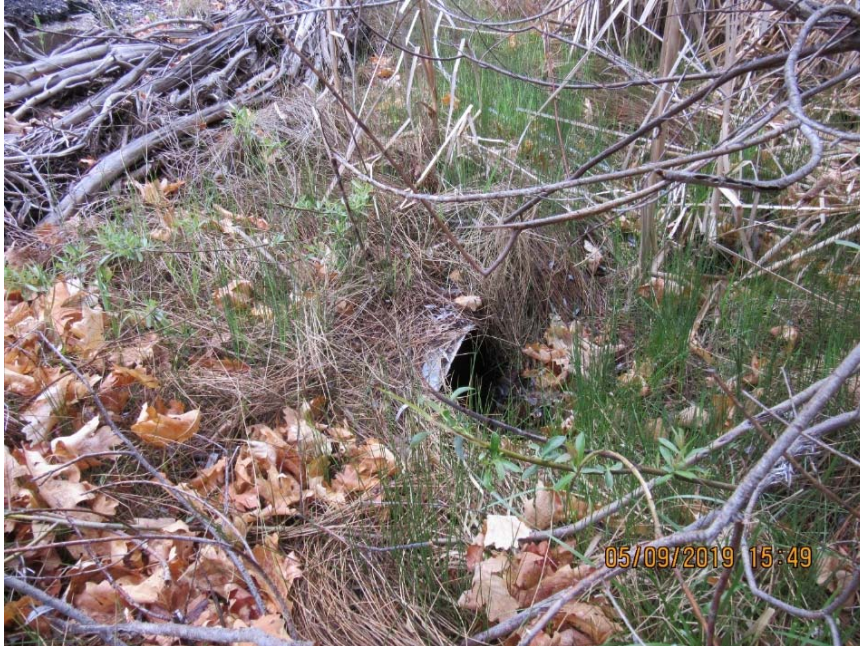
Photo C-3.5-2 May 2019—culvert inlet. Willows and wetland vegetation well established, stable, and clear of trash/debris. No seepage or piping occurring.

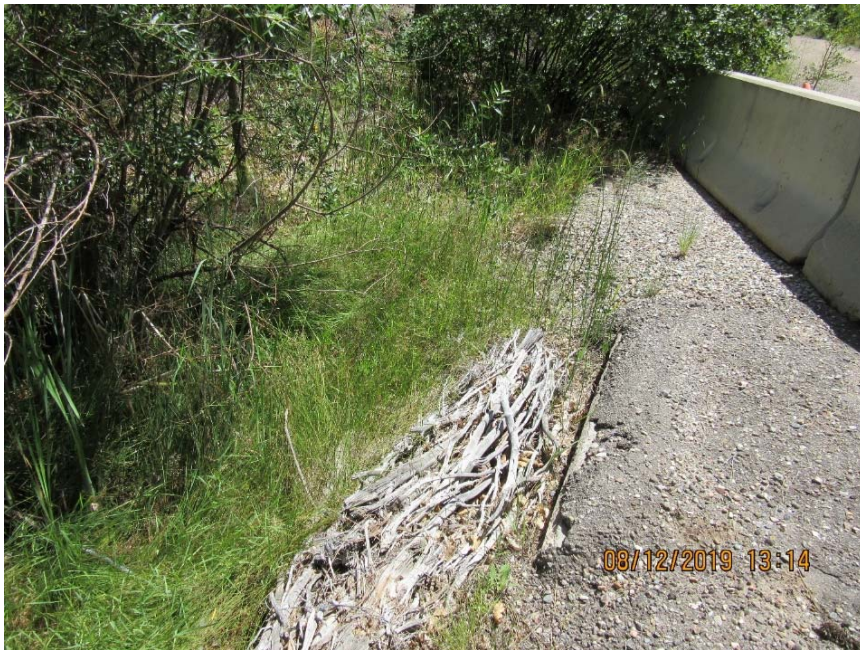
Photo C-3.5-3 Flow event inspection for August 7, 2019, storm event—Culvert inlet is covered with branches.

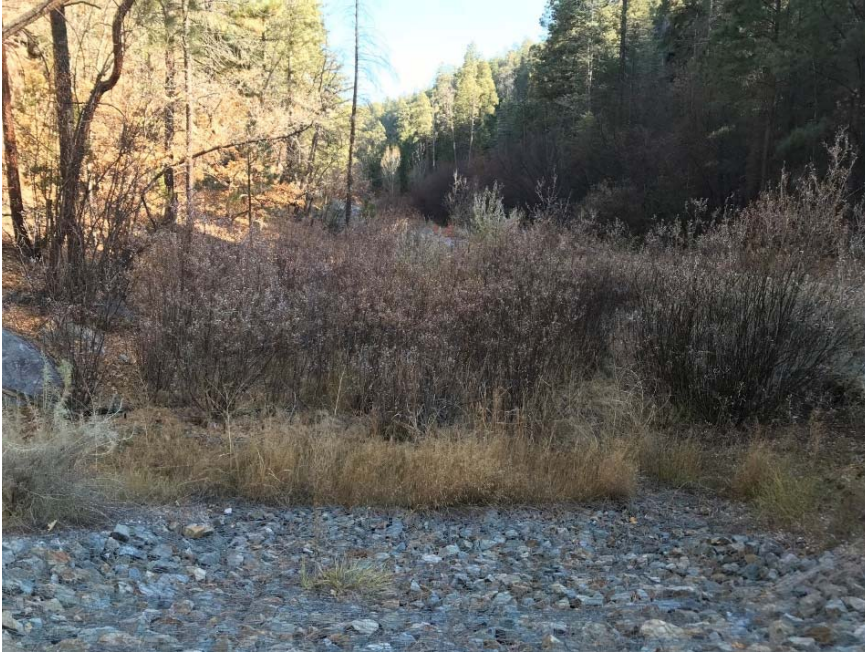
Photo C-3.5-4 November 2019—wetland vegetation. Good coverage.

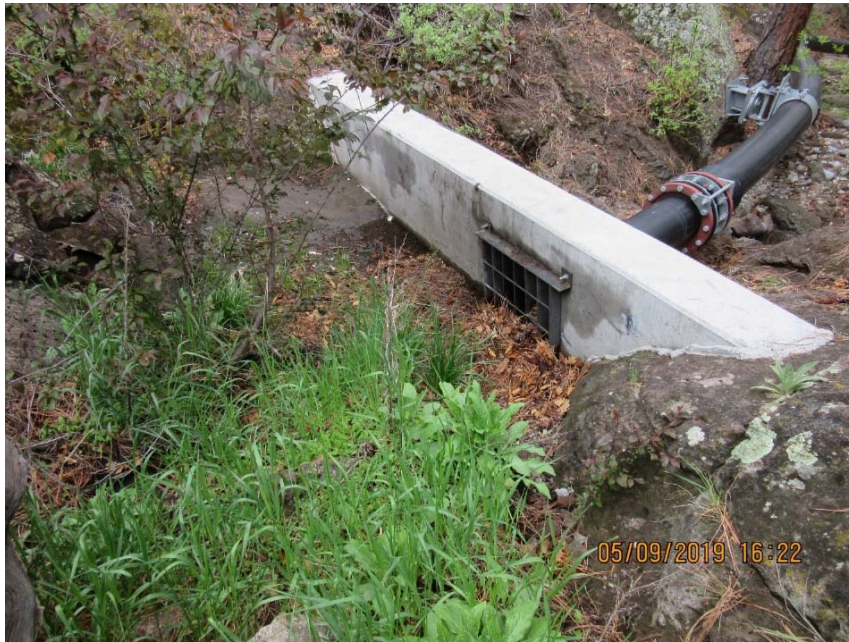
Photo C-3.6-1 May 2019—pipeline headwall. Headwall functioning as designed. Needlecast is blocking portion of pipe inlet grate. Recommend maintenance to remove needlecast.

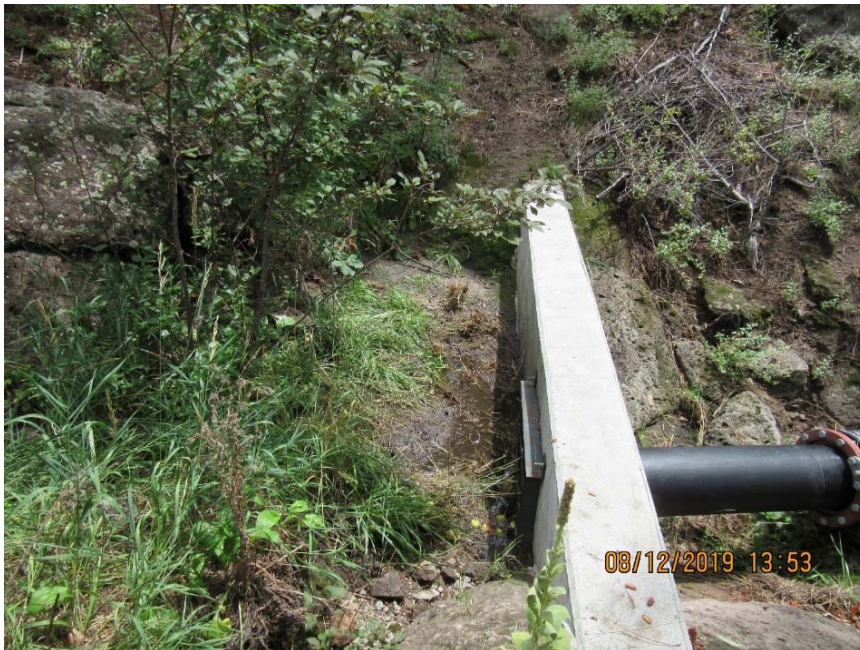
Photo C-3.6-2 Flow event inspection for August 7, 2019, storm event—pipeline headwall. Needlecast debris was removed.

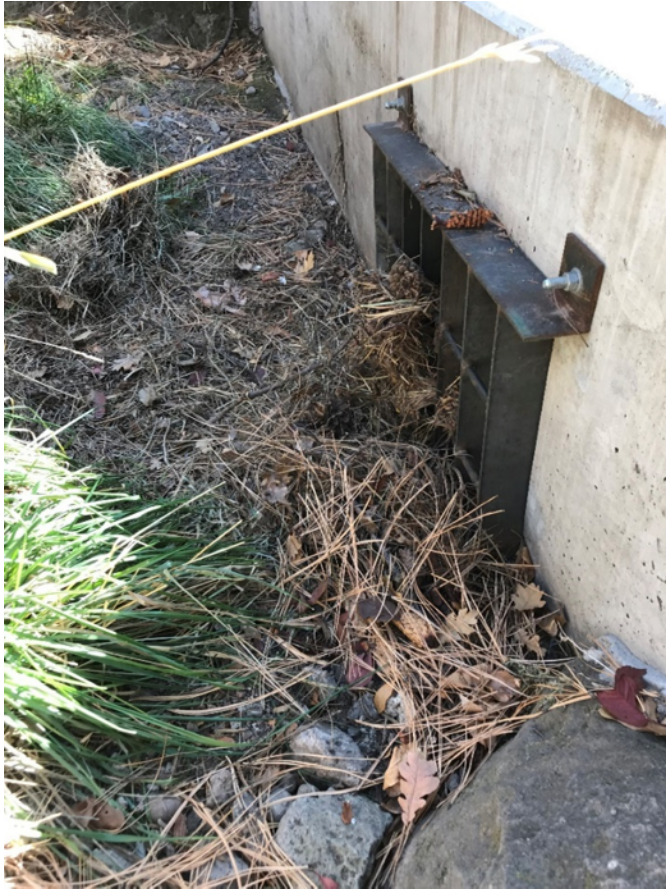
Photo C-3.6-3 November 2019—pipeline headwall. Needlecast debris at trash rack blocking inlet. Blockage removed. Recommend replacement of trash rack with one that is not in line with the pipe inlet.

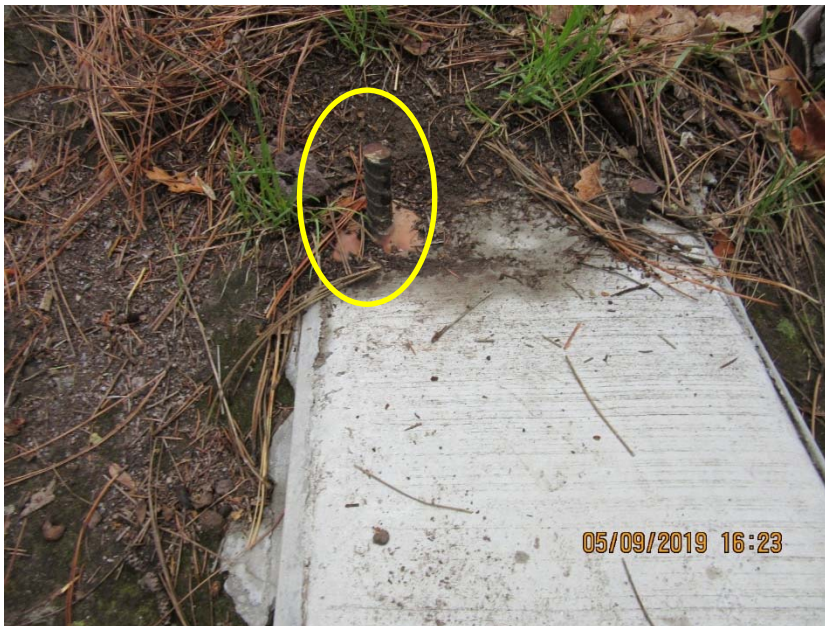
Photo C-3.6-4 May 2019—pipeline headwall. Rebar sticking up on headwall is a tripping hazard. Recommend removal.

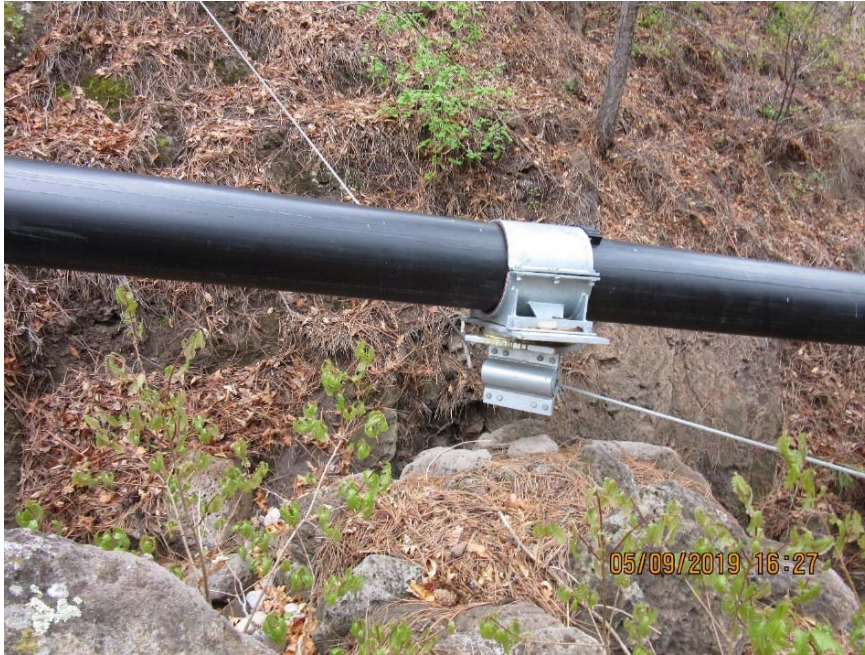
Photo C-3.6-5 May 2019—Pipeline cable support is no longer skewed.

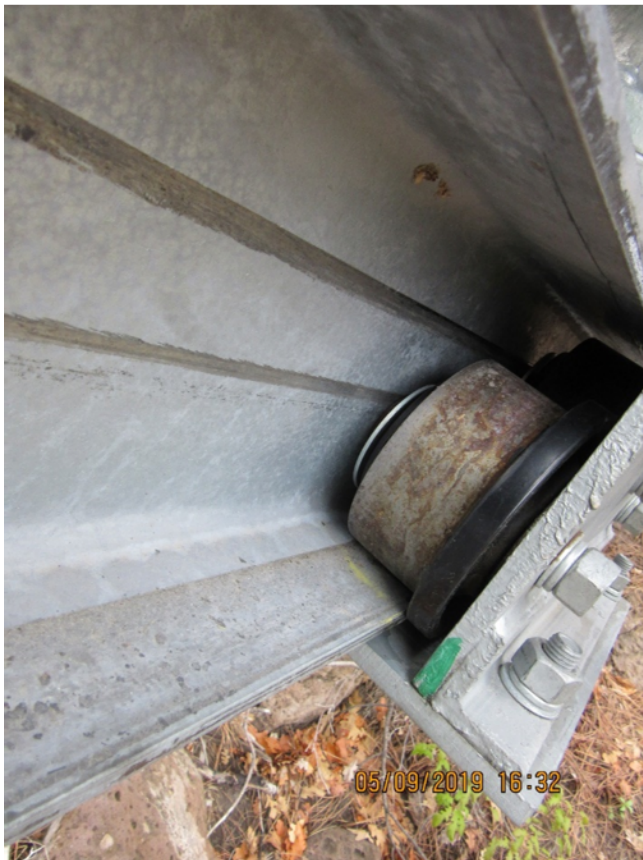
Photo C-3.6-6 May 2019—Trolley flanged wheels on beam trolley supports are gouging the I-beam supports. Noted deterioration of coating on trolley flanged wheels. Recommend further investigation.

The May 2019 Los Alamos Canyon sediment pond inspection revealed degradation of the coating on the beam trolley wheels and gouging of the I-beams at the trolley pipe supports located above the Los Alamos Canyon sediment ponds. These observations resulted in a recommendation for further investigation. In response, two special inspections were conducted at the I-beam trolley pipe supports: a special inspection on June 19, 2019, to take measurements, and a follow-up on June 26, 2019, with the pipe support manufacturer and the pipe design-build contractor to discuss the measurements taken on June 19. The findings of these special inspections are described below.

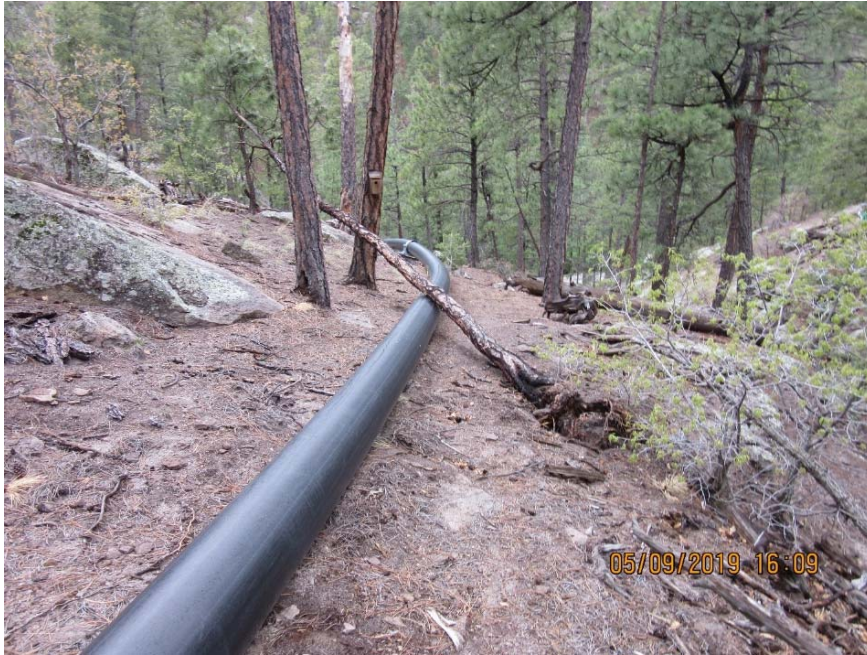
Photo C-3.6-7 May 2019—fallen tree on pipeline. Recommend relocation of fallen tree.

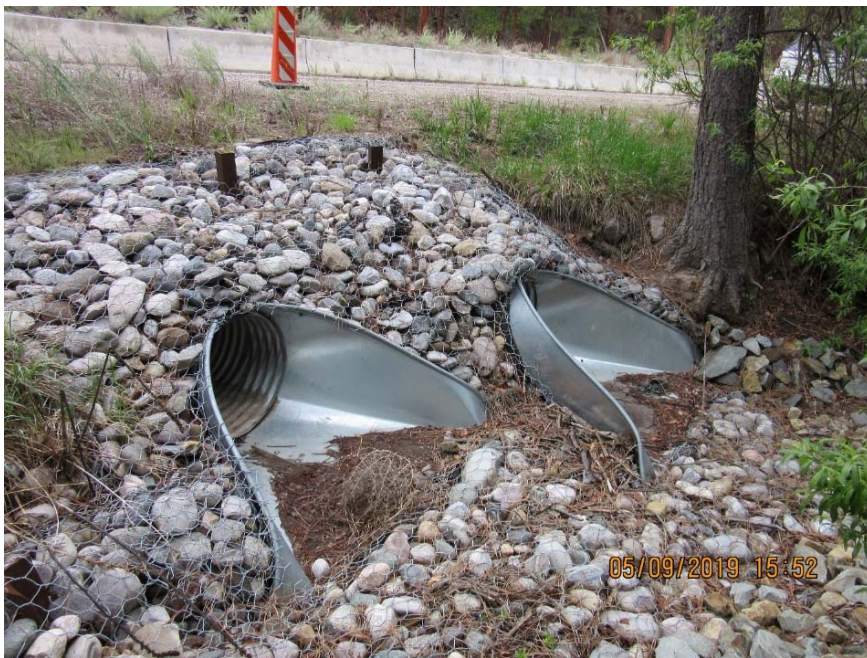
Photo C-3.6-8 May 2019—pipeline outlet downstream of Los Alamos Canyon road

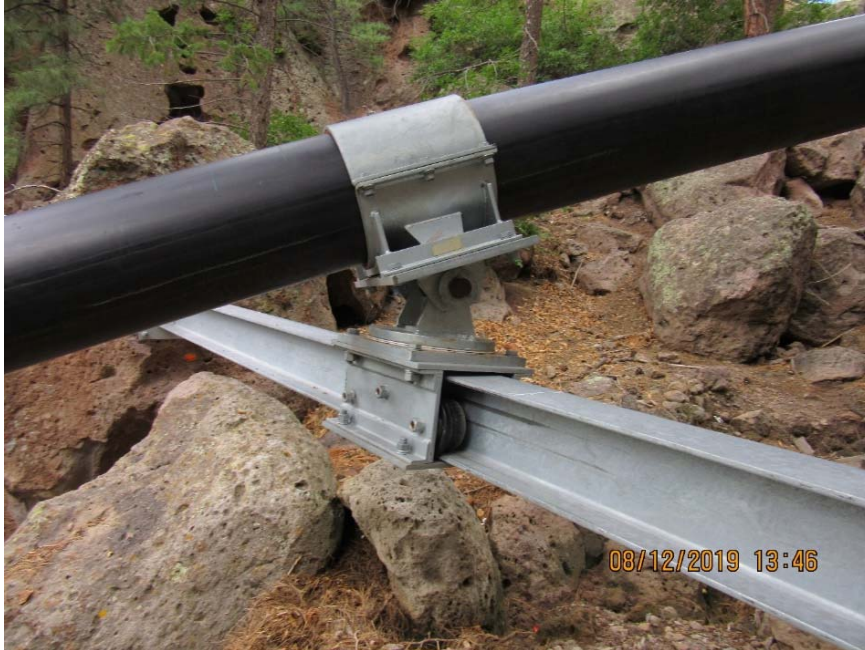
Photo C-3.6-9 Flow event inspection for August 7, 2019, storm event—Castor gouging due to skewed support on beam trolley support 15, south side. Continue to monitor.

On June 19, 2019, a special inspection occurred in the morning and afternoon to measure pipe temperature changes and measure pipe movement. During the inspection, a change in pipe temperature of 59.7°F (51.6°F to 111.3°F) was observed. At the upper beam trolley pipe support, the pipe moved to the west by approximately 9.5 in. and at the lower beam trolley, the pipe moved 13.75 in.

During the June 26, 2019, inspection, the lower beam trolley support and the I-beam were observed to be out of plane. Level readings indicated twisting in the beam, which was attributed to horizontal forces acting on the trolley supports in the north/south direction because of pipe expansion and contraction caused by fluctuations in temperature. Measurements taken during the June 19 inspection at the I-beam pipe supports were discussed and noted as expected behavior. Degradation of the trolley wheels was noted as “normal wear and tear.” The pipe support manufacturer indicated that the beam supports could last another 80 yr, recommended a follow-up inspection to measure pipe movement, and suggested the wheel trolleys be replaced every 20 yr.

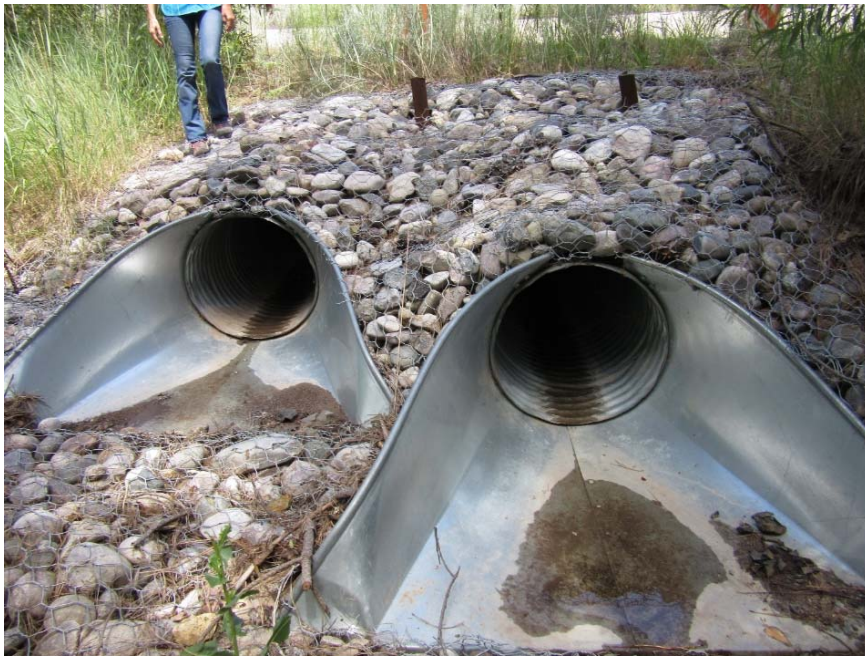
Photo C-3.6-10 Flow event inspection for August 7, 2019, storm event—pipeline outlet downstream of Los Alamos Canyon road

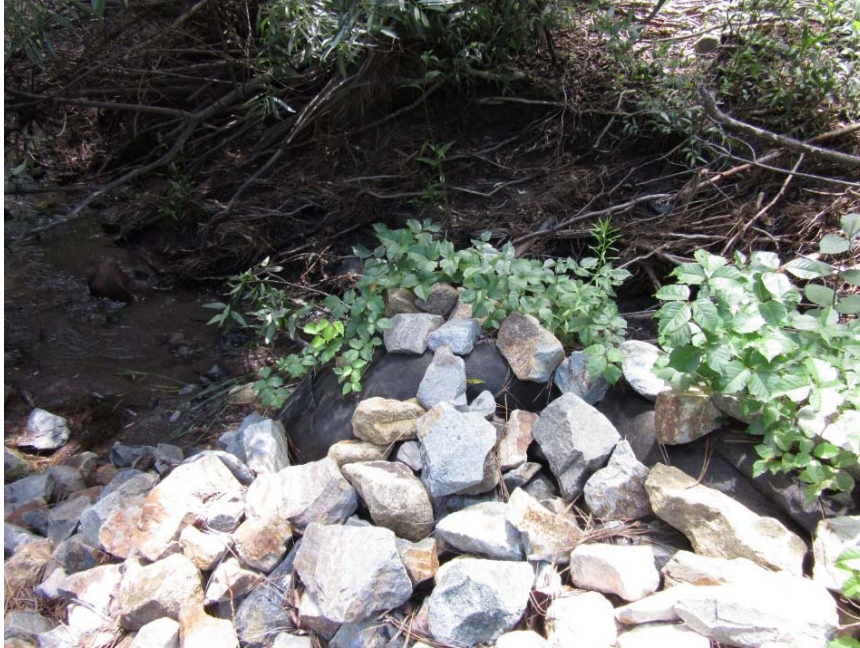
Photo C-3.6-11 Flow event inspection for August 7, 2019, storm event—discharge culvert north of Los Alamos Canyon road. Geotextile exposed. Recommend placement of riprap to cover geotextile.

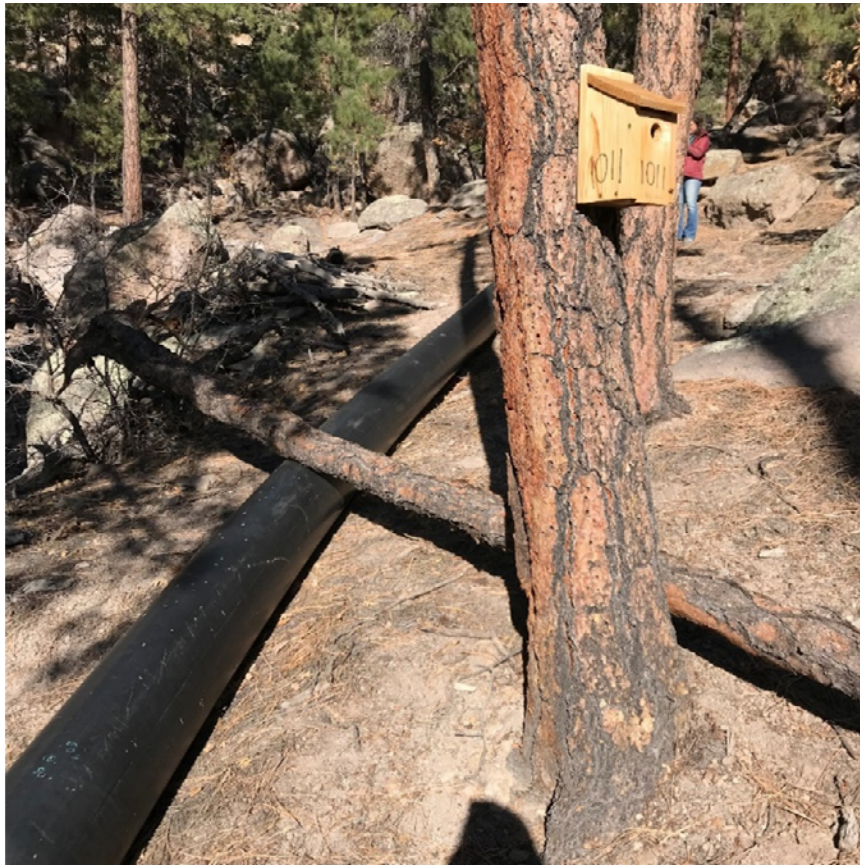
Photo C-3.6-12 November 2019—Tree fell on pipeline. Removal recommended.

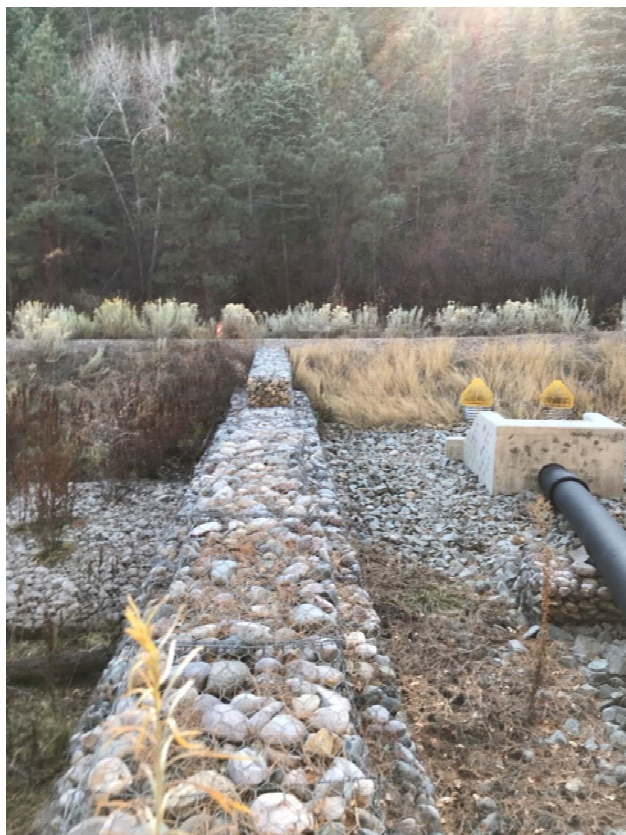
Photo C-3.6-13 November 2019—discharge culvert inlet and riser pipe. Evidence of water level found at top of spillway (needlecast deposition).

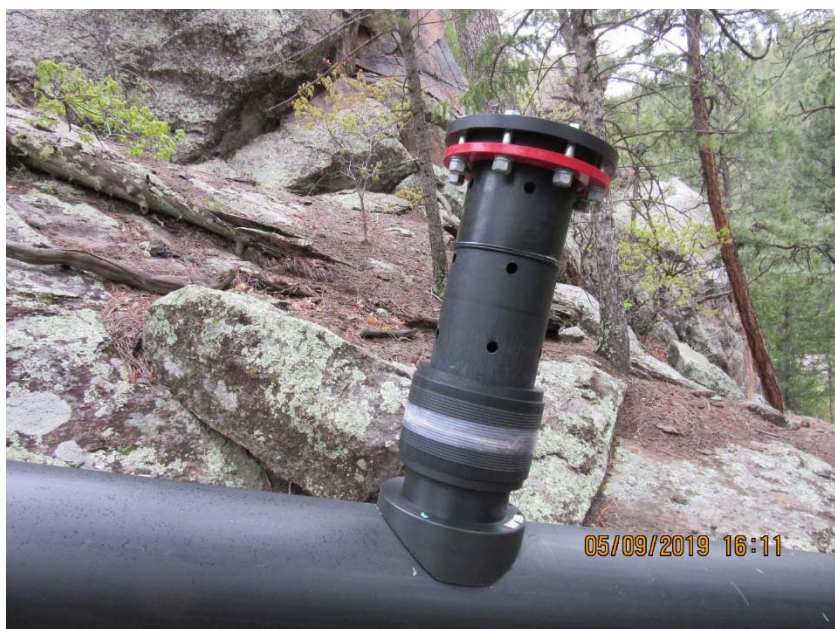
Photo C-3.7-1 May 2019—pipeline vacuum breaker. Control is operating as designed with no apparent issues to structure.

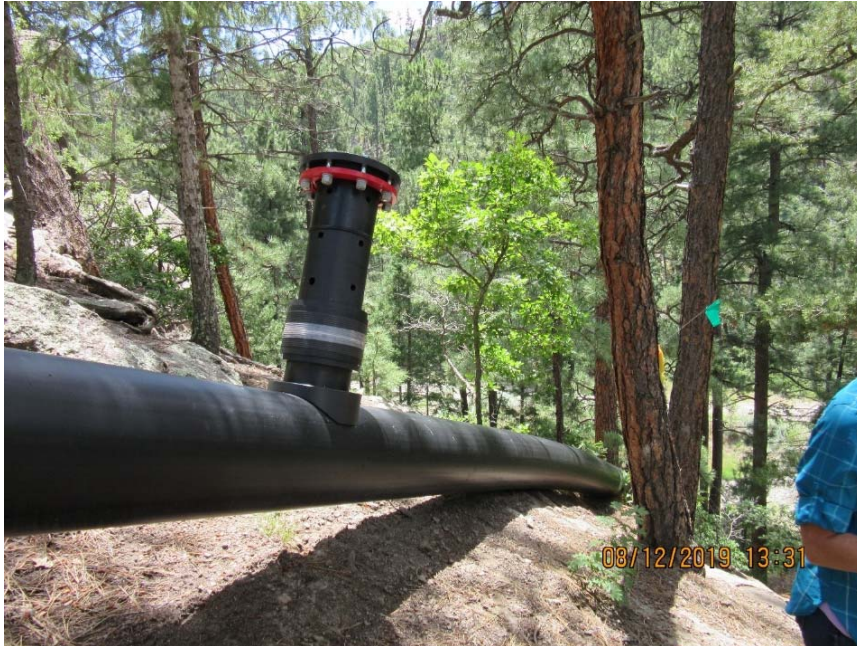
Photo C-3.7-2 Flow event inspection for August 7, 2019, storm event—pipeline vacuum breaker. Control is operating as designed with no apparent issues to structure.

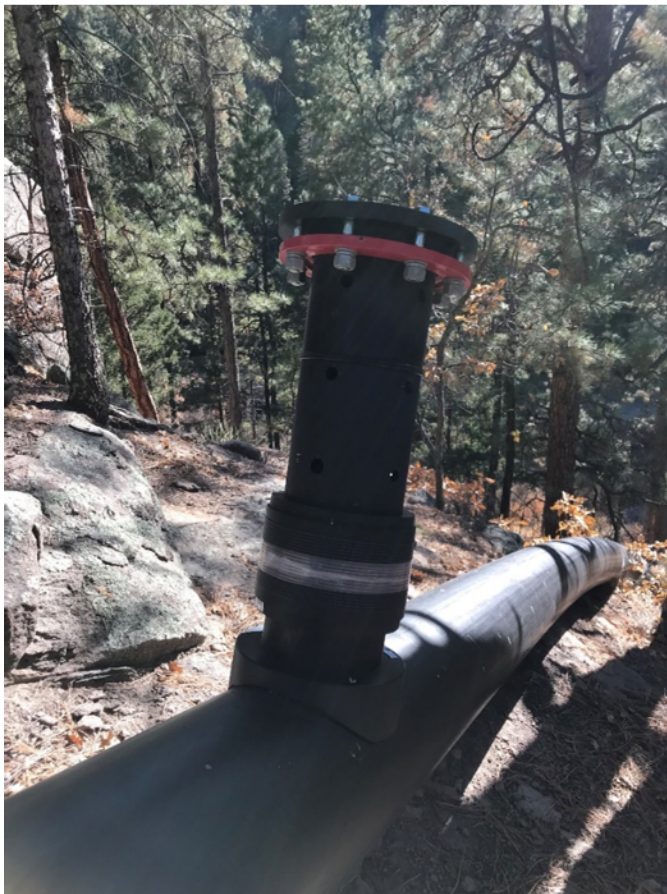
Photo C-3.7-3 November 2019—pipeline vacuum breaker. Control is operating as designed with no apparent issues to structure.

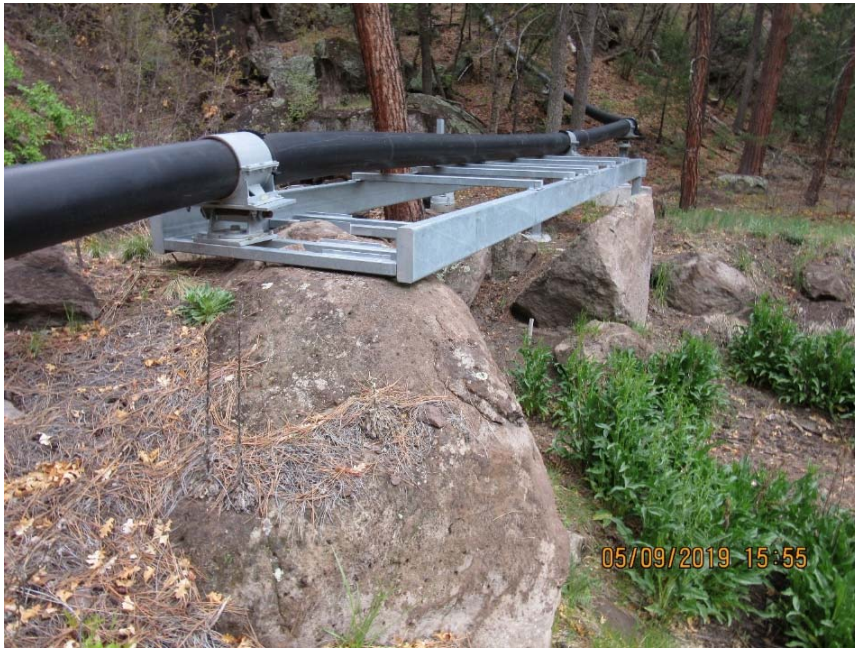
Photo C-3.8-1 May 2019—pipeline bridge structure. Control is operating as designed with no apparent issues to structure.

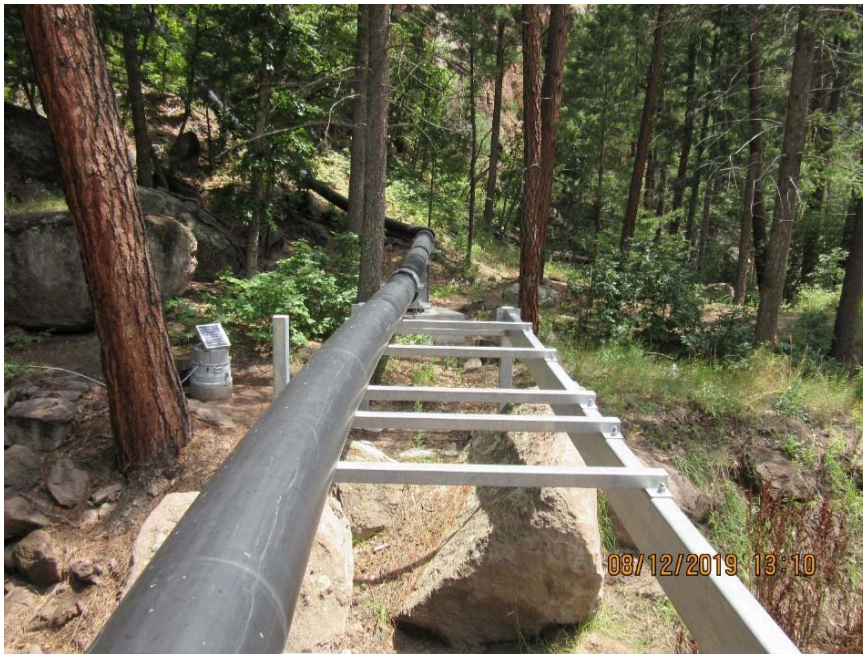
Photo C-3.8-2 Flow event inspection for August 7, 2019, storm event—pipeline bridge structure. Control is operating as designed with no apparent issues to structure.

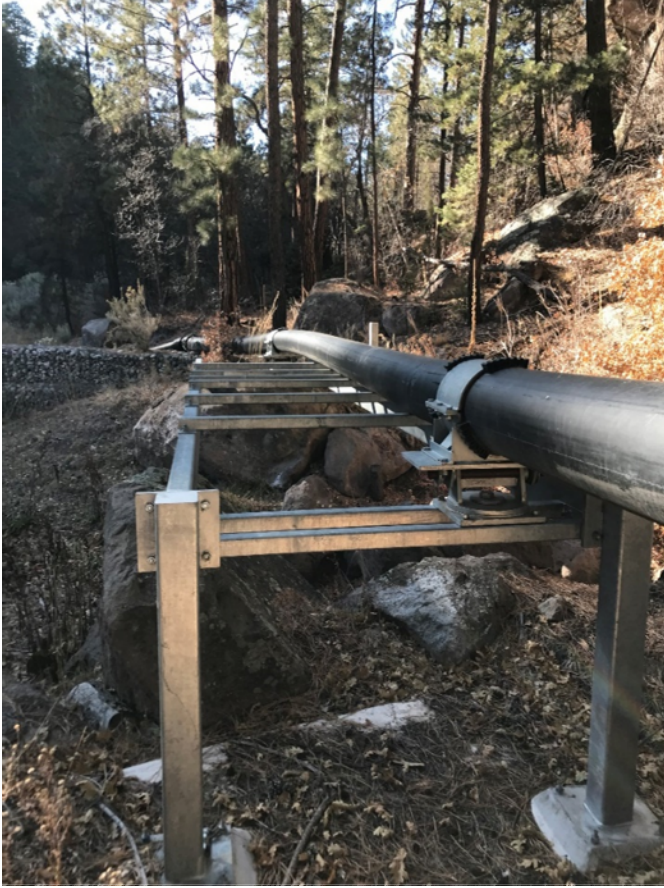
Photo C-3.8-3 November 2019—pipeline bridge structure. Control is operating as designed with no apparent issues to structure.

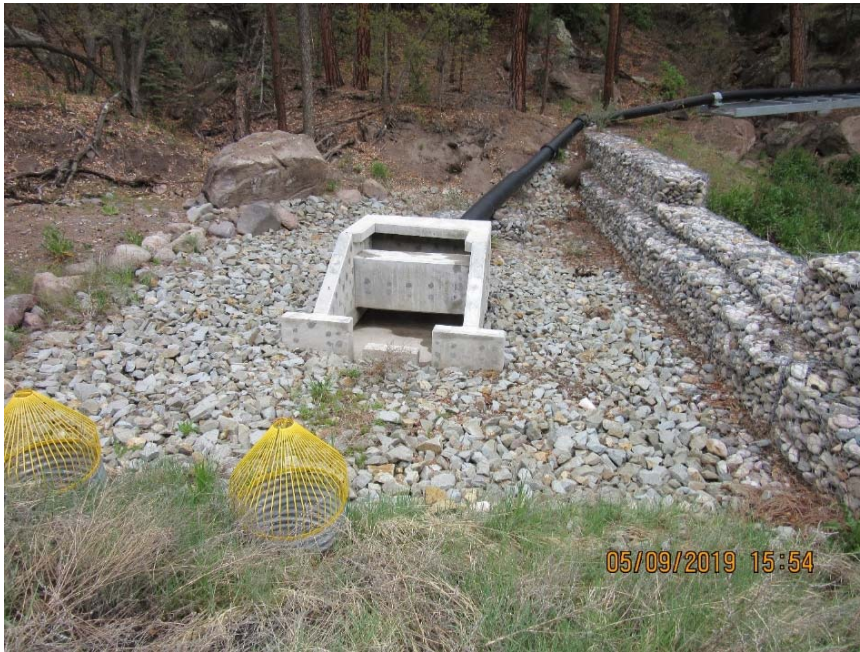
Photo C-3.9-1 May 2019—pipeline outlet, energy dissipater, and gabion overflow structure. Control is operating as designed with no apparent issues to structure.

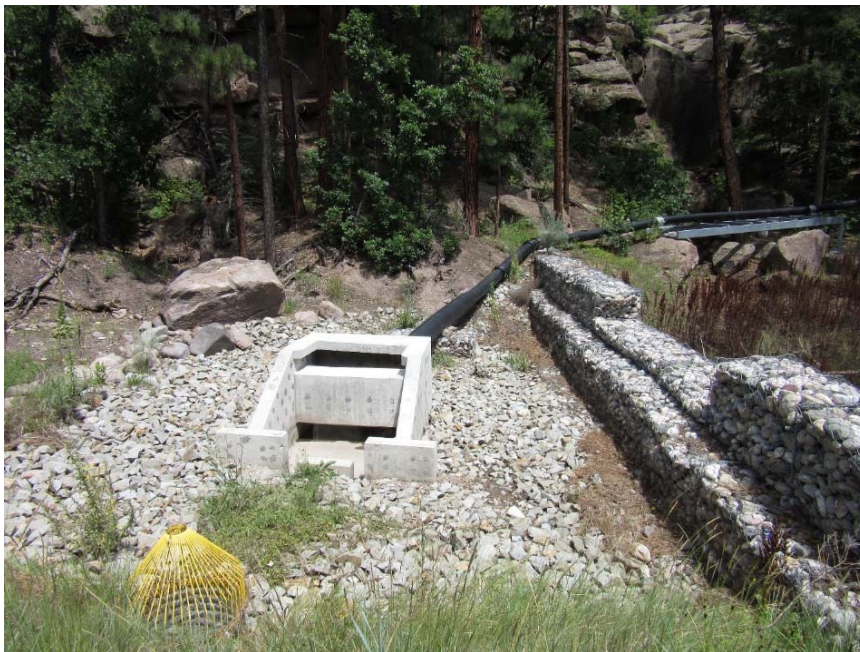
Photo C-3.9-2 Flow event inspection for August 7, 2019, storm event—pipeline outlet, energy dissipater, and gabion overflow structure. Control is operating as designed with no apparent issues to structure.

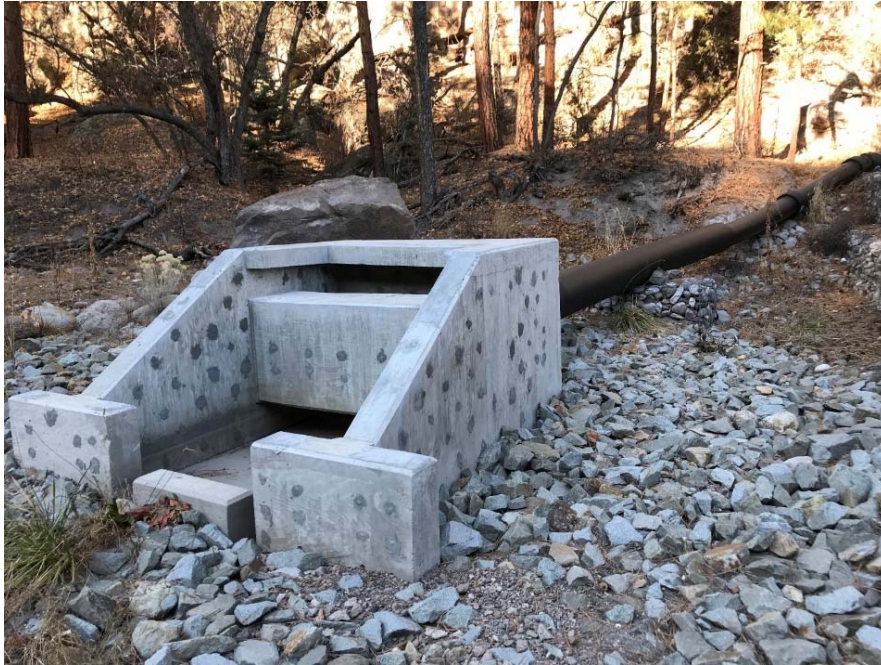
Photo C-3.9-3 November 2019—pipeline outlet, energy dissipater, and gabion overflow structure. Control is operating as designed with no apparent issues to structure.

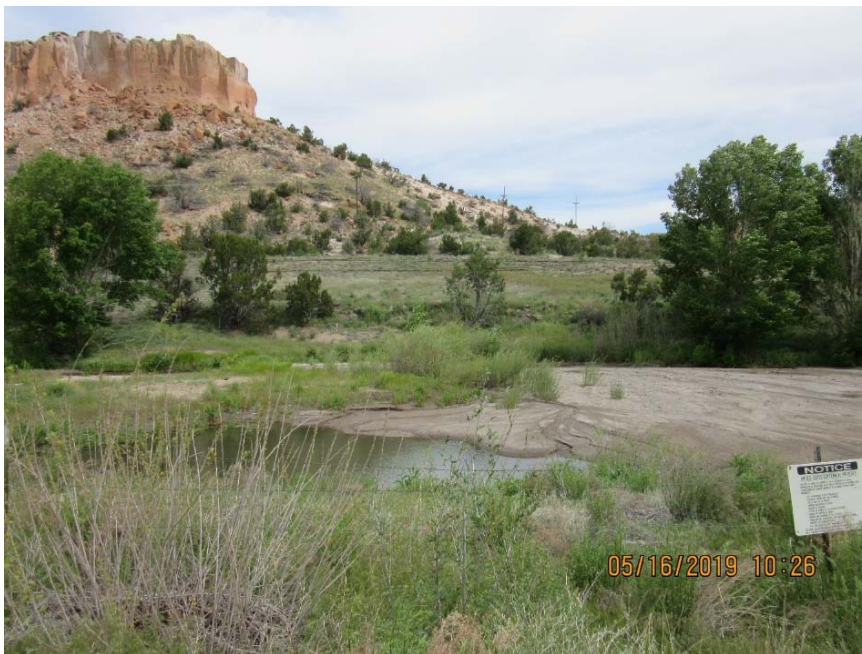
Photo C-4.1-1 May 2019—upstream northern embankment slope. Slope embankment is stable with established vegetation.

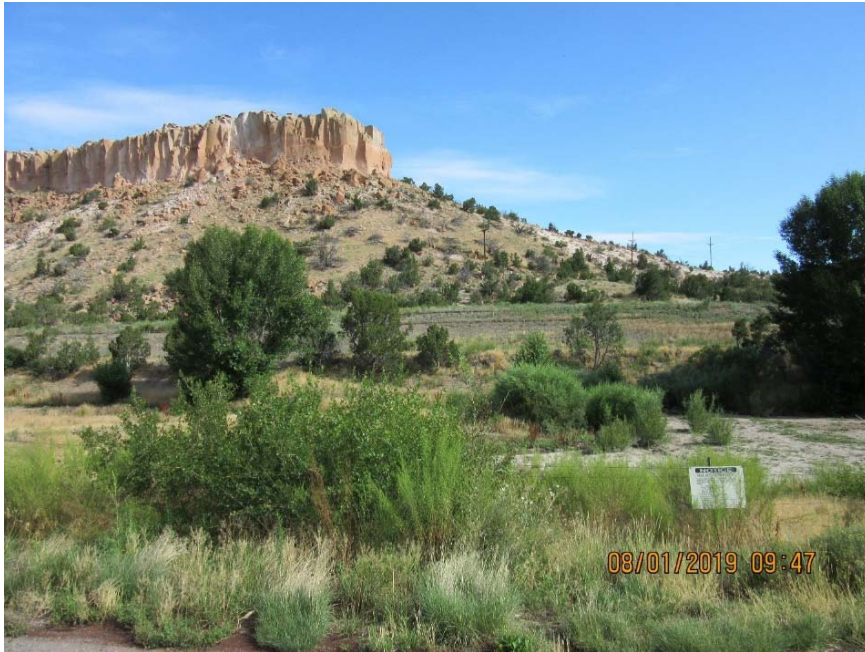
Photo C-4.1-2 Flow event inspection for July 26, 2019, storm event—upstream northern embankment slope. Slope embankment is stable with established vegetation.

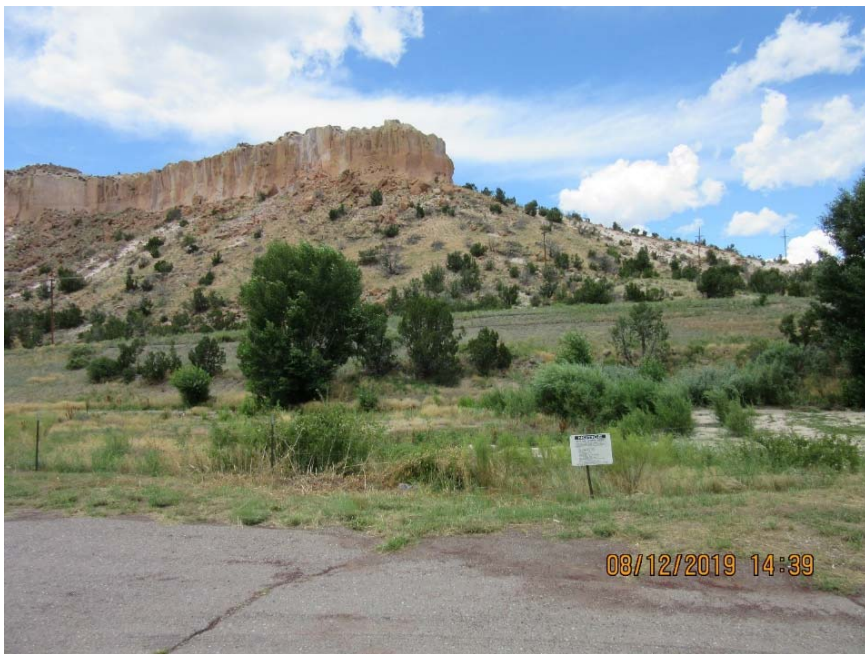
Photo C-4.1-3 Flow event inspection for August 7, 2019, storm event—upstream northern embankment slope. Slope embankment is stable with established vegetation.

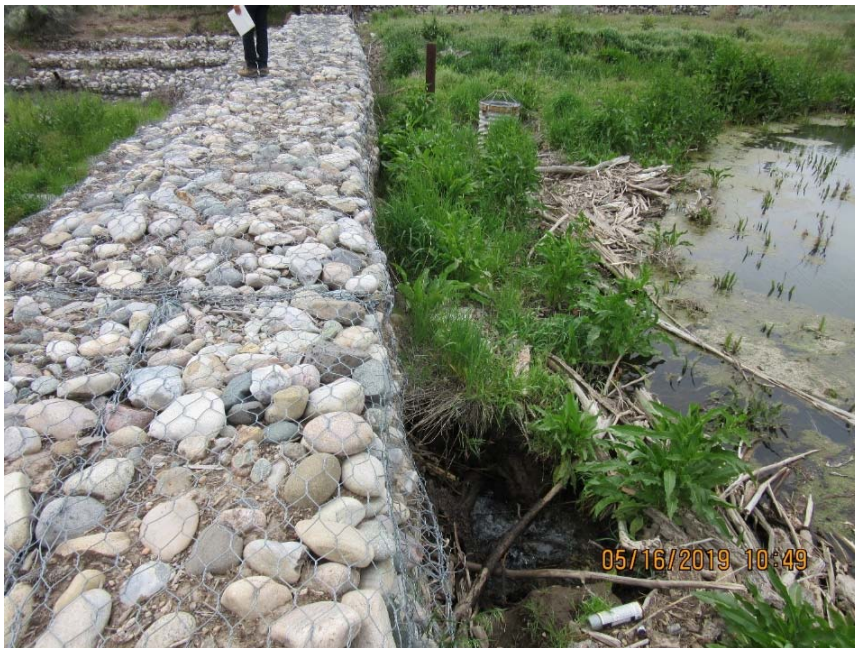
Photo C-4.2-1 May 2019—abutment looking south. Sinkholes still present. Four to five areas of preferential flow. Will continue to monitor. Lower pond filled with approximately 2-3 ft water. Actively flowing. Minor amount of trash on upstream side against the abutment. Recommend collection and disposal of trash.

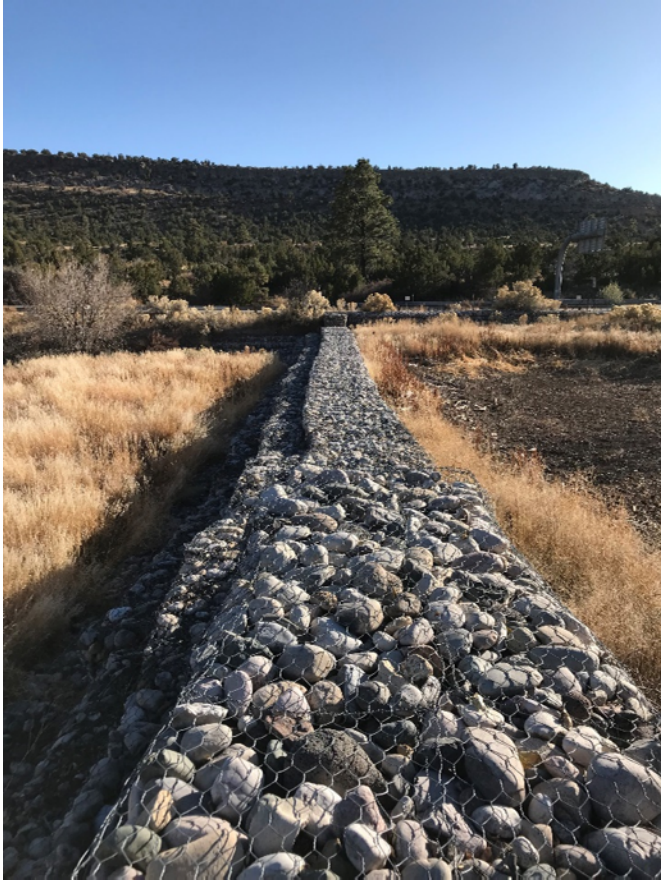
Photo C-4.2-2 November 2019—abutment looking south. No change since last inspection.

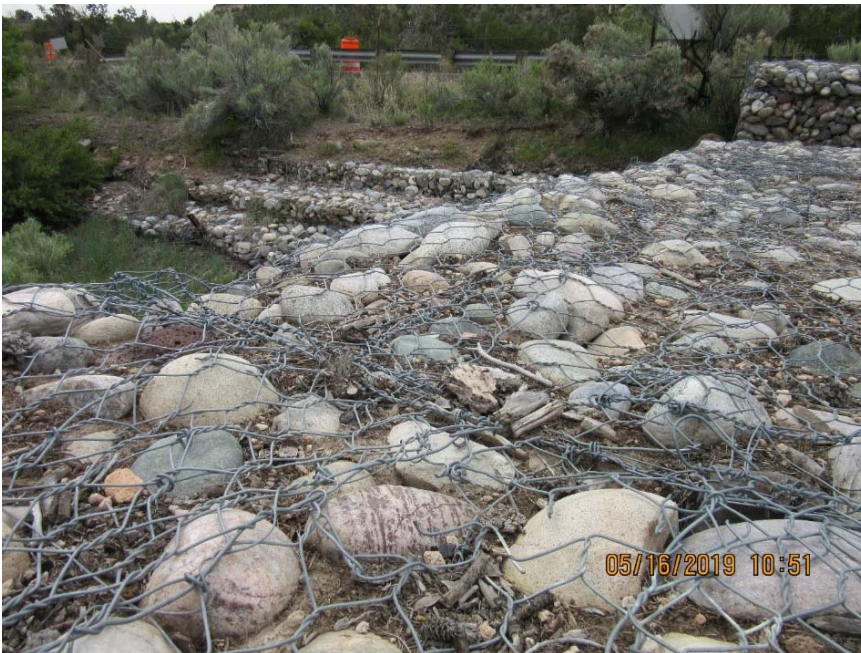
Photo C-4.3-1 May 2019—downstream southern embankment slope. No deficiency found.

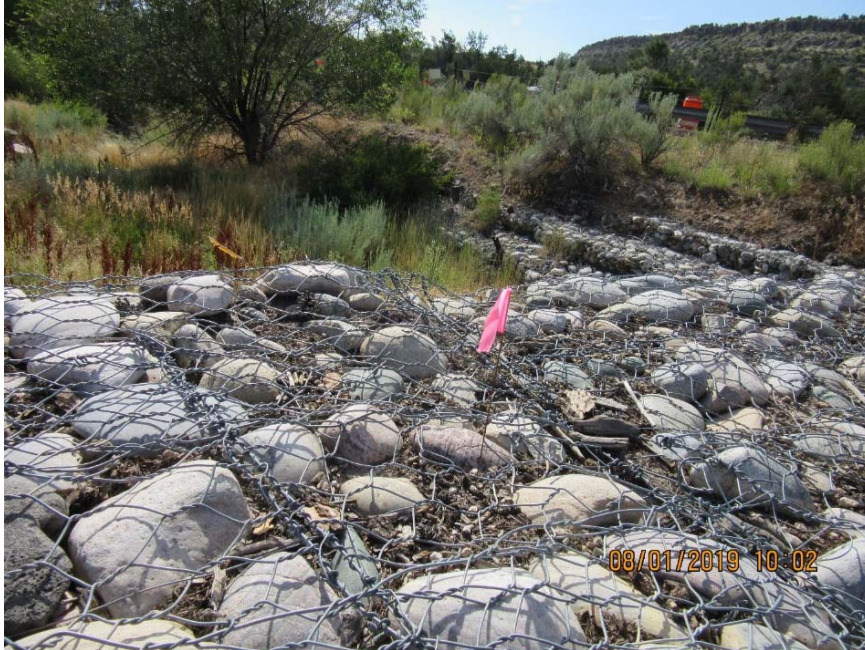
Photo C-4.3-2 Flow event inspection for July 26, 2019, storm event—downstream southern embankment slope. Sediment deposited from runoff coming from dirt roads upgradient of the northside gabion embankment. Will continue to monitor.

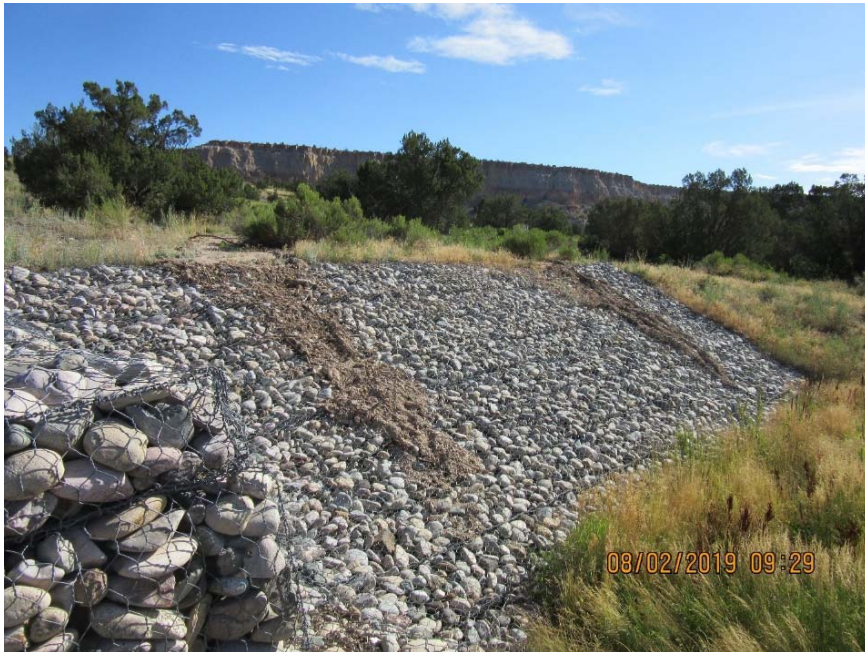
Photo C-4.3-3 Flow event inspection for July 26, 2019, storm event—downstream northern embankment slope. Recommend wattle or gravel bag placement at top of gabion baskets.

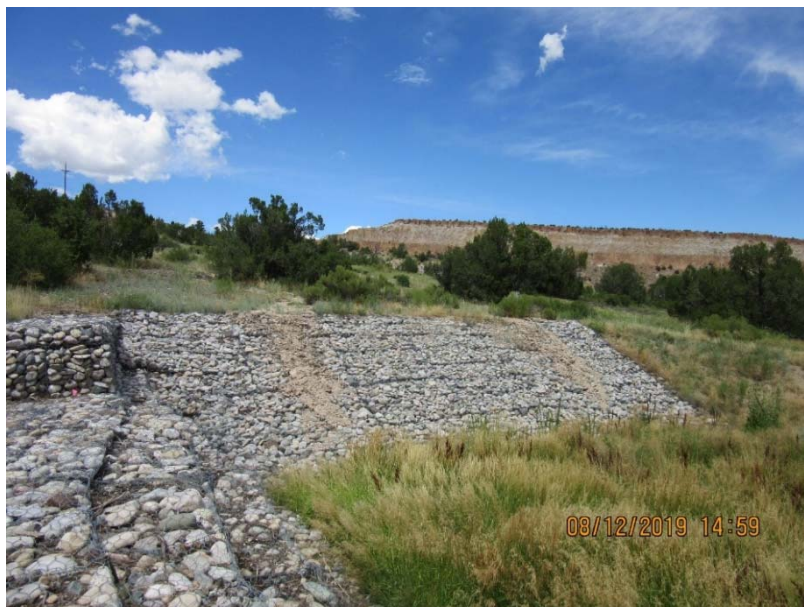
Photo C-4.3-4 Flow event inspection for August 7, 2019, storm event—downstream northern embankment slope. Surface water collecting on the paths downstream of the weir causing deposition of coarse sediments on the north gabion embankment. Recommend placement of gravel bags or wattles at the top of the gabions and relocating sediments deposited to north of the gravel bags or wattles.

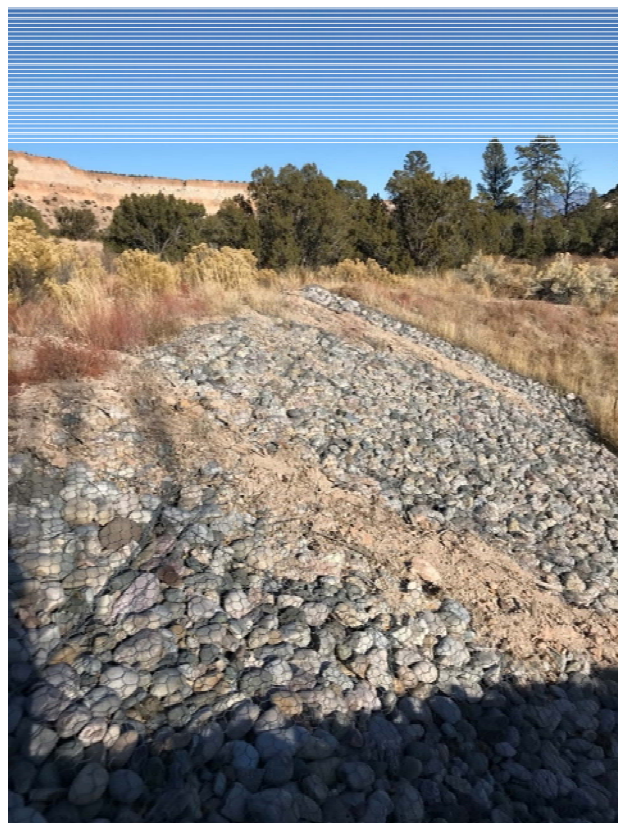
Photo C-4.3-5 November 2019—downstream northern embankment slope. Recommend wattle or gravel bag placement on top of gabion baskets.

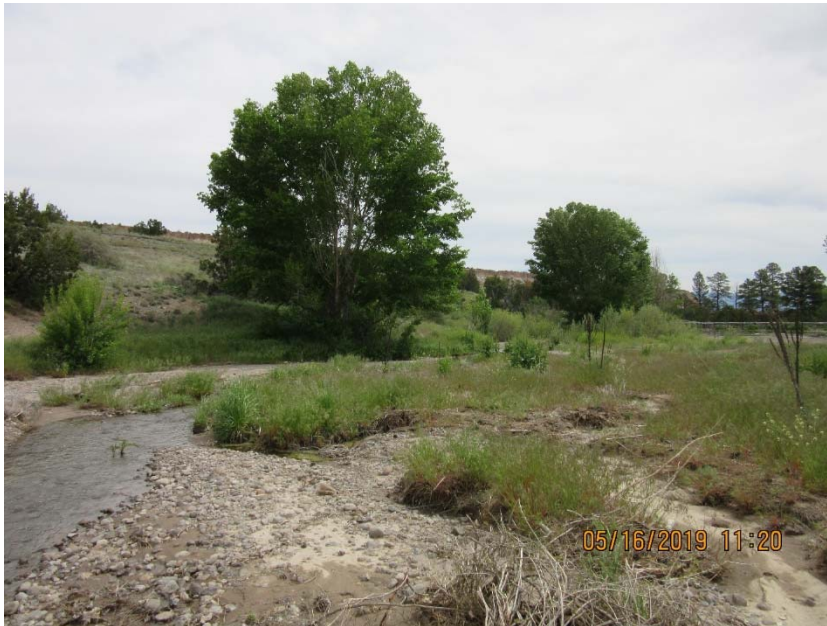
Photo C-4.4-1 May 2019—Los Alamos Pond 1 (upper) looking downstream. Pond appears to have been breached. Pond has no capacity to retain sediment.

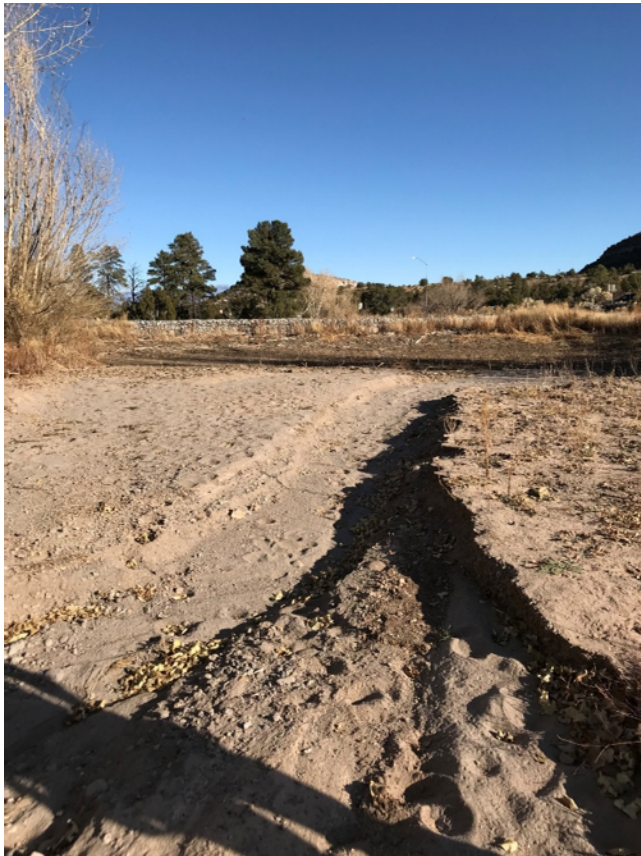
Photo C-4.4-2 November 2019—Los Alamos Pond 1 (upper) looking downstream. Pond has been breached and has no sediment capacity.
