Subject: Submittal of the 2019 Monitoring Report for Los Alamos/Pueblo Watershed Sediment Transport Mitigation Project

1. Two hard copies with electronic files – 2019 Monitoring Report for Los Alamos/Pueblo Watershed Sediment Transport Mitigation Project (EM2020-0019)

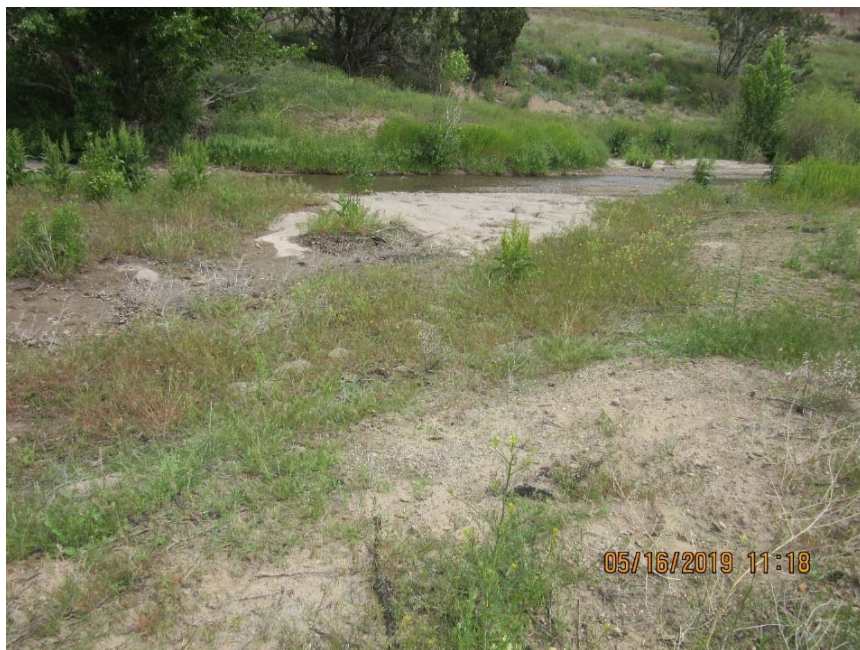
Photo C-4.5-1 May 2019—Los Alamos Pond 2 (middle) looking downstream. Pond appears to have been breached. Minor ponding on the south side of channel. Pond has no capacity to retain sediment.

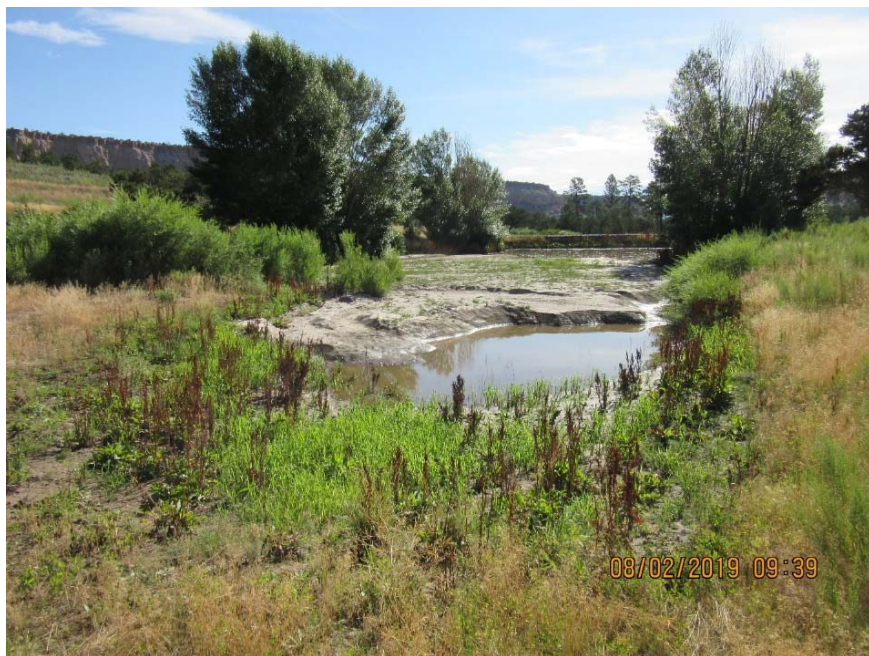
Photo C-4.5-2 Flow event inspection for July 26, 2019, storm event—Los Alamos Pond 2 (middle) looking downstream. Pond has been breached. No sediment capacity at flow line. Deposition of medium gradation (approximately 0.25-in.-diameter) size sediments noted at flow line.

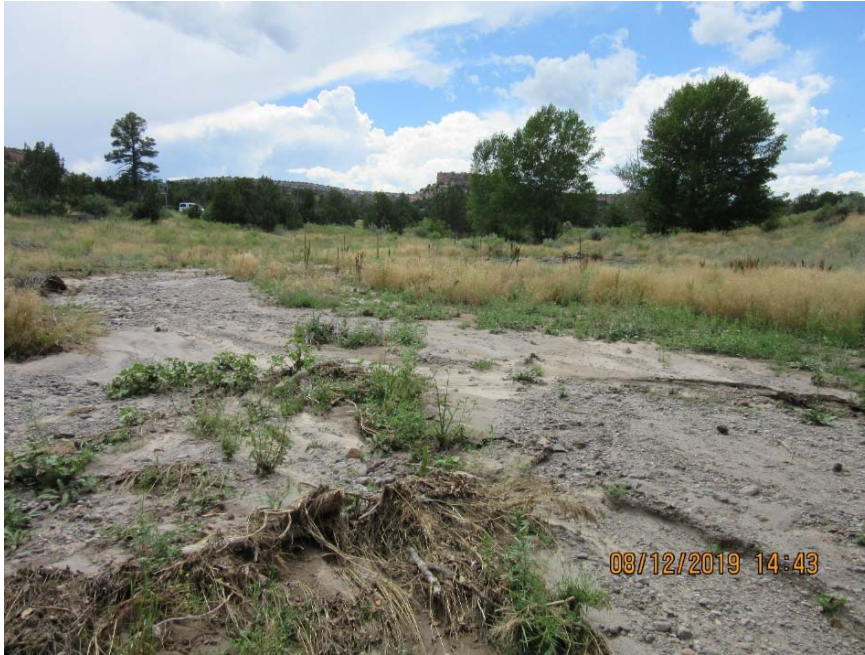
Photo C-4.5-3 Flow event inspection for August 7, 2019, storm event—Los Alamos Pond 2 (middle). Pond has been breached and has no sediment capacity.

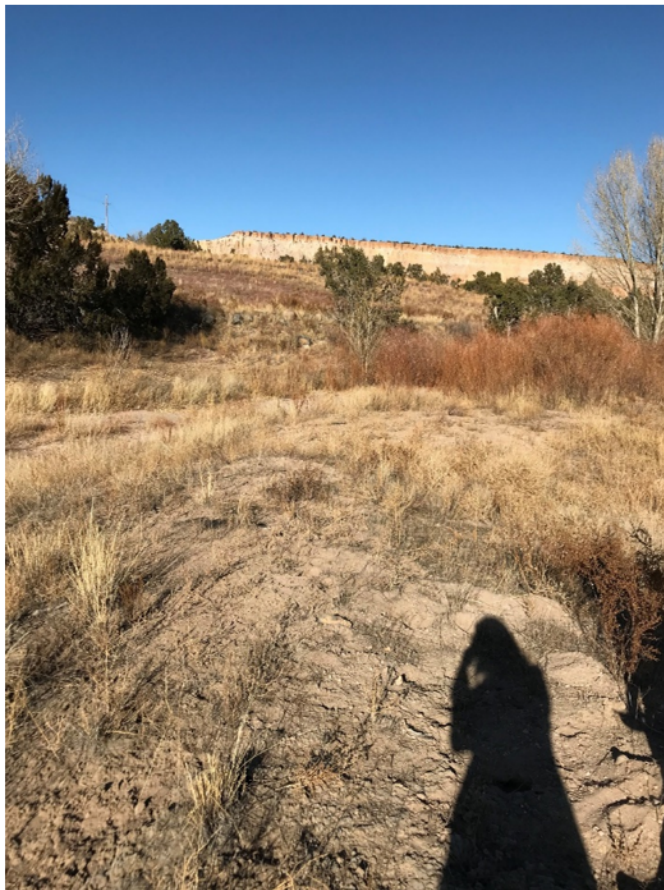
Photo C-4.5-4 November 2019—Los Alamos Pond 2 (middle). Pond has been breached and has no sediment capacity.

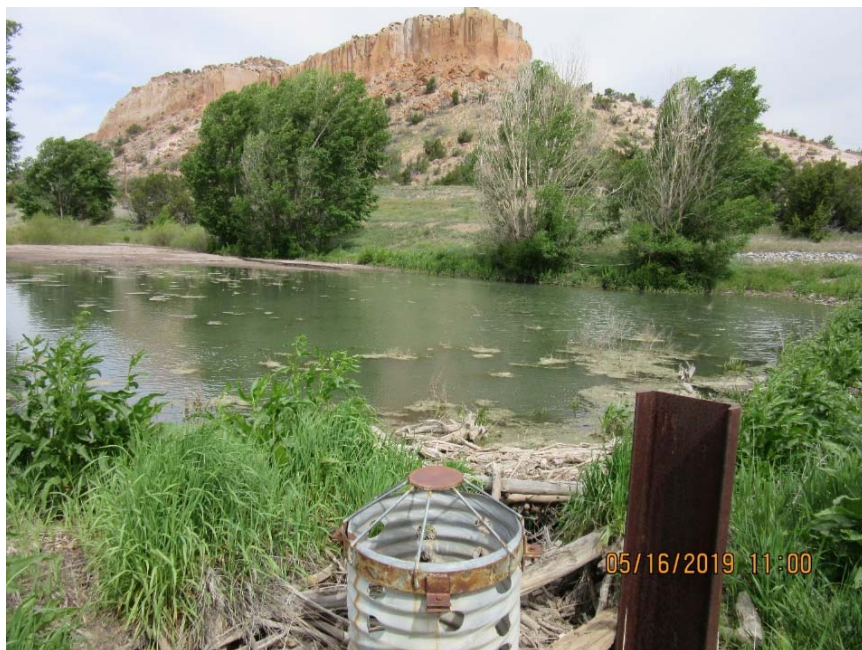
Photo C-4.6-1 May 2019—Los Alamos Pond 3 (lower). Water level is 4–5 ft below the spillway crest.

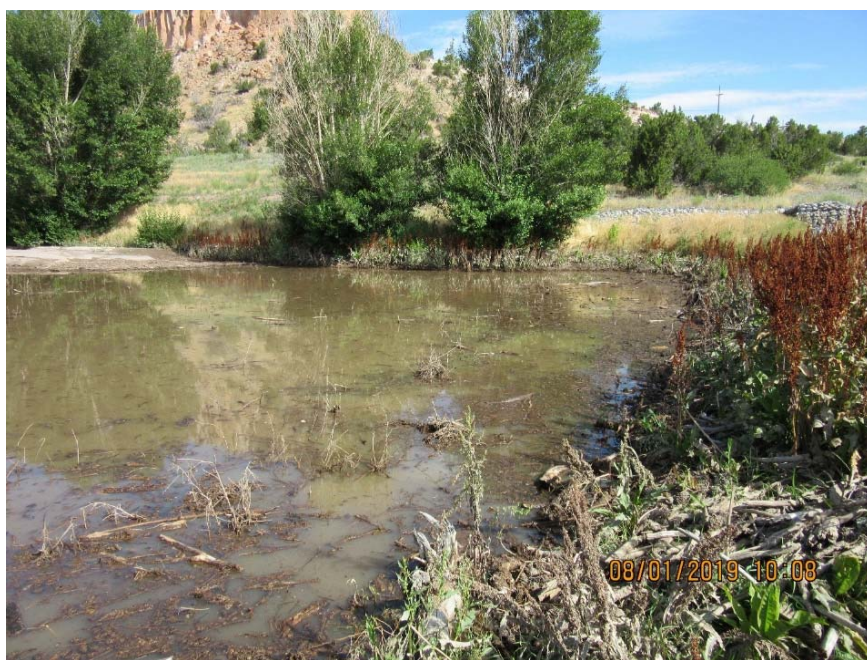
Photo C-4.6-2 Flow event inspection for July 26, 2019, storm event—Los Alamos Pond 3 (lower). Pond level approximately 0.5-ft deep in lower pond. Tadpoles noted. Approximately 0.5 ft sediment deposition upstream of pond. High flows on north side of pond; low flows at south side of pond. Will continue to monitor.

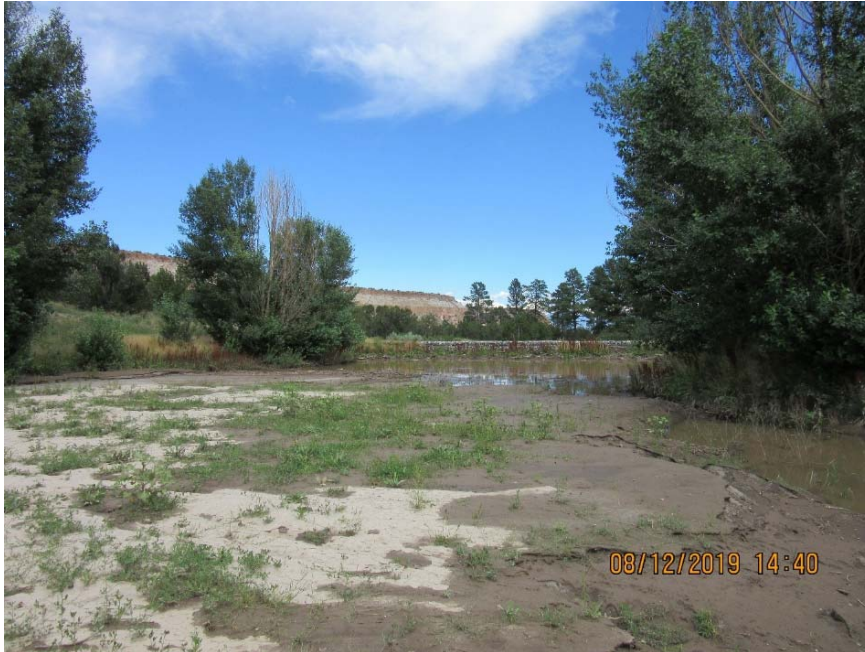
Photo C-4.6-3 Flow event inspection for August 7, 2019, storm event—Los Alamos Pond 3 (lower). Sediment deposition area extended approximately 3 ft to the east (downstream).

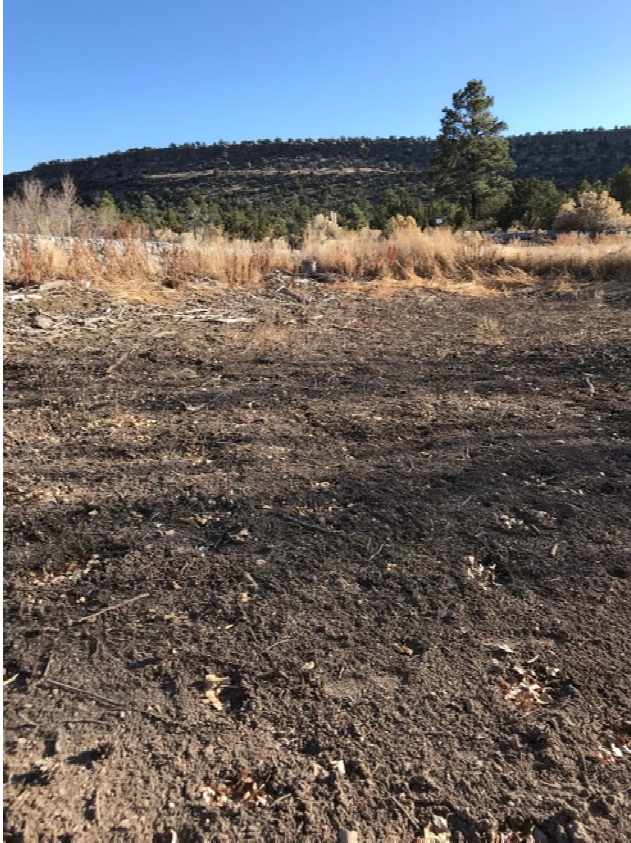
Photo C-4.6-5 November 2019—Los Alamos Pond 3 (lower). No significant change since last inspection.

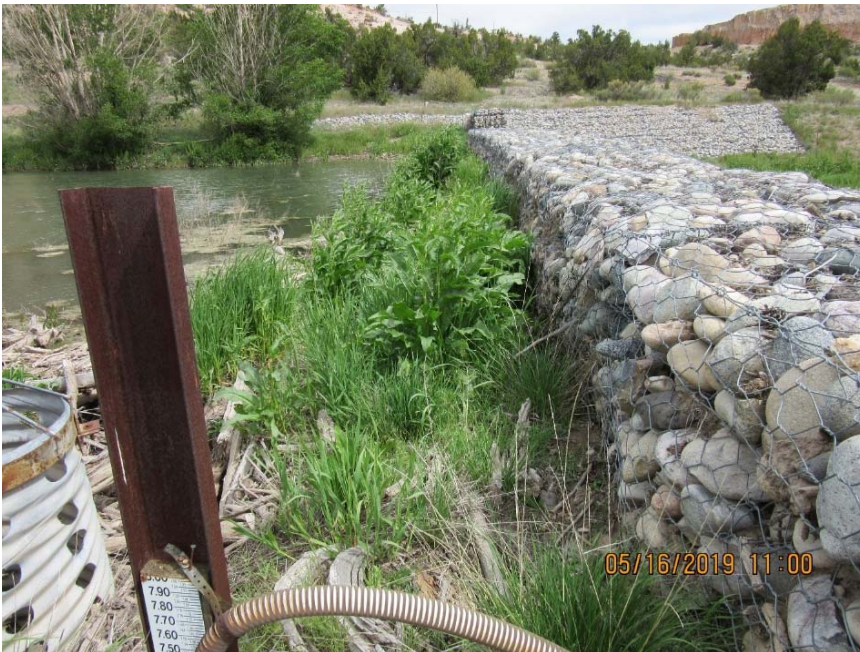
Photo C-4.7-1 May 2019—upstream weir face. Continue to monitor bulging gabion baskets.

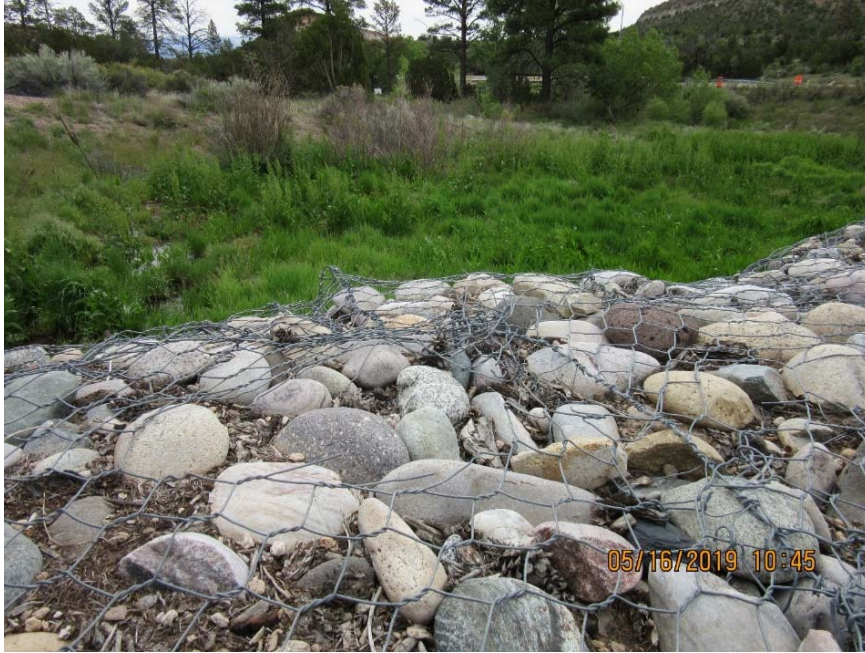
Photo C-4.7-2 May 2019—broken gabion wires on north end of weir crest. Recommend repair of holes in gabion basket.

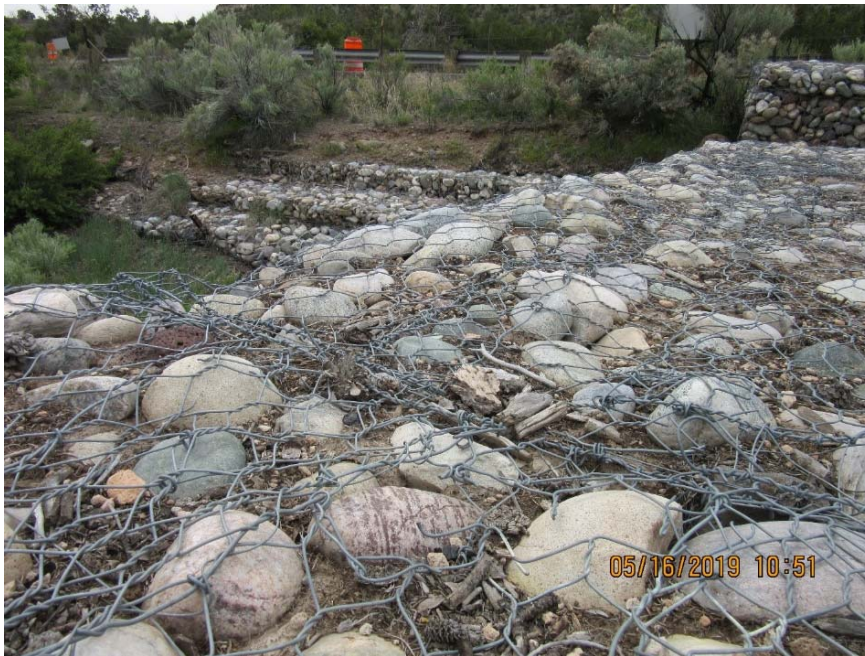
Photo C-4.7-3 May 2019—broken gabions on south end of crest. Recommend repair of holes in gabion basket.

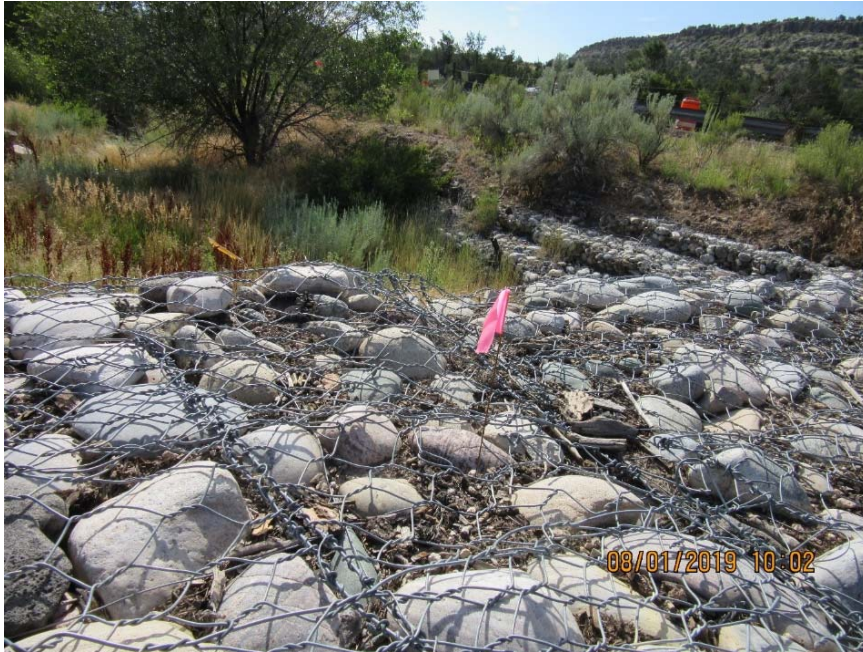
Photo C-4.7-4 Flow event inspection for July 26, 2019, storm event—broken gabion wires on north end of weir crest. Recommend repair.

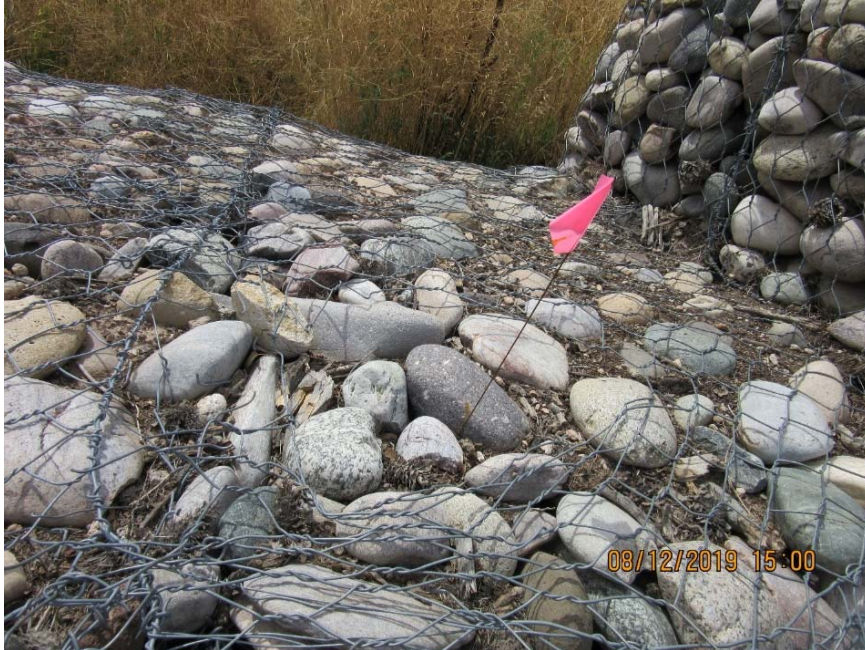
Photo C-4.7-6 Flow event inspection for August 7, 2019, storm event—broken gabion wires on north end of weir crest. Recommend repair.

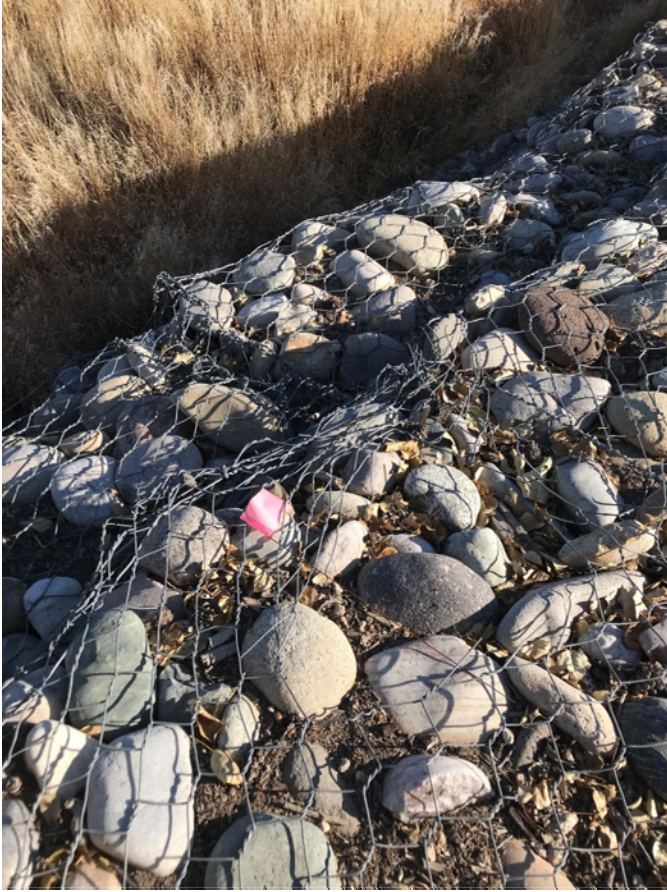
Photo C-4.7-8 **November 2019—broken gabion wires on north end of weir crest. Recommend repair.**

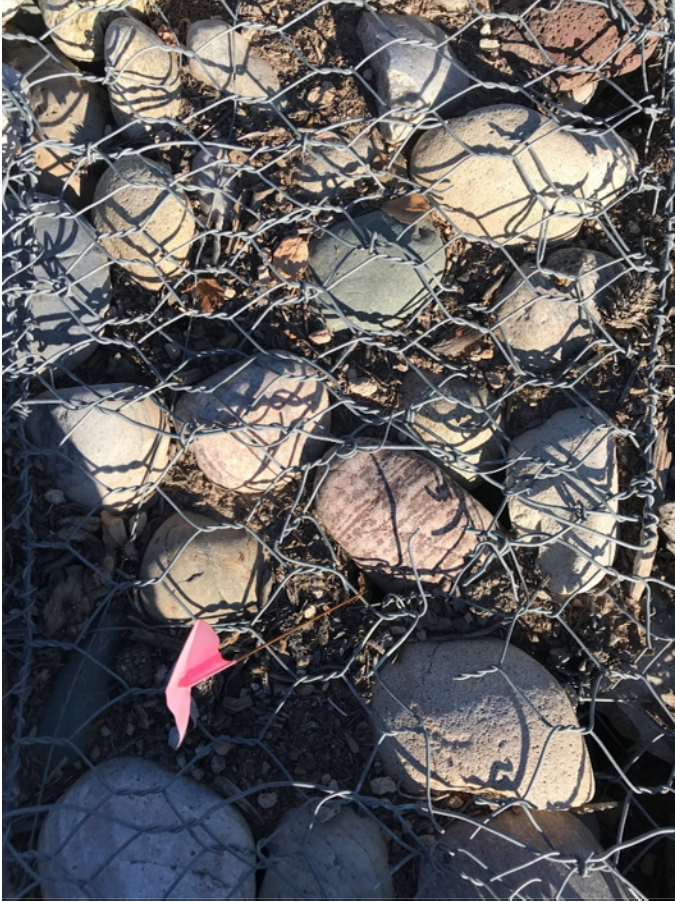
Photo C-4.7-9 November 2019—broken gabion wires on south end of weir crest. Recommend repair.

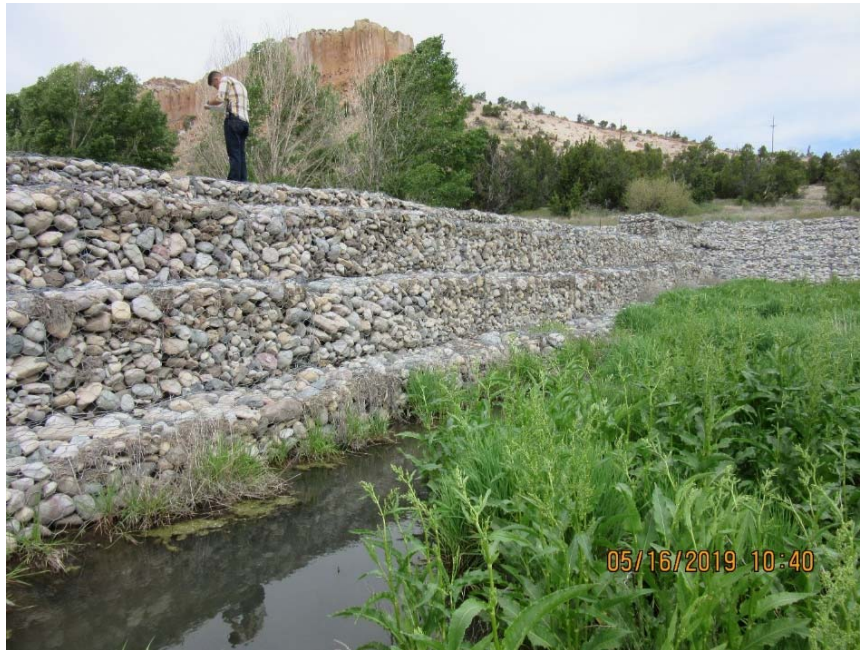
Photo C-4.8-1 May 2019—downstream weir face. Continue to monitor bulging baskets and joints.

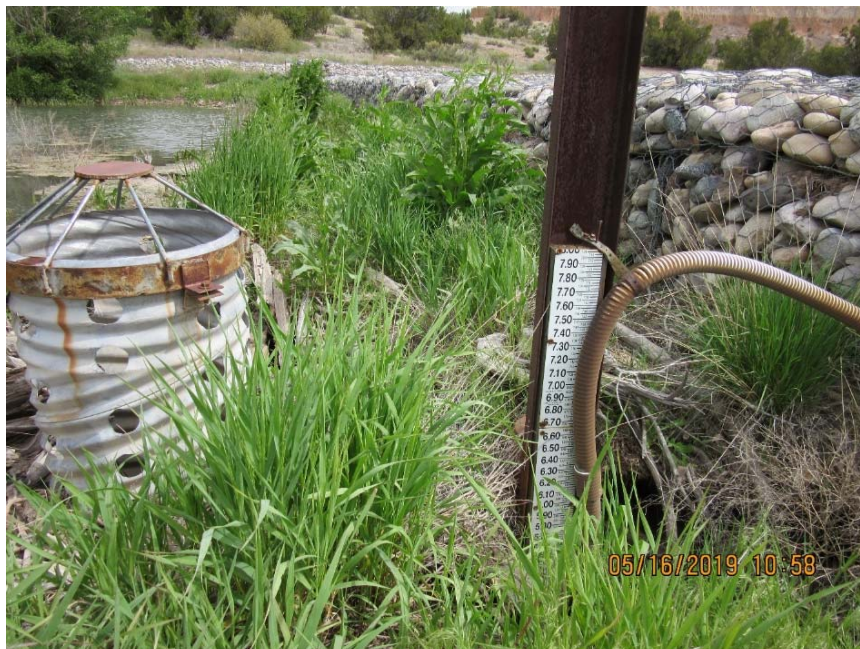
Photo C-4.9-1 May 2019—standpipe. Gage reads approximately 6 ft of sediment and debris. Approximately 3 ft of standpipe exposed. No deficiency found.

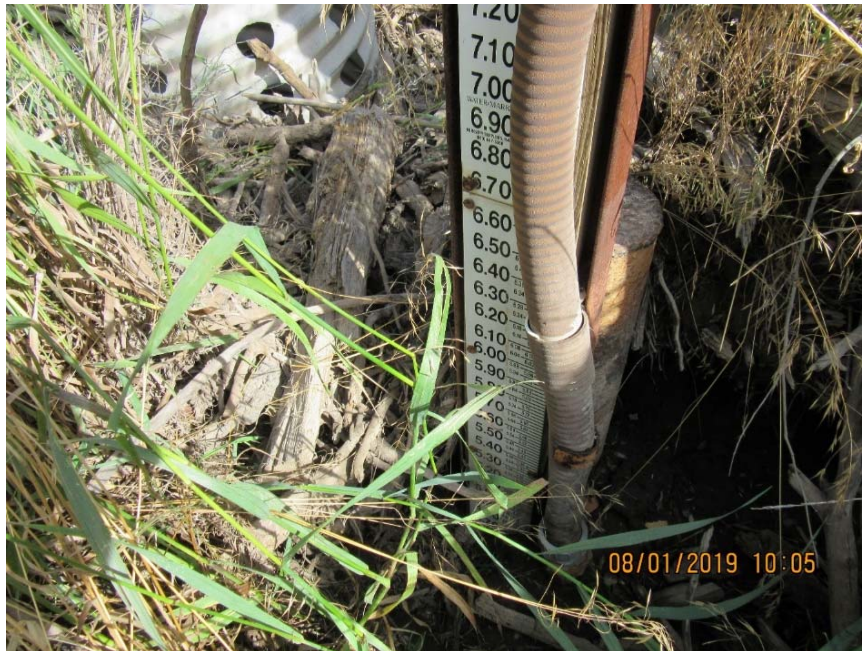
Photo C-4.9-2 Flow event inspection for July 26, 2019, storm event—standpipe. Sediment is approximately 4 ft deep. Debris accumulation (branches, pinecones, plastic bottles) is approximately 2 ft above sediment level. Approximately 3 ft of standpipe exposed.

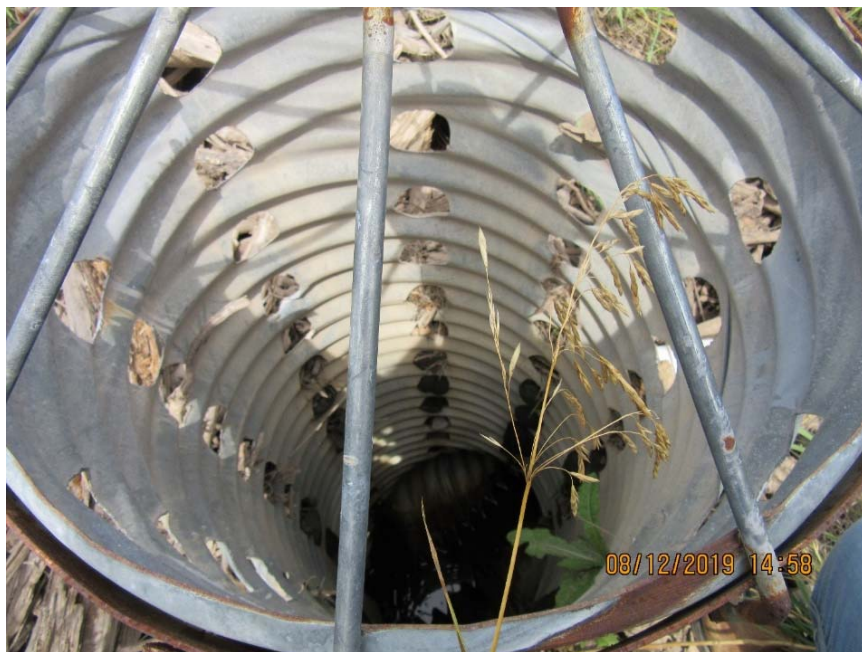
Photo C-4.9-3 Flow event inspection for August 7, 2019, storm event—standpipe. Sediment upstream of weir at 4.7-ft depth and debris at 6-ft depth. Approximately 3 ft of standpipe exposed. No significant change since last inspection.

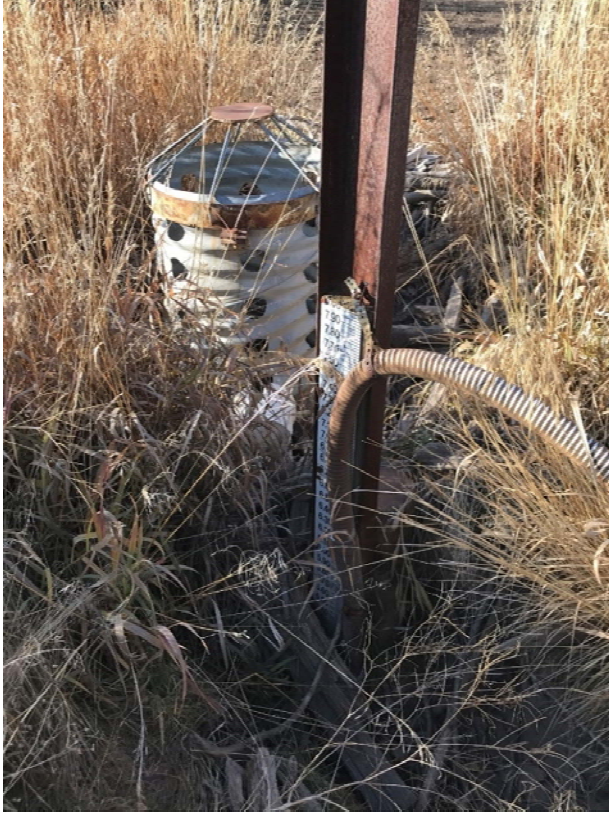
Photo C-4.9-4 November 2019—standpipe. Sediment and debris level at 4.6 ft on gage.

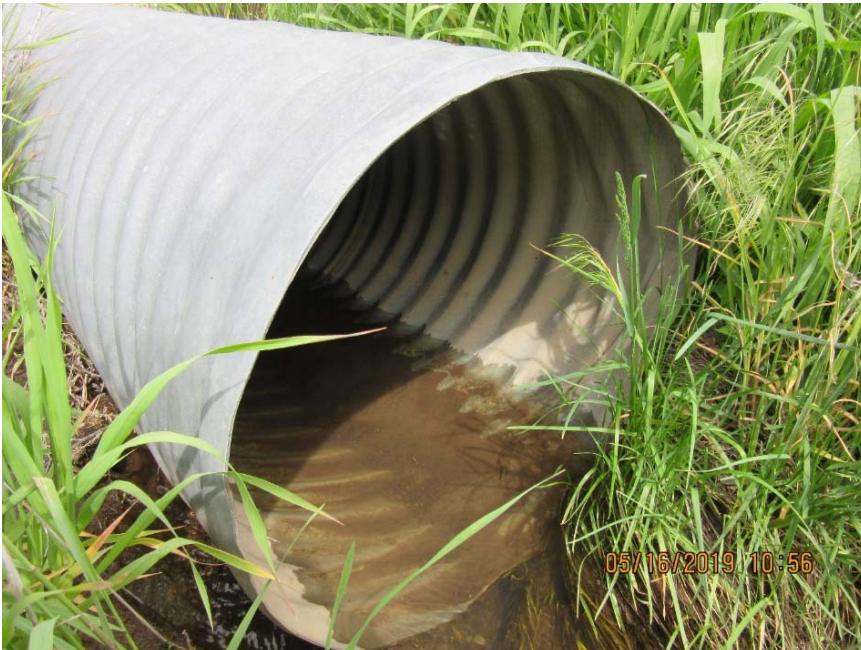
Photo C-4.10-1 May 2019—weir outlet. Water flowing/seeping through gabions at various locations. Pipe has some flow. Continue to monitor erosion occurring 50–60 ft downstream of the weir. No sediment present. Highly vegetated.

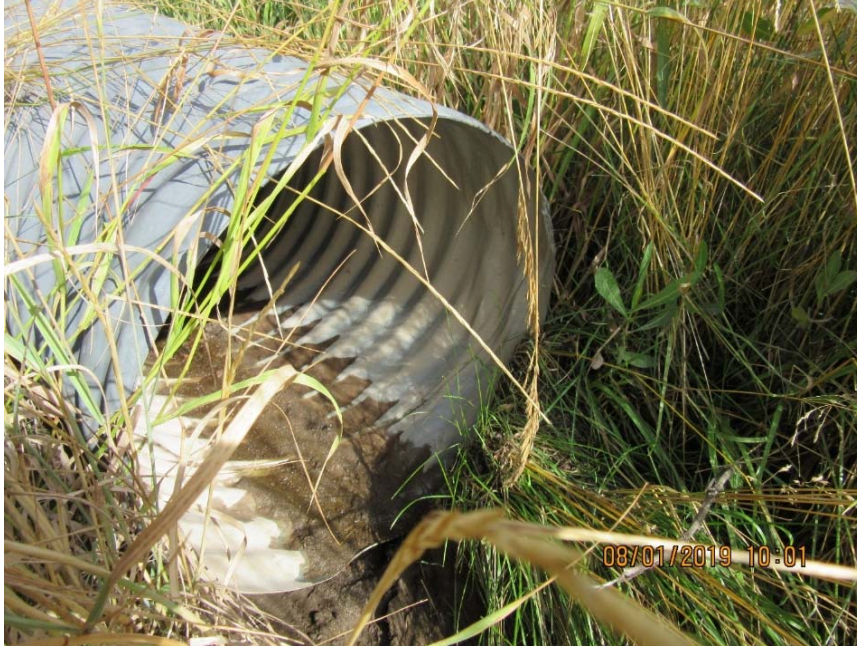
Photo C-4.10-2 Flow event inspection for July 26, 2019, storm event—weir outlet. Vegetation well established in gabion basket at outlet and blocks channelization noted in previous inspections from view. Sounds of continuous low flow not heard. Will continue to monitor. Scour hole developed downstream of apron at outlet. No significant change since last inspection. Recommend replacement of riprap to cover exposed filter fabric and protect undercut bank downgradient of pond culvert outlet.

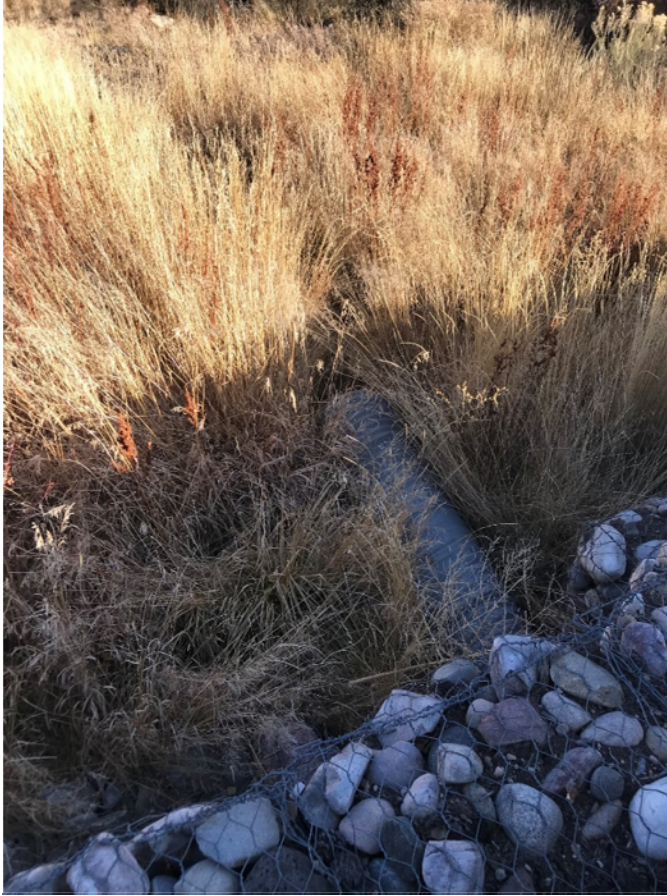
Photo C-4.10-3 November 2019—weir outlet. Erosion occurring in sediments deposited on top of gabion mattress. Erosion is resolved before end of gabion mattress apron. Sediment deposits on top of gabion mattress apron are approximately 1 in. below bottom of outlet invert.

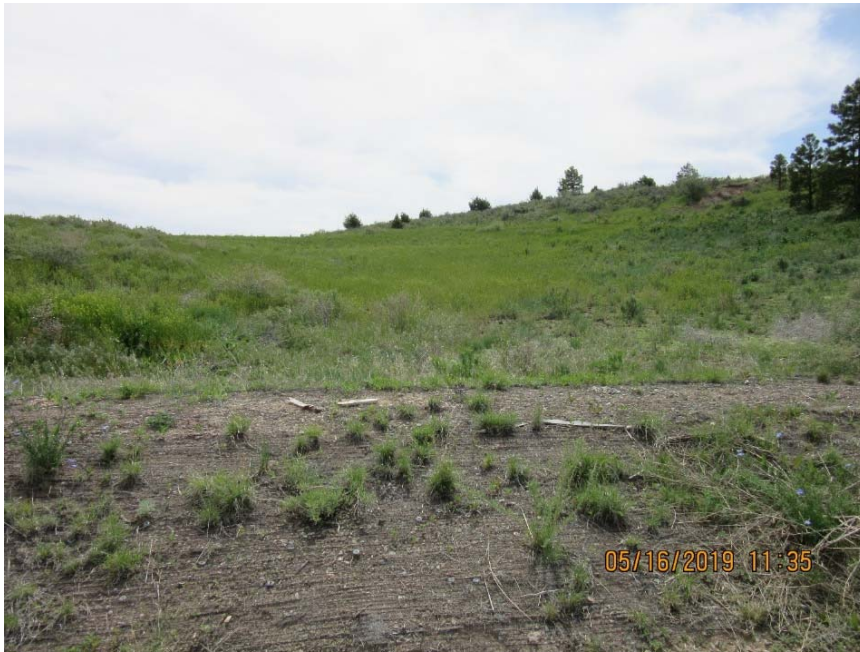
Photo C-4.11-1 May 2019—borrow pit and berm. Minor erosion on upper end of borrow pit. Vegetation well established.

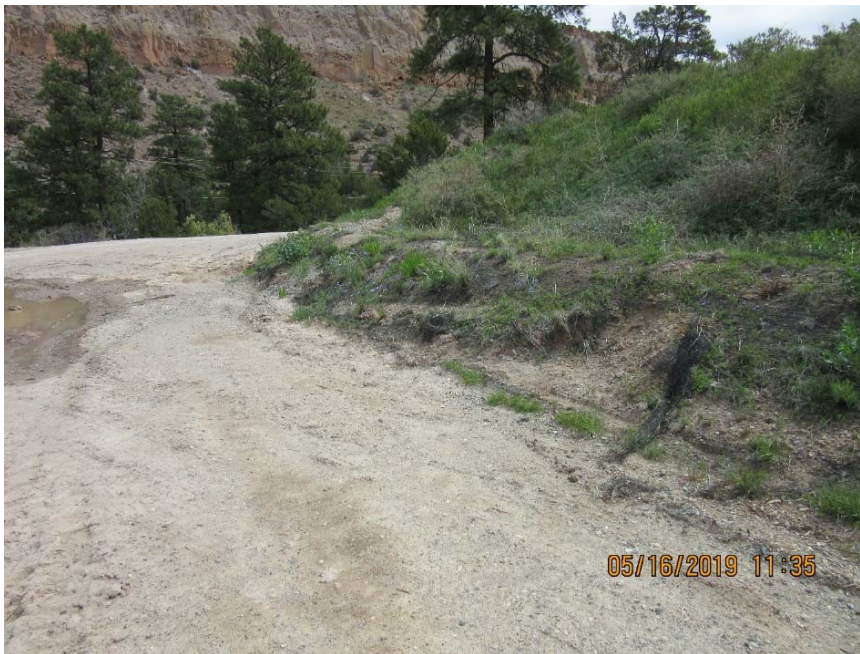
Photo C-4.11-2 May 2019—Berm and TRM damage (north end) occurred during nearby Los Alamos County well construction. If additional sediment is brought in, the recommendation is to increase the entire berm height.

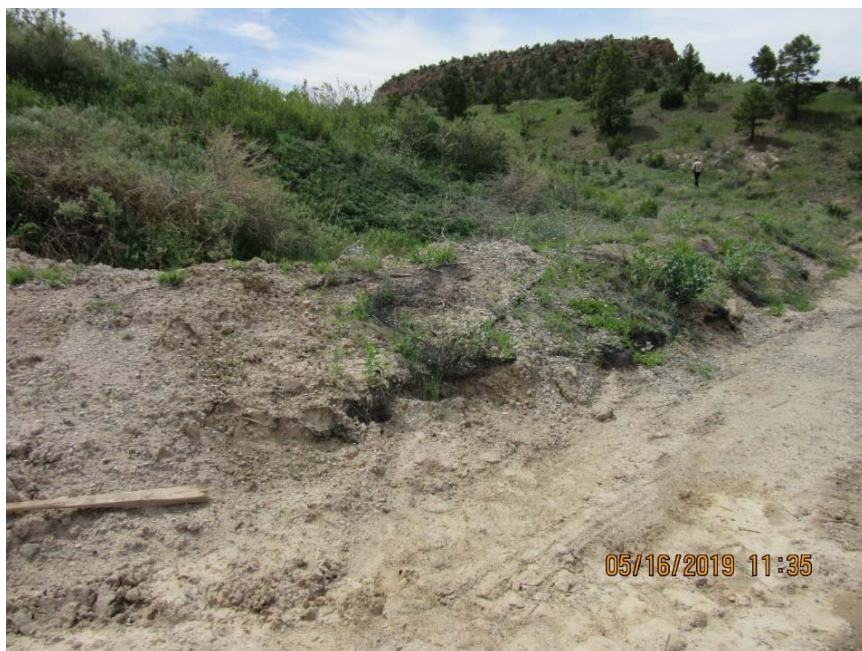
Photo C-4.11-3 May 2019—Berm and TRM damage (north end) occurred during nearby Los Alamos County well construction. If additional sediment is brought in, the recommendation is to increase the entire berm height.

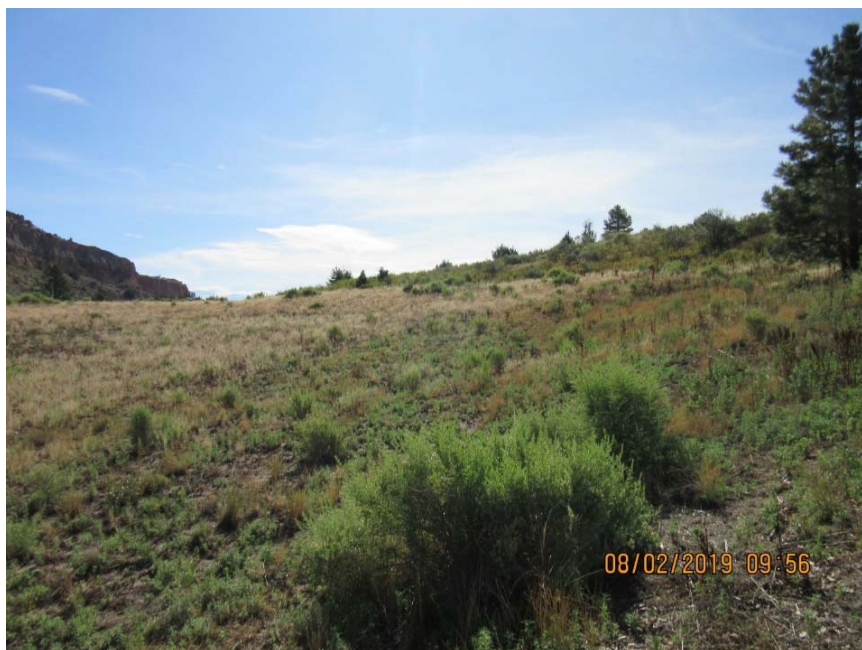
Photo C-4.11-4 Flow event inspection for July 26, 2019, storm event—borrow pit. Vegetation is 60% established. Minor rilling (1–2 areas) in the upper area where sediments from the Los Alamos weir were previously placed. Minor rilling ends within the upper third of the sediment placement area. No significant change in the large undercut area encountered upgradient of the area where sediments from the Los Alamos weir were previously placed (noted in previous inspections).

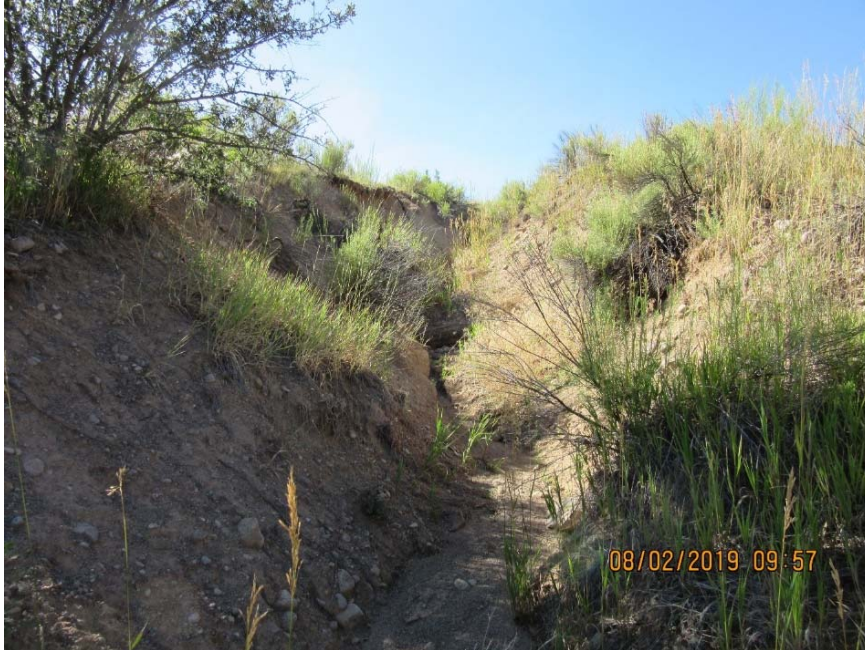
Photo C-4.11-5 Flow event inspection for July 26, 2019, storm event—borrow pit. Channelization is stabilized upstream of a log in the large undercut area. Will continue to monitor. Berm and TRM damage noted at north end of the berm. Damage occurred during nearby Los Alamos County well construction. Recommend discussion with Los Alamos County to repair berm and TRM damage. Filter fabric exposed and detached downstream of the berm on the south end. Recommend filter fabric restapling and then covering with base course.

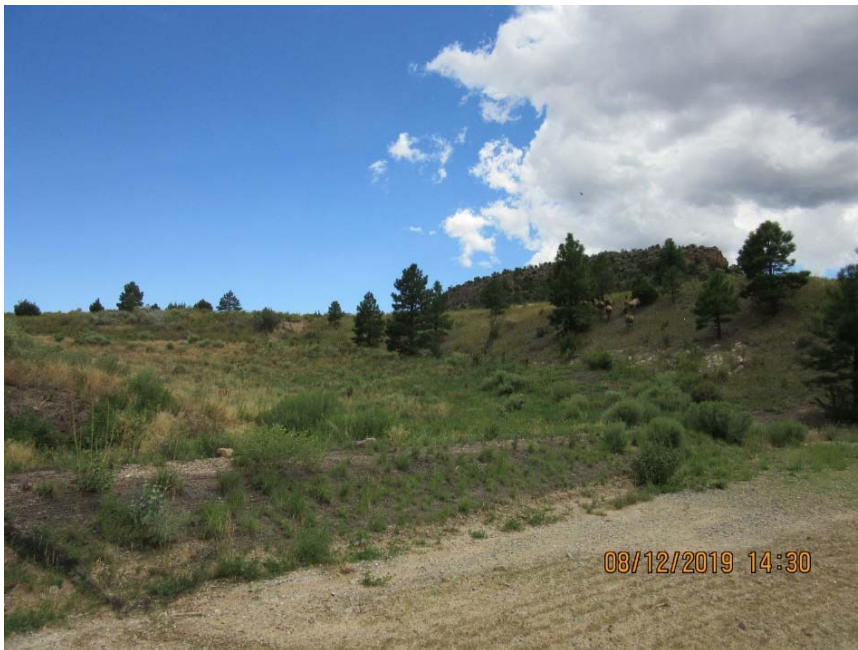
Photo C-4.11-6 Flow event inspection for August 7, 2019, storm event—borrow pit. Vegetation is well established.

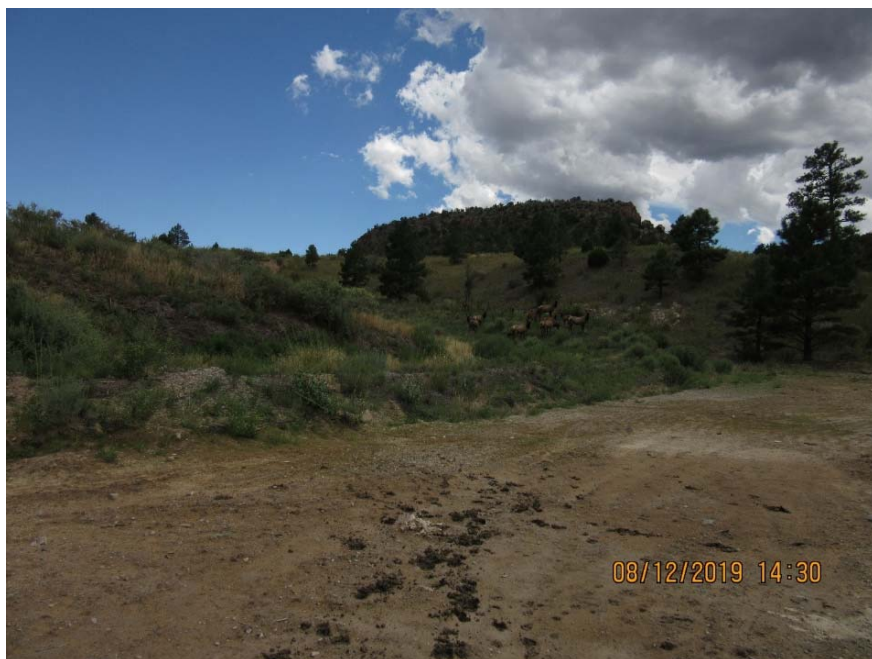
Photo C-4.11-7 Flow event inspection for August 7, 2019, storm event—borrow pit. Herd of elk encountered at borrow pit. Berm and TRM damage on north end of berm due to Los Alamos County well construction. Recommend coordination of berm and TRM repair with Los Alamos County. If additional sediment is brought into the area, recommend increasing the height of the berm.

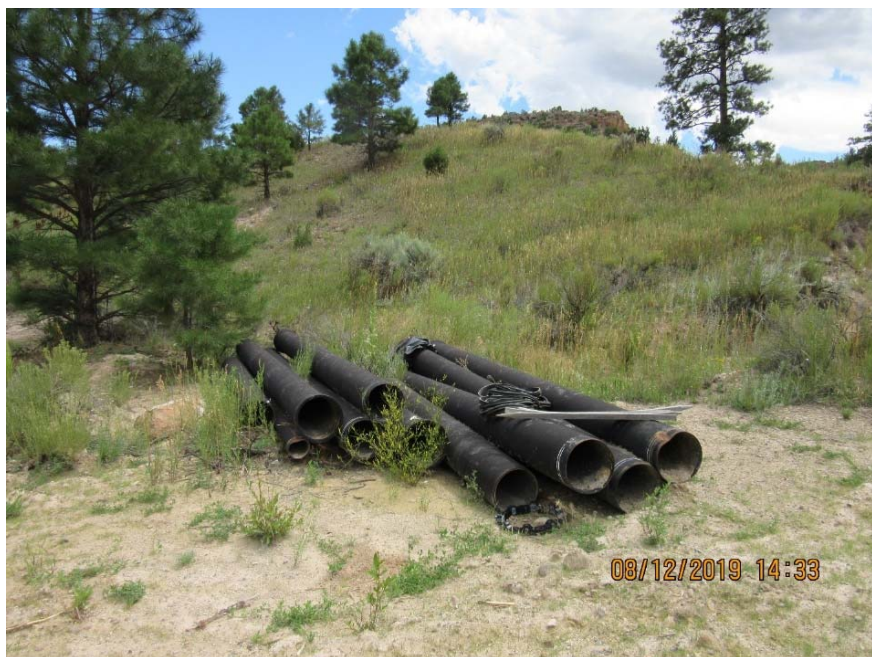
Photo C-4.11-8 Flow event inspection for August 7, 2019, storm event—borrow pit. Los Alamos County well construction materials left on-site downgradient of the berm. Recommend coordination of material removal/disposal with Los Alamos County.

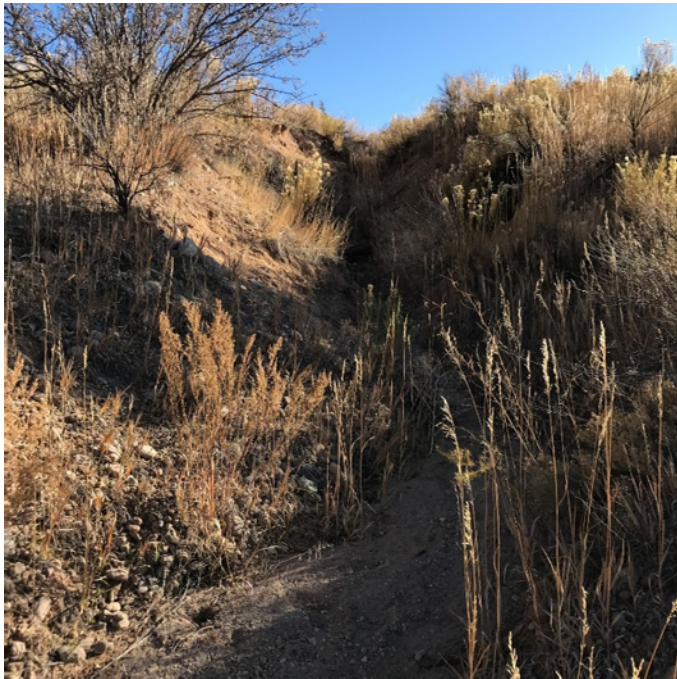
Photo C-4.11-10 November 2019—borrow pit. Damage on north end is not resolved by Los Alamos County. Recommend notification to Los Alamos County to have berm and TRM damage repaired.

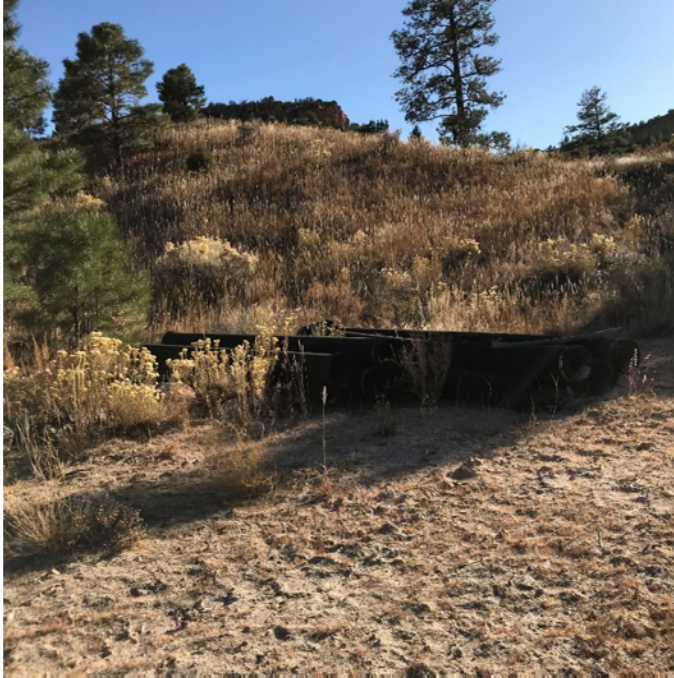
Photo C-4.11-11 November 2019—borrow pit. Construction materials from Los Alamos County well project. Recommend request be sent to Los Alamos County for removal of materials downstream of the borrow-pit berm.

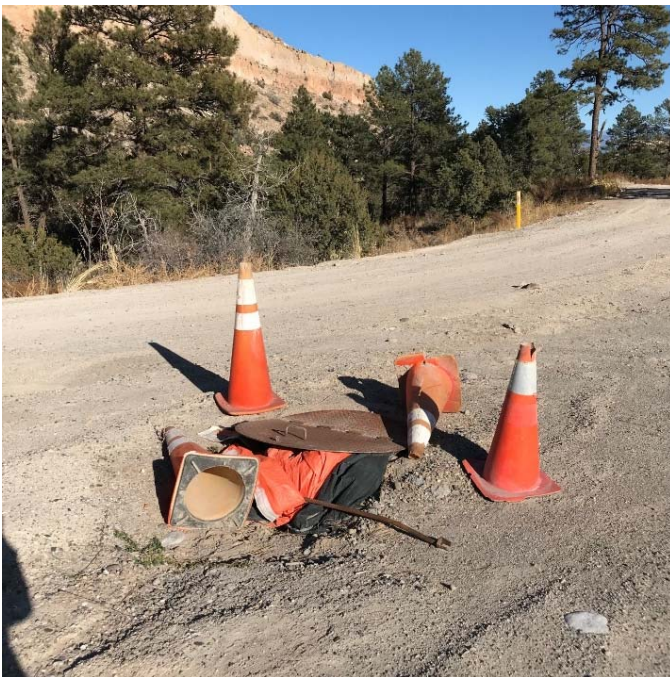
Photo C-4.11-12 November 2019—borrow pit. Construction materials from Los Alamos County well project. Recommend request be sent to Los Alamos County for removal of materials downstream of the borrow-pit berm.

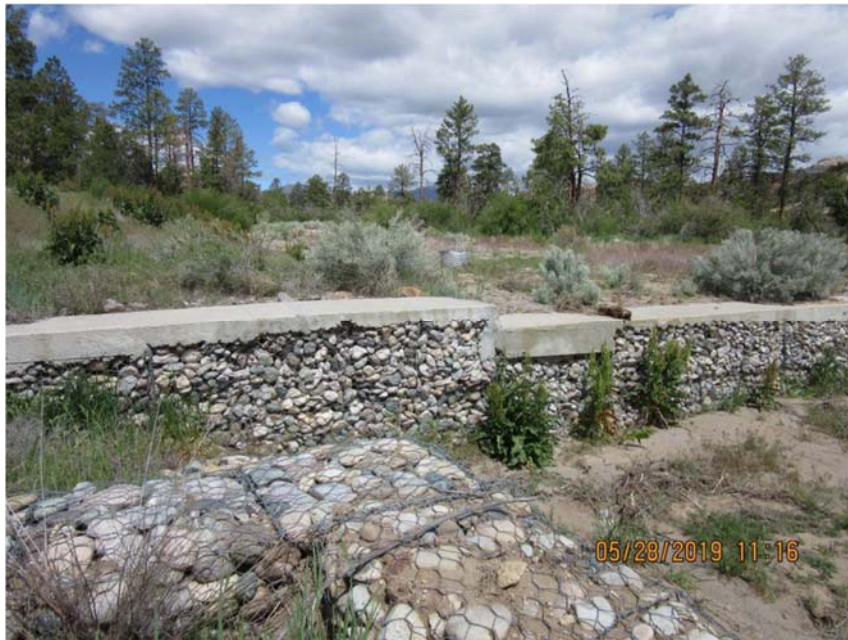
Photo C-5.1-1 May 2019—south embankment, looking west. Well-established vegetation on embankment. No signs of erosion or undermining.

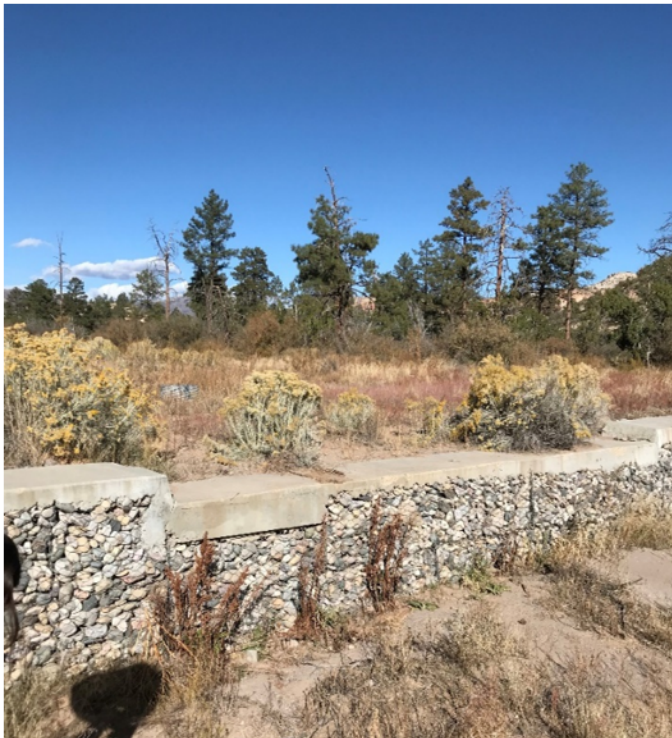
Photo C-5.1-2 October 2019—south embankment, looking west. Well-established vegetation on embankment. No signs of erosion or undermining.

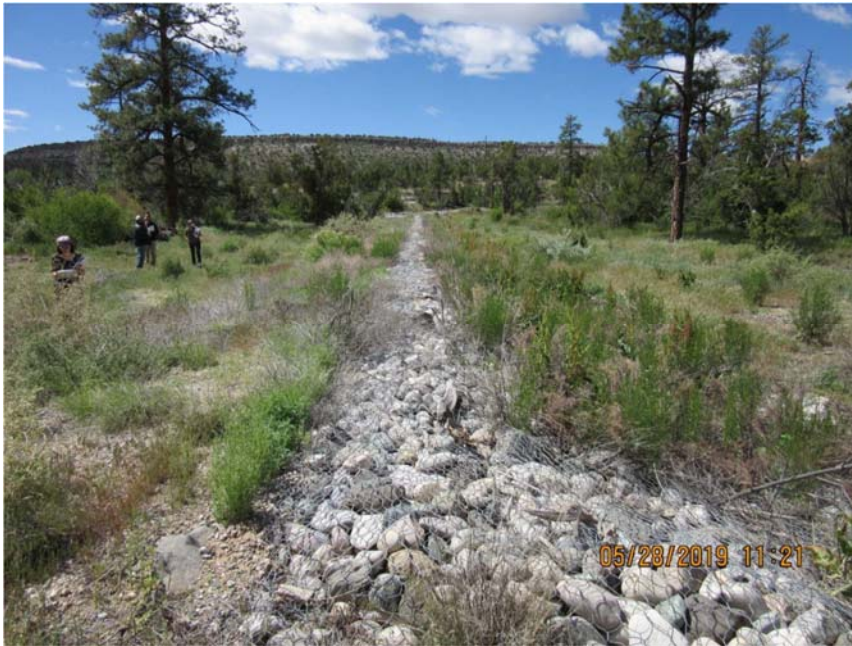
Photo C-5.2-1 May 2019—embankment abutment from north side of channel, looking south. Well-established vegetation surrounding control. No presence of trash/debris.

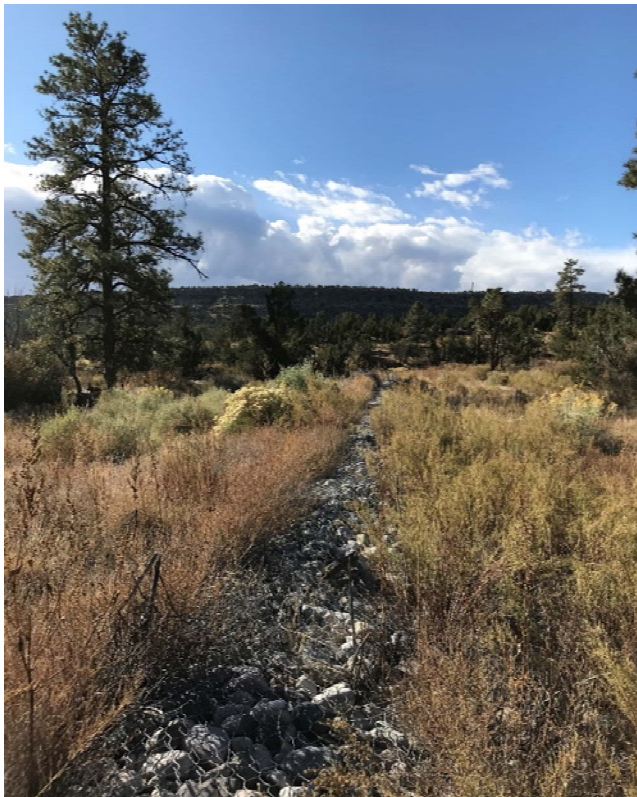
Photo C-5.2-2 October 2019—embankment abutment from north side of channel, looking south. Well-established vegetation surrounding control. No presence of trash/debris.
