Subject: Submittal of the 2019 Monitoring Report for Los Alamos/Pueblo Watershed Sediment Transport Mitigation Project

1. Two hard copies with electronic files – 2019 Monitoring Report for Los Alamos/Pueblo Watershed Sediment Transport Mitigation Project (EM2020-0019)

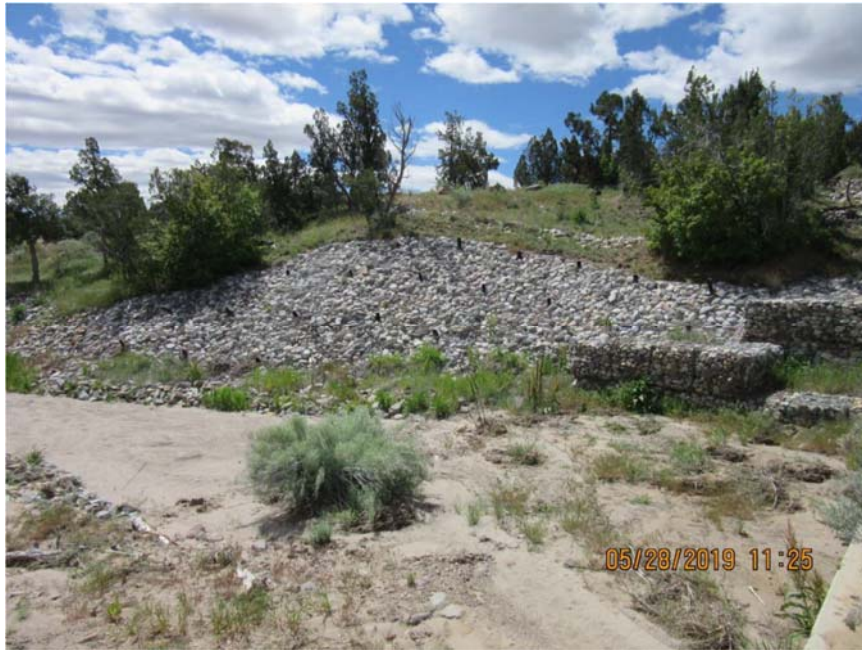
Photo C-5.3-1 May 2019—downstream south embankment and scour-stop, looking south. Control is operating as designed. No buckling of embankment occurring. Riprap functioning as designed. Vegetation established and no evidence of erosion. Minor rodent burrows. Will continue to monitor.

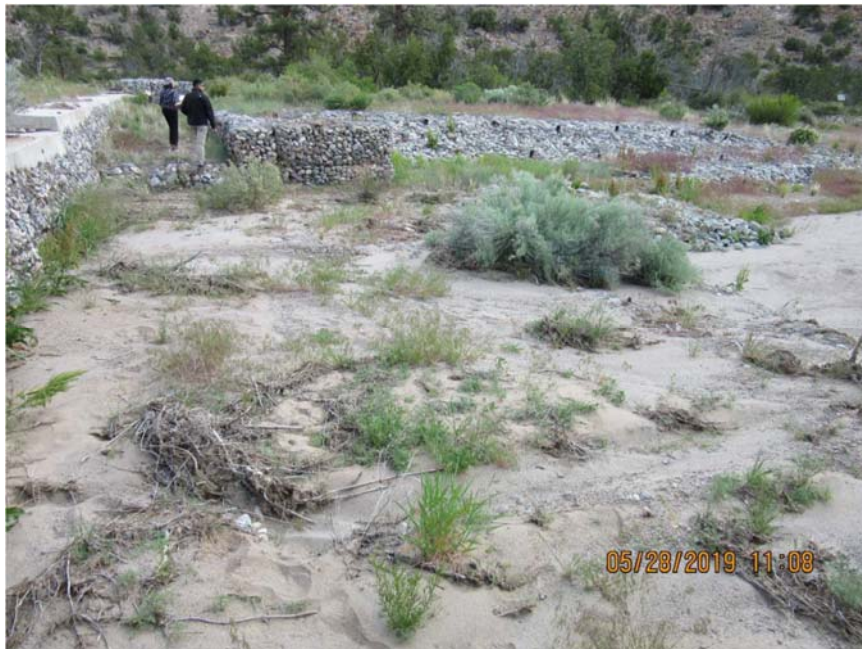
Photo C-5.3-2 May 2019—downstream north embankment and scour-stop, looking north. Control is operating as designed. No buckling of embankment occurring. Riprap functioning as designed. Vegetation established and no evidence of erosion. Minor rodent burrows. Will continue to monitor.

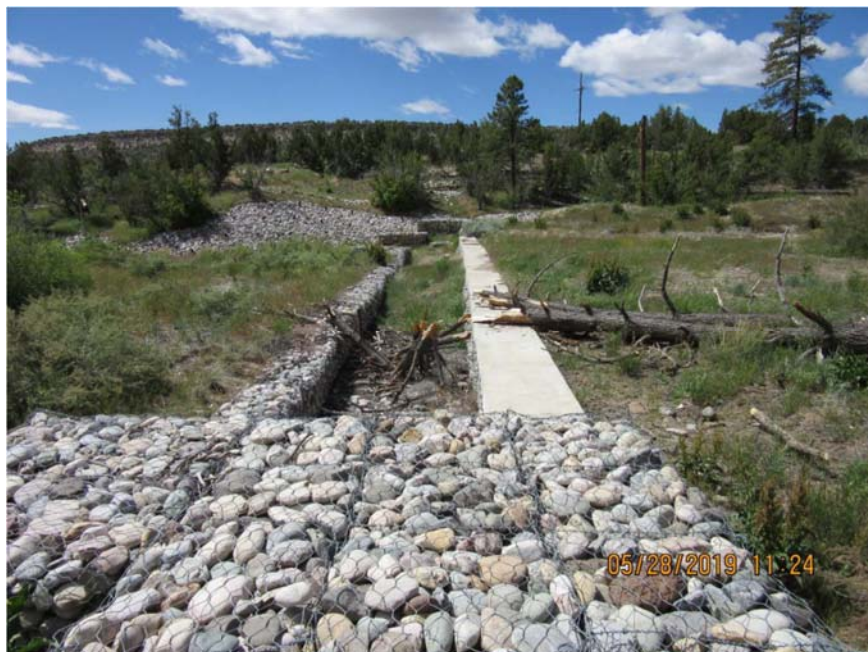
Photo C-5.4-1 May 2019—weir crest and flow-way, looking south. Cracks in concrete are apparent where overflow weir intersects the spillway (both corners of the spillway). Alignment is fine. There appears to be a twisting of the overflow concrete weir and spillway crests as a result of gabion movement/settling. Will continue to monitor.

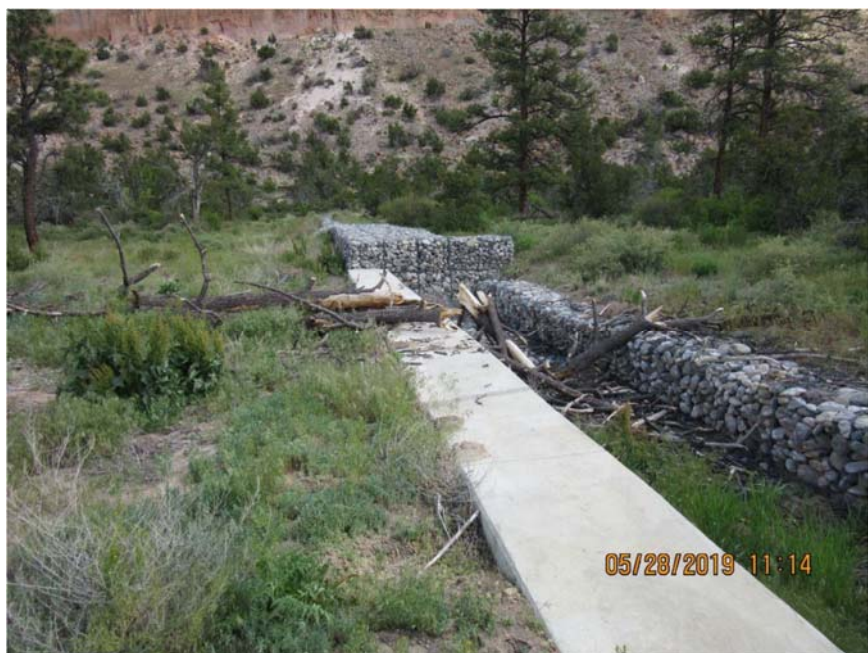
Photo C-5.4-2 May 2019—weir crest and flow-way, looking north. A tree has fallen over the overflow weir structure. Recommend removal of the tree. Bulging gabions and minor cracks present. Gabion wiring has failed in one location and created a hole approximately 1 ft in diameter. Recommend repair.

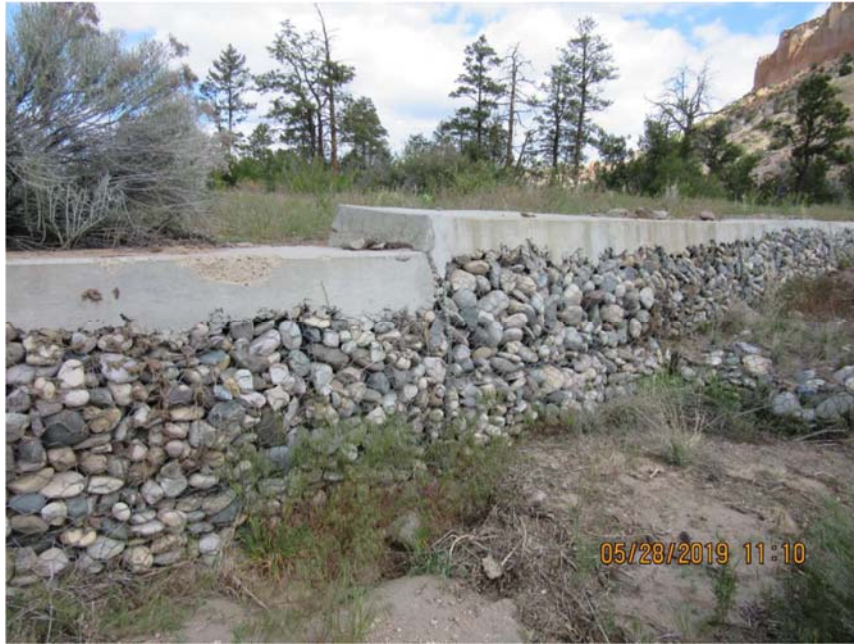
Photo C-5.4-3 May 2019—weir spillway and flow-way, looking west. Minor spalling/chipping of concrete on downstream side of the spillway. Will continue to monitor.

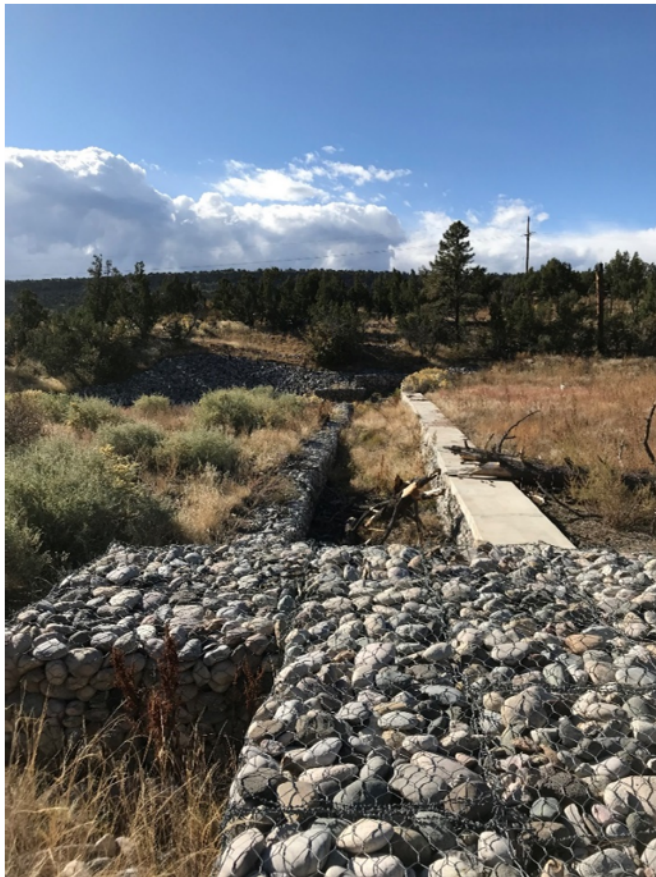
Photo C-5.4-4 October 2019—weir crest and flow-way, looking south. Recommend relocation of fallen tree.

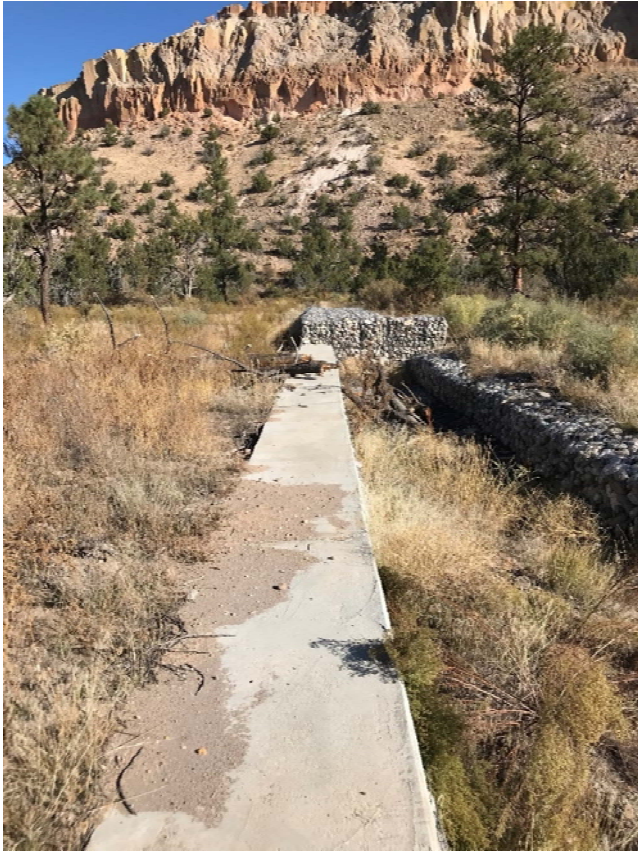
Photo C-5.4-5 October 2019—weir crest and flow-way, looking north

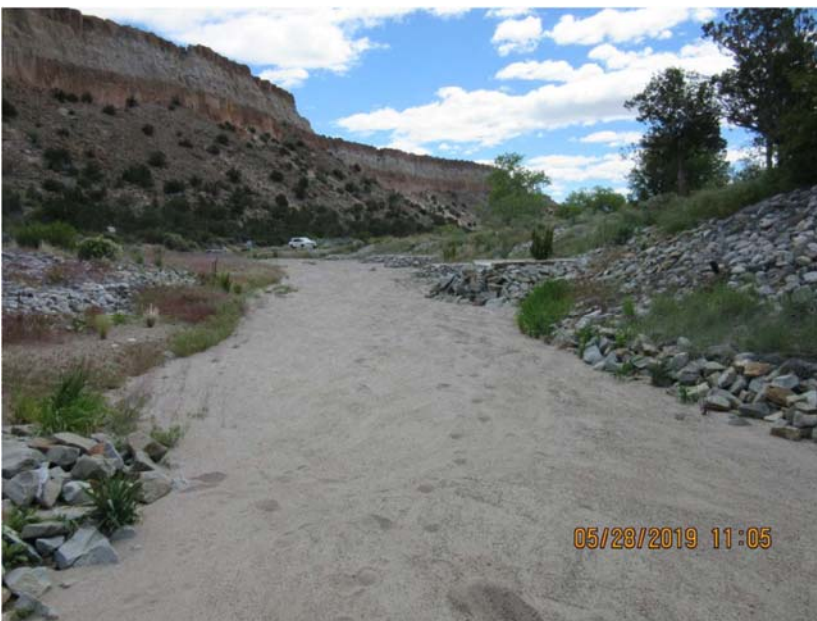
Photo C-5.5-1 May 2019—Redi-Rock spurs, looking east. Well-established vegetation along all hillslopes. No erosion apparent along slopes or near TRM. All structures functioning as designed.

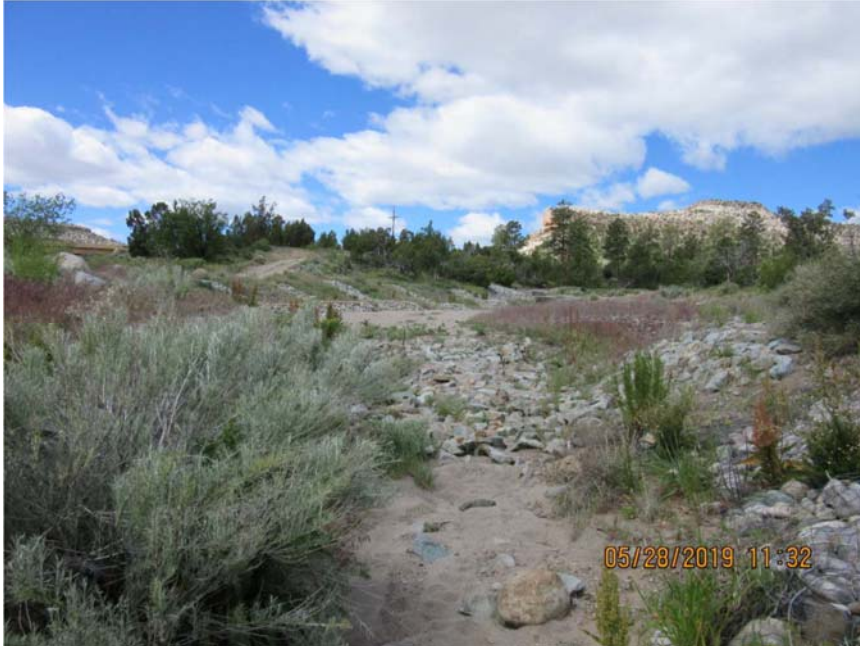
Photo C-5.5-2 May 2019—Redi-Rock spurs, looking west. Medium size (12-in. nominal diameter) rocks deposited upstream of flow gage. Will continue to monitor.

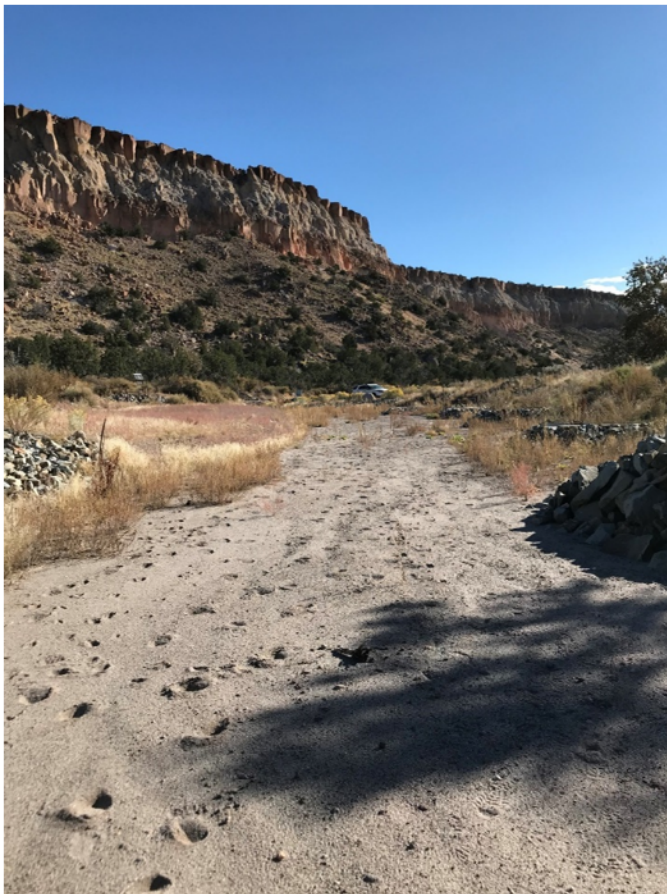
Photo C-5.5-3 October 2019—Redi-Rock spurs, looking east

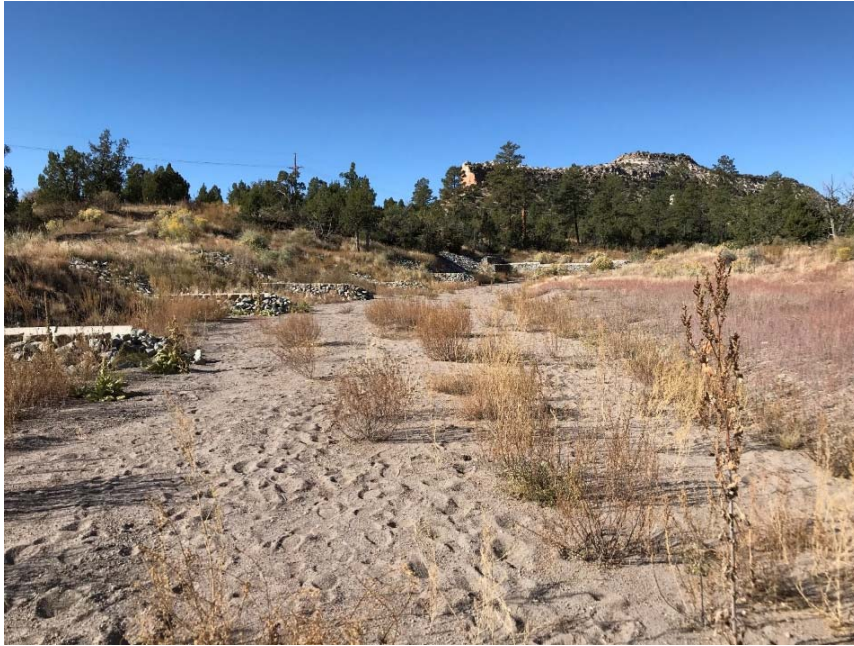
Photo C-5.5-4 **October 2019—Redi-Rock spurs, looking west**

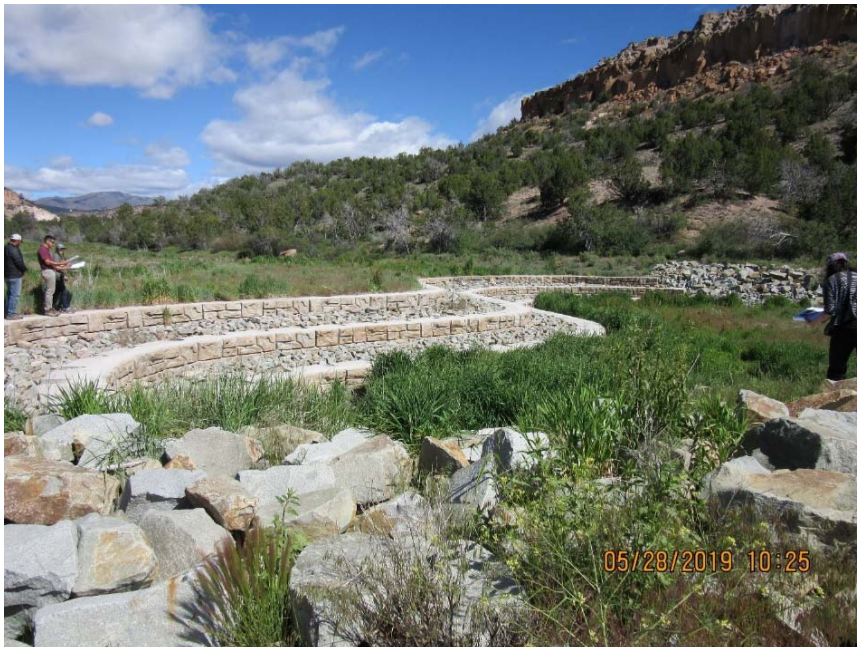
Photo C-6.1-1 **May 2019—Redi-Rock block structure, looking north. Redi-Rock structure shows no evidence of displacement or settling. Vegetation well established.**

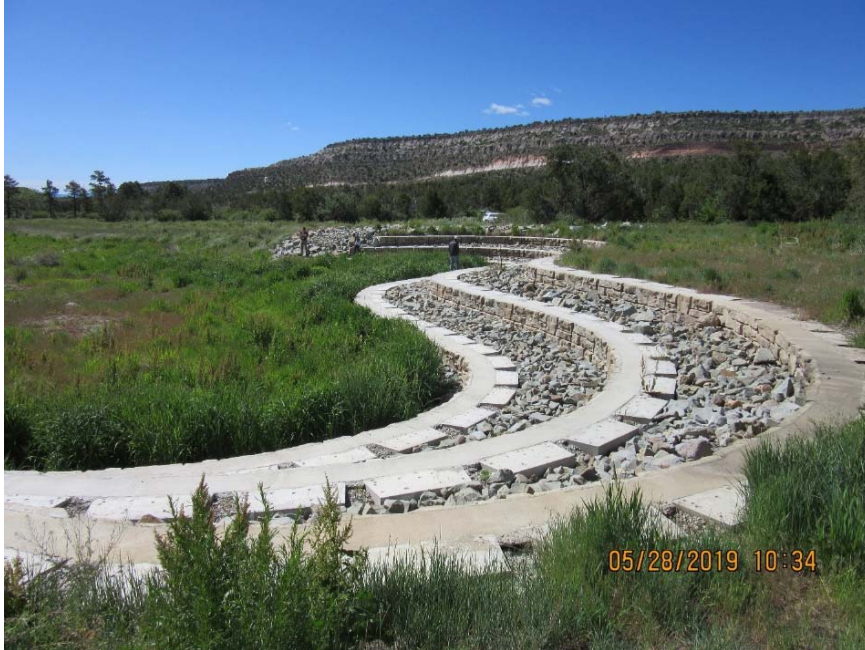
Photo C-6.1-2 May 2019—Redi-Rock block structure, looking southeast. Redi-Rock structure shows no evidence of displacement or settling. Vegetation well established.

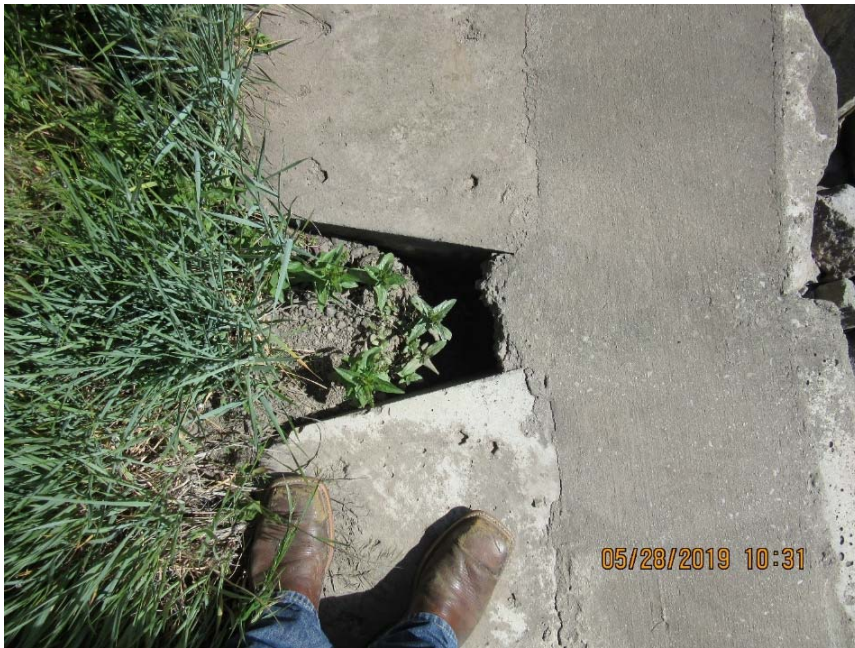
Photo C-6.1-3 May 2019—Redi-Rock block structure. Preferential flow path located mid-upper level. The crushed stone placed in the void space between block 13 and 14 (as counted from north end of structure) washed out. Will continue to monitor.

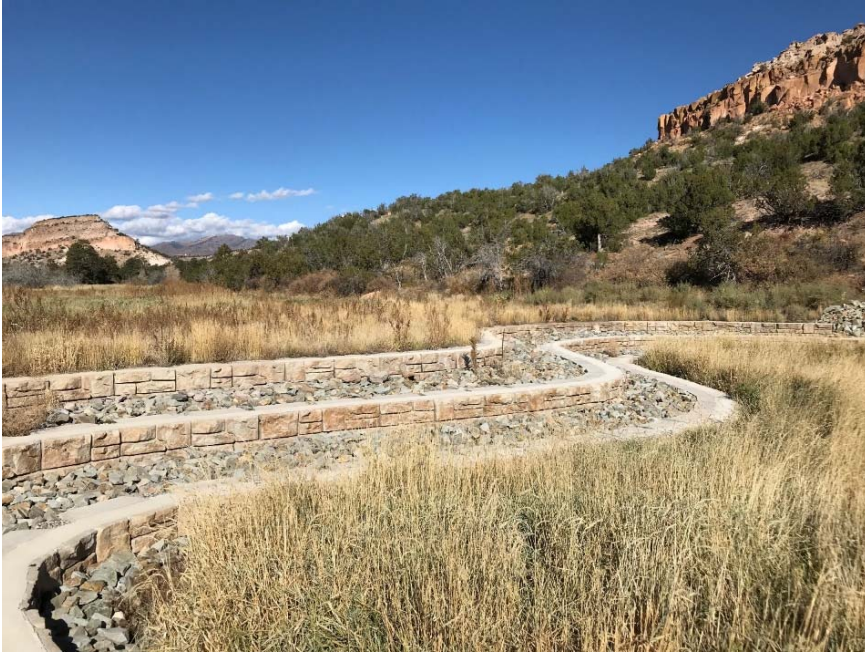
Photo C-6.1-4 October 2019—Redi-Rock block structure, looking north. No deficiency found.

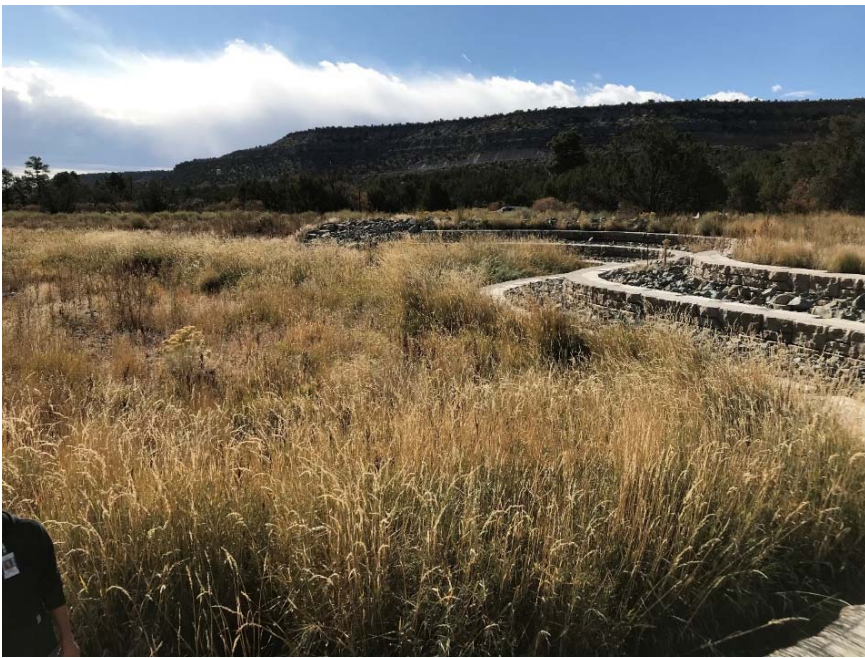
Photo C-6.1-5 October 2019—Redi-Rock block structure, looking southeast. No deficiency found.

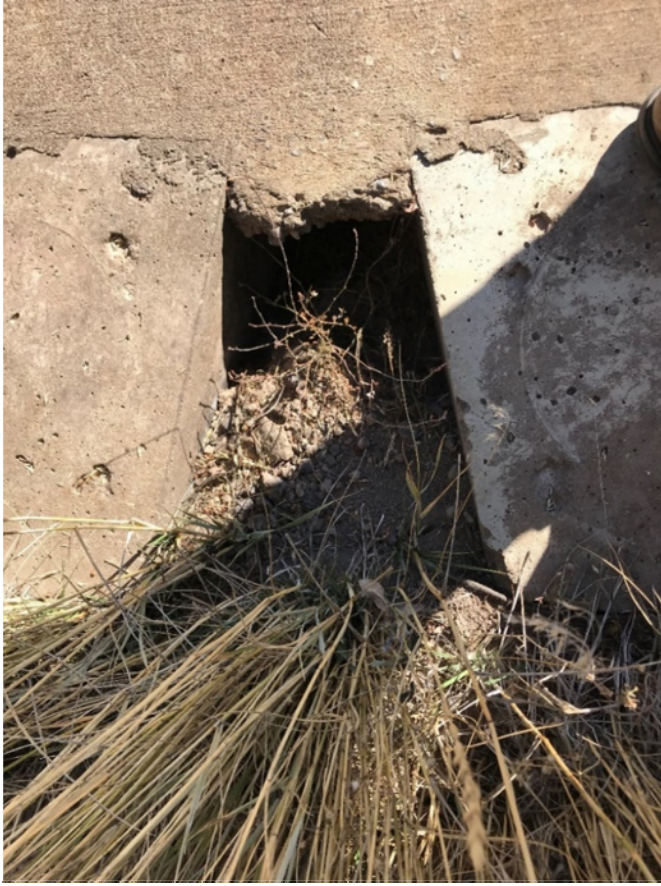
Photo C-6.1-6 **October 2019—Redi-Rock block structure. Note preferential flow path. Recommend fill of void with a large gradation gravel.**

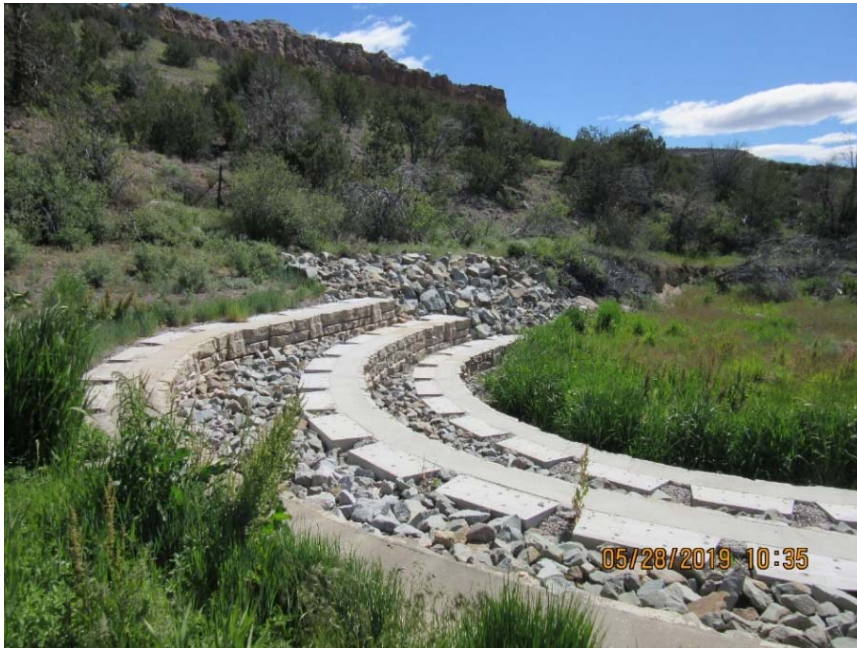
Photo C-6.2-1 May 2019—wetland north bank, looking northeast. Slope is stable with no evidence of erosion where riprap is located. Structure is functioning as designed with established vegetation.

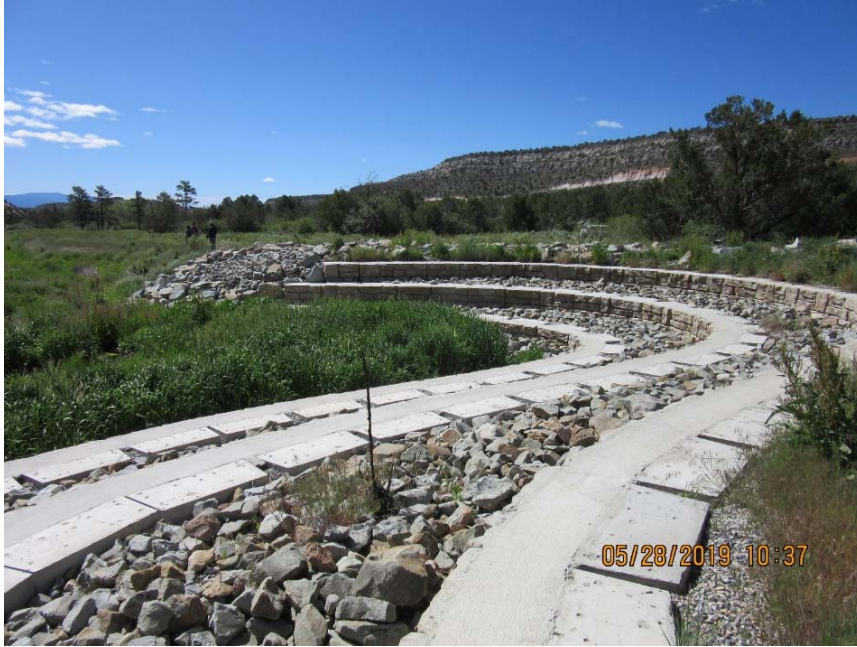
Photo C-6.3-1 May 2019—south bank, looking southeast. Structure is functioning as designed with established vegetation.

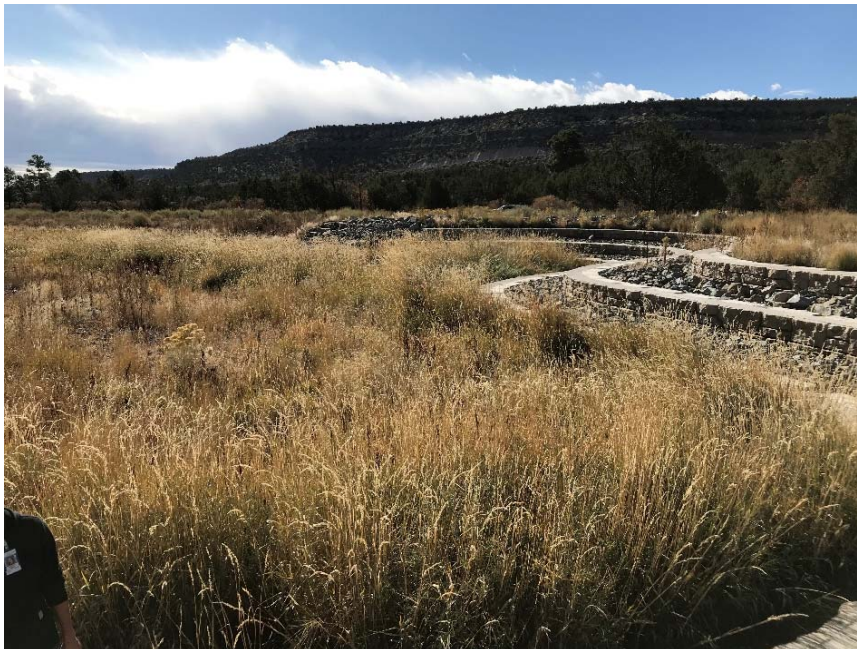
Photo C-6.3-2 October 2019—south bank, looking southeast. Structure is functioning as designed with established vegetation.

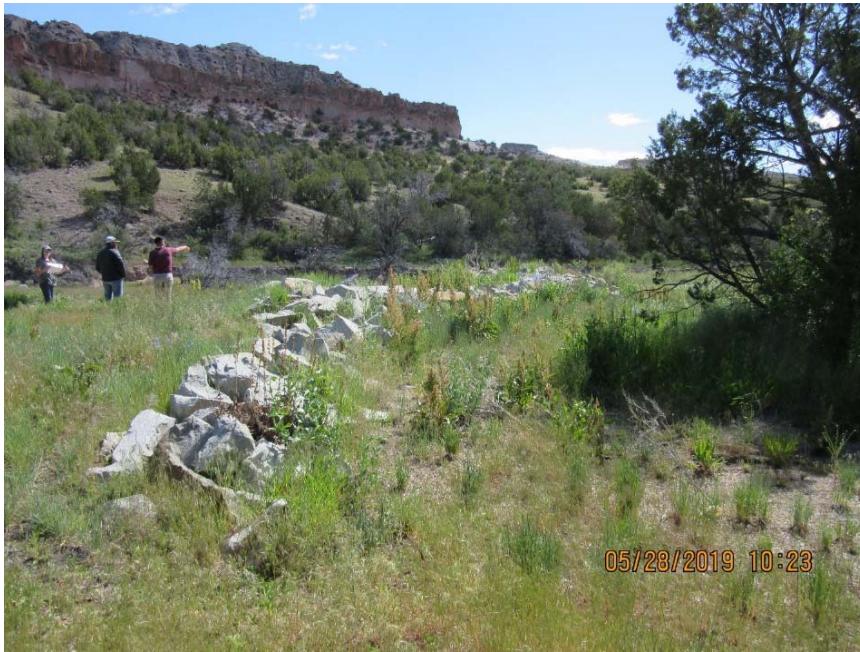
Photo C-6.4-1 May 2019—south-bank berm, looking northeast. Berm is stable; no noted erosion or breaching/slides/cracks to berm.

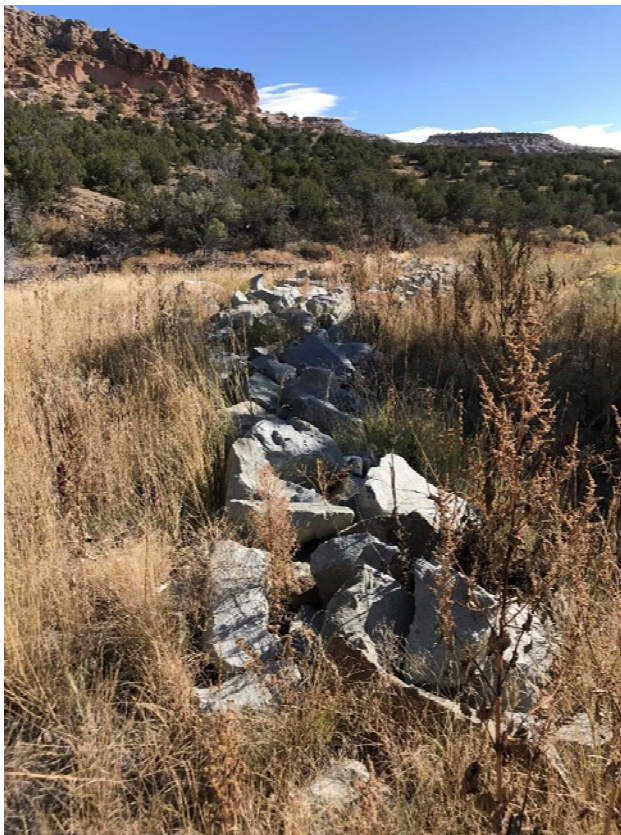
Photo C-6.4-2 October 2019—south-bank berm, looking northeast. Berm is stable; no noted erosion or breaching/slides/cracks to berm.

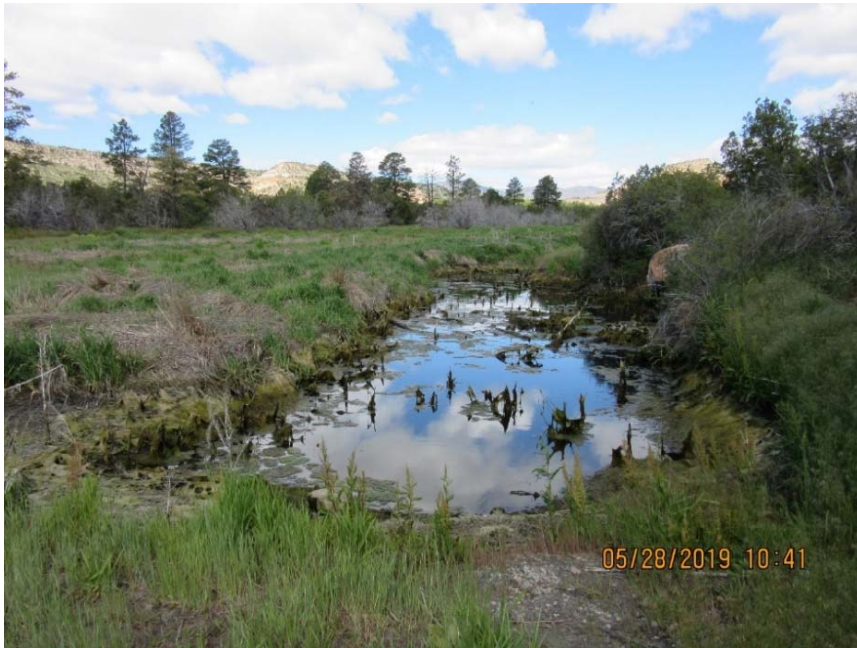
Photo C-6.5-1 May 2019—upstream pond, looking upstream. Water present in pond. There is capacity for additional sediment accumulation.

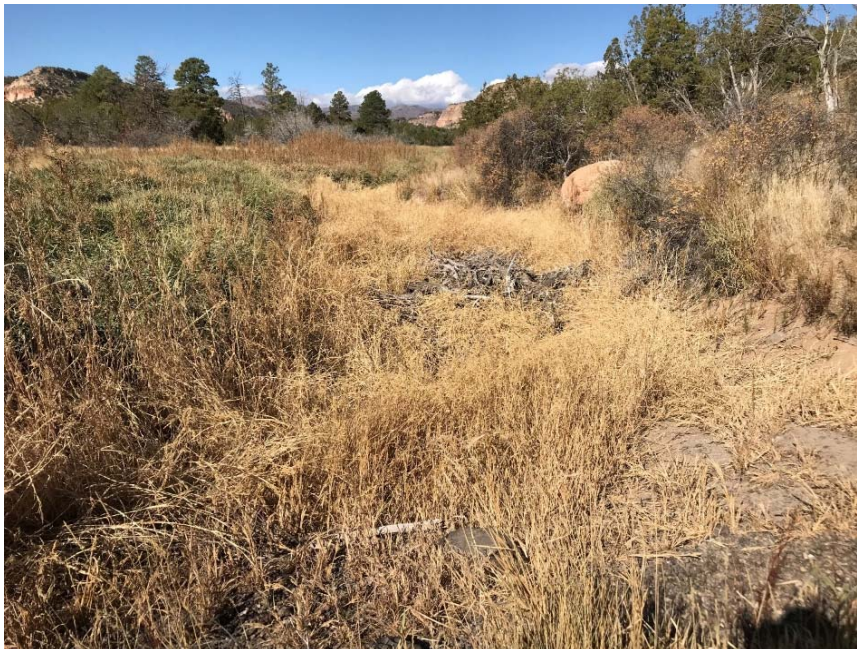
Photo C-6.5-2 October 2019—upstream pond, looking upstream. Pond is dry. TRM is covered with sediment. Pond has approximately 1-ft depth for accumulation of sediment.
