EMLA-2021-0018-02-001

Subject: Biennial Inspection and Maintenance Report on Erosion Controls in Drainages to the

90s Line Pond at Technical Area 16

Figures for the Biennial Inspection and Maintenance Report on Erosion Controls in Drainages to the 90s Line Pond at Technical Area 16

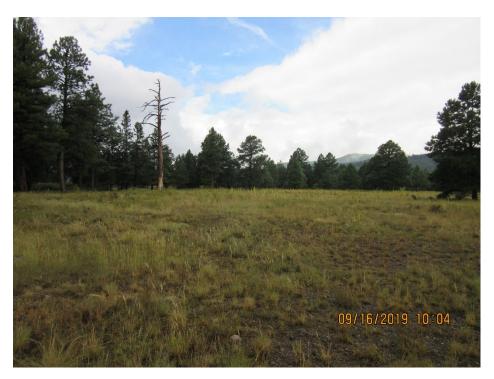
Figure 1 Vegetated Consolidated Unit 16-008(a)-99 draining to 90s Line Pond, September 2019

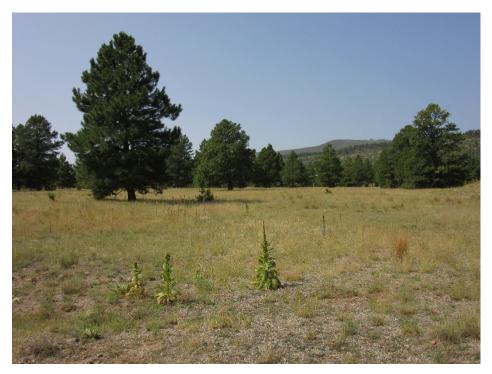
Figure 2 Vegetated Consolidated Unit 16-008(a)-99 draining to 90s Line Pond, September 2020

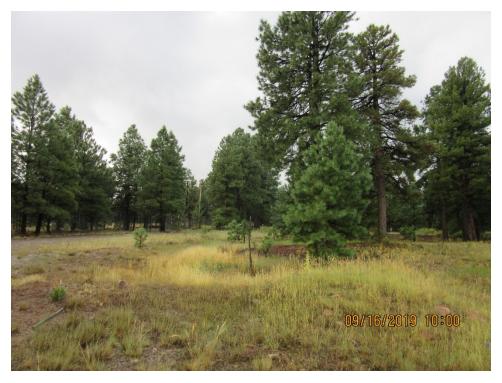
Figure 3 Run-on control earthen berm in the vegetated area draining to 90s Line Pond, September 2019

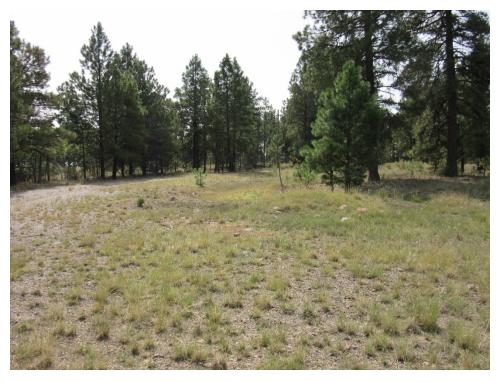
Figure 4 Run-on control earthen berm in the vegetated area draining to 90s Line Pond, September 2020

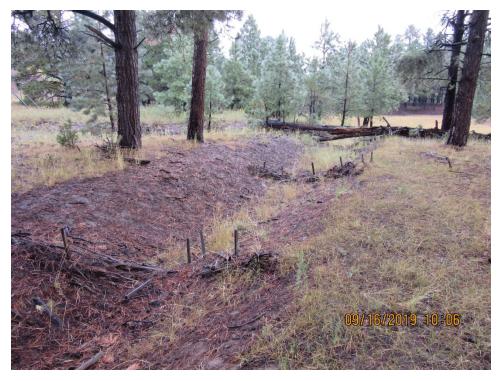
Figure 5 Juniper bale check dams located in drainage channel to 90s Line Pond, September 2019. Note vegetation in channel.

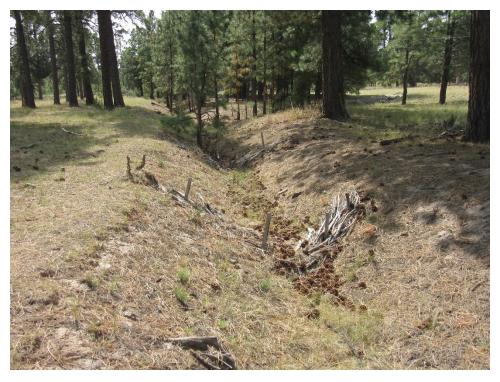
Figure 6 Juniper bale check dams located in drainage channel to 90s Line Pond, September 2020. Note vegetation in channel.

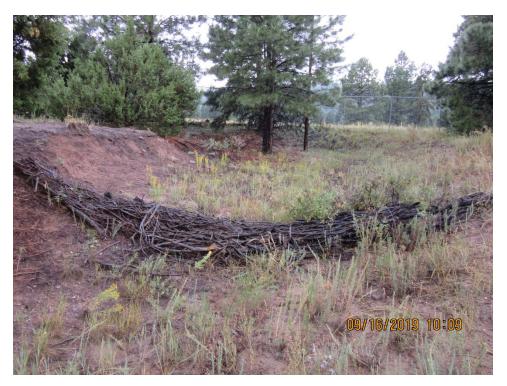
Figure 7 Juniper bale check dam located in drainage channel to 90s Line Pond, September 2019. Note vegetation in channel.

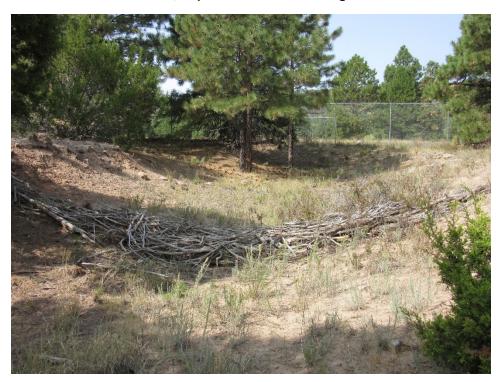
Figure 8 Juniper bale check dam located in drainage channel to 90s Line Pond, September 2020. Note vegetation in channel.

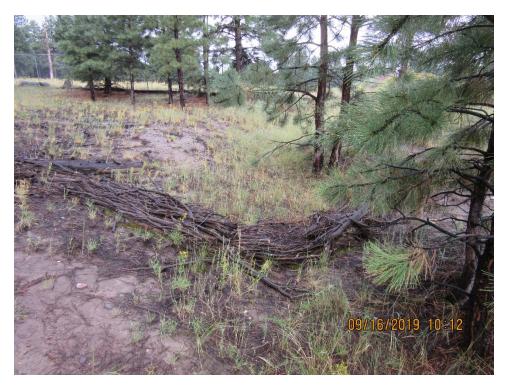
Figure 9 Juniper bale check dam located in drainage channel to 90s Line Pond, September 2019. Note vegetation in channel.

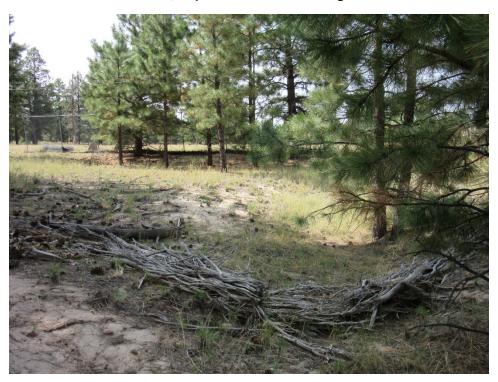
Figure 10 Juniper bale check dam located in drainage channel to 90s Line Pond, September 2020. Note vegetation in channel.

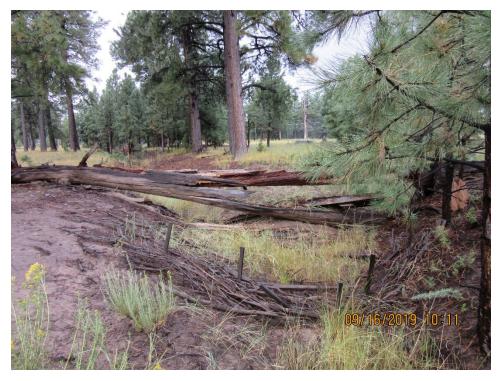
Figure 11 Juniper bale check dam located in drainage channel to 90s Line Pond, September 2019. Note vegetation in channel.

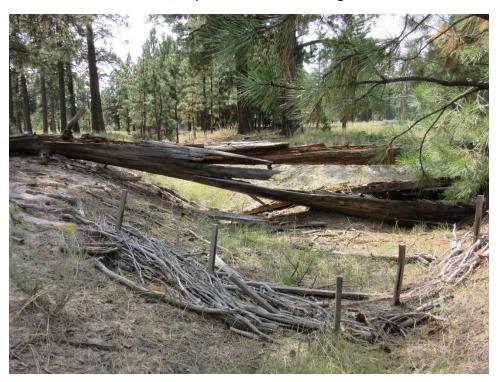
Figure 12 Juniper bale check dam located in drainage channel to 90s Line Pond, September 2020. Note vegetation in channel.

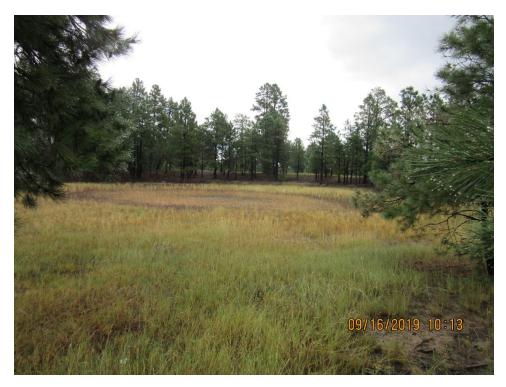
Figure 13 90s Line Pond, September 2019

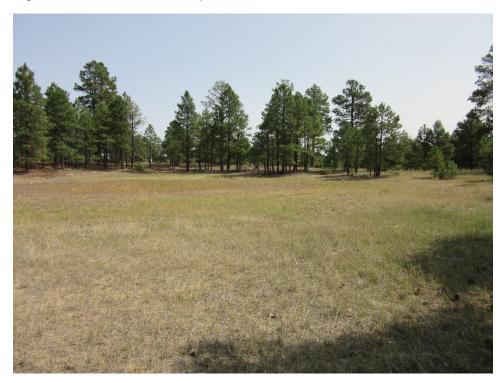
Figure 14 90s Line Pond, September 2020
