EMLA-2022-BF078-02-001

Subject: Submittal of the 2021 Monitoring Report and 2022 Monitoring Plan for
Los Alamos/Pueblo Watershed Sediment Transport Mitigation Project

2021 Monitoring Report and 2022 Monitoring Plan for Los Alamos/Pueblo Watershed Sediment Transport Mitigation Project

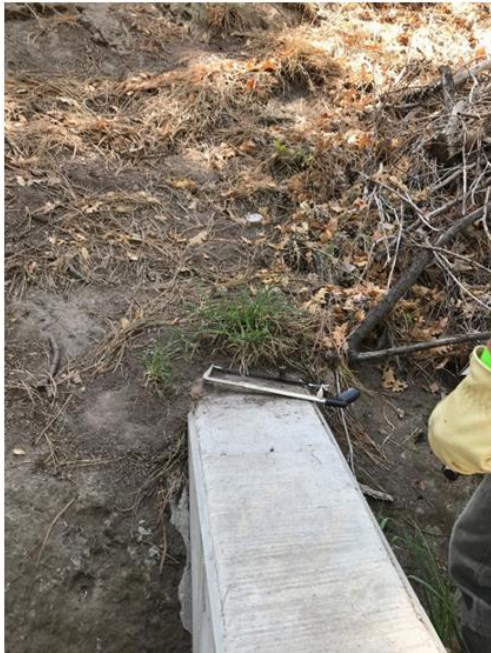
Photo C-3.5-1 May 2021—Rebar noted in earlier inspections has been removed.

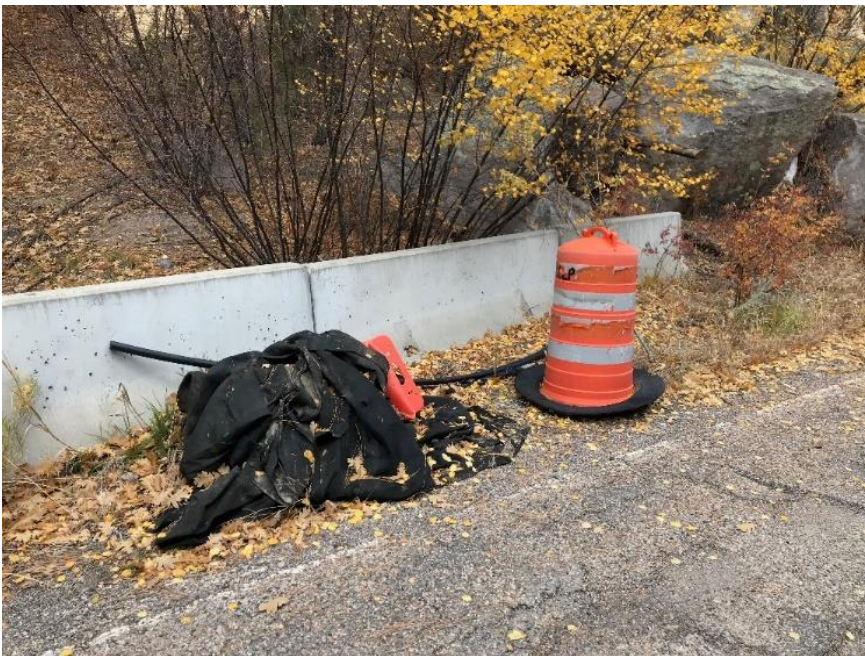
Photo C-3.5-2 October 2021—Recommend trash removal during spring 2022 inspection.

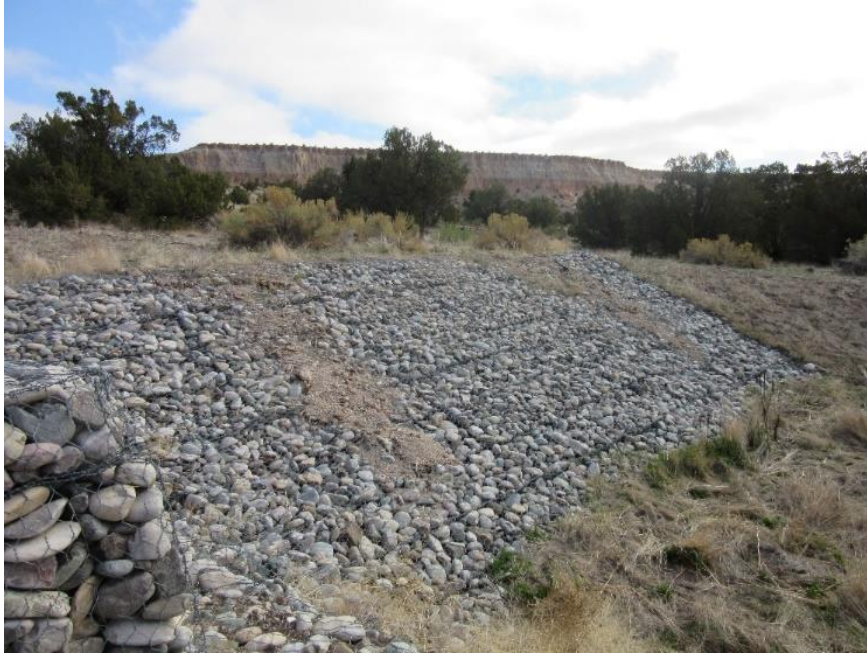
Photo C-4.1-5 **May 2021—Downstream northern embankment, looking east/downstream. Sediment deposited from runoff coming from dirt roads upgradient of the embankment. No action recommended.**

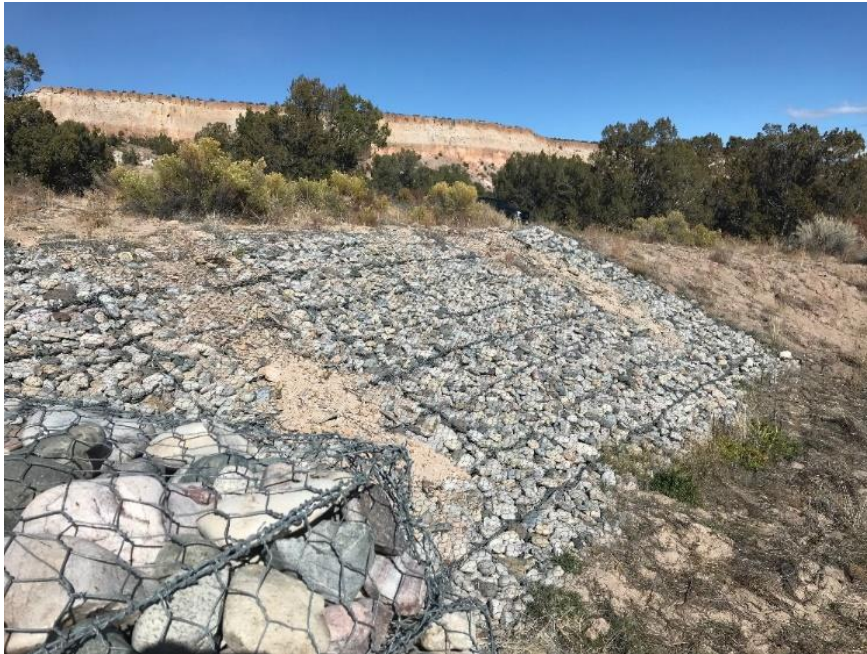
Photo C-4.1-6 **October 2021—Downstream northern embankment, looking east/downstream. Sediment deposited from runoff coming from dirt roads upgradient of the embankment. No action recommended.**

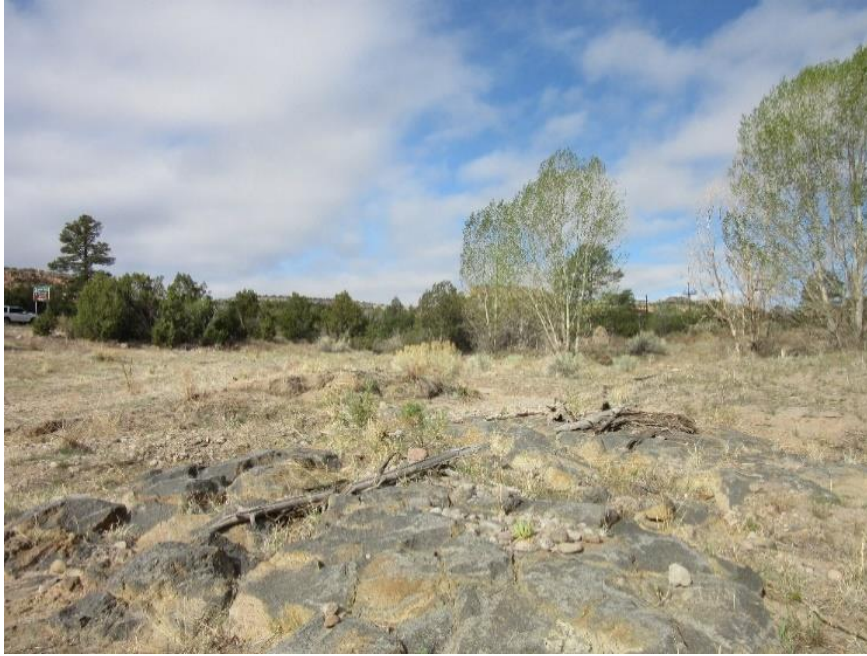
Photo C-4.2-1 May 2021—Upper basin, looking west/upstream. Upper basin has no remaining sediment capacity; the lower basin has significant capacity remaining.

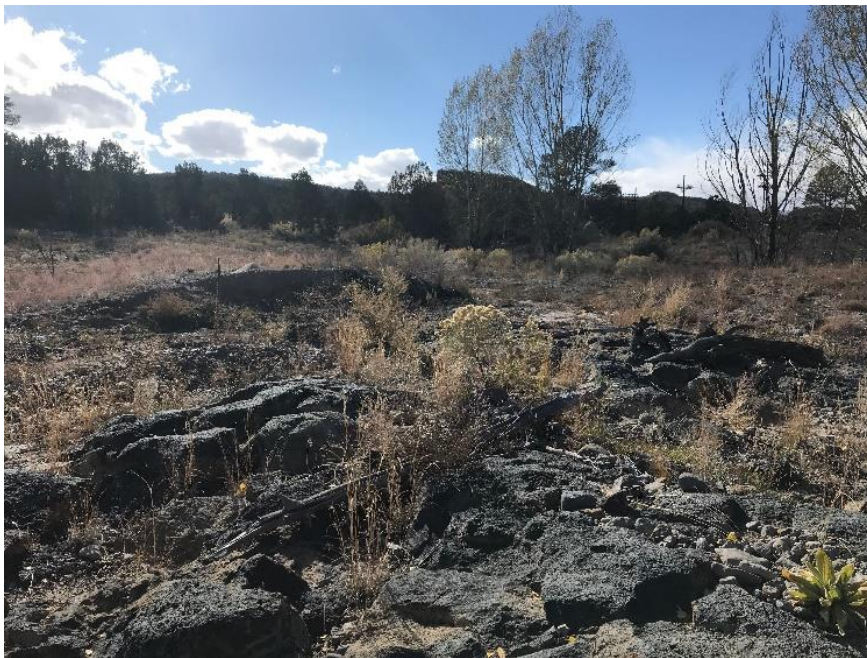
Photo C-4.2-2 October 2021—Upper basin, looking west/upstream. Upper basin has no remaining sediment capacity; the lower basin has significant capacity remaining.

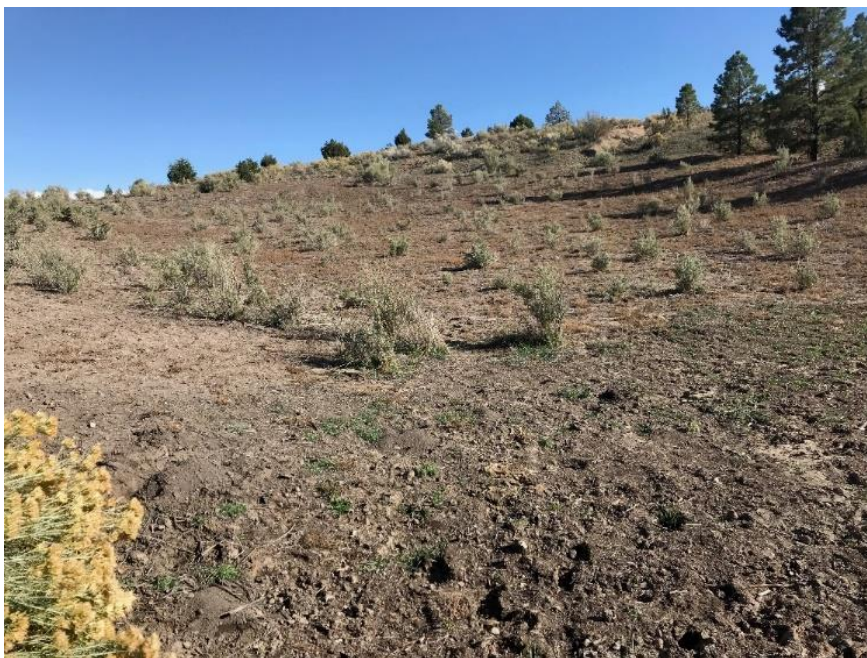
Photo C-4.6-2 October 2021—Borrow pit, looking east. Vegetation has been impacted by feral cows and additional rilling has been noted. Feral cows were removed from the canyon. Continue to monitor.

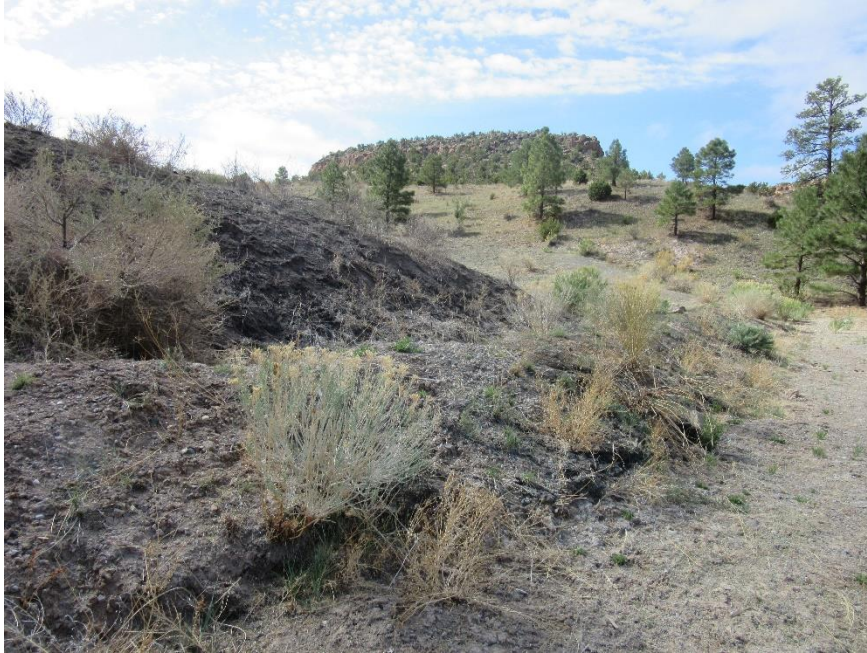
Photo C-4.6-3 **May 2021—Borrow pit runoff retention berm. Berm has been impacted by recent Los Alamos County well construction activities. Berm is still functioning and stable, no action recommended. Continue to monitor.**

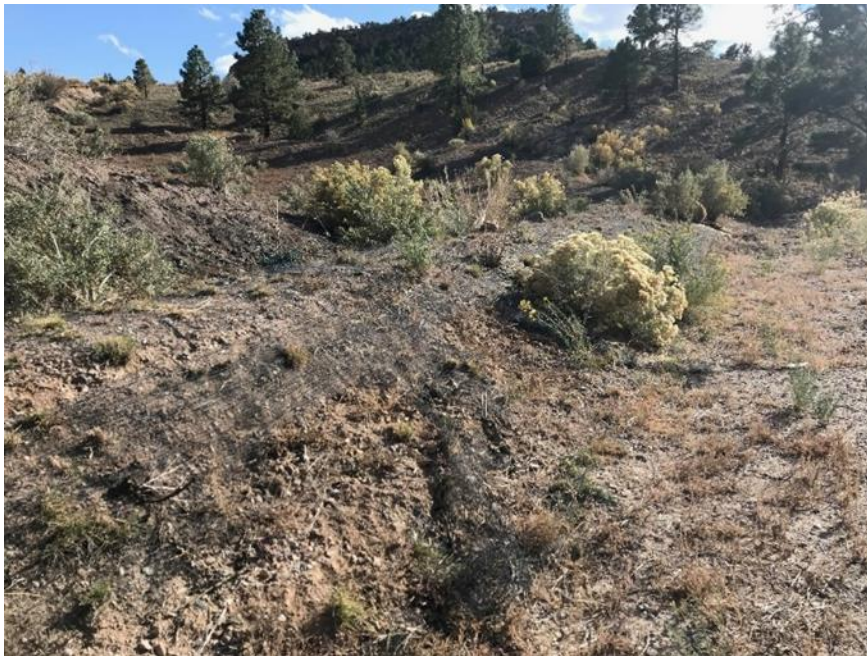
Photo C-4.6-4 **October 2021—Borrow pit runoff retention berm. Berm has been impacted by recent Los Alamos County well construction activities. Berm is still functioning and stable, no action recommended. Continue to monitor.**

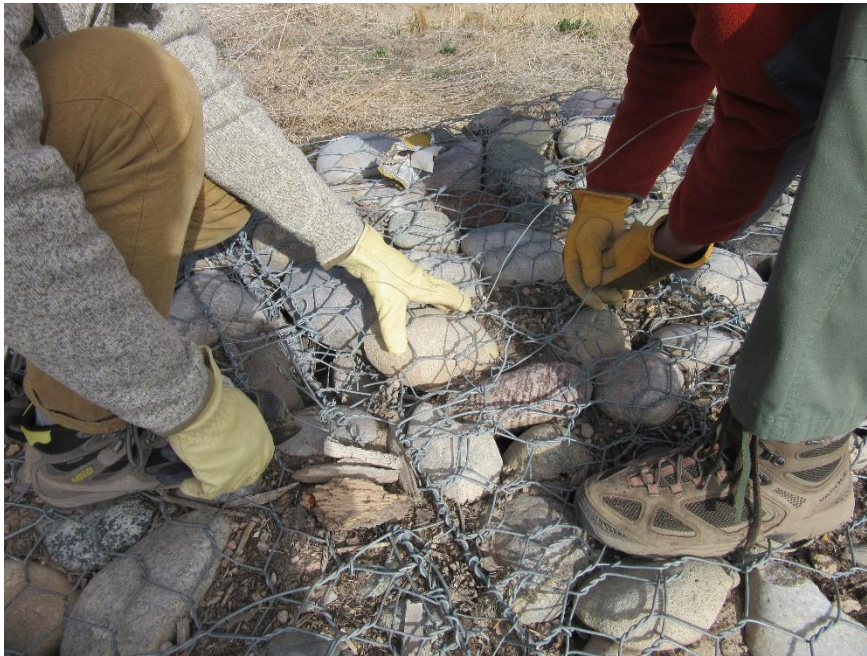
Photo C-4.7-1 **May 2021—Repair of holes in gabion baskets noted in earlier inspections. Trash was also picked up from weir ponding area.**

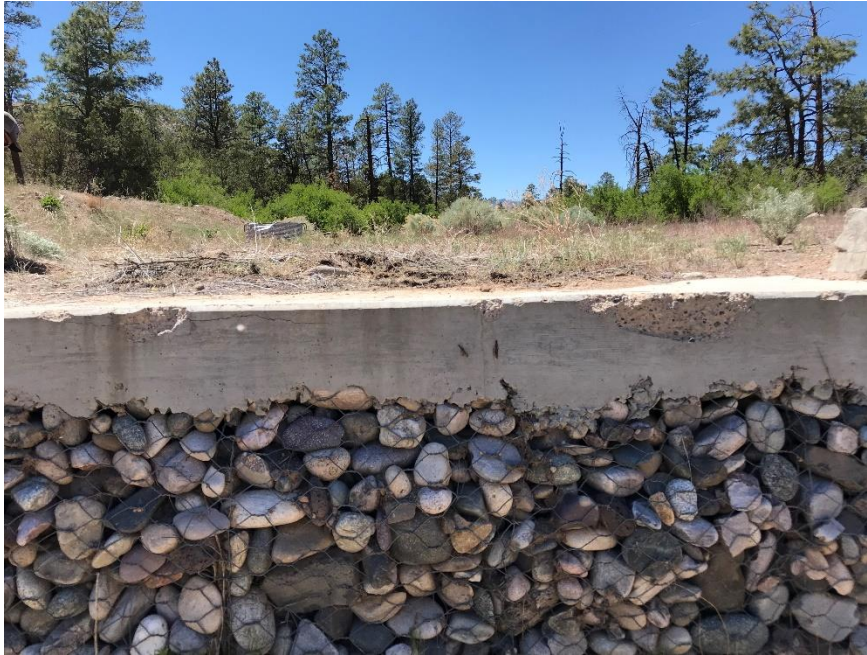
Photo C-5.2-5 **May 2021—Spalling on concrete weir spillway. No action recommended, continue to monitor.**

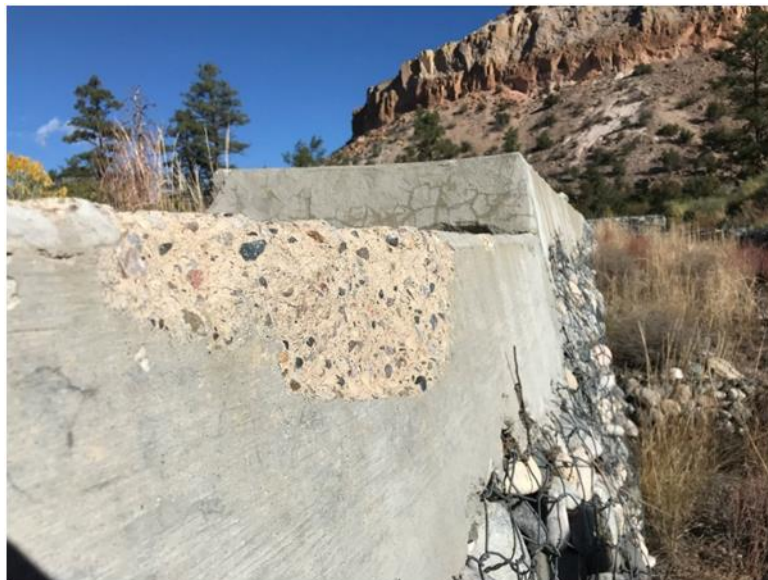
Photo C-5.2-6 **October 2021—Spalling on concrete weir spillway. No action recommended, continue to monitor.**

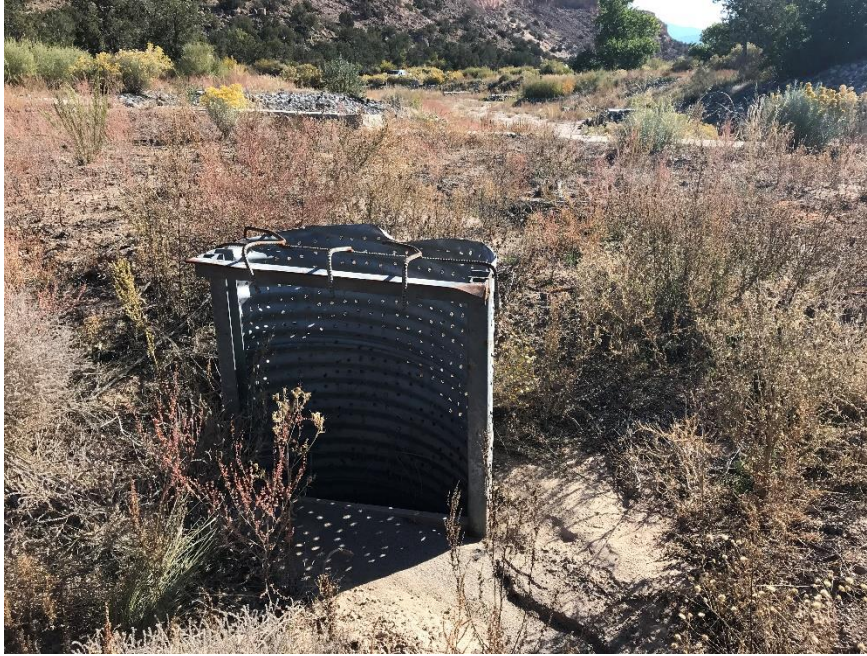
Photo C-5.3-1 **October 2021—Outlet culvert standpipe. Outlet is approximately two-thirds belowgrade and remains functional.**

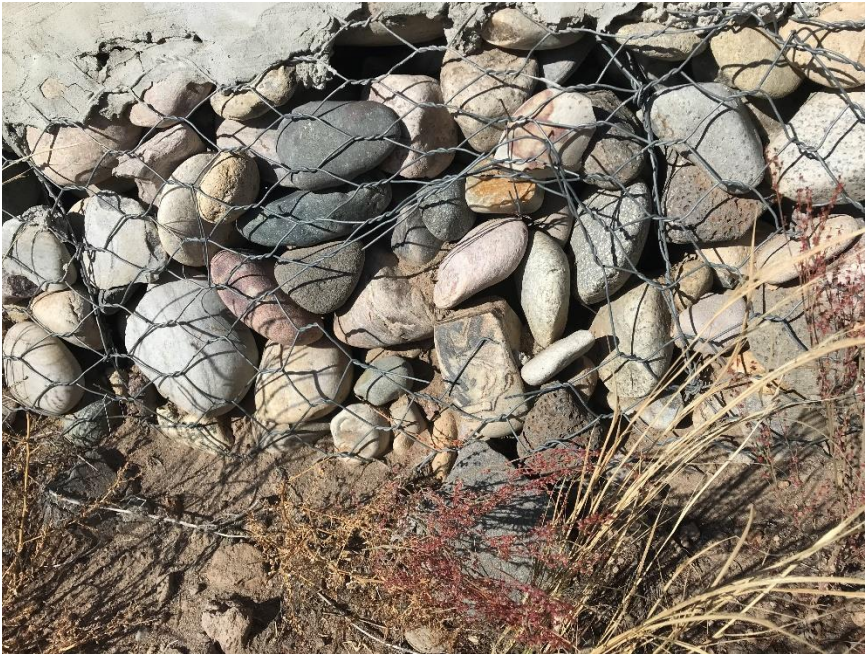
Photo C-5.5-1 October 2021—Identified broken wire in gabions at weir. Maintenance will be done during spring 2022 inspection.
