**Subject:** Submittal of the 2023 Biennial Asphalt Monitoring and Removal Report for Area of Concern C-00-041, Guaje/Barrancas/Rendija Canyons Aggregate Area

December 2023  
EM2023-0778

# **2023 Biennial Asphalt Monitoring and Removal Report for Area of Concern C-00-041, Guaje/Barrancas/Rendija Canyons Aggregate Area**

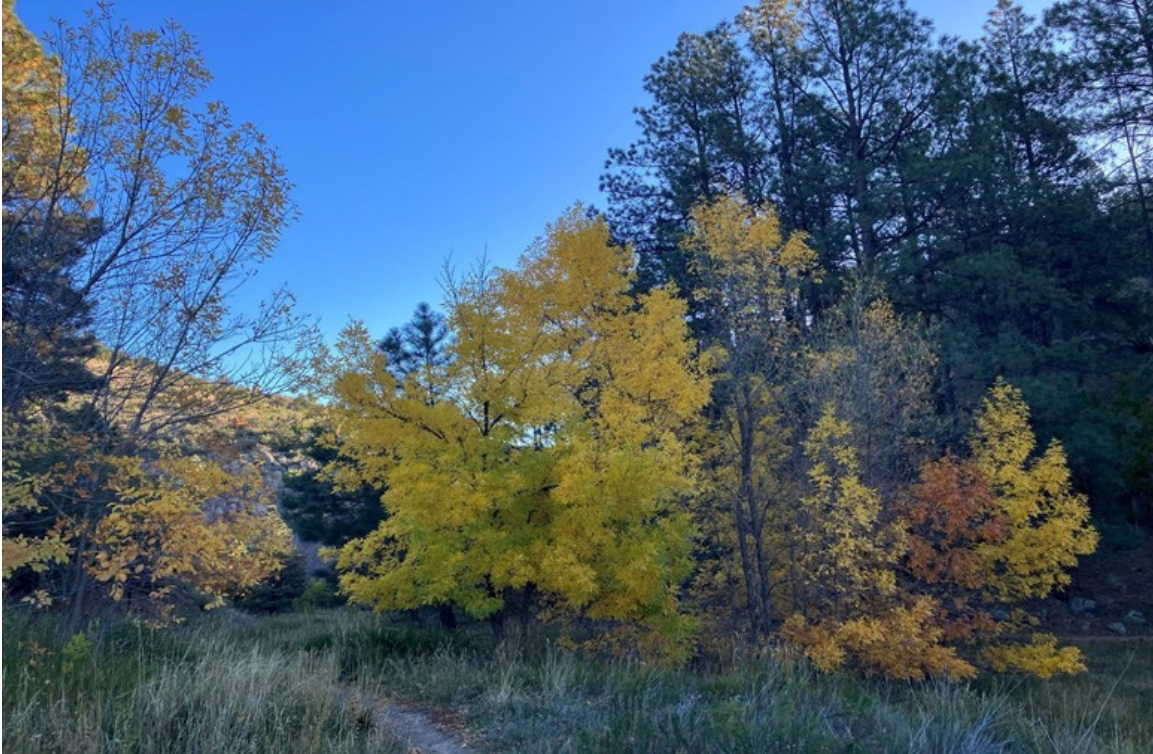
**Figure 4.0-1 AOC C-00-041 site conditions on USFS property looking northeast**

The 2023 activities at AOC C-00-041 took place on both USFS property and LAC property (Figures 4.0-1 through 4.0-3). The site was accessed through LAC property, and all work was subject to approval by the applicable property owner(s) through access agreements or the functional equivalent.

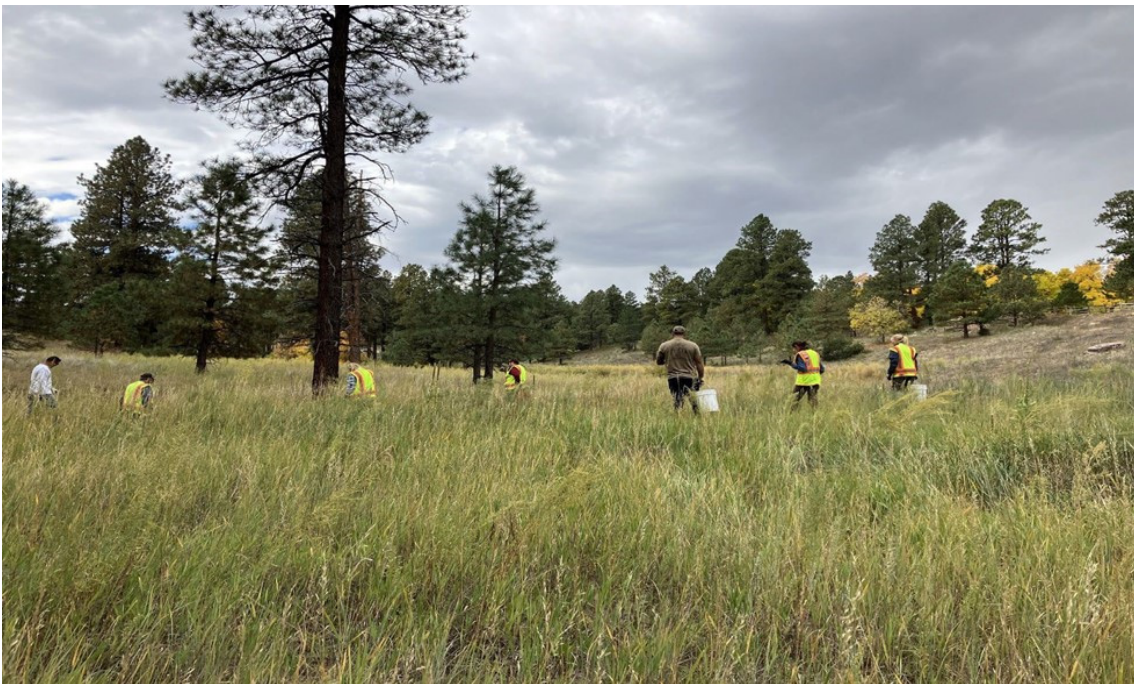
**Figure 4.0-2 AOC C-00-041 site conditions and crew on LAC property looking west**

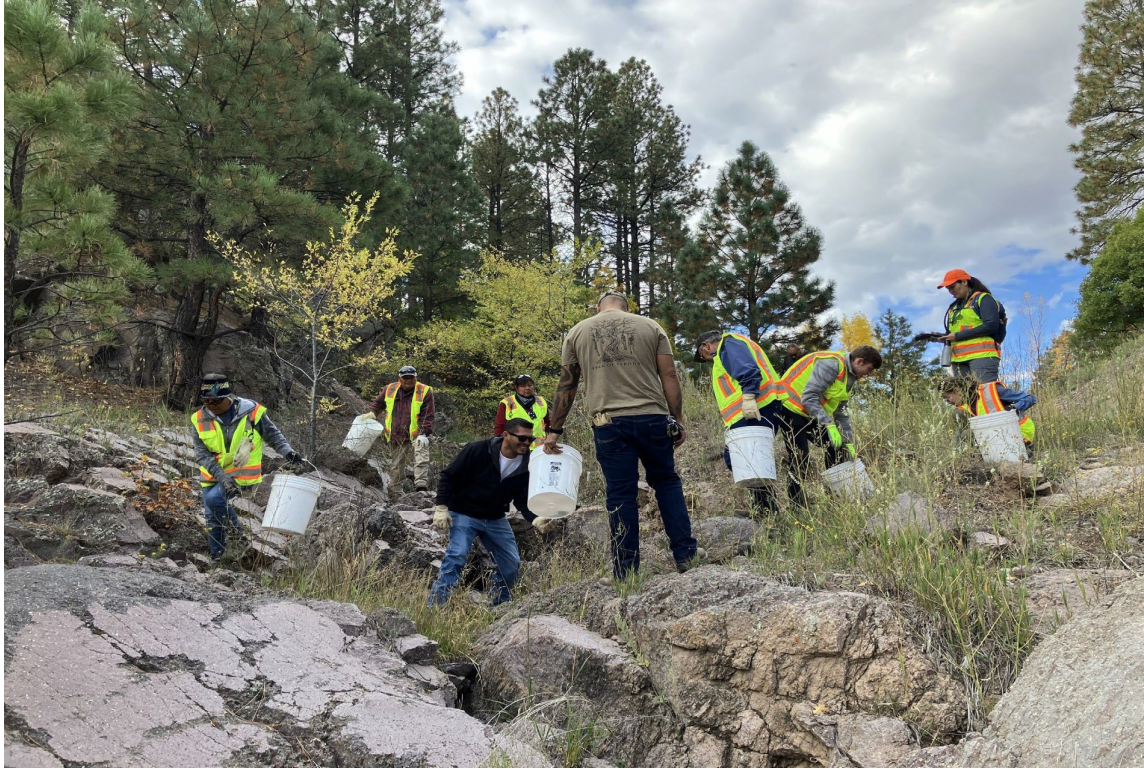
**Figure 4.0-3** AOC C-00-041 site conditions and crew on LAC property, north view main drainage area within AOC C-00-041

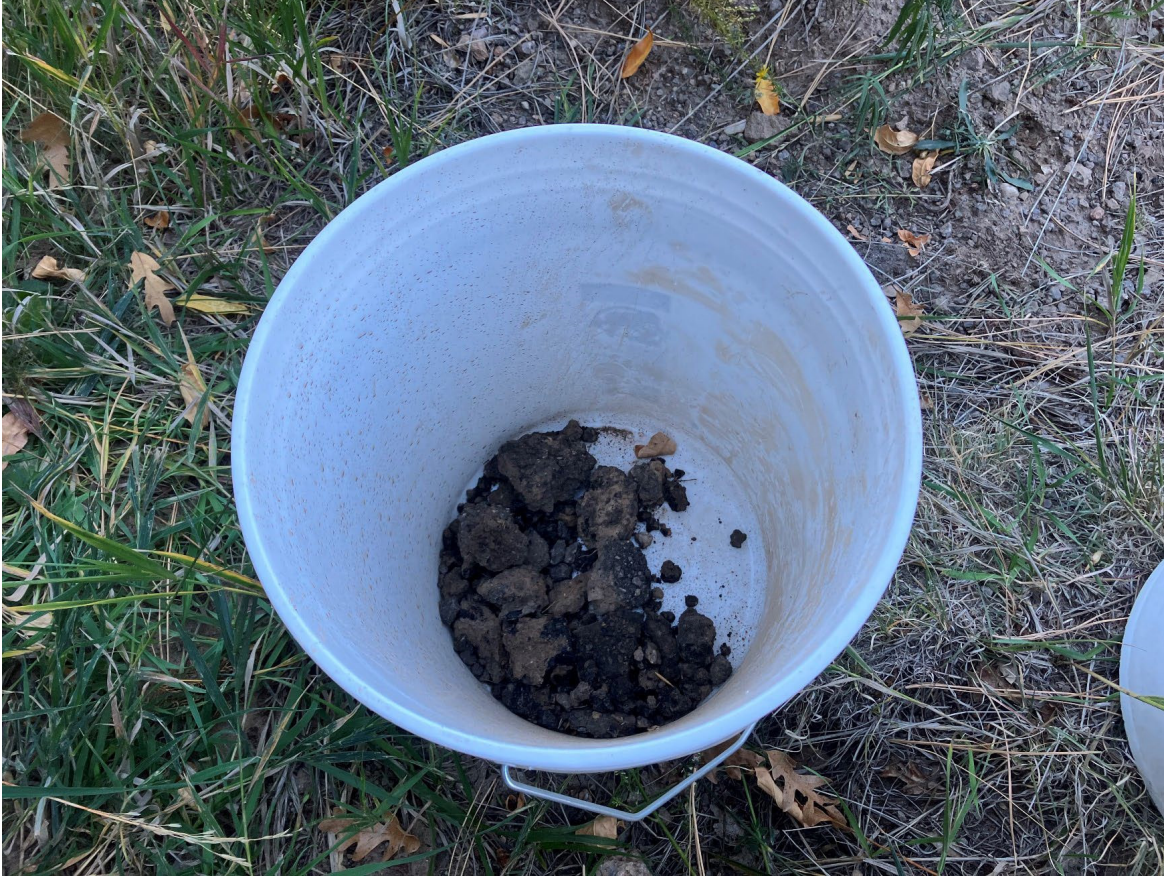
**Figure 4.2-1** Example of asphalt debris collected in 5-gal. buckets

On October 10, 2023, exposed asphalt debris and tar fragments were found and removed during the site inspection of AOC C-00-041. Asphalt or tar was removed only if it was visible at the surface and involved no excavation or significant soil disturbance. The majority of material found and removed within AOC C-00-041 was asphalt debris (Figures 2.0-2 and 4.2-1). A few pieces of tar were found and removed from the same location within AOC C-00-041 as in 2019 (Figure 4.2-2). The tar pieces were less than 3 in. long, 1 in. wide, and less than 0.25 in. thick. The asphalt pieces ranged in size from less than 1 in. to 1 ft. long and up to 6 in. wide. Asphalt and tar pieces were collected in buckets and transferred to the bed of a pickup truck. The total quantity of material removed, approximately two-thirds of a 55-gal. drum, was less than the quantity removed in 2021 (three-quarters of a 55-gal. drum) and in 2019 (one and one-half 55-gal. drums). Overall, the pieces were similar in size to those from prior asphalt removals. As in 2019, larger pieces of asphalt were predominantly discovered towards the end of the channel along AOC C-00-041 in the highly eroded banks before the tributary reaches the main Rendija Canyon drainage. Figure 2.0-1 highlights the two primary locations where asphalt was collected and the varied sizes of asphalt that were observed at each area. The asphalt and tar removed were containerized for disposition at the LAC Eco Station for recycling. Figures 4.2-1 through 4.2-4 are photographs of asphalt and tar samples and collection activities.

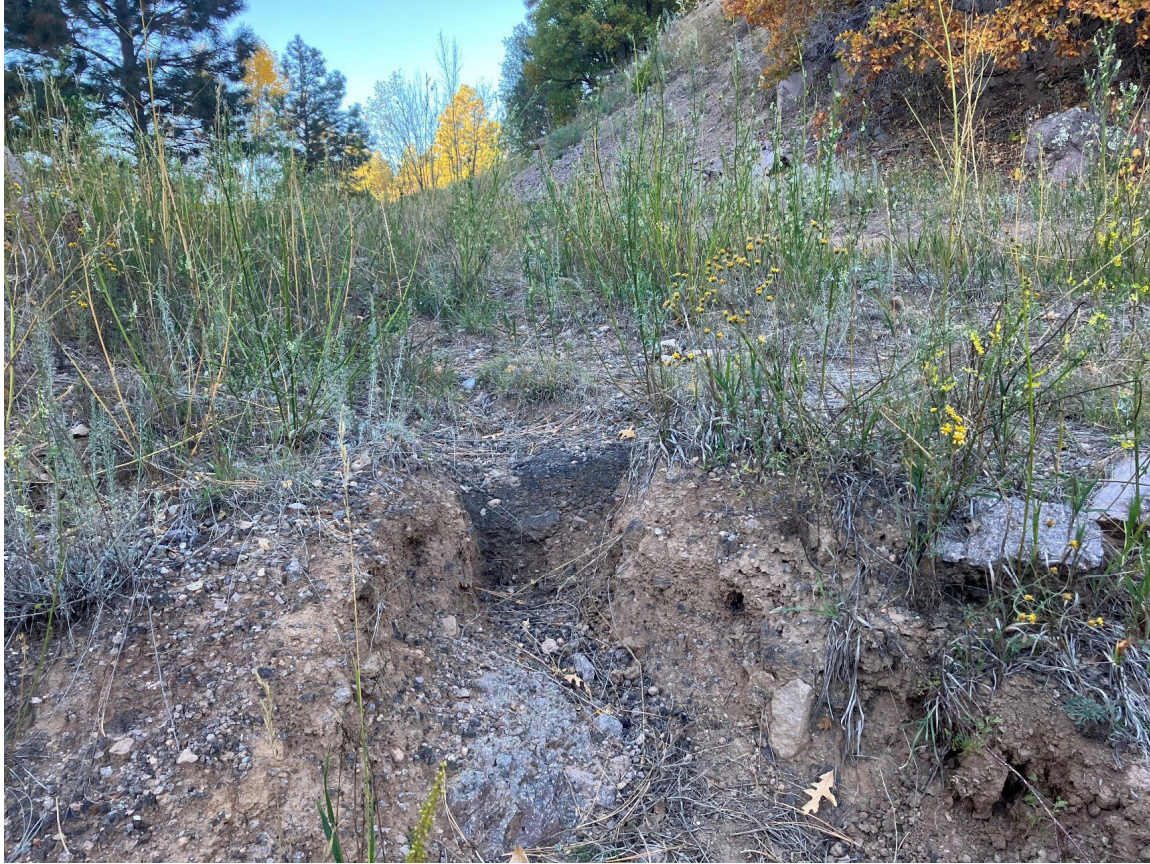
**Figure 4.2-2** Example of tar and asphalt in the banks of the drainage channel

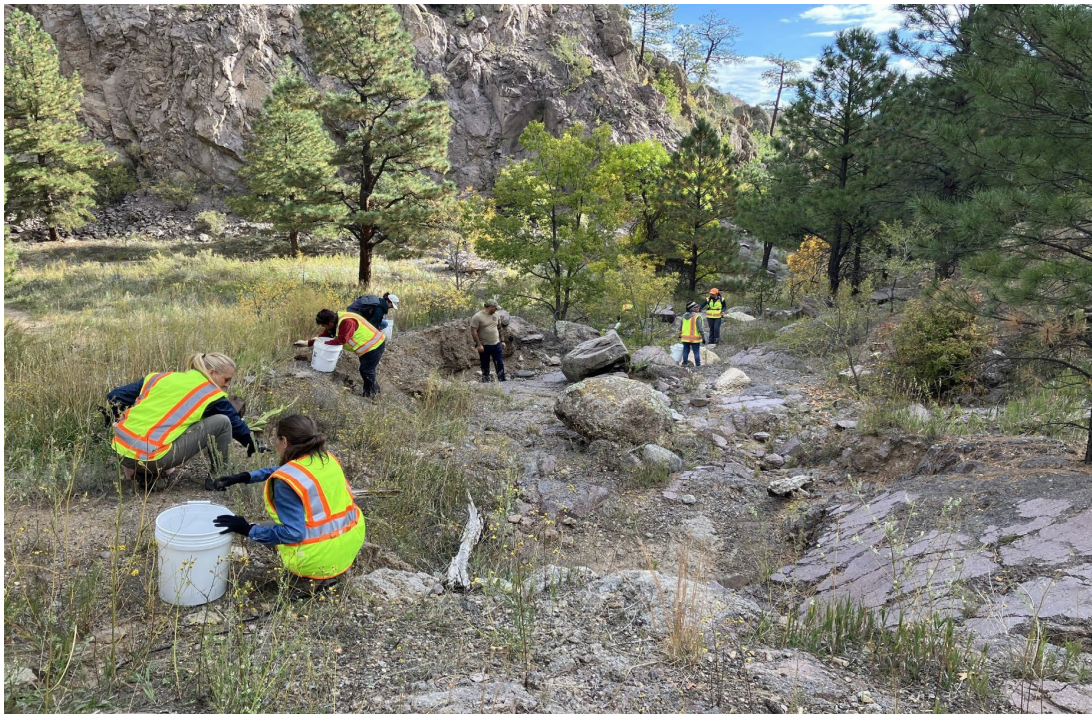
**Figure 4.2-3** Field crew collecting asphalt debris in drainage channel within AOC C-00-041

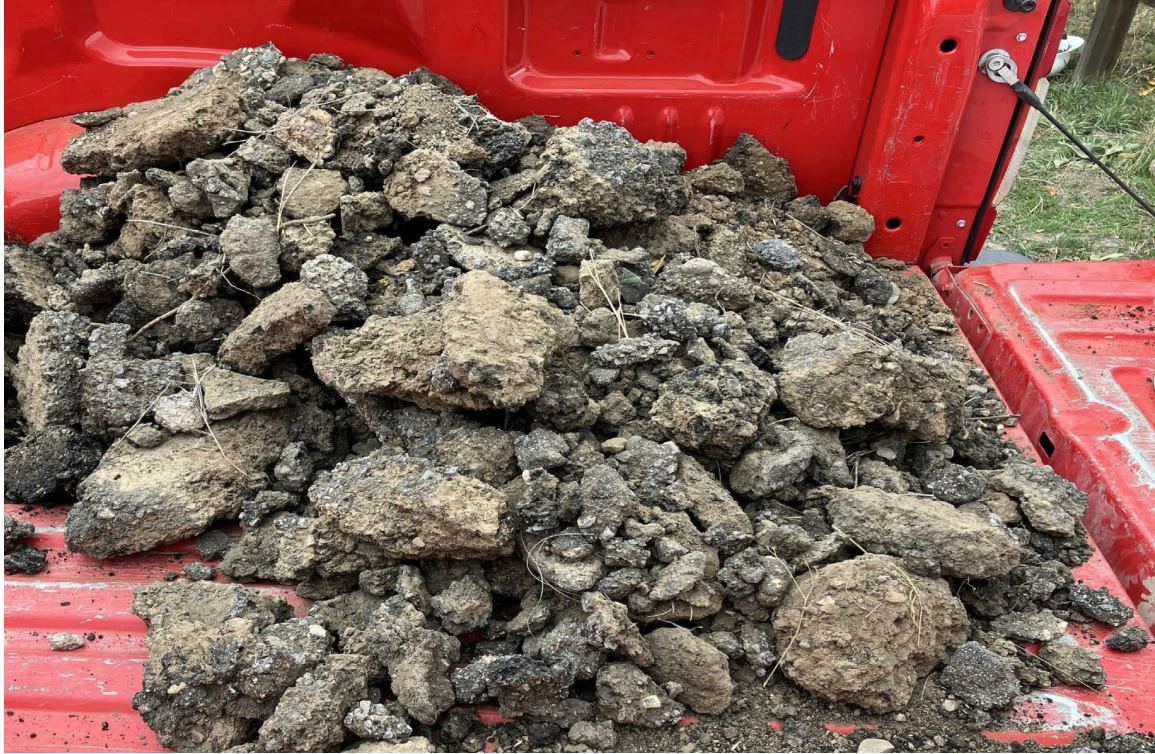
of asphalt collected were similar in size to the materials recovered in 2021, but the quantity collected was slightly less, at two-thirds of a 55-gal. drum.

**Figure 4.2-4** Asphalt debris removed from AOC C-00-041 in 2023. The asphalt pieces were generally similar in size compared with the asphalt pieces removed in 2021, but the quantity removed in 2023 was less than the quantity removed in 2021.
