Subject: Submittal of the 2021 Annual Long-Term Monitoring and Maintenance Report for the Corrective Measures Implementation at Former 260 Outfall Area

September 2021
EM2021-0468

2021 Annual Long-Term Monitoring and Maintenance Report for the Corrective Measures Implementation at Former 260 Outfall Area

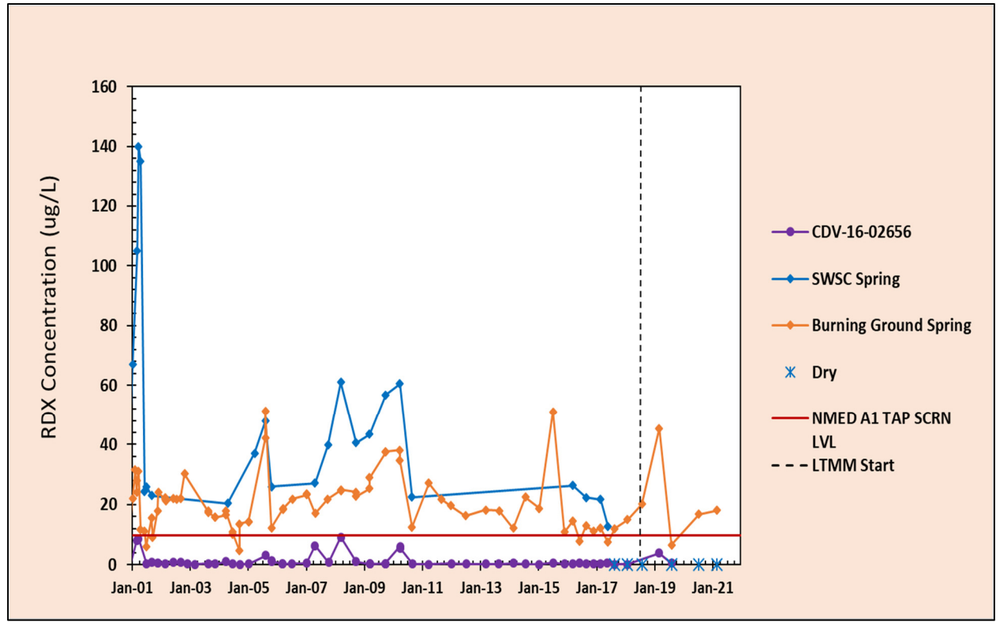
Figure 4.1-1 Cañon de Valle segment 1 RDX data record

The complete RDX data records for Cañon de Valle segments 1 and 2 are presented in Figures 4.1-1 and 4.1-2, respectively. These figures provide a comprehensive review of the RDX concentrations in waters in each segment and how the RDX sample results compare with the historical data trends. Based on a review of these data, it can be concluded that the temporal and spatial trends and conditions in the surface water, alluvial groundwater, and springs are consistent with the concept that RDX concentrations

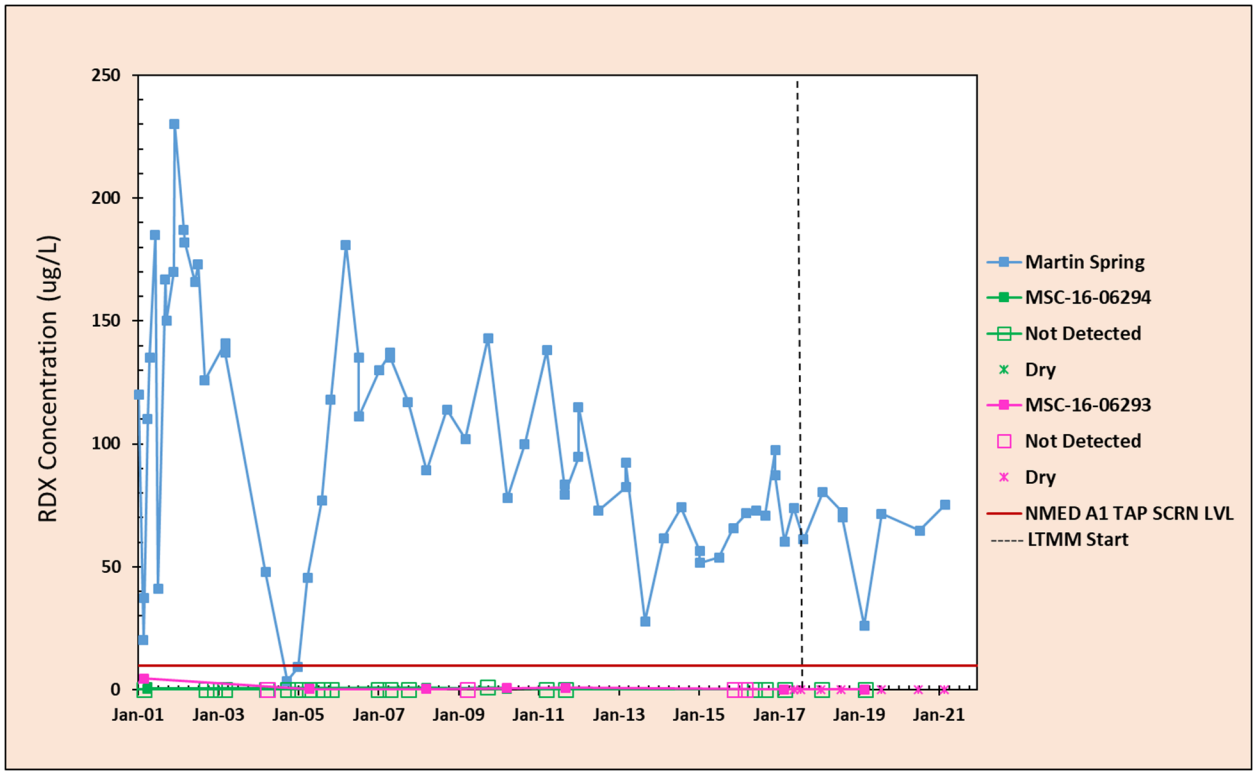
Figure 4.1-3 S-Site Canyon RDX data record

The S-Site Canyon RDX data record is shown in Figure 4.1-3, and the spatial distribution of RDX detected since the corrective measures is provided on Plate 1. The Martin Spring water RDX concentrations remain above the screening level, although the sample results are consistent with the conclusion that RDX levels continue to decline over time. Both MSC-16-06293 and MSC-16-06294 were dry during the last sampling event. Plate 1 shows declining levels of RDX across the canyon with no impacts to surface water downgradient of Martin Spring, suggesting the RDX concentration in Martin Spring is a localized condition.

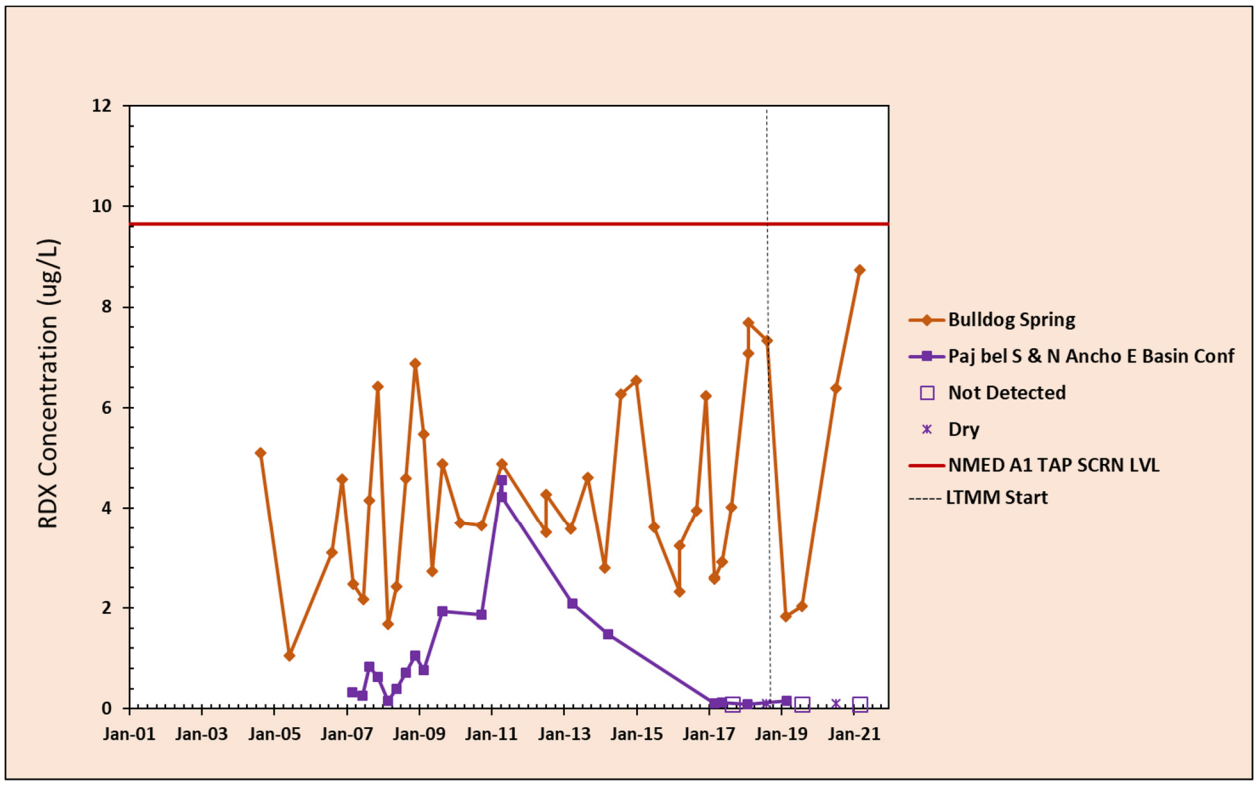
Figure 4.1-4 Pajarito Canyon RDX data record

The Pajarito Canyon locations include a spring location at Bulldog Spring and a surface water location at the Confluence. Figure 4.1-4 presents the data record for both locations. Bulldog Spring water RDX concentrations are consistently below the screening level, including the result of the samples collected in March 2021. At the Confluence surface water location, the RDX results are consistent with past data—concentrations are below 9.66 µg/L and support the sharply decreasing trend in RDX concentration.

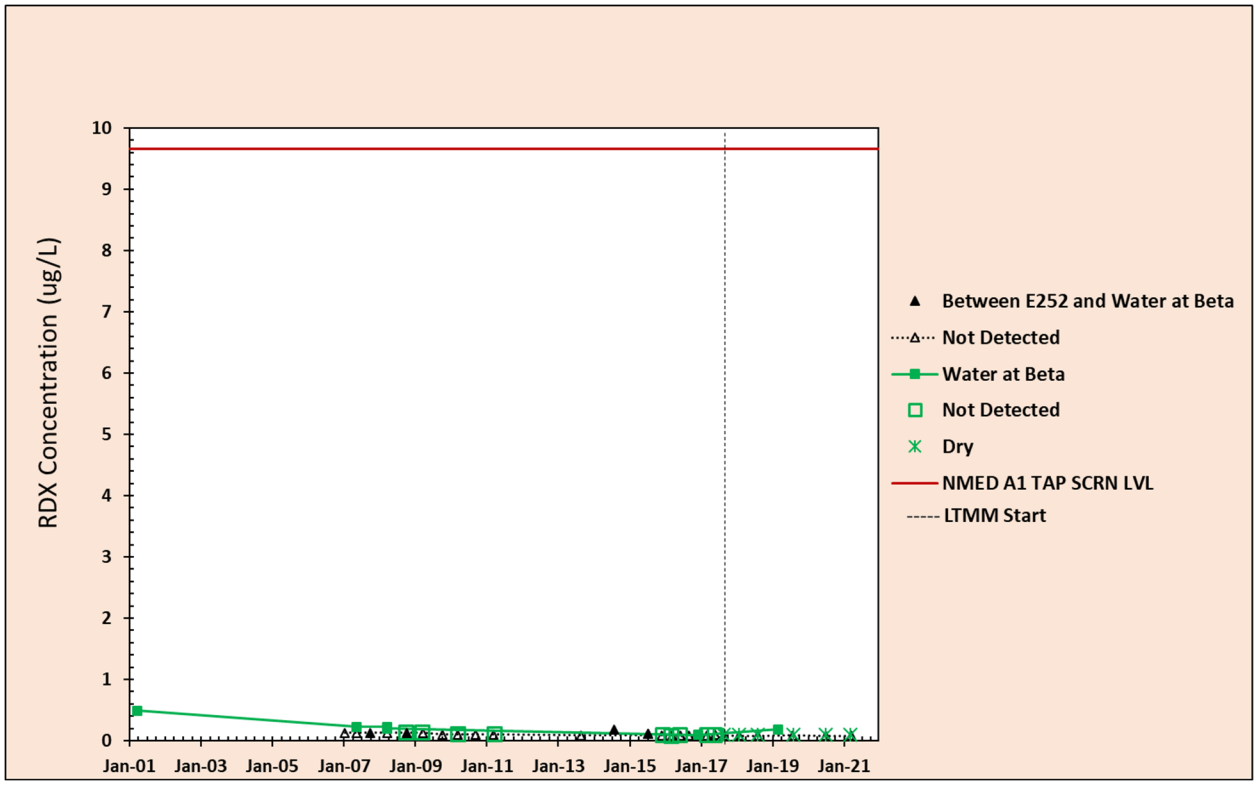
Figure 4.1-5 Water Canyon RDX data record

The Water Canyon RDX data record is presented in Figure 4.1-5. Figure 4.1-5 demonstrates that the samples are consistent with historical results, which indicate RDX is well below the screening level or not detected. Samples from the March 2021 sampling event were not available for Water Canyon at Beta because the location was dry at the time of sampling; however, Between E252 and Water at Beta was sampled and sample results were nondetected for RDX.

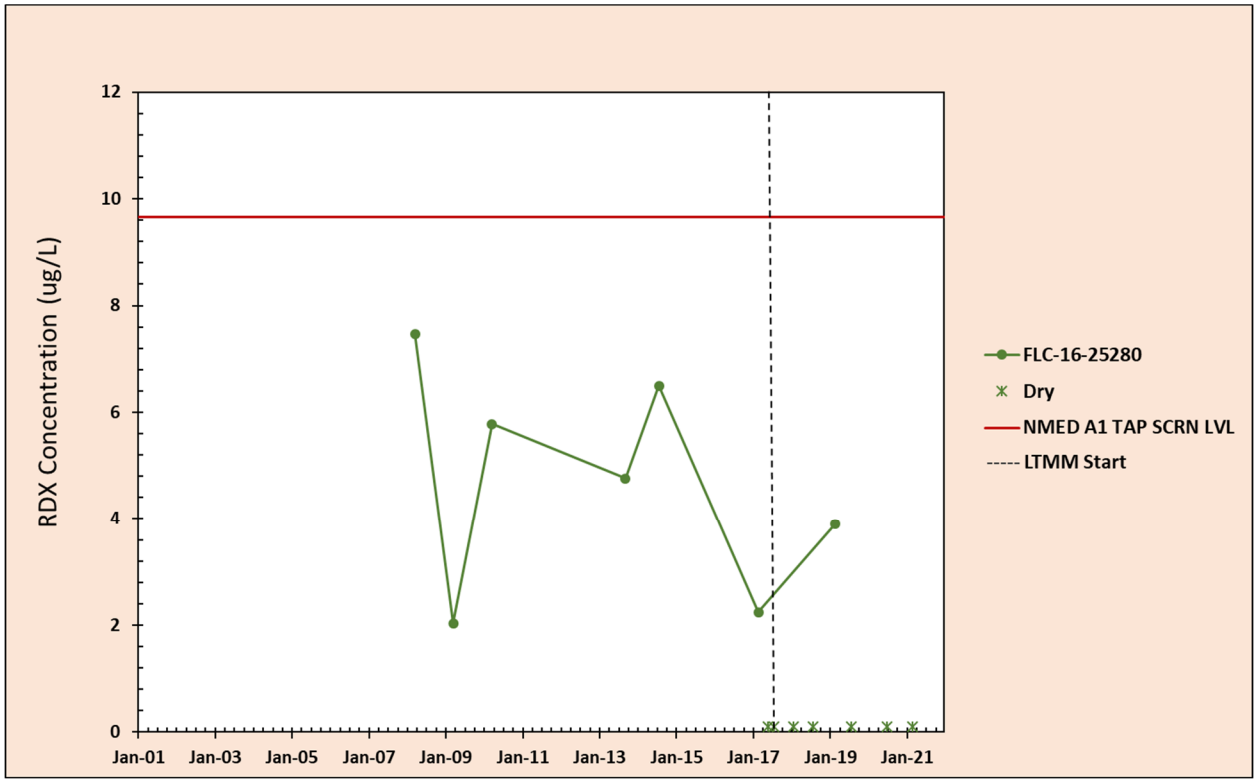
Figure 4.1-6 Fishladder Canyon RDX data record

Figure 4.1-6 presents the data record for the Fishladder Canyon. In March 2021 results were not available because the location was dry at the time of sampling. However, the historical record indicates no impacts to Fishladder Canyon alluvial groundwater above the RDX screening level.

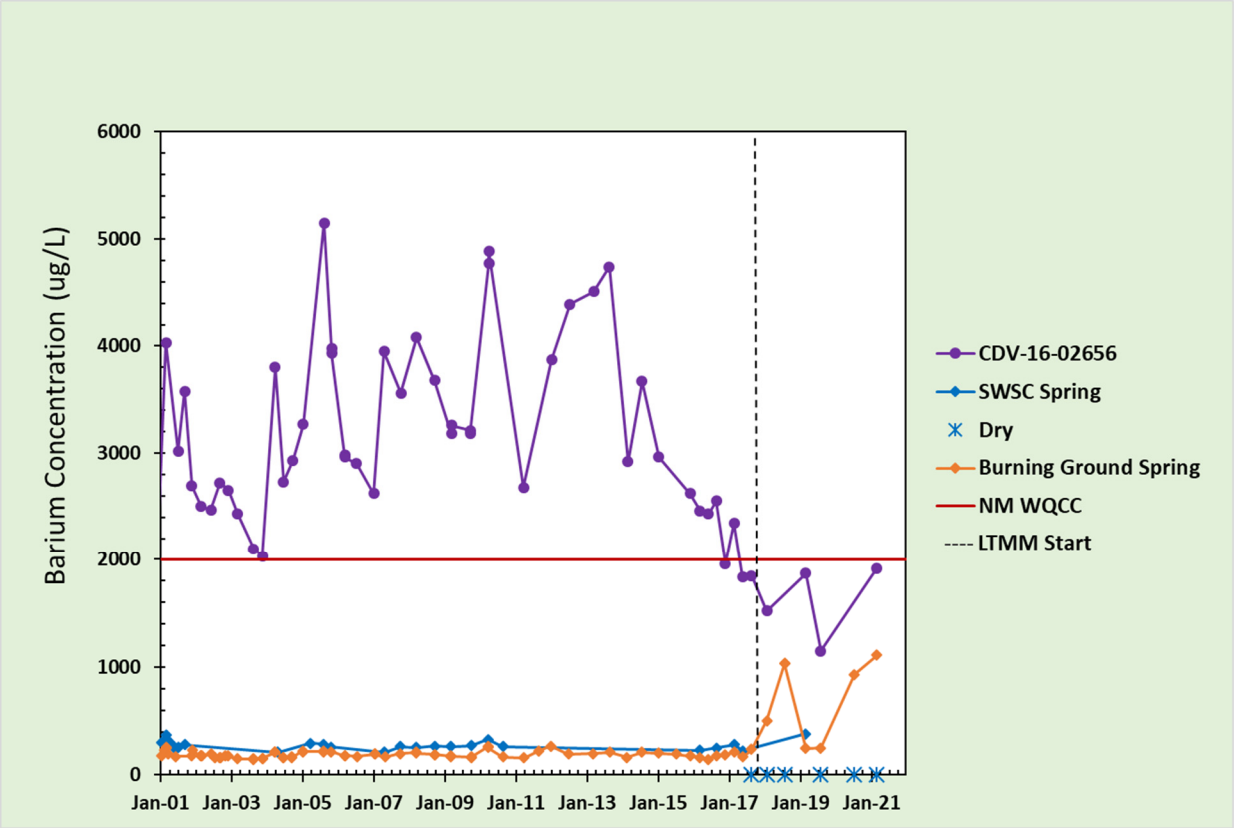
Figure 4.2-1 Cañon de Valle segment 1 barium data record

Barium concentration data records for the Cañon de Valle segments 1 and 2 are presented in Figures 4.2-1 and 4.2-2, respectively. These figures provide a comprehensive review of barium impacts to each segment since the start of the IFGMP program and a comparison of the sample barium results with the existing data trends. A review of these data indicate that the temporal and spatial trends, and conditions in the surface water, alluvial groundwater, and springs, are consistent with conditions described in the CMI remedy report (LANL 2017, 602597); therefore, these conditions are still considered protective of the regional groundwater.

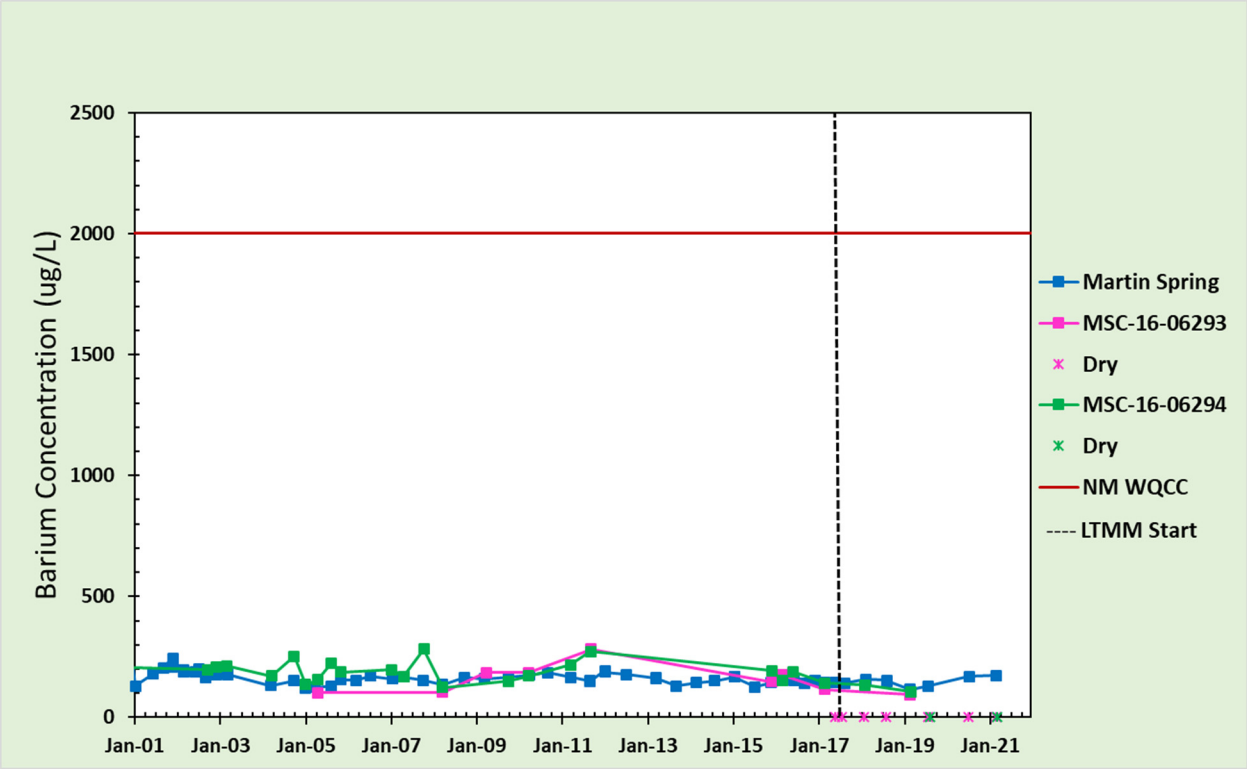
Figure 4.2-3 S-Site Canyon barium data record

In S-Site Canyon, Pajarito Canyon, Water Canyon, and Fishladder Canyon, barium is not detected above the 2000-µg/L screening level, which is consistent with the historical data record as seen in Figure 4.2-3 (S-Site Canyon), Figure 4.2-4 (Pajarito Canyon), Figure 4.2-5 (Water Canyon), and Figure 4.2-6 (Fishladder Canyon).
