Date: **MAR 05 2019**
Refer To: N3B-19-0065

**Subject: Response to Request for Information Regarding Damage to Technical Area 54
Domes 229 and 230 and Compliance with Los Alamos National Laboratory
Hazardous Waste Facility Permit, EPA ID No. NM0890010515**

Event Summary:

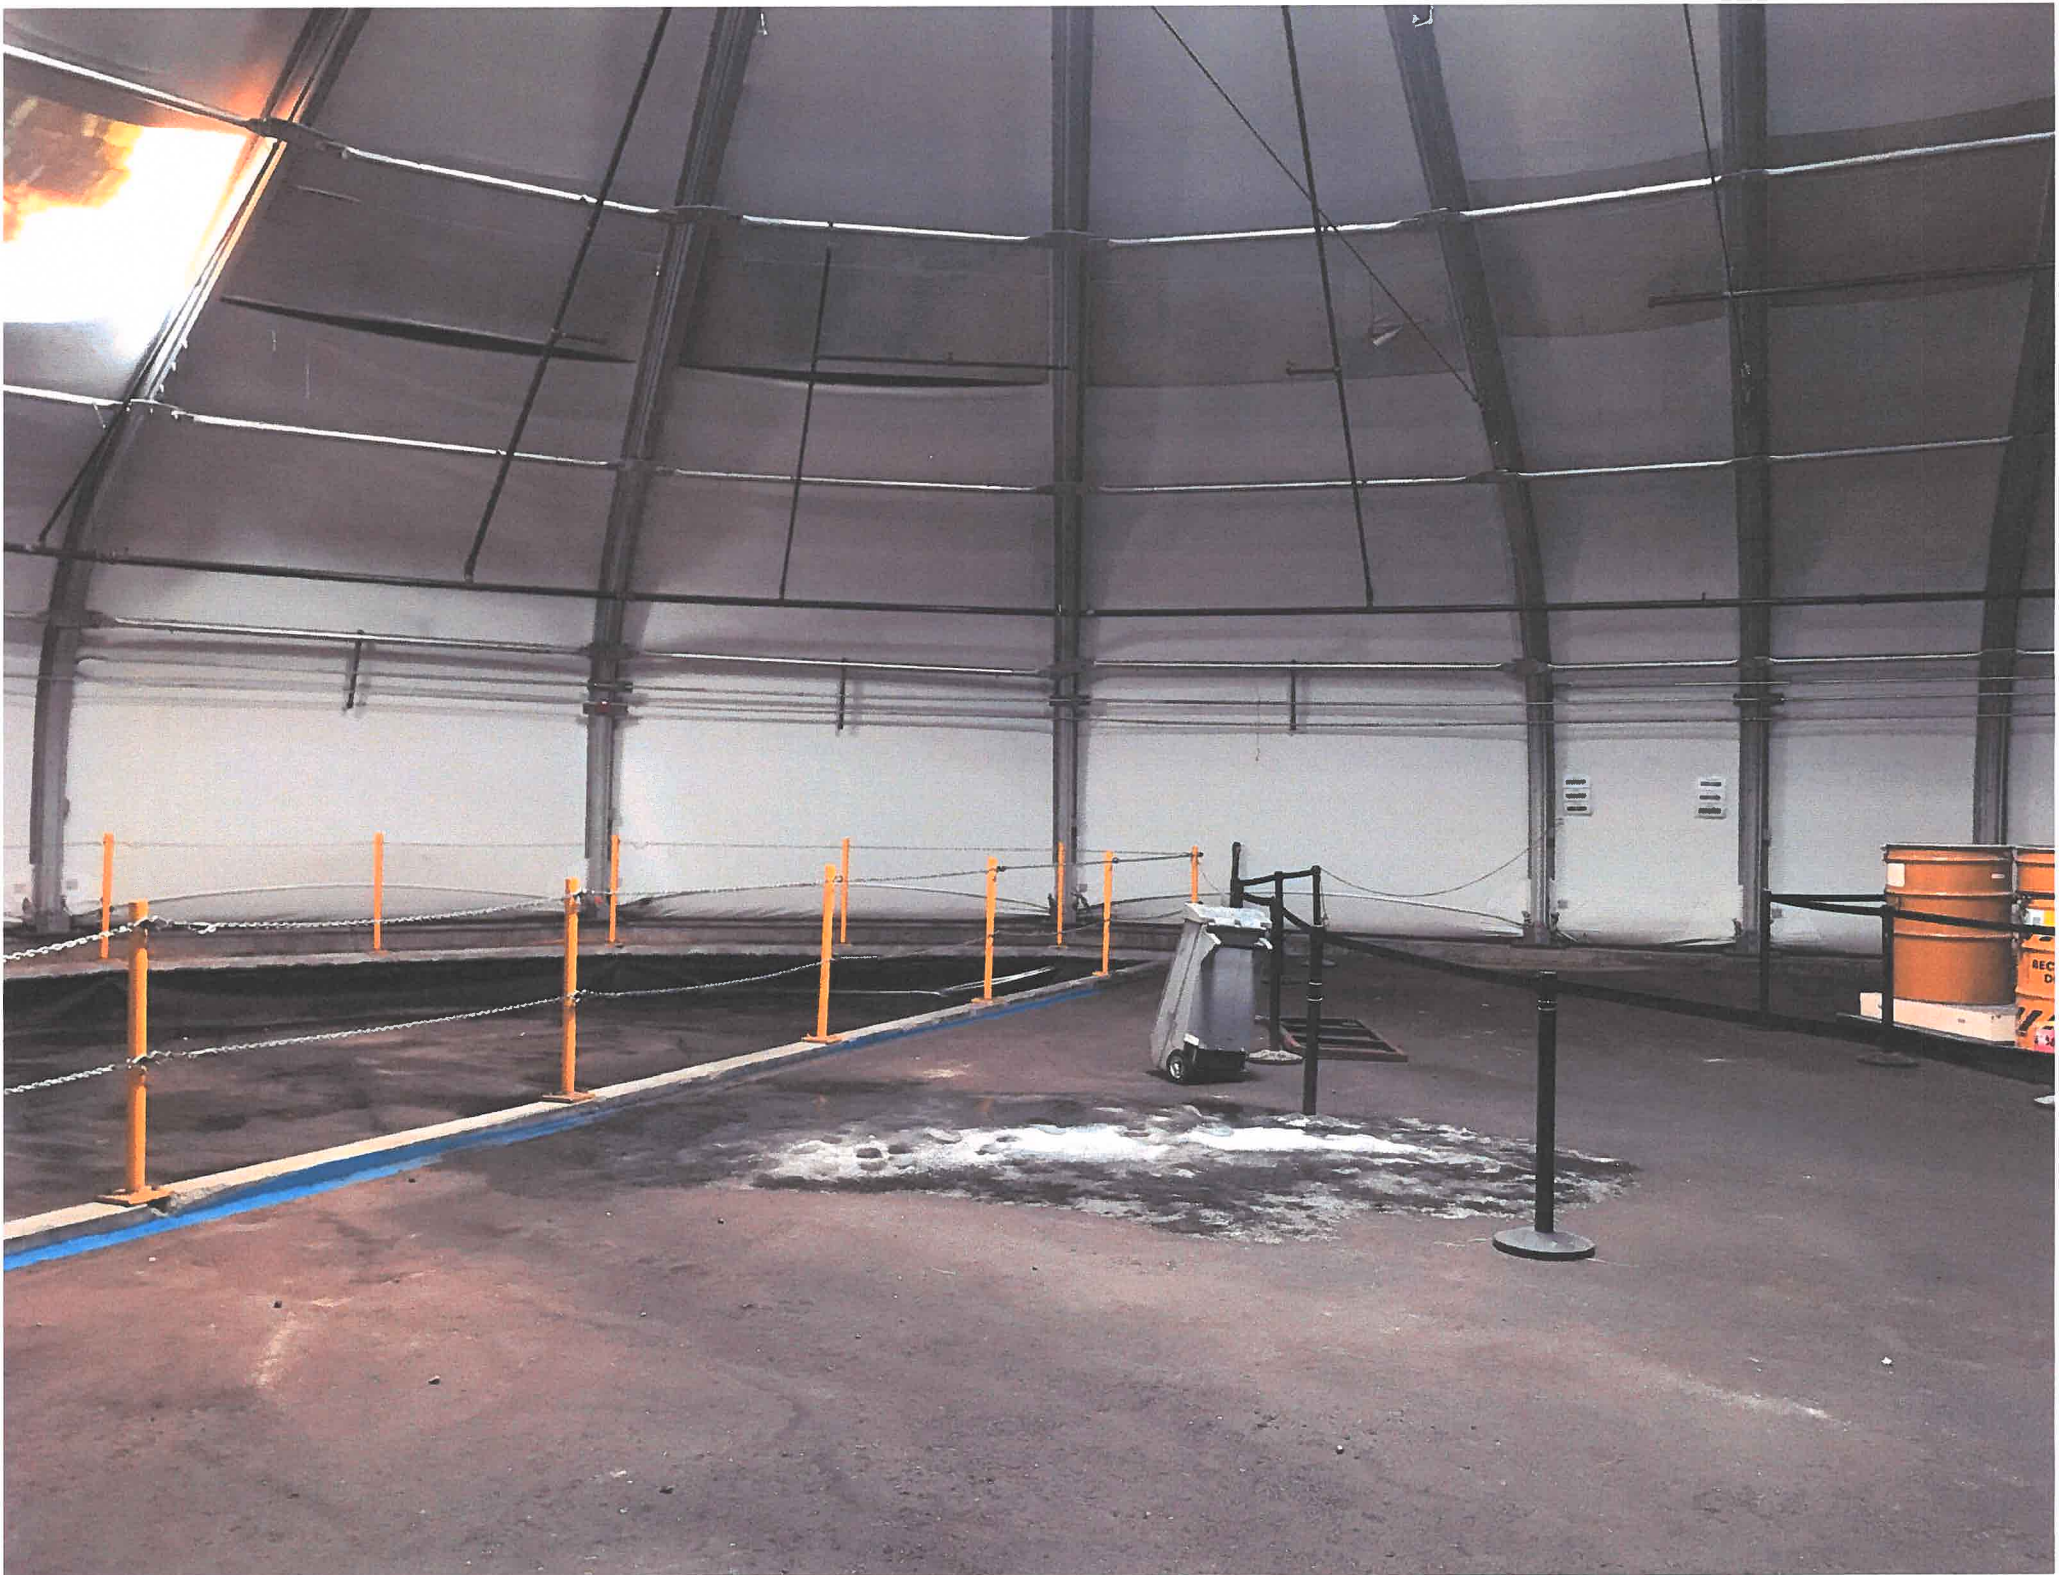
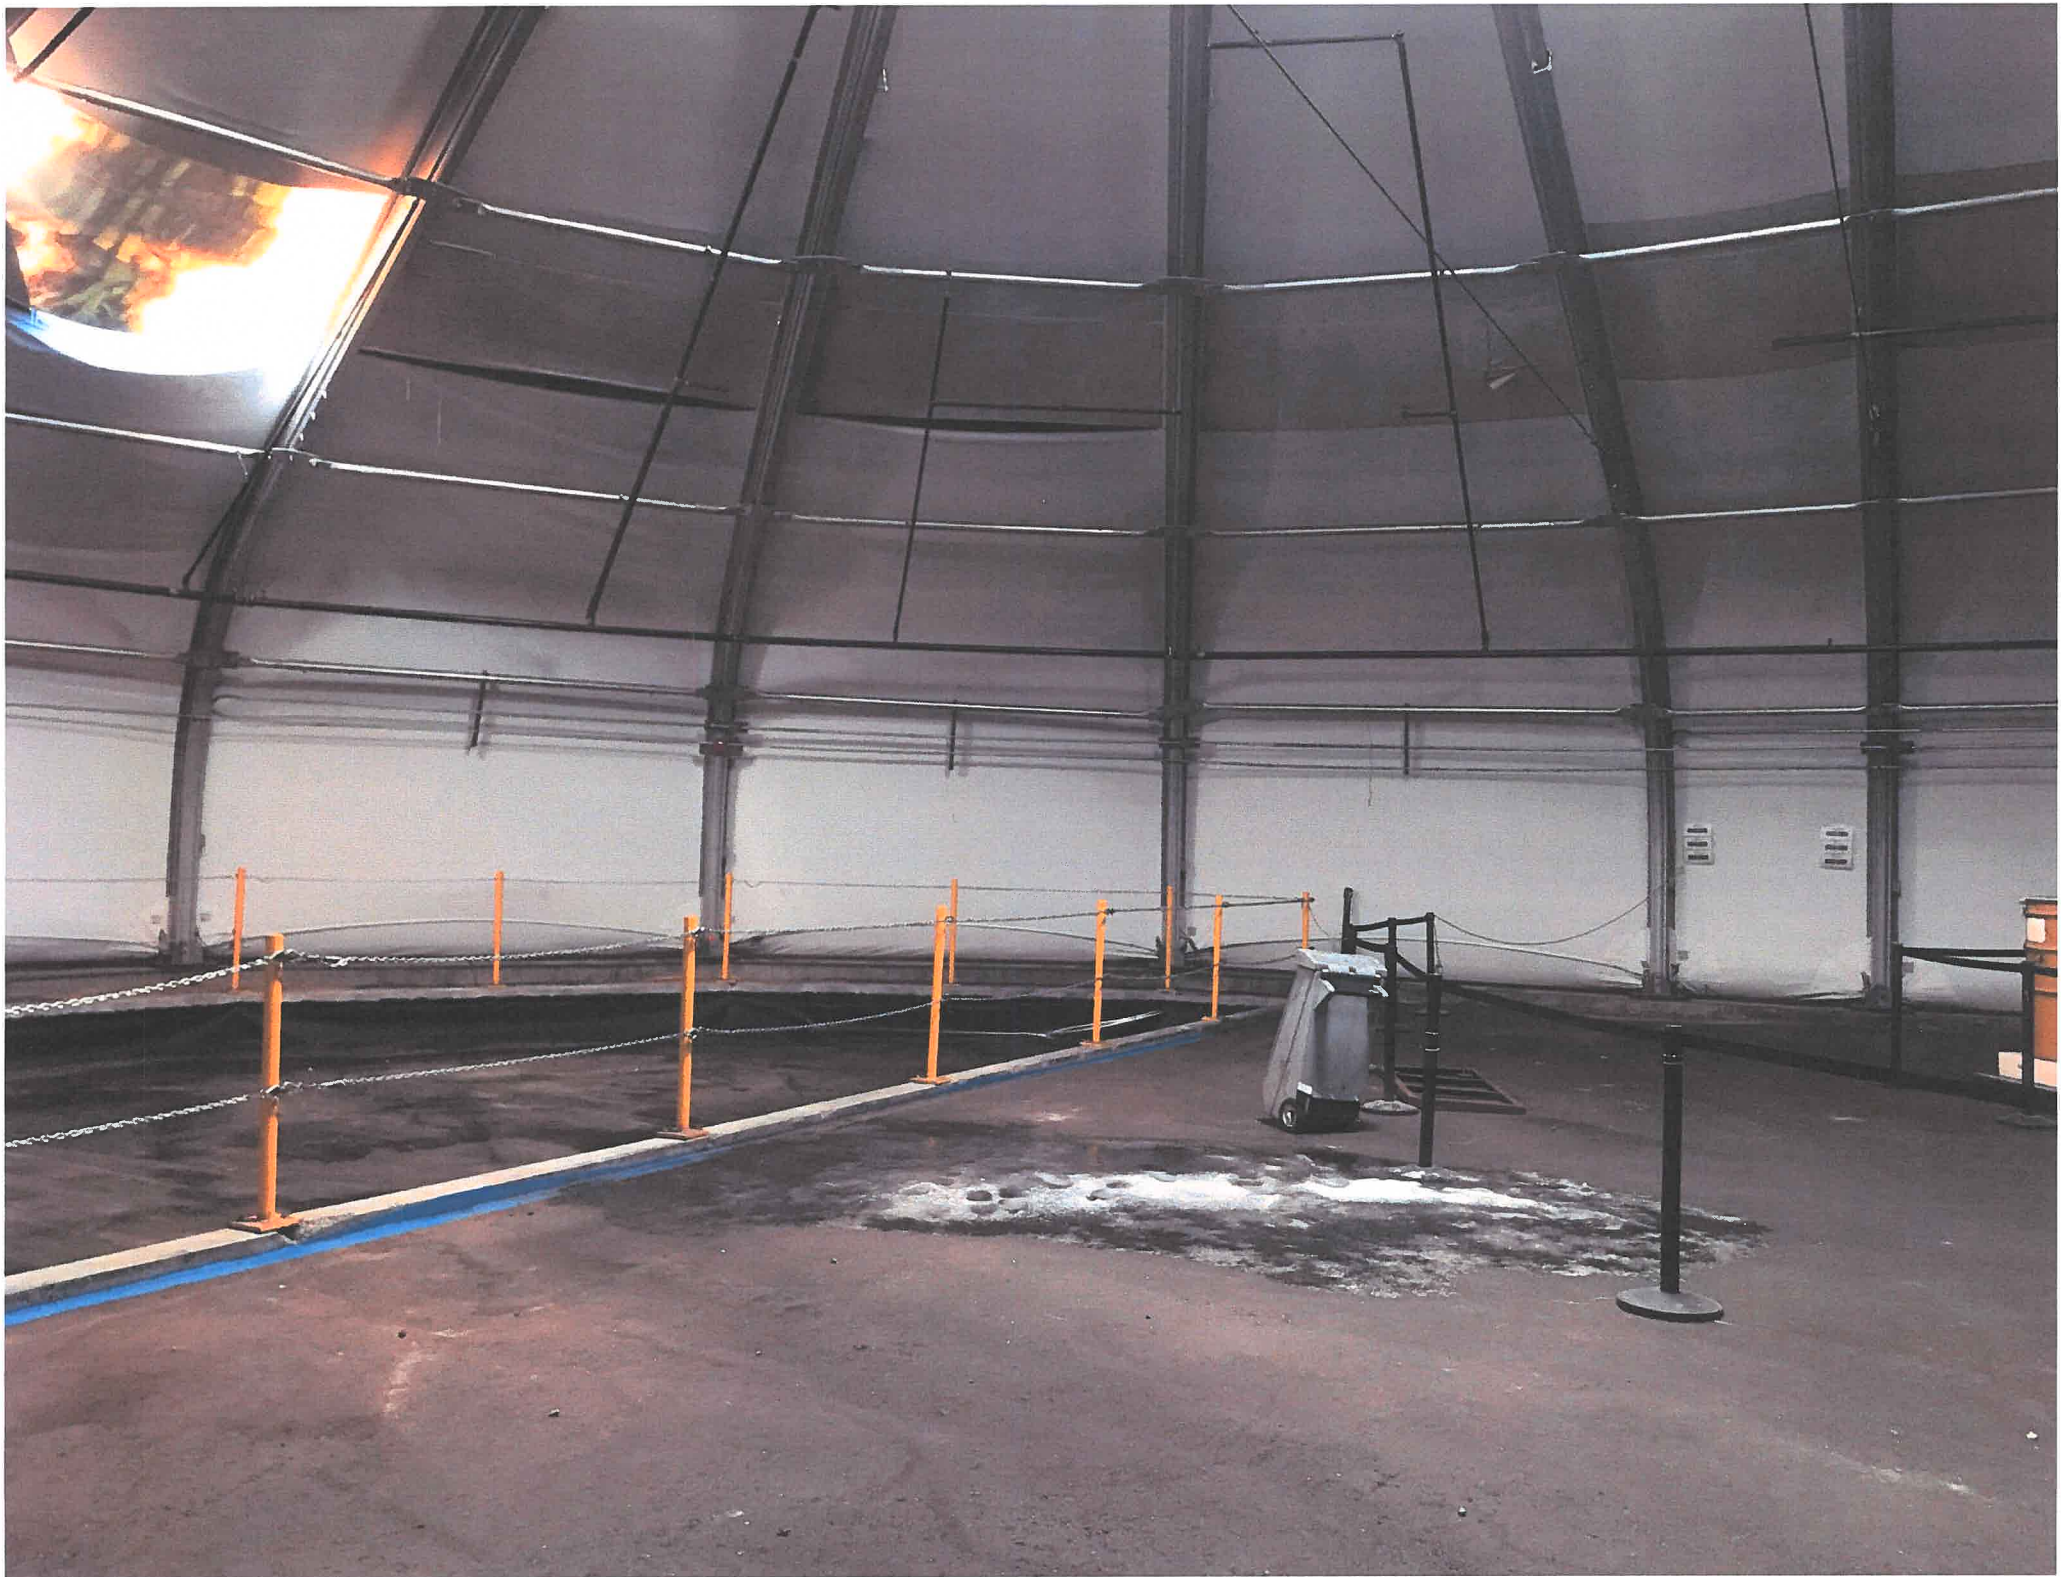
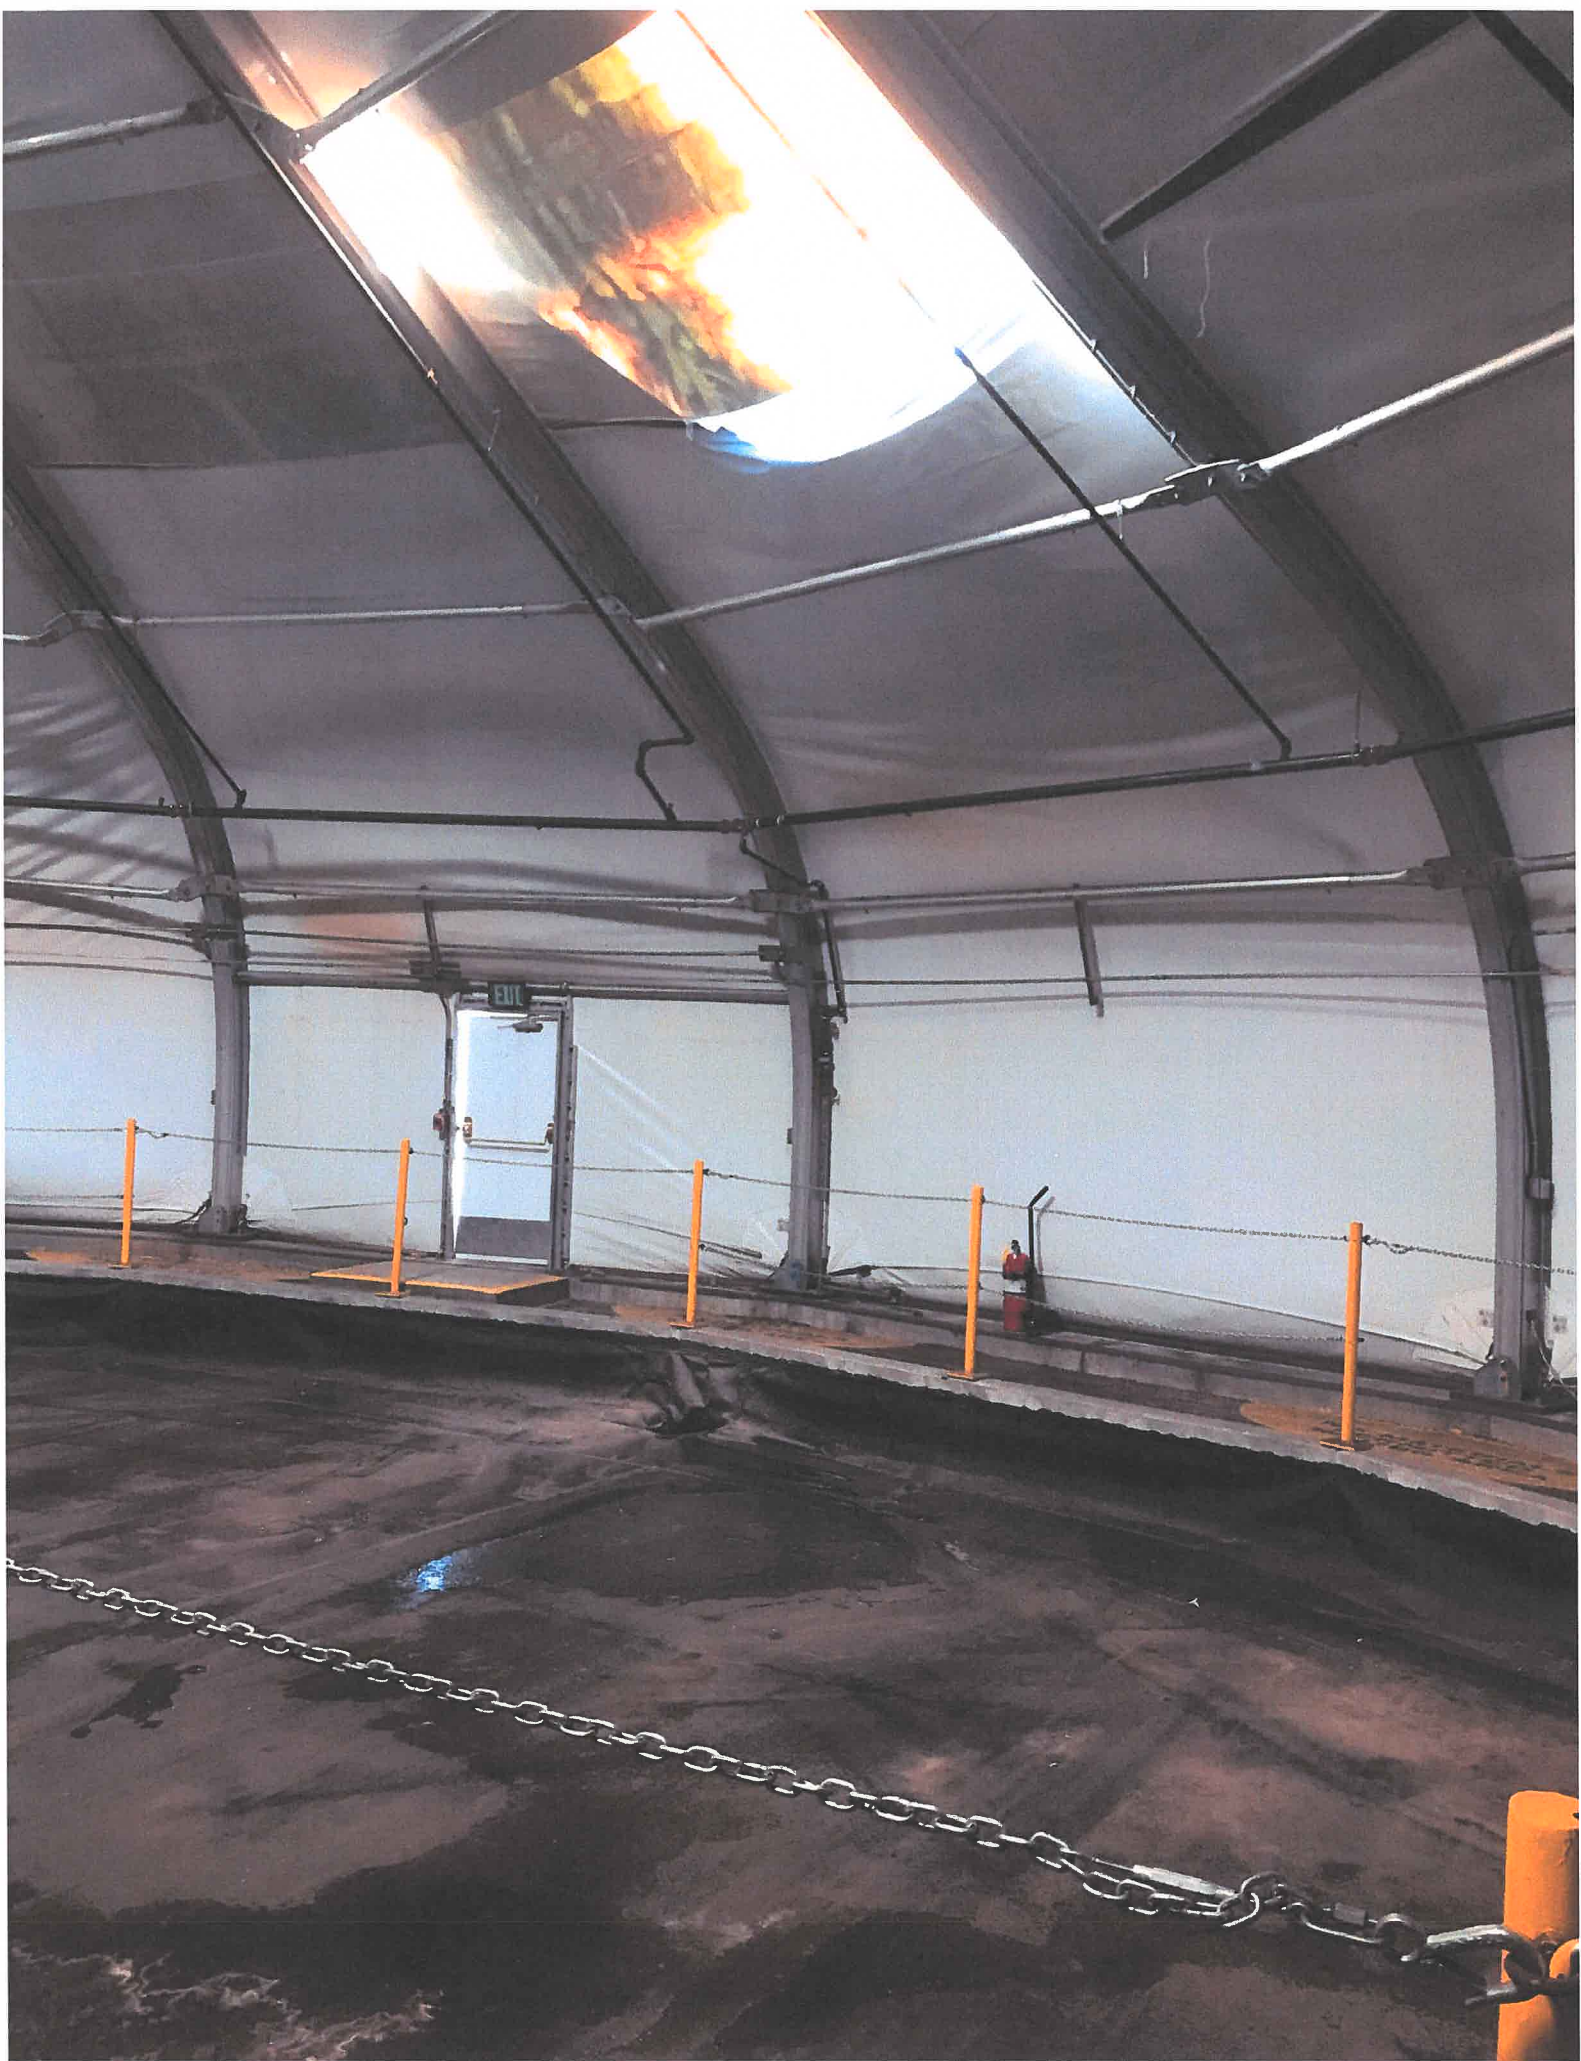
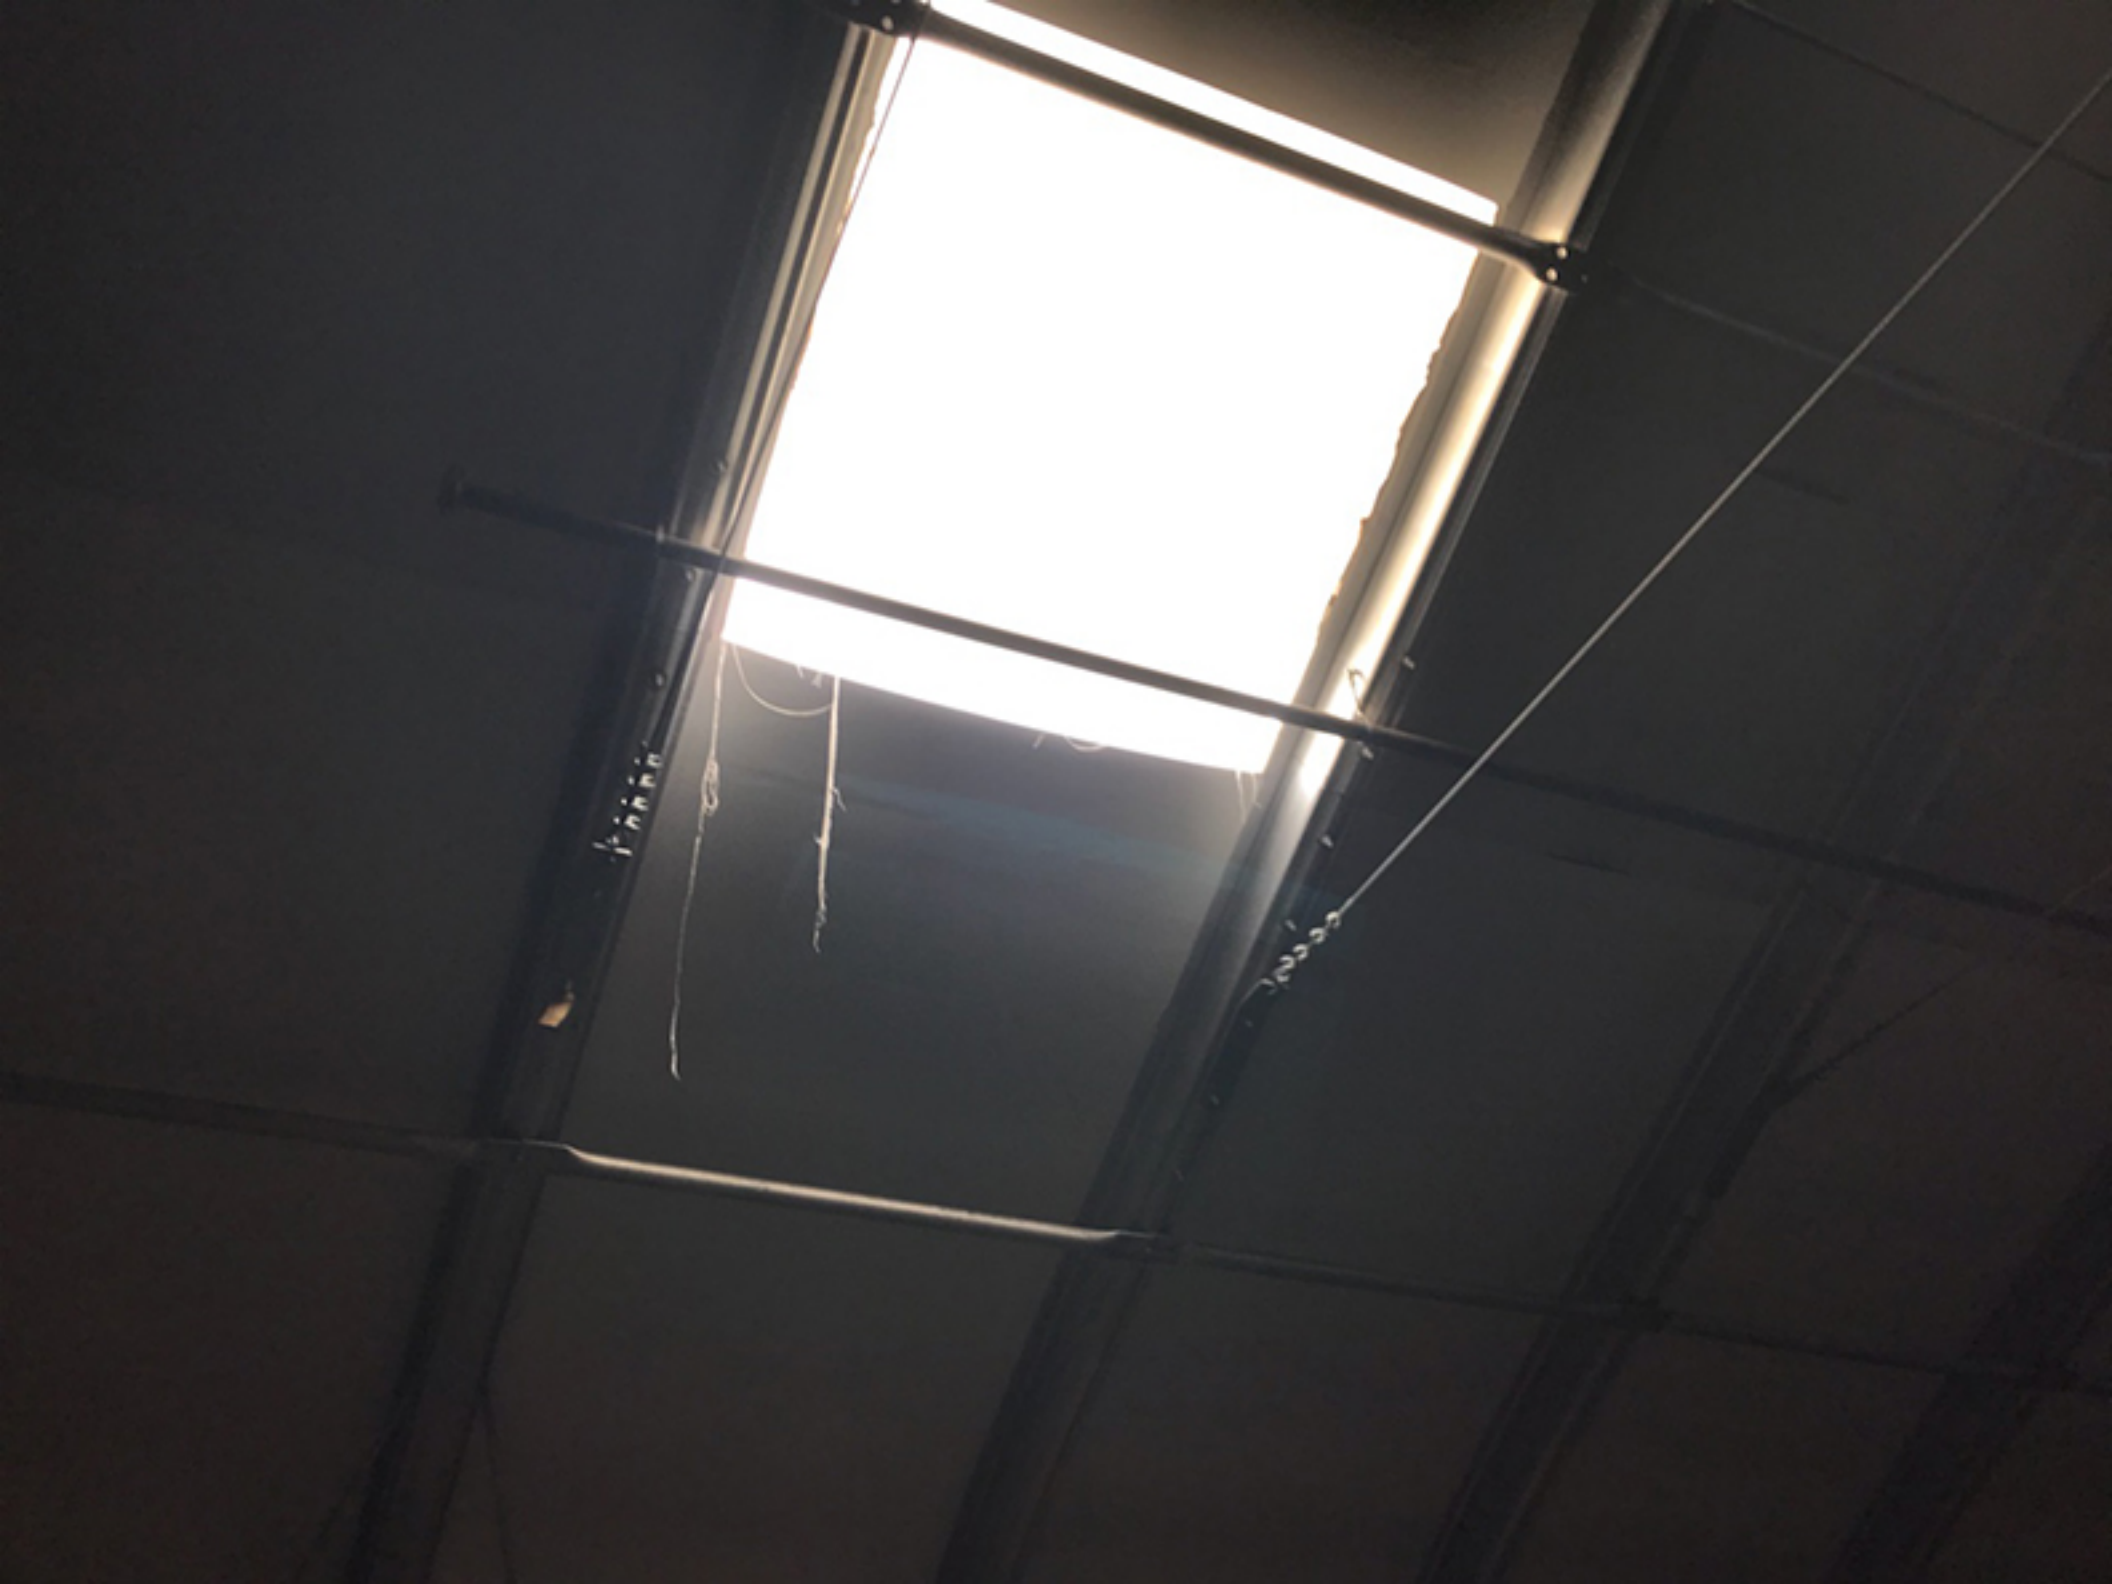
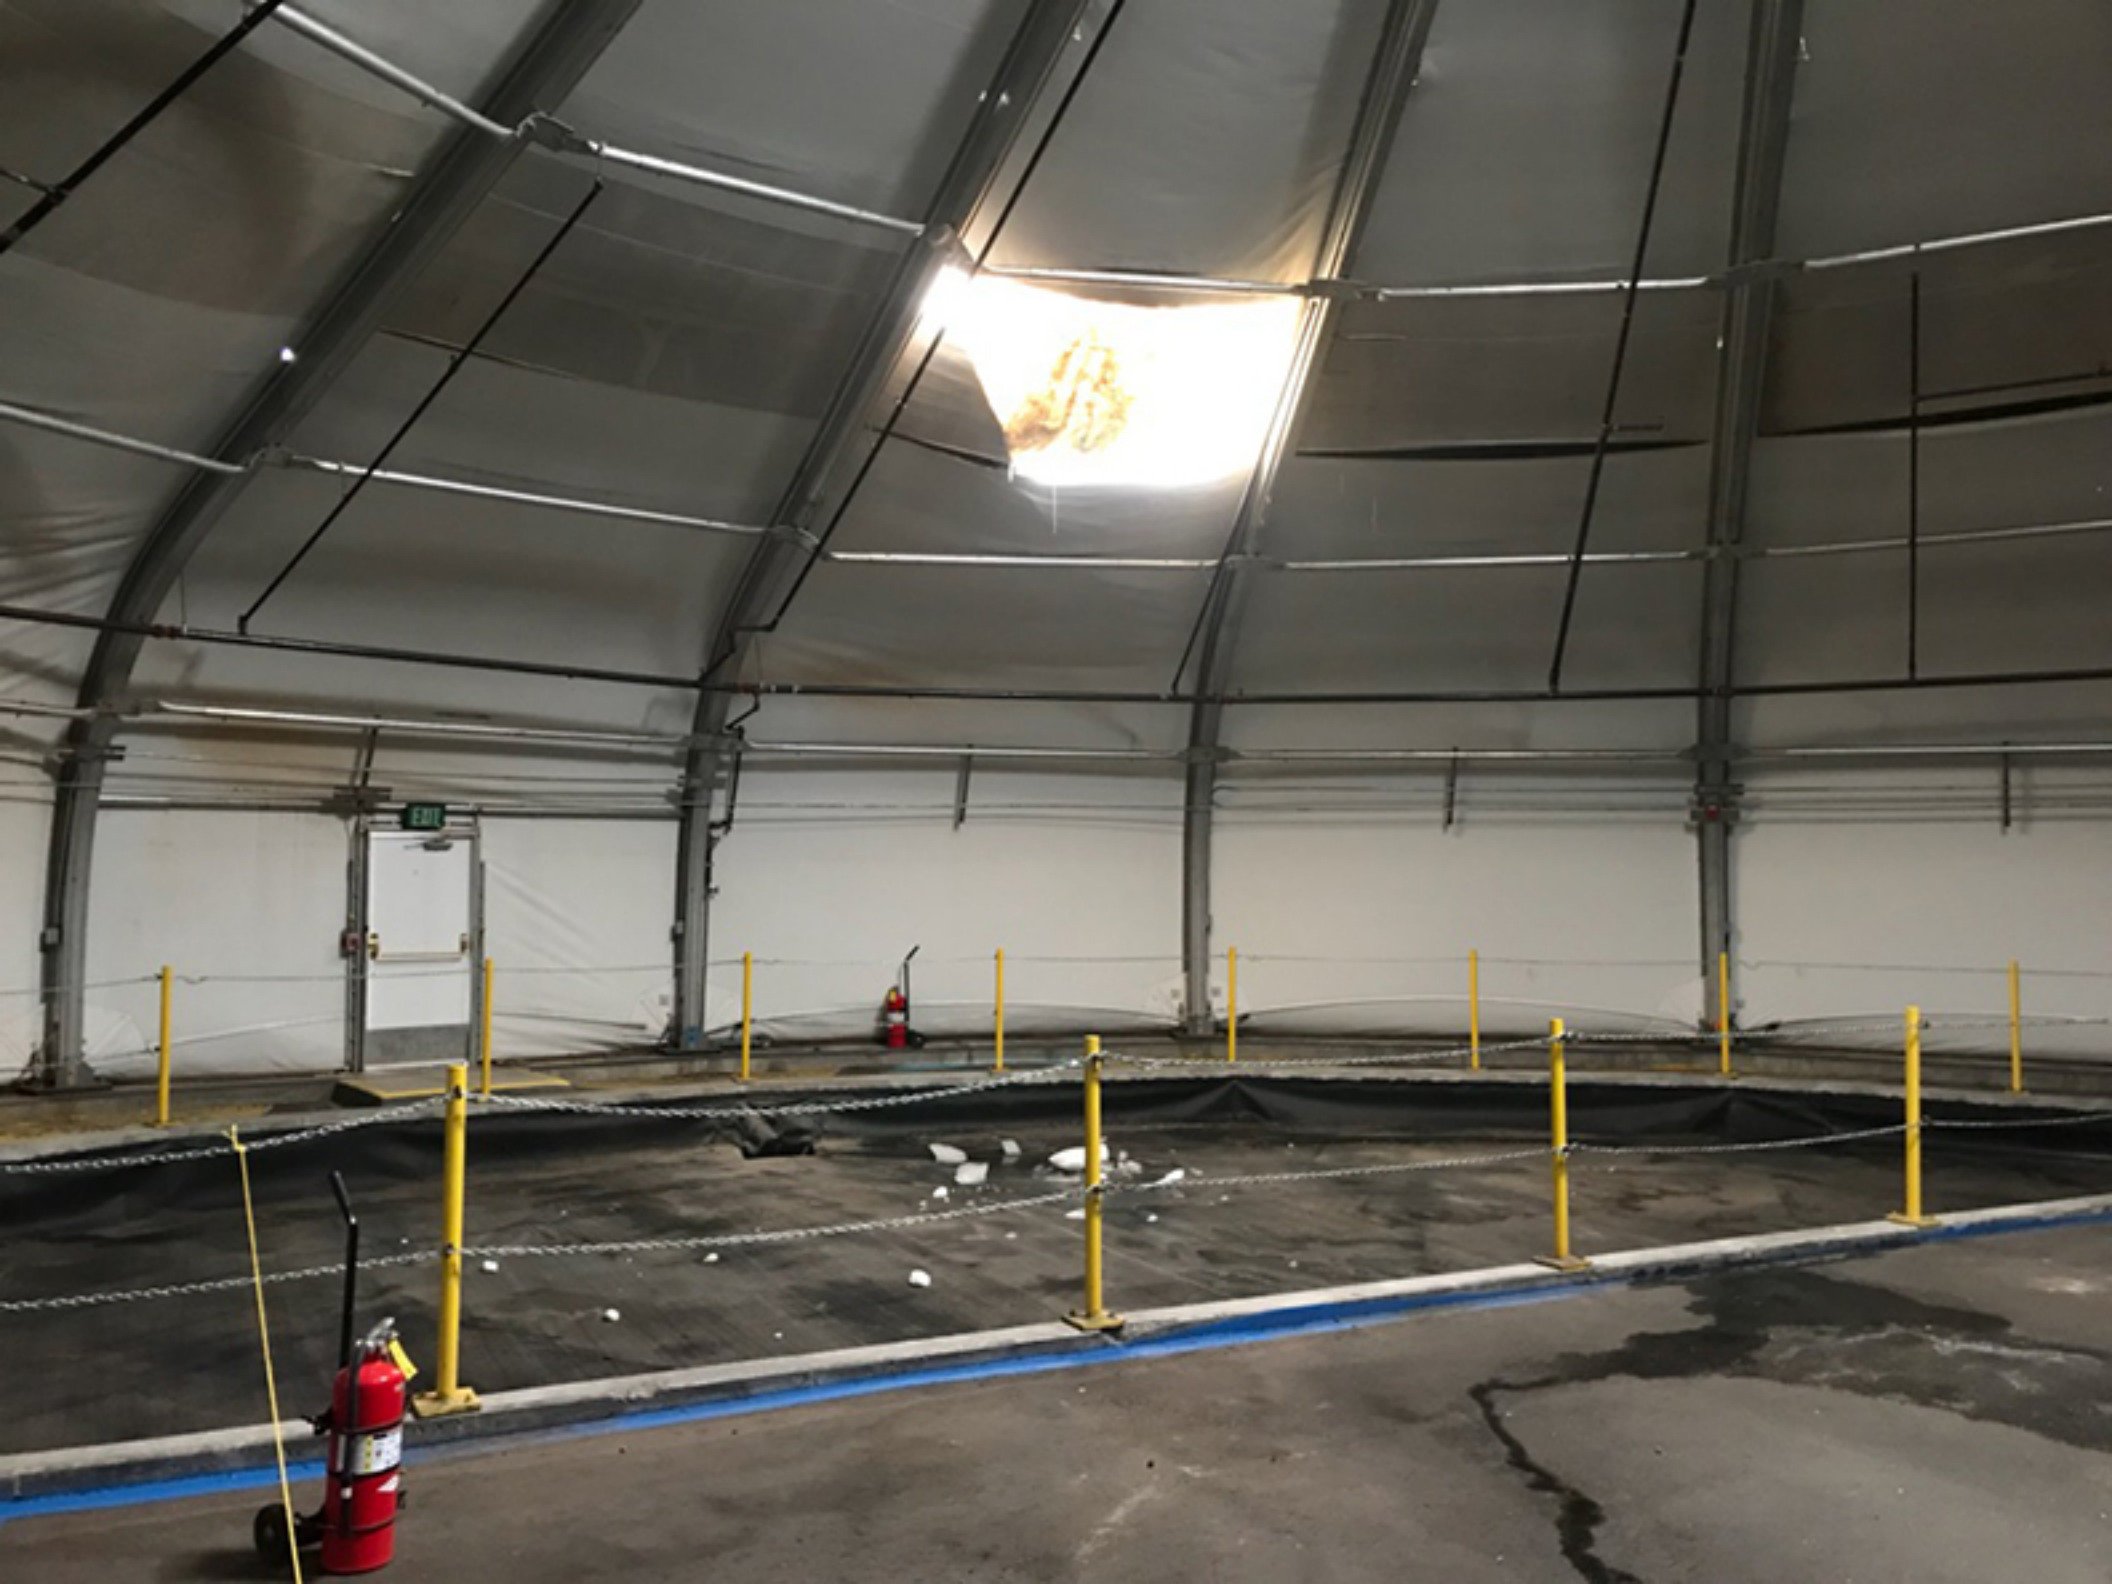
On January 7, 2019, a notification was made to N3B management regarding potential structural integrity issues at Domes 229 and 230 in Area G at TA-54. Dome 229 was observed to have a broken dome structure cross member, along with broken and bent dome structure cross-member brackets, and torn dome fabric. Dome 230 was observed to have only broken and bent dome structure cross-member brackets and torn dome fabric. Because of the torn dome fabric, snow had fallen and entered into the dome; however, the snow was contained in the sump collection areas of each dome. No waste containers were impacted. Damage was the result of the largest snowfall to the Los Alamos area since 1986.

2. Enclosure 1 provides photos of Dome 229 and Enclosure 2 provides photos of Dome 230. The engineering diagram provided at the end of each enclosure illustrates the location of the damage to each dome and the relative distance between the snow and the closest waste containers. Distance from the snow to containers is approximately 25 ft in Dome 229 and approximately 15 ft in Dome 230.

4. Reskinning (i.e., replacement of the dome fabric) the domes had already been planned for 2019. A contract for reskinning multiple domes at TA-54 was issued in August 2018. Repairs and reskinning for Dome 230 will begin in March 2019. Repairs and reskinning for Dome 229 will begin in June 2019. During reskinning, the Permittees will ensure that all containers stored at these permitted units will remain in compliance with the provisions of the Permit.

6. Damage to Domes 229 and 230 and snow accumulation through January 4, 2019, did not impact hazardous waste containers in either dome. However, on a case-by-case basis, containers are being covered with tarps (i.e., fire retardant plastic) to protect them until domes are repaired and/or reskinned.
