Date: **MAR 05 2019**
Refer To: N3B-19-0065

**Subject: Response to Request for Information Regarding Damage to Technical Area 54
Domes 229 and 230 and Compliance with Los Alamos National Laboratory
Hazardous Waste Facility Permit, EPA ID No. NM0890010515**

Event Summary:

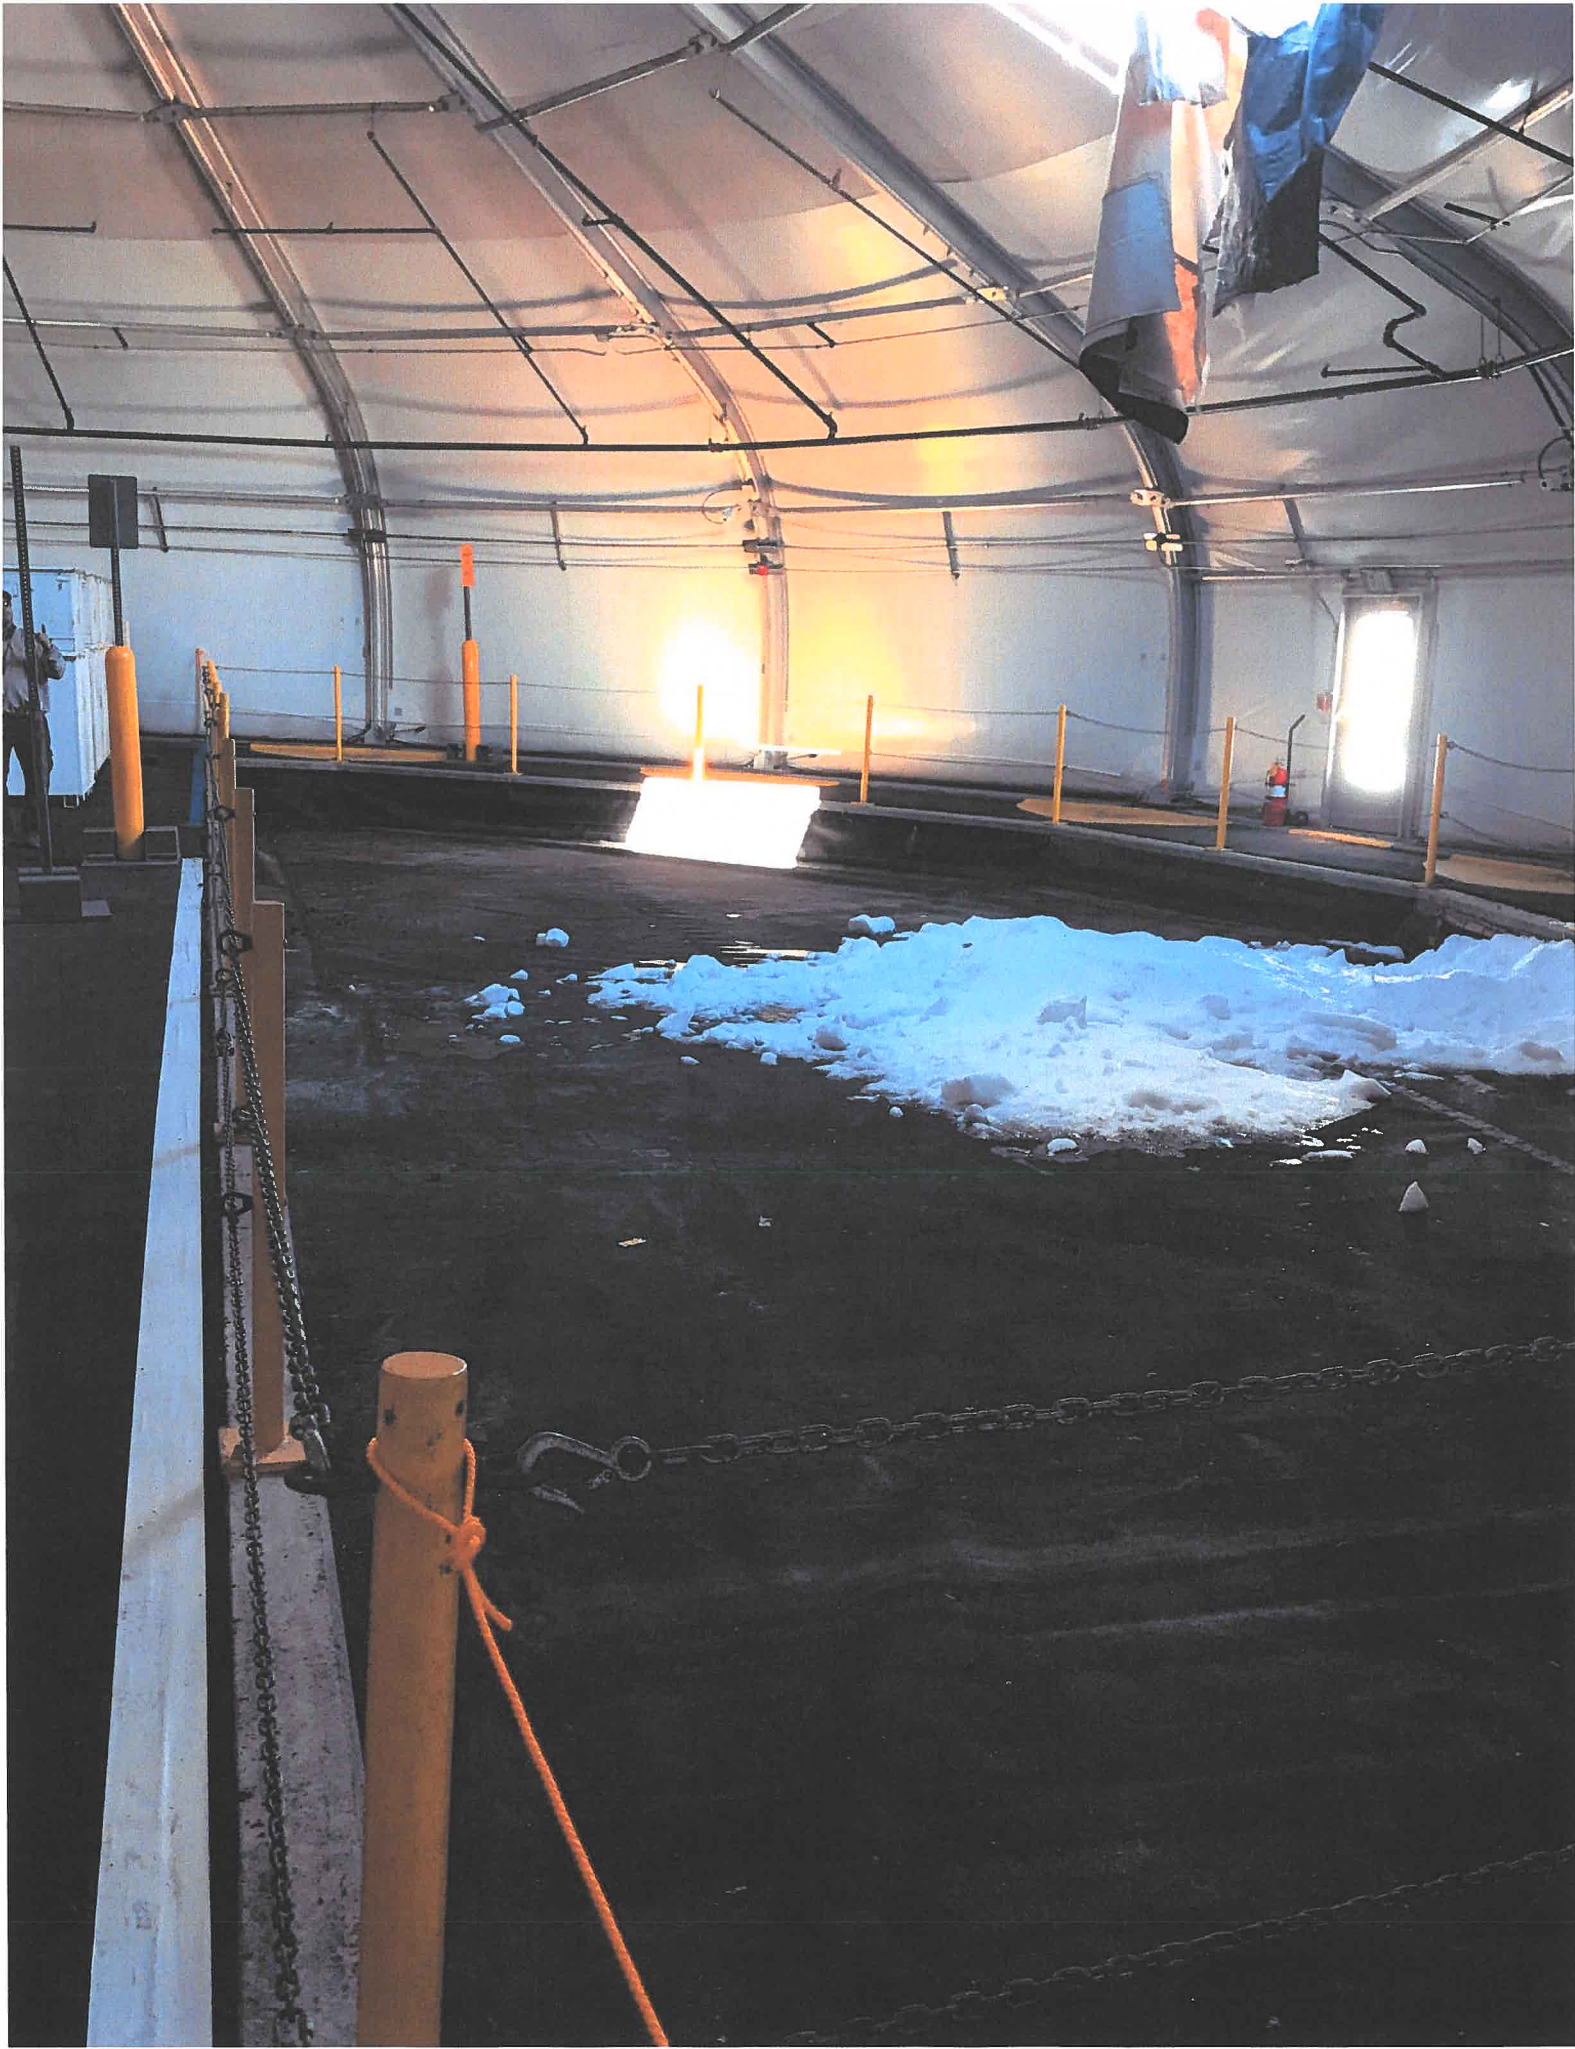
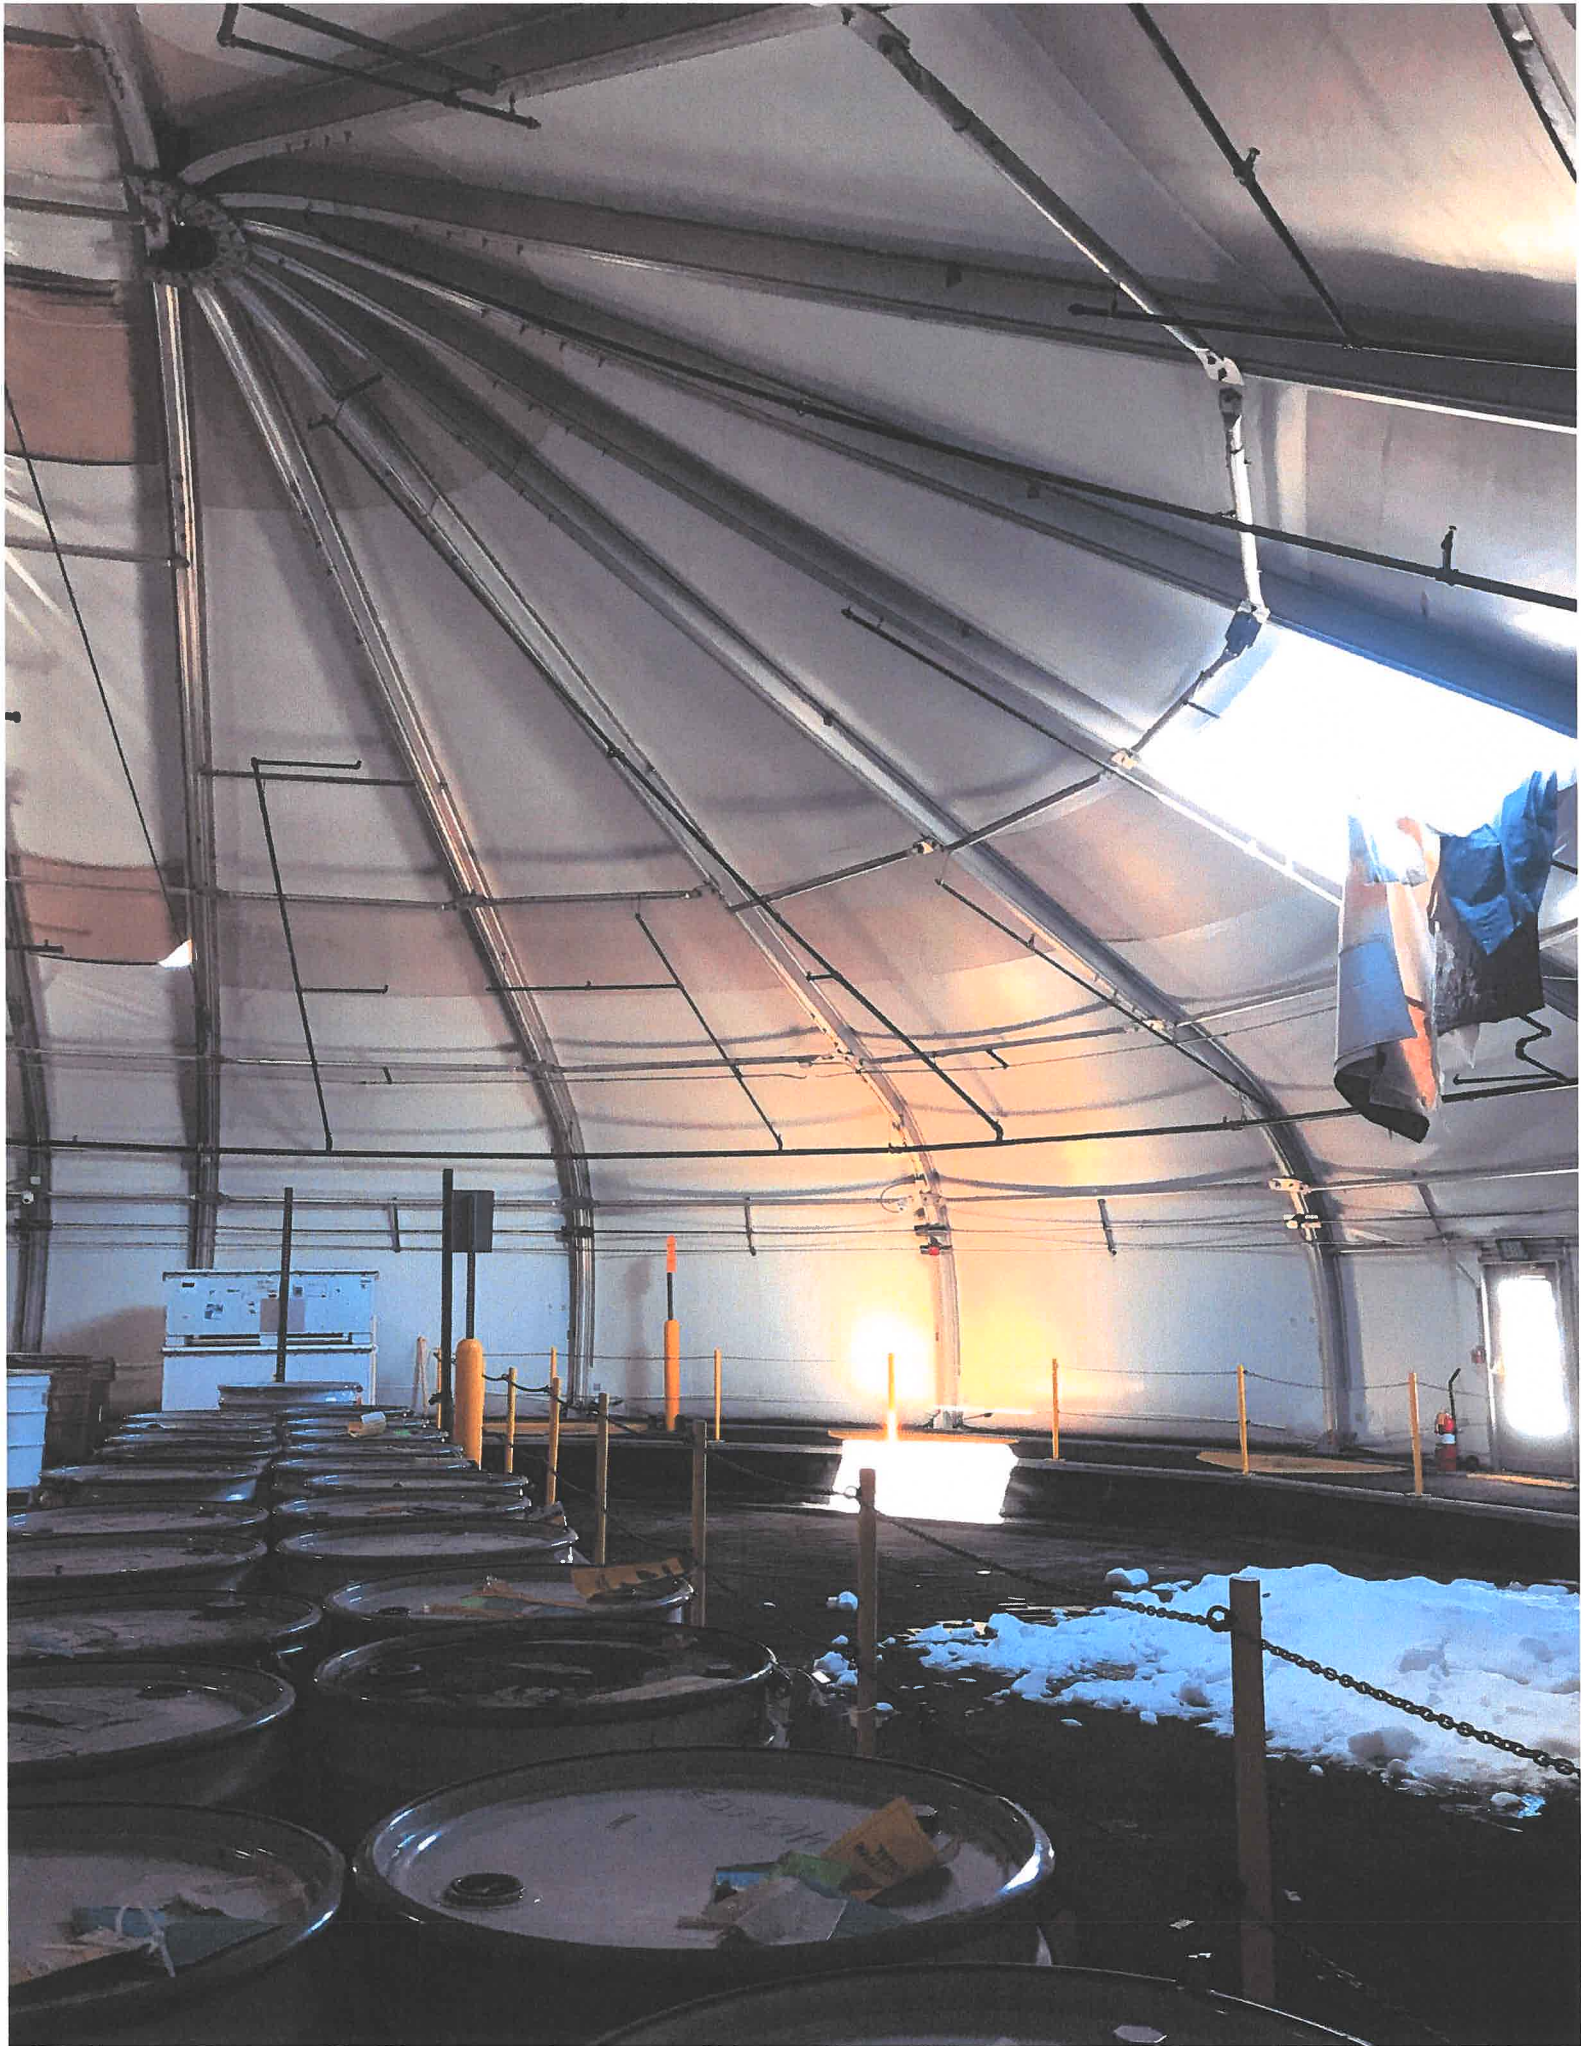
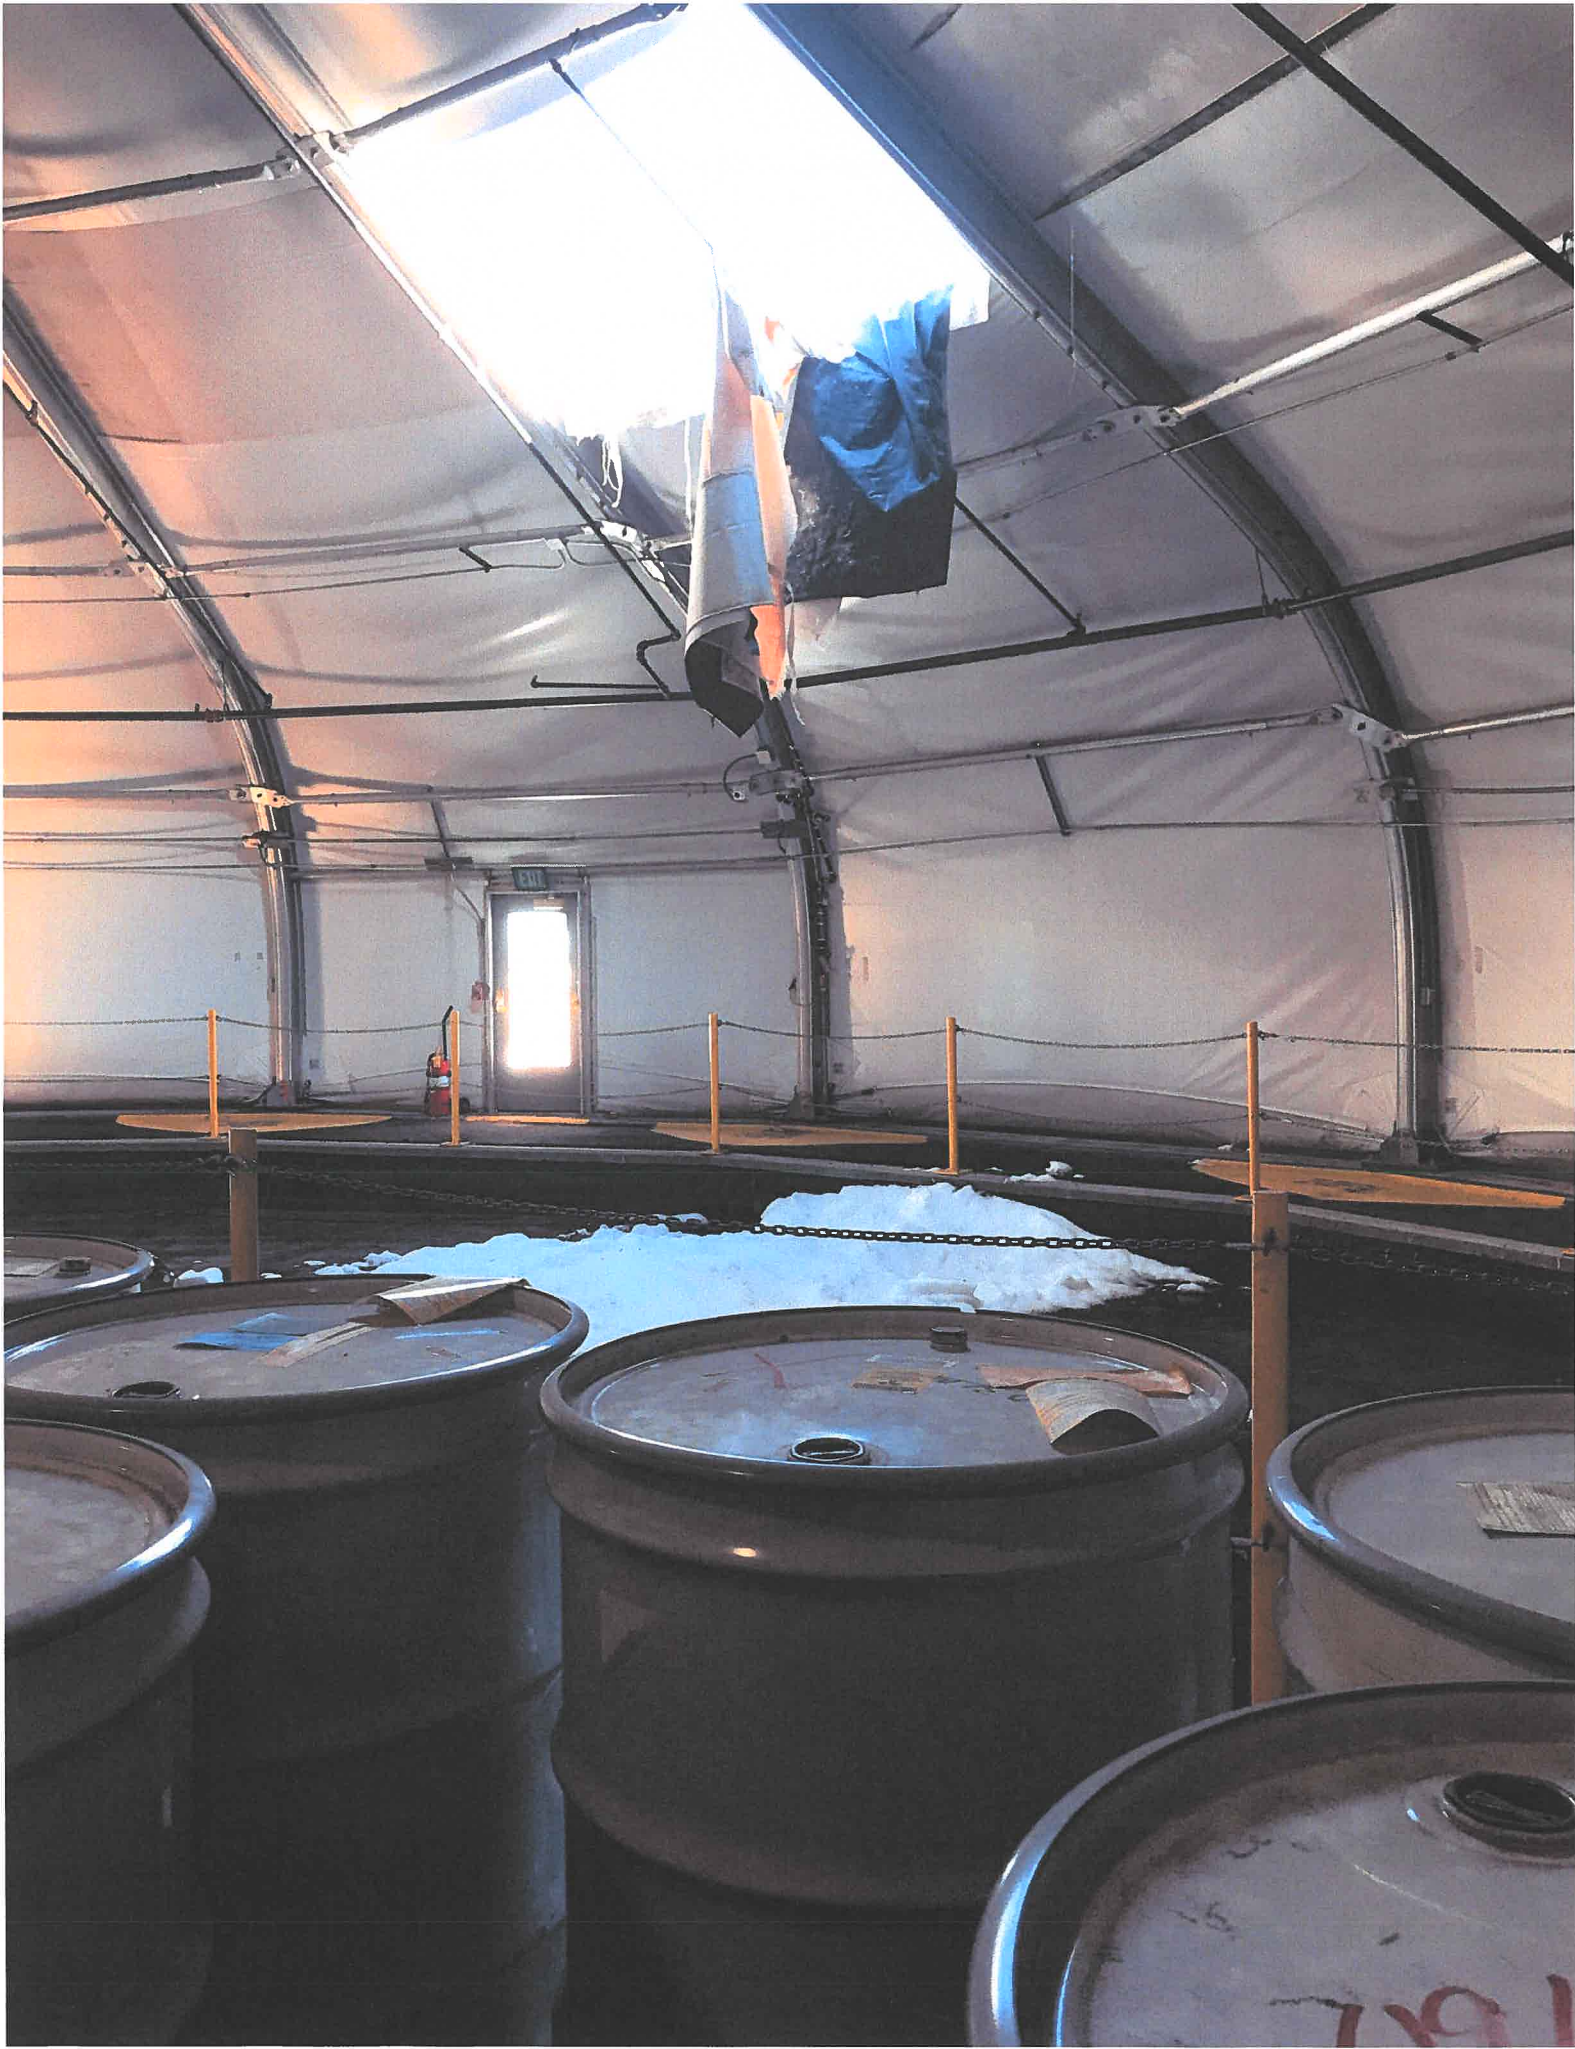
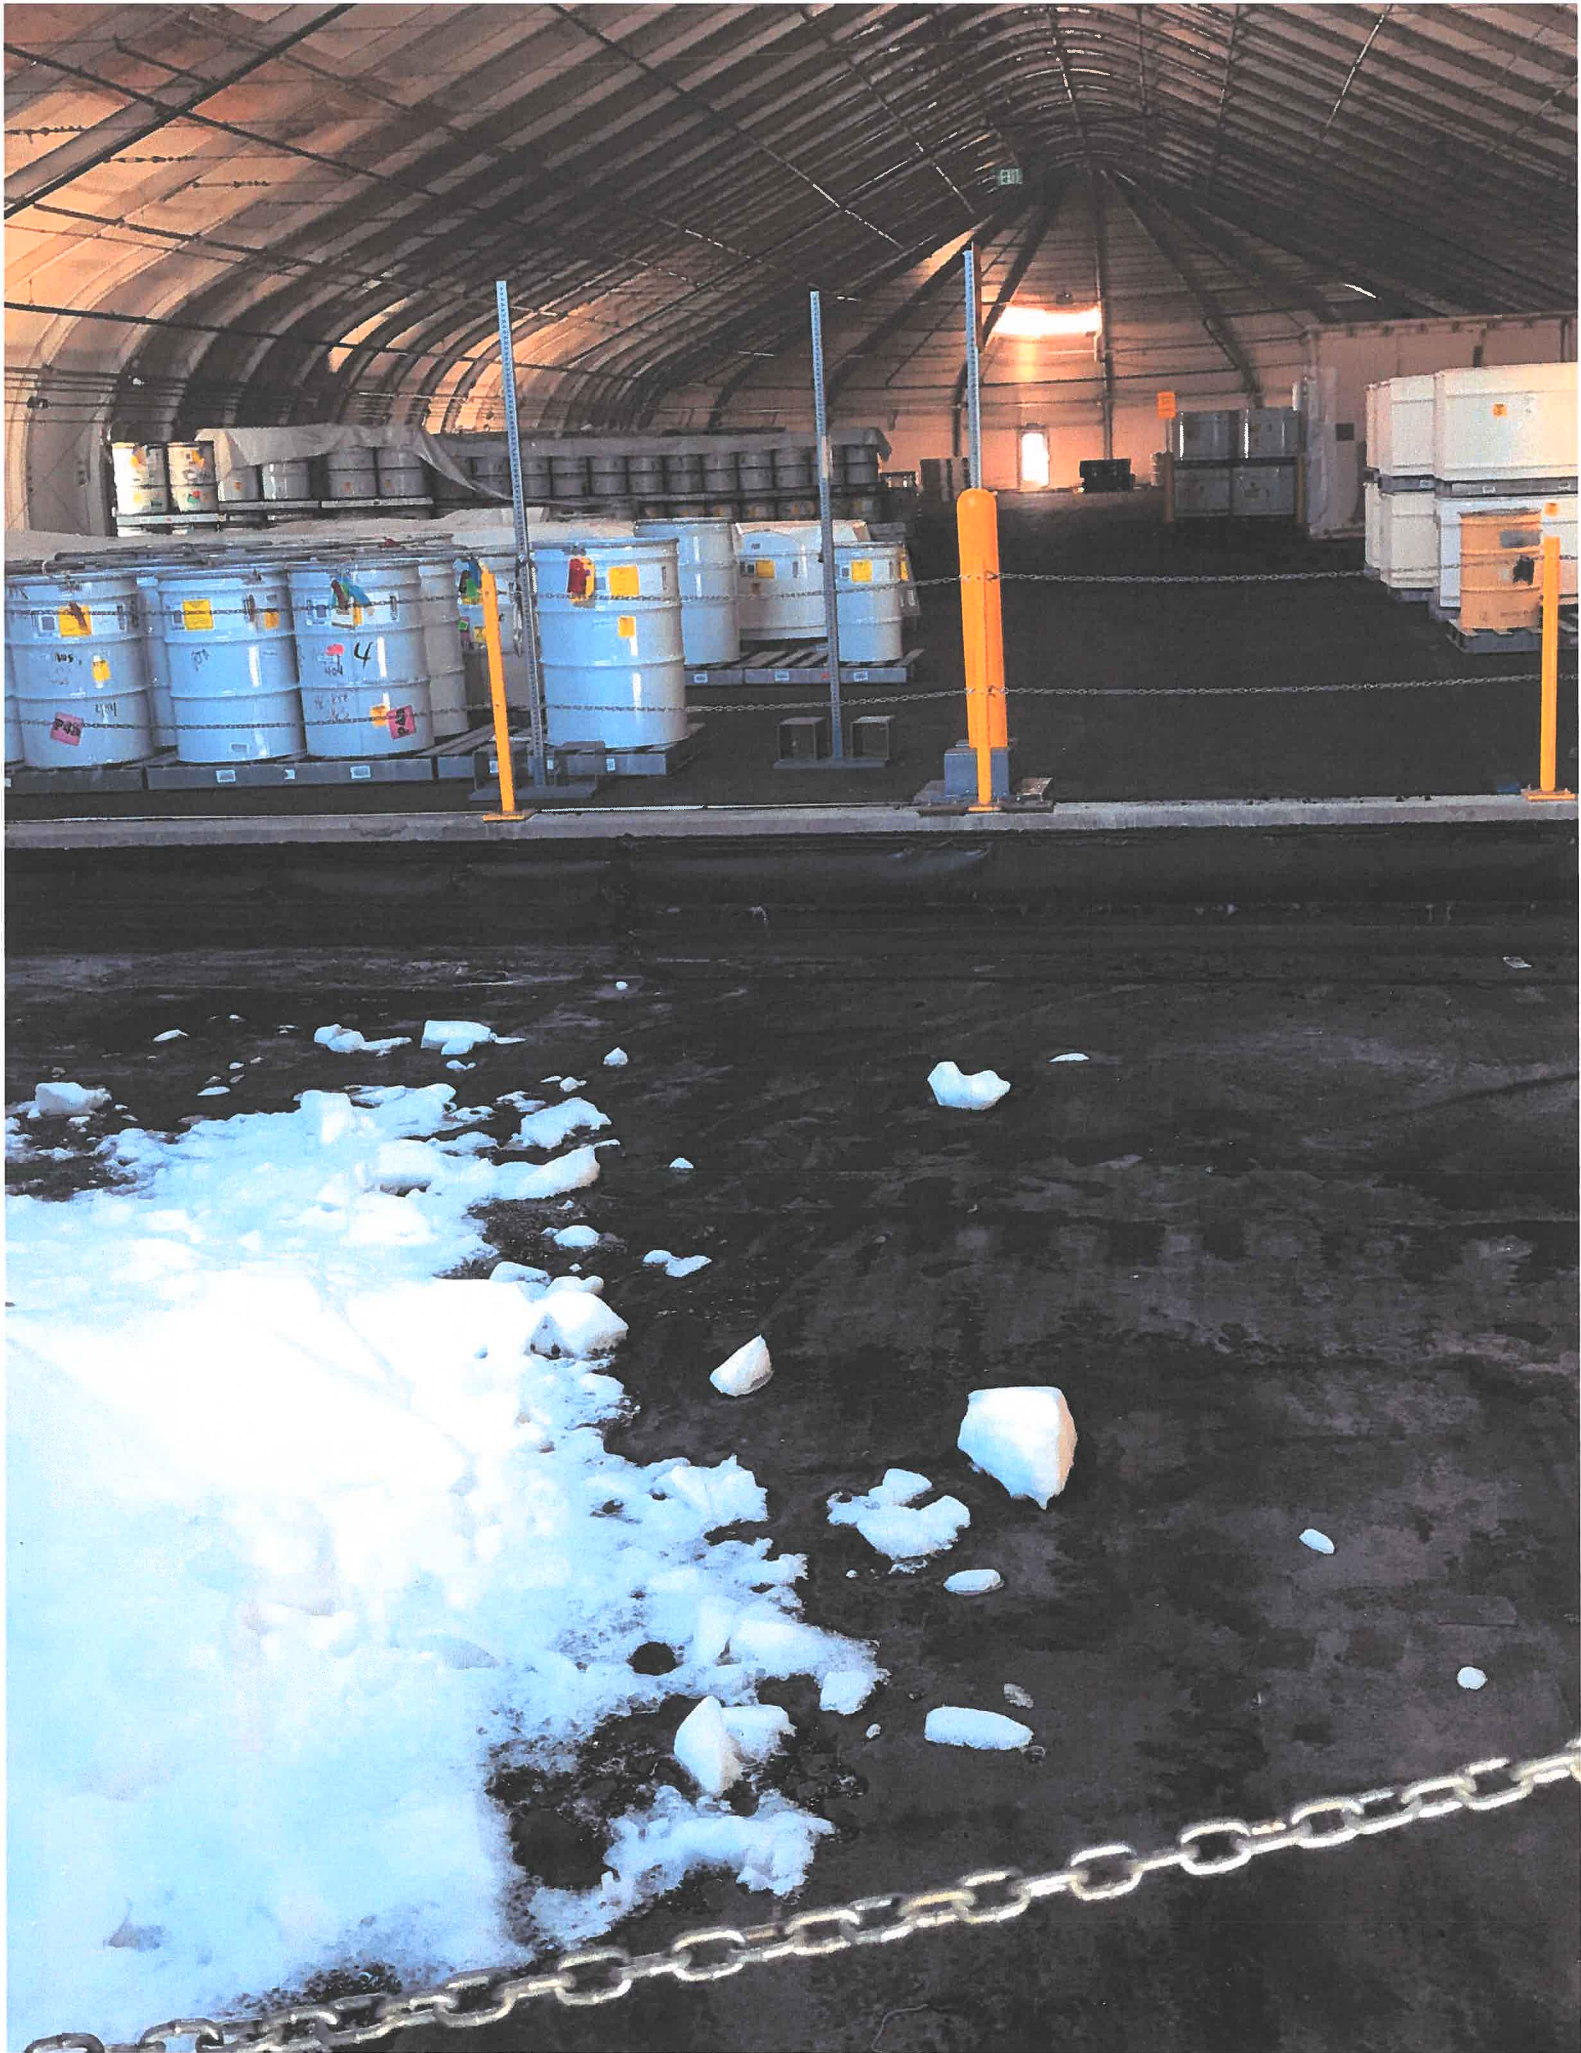
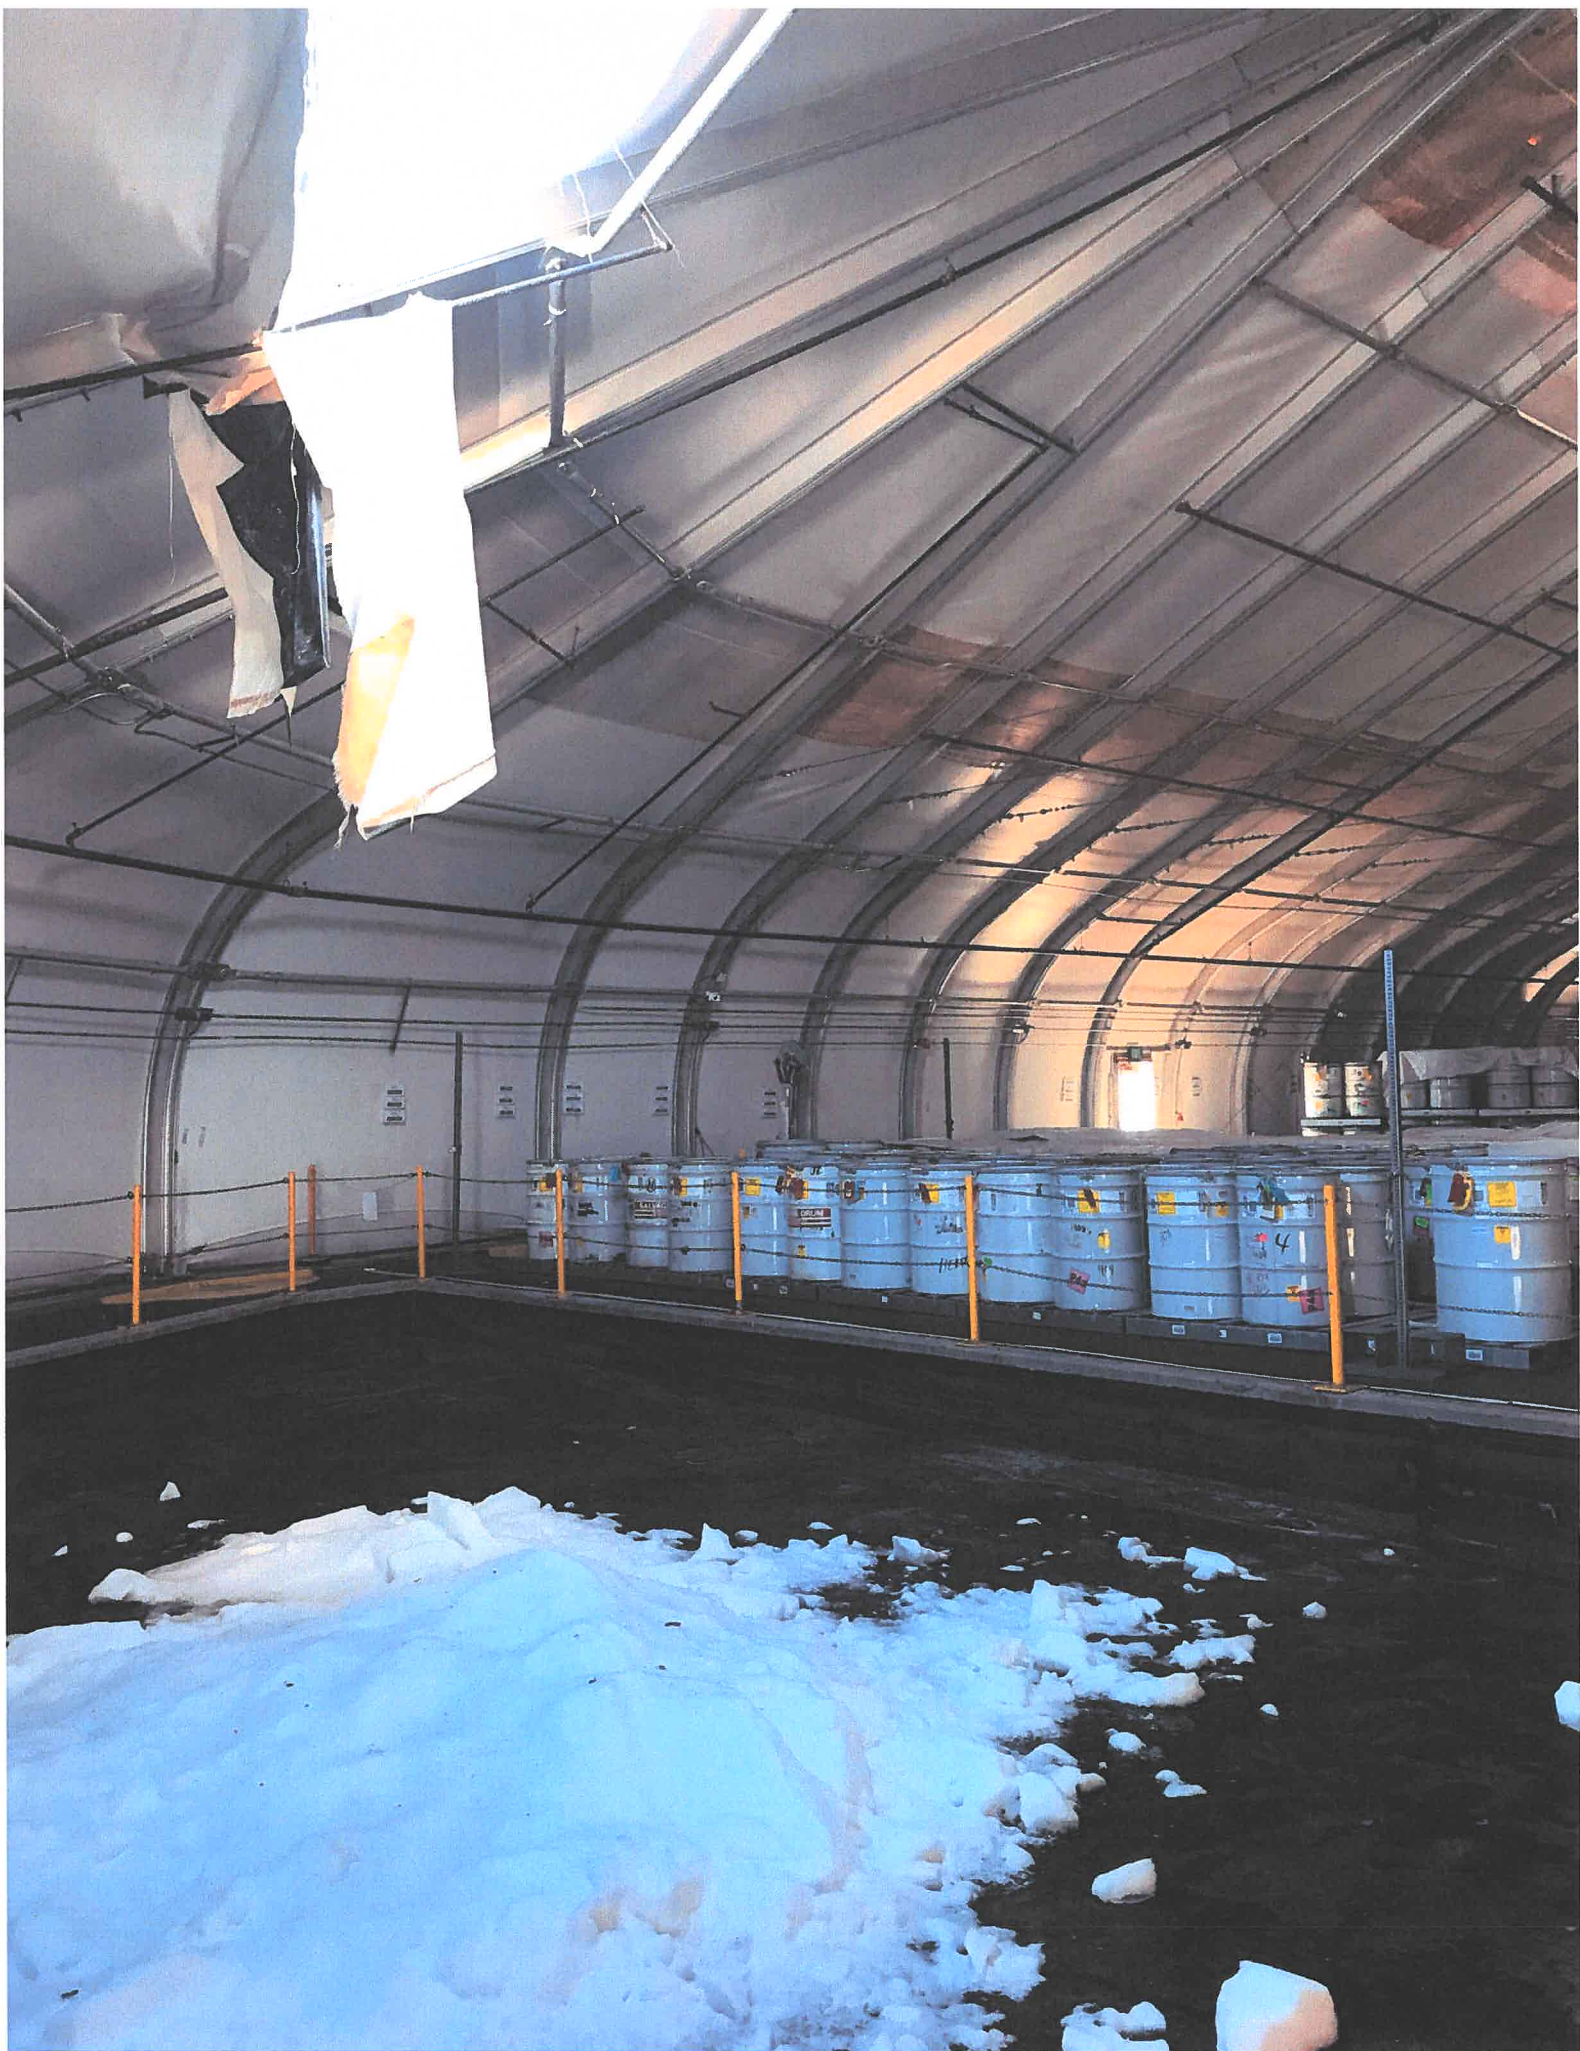
2. Enclosure 1 provides photos of Dome 229 and Enclosure 2 provides photos of Dome 230. The engineering diagram provided at the end of each enclosure illustrates the location of the damage to each dome and the relative distance between the snow and the closest waste containers. Distance from the snow to containers is approximately 25 ft in Dome 229 and approximately 15 ft in Dome 230.

4. Reskinning (i.e., replacement of the dome fabric) the domes had already been planned for 2019. A contract for reskinning multiple domes at TA-54 was issued in August 2018. Repairs and reskinning for Dome 230 will begin in March 2019. Repairs and reskinning for Dome 229 will begin in June 2019. During reskinning, the Permittees will ensure that all containers stored at these permitted units will remain in compliance with the provisions of the Permit.

6. Damage to Domes 229 and 230 and snow accumulation through January 4, 2019, did not impact hazardous waste containers in either dome. However, on a case-by-case basis, containers are being covered with tarps (i.e., fire retardant plastic) to protect them until domes are repaired and/or reskinned.
