EMID-700411

2018 Update to the Site Discharge Pollution Prevention Plan, Revision 1

NPDES Permit No. NM0030759

Volume 3

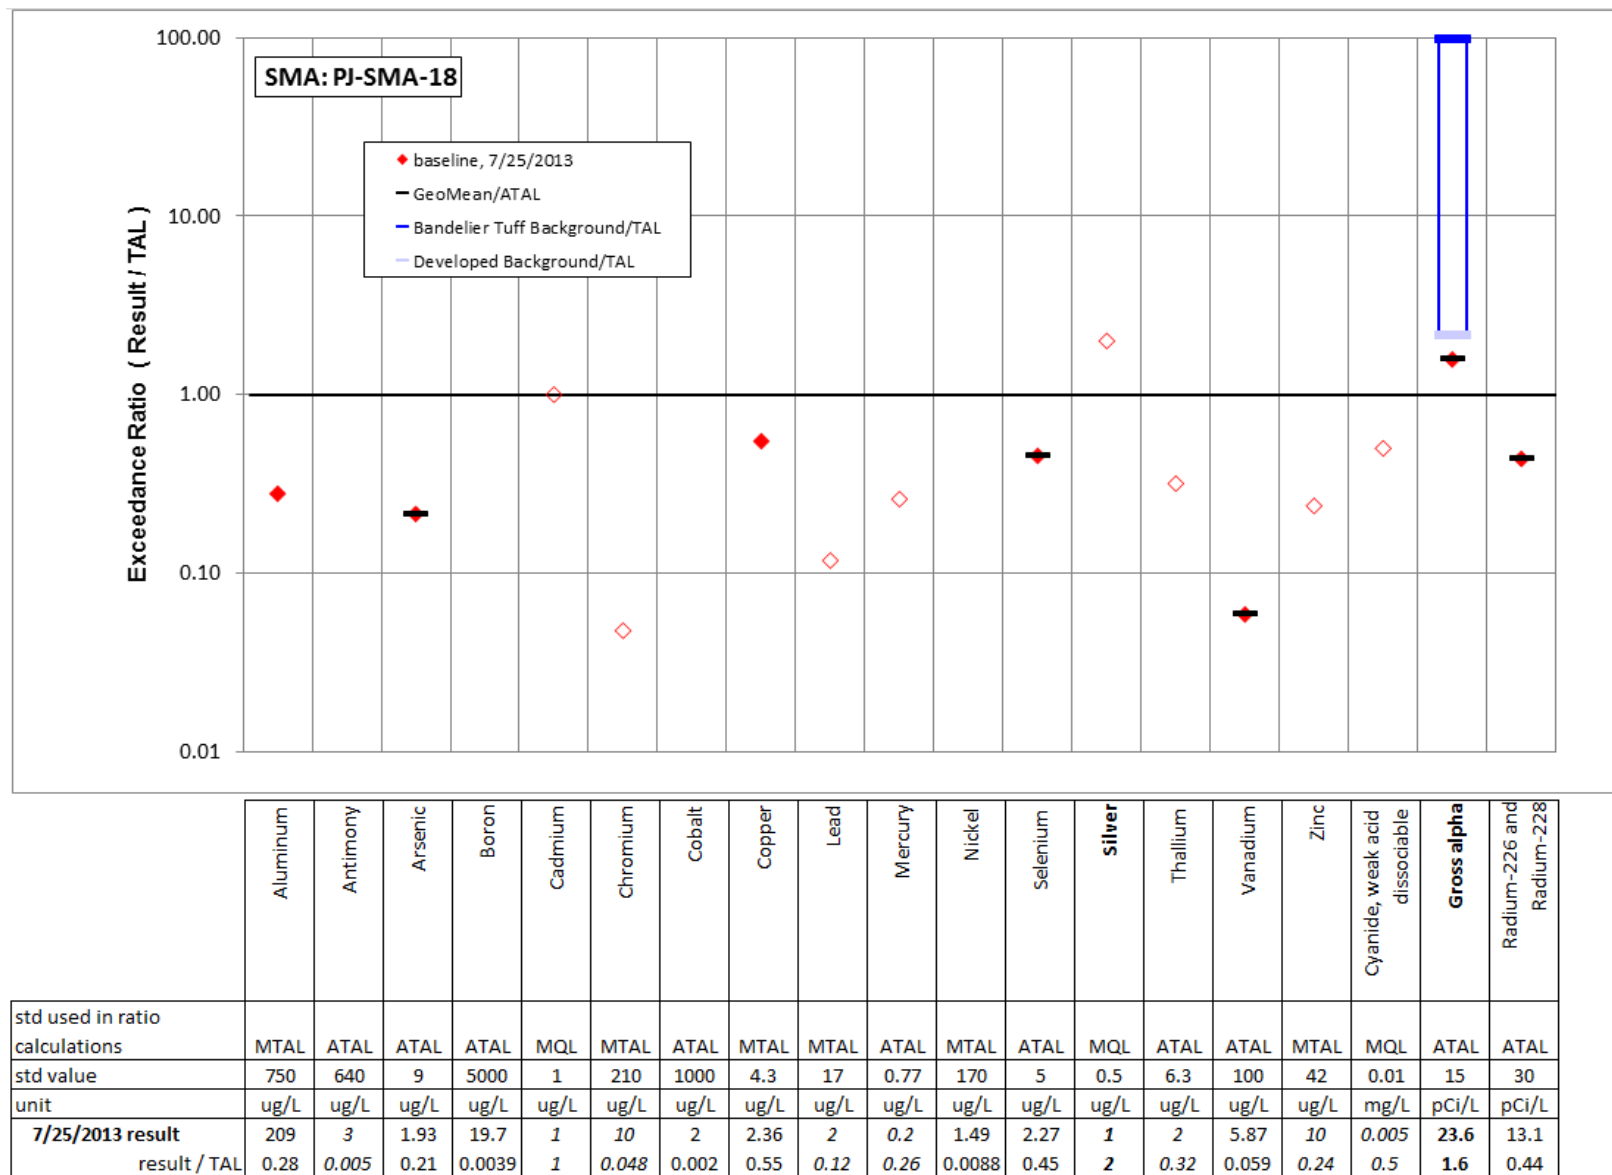
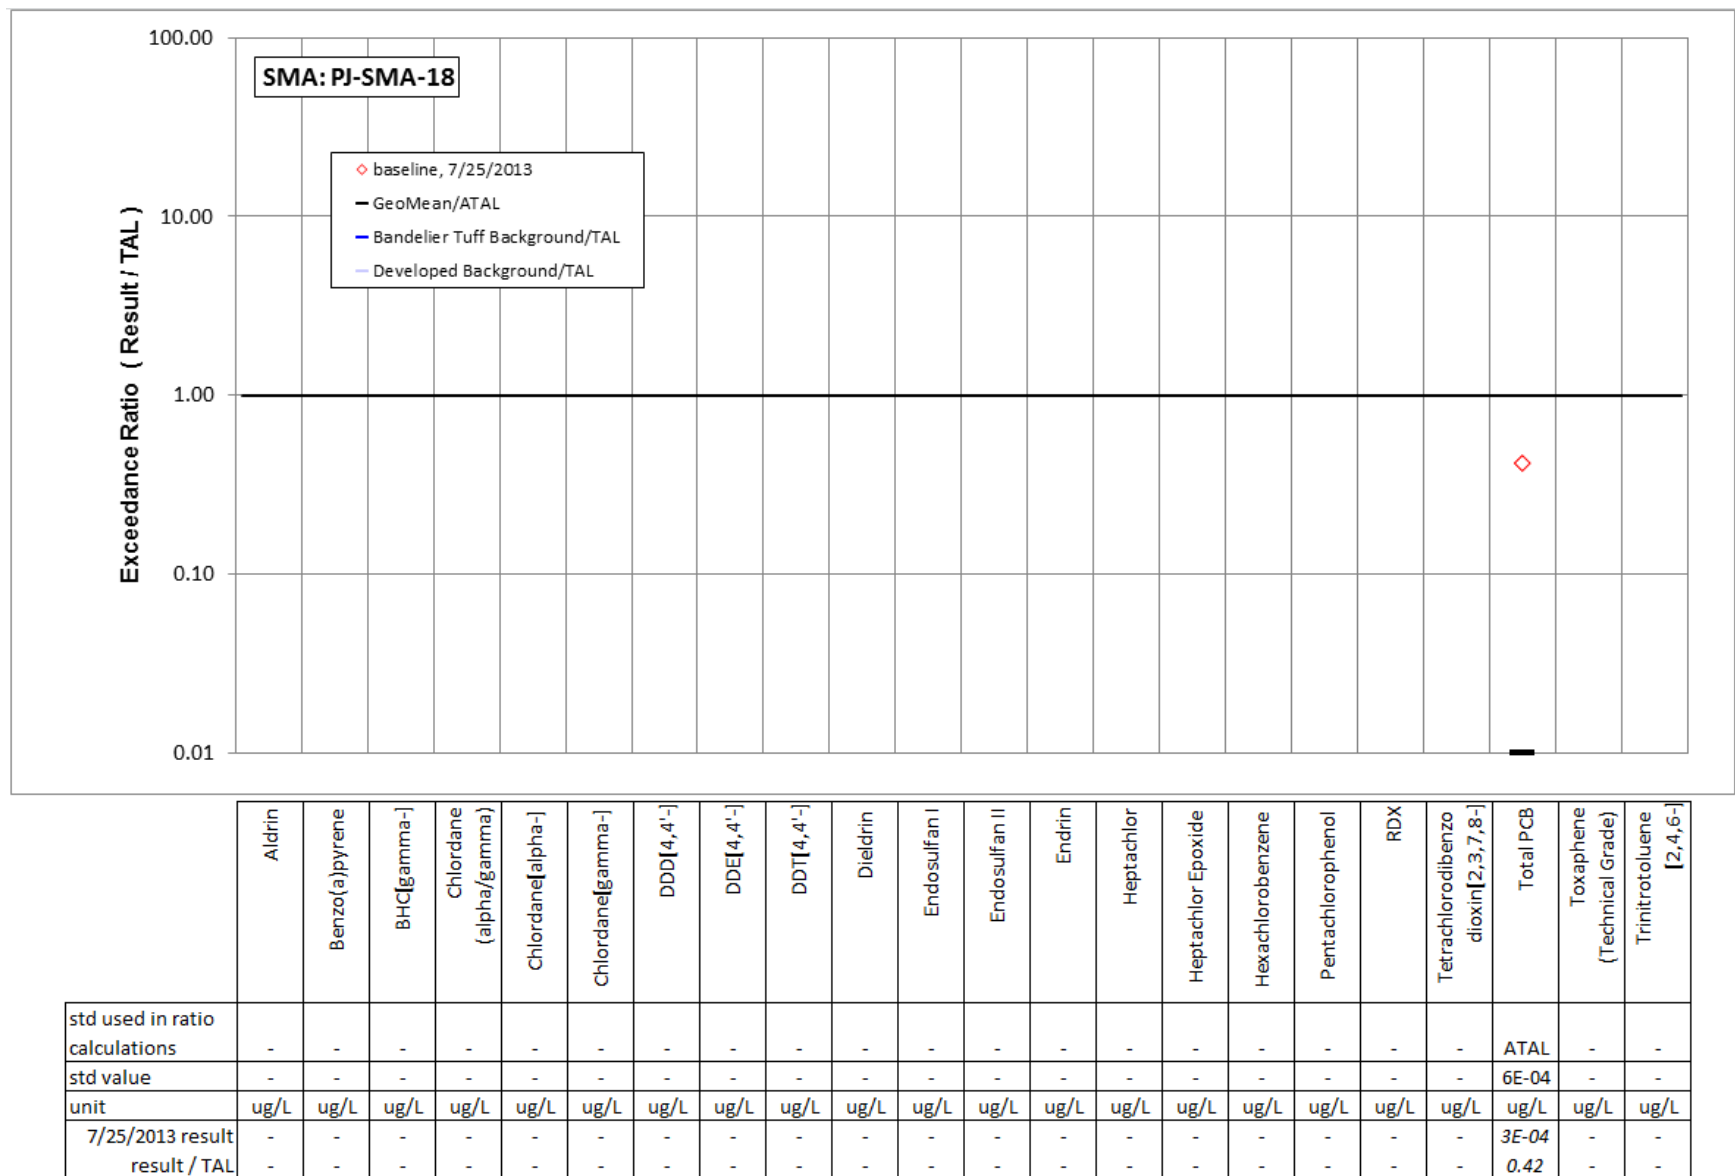
Figure 173-2 Inorganic analytical results summary plot for PJ-SMA-18

SWMUs 54-014(d) and 54-017 were monitored within PJ-SMA-18. Following the installation of baseline control measures, a baseline storm water sample was collected on July 25, 2013 (Figures 173-2 and 173-3). No exposure was certified and a completion of corrective action for PJ-SMA-18 was submitted on August 28, 2014. This Site is now certified as corrective action complete, and monitoring of storm water discharges has ceased at PJ-SMA-18. No further sampling is required for PJ-SMA-18 for the remainder of the IP. In Figure 173-2, cadmium and silver are reported as nondetectable results equal to or greater than their respective TALs. These values are reported at the PQL; however, the MDLs for these analytes are below the TAL. Analytical results from this sample yielded the following TAL exceedance:

A no exposure confirmation sample was collected on August 10, 2018 (Figures 173-2 and 173-3). Analytical results from this sample yielded the following TAL exceedances:

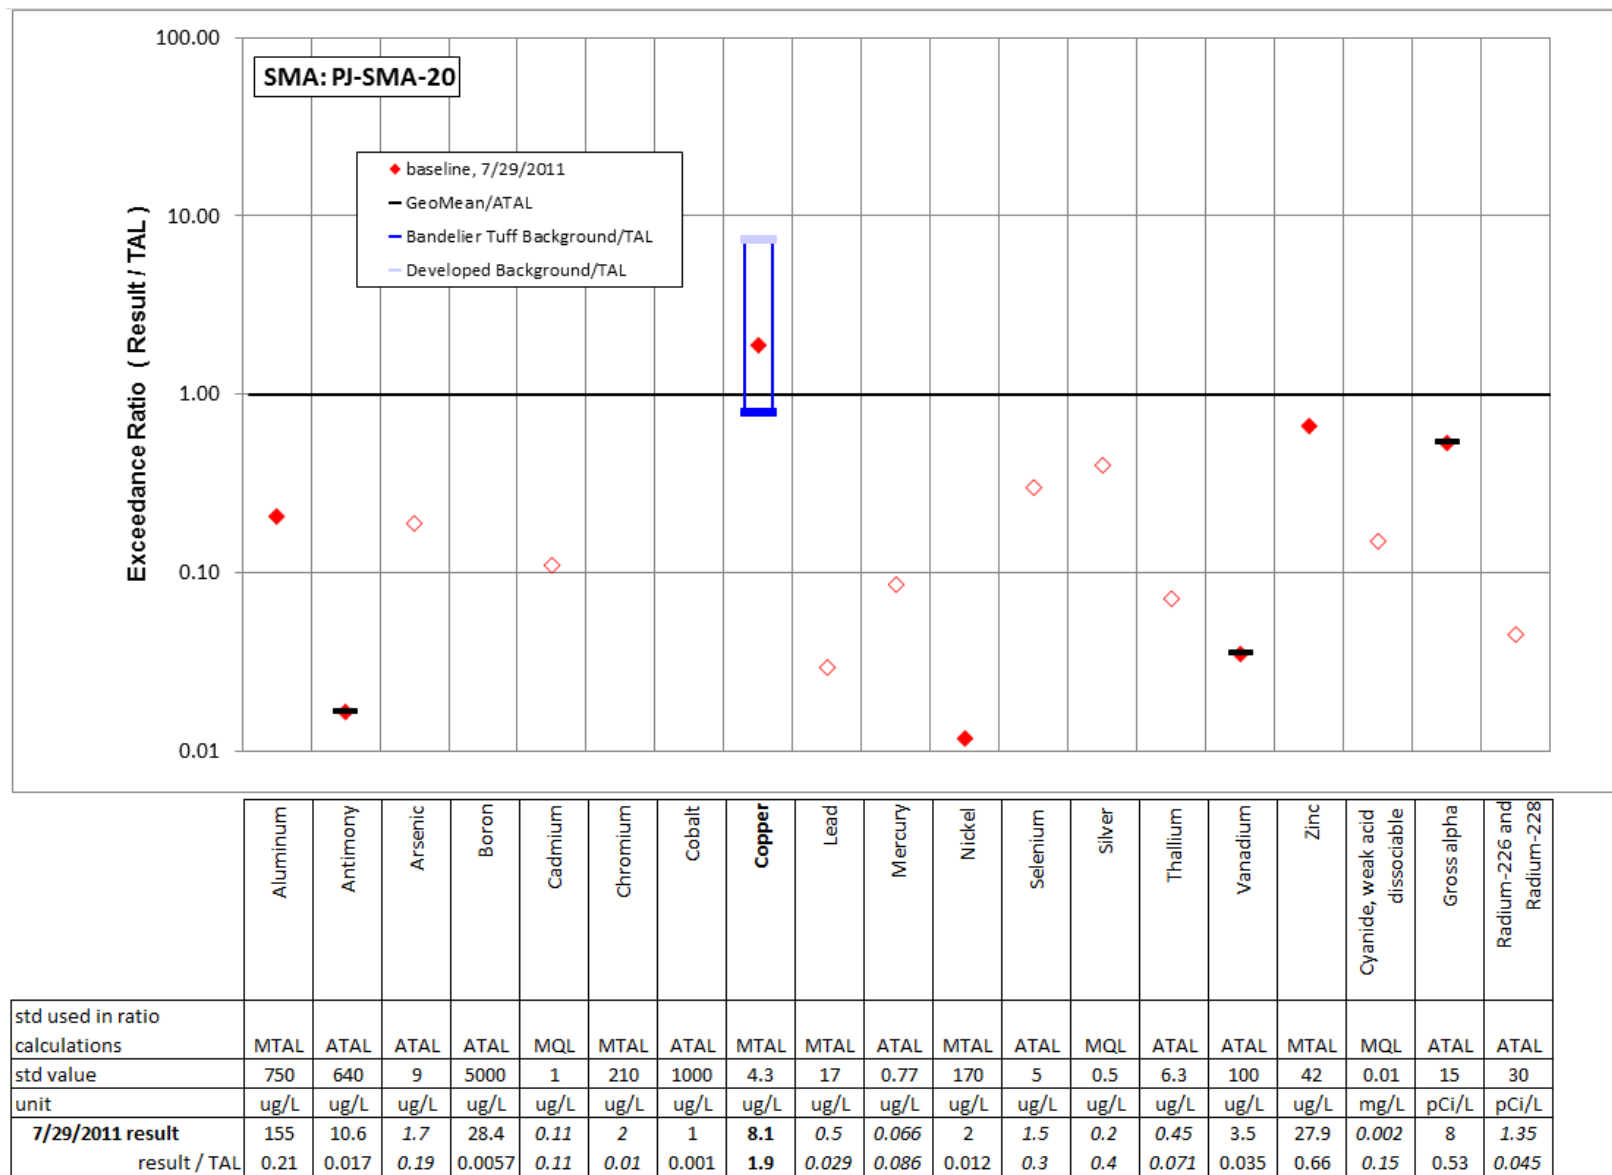
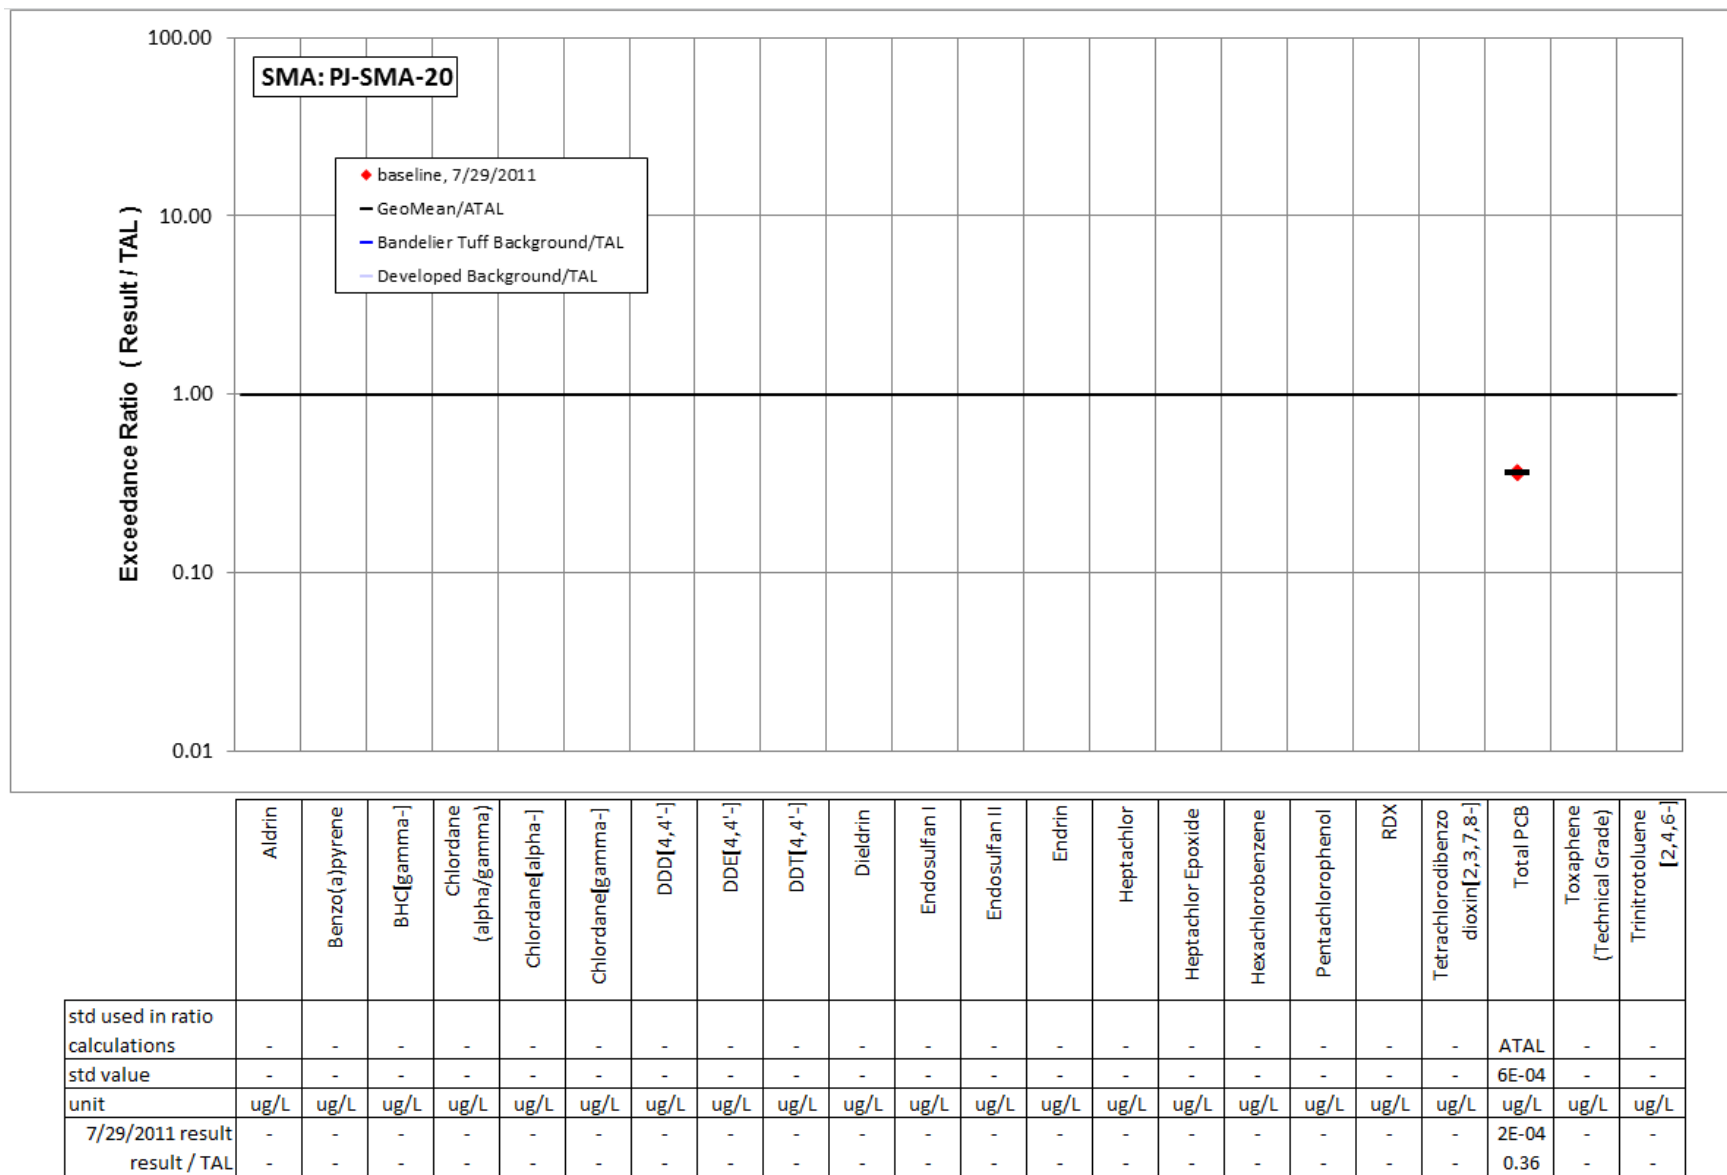
Figure 175-2 Inorganic analytical results summary plot for PJ-SMA-20

SWMU 54-017 was monitored within PJ-SMA-20. Following the installation of baseline control measures, a baseline storm water sample was collected on July 29, 2011 (Figures 175-2 and 175-3). On October 25, 2013, a document certifying the no exposure condition of SWMU 54-017 was completed and submitted to EPA. This Site is now certified as corrective action complete, and monitoring of storm water discharges has ceased at PJ-SMA-20. No further sampling is required for PJ-SMA-20 for the remainder of the IP. Analytical results from this sample yielded the following TAL exceedances:

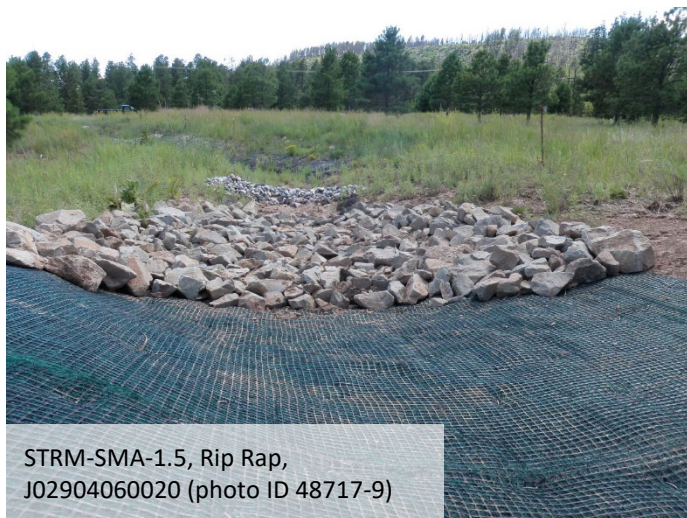
STRM-SMA-1.5, Rip Rap,
 J02904060020 (photo ID 48717-9)

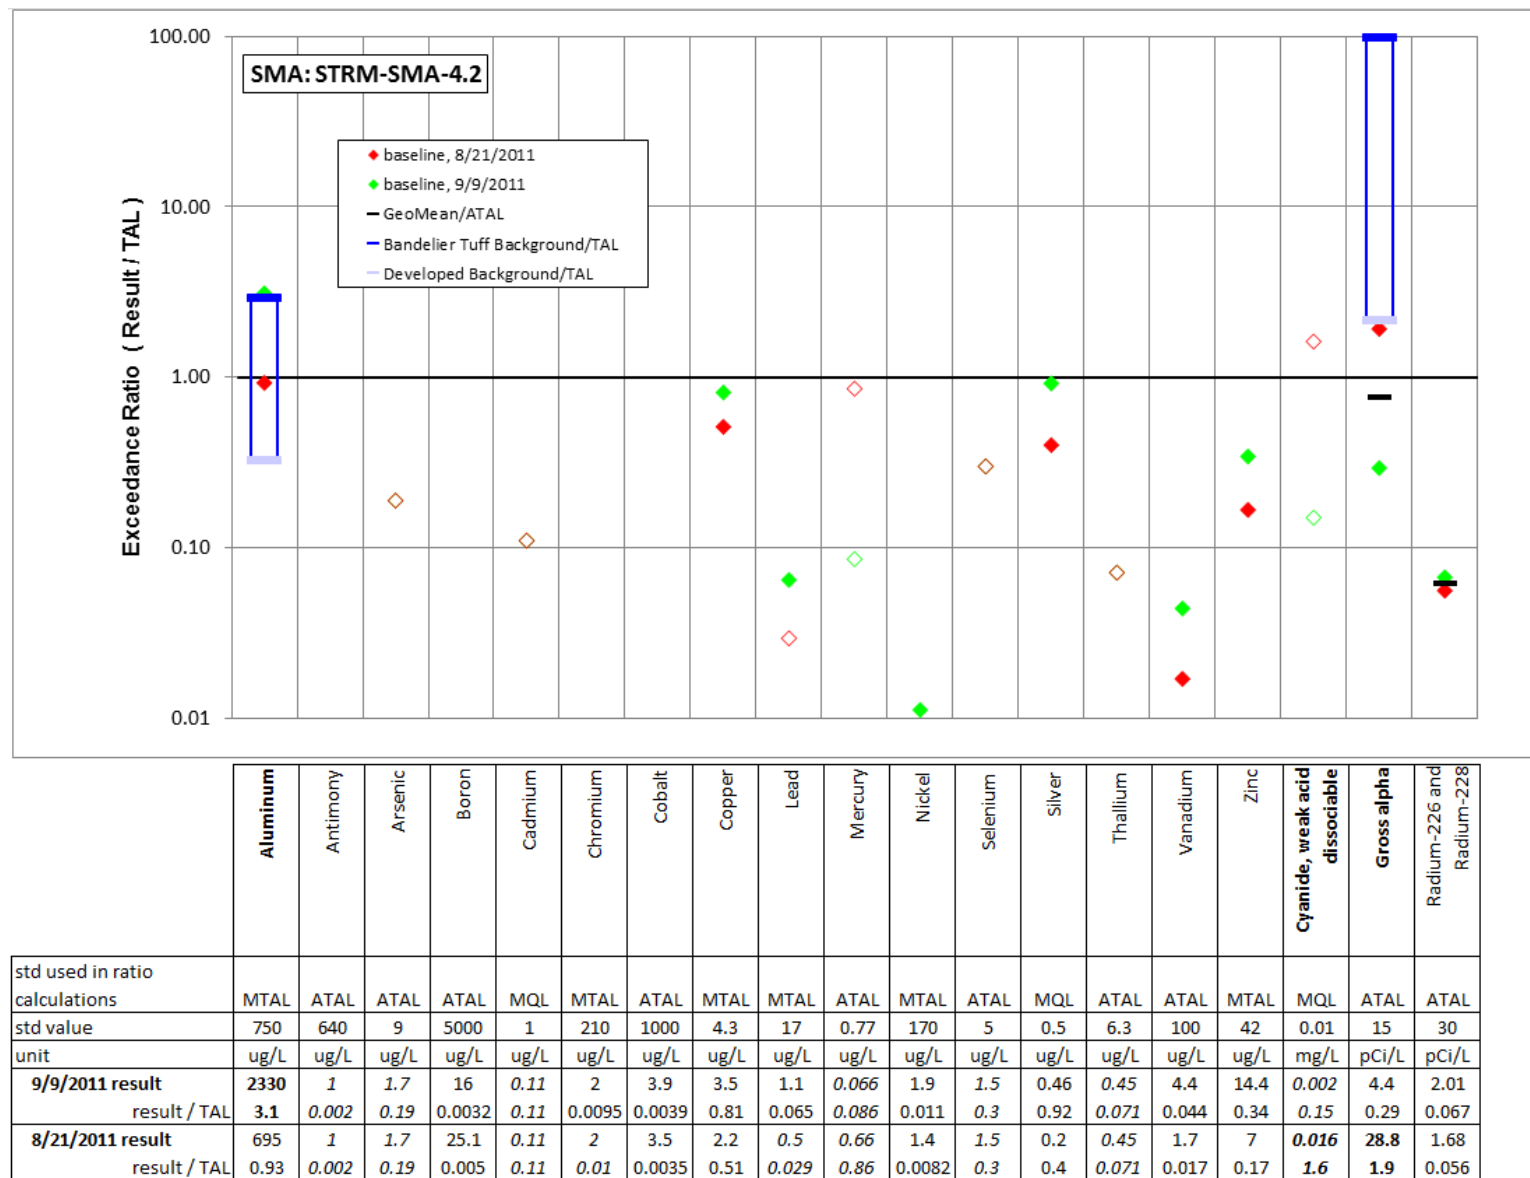
Figure 178-2b Inorganic analytical results summary plot for STRM-SMA-4.2

SWMU 09-008(b) is monitored within STRM-SMA-4.2. Following the installation of baseline control measures, baseline storm water samples were collected on August 21, 2011, and September 9, 2011 (Figure 178-2b). In Figure 178-2b, cyanide is reported as a nondetectable result equal to or greater than the TALs. This value is reported at the PQL; however, the MDL for this analyte is below the TAL. Analytical results from this sample yielded the following TAL exceedance:

Enhanced control confirmation storm water samples were collected on July 29, 2017, and September 27, 2017 (Figure 178-2b). Analytical results from these samples yielded the following TAL exceedances:
