Subject: Submittal of the 2018/2019 Annual Long-Term Monitoring Status Report (July 2018 through June 2019) for Los Alamos County Airport Landfill Cover System Replacement, Solid Waste Management Units 73-001(a,d), Technical Area 73

### **LOS ALAMOS COUNTY AIRPORT LANDFILL COVER SYSTEM REPLACEMENT SOLID WASTE MANAGEMENT UNITS 73-001(a,d) TECHNICAL AREA 73**

<b>Site Name: Los Alamos County Airport Landfill Cover Replacement</b>	<b>Date of Inspection: October 1, 2018</b>
<b>City: Los Alamos</b>	<b>Weather: warm, partly cloudy, breezy</b>
<b>State: New Mexico</b>	<b>Temperature: 70s</b>
<b>Agency: Department of Energy</b>	<b>Inspector: Stephen F Dwyer, PhD, PE</b>
<b>Site Element</b>	<b>Remarks</b>
1. Construction of the new LA County Airport Hangar continues. This is west of the footprint of the landfill. The seeded areas adjacent to this work in the waste removal areas have been disturbed. This area is scheduled to be reseeded by the Los Alamos County upon completion of the hangar and utility work (Pictures 3, 7 and 8).	1. This work is west of the landfill and does not affect the performance of the cover or related facilities.

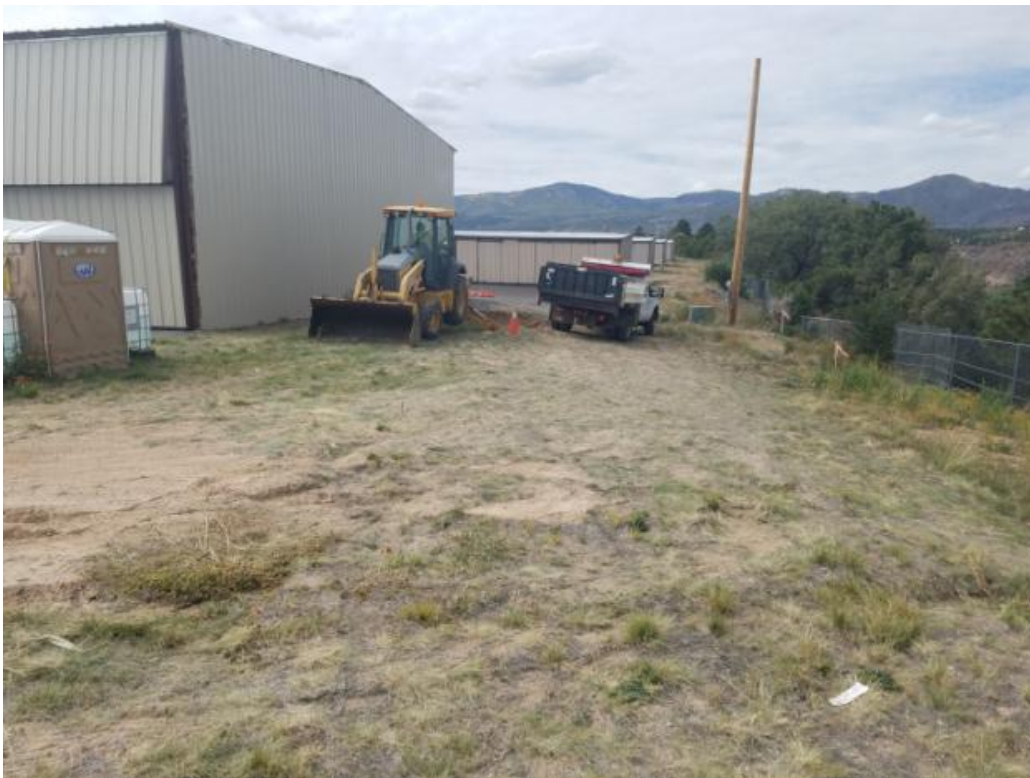
Picture 7. Ongoing Utility Work for New Hangar by Los Alamos County, West of Landfill

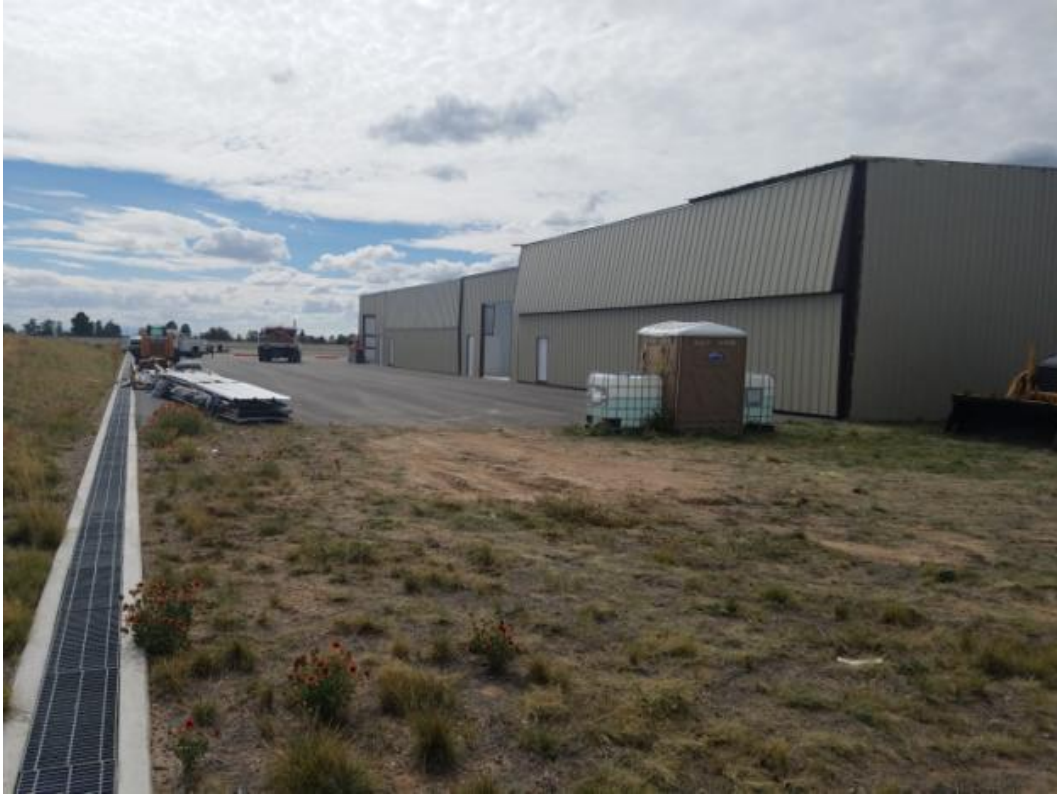
Picture 8. New Asphalt and Hangar Under Construction - West of Landfill

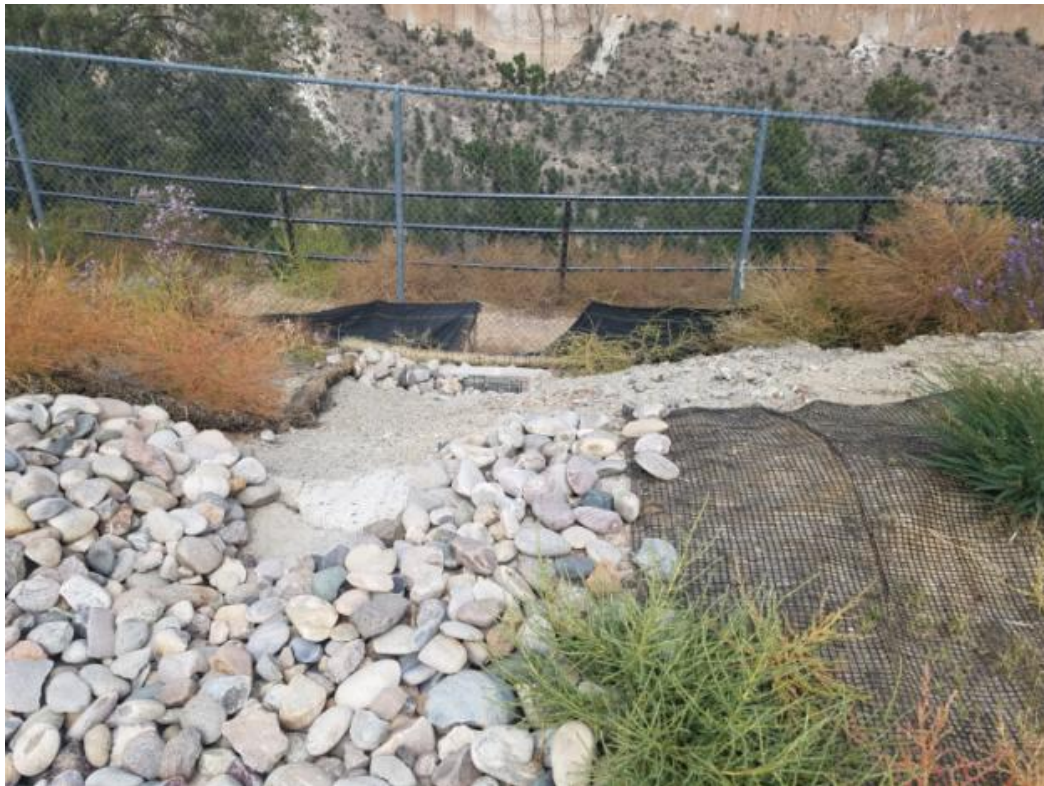
Picture 9. New Drop Inlet Structure Installed by Los Alamos County North of New Hangar Pad

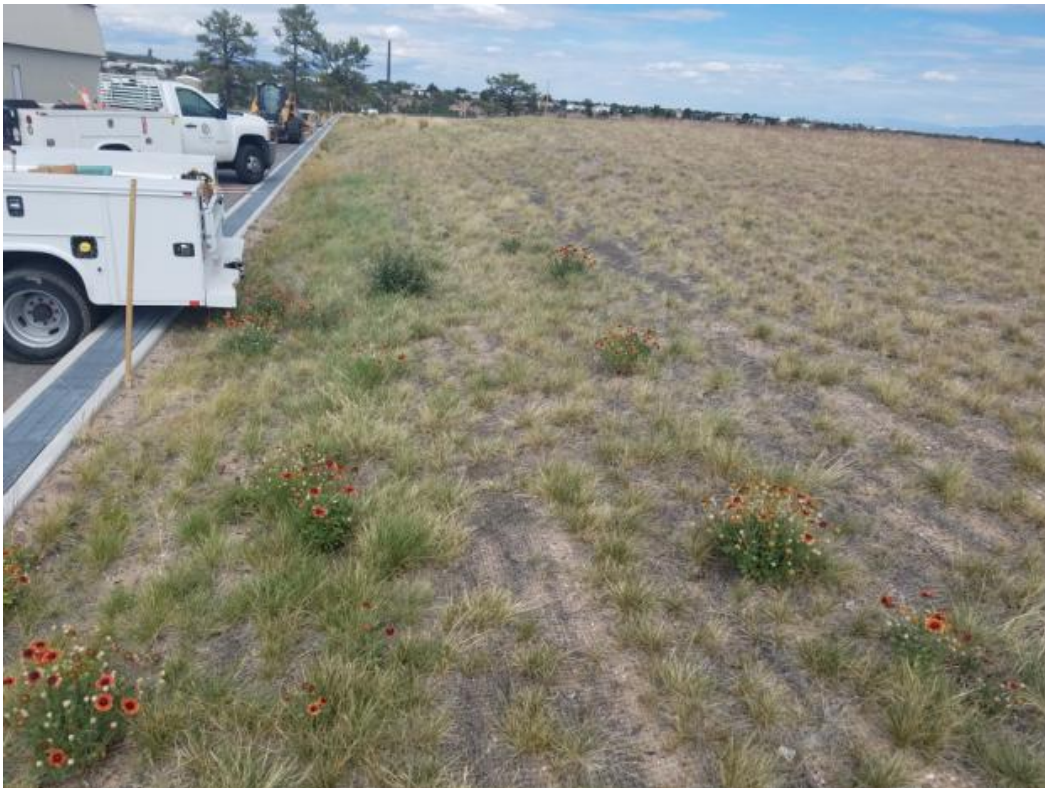
Picture 13. Concrete Culvert - West Perimeter of ET Cover

<b>Site Name: Los Alamos County Airport Landfill Cover Replacement</b>	<b>Date of Inspection: October 1, 2018</b>
<b>City: Los Alamos</b>	<b>Weather: warm, partly cloudy, breezy</b>
<b>State: New Mexico</b>	<b>Temperature: 70s</b>
<b>Agency: Department of Energy</b>	<b>Inspector: Stephen F Dwyer, PhD, PE</b>
<b>Site Element</b>	<b>Remarks</b>
Repairs Necessary Yes ( ) No ( X ) If yes, explain	
<b>7. Siltation:</b> Yes ( ) No ( X ) Areal Extent: NA Depth: NA Repairs Necessary Yes ( ) No ( X ) If yes, explain	No siltation noted to date.
<b>8. Drop Inlet Structures:</b> Working Properly Yes ( X ) No ( ) Condition: good Extent of Damage: NA Repairs Necessary Yes ( ) No ( X ) If yes, explain	Drop inlet structures are in good condition (Picture 12).
<b>Concrete Culvert</b>	
<b>1. Siltation:</b> Yes ( ) No ( X ) Areal Extent: NA Depth: NA Repairs Necessary Yes ( ) No ( X ) If yes, explain	No siltation noted to date (Picture 13).

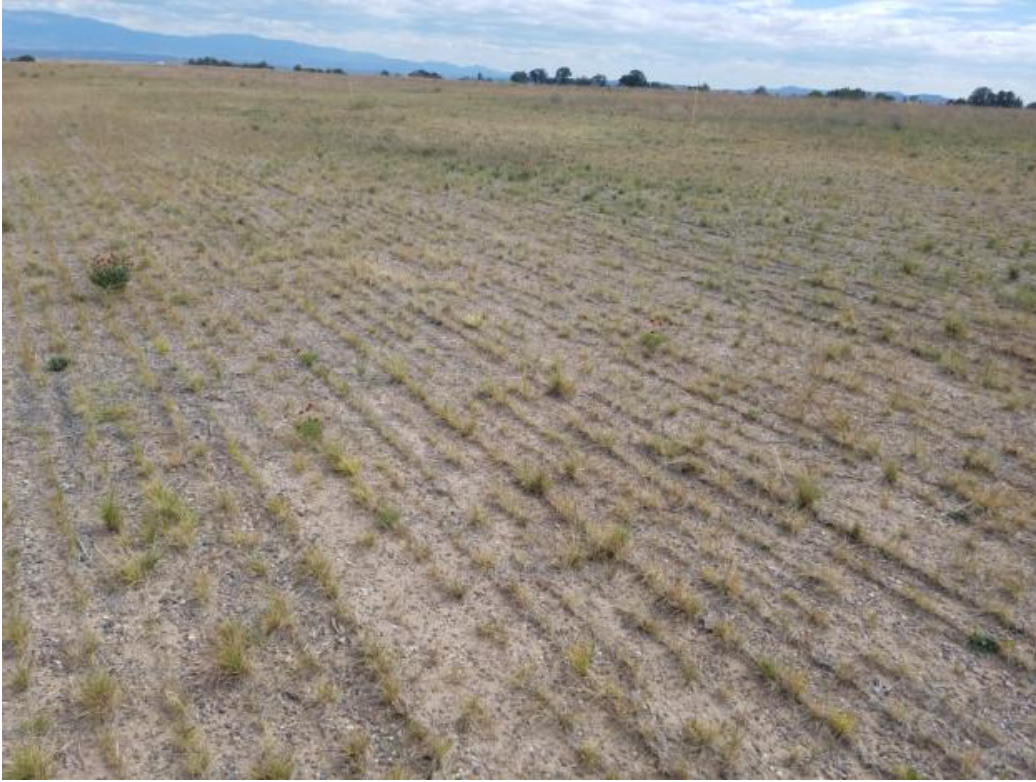
**Picture 14. ET Cover - Southeast View**

The settlement survey grid was performed to quantify differential settlement. The annual differential settlement values will be computed and included in each annual report. The area with the highest differential settlement [Survey point 34 – center of northern half of cover (Figure 8) and Picture 14 and 29] in past surveys did not increase.

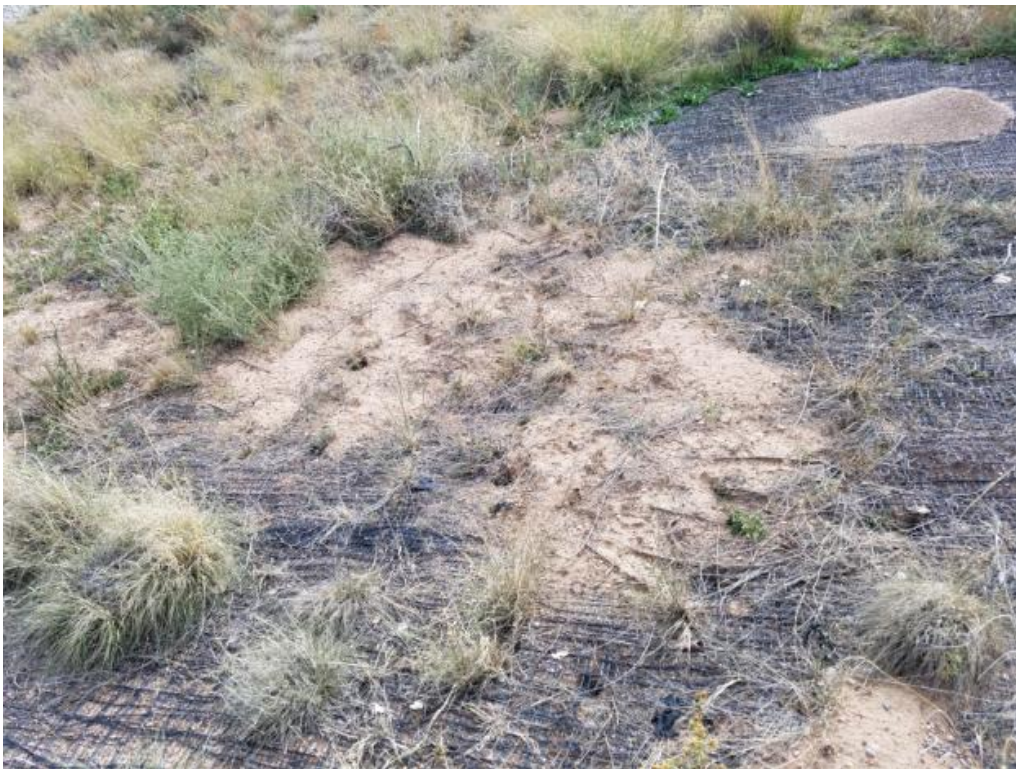
<b>2. Surface Cracks:</b> Yes ( ) No ( X ) Length: NA Width: NA Depth: NA Repairs Necessary Yes ( ) No ( X ) If yes, explain	No surface cracks in the ET Cover were identified.  Tension cracks along and parallel to the top of the older side slopes of the prescriptive cover system were identified. They appear to be due to differential settlement (Pictures 28 and 29).
<b>3. Erosion:</b> Yes ( ) No ( X ) Areal Extent: NA Depth: NA Repairs Necessary Yes ( ) No ( X ) If yes, explain	No significant erosion noted to date. The gravel/soil top admixture top layer (6-inches thick) referred to as a 'desert pavement' is developing well and appears to be working as designed to minimize erosion.
<b>4. Biointrusion Holes:</b> Yes ( X ) No ( ) Areal Extent: minimal	No biointrusion noted on the new ET Cover.  There was minimal biointrusion (small animal burrow holes) noted on the side slopes of the older prescriptive

**Picture 19. Biointrusion in Older Landfill Side Slope, East of ET Cover**

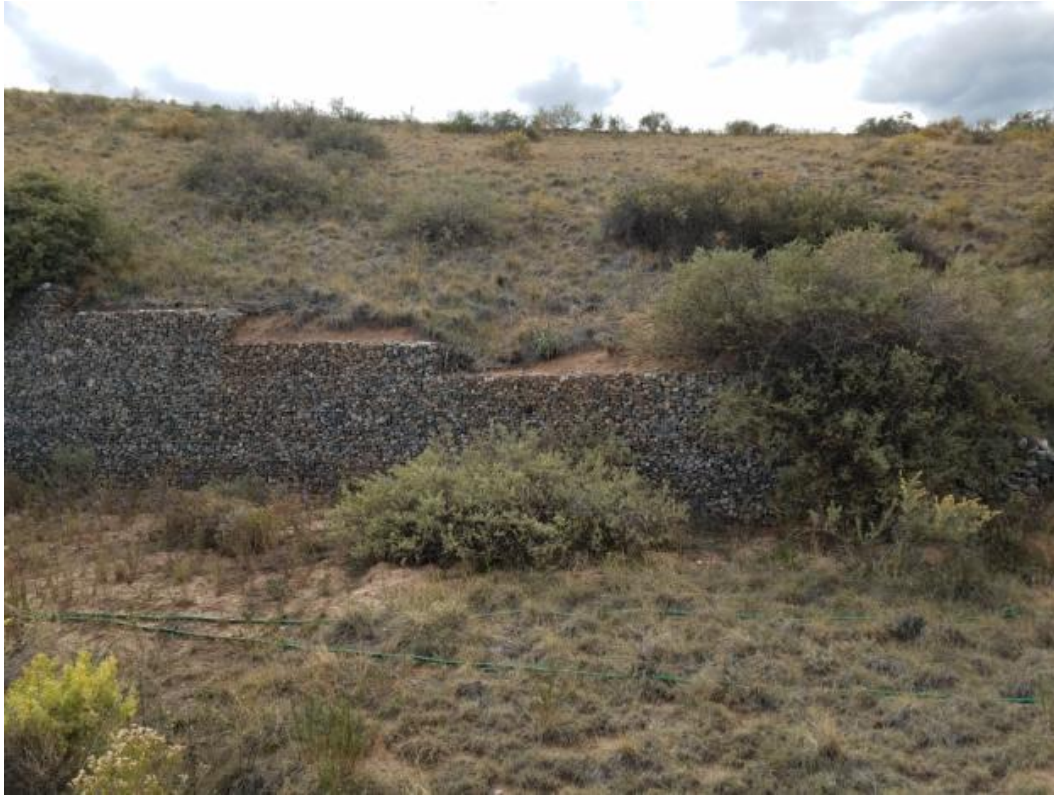
Picture 22. Gabion Retaining Structure - East End of Landfill

<b>Site Name: Los Alamos County Airport Landfill Cover Replacement</b>	<b>Date of Inspection: October 1, 2018</b>
<b>City: Los Alamos</b>	<b>Weather: warm, partly cloudy, breezy</b>
<b>State: New Mexico</b>	<b>Temperature: 70s</b>
<b>Agency: Department of Energy</b>	<b>Inspector: Stephen F Dwyer, PhD, PE</b>
<b>Site Element</b>	<b>Remarks</b>
<b>Fencing</b>	
<b>1. Airport Fence Adjacent to Landfill:</b> bent posts: Yes ( ) No ( X ) loose posts: Yes ( ) No ( X ) broken links or wire: Yes ( ) No ( X ) damaged gates: Yes ( ) No ( X ) Description of damage: NA Repairs Necessary Yes ( ) No ( X ) If yes, explain	Airport fencing is in good condition and securing the site (Pictures 9, 21, 23, 25 and 26). This fencing is maintained by the County of Los Alamos.
<b>Retaining Wall</b>	
<b>1.Retaining Wall Condition:</b> General Condition progressing as expected: Yes ( X ) No ( ) If no, explain	Retaining walls are in good condition. No damage or issues were noted (Pictures 22 to 25).

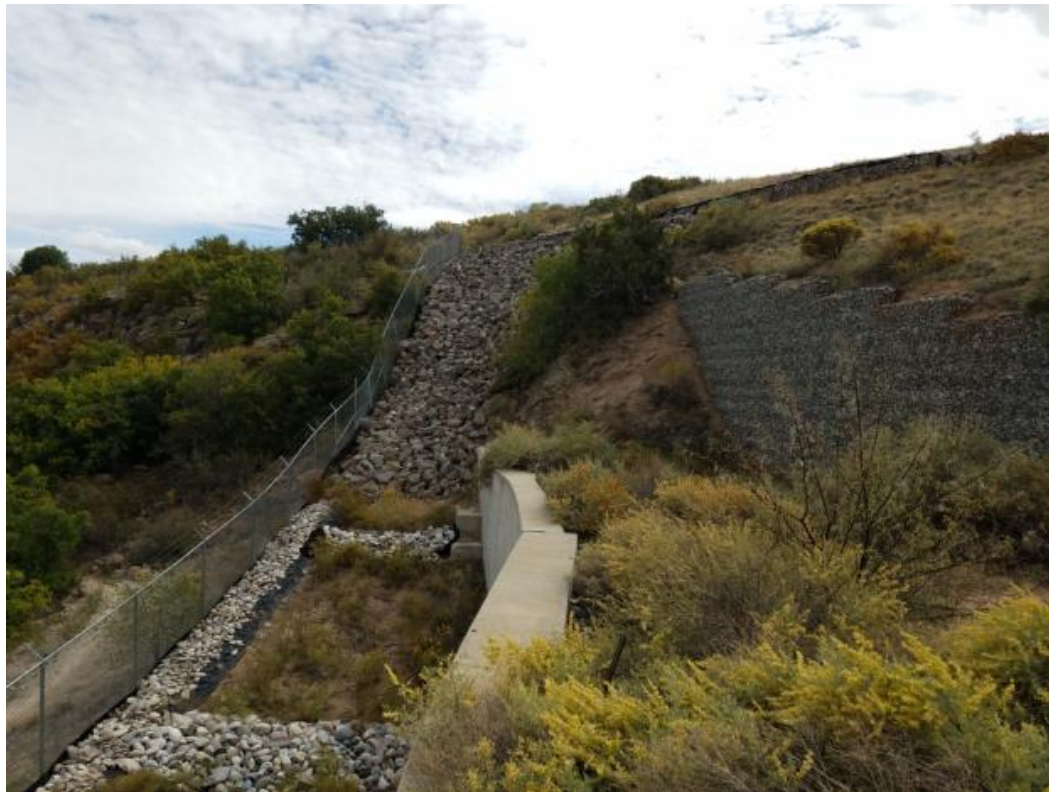
Picture 23. Large Rip Rap Slope and Gabion Retainment Wall - East End of Landfill Site

<b>2. Retaining Wall Damage Description (if any):</b> Issues Observed: Yes ( ) No ( X ) If yes, explain	None
<b>3.Repairs Necessary</b> Repairs Necessary: Yes ( ) No ( X ) If yes, explain	None
<b>Permanent Erosion &amp; Sedimentation Control Measures</b>	
<b>1. Rip Rap Berm near Retaining Wall:</b> Functional Yes ( X ) No ( ) if no, describe locations Damage or degradation: Yes ( ) No ( X ) Description of damage: NA Repairs Necessary Yes ( ) No ( X ) If yes, explain	The Rip Rap drainage on side slope is in good condition (Picture 18).
<b>2. Rock Check Dams near Retaining Wall:</b> Functional Yes ( X ) No ( ) if no, describe locations Damage, displaced rock, or other damage: Yes ( ) No ( X ) Description of damage: NA	The rock check dams are in good condition (Pictures 23 to 26).

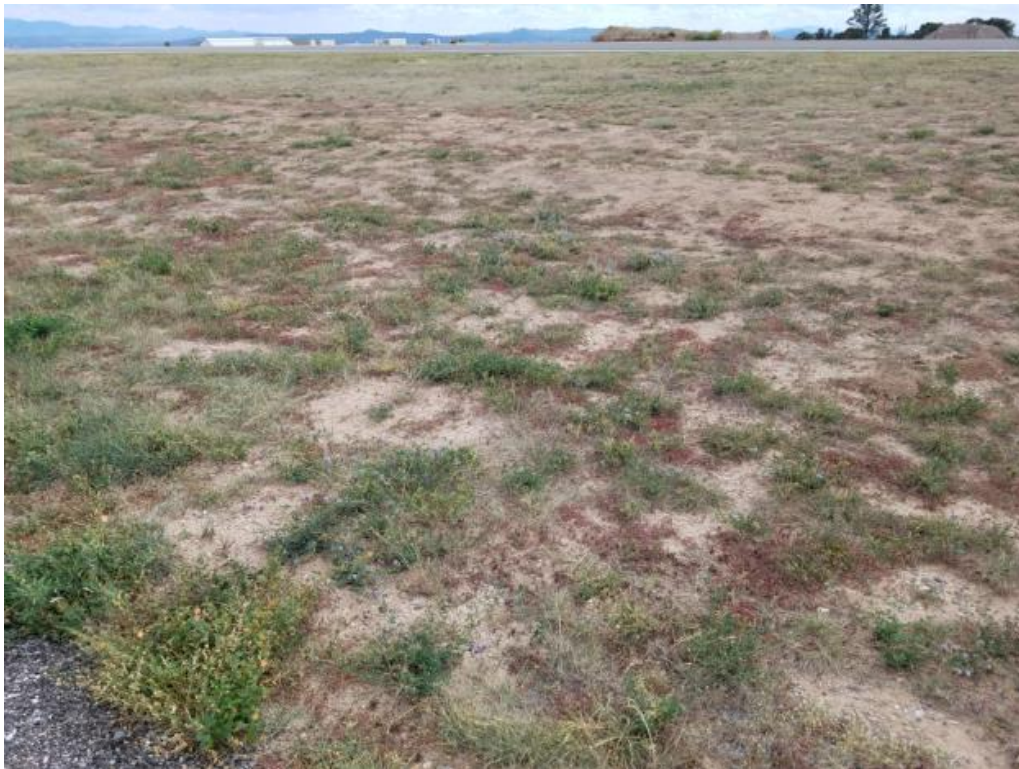
**Picture 27. Debris Disposal Area**

27). Vegetation is in good condition and varies in height from a few inches to about a foot. This area is mowed during the summer months by the airport personnel to remain compliant with FAA regulations (vegetation mowed to be less than a foot in height). There was some small mammal burrowing noted on the cover. The amount of burrowing does not appear to be excessive at this time.
<b>General</b>	
<b>1. Vandalism:</b> Yes ( ) No ( X ) Description of damage: Repairs Necessary Yes ( ) No ( ) If yes, explain	No vandalism noted.
<b>2. Land Use Change:</b> Yes ( ) No ( X ) Description: Repairs Necessary Yes ( ) No ( ) If yes, explain	No land use changes.
<b>Summary of Recommended Maintenance and/or Repairs</b>	
<b>1. Maintenance</b> / Repairs Necessary Yes ( ) No ( X ) If yes, explain	None at this time.
<b>Other</b>

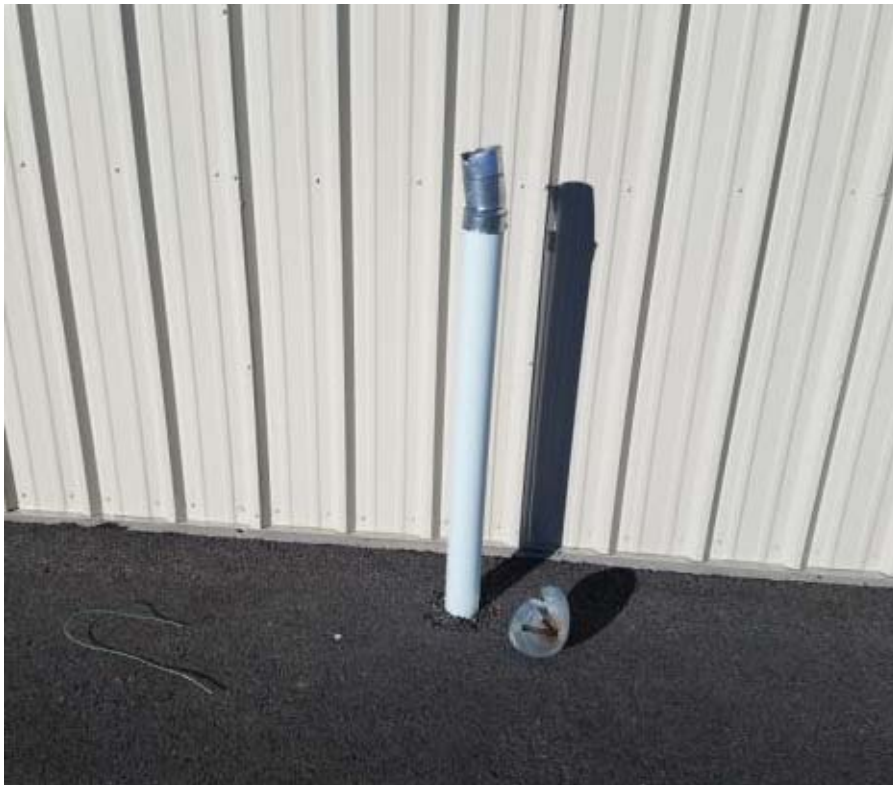
**Picture 2. Methane Monitoring Port - West of Landfill, South of New Hangar**

<b>General</b>	
<b>1. Vandalism:</b> Yes ( ) No ( X ) Description of damage: Repairs Necessary Yes ( ) No ( ) If yes, explain	No vandalism noted.  The methane port south of the new airport hangar pad had the upper vent damaged and knocked off (Picture 2). This will be replaced.
<b>2. Land Use Change:</b> Yes ( ) No ( X ) Description: Repairs Necessary Yes ( ) No ( ) If yes, explain	No land use changes.
<b>Summary of Recommended Maintenance and/or Repairs</b>	
<b>1. Maintenance / Repairs Necessary</b> Yes ( ) No ( X ) If yes, explain	None at this time.

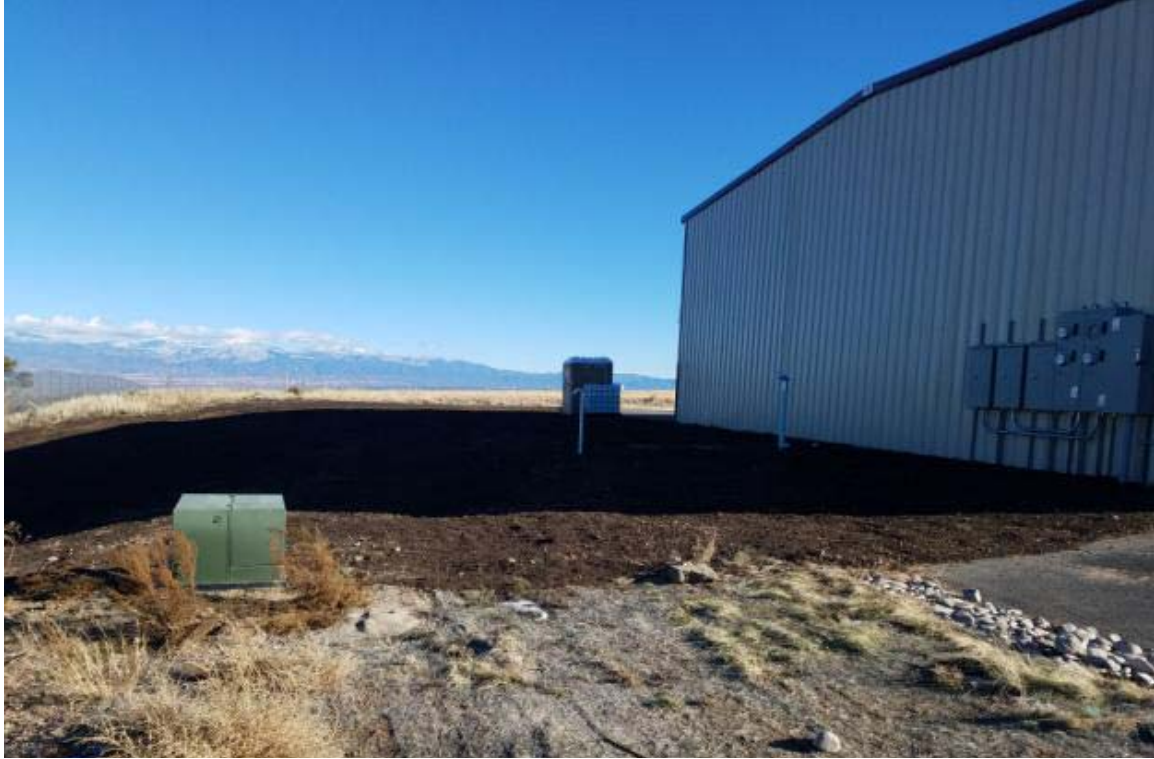
Picture 7. Completed Utility Work for New Hangar by Los Alamos County, West of Landfill

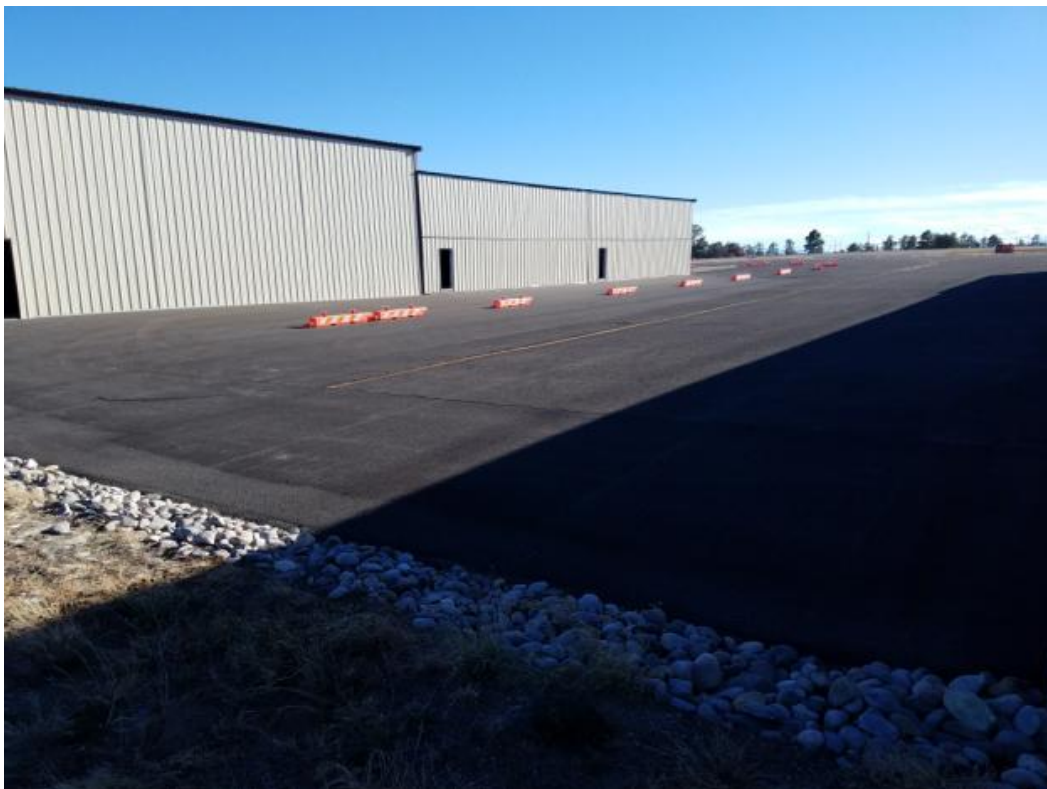
1. Construction of the new LA County Airport Hangar continues. This is west of the footprint of the landfill. The areas adjacent to this work in the waste removal areas has been reseeded (Pictures 3 and 7).	1. This work is west of the landfill and does not affect the performance of the cover or related facilities. 2. There were some tire depressions along the western perimeter of the landfill made by construction equipment during work on the Hangar. These depressions should be filled in with soil meeting cover soil specifications.

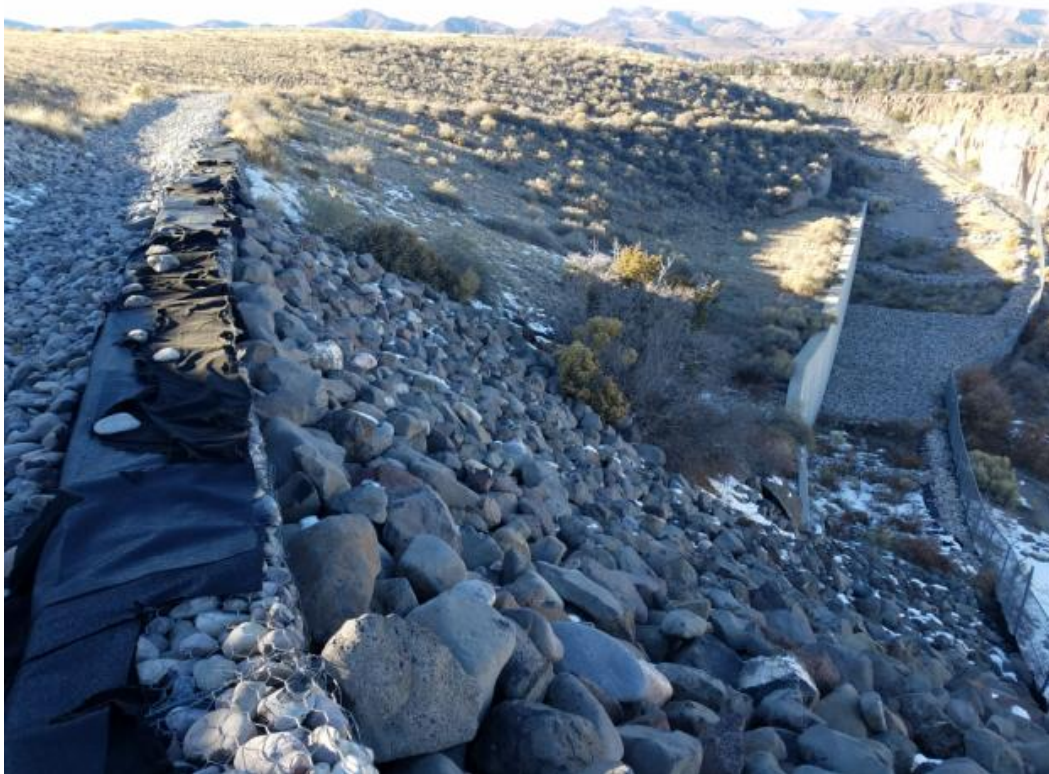
**Picture 19. Biointrusion in Older Landfill Side Slope, North of ET Cover**

<p><b>4. Biointrusion Holes:</b></p> <p>Yes ( X ) No ( )</p> <p>Areal Extent: minimal</p> <p>Depth: approx. 12-inches</p> <p>Suspected Cause (Rodent or Other): small mammal and ants</p> <p>Repairs Necessary Yes ( ) No ( X ) If yes, explain</p>	<p>No biointrusion noted on the new ET Cover.</p> <p>There was minimal biointrusion (small animal burrow holes and ant hill) noted on the side slopes of the older prescriptive cover system (Pictures 19 and 29). The biointrusion noted is localized. The amount of burrowing was consistent with that observed in the prior inspection.</p>
<p><b>5. Vegetation Condition:</b></p> <p>General Condition progressing as expected:</p> <p>Yes ( X ) No ( ) If no, explain</p> <p>Issues Observed: Yes ( ) No ( X ) If yes, explain</p> <p>Repairs Necessary: Yes ( ) No ( X ) If yes, explain</p>	<p>All vegetation was dormant during this inspection. Vegetation has full coverage on the cover system. The size/height of the vegetation is uneven across the cover (Pictures 1, 2, 4, 5, 6, 14, 15, and 16). The vegetation is predominantly native grasses that were seeded at the conclusion of the construction of the cover system. The grasses vary in height from a few inches to about a foot.</p> <p>The vegetation on the debris disposal area (DDA) (Picture 27) appears relatively mature and consists of grasses generally less than a foot in height. This vegetation was dormant during this inspection.</p> <p>The side slopes of the older prescriptive cover (Pictures 17, 18 and 20) appear mature dominated by grass mixed with forbs. These areas are not mowed due to the steepness of the slope.</p>

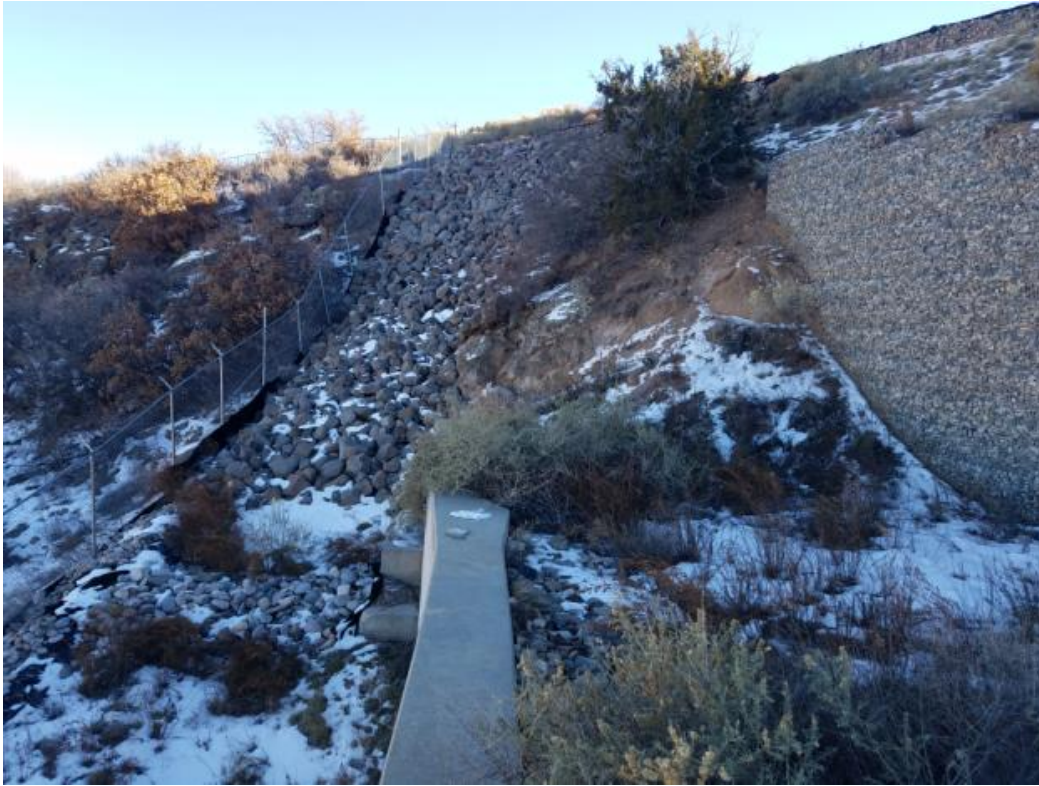
**Picture 22. Gabion Retaining Structure - East End of Landfill**

<b>Fencing</b>	
<b>1. Airport Fence Adjacent to Landfill:</b> bent posts: Yes ( ) No ( X ) loose posts: Yes ( ) No ( X ) broken links or wire: Yes ( ) No ( X ) damaged gates: Yes ( ) No ( X ) Description of damage: NA Repairs Necessary Yes ( ) No ( X ) If yes, explain	Airport fencing is in good condition and securing the site (Pictures 9, 23 and 25). This fencing is maintained by the County of Los Alamos. Some of the perimeter fencing along the highway and airport entrance was replaced with a more robust fence (Picture 9).
<b>Retaining Wall</b>	
<b>1. Retaining Wall Condition:</b> General Condition progressing as expected: Yes ( X ) No ( ) If no, explain	Retaining walls are in good condition. No significant damage or issues were noted (Pictures 22 to 26).

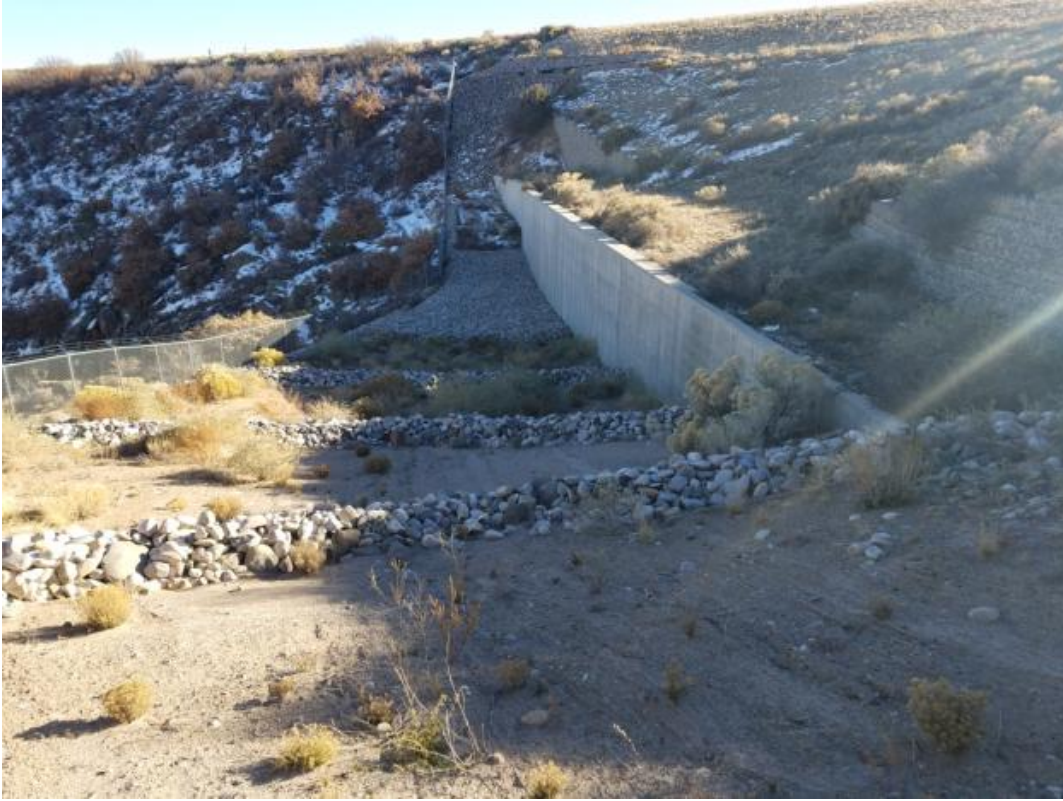
**Picture 24. Small Crack in Concrete Retaining Wall - East End of Landfill**

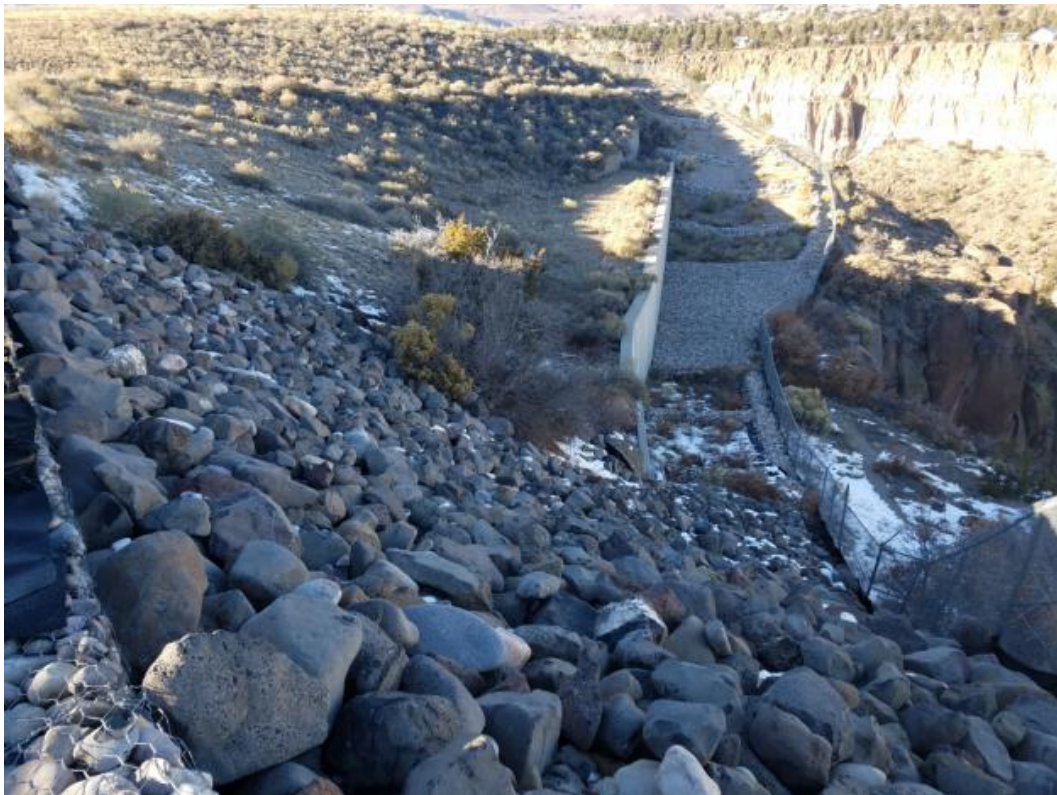
**Picture 25. Erosion Control below Concrete Retaining Wall - NE End of Landfill**

<b>Site Name: Los Alamos County Airport Landfill Cover Replacement</b>	<b>Date of Inspection: March 20, 2019</b>
<b>City: Los Alamos</b>	<b>Weather: cool, partly cloudy, breezy</b>
<b>State: New Mexico</b>	<b>Temperature: 40s</b>
<b>Agency: Department of Energy</b>	<b>Inspector: Stephen F Dwyer, PhD, PE</b>
<b>Site Element</b>	<b>Remarks</b>
<b>2. Retaining Wall Damage Description (if any):</b> Issues Observed: Yes ( ) No ( X ) If yes, explain	None
<b>3. Repairs Necessary</b> Repairs Necessary: Yes ( ) No ( X ) If yes, explain	None
<b>Permanent Erosion &amp; Sedimentation Control Measures</b>	
<b>1. Rip Rap Berm near Retaining Wall:</b> Functional Yes ( X ) No ( ) if no, describe locations Damage or degradation: Yes ( ) No ( X ) Description of damage: NA Repairs Necessary Yes ( ) No ( X ) If yes, explain	The Rip Rap drainage on the side slopes is in good condition (Pictures 18, 20 and 21).
<b>2. Rock Check Dams near Retaining Wall:</b> Functional Yes ( X ) No ( ) if no, describe locations Damage, displaced rock, or other damage: Yes ( ) No ( X ) Description of damage: NA Repairs Necessary Yes ( ) No ( X ) If yes, explain	The rock check dams are in good condition (Pictures 23 and 25).

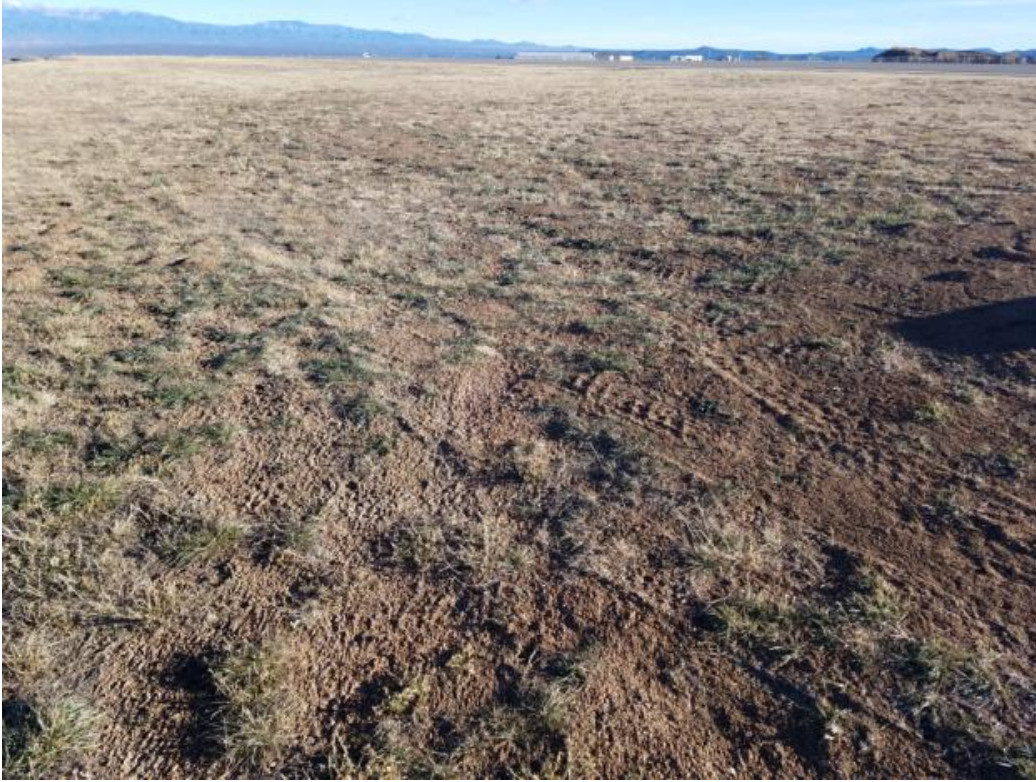
**Picture 26. Side Slopes and Erosion Control, East End of Landfill**

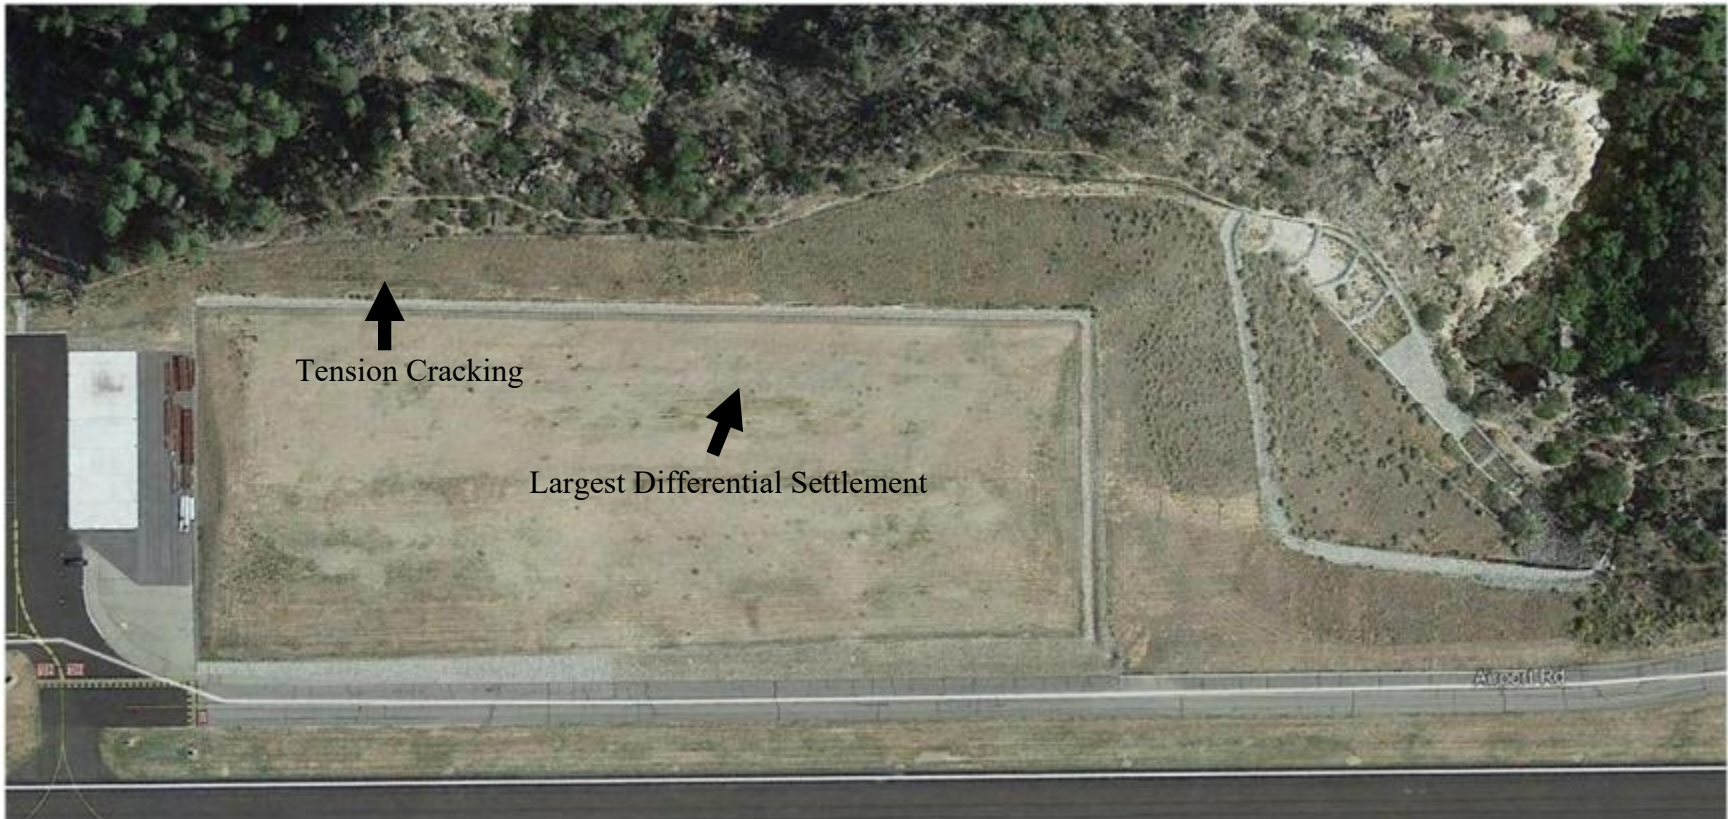
**Picture 29. Tension Cracking near Top of Side Slope of Older Landfill Cover, North of ET Cover**

All features of the closure are currently in good condition. The vegetation has full coverage although it was dormant during this most recent inspection. All drainage systems are in excellent working condition. There are no erosion issues on the cover or side slopes. There is no biointrusion to date on the new ET Cover. There is localized animal burrowing and a few ant hills on the existing side slopes of the older cover system (north and east of new ET Cover). There was also some burrowing noted in the Debris Disposal Area (DDA) cover. The tension cracks identified along the top of the older landfill side slope north of the ET Cover in the prior inspection was still visible although it had some sediment infill as well as animal burrowing activity within it (Picture 29). No maintenance or repairs are recommended at this time.

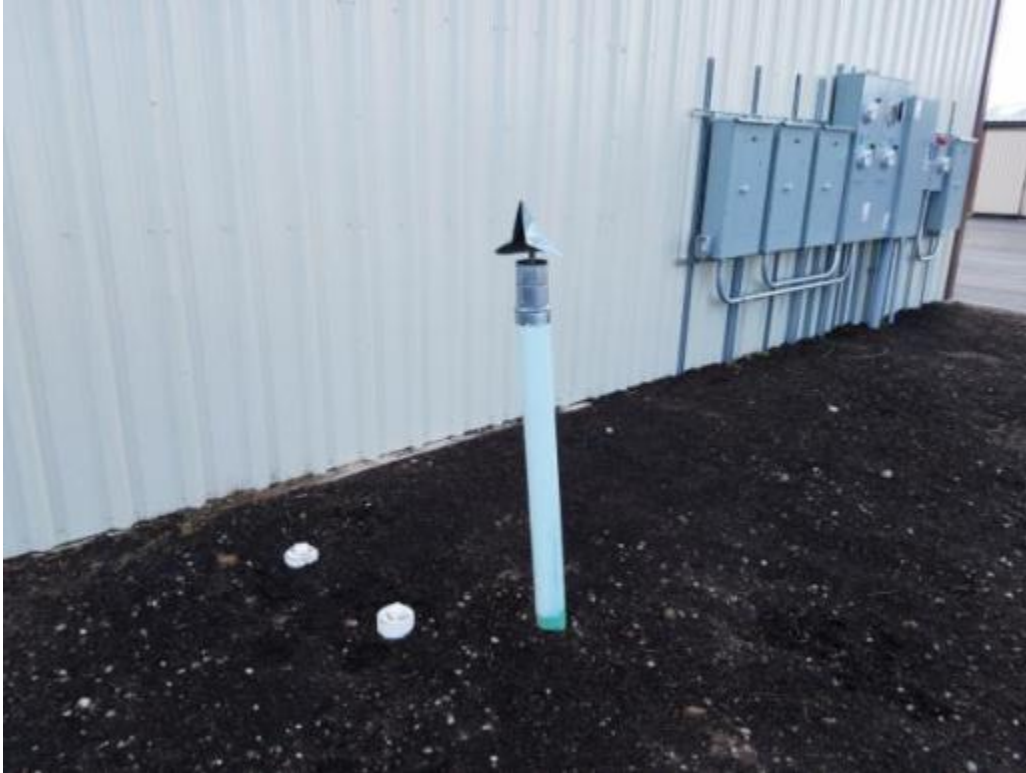
<b>Site Name: Los Alamos County Airport Landfill Cover Replacement</b>	<b>Date of Inspection: March 20, 2019</b>
<b>City: Los Alamos</b>	<b>Weather: cool, partly cloudy, breezy</b>
<b>State: New Mexico</b>	<b>Temperature: 40s</b>
<b>Agency: Department of Energy</b>	<b>Inspector: Stephen F Dwyer, PhD, PE</b>
<b>Site Element</b>	<b>Remarks</b>
<b>9. Methane Monitoring Instrumentation:</b> Functioning Properly: Yes ( <input checked="" type="checkbox"/> ) No ( <input type="checkbox"/> ) Damage: Yes ( <input type="checkbox"/> ) No ( <input checked="" type="checkbox"/> ) Repairs Necessary Yes ( <input type="checkbox"/> ) No ( <input checked="" type="checkbox"/> ) If yes, explain	Methane was monitored on March 20, 2019. No methane was detected. Refer to Figure 8 for methane monitoring locations and Pictures 4 and 5 for methane monitoring ports. Methane station 2 that had accidentally been damaged was repaired and in good condition. The area directly north of the new airport hangar pad was restored and reseeded after the completion of the recent utility work (Pictures 3 and 7).

**Picture 3. Methane Monitoring Port - West of Landfill, North of New Hangar**

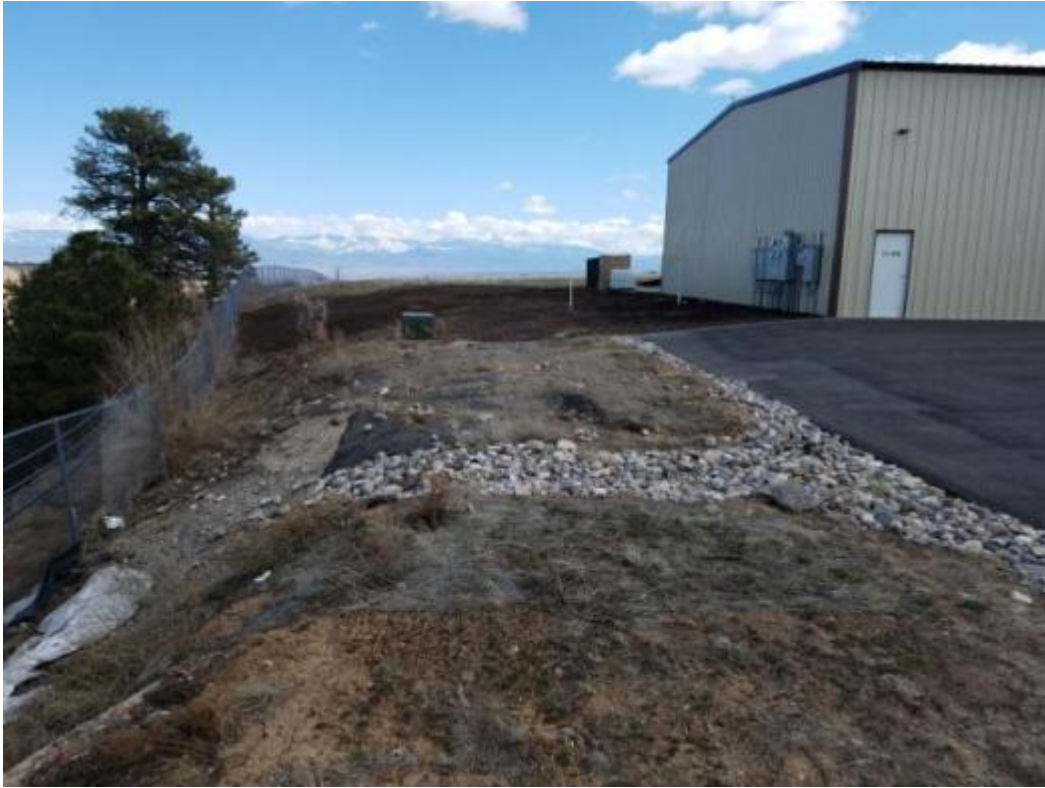
Picture 7. Completed Utility Work North of New Hangar by Los Alamos County, West of Landfill

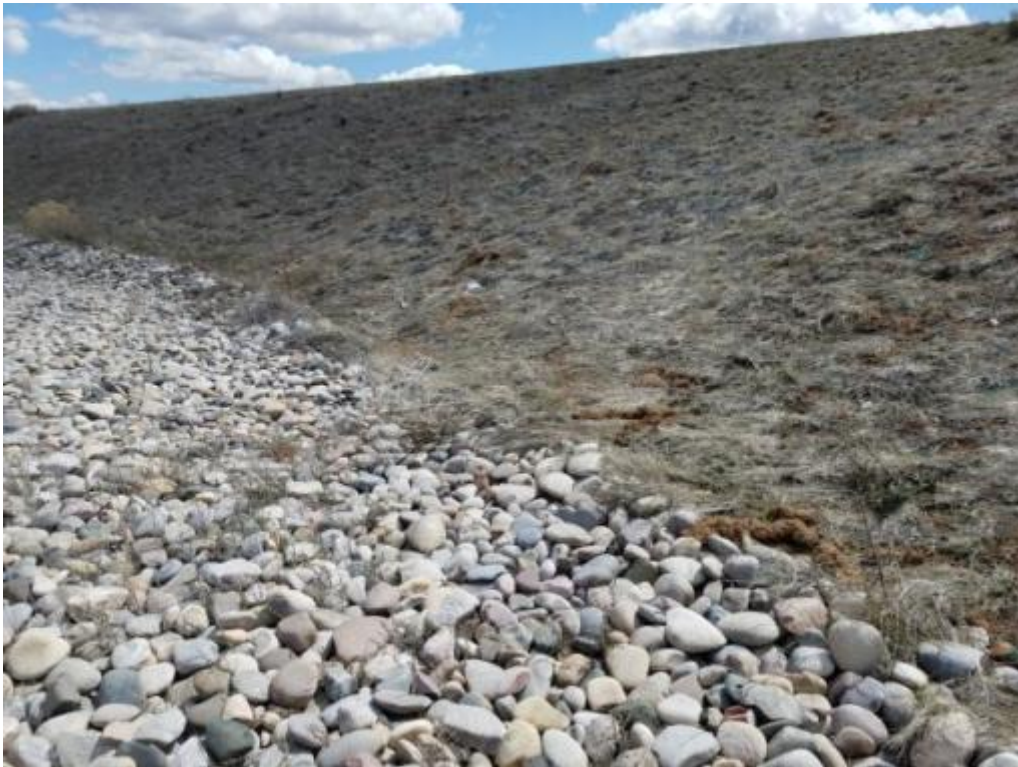
Picture 19. Biointrusion in Older Landfill Side Slope, North of ET Cover

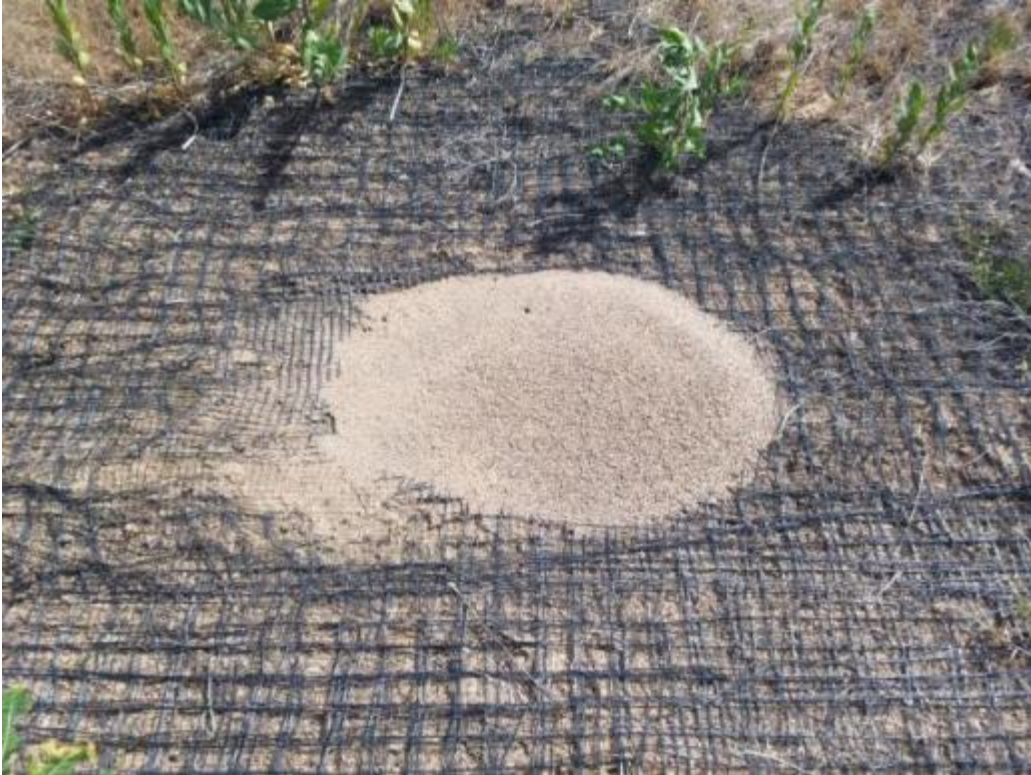
<p><b>4. Biointrusion Holes:</b> Yes ( X ) No ( ) Areal Extent: minimal Depth: approx. 12-inches Suspected Cause (Rodent or Other): small mammal and ants Repairs Necessary Yes ( ) No ( X ) If yes, explain</p>	<p>No biointrusion noted on the new ET Cover.</p> <p>There was minimal biointrusion (small animal burrow holes and ant hills) noted on the side slopes of the older prescriptive cover system (Picture 19). The biointrusion identified is localized. The amount of burrowing was consistent with that observed in the prior inspection.</p>
<p><b>5. Vegetation Condition:</b> General Condition progressing as expected: Yes ( X ) No ( ) If no, explain Issues Observed: Yes ( ) No ( X ) If yes, explain Repairs Necessary: Yes ( ) No ( X ) If yes, explain</p>	<p>The vegetation has increased in size from the prior inspection. Vegetation has full coverage on the cover system. The size/height of the vegetation is uneven across the cover (Pictures 1, 2, 4, 5, 9, 14, 15, and 16). The vegetation is predominantly native grasses that were seeded at the conclusion of the construction of the cover system. The grasses vary in height from a few inches to about 2.5-ft. Some clover and alfalfa have emerged on</p>

**Picture 19. Biointrusion (Ant Hill) in Older Landfill Side Slope, North of ET Cover**
