Subject: Submittal of the 2018/2019 Annual Long-Term Monitoring Status Report (July 2018 through June 2019) for Los Alamos County Airport Landfill Cover System Replacement, Solid Waste Management Units 73-001(a,d), Technical Area 73

### **LOS ALAMOS COUNTY AIRPORT LANDFILL COVER SYSTEM REPLACEMENT SOLID WASTE MANAGEMENT UNITS 73-001(a,d) TECHNICAL AREA 73**

<b>Site Name: Los Alamos County Airport Landfill Cover Replacement</b>	<b>Date of Inspection: October 1, 2018</b>
<b>City: Los Alamos</b>	<b>Weather: warm, partly cloudy, breezy</b>
<b>State: New Mexico</b>	<b>Temperature: 70s</b>
<b>Agency: Department of Energy</b>	<b>Inspector: Stephen F Dwyer, PhD, PE</b>
<b>Site Element</b>	<b>Remarks</b>
1. Construction of the new LA County Airport Hangar continues. This is west of the footprint of the landfill. The seeded areas adjacent to this work in the waste removal areas have been disturbed. This area is scheduled to be reseeded by the Los Alamos County upon completion of the hangar and utility work (Pictures 3, 7 and 8).	1. This work is west of the landfill and does not affect the performance of the cover or related facilities.

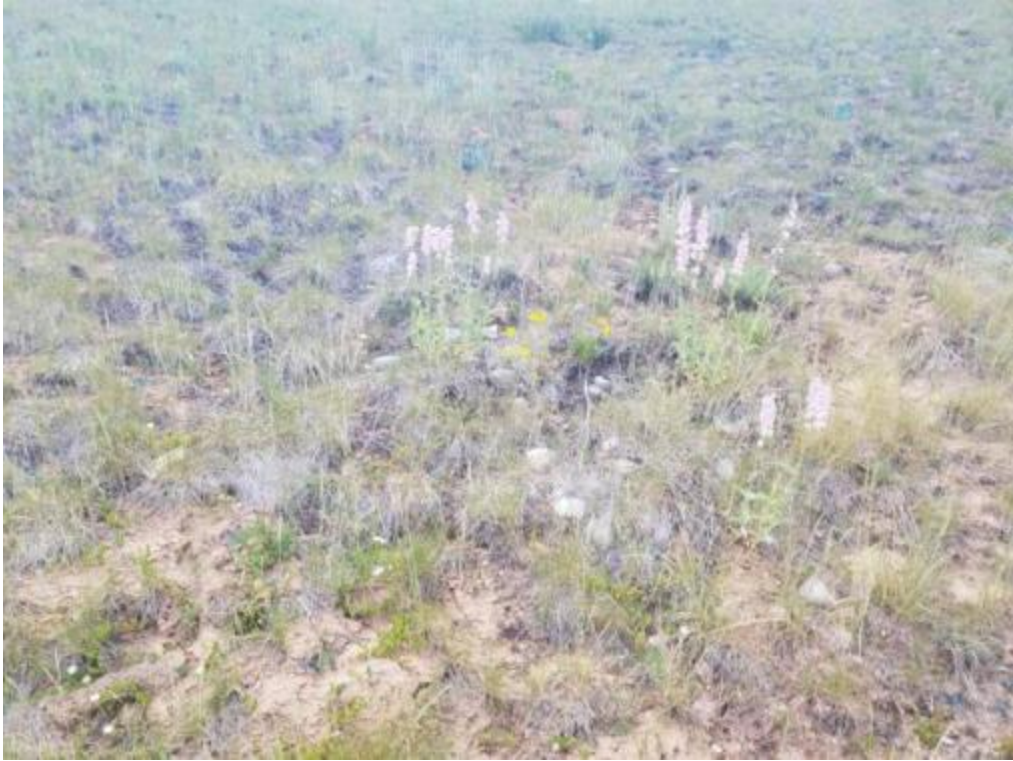
All features of the ET Cover are currently in good condition. The vegetation has full coverage and ranges in height from a few inches to about 2.5-ft. All drainage systems are in excellent working condition. There are no erosion issues on the cover. There is no biointrusion to date on the new ET Cover. There is localized animal burrowing and a few ant hills on the existing side slopes of the older cover system (north and east of new ET Cover). There was also some burrowing noted in the Debris Disposal Area (DDA) cover. The tension cracking identified along the top of the older landfill side slope north of the ET Cover in the prior inspection was still visible although it had some sediment infill as well as animal burrowing activity within it. The small amount of rill erosion at the base of the eastern slope has increased slightly and is recommended to be repaired at this time (Pictures 26 and 27). The rilling is due to concentrated flow created by the geometry of the side slopes.

**Picture 27. Rilling at Base of Eastern Slope – East of Landfill**

<b>General</b>	
<b>1. Vandalism:</b> Yes ( ) No ( X ) Description of damage: Repairs Necessary Yes ( ) No ( ) If yes, explain	No vandalism noted.
<b>2. Land Use Change:</b> Yes ( ) No ( X ) Description: Repairs Necessary Yes ( ) No ( ) If yes, explain	No land use changes.
<b>Summary of Recommended Maintenance and/or Repairs</b>	
<b>1. Maintenance</b> / Repairs Necessary Yes ( X ) No ( ) If yes, explain	The isolated rill erosion at the base of the eastern side slope – east of the landfill should be repaired (Pictures 25 and 26). Recommend preventive measures be taken to slow the runoff velocity of water in this area (Picture 30).

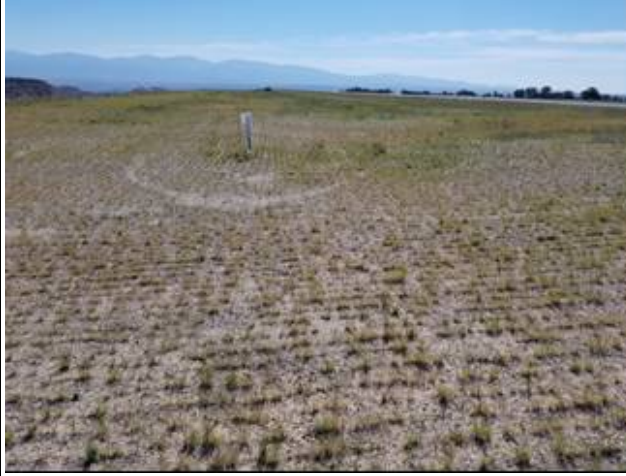
Element	Inspection Remarks
1. ET Cover	No erosion or damage noted
2. Cover Side Slopes directly adjacent to the ET Cover	No erosion or damage noted
3. Surface Water Drainage Ditches	No erosion or damage noted

<p style="text-align: center;">Figure 1. Cover - East View</p>	<p style="text-align: center;">Figure 2. Cover – West View</p>

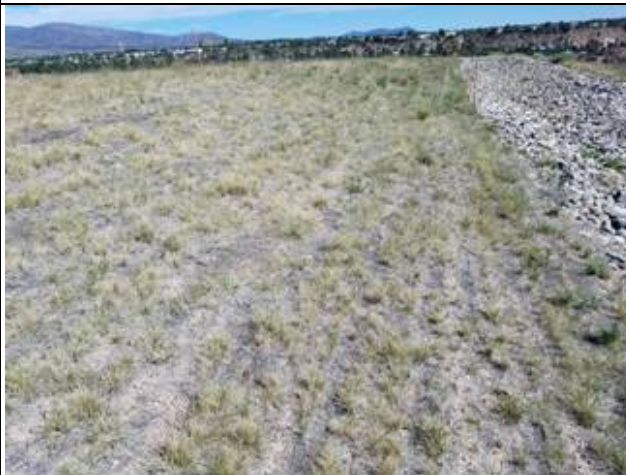
<p style="text-align: center;">Figure 3. Eastern Slope of ET Cover</p>	<p style="text-align: center;">Figure 4. Side Slope of Older Cover adjacent to Taxiway</p>

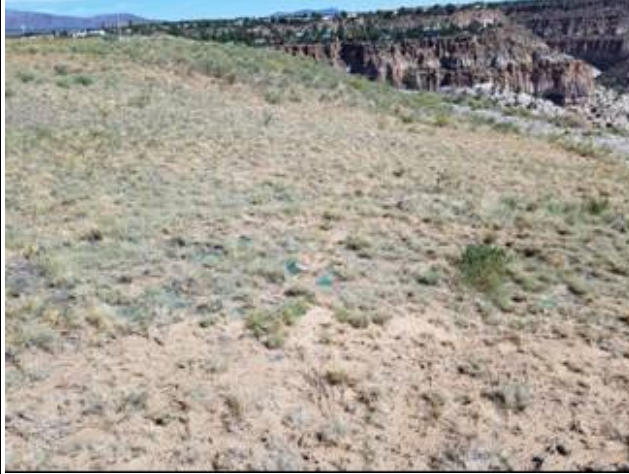
4. Debris Disposal Area	No erosion or damage noted
5. Eastern Side Slopes near Concrete Retaining Walls	No erosion or damage noted
6. Retaining Walls	No erosion or damage noted

<b>Figure 5. Side Slope of Older Cover – East of ET Cover</b>	<b>Figure 6. Retaining Walls &amp; Lower Erosion Control Measures</b>

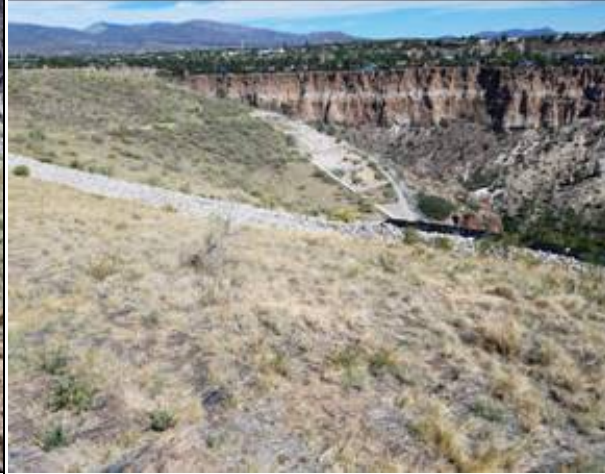
7. Surface Water Control Features below and adjacent to Retaining Wall	No erosion or damage noted
<b>Pictures</b>

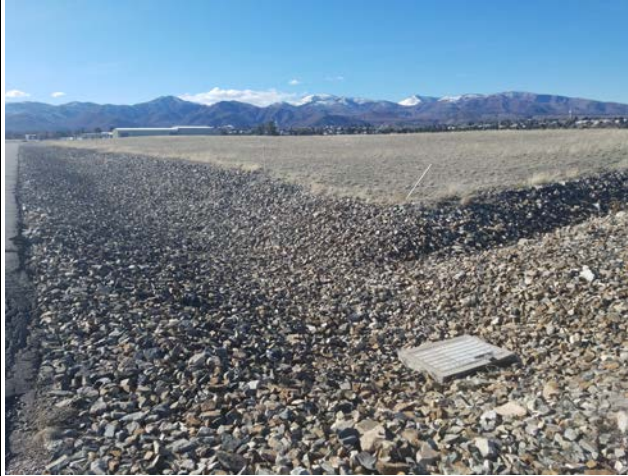
1. ET Cover	No erosion or damage noted. Soil was very wet due to the recent rain and snow (melted prior to inspection).
2. Cover Side Slopes directly adjacent to the ET Cover	No erosion or damage noted

Figure 5. ET Cover and Adjacent Drainage trenches – NW View	Figure 6. Eastern Side Slopes

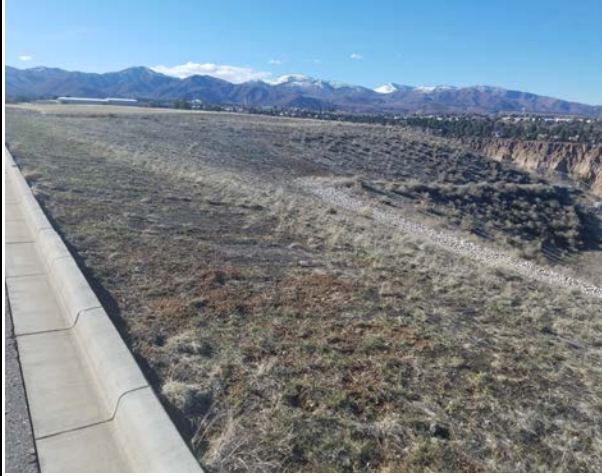
3. Surface Water Drainage Ditches	No erosion or damage noted
4. Debris Disposal Area	No erosion or damage noted
5. Eastern Side Slopes above Concrete Retaining Walls	The older eastern side slope just above the interceptor trench that directs the water toward the north had some sediment movement due to sheet flow. There were no rills or gullies formed. The sediment is evident above and adjacent to the interceptor trench (Figure 4). This is in an area where the vegetation is not as mature as the adjacent area directly to the north. The amount of sediment is not considered significant and does not require maintenance at this time.
