2021 Update to the Site Discharge Pollution Prevention Plan, Revision 1

NPDES Permit No. NM0030759

May 1, 2022

Pajarito Watershed

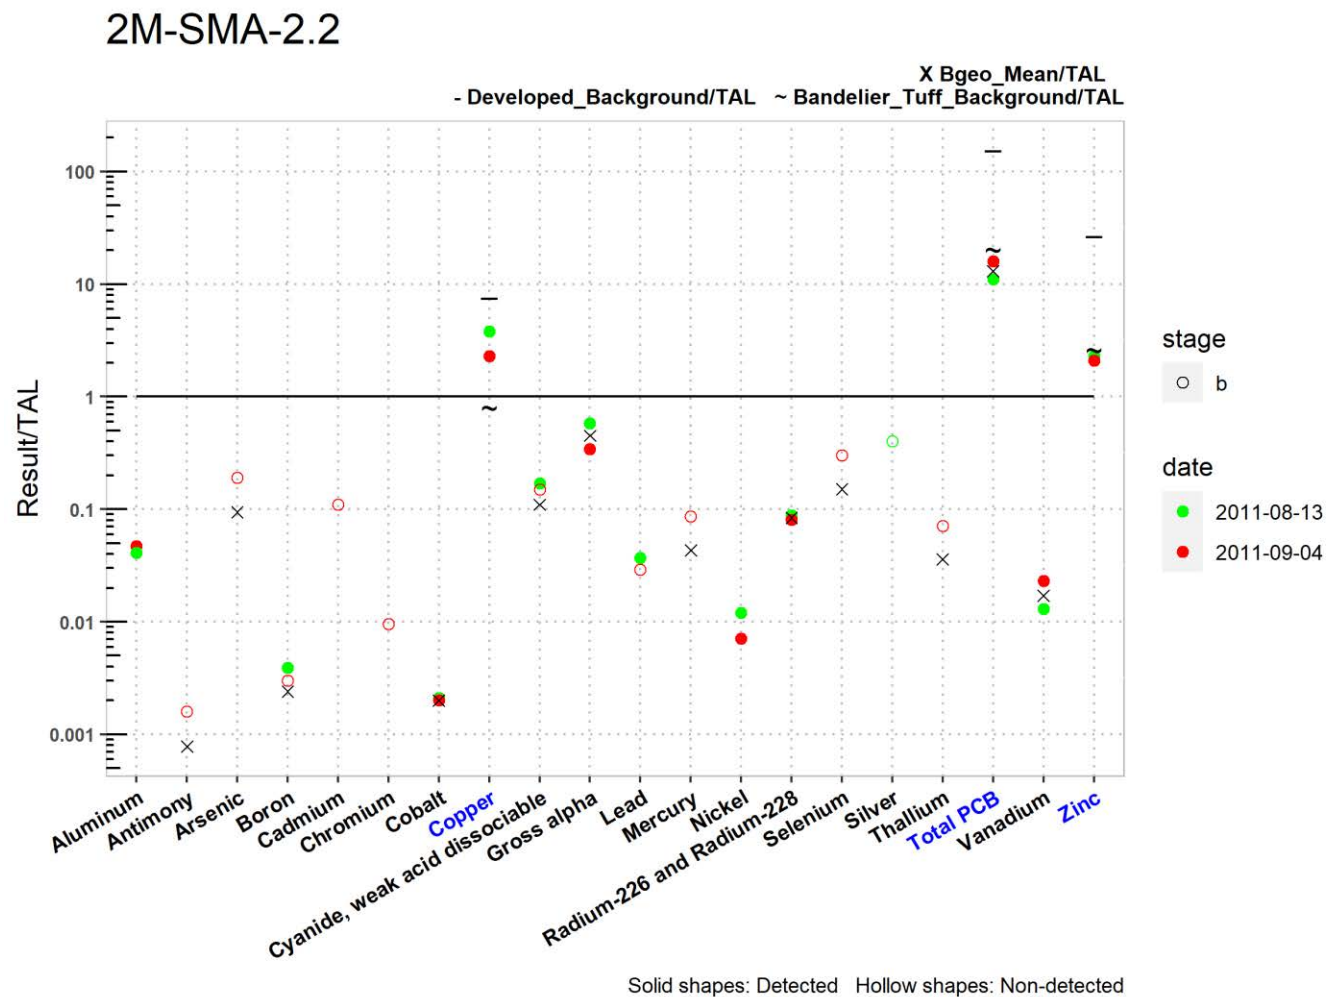
Figure 141-2 Analytical results summary for 2M-SMA-2.2

AOC 03-003(k) was monitored within 2M-SMA-2.2. Following the installation of baseline control measures, two baseline storm water samples were collected on August 13, 2011, and September 4, 2011 (Figure 141-2). Analytical results from these samples yielded TAL exceedances for copper (10.1 µg/L and 16.4 µg/L), PCB concentrations (7 ng/L and 10 ng/L), and zinc (90.1 µg/L and 97.2 µg/L) and are presented in Figure 141-2.

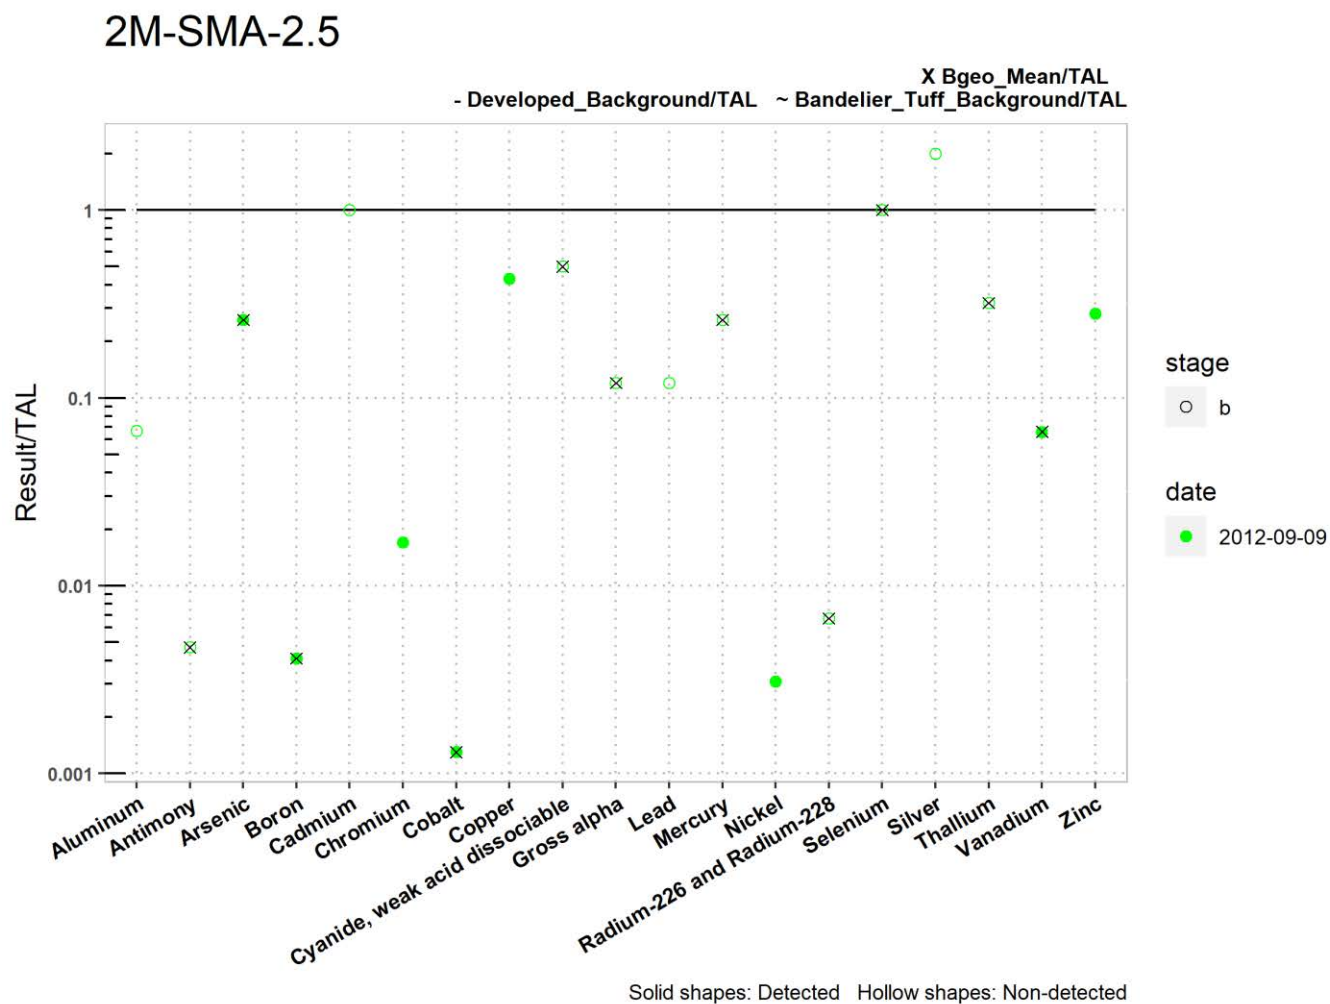
Figure 142-2 Analytical results summary for 2M-SMA-2.5

SWMU 40-001(c) is monitored within 2M-SMA-2.5. Following the installation of baseline control measures, a baseline storm water sample was collected on September 9, 2012 (Figure 142-2). In Figure 142-2, cadmium, selenium, and silver are reported as nondetected results greater than their respective TALs. These values are reported at the PQL; the MDLs for these analytes are below their respective TALs. The values are nondetects and thus not considered TAL exceedances. Analytical results from this sample yielded no TAL exceedances. Baseline confirmation monitoring continues for 2M-SMA-2.5 in order to collect a second sample with all results below the applicable MTAL or ATAL.

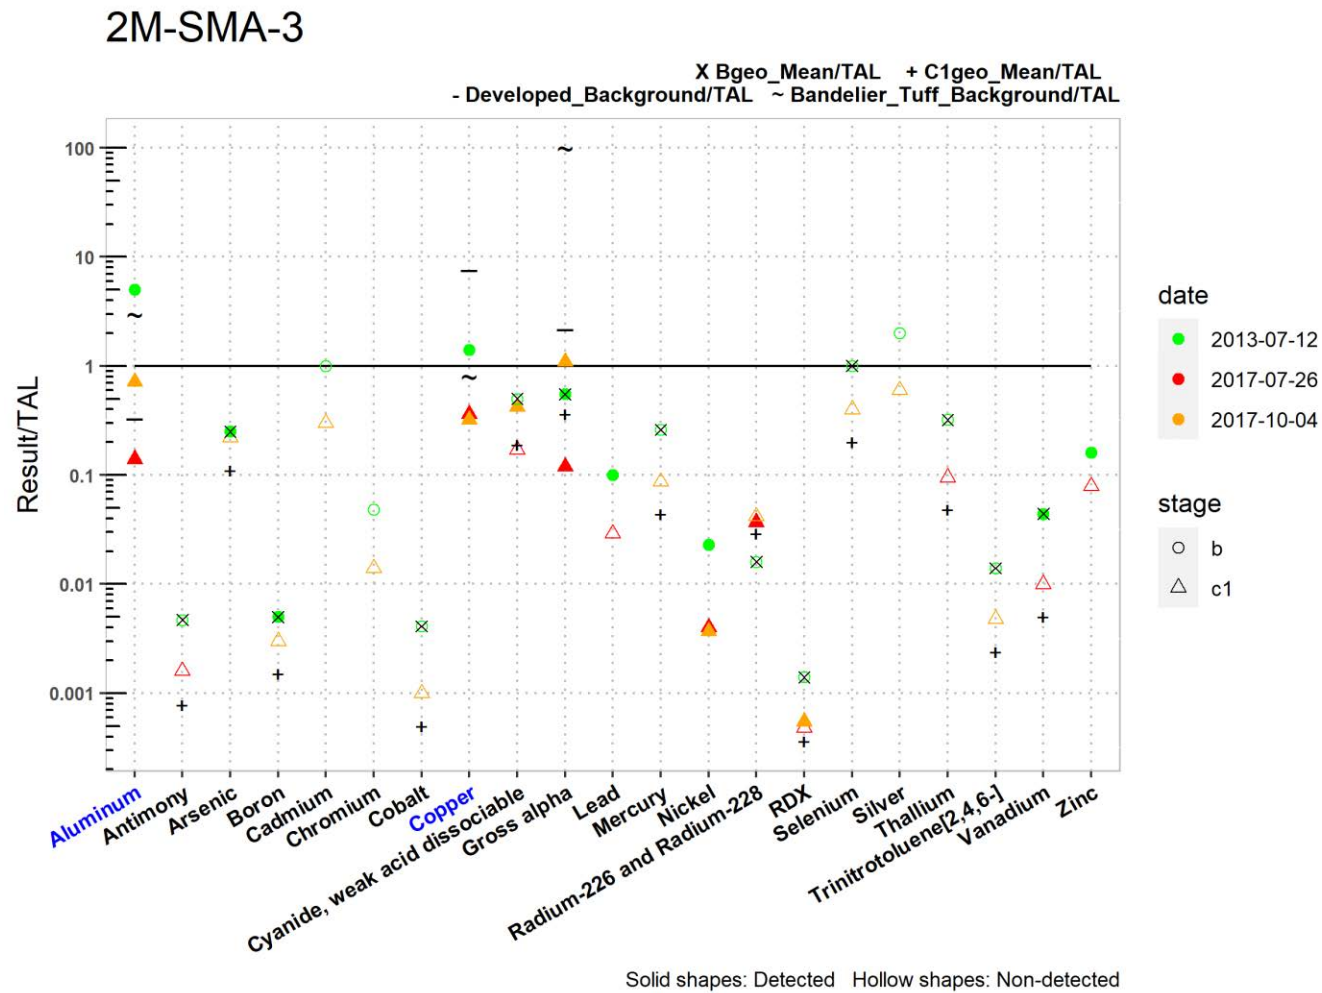
Figure 143-2 Analytical results summary for 2M-SMA-3

SWMUs 07-001(a), 07-001(b), 07-001(c), and 07-001(d) are monitored within 2M-SMA-3. Following the installation of baseline control measures, a baseline storm water sample was collected on July 12, 2013 (Figure 143-2). In Figure 143-2, cadmium, selenium, and silver are reported as nondetected results greater than their respective TALs. These values are reported at the PQL; the MDLs for these analytes are below their respective TALs. The values are nondetects and thus not considered TAL exceedances. Analytical results from this sample yielded TAL exceedances for aluminum (3750 µg/L) and copper (6.05 µg/L) and are presented in Figure 143-2.

Enhanced control confirmation monitoring storm water samples were collected on July 26, 2017, and October 4, 2017 (Figure 143-2). Analytical results from these samples yielded no TAL exceedances. Gross-alpha activity exceeded the TAL in the October 4, 2017, sample, but not in the July 26, 2017, sample. As both corrective action samples are used to calculate the geomean, the geomean is less than the ATAL and thus not considered a TAL exceedance in corrective action monitoring. Corrective action monitoring is complete for associated SWMUs 07-001(a), 07-001(b), and 07-001(d) because all applicable sampling results are below the applicable MTAL or ATAL. Analytical results from the sample collected in 2017 are not representative of 07-001(c) and corrective action monitoring will continue for 2M-SMA-3 and associated SWMU 07-001(c).

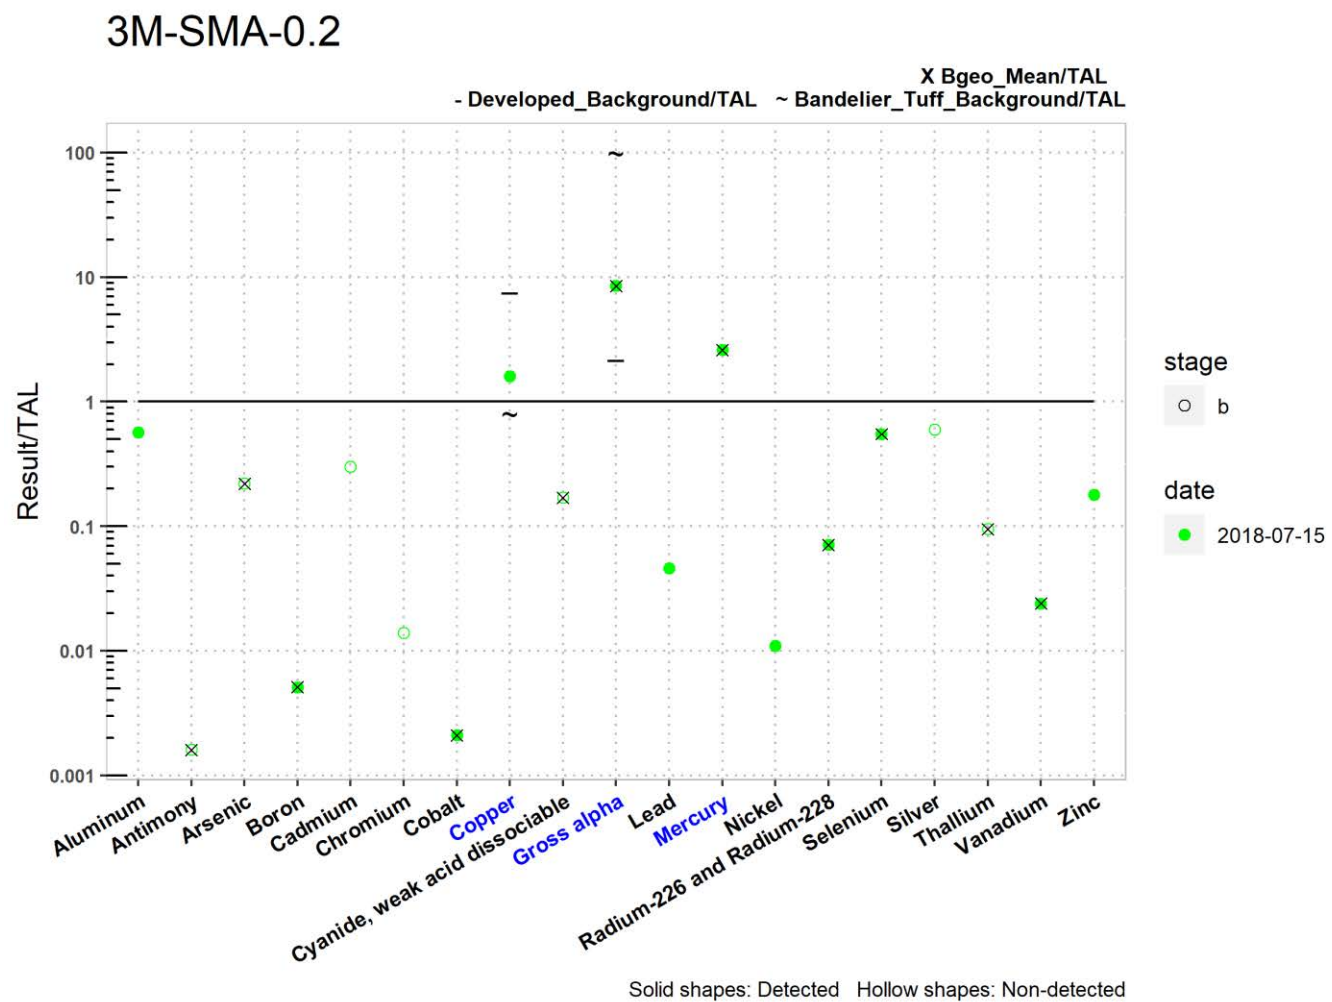
Figure 144-2 Analytical results summary for 3M-SMA-0.2

SWMU 15-010(b) is monitored within 3M-SMA-0.2. Following the installation of baseline control measures and the monitoring station relocation, a storm water sample was collected on July 15, 2018 (Figure 144-2). Analytical results from the sample collected yielded TAL exceedances for copper (6.72 µg/L), gross-alpha activity (127 pCi/L), and mercury (2.02 µg/L) and are presented in Figure 144-2.

TAL exceedances were also evaluated against the appropriate storm water BV, that is, “Bandelier Tuff Background” for undisturbed SMAs or “developed background” for urban settings. BVs are expressed as UTLs using the approved EPA method for calculating BVs. UTLs for undisturbed SMAs were derived from storm water runoff containing entrained sediments derived from Bandelier Tuff and are labeled “Bandelier Tuff Background” in Figure 144-2. UTLs developed for urban settings were derived from runoff from developed landscapes on the Pajarito Plateau, including buildings, parking lots, roads, and associated features, and are labeled “Developed Background” in Figure 144-2.

Monitoring location 3M-SMA-0.2 is located on Bandelier Tuff and no run-on occurs from developed facilities (i.e., buildings, pavement, and parking lots); therefore, calculated storm water UTLs from locations containing sediment derived from Bandelier Tuff were compared with the storm water exceedances. Gross alpha in Bandelier Tuff is associated with naturally occurring radioactive uranium- and thorium-bearing minerals. Metals including copper are found at low concentrations in the Bandelier Tuff, as well.

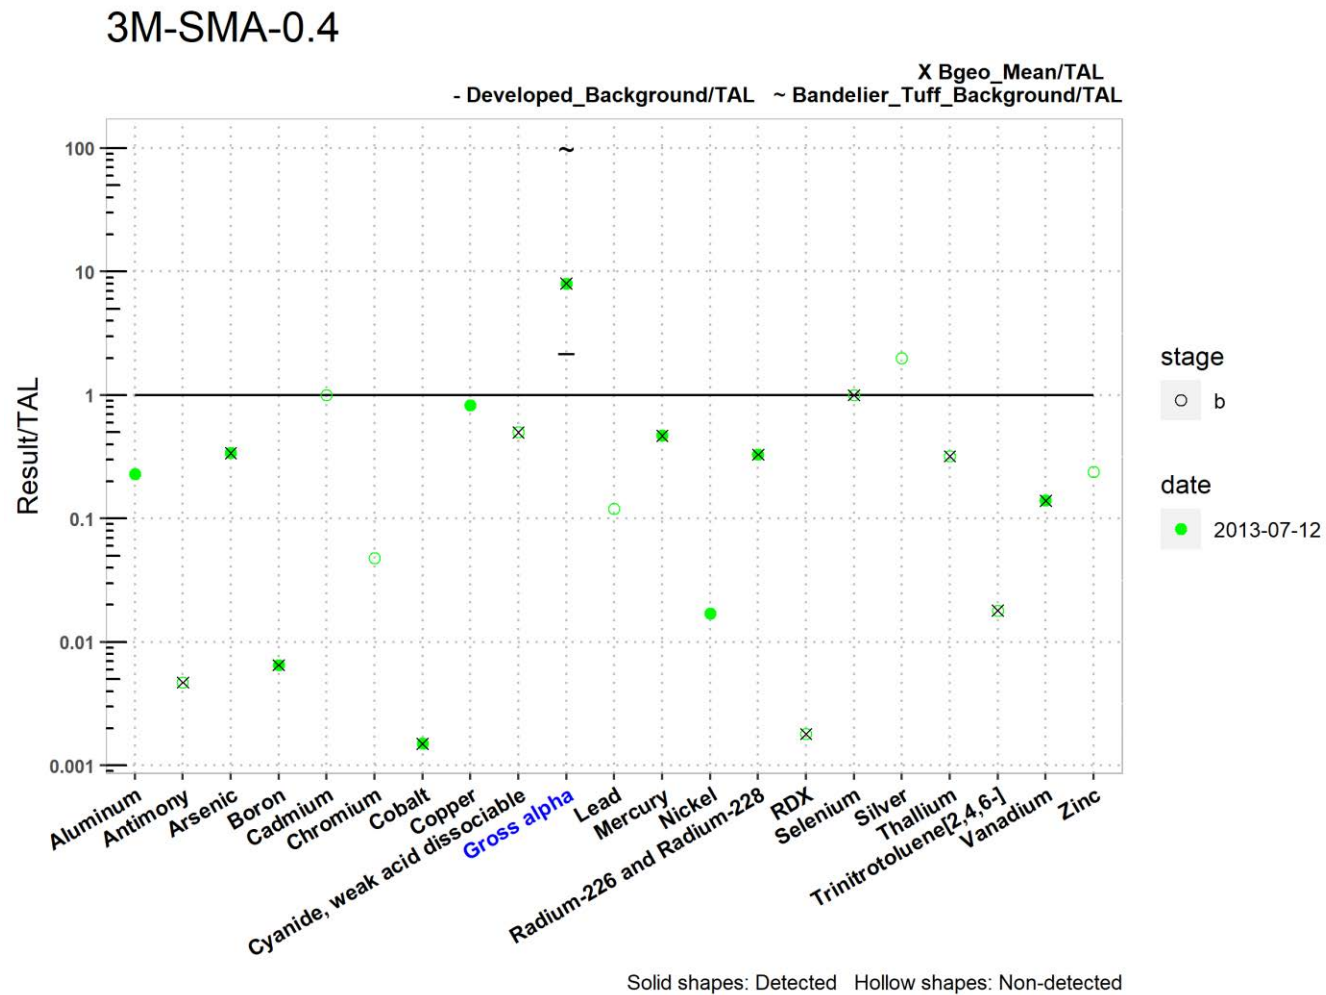
Figure 145-2 Analytical results summary for 3M-SMA-0.4

TAL exceedances were also evaluated against the appropriate storm water BVs, that is, “Bandelier Tuff Background” for undisturbed SMAs or “developed background” for urban settings. BVs are expressed as UTLs using the approved EPA method for calculating BVs. UTLs for undisturbed SMAs were derived from storm water runoff containing entrained sediments derived from Bandelier Tuff and are labeled “Bandelier Tuff Background” in Figure 145-2. UTLs developed for urban settings were derived from runoff from developed landscapes on the Pajarito Plateau, including buildings, parking lots, roads, and associated features, and are labeled “Developed Background” in Figure 145-2.

Monitoring location 3M-SMA-0.4 is located on Bandelier Tuff, and no run-on occurs from developed facilities (i.e., buildings, pavement, and parking lots); therefore, calculated storm water UTLs from locations containing sediments derived from Bandelier Tuff were compared with storm water exceedances. Gross alpha in Bandelier Tuff is associated with naturally occurring radioactive uranium- and thorium-bearing minerals.

- Gross alpha—The gross-alpha UTL for background storm water containing sediment derived from Bandelier Tuff is 1490 pCi/L. The 2013 gross-alpha result is less than this value.

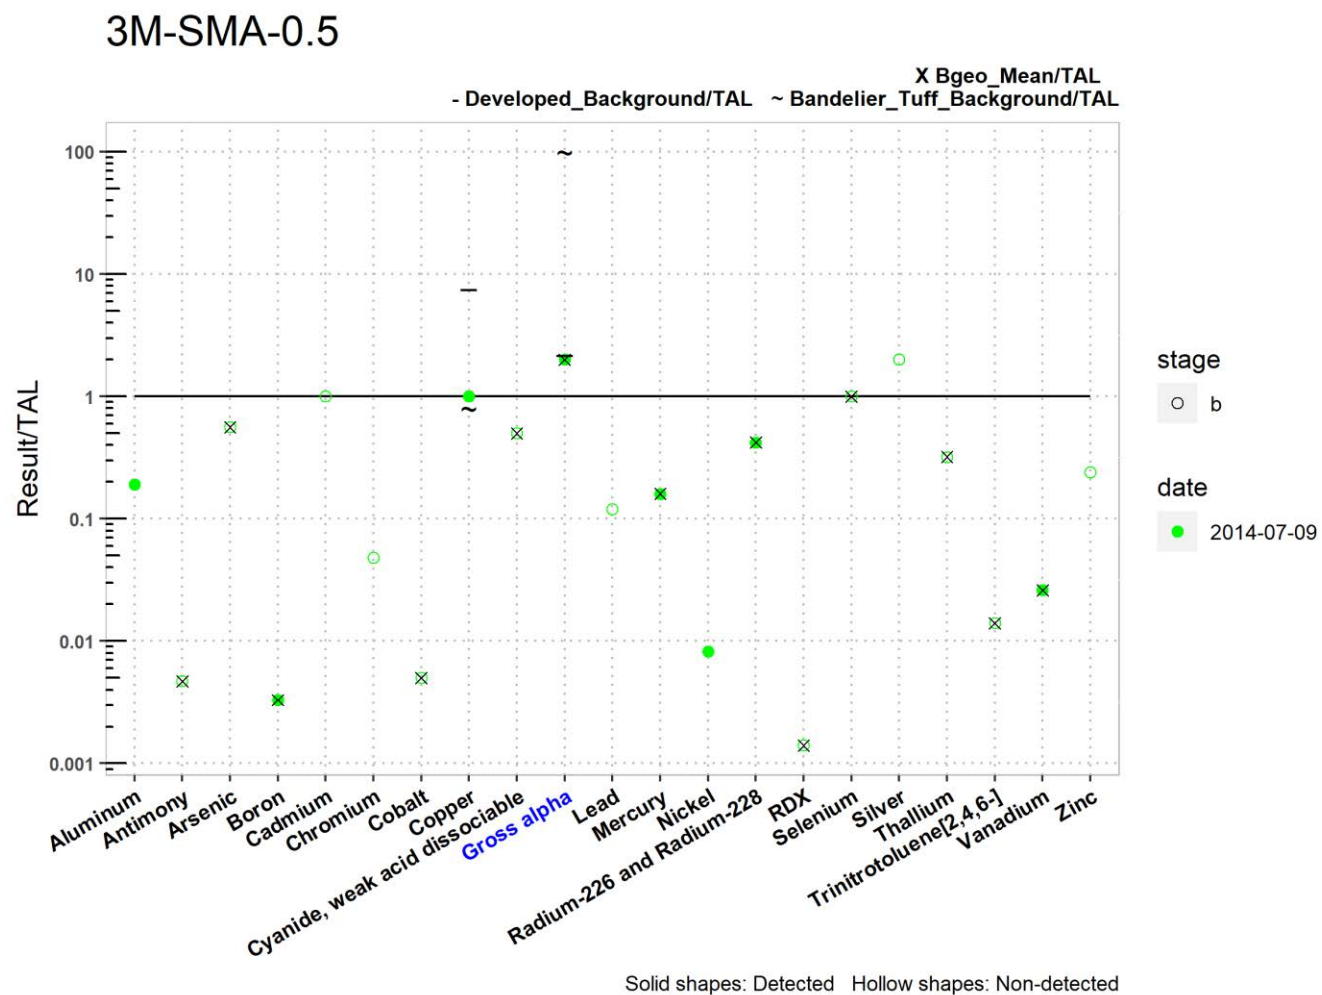
Figure 146-2 Analytical results summary for 3M-SMA-0.5

Monitoring location 3M-SMA-0.5 is located on Bandelier Tuff and no run-on occurs from developed facilities (i.e., buildings, pavement, and parking lots); therefore, calculated storm water UTLs from locations containing sediments derived from Bandelier Tuff were compared with storm water exceedances. Gross alpha in Bandelier Tuff is associated with naturally occurring radioactive uranium- and thorium-bearing minerals. Metals including copper are found at low concentrations in the Bandelier Tuff, as well.
