EMLA-23-BF315-2-1

Subject: Submittal of the 2023 Annual Long-Term Monitoring and Maintenance Report for the
Corrective Measures Implementation at Former 260 Outfall Area

September 2023
EM2023-0581

2023 Annual Long-Term Monitoring and Maintenance Report for the Corrective Measures Implementation at Former 260 Outfall Area

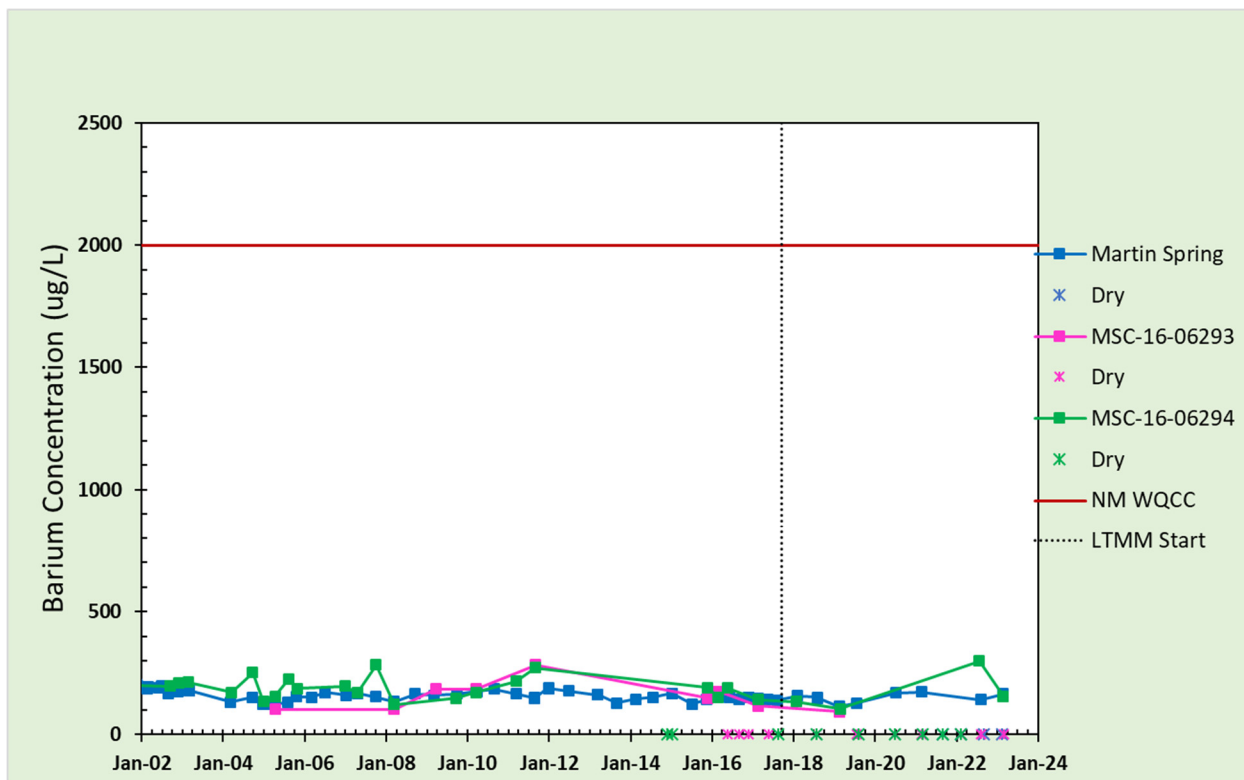
Figure 4.2-3 S-Site Canyon barium data record

Barium was not detected above the 2 mg/L (2000 µg/L) NMED screening level in S-Site Canyon (Figure 4.2-3), Pajarito Canyon (Figure 4.2-4), Water Canyon (Figure 4.2-5), or Fishladder Canyon (Figure 4.2-6). The results are consistent with the historical data record.
