# **2020 Update to the Site Discharge Pollution Prevention Plan, Revision 1**

NPDES Permit No. NM0030759  
May 1, 2021

## **Pajarito Watershed**

### **Volume 3**

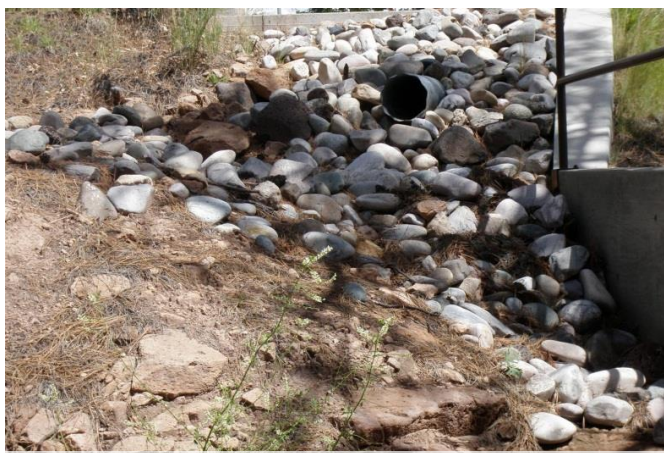
2M-SMA-1, Rip Rap, E00104060010, (photo ID 7516-5)

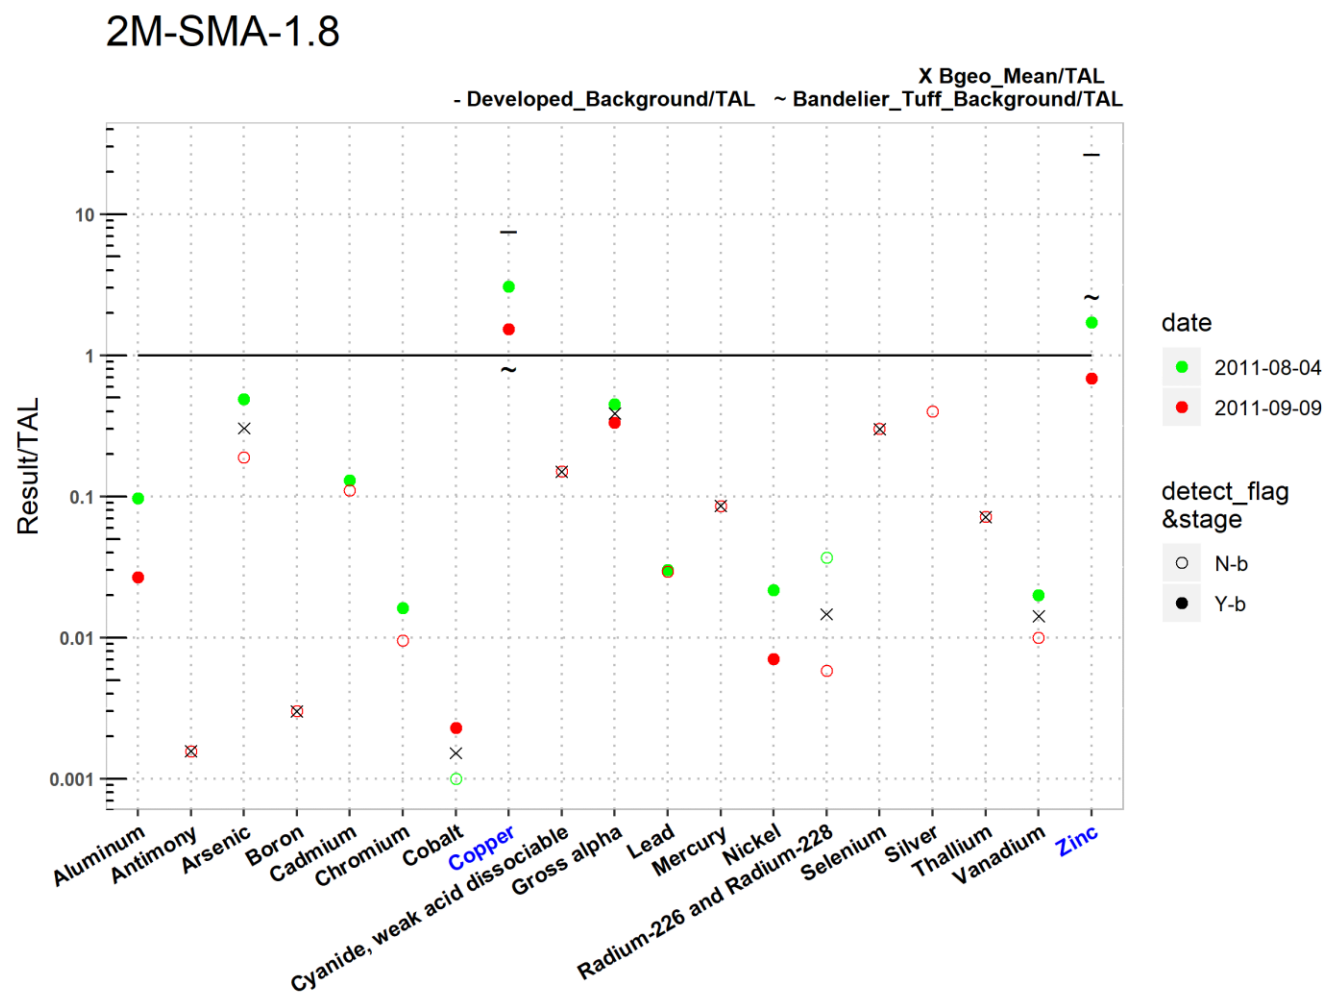
**Figure 138-2 Analytical results summary for 2M-SMA-1.8**

Bold font indicate TAL exceedance; d=detected\_result/TAL, nd=nondetected\_result/TAL

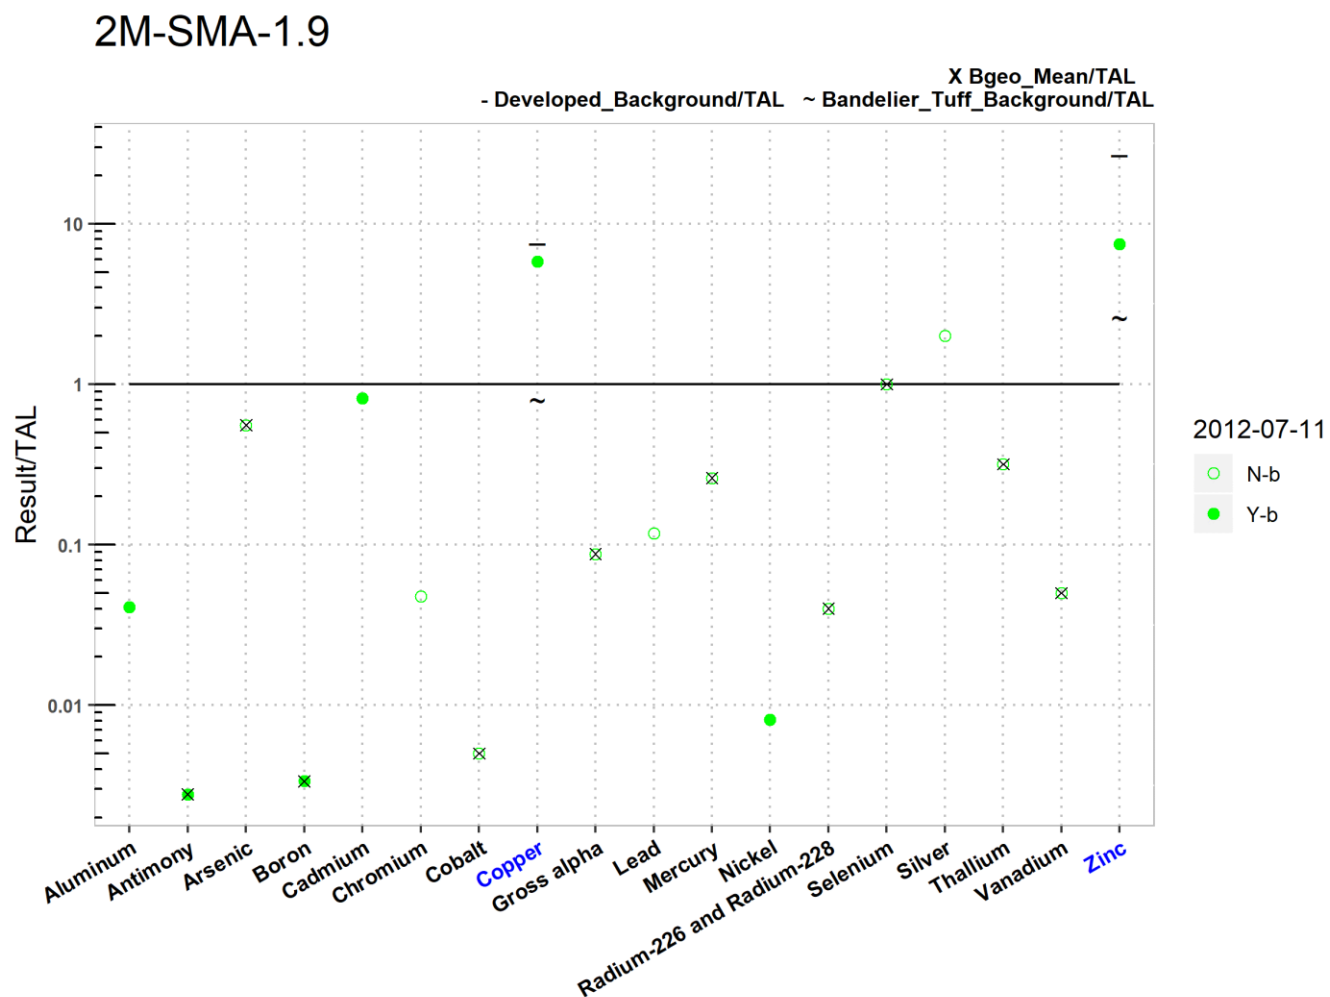
**Figure 139-2 Analytical results summary for 2M-SMA-1.9**

2M-SMA-1.9																		
	Aluminum	Antimony	Arsenic	Boron	Cadmium	Chromium	Cobalt	Copper	Gross alpha	Lead	Mercury	Nickel	Radium-226 and Radium-228	Selenium	Silver	Thallium	Vanadium	Zinc
TAL	750	640	9	5000	1	210	1000	4.3	15	17	0.77	170	30	5	0.5	6.3	100	42
MQL	2.5	60	0.5	100	1	10	50	0.5	NA	0.5	0.005	0.5	NA	5	0.5	0.5	50	20
ATAL	NA	640	9	5000	NA	NA	1000	NA	15	NA	0.77	NA	30	5	NA	6.3	100	NA
MTAL	750	NA	340	NA	0.6	210	NA	4.3	NA	17	1.4	170	NA	20	0.4	NA	NA	42
unit	ug/L	ug/L	ug/L	ug/L	ug/L	ug/L	ug/L	ug/L	pCi/L	ug/L	ug/L	ug/L	pCi/L	ug/L	ug/L	ug/L	ug/L	ug/L
Bgeo_mean/ATAL	NA	0.0028	0.56	0.0034	NA	NA	0.005	NA	0.087	NA	0.26	NA	0.04	1	NA	0.32	0.05	NA
2012-07-11 d	0.041	0.0028	NA	0.0034	0.82	NA	NA	<b>5.8</b>	NA	NA	NA	0.0081	NA	NA	NA	NA	NA	<b>7.5</b>
2012-07-11 nd	NA	NA	0.56	NA	NA	0.048	0.005	NA	0.087	0.12	0.26	NA	0.04	1	2	0.32	0.05	NA

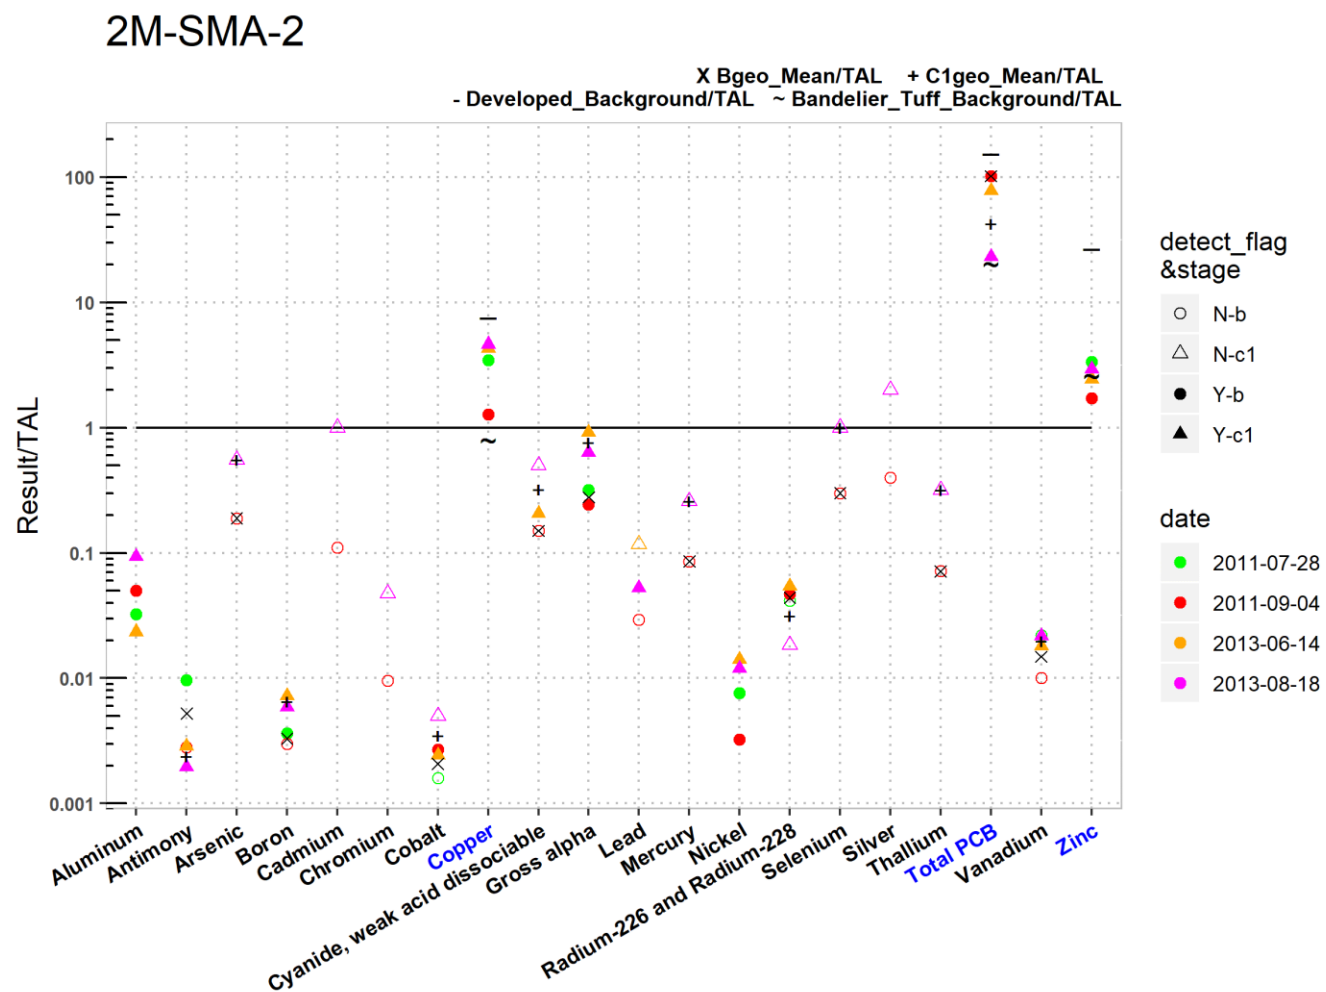
Figure 140-2 Analytical results summary for 2M-SMA-2

2M-SMA-2																			
		Aluminum	Antimony	Arsenic	Boron	Cadmium	Chromium	Cobalt	Copper	Cyanide, weak acid dissociable	Gross alpha	Lead	Mercury	Nickel	Radium-226 and Radium-228	Selenium	Silver	Thallium	Total PCB	Vanadium	Zinc
TAL		750	640	9	5000	1	210	1000	4.3	10	15	17	0.77	170	30	5	0.5	6.3	0.00064	100	42
MQL		2.5	60	0.5	100	1	10	50	0.5	10	NA	0.5	0.005	0.5	NA	5	0.5	0.5	NA	50	20
ATAL		NA	640	9	5000	NA	NA	1000	NA	10	15	NA	0.77	NA	30	5	NA	6.3	0.00064	100	NA
MTAL		750	NA	340	NA	0.6	210	NA	4.3	22	NA	17	1.4	170	NA	20	0.4	NA	NA	NA	42
unit		ug/L	ug/L	ug/L	ug/L	ug/L	ug/L	ug/L	ug/L	ug/L	pCi/L	ug/L	ug/L	ug/L	pCi/L	ug/L	ug/L	ug/L	ug/L	ug/L	ug/L
Bgeo_mean/ATAL		NA	0.0052	0.19	0.0033	NA	NA	0.0021	NA	0.15	0.28	NA	0.086	NA	0.044	0.3	NA	0.071	<b>100</b>	0.015	NA
C1geo_mean/ATAL		NA	0.0024	0.56	0.0065	NA	NA	0.0035	NA	0.32	0.76	NA	0.26	NA	0.032	1	NA	0.32	<b>42</b>	0.02	NA
2011-07-28 d		0.033	0.0097	NA	0.0036	NA	NA	NA	<b>3.5</b>	NA	0.32	NA	NA	0.0076	NA	NA	NA	NA	NA	NA	<b>3.3</b>

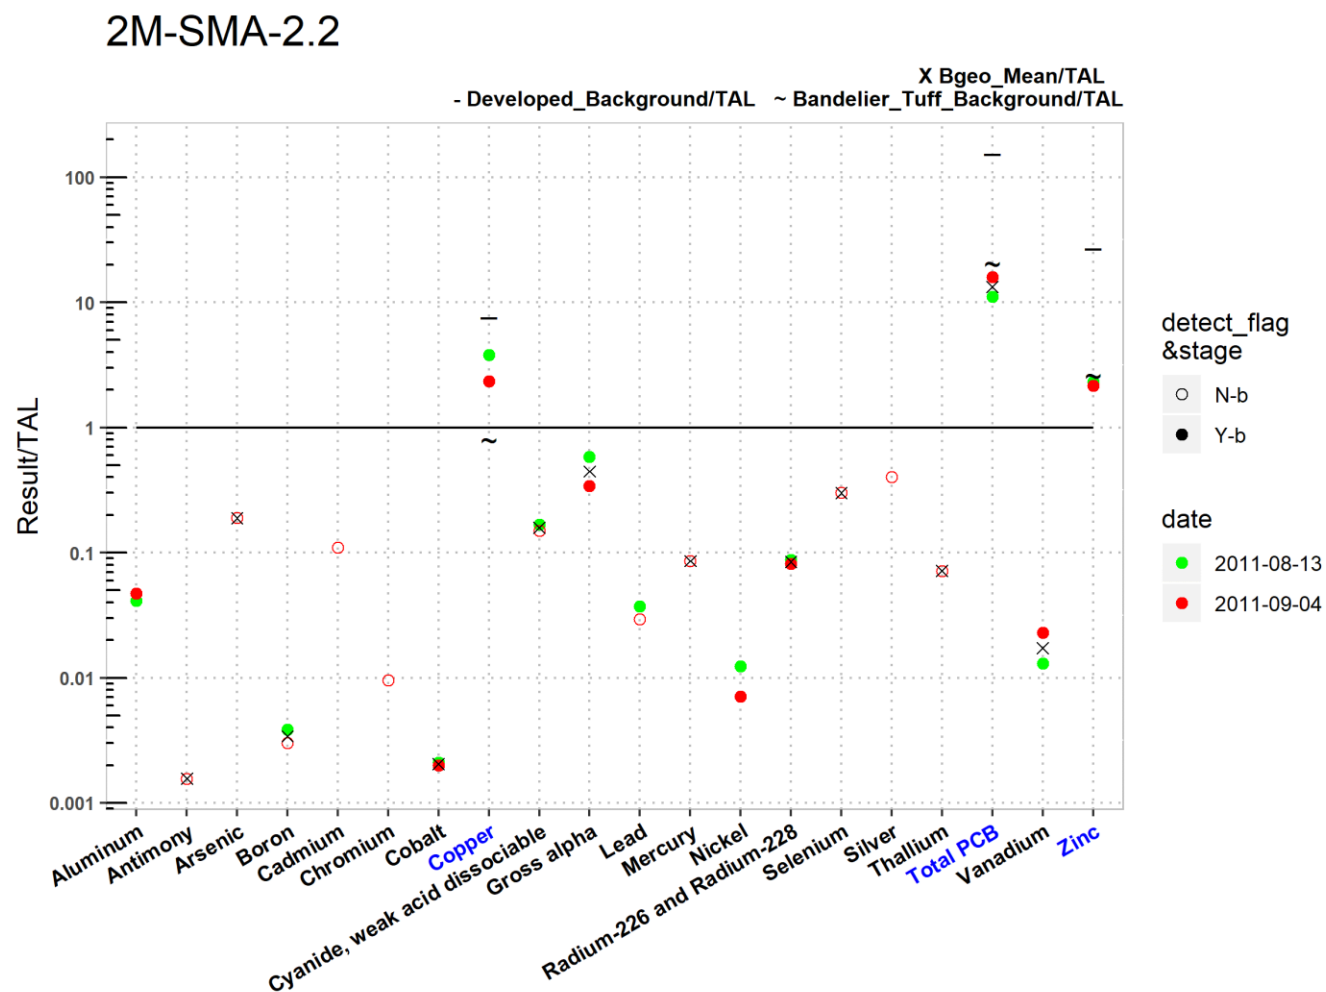
Figure 141-2 Analytical results summary for 2M-SMA-2.2

2M-SMA-2.2																			
		Aluminum	Antimony	Arsenic	Boron	Cadmium	Chromium	Cobalt	Copper	Cyanide, weak acid dissociable	Gross alpha	Lead	Mercury	Nickel	Radium-226 and Radium-228	Selenium	Silver	Thallium	Total PCB	Vanadium	Zinc
TAL		750	640	9	5000	1	210	1000	4.3	10	15	17	0.77	170	30	5	0.5	6.3	0.00064	100	42
MQL		2.5	60	0.5	100	1	10	50	0.5	10	NA	0.5	0.005	0.5	NA	5	0.5	0.5	NA	50	20
ATAL		NA	640	9	5000	NA	NA	1000	NA	10	15	NA	0.77	NA	30	5	NA	6.3	0.00064	100	NA
MTAL		750	NA	340	NA	0.6	210	NA	4.3	22	NA	17	1.4	170	NA	20	0.4	NA	NA	NA	42
unit		ug/L	ug/L	ug/L	ug/L	ug/L	ug/L	ug/L	ug/L	ug/L	pCi/L	ug/L	ug/L	ug/L	pCi/L	ug/L	ug/L	ug/L	ug/L	ug/L	ug/L
Bgeo_mean/ATAL		NA	0.0016	0.19	0.0034	NA	NA	0.002	NA	0.16	0.45	NA	0.086	NA	0.084	0.3	NA	0.071	<b>13</b>	0.017	NA
2011-08-13 d		0.041	NA	NA	0.0039	NA	NA	0.0021	<b>3.8</b>	0.17	0.58	0.037	NA	0.012	0.088	NA	NA	NA	<b>11</b>	0.013	<b>2.3</b>
2011-08-13 nd		NA	0.0016	0.19	NA	0.11	0.0095	NA	NA	NA	NA	NA	0.086	NA	NA	0.3	0.4	0.071	NA	NA	NA

AOC 03-003(k) is monitored within 2M-SMA-2.2. Following the installation of baseline control measures, two baseline storm water samples were collected on August 13, 2011, and September 4, 2011 (Figure 141-2). Analytical results from these samples yielded TAL exceedances for copper (10.1 µg/L and 16.4 µg/L), PCB concentrations (7 ng/L and 10 ng/L), and zinc (90.1 µg/L and 97.2 µg/L) and are presented in Figure 141-2.

**Figure 141-2 (continued) Analytical results summary for 2M-SMA-2.2**

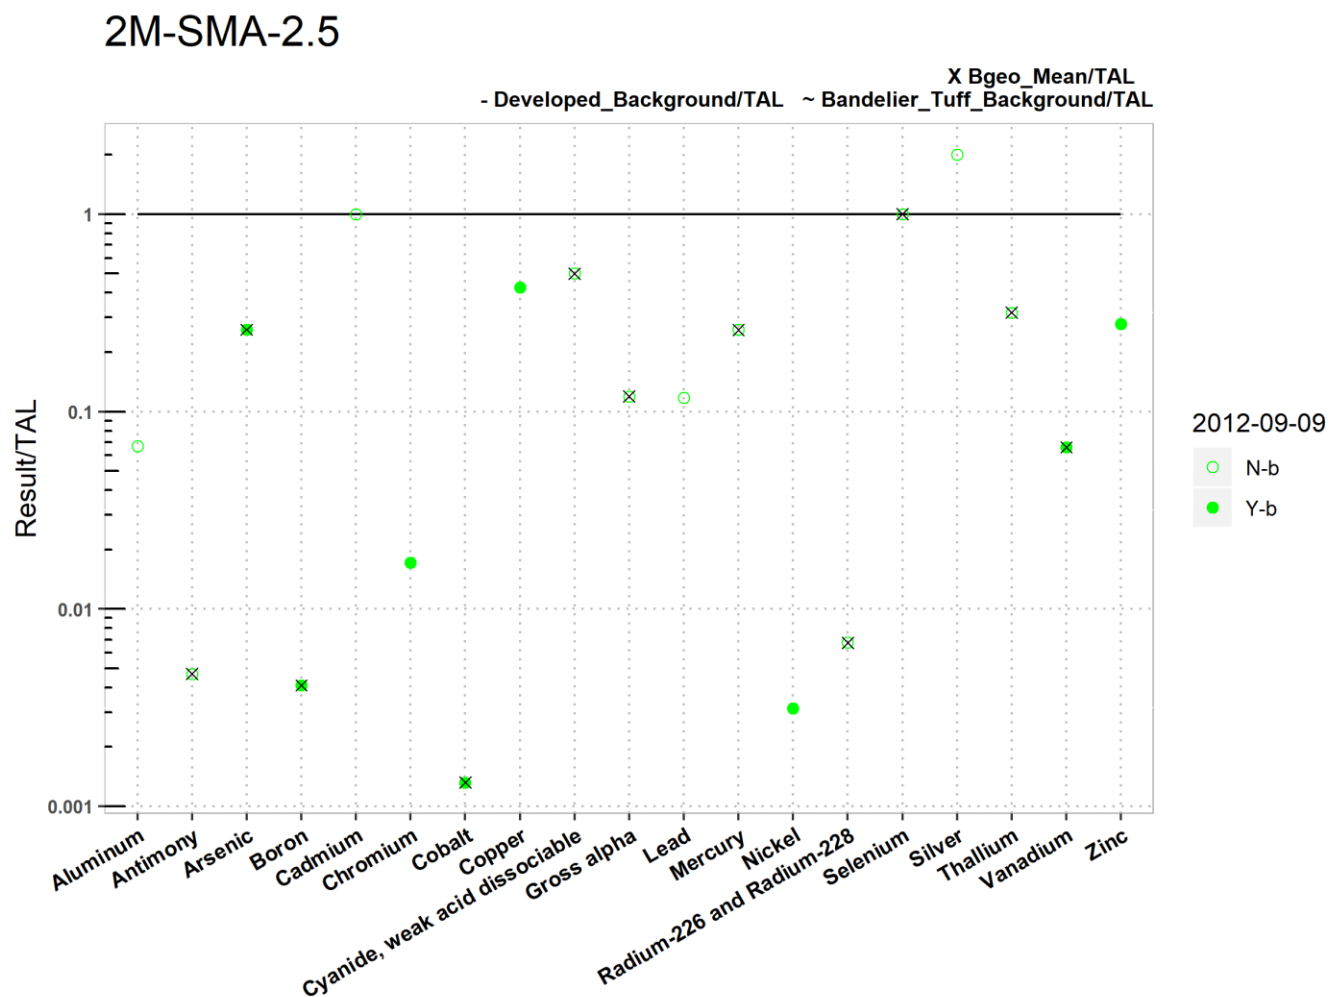
**Figure 142-2 Analytical results summary for 2M-SMA-2.5**

2M-SMA-2.5																		
		Aluminum	Antimony	Arsenic	Boron	Cadmium	Chromium	Cobalt	Copper	Cyanide, weak acid dissociable	Gross alpha	Lead	Mercury	Nickel	Radium-226 and Radium-228	Selenium	Silver	Thallium	Vanadium	Zinc
TAL		750	640	9	5000	1	210	1000	4.3	10	15	17	0.77	170	30	5	0.5	6.3	100	42
MQL		2.5	60	0.5	100	1	10	50	0.5	10	NA	0.5	0.005	0.5	NA	5	0.5	0.5	50	20
ATAL		NA	640	9	5000	NA	NA	1000	NA	10	15	NA	0.77	NA	30	5	NA	6.3	100	NA
MTAL		750	NA	340	NA	0.6	210	NA	4.3	22	NA	17	1.4	170	NA	20	0.4	NA	NA	42
unit		ug/L	ug/L	ug/L	ug/L	ug/L	ug/L	ug/L	ug/L	ug/L	pCi/L	ug/L	ug/L	ug/L	pCi/L	ug/L	ug/L	ug/L	ug/L	ug/L
Bgeo_mean/ATAL		NA	0.0047	0.26	0.0041	NA	NA	0.0013	NA	0.5	0.12	NA	0.26	NA	0.0067	1	NA	0.32	0.066	NA
2012-09-09 d		NA	NA	0.26	0.0041	NA	0.017	0.0013	0.43	NA	NA	NA	NA	0.0031	NA	NA	NA	NA	0.066	0.28
2012-09-09 nd		0.067	0.0047	NA	NA	1	NA	NA	NA	0.5	0.12	0.12	0.26	NA	0.0067	1	2	0.32	NA	NA
		Bold font indicate TAL exceedance; d=detected_result/TAL, nd=nondetected_result/TAL

SWMU 40-001(c) is monitored within 2M-SMA-2.5. Following the installation of baseline control measures, a baseline storm water sample was collected on September 9, 2012 (Figure 142-2). In Figure 142-2, cadmium, selenium, and silver are reported as nondetected results greater than their respective TALs. These values are reported at the PQL, the MDL for these analytes are below the TAL. The values are nondetects and thus not considered TAL exceedances. Analytical results from this sample yielded no TAL exceedances. Baseline confirmation monitoring continues for 2M-SMA-2.5 in order to collect a second sample with all results below the applicable MTAL or ATAL.

**Figure 142-2 (continued) Analytical results summary for 2M-SMA-2.5**

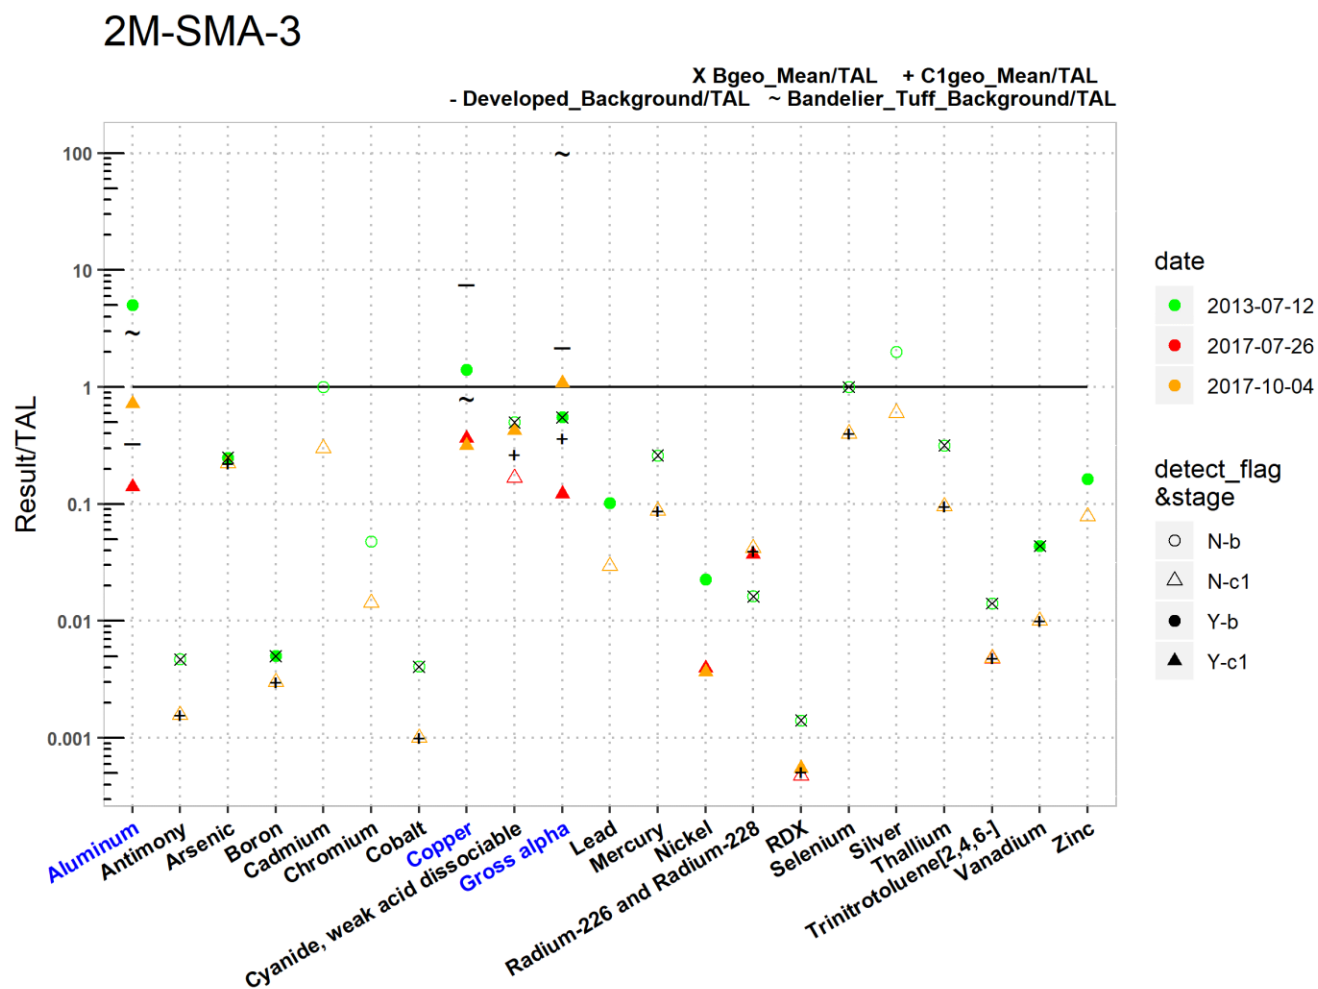
**Figure 143-2 Analytical results summary for 2M-SMA-3**

2M-SMA-3																				
		Aluminum	Antimony	Arsenic	Boron	Cadmium	Chromium	Cobalt	Copper	Cyanide, weak acid dissociable	Gross alpha	Lead	Mercury	Nickel	Radium-226 and Radium-228	RDX	Selenium	Silver	Thallium	Trinitrotoluene [2,4,6-]	Vanadium	Zinc
	TAL	750	640	9	5000	1	210	1000	4.3	10	15	17	0.77	170	30	200	5	0.5	6.3	20	100	42
	MQL	2.5	60	0.5	100	1	10	50	0.5	10	NA	0.5	0.005	0.5	NA	NA	5	0.5	0.5	NA	50	20
	ATAL	NA	640	9	5000	NA	NA	1000	NA	10	15	NA	0.77	NA	30	200	5	NA	6.3	20	100	NA
	MTAL	750	NA	340	NA	0.6	210	NA	4.3	22	NA	17	1.4	170	NA	NA	20	0.4	NA	NA	NA	42
	unit	ug/L	ug/L	ug/L	ug/L	ug/L	ug/L	ug/L	ug/L	ug/L	pCi/L	ug/L	ug/L	ug/L	pCi/L	ug/L	ug/L	ug/L	ug/L	ug/L	ug/L	ug/L
Bgeo_mean/	ATAL	NA	0.0047	0.25	0.005	NA	NA	0.0041	NA	0.5	0.55	NA	0.26	NA	0.016	0.0014	1	NA	0.32	0.014	0.044	NA
C1geo_mean/	ATAL	NA	0.0016	0.22	0.003	NA	NA	0.001	NA	0.27	0.36	NA	0.087	NA	0.039	0.00051	0.4	NA	0.095	0.0048	0.01	NA
	2013-07-12 d	5	NA	0.25	0.005	NA	NA	NA	1.4	NA	0.55	0.1	NA	0.023	NA	NA	NA	NA	NA	NA	0.044	0.16

SWMUs 07-001(a), 07-001(b), 07-001(c), and 07-001(d) are monitored within 2M-SMA-3. Following the installation of baseline control measures, a baseline storm water sample was collected on July 12, 2013 (Figure 143-2). In Figure 143-2, cadmium, selenium, and silver are reported as nondetected results greater than their respective TALs. These values are reported at the PQL, the MDL for these analytes are below the TAL. The values are nondetects and thus not considered TAL exceedances. Analytical results from this sample yielded TAL exceedances for aluminum (3750 µg/L) and copper (6.05 µg/L) and are presented in Figure 143-2.

Enhanced control confirmation monitoring storm water samples were collected on July 26, 2017, and October 4, 2017 (Figure 143-2). Analytical results from these samples yielded no TAL exceedances. Gross-alpha activity exceeded the TAL in the October 4, 2017, sample, but not in the July 26, 2017, sample. As both corrective action samples are used to calculate the geomean, the geomean is less than the ATAL and thus not considered a TAL exceedance in corrective action monitoring. Corrective action monitoring is complete for associated SWMUs 07-001(a), 07-001(b), and 07-001(d) because all applicable sampling results are below the applicable MTAL or ATAL. Analytical results from the sample collected in 2017 are not representative of 07-001(c) and corrective action monitoring will continue for 2M-SMA-3 and associated SWMU 07-001(c).

**Figure 143-2 (continued) Analytical results summary for 2M-SMA-3**

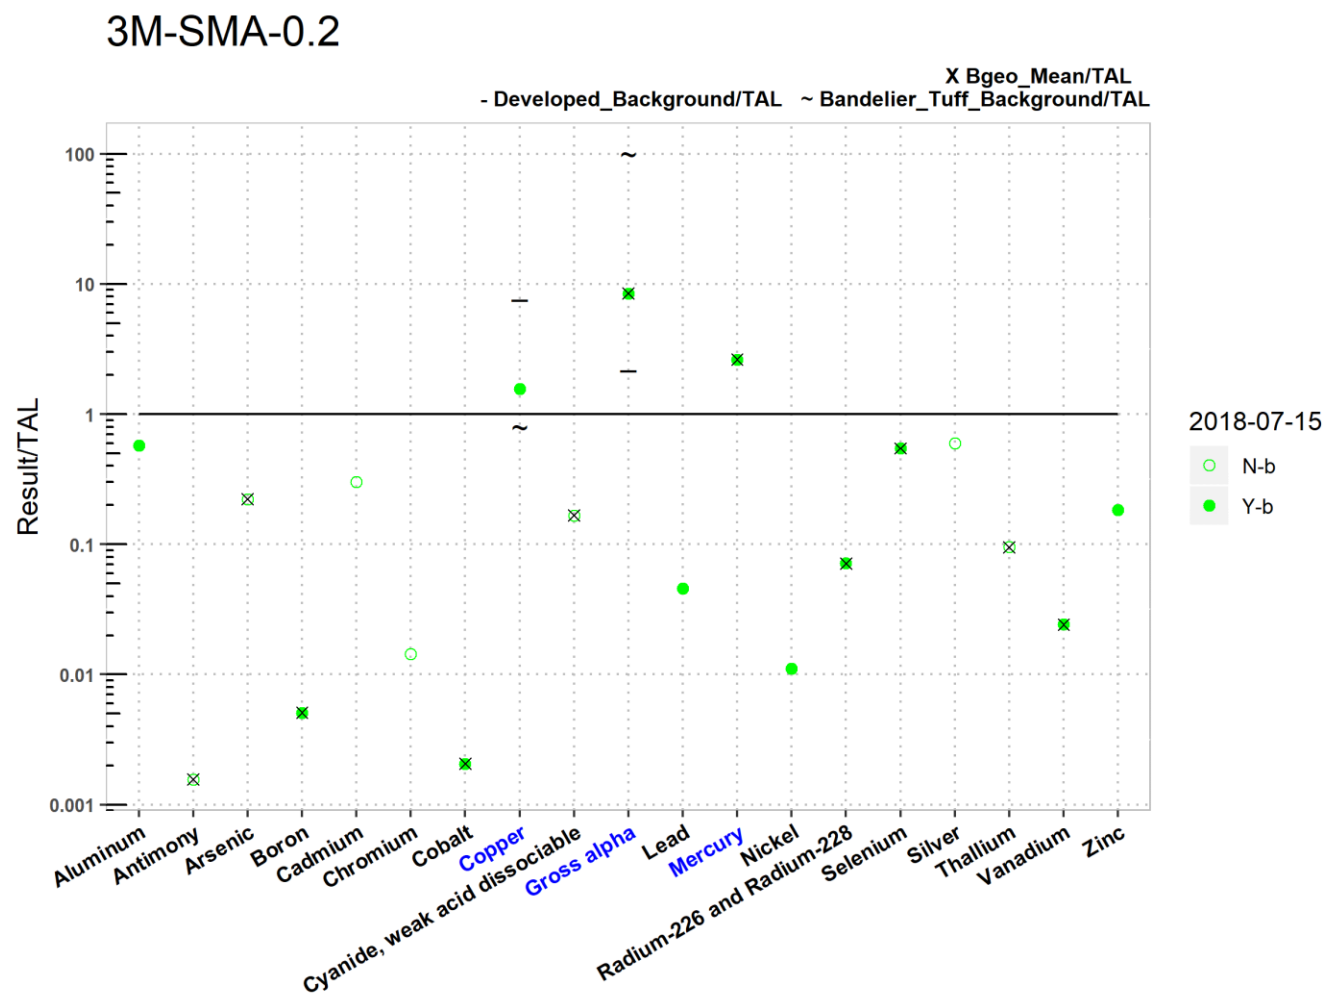
Figure 144-2 Analytical results summary for 3M-SMA-0.2

3M-SMA-0.2																			
	Aluminum	Antimony	Arsenic	Boron	Cadmium	Chromium	Cobalt	Copper	Cyanide, weak acid dissociable	Gross alpha	Lead	Mercury	Nickel	Radium-226 and Radium-228	Selenium	Silver	Thallium	Vanadium	Zinc
TAL	750	640	9	5000	1	210	1000	4.3	10	15	17	0.77	170	30	5	0.5	6.3	100	42
MDL	2.5	60	0.5	100	1	10	50	0.5	10	NA	0.5	0.005	0.5	NA	5	0.5	0.5	50	20
ATL	NA	640	9	5000	NA	NA	1000	NA	10	15	NA	0.77	NA	30	5	NA	6.3	100	NA
MDL	750	NA	340	NA	0.6	210	NA	4.3	22	NA	17	1.4	170	NA	20	0.4	NA	NA	42
unit	ug/L	ug/L	ug/L	ug/L	ug/L	ug/L	ug/L	ug/L	ug/L	pCi/L	ug/L	ug/L	ug/L	pCi/L	ug/L	ug/L	ug/L	ug/L	ug/L
Bgeo_mean/ATL	NA	0.0016	0.22	0.0051	NA	NA	0.0021	NA	0.17	<b>8.5</b>	NA	<b>2.6</b>	NA	0.071	0.55	NA	0.095	0.024	NA
2018-07-15 d	0.57	NA	NA	0.0051	NA	NA	0.0021	<b>1.6</b>	NA	<b>8.5</b>	0.046	<b>2.6</b>	0.011	0.071	0.55	NA	NA	0.024	0.18
2018-07-15 nd	NA	0.0016	0.22	NA	0.3	0.014	NA	NA	0.17	NA	NA	NA	NA	NA	0.6	0.095	NA	NA	NA

SWMU 15-010(b) is monitored within 3M-SMA-0.2. Following the installation of baseline control measures and the monitoring station relocation, a storm water sample was collected on July 15, 2018 (Figure 144-2). Analytical results from the sample collected yielded TAL exceedances for copper (6.72 µg/L), gross-alpha activity (127 pCi/L), and mercury (2.02 µg/L) and are presented in Figure 144-2.

TAL exceedances were also evaluated against the appropriate storm water BV, that is, “Bandelier Tuff background” for undisturbed SMAs or “developed background” for urban settings. BVs are expressed as UTLs using the approved EPA method for calculating BVs. UTLs for undisturbed SMAs were derived from storm water runoff containing entrained sediments derived from Bandelier Tuff and are labeled “Bandelier Tuff Background” in Figure 144-2. UTLs developed for urban settings were derived from runoff from developed landscapes on the Pajarito Plateau, including buildings, parking lots, roads, and associated features, and are labeled “Developed Background” in Figure 144-2.

**Figure 144-2 (continued) Analytical results summary for 3M-SMA-0.2**

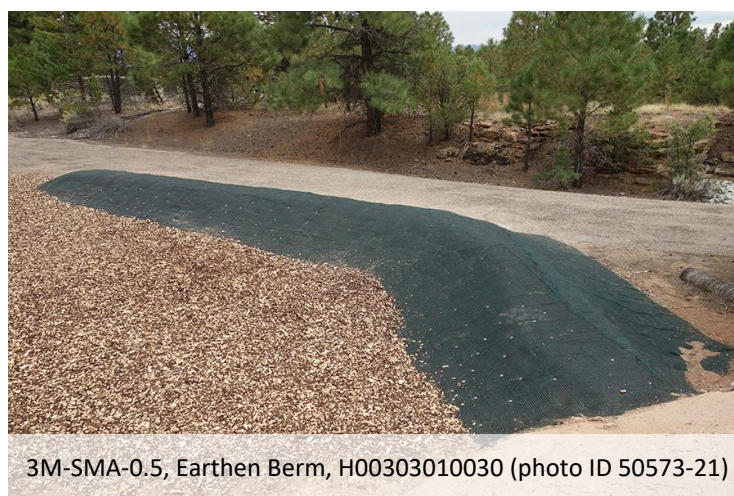
3M-SMA-0.5, Earthen Berm, H00303010030 (photo ID 50573-21)

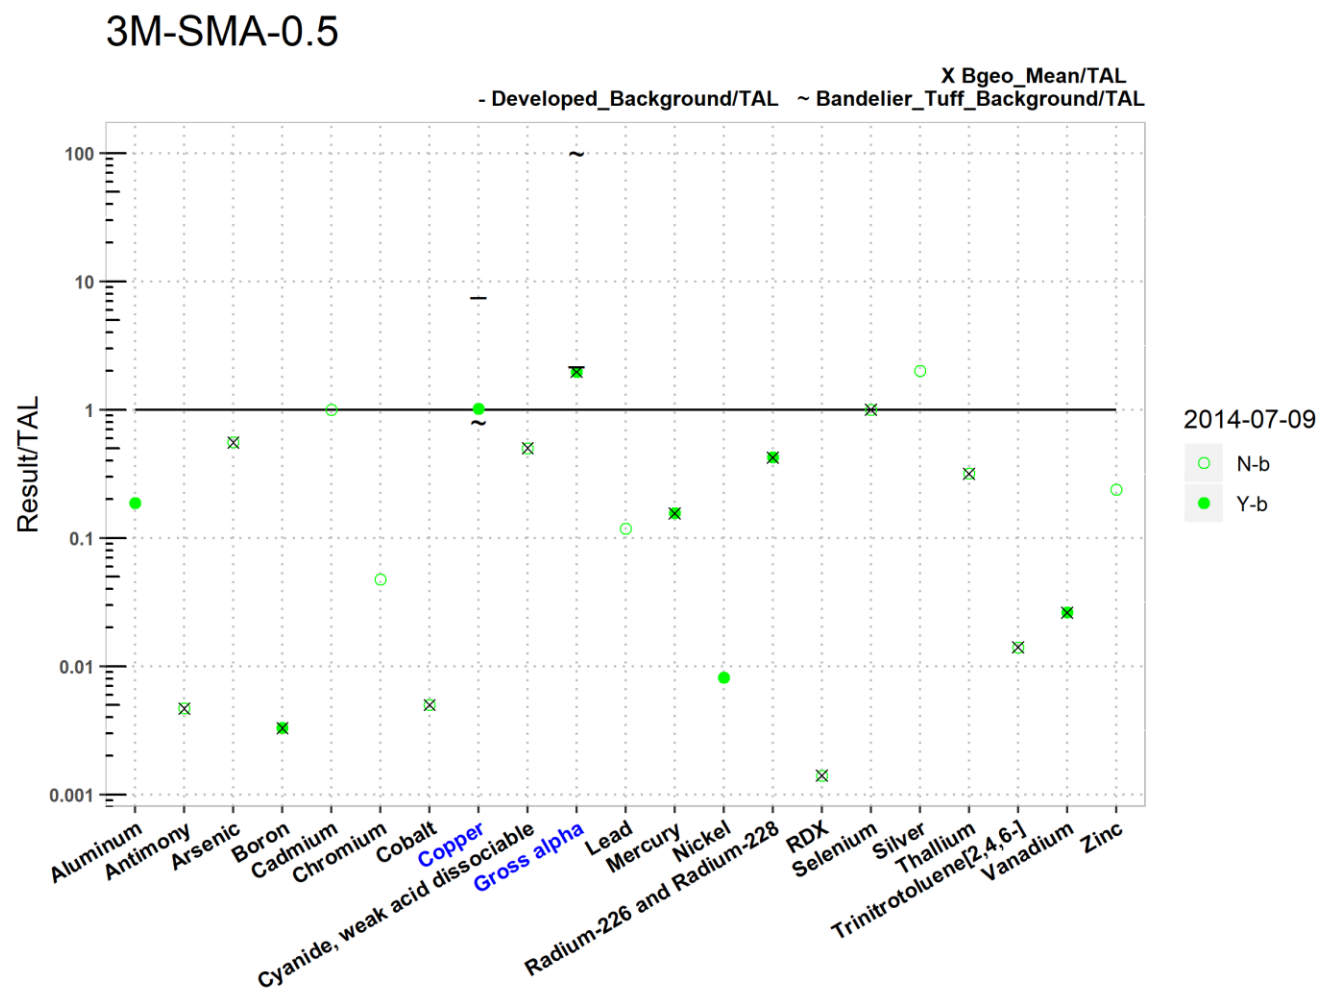
**Figure 146-2 Analytical results summary for 3M-SMA-0.5**

3M-SMA-0.5																					
	Aluminum	Antimony	Arsenic	Boron	Cadmium	Chromium	Cobalt	Copper	Cyanide, weak acid dissociable	Gross alpha	Lead	Mercury	Nickel	Radium-226 and Radium-228	RDX	Selenium	Silver	Thallium	Trinitrotoluene [2,4,6-]	Vanadium	Zinc
TAL	750	640	9	5000	1	210	1000	4.3	10	15	17	0.77	170	30	200	5	0.5	6.3	20	100	42
MQL	2.5	60	0.5	100	1	10	50	0.5	10	NA	0.5	0.005	0.5	NA	NA	5	0.5	0.5	NA	50	20
ATAL	NA	640	9	5000	NA	NA	1000	NA	10	15	NA	0.77	NA	30	200	5	NA	6.3	20	100	NA
MTAL	750	NA	340	NA	0.6	210	NA	4.3	22	NA	17	1.4	170	NA	NA	20	0.4	NA	NA	NA	42
unit	ug/L	ug/L	ug/L	ug/L	ug/L	ug/L	ug/L	ug/L	ug/L	pCi/L	ug/L	ug/L	ug/L	pCi/L	ug/L	ug/L	ug/L	ug/L	ug/L	ug/L	ug/L
Bgeo_mean/ATAL	NA	0.0047	0.56	0.0033	NA	NA	0.005	NA	0.5	<b>2</b>	NA	0.16	NA	0.42	0.0014	1	NA	0.32	0.014	0.026	NA
2014-07-09 d	0.19	NA	NA	0.0033	NA	NA	NA	<b>1</b>	NA	<b>2</b>	NA	0.16	0.0082	0.42	NA	NA	NA	NA	NA	0.026	NA
2014-07-09 nd	NA	0.0047	0.56	NA	1	0.048	0.005	NA	0.5	NA	0.12	NA	NA	NA	0.0014	1	2	0.32	0.014	NA	0.24

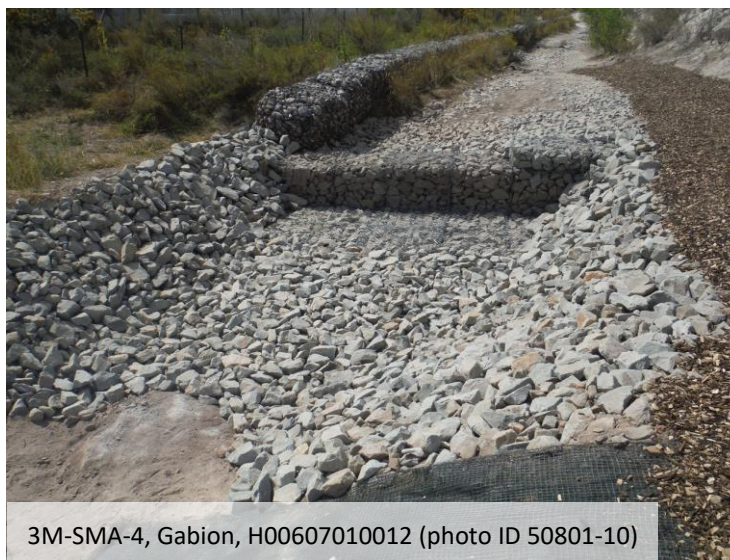
3M-SMA-4, Gabion, H00607010012 (photo ID 50801-10)

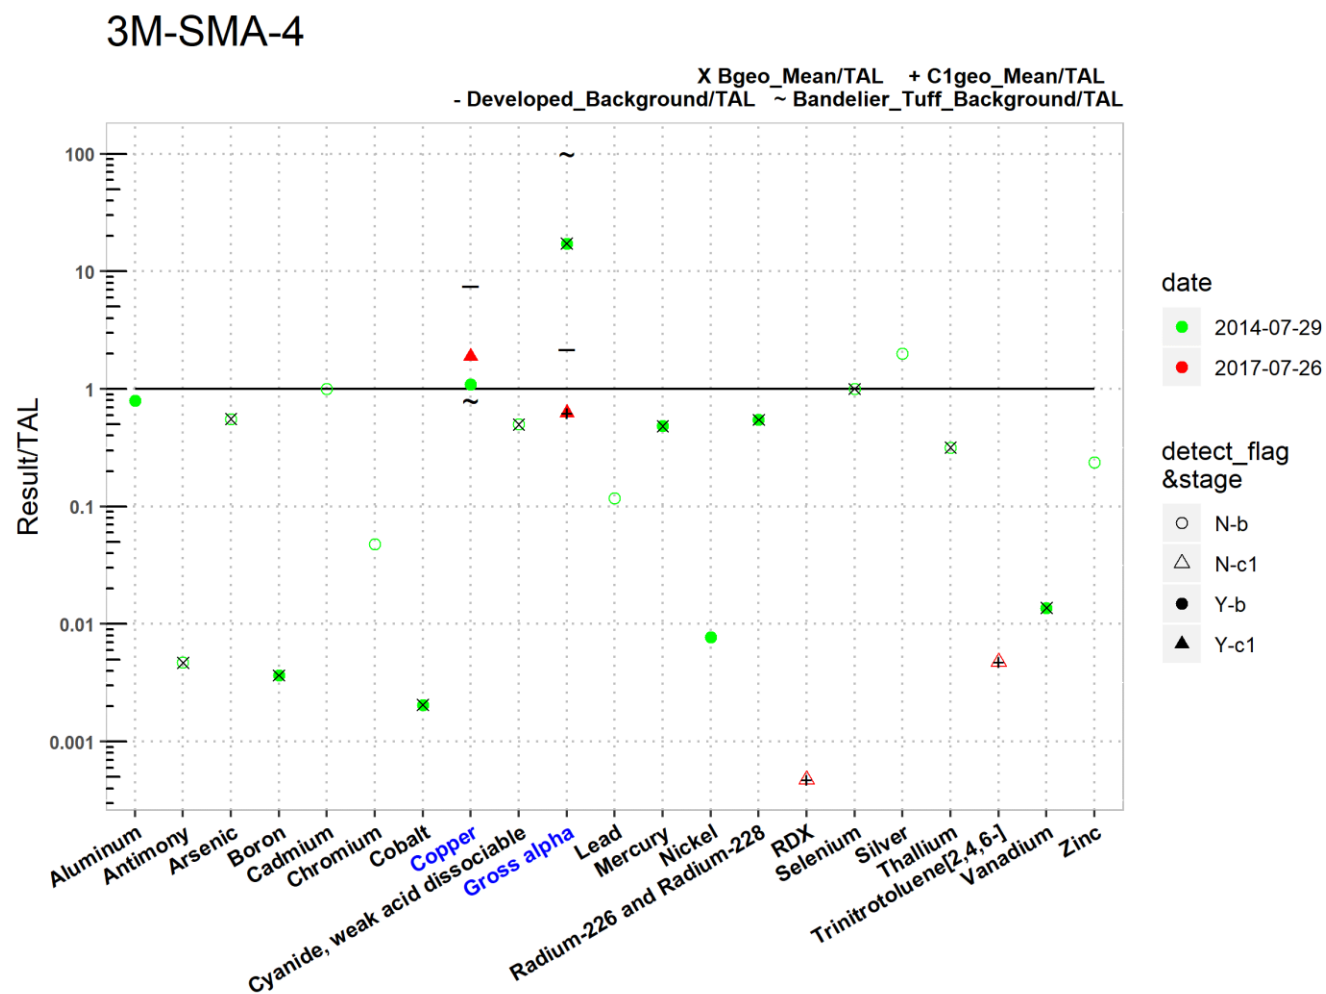
**Figure 149-2 Analytical results summary for 3M-SMA-4**

3M-SMA-4																				
		Aluminum	Antimony	Arsenic	Boron	Cadmium	Chromium	Cobalt	Copper	Cyanide, weak acid dissociable	Gross alpha	Lead	Mercury	Nickel	Radium-226 and Radium-228	RDX	Selenium	Silver	Thallium	Trinitrotoluene [2,4,6-]	Vanadium	Zinc
Bgeo_mean/ATAL C1geo_mean/ATAL	TAL	750	640	9	5000	1	210	1000	4.3	10	15	17	0.77	170	30	200	5	0.5	6.3	20	100	42
	MQL	2.5	60	0.5	100	1	10	50	0.5	10	NA	0.5	0.005	0.5	NA	NA	5	0.5	0.5	NA	50	20
	ATAL	NA	640	9	5000	NA	NA	1000	NA	10	15	NA	0.77	NA	30	200	5	NA	6.3	20	100	NA
	MTAL	750	NA	340	NA	0.6	210	NA	4.3	22	NA	17	1.4	170	NA	NA	20	0.4	NA	NA	NA	42
	unit	ug/L	ug/L	ug/L	ug/L	ug/L	ug/L	ug/L	ug/L	ug/L	pCi/L	ug/L	ug/L	ug/L	pCi/L	ug/L	ug/L	ug/L	ug/L	ug/L	ug/L	ug/L
	2014-07-29 d	0.79	NA	NA	0.0037	NA	NA	0.002	1.1	NA	17	NA	0.48	0.0077	0.55	NA	NA	NA	NA	NA	0.014	NA
	2014-07-29 nd	NA	0.0047	0.56	NA	1	0.048	NA	NA	0.5	NA	0.12	NA	NA	NA	NA	1	2	0.32	NA	NA	0.24
	2017-07-26 d	NA	NA	NA	NA	NA	NA	NA	1.9	NA	0.63	NA	NA	NA	NA	NA	NA	NA	NA	NA	NA	NA

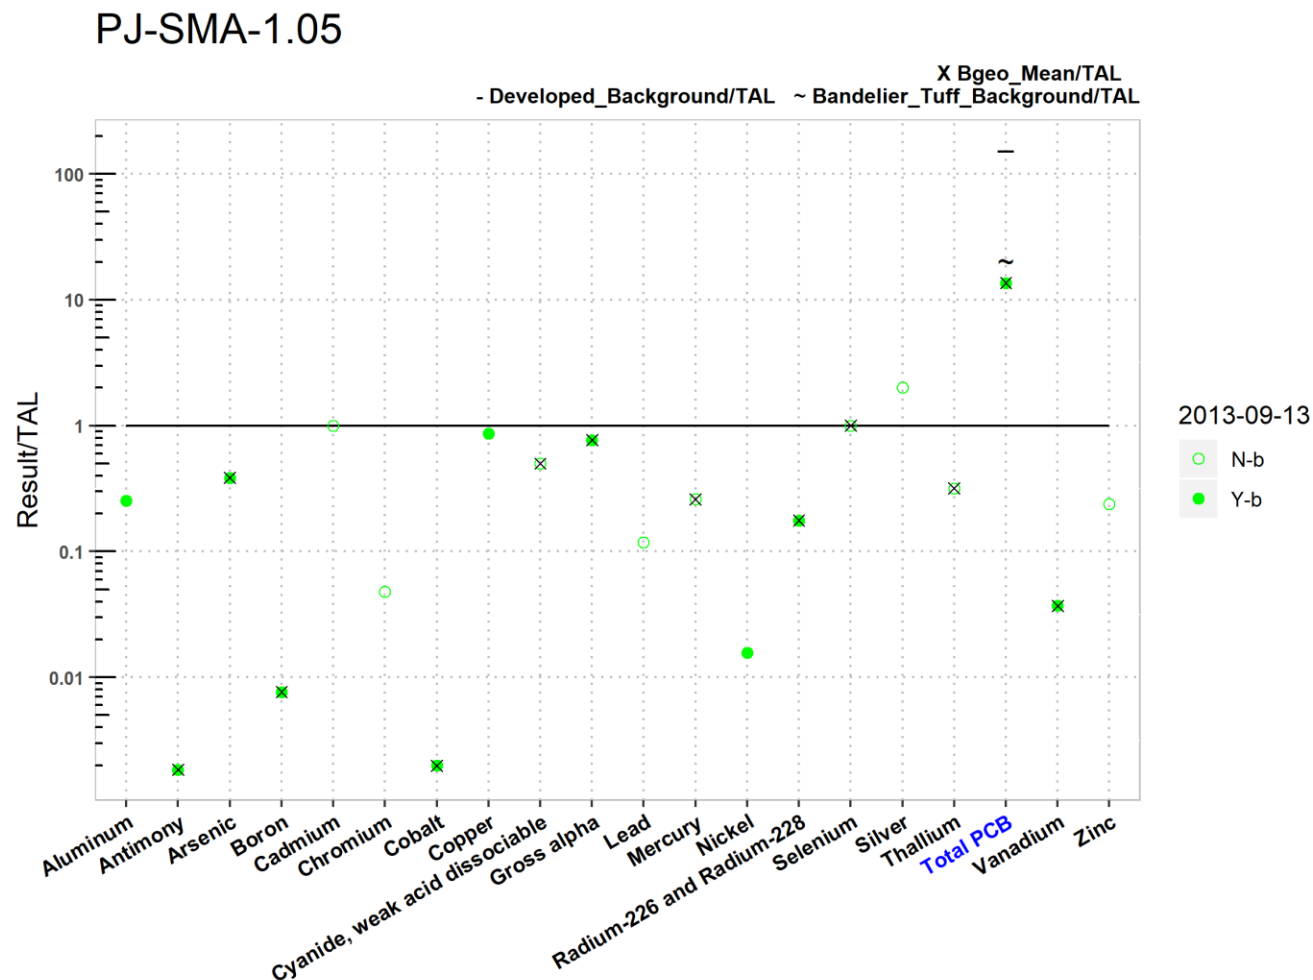
**Figure 150-2 Analytical results summary for PJ-SMA-1.05**

PJ-SMA-1.05																				
	Aluminum	Antimony	Arsenic	Boron	Cadmium	Chromium	Cobalt	Copper	Cyanide, weak acid dissociable	Gross alpha	Lead	Mercury	Nickel	Radium-226 and Radium-228	Selenium	Silver	Thallium	Total PCB	Vanadium	Zinc
TAL	750	640	9	5000	1	210	1000	4.3	10	15	17	0.77	170	30	5	0.5	6.3	0.00064	100	42
MQL	2.5	60	0.5	100	1	10	50	0.5	10	NA	0.5	0.005	0.5	NA	5	0.5	0.5	NA	50	20
ATAL	NA	640	9	5000	NA	NA	1000	NA	10	15	NA	0.77	NA	30	5	NA	6.3	0.00064	100	NA
MTAL	750	NA	340	NA	0.6	210	NA	4.3	22	NA	17	1.4	170	NA	20	0.4	NA	NA	NA	42
unit	ug/L	ug/L	ug/L	ug/L	ug/L	ug/L	ug/L	ug/L	ug/L	pCi/L	ug/L	ug/L	ug/L	pCi/L	ug/L	ug/L	ug/L	ug/L	ug/L	ug/L
Bgeo_mean/ATAL	NA	0.0018	0.39	0.0076	NA	NA	0.002	NA	0.5	0.77	NA	0.26	NA	0.18	1	NA	0.32	<b>14</b>	0.037	NA
2013-09-13 d	0.25	0.0018	0.39	0.0076	NA	NA	0.002	0.86	NA	0.77	NA	NA	0.016	0.18	NA	NA	NA	<b>14</b>	0.037	NA
2013-09-13 nd	NA	NA	NA	NA	1	0.048	NA	NA	0.5	NA	0.12	0.26	NA	NA	1	2	0.32	NA	NA	0.24

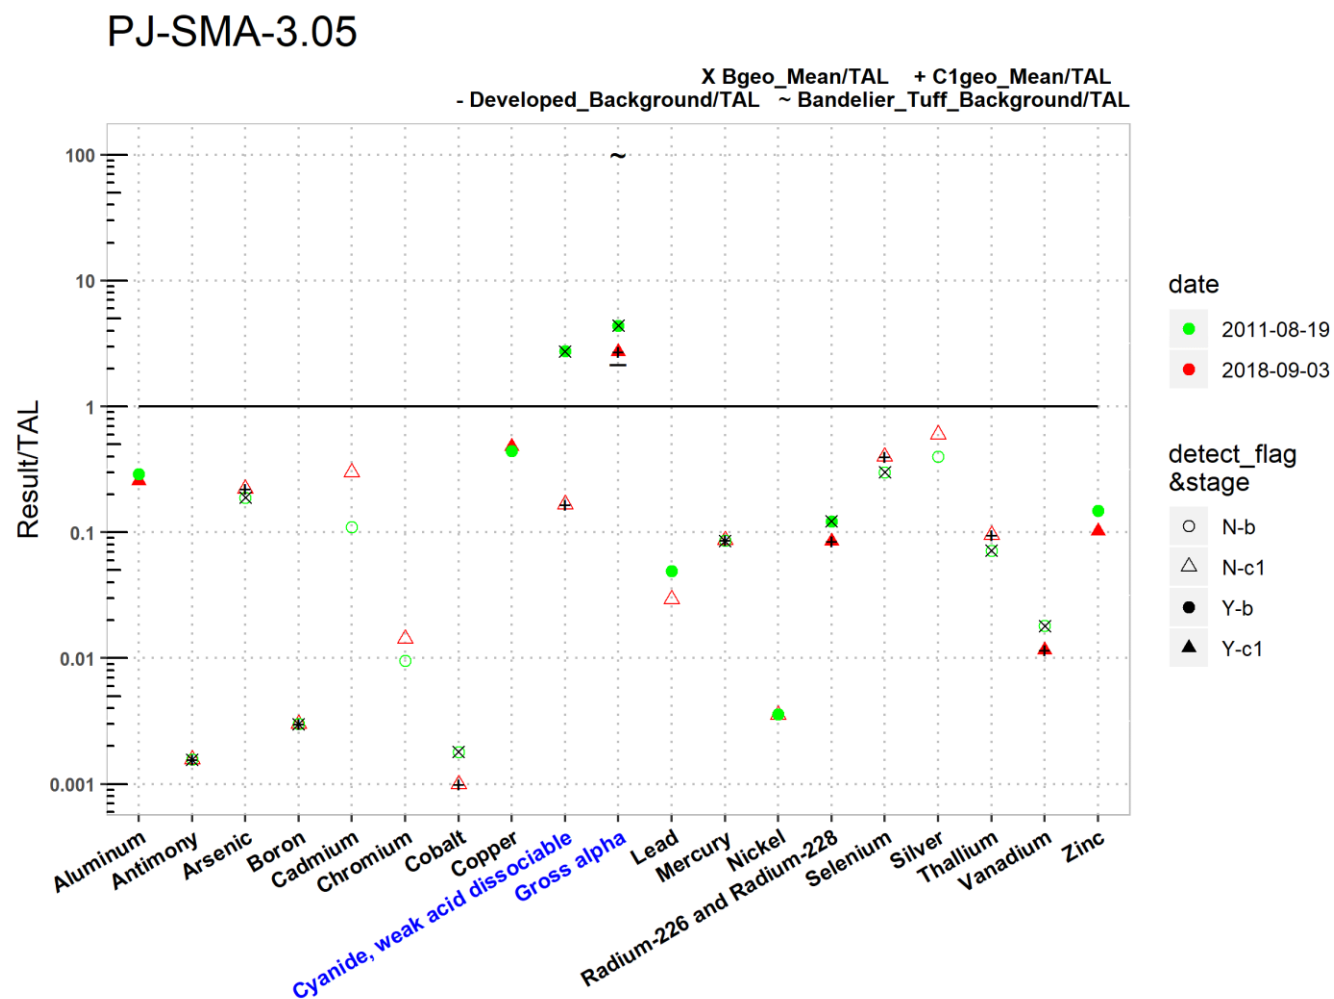
Figure 152-2 Analytical results summary for PJ-SMA-3.05

PJ-SMA-3.05																			
	Aluminum	Antimony	Arsenic	Boron	Cadmium	Chromium	Cobalt	Copper	Cyanide, weak acid dissociable	Gross alpha	Lead	Mercury	Nickel	Radium-226 and Radium-228	Selenium	Silver	Thallium	Vanadium	Zinc
<i>TAL</i>	750	640	9	5000	1	210	1000	4.3	10	15	17	0.77	170	30	5	0.5	6.3	100	42
<i>MQL</i>	2.5	60	0.5	100	1	10	50	0.5	10	NA	0.5	0.005	0.5	NA	5	0.5	0.5	50	20
<i>ATAL</i>	NA	640	9	5000	NA	NA	1000	NA	10	15	NA	0.77	NA	30	5	NA	6.3	100	NA
<i>MTAL</i>	750	NA	340	NA	0.6	210	NA	4.3	22	NA	17	1.4	170	NA	20	0.4	NA	NA	42
<i>unit</i>	ug/L	ug/L	ug/L	ug/L	ug/L	ug/L	ug/L	ug/L	ug/L	pCi/L	ug/L	ug/L	ug/L	pCi/L	ug/L	ug/L	ug/L	ug/L	ug/L
<i>Bgeo_mean/ATAL</i>	NA	0.0016	0.19	0.003	NA	NA	0.0018	NA	<b>2.7</b>	<b>4.4</b>	NA	0.086	NA	0.12	0.3	NA	0.071	0.018	NA
<i>C1geo_mean/ATAL</i>	NA	0.0016	0.22	0.003	NA	NA	0.001	NA	0.17	<b>2.7</b>	NA	0.087	NA	0.085	0.4	NA	0.095	0.012	NA
<i>2011-08-19 d</i>	0.29	NA	NA	NA	NA	NA	NA	0.44	<b>2.7</b>	<b>4.4</b>	0.049	NA	0.0036	0.12	NA	NA	NA	NA	0.15

SWMU 09-004(o) is monitored within PJ-SMA-3.05. Following the installation of baseline control measures, a baseline storm water sample was collected on August 19, 2011 (Figure 152-2). Analytical results from this sample yielded TAL exceedances for cyanide (0.02 mg/L) and gross-alpha activity (65.9 pCi/L) and are presented in Figure 152-2.

Following the installation of enhanced control measures at PJ-SMA-3.05, a corrective action storm water sample was collected on September 3, 2018 (Figure 152-2). Analytical results from this corrective action monitoring sample yielded a TAL exceedance for gross-alpha activity (40.8 pCi/L) and are presented in Figure 152-2.

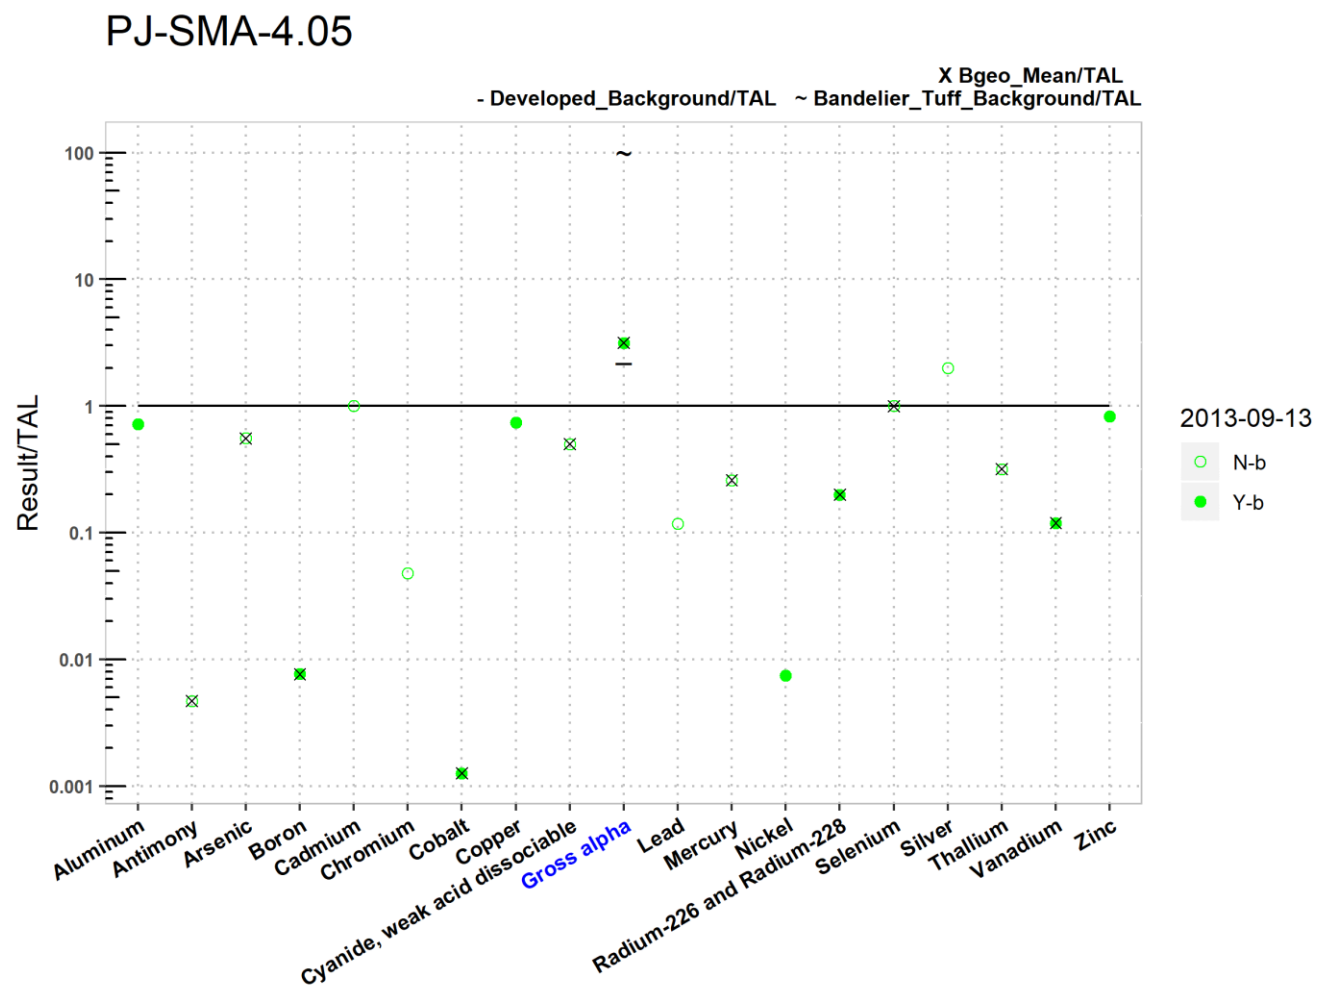
**Figure 153-2 Analytical results summary for PJ-SMA-4.05**

PJ-SMA-4.05																			
	Aluminum	Antimony	Arsenic	Boron	Cadmium	Chromium	Cobalt	Copper	Cyanide, weak acid dissociable	Gross alpha	Lead	Mercury	Nickel	Radium-226 and Radium-228	Selenium	Silver	Thallium	Vanadium	Zinc
TAL	750	640	9	5000	1	210	1000	4.3	10	15	17	0.77	170	30	5	0.5	6.3	100	42
MQL	2.5	60	0.5	100	1	10	50	0.5	10	NA	0.5	0.005	0.5	NA	5	0.5	0.5	50	20
ATAL	NA	640	9	5000	NA	NA	1000	NA	10	15	NA	0.77	NA	30	5	NA	6.3	100	NA
MTAL	750	NA	340	NA	0.6	210	NA	4.3	22	NA	17	1.4	170	NA	20	0.4	NA	NA	42
unit	ug/L	ug/L	ug/L	ug/L	ug/L	ug/L	ug/L	ug/L	ug/L	pCi/L	ug/L	ug/L	ug/L	pCi/L	ug/L	ug/L	ug/L	ug/L	ug/L
Bgeo_mean/ATAL	NA	0.0047	0.56	0.0076	NA	NA	0.0013	NA	0.5	<b>3.1</b>	NA	0.26	NA	0.2	1	NA	0.32	0.12	NA
2013-09-13 d	0.71	NA	NA	0.0076	NA	NA	0.0013	0.74	NA	<b>3.1</b>	NA	NA	0.0075	0.2	NA	NA	NA	0.12	0.83
2013-09-13 nd	NA	0.0047	0.56	NA	1	0.048	NA	NA	0.5	NA	0.12	0.26	NA	NA	1	2	0.32	NA	NA

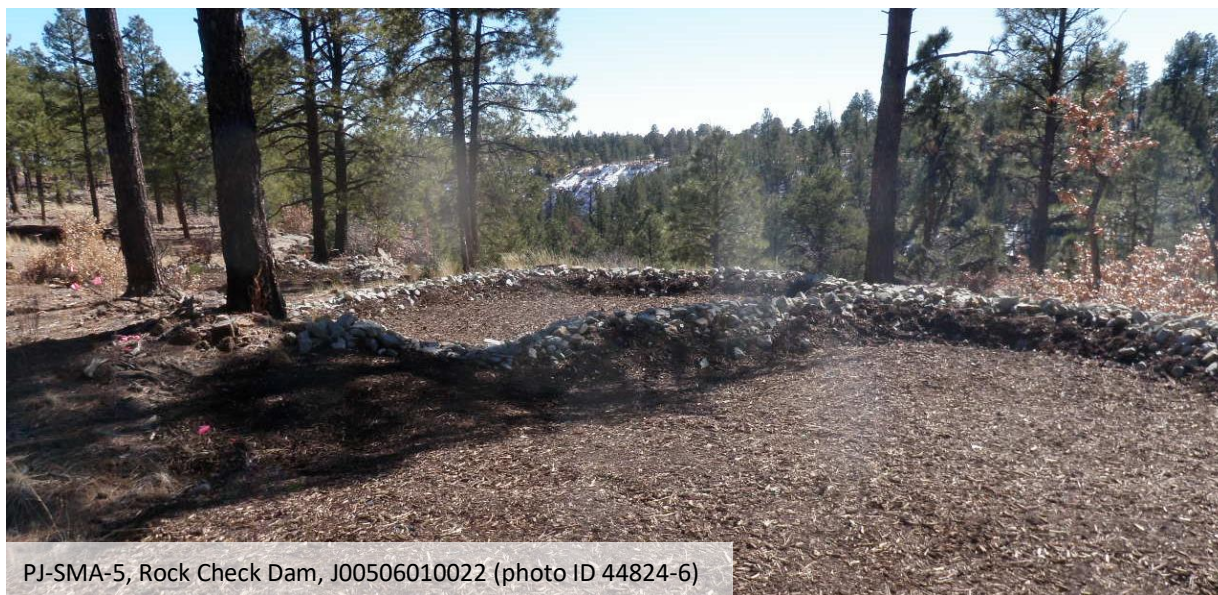
PJ-SMA-5, Rock Check Dam, J00506010022 (photo ID 44824-6)

Enhanced controls were installed and certified on July 18, 2015, and December 9, 2020, and submitted to EPA on August 17, 2015, and December 14, 2020, respectively, as part of corrective action. Photographs of the enhanced controls are available at <https://ext.em-la.doe.gov/IPS/Home/ConstructionCertifications>.
