# **2020 Update to the Site Discharge Pollution Prevention Plan, Revision 1**

NPDES Permit No. NM0030759  
May 1, 2021

## **Pajarito Watershed**

### **Volume 3**

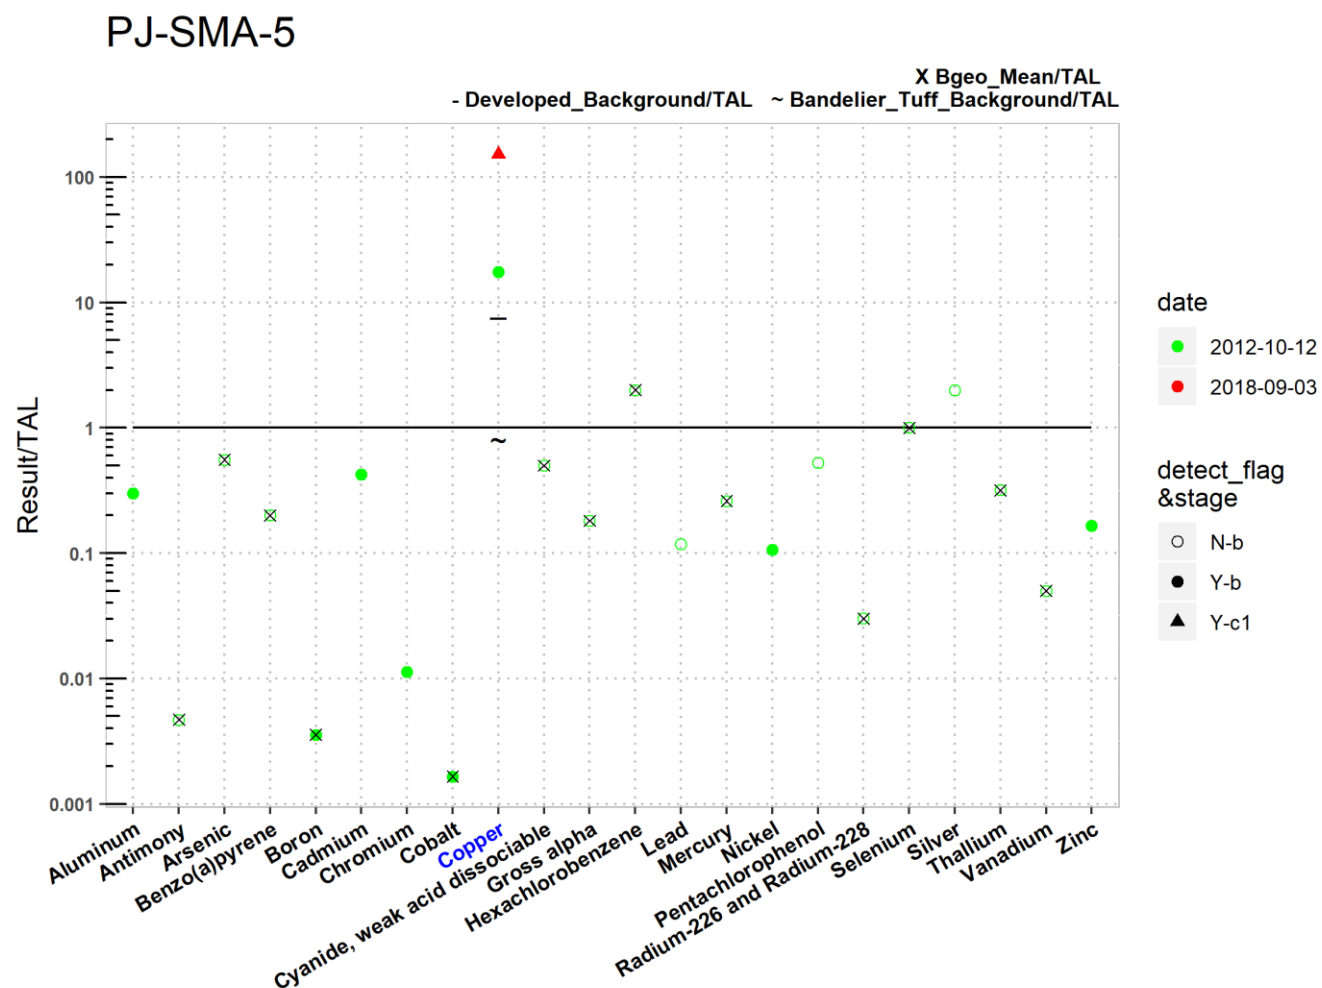
Figure 154-2 Analytical results summary for PJ-SMA-5

PJ-SMA-5																					
		Aluminum	Antimony	Arsenic	Benzo(a)pyrene	Boron	Cadmium	Chromium	Cobalt	Copper	Cyanide, weak acid dissociable	Gross alpha	Hexachlorobenzene	Lead	Mercury	Nickel	Pentachlorophenol	Radium-226 and Radium-228	Selenium	Silver	Thallium	Vanadium	Zinc
Bgeo_mean/ATAL	TAL	750	640	9	5	5000	1	210	1000	4.3	10	15	5	17	0.77	170	19	30	5	0.5	6.3	100	42
	MQL	2.5	60	0.5	5	100	1	10	50	0.5	10	NA	5	0.5	0.005	0.5	5	NA	5	0.5	0.5	50	20
	ATAL	NA	640	9	5	5000	NA	NA	1000	NA	10	15	5	NA	0.77	NA	NA	30	5	NA	6.3	100	NA
	MTAL	750	NA	340	NA	NA	0.6	210	NA	4.3	22	NA	NA	17	1.4	170	19	NA	20	0.4	NA	NA	42
	unit	ug/L	ug/L	ug/L	ug/L	ug/L	ug/L	ug/L	ug/L	ug/L	ug/L	pCi/L	ug/L	ug/L	ug/L	ug/L	ug/L	pCi/L	ug/L	ug/L	ug/L	ug/L	ug/L
	2012-10-12 d	0.3	NA	NA	NA	0.0036	0.43	0.011	0.0016	<b>18</b>	NA	NA	NA	NA	NA	0.11	NA	NA	NA	NA	NA	NA	0.17
	2012-10-12 nd	NA	0.0047	0.56	0.2	NA	NA	NA	NA	NA	0.5	0.18	2	0.12	0.26	NA	0.53	0.03	1	2	0.32	0.05	NA

TAL exceedances were also evaluated against the appropriate storm water BV, that is, “Bandelier Tuff background” for undisturbed SMAs or “developed background” for urban settings. BVs are expressed as UTLs using the approved EPA method for calculating BVs. UTLs for undisturbed SMAs were derived from storm water runoff containing entrained sediments derived from Bandelier Tuff and are labeled “Bandelier Tuff Background” in Figure 154-2. UTLs developed for urban settings were derived from runoff from developed landscapes on the Pajarito Plateau, including buildings, parking lots, roads, and associated features, and are labeled “Developed Background” in Figure 154-2.

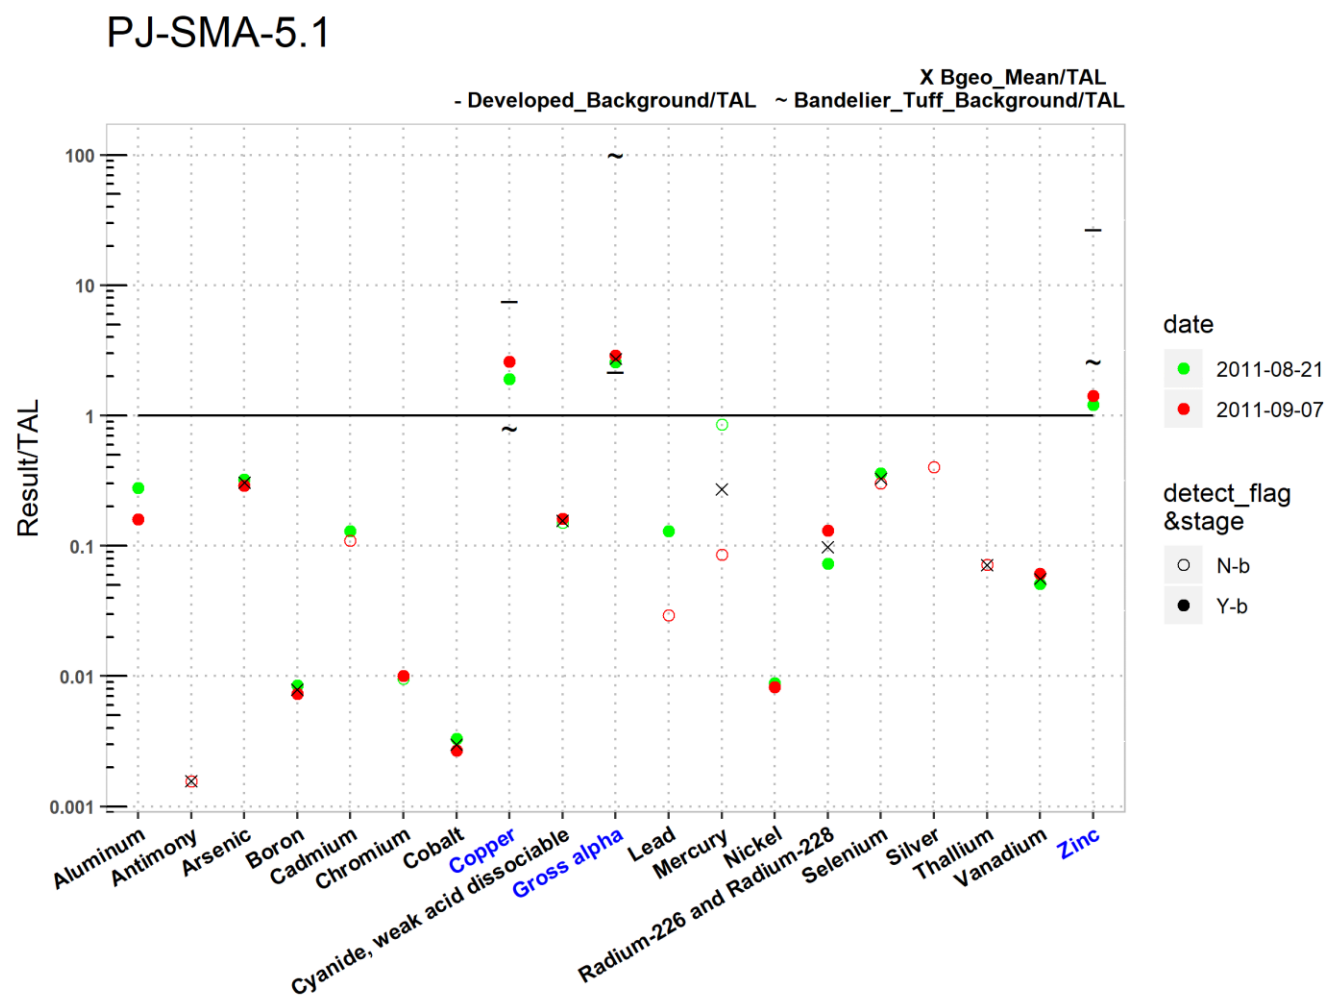
Figure 155-2 Analytical results summary for PJ-SMA-5.1

PJ-SMA-5.1																		
		Aluminum	Antimony	Arsenic	Boron	Cadmium	Chromium	Cobalt	Copper	Cyanide, weak acid dissociable	Gross alpha	Lead	Mercury	Nickel	Radium-226 and Radium-228	Selenium	Silver	Thallium	Vanadium	Zinc
TAL		750	640	9	5000	1	210	1000	4.3	10	15	17	0.77	170	30	5	0.5	6.3	100	42
MQL		2.5	60	0.5	100	1	10	50	0.5	10	NA	0.5	0.005	0.5	NA	5	0.5	0.5	50	20
ATAL		NA	640	9	5000	NA	NA	1000	NA	10	15	NA	0.77	NA	30	5	NA	6.3	100	NA
MTAL		750	NA	340	NA	0.6	210	NA	4.3	22	NA	17	1.4	170	NA	20	0.4	NA	NA	42
unit		ug/L	ug/L	ug/L	ug/L	ug/L	ug/L	ug/L	ug/L	ug/L	pCi/L	ug/L	ug/L	ug/L	pCi/L	ug/L	ug/L	ug/L	ug/L	ug/L
Bgeo_mean/ATAL		NA	0.0016	0.31	0.0079	NA	NA	0.003	NA	0.16	<b>2.7</b>	NA	0.27	NA	0.098	0.33	NA	0.071	0.056	NA
2011-08-21 d		0.28	NA	0.32	0.0085	0.13	NA	0.0033	<b>1.9</b>	NA	<b>2.6</b>	0.13	NA	0.0088	0.073	0.36	NA	NA	0.051	<b>1.2</b>
2011-08-21 nd		NA	0.0016	NA	NA	NA	0.0095	NA	NA	0.15	NA	NA	0.86	NA	NA	NA	0.4	0.071	NA	NA

SWMUs 22-010(b) and 22-016 are monitored within PJ-SMA-5.1. Following the installation of baseline control measures, two baseline storm water samples were collected on August 21, 2011, and September 7, 2011 (Figure 155-2). Analytical results from these samples yielded TAL exceedances for copper (8.2 µg/L and 11.1 µg/L), gross-alpha activity (38.4 pCi/L and 43.5 pCi/L), and zinc (50.6 µg/L and 59.4 µg/L) and are presented in Figure 155-2.

“Bandelier Tuff Background” in Figure 155-2. UTLs developed for urban settings were derived from runoff from developed landscapes on the Pajarito Plateau, including buildings, parking lots, roads, and associated features, and are labeled “Developed Background” in Figure 155-2.

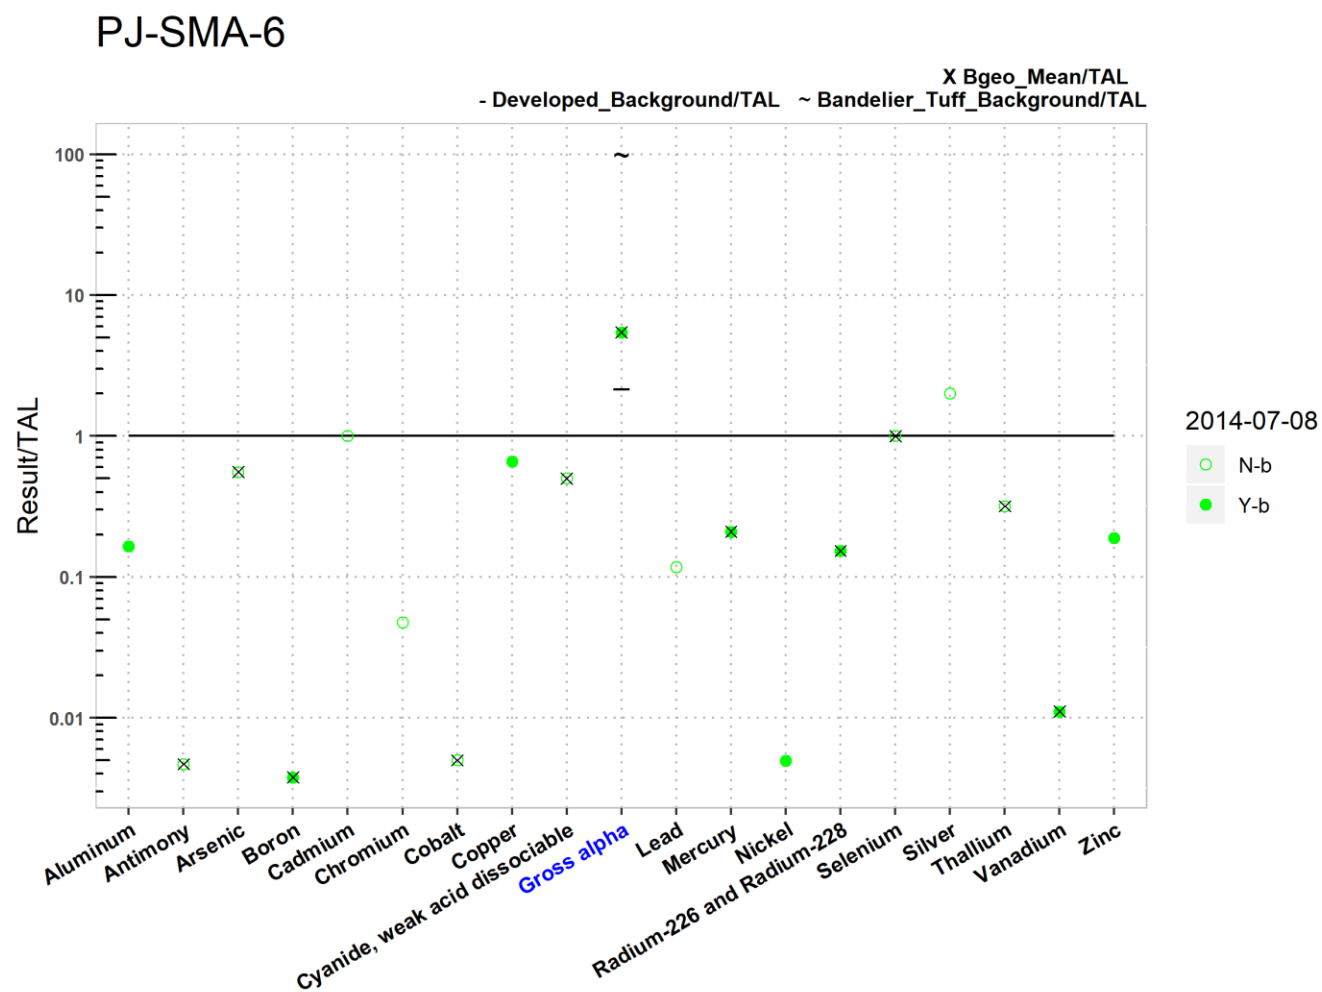
Figure 156-2 Analytical results summary for PJ-SMA-6

PJ-SMA-6																		
		Aluminum	Antimony	Arsenic	Boron	Cadmium	Chromium	Cobalt	Copper	Cyanide, weak acid dissociable	Gross alpha	Lead	Mercury	Nickel	Radium-226 and Radium-228	Selenium	Silver	Thallium	Vanadium	Zinc
	TAL	750	640	9	5000	1	210	1000	4.3	10	15	17	0.77	170	30	5	0.5	6.3	100	42
	MQL	2.5	60	0.5	100	1	10	50	0.5	10	NA	0.5	0.005	0.5	NA	5	0.5	0.5	50	20
	ATAL	NA	640	9	5000	NA	NA	1000	NA	10	15	NA	0.77	NA	30	5	NA	6.3	100	NA
	MTAL	750	NA	340	NA	0.6	210	NA	4.3	22	NA	17	1.4	170	NA	20	0.4	NA	NA	42
	unit	ug/L	ug/L	ug/L	ug/L	ug/L	ug/L	ug/L	ug/L	ug/L	pCi/L	ug/L	ug/L	ug/L	pCi/L	ug/L	ug/L	ug/L	ug/L	ug/L
Bgeo_mean/	ATAL	NA	0.0047	0.56	0.0038	NA	NA	0.005	NA	0.5	5.4	NA	0.21	NA	0.15	1	NA	0.32	0.011	NA
	2014-07-08 d	0.16	NA	NA	0.0038	NA	NA	NA	0.66	NA	5.4	NA	0.21	0.005	0.15	NA	NA	NA	0.011	0.19
	2014-07-08 nd	NA	0.0047	0.56	NA	1	0.048	0.005	NA	0.5	NA	0.12	NA	NA	NA	1	2	0.32	NA	NA
Bold font indicate TAL exceedance; d=detected_result/TAL, nd=nondetected_result/TAL

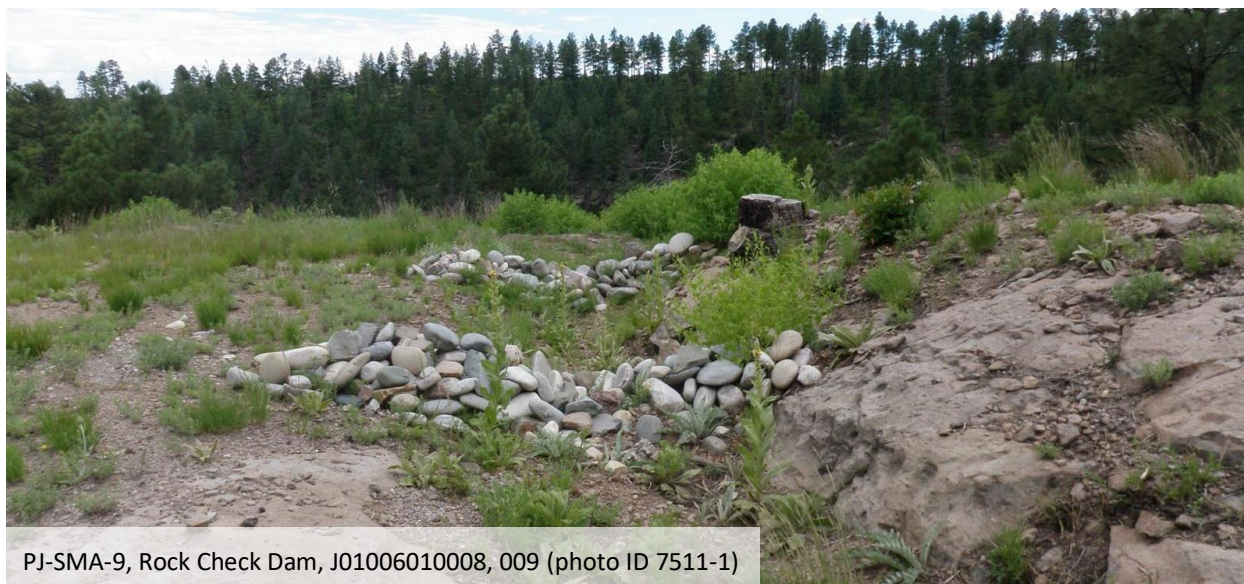
PJ-SMA-9, Rock Check Dam, J01006010008, 009 (photo ID 7511-1)

Enhanced controls were installed and certified on October 28, 2015, and submitted to EPA on October 30, 2015, as part of corrective action. Photographs of the enhanced controls are available at <https://ext.em-la.doe.gov/IPS/Home/ConstructionCertifications>.

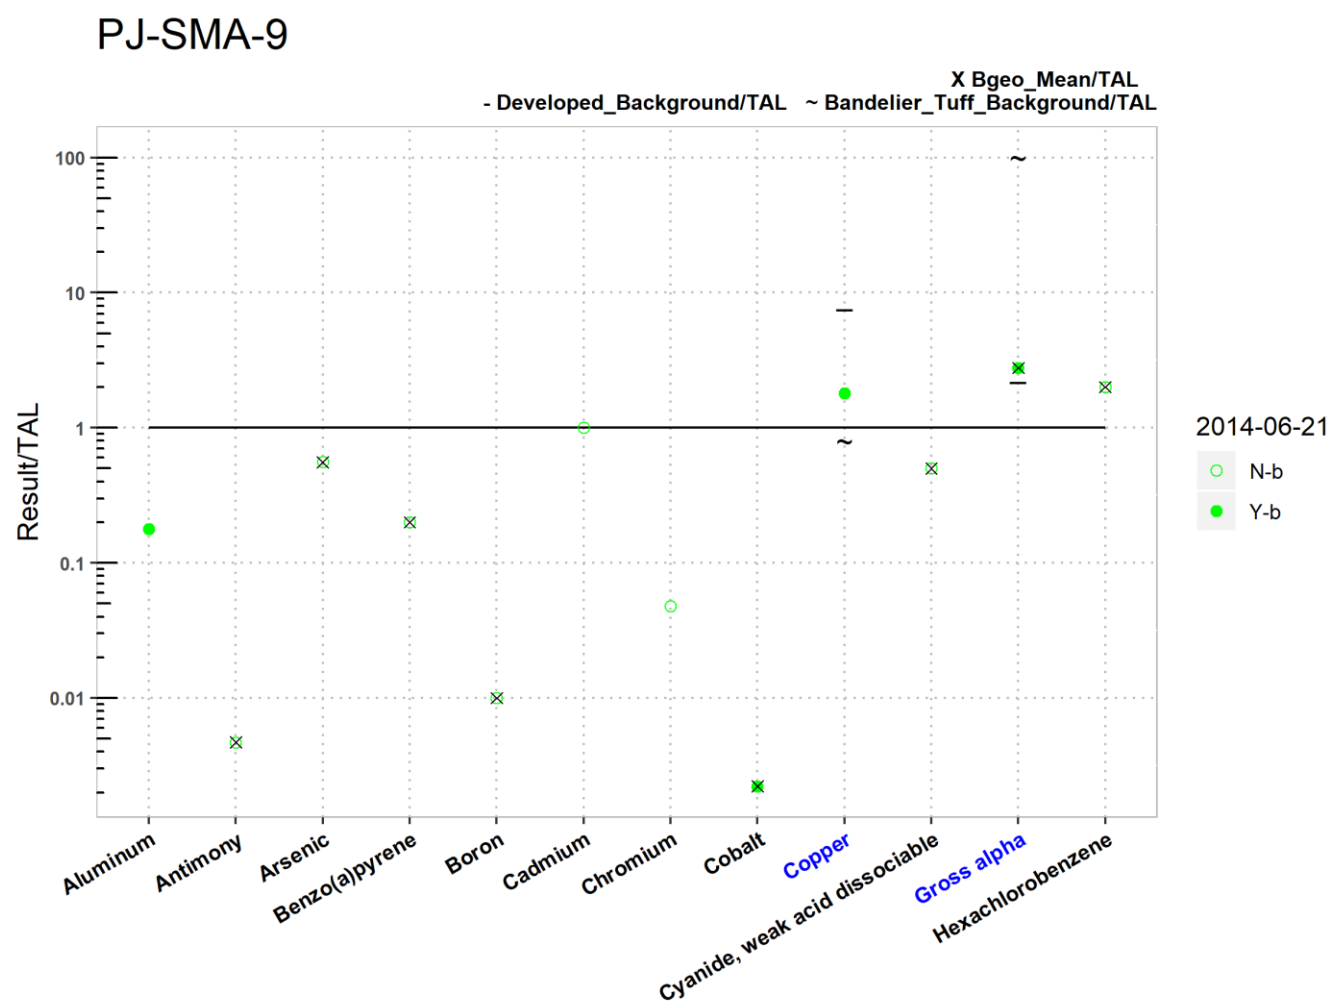
Figure 159-2 Analytical results summary for PJ-SMA-9

PJ-SMA-9											
	Aluminum	Antimony	Arsenic	Benzo(a)pyrene	Boron	Cadmium	Chromium	Cobalt	Copper	Cyanide, weak acid dissociable	Gross alpha	Hexachlorobenzene
TAL	750	640	9	5	5000	1	210	1000	4.3	10	15	5
MQL	2.5	60	0.5	5	100	1	10	50	0.5	10	NA	5
ATAL	NA	640	9	5	5000	NA	NA	1000	NA	10	15	5
MTAL	750	NA	340	NA	NA	0.6	210	NA	4.3	22	NA	NA
unit	ug/L	ug/L	ug/L	ug/L	ug/L	ug/L	ug/L	ug/L	ug/L	ug/L	pCi/L	ug/L
Bgeo_mean/ATAL	NA	0.0047	0.56	0.2	0.01	NA	NA	0.0022	NA	0.5	<b>2.8</b>	<b>2</b>
2014-06-21 d	0.18	NA	NA	NA	NA	NA	NA	0.0022	<b>1.8</b>	NA	<b>2.8</b>	NA
2014-06-21 nd	NA	0.0047	0.56	0.2	0.01	1	0.048	NA	NA	0.5	NA	2

SWMU 40-009 is monitored within PJ-SMA-9. Following the installation of baseline control measures, a baseline storm water sample was collected on June 21, 2014 (Figure 159-2). In Figure 159-2, cadmium, selenium, silver, and hexachlorobenzene are reported as nondetected results greater than their respective TALs. These values are reported at the PQL, the MDL for these analytes are below the TAL. The values are nondetects and thus not considered TAL exceedances. Analytical results from this sample yielded TAL exceedances for copper (7.76 µg/L) and gross-alpha activity (41.6 pCi/L) and are presented in Figure 159-2.

TAL exceedances were also evaluated against the appropriate storm water BVs, that is, “Bandelier Tuff background” for undisturbed SMAs or “developed background” for urban settings. BVs are expressed as UTLs using the approved EPA method for calculating BVs. UTLs for undisturbed SMAs were derived from storm water runoff containing entrained sediments derived from Bandelier Tuff and are labeled “Bandelier Tuff Background” in Figure 159-2. UTLs developed for urban settings were derived from

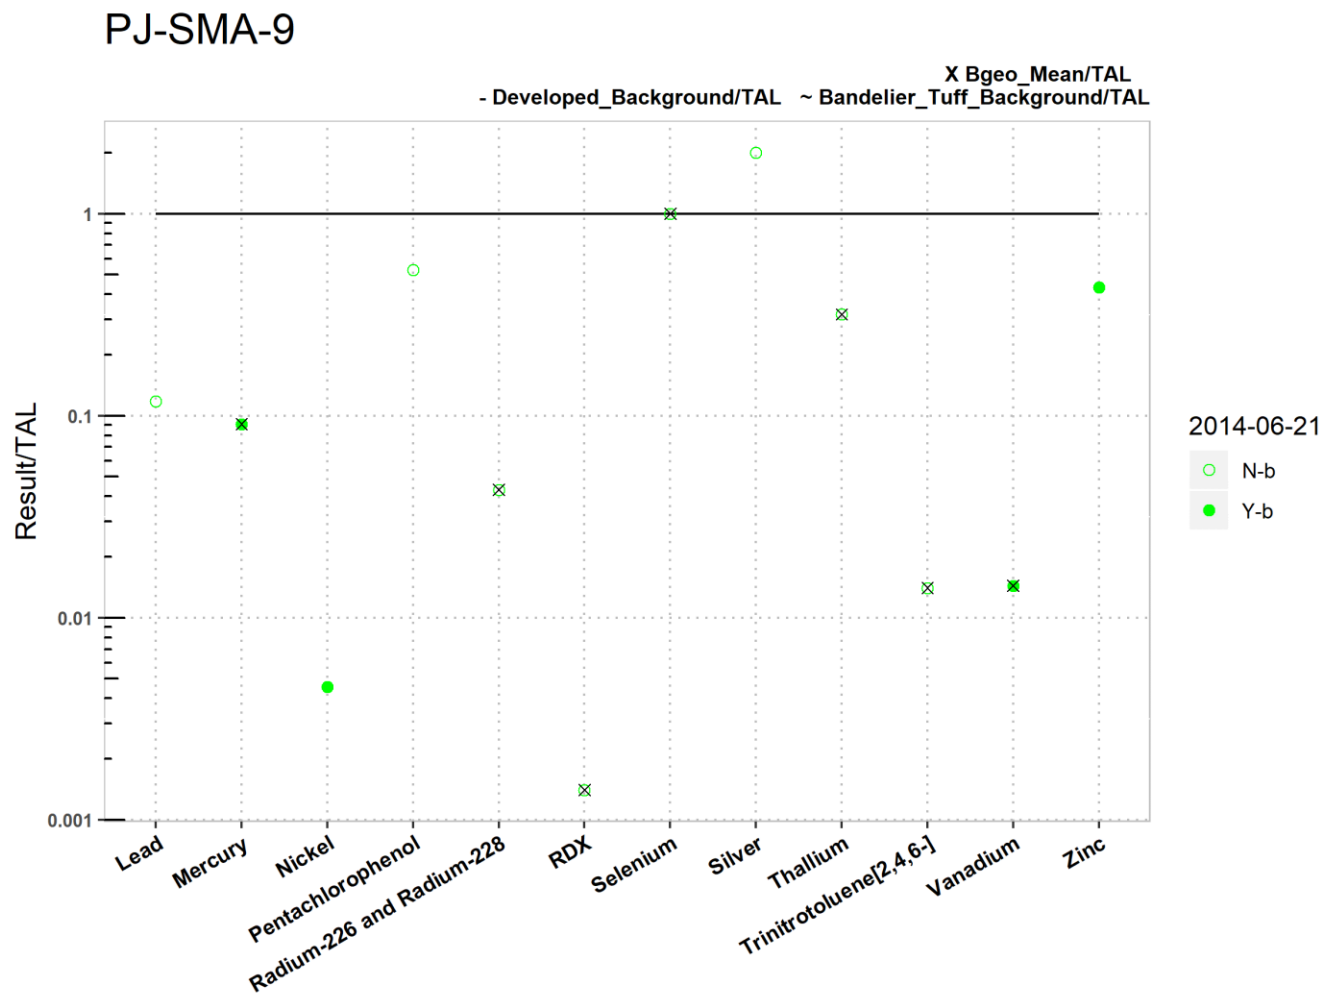
**Figure 159-2 (continued) Analytical results summary for PJ-SMA-9**

PJ-SMA-9											
	Lead	Mercury	Nickel	Pentachlorophenol	Radium-226 and Radium-228	RDX	Selenium	Silver	Thallium	Trinitrotoluene [2,4,6-]	Vanadium	Zinc
<i>TAL</i>	17	0.77	170	19	30	200	5	0.5	6.3	20	100	42
<i>MDL</i>	0.5	0.005	0.5	5	NA	NA	5	0.5	0.5	NA	50	20
<i>ATL</i>	NA	0.77	NA	NA	30	200	5	NA	6.3	20	100	NA
<i>MTL</i>	17	1.4	170	19	NA	NA	20	0.4	NA	NA	NA	42
<i>unit</i>	ug/L	ug/L	ug/L	ug/L	pCi/L	ug/L	ug/L	ug/L	ug/L	ug/L	ug/L	ug/L
<i>Bgeo_mean/ATL</i>	NA	0.091	NA	NA	0.043	0.0014	1	NA	0.32	0.014	0.014	NA
<i>2014-06-21 d</i>	NA	0.091	0.0045	NA	NA	NA	NA	NA	NA	NA	0.014	0.43
<i>2014-06-21 nd</i>	0.12	NA	NA	0.53	0.043	0.0014	1	2	0.32	0.014	NA	NA

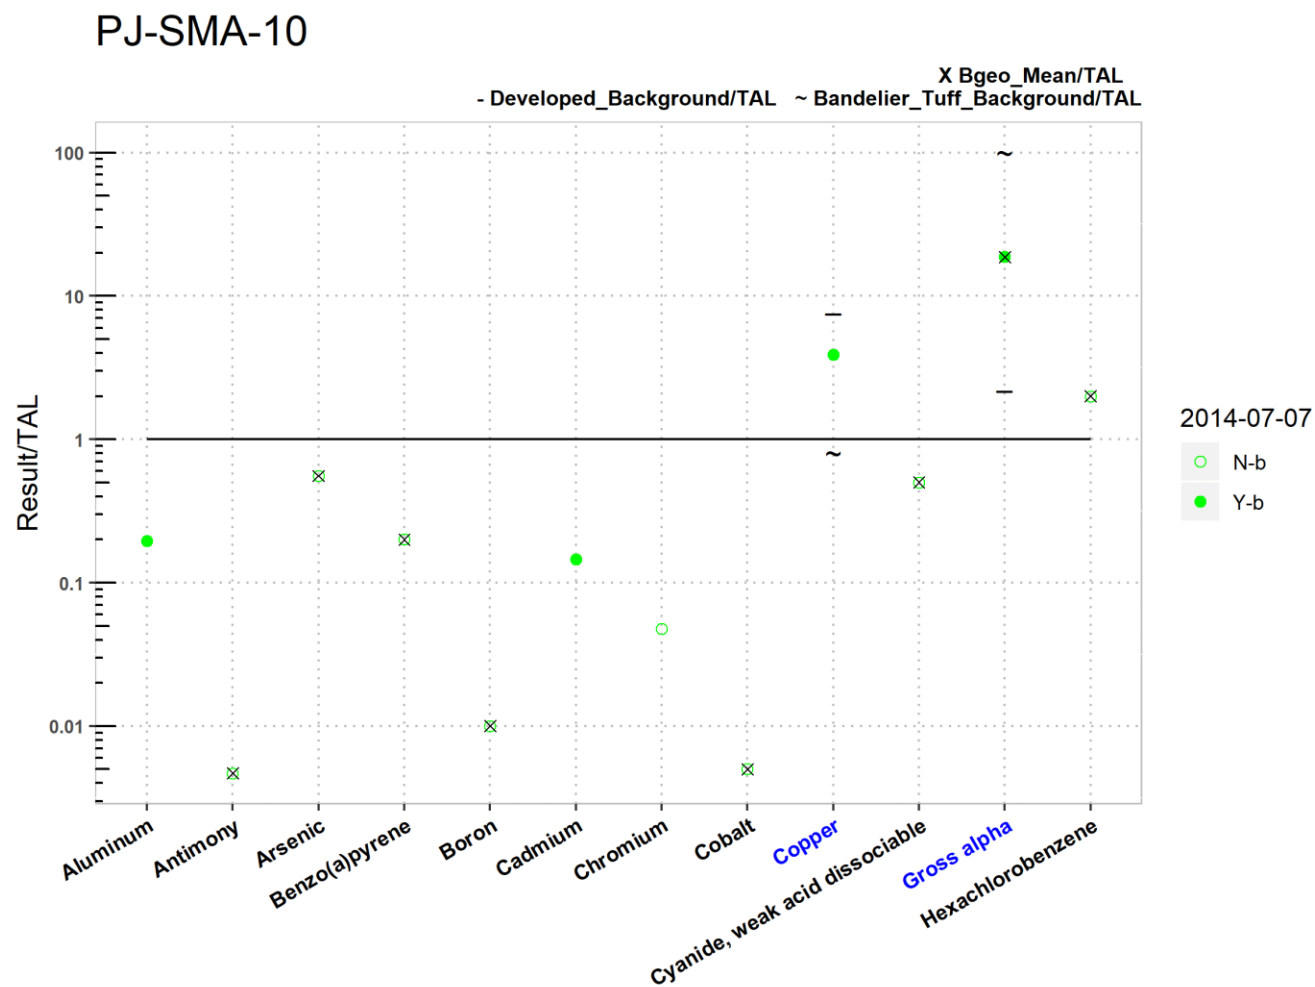
Figure 160-2 Analytical results summary for PJ-SMA-10

PJ-SMA-10												
	Aluminum	Antimony	Arsenic	Benzo(a)pyrene	Boron	Cadmium	Chromium	Cobalt	Copper	Cyanide, weak acid dissociable	Gross alpha	Hexachlorobenzene
TAL	750	640	9	5	5000	1	210	1000	4.3	10	15	5
MQL	2.5	60	0.5	5	100	1	10	50	0.5	10	NA	5
ATAL	NA	640	9	5	5000	NA	NA	1000	NA	10	15	5
MTAL	750	NA	340	NA	NA	0.6	210	NA	4.3	22	NA	NA
unit	ug/L	ug/L	ug/L	ug/L	ug/L	ug/L	ug/L	ug/L	ug/L	ug/L	pCi/L	ug/L
Bgeo_mean/ATAL	NA	0.0047	0.56	0.2	0.01	NA	NA	0.005	NA	0.5	<b>19</b>	<b>2</b>
2014-07-07 d	0.19	NA	NA	NA	NA	0.14	NA	NA	<b>3.9</b>	NA	<b>19</b>	NA
2014-07-07 nd	NA	0.0047	0.56	0.2	0.01	NA	0.048	0.005	NA	0.5	NA	2

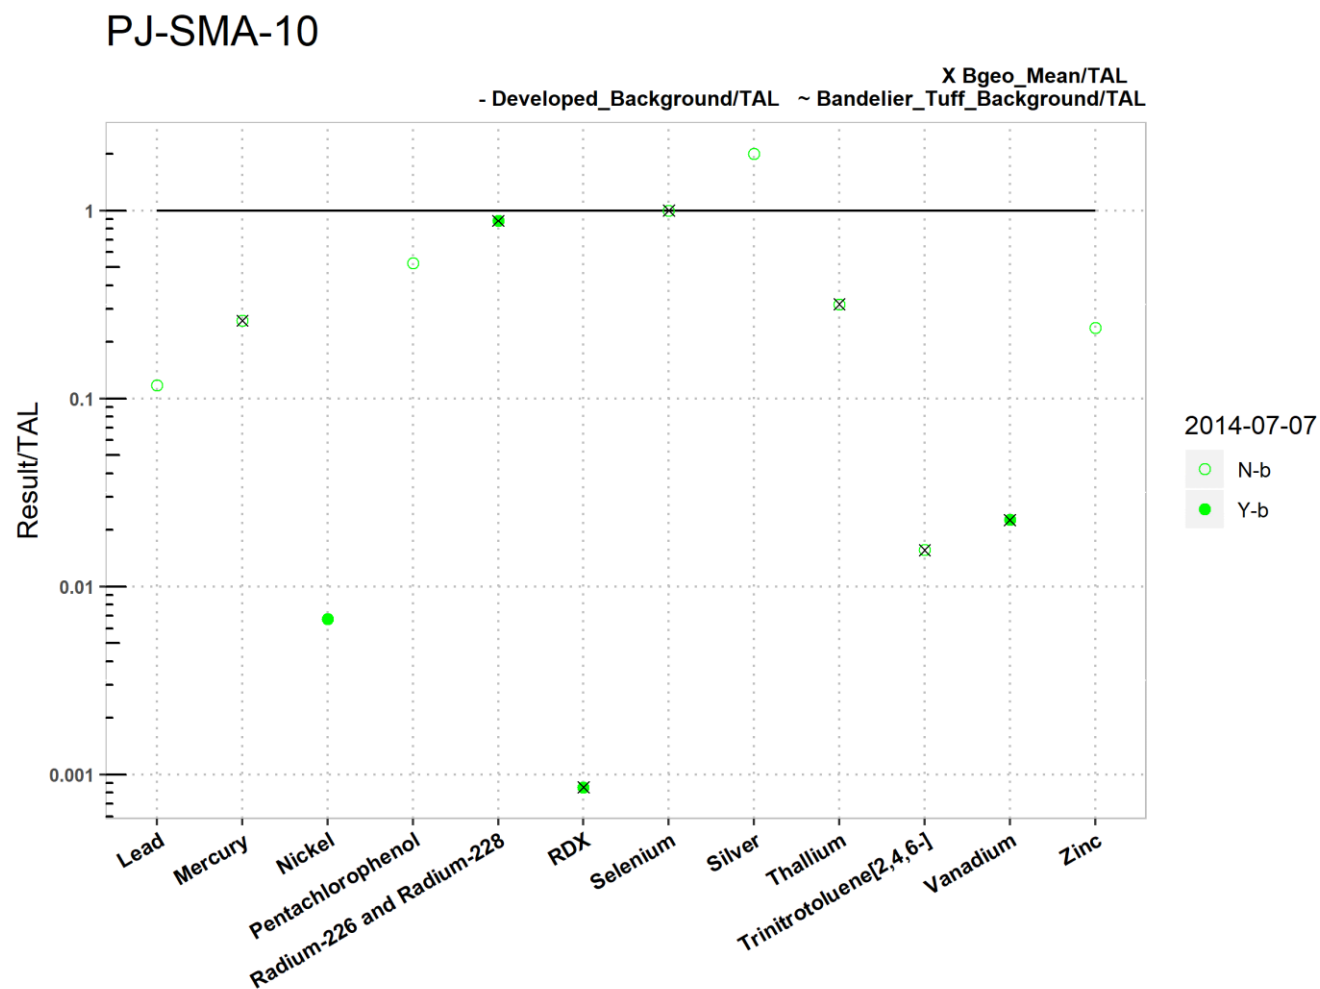
**Figure 160-2 (continued) Analytical results summary for PJ-SMA-10**

PJ-SMA-10											
	Lead	Mercury	Nickel	Pentachlorophenol	Radium-226 and Radium-228	RDX	Selenium	Silver	Thallium	Trinitrotoluene [2,4,6-]	Vanadium	Zinc
<i>TAL</i>	17	0.77	170	19	30	200	5	0.5	6.3	20	100	42
<i>MQL</i>	0.5	0.005	0.5	5	NA	NA	5	0.5	0.5	NA	50	20
<i>ATAL</i>	NA	0.77	NA	NA	30	200	5	NA	6.3	20	100	NA
<i>MTAL</i>	17	1.4	170	19	NA	NA	20	0.4	NA	NA	NA	42
<i>unit</i>	ug/L	ug/L	ug/L	ug/L	pCi/L	ug/L	ug/L	ug/L	ug/L	ug/L	ug/L	ug/L
<i>Bgeo_mean/ATAL</i>	NA	0.26	NA	NA	0.88	0.00086	1	NA	0.32	0.016	0.023	NA
<i>2014-07-07 d</i>	NA	NA	0.0067	NA	0.88	0.00086	NA	NA	NA	NA	0.023	NA
<i>2014-07-07 nd</i>	0.12	0.26	NA	0.53	NA	NA	1	2	0.32	0.016	NA	0.24

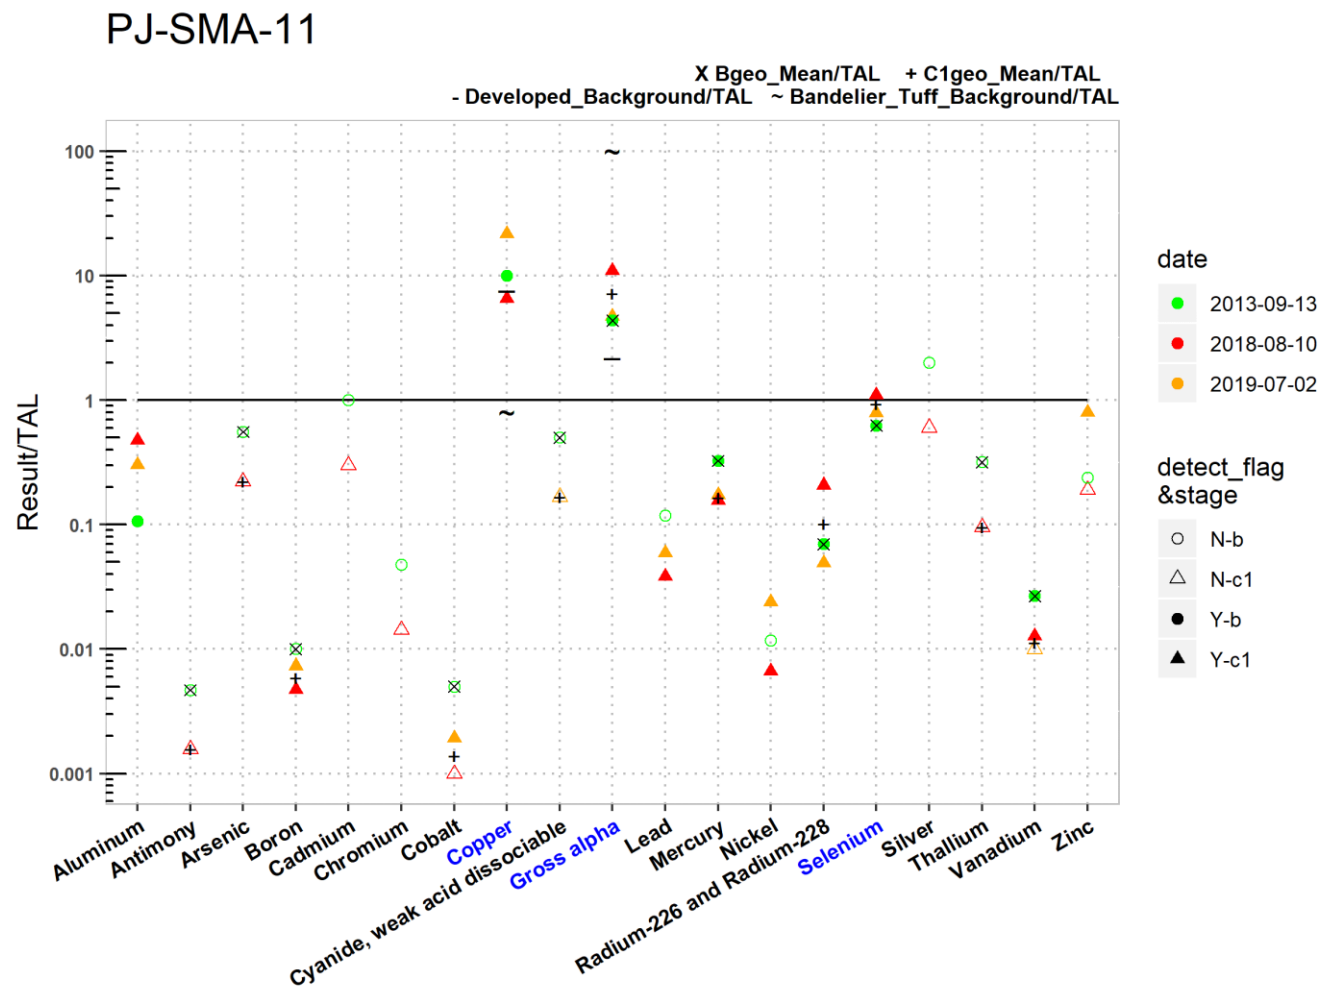
Figure 161-2 Analytical results summary for PJ-SMA-11

PJ-SMA-11																		
		Aluminum	Antimony	Arsenic	Boron	Cadmium	Chromium	Cobalt	Copper	Cyanide, weak acid dissociable	Gross alpha	Lead	Mercury	Nickel	Radium-226 and Radium-228	Selenium	Silver	Thallium	Vanadium	Zinc
	TAL	750	640	9	5000	1	210	1000	4.3	10	15	17	0.77	170	30	5	0.5	6.3	100	42
	MQL	2.5	60	0.5	100	1	10	50	0.5	10	NA	0.5	0.005	0.5	NA	5	0.5	0.5	50	20
	ATAL	NA	640	9	5000	NA	NA	1000	NA	10	15	NA	0.77	NA	30	5	NA	6.3	100	NA
	MTAL	750	NA	340	NA	0.6	210	NA	4.3	22	NA	17	1.4	170	NA	20	0.4	NA	NA	42
	unit	ug/L	ug/L	ug/L	ug/L	ug/L	ug/L	ug/L	ug/L	ug/L	pCi/L	ug/L	ug/L	ug/L	pCi/L	ug/L	ug/L	ug/L	ug/L	ug/L
C1	geo_mean/ATAL	NA	0.0047	0.56	0.01	NA	NA	0.005	NA	0.5	<b>4.4</b>	NA	0.32	NA	0.07	0.62	NA	0.32	0.027	NA
	geo_mean/ATAL	NA	0.0016	0.22	0.0059	NA	NA	0.0014	NA	0.17	<b>7.2</b>	NA	0.16	NA	0.1	0.93	NA	0.095	0.011	NA
	2013-09-13 d	0.11	NA	NA	NA	NA	NA	NA	<b>10</b>	NA	<b>4.4</b>	NA	0.32	NA	0.07	0.62	NA	NA	0.027	NA

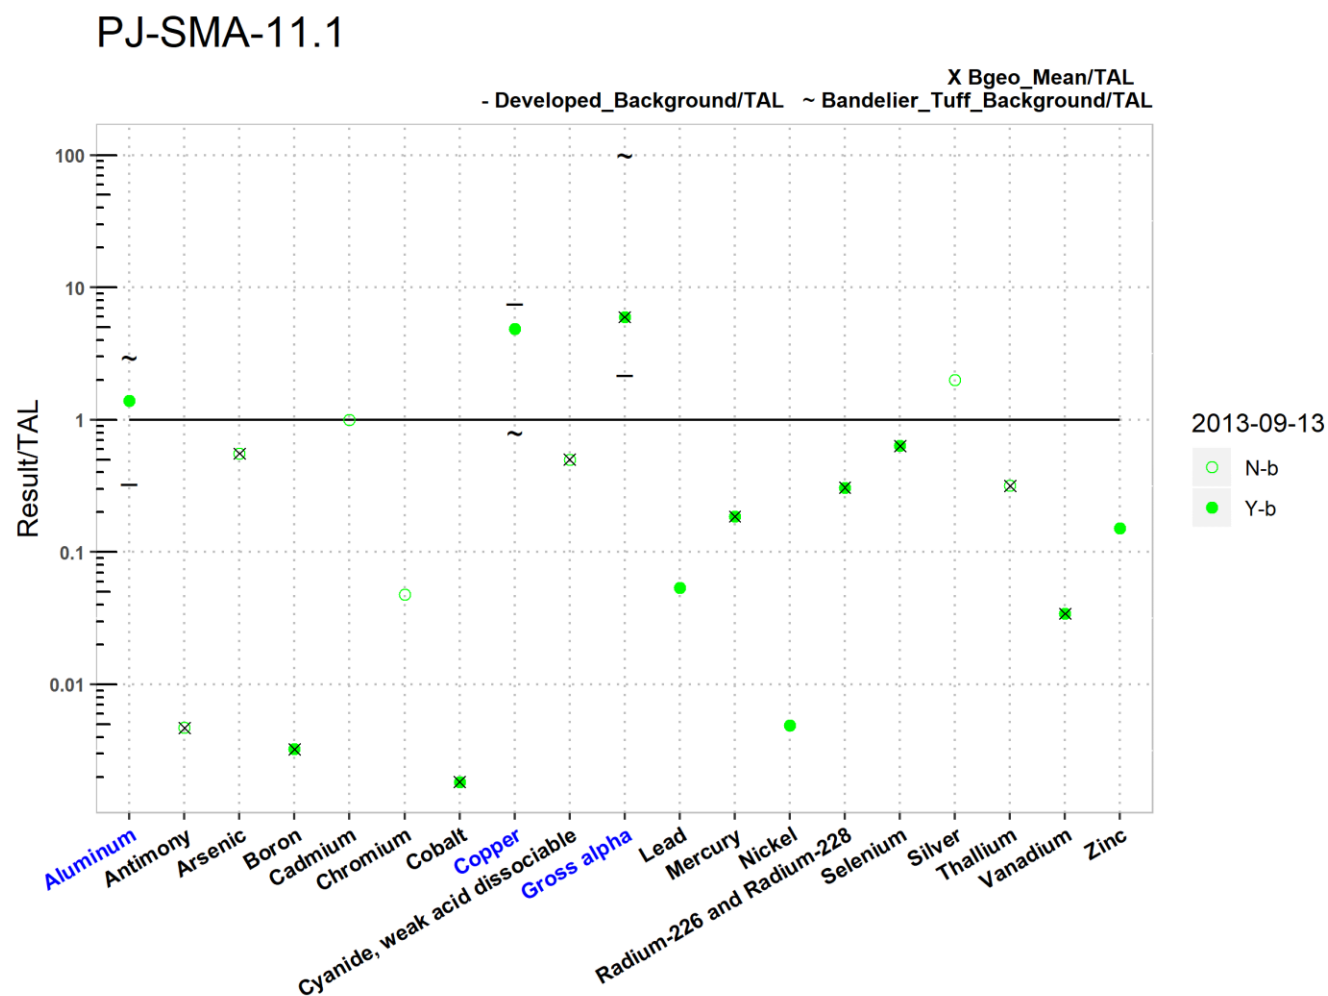
**Figure 162-2 Analytical results summary t for PJ-SMA-11.1**

PJ-SMA-11.1																		
		Aluminum	Antimony	Arsenic	Boron	Cadmium	Chromium	Cobalt	Copper	Cyanide, weak acid dissociable	Gross alpha	Lead	Mercury	Nickel	Radium-226 and Radium-228	Selenium	Silver	Thallium	Vanadium	Zinc
TAL		750	640	9	5000	1	210	1000	4.3	10	15	17	0.77	170	30	5	0.5	6.3	100	42
MQL		2.5	60	0.5	100	1	10	50	0.5	10	NA	0.5	0.005	0.5	NA	5	0.5	0.5	50	20
ATAL		NA	640	9	5000	NA	NA	1000	NA	10	15	NA	0.77	NA	30	5	NA	6.3	100	NA
MTAL		750	NA	340	NA	0.6	210	NA	4.3	22	NA	17	1.4	170	NA	20	0.4	NA	NA	42
unit		ug/L	ug/L	ug/L	ug/L	ug/L	ug/L	ug/L	ug/L	ug/L	pCi/L	ug/L	ug/L	ug/L	pCi/L	ug/L	ug/L	ug/L	ug/L	ug/L
Bgeo_mean/ATAL		NA	0.0047	0.56	0.0032	NA	NA	0.0018	NA	0.5	<b>6</b>	NA	0.19	NA	0.31	0.63	NA	0.32	0.034	NA
2013-09-13 d		<b>1.4</b>	NA	NA	0.0032	NA	NA	0.0018	<b>4.9</b>	NA	<b>6</b>	0.053	0.19	0.0049	0.31	0.63	NA	NA	0.034	0.15
2013-09-13 nd		NA	0.0047	0.56	NA	1	0.048	NA	NA	0.5	NA	NA	NA	NA	NA	NA	2	0.32	NA	NA

Monitoring location PJ-SMA-11.1 receives storm water run-on from landscapes containing sediment derived from Bandelier Tuff. Metals including aluminum are found at low concentrations in the Bandelier Tuff. Gross alpha in Bandelier Tuff is associated with naturally occurring radioactive uranium- and thorium-bearing minerals.

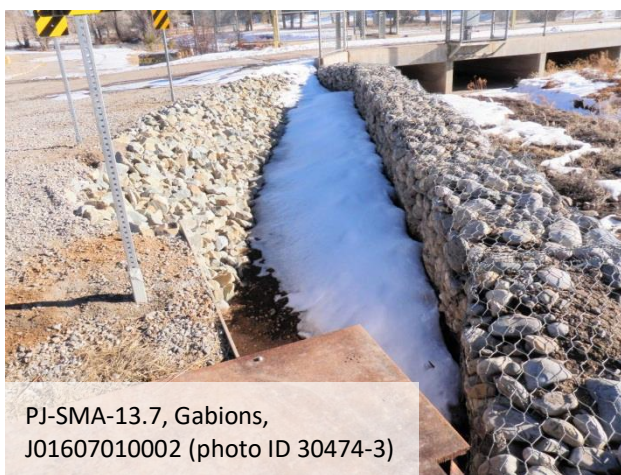
PJ-SMA-13.7, Gabions,  
J01607010002 (photo ID 30474-3)

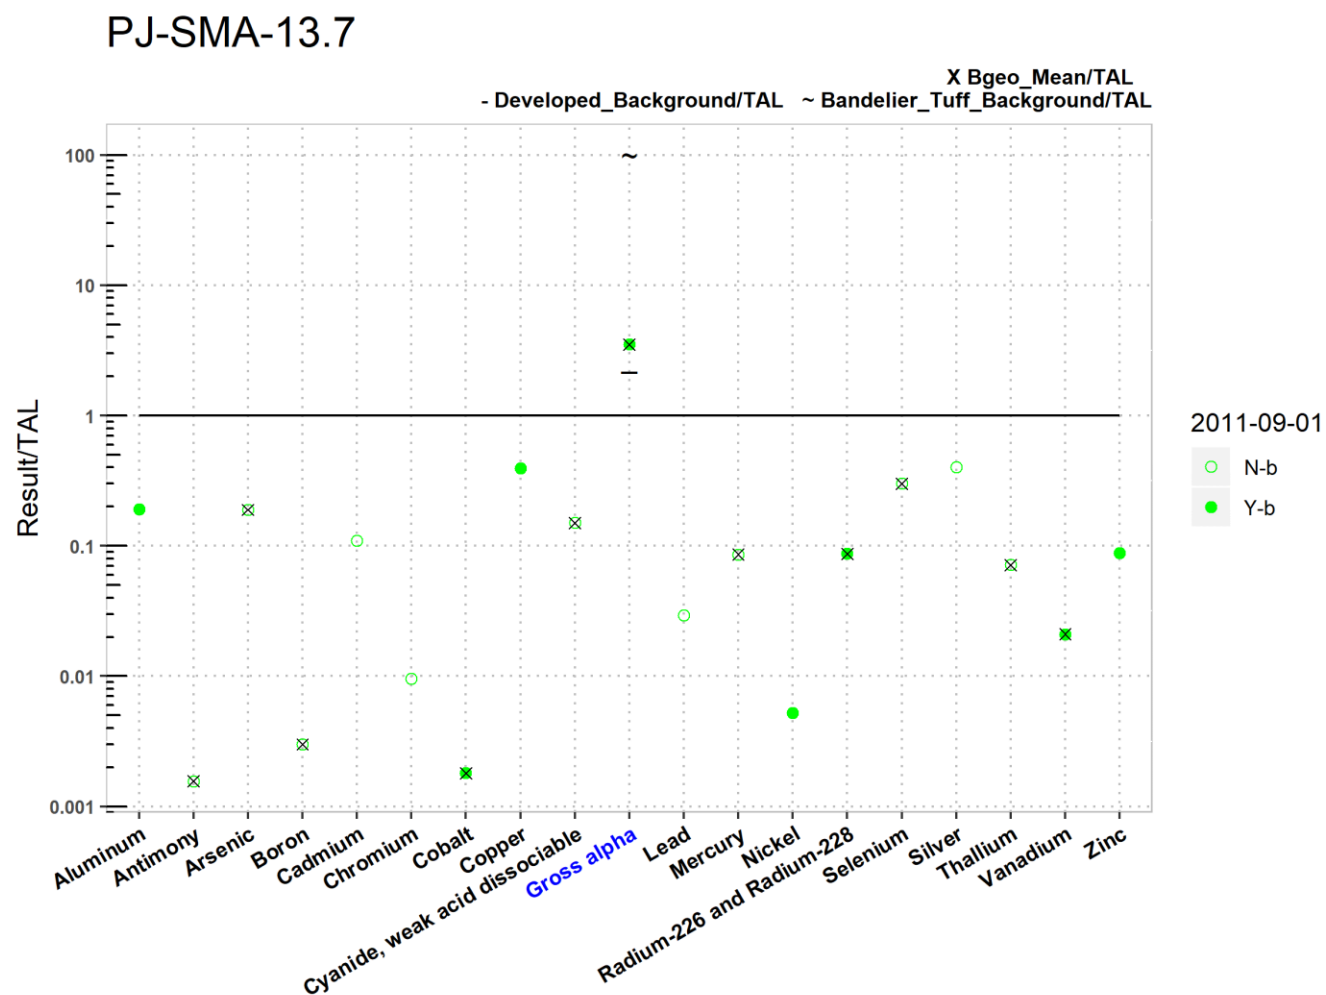
Figure 164-2 Analytical results summary for PJ-SMA-13.7

Aluminum	Antimony	Arsenic	Boron	Cadmium	Chromium	Cobalt	Copper	Cyanide, weak acid dissociable	Gross alpha	Lead	Mercury	Nickel	Radium-226 and Radium-228	Selenium	Silver	Thallium	Vanadium	Zinc
<i>TAL</i>	750	640	9	5000	1	210	1000	4.3	10	15	17	0.77	170	30	5	0.5	6.3	100	42
<i>MQL</i>	2.5	60	0.5	100	1	10	50	0.5	10	NA	0.5	0.005	0.5	NA	5	0.5	0.5	50	20
<i>ATAL</i>	NA	640	9	5000	NA	NA	1000	NA	10	15	NA	0.77	NA	30	5	NA	6.3	100	NA
<i>MTAL</i>	750	NA	340	NA	0.6	210	NA	4.3	22	NA	17	1.4	170	NA	20	0.4	NA	NA	42
<i>unit</i>	ug/L	ug/L	ug/L	ug/L	ug/L	ug/L	ug/L	ug/L	ug/L	pCi/L	ug/L	ug/L	ug/L	pCi/L	ug/L	ug/L	ug/L	ug/L	ug/L
<i>Bgeo_mean/ATAL</i>	NA	0.0016	0.19	0.003	NA	NA	0.0018	NA	0.15	<b>3.5</b>	NA	0.086	NA	0.087	0.3	NA	0.071	0.021	NA
<i>2011-09-01 d</i>	0.19	NA	NA	NA	NA	NA	0.0018	0.4	NA	<b>3.5</b>	NA	NA	0.0052	0.087	NA	NA	NA	0.021	0.088
<i>2011-09-01 nd</i>	NA	0.0016	0.19	0.003	0.11	0.0095	NA	NA	0.15	NA	0.029	0.086	NA	NA	0.3	0.4	0.071	NA	NA

TAL exceedances were also evaluated against the appropriate storm water BV, that is, “Bandelier Tuff background” for undisturbed SMAs or “developed background” for urban settings. BVs are expressed as UTLs using the approved EPA method for calculating BVs. UTLs for undisturbed SMAs were derived from storm water runoff containing entrained sediments derived from Bandelier Tuff and are labeled “Bandelier Tuff Background” in Figure 164-2. UTLs developed for urban settings were derived from runoff from developed landscapes on the Pajarito Plateau, including buildings, parking lots, roads, and associated features, and are labeled “Developed Background” in Figure 164-2.

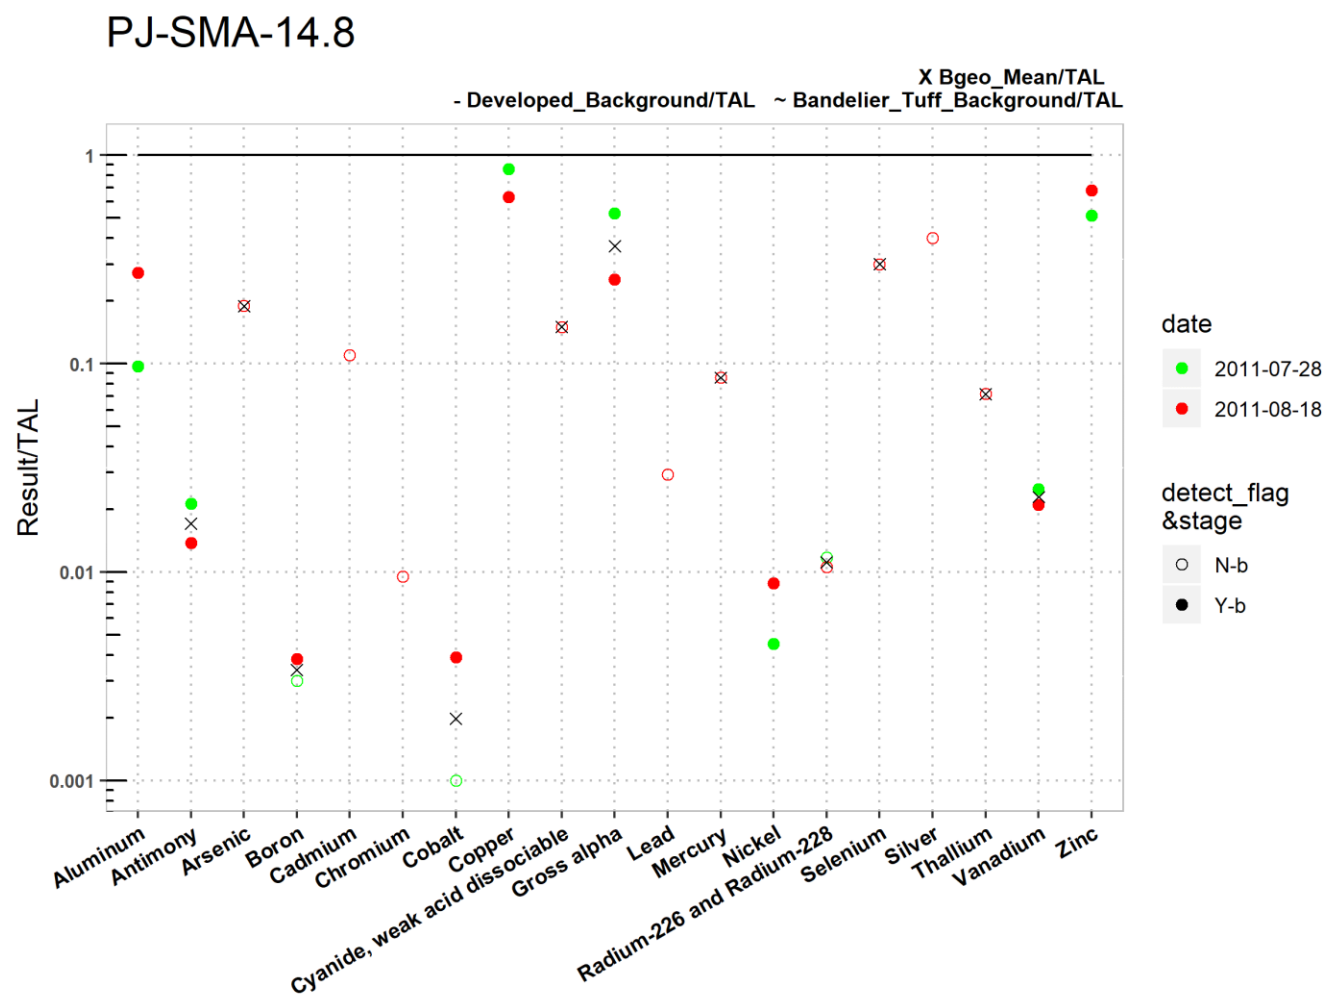
Figure 170-2 Analytical results summary for PJ-SMA-14.8

PJ-SMA-14.8																			
	Aluminum	Antimony	Arsenic	Boron	Cadmium	Chromium	Cobalt	Copper	Cyanide, weak acid dissociable	Gross alpha	Lead	Mercury	Nickel	Radium-226 and Radium-228	Selenium	Silver	Thallium	Vanadium	Zinc
<i>TAL</i>	750	640	9	5000	1	210	1000	4.3	10	15	17	0.77	170	30	5	0.5	6.3	100	42
<i>MQL</i>	2.5	60	0.5	100	1	10	50	0.5	10	NA	0.5	0.005	0.5	NA	5	0.5	0.5	50	20
<i>ATAL</i>	NA	640	9	5000	NA	NA	1000	NA	10	15	NA	0.77	NA	30	5	NA	6.3	100	NA
<i>MTAL</i>	750	NA	340	NA	0.6	210	NA	4.3	22	NA	17	1.4	170	NA	20	0.4	NA	NA	42
<i>unit</i>	ug/L	ug/L	ug/L	ug/L	ug/L	ug/L	ug/L	ug/L	ug/L	pCi/L	ug/L	ug/L	ug/L	pCi/L	ug/L	ug/L	ug/L	ug/L	ug/L
<i>Bgeo_mean/ATAL</i>	NA	0.017	0.19	0.0034	NA	NA	0.002	NA	0.15	0.37	NA	0.086	NA	0.011	0.3	NA	0.071	0.023	NA
<i>2011-07-28 d</i>	0.097	0.021	NA	NA	NA	NA	NA	0.86	NA	0.53	NA	NA	0.0045	NA	NA	NA	NA	0.025	0.51
<i>2011-07-28 nd</i>	NA	NA	0.19	0.003	0.11	0.0095	0.001	NA	0.15	NA	0.029	0.086	NA	0.012	0.3	0.4	0.071	NA	NA

SWMU 18-012(a) is monitored within PJ-SMA-14.8. Following the installation of baseline control measures, baseline storm water samples were collected on July 28 and August 18, 2011 (Figure 170-2). Analytical results from these samples yielded no TAL exceedances. Baseline confirmation is complete for PJ-SMA-14.8 and the associated SWMU 18-012(a) because all applicable sampling results are below the applicable MTAL or ATAL. No further sampling is required for PJ-SMA-14.8 for the duration of the IP.

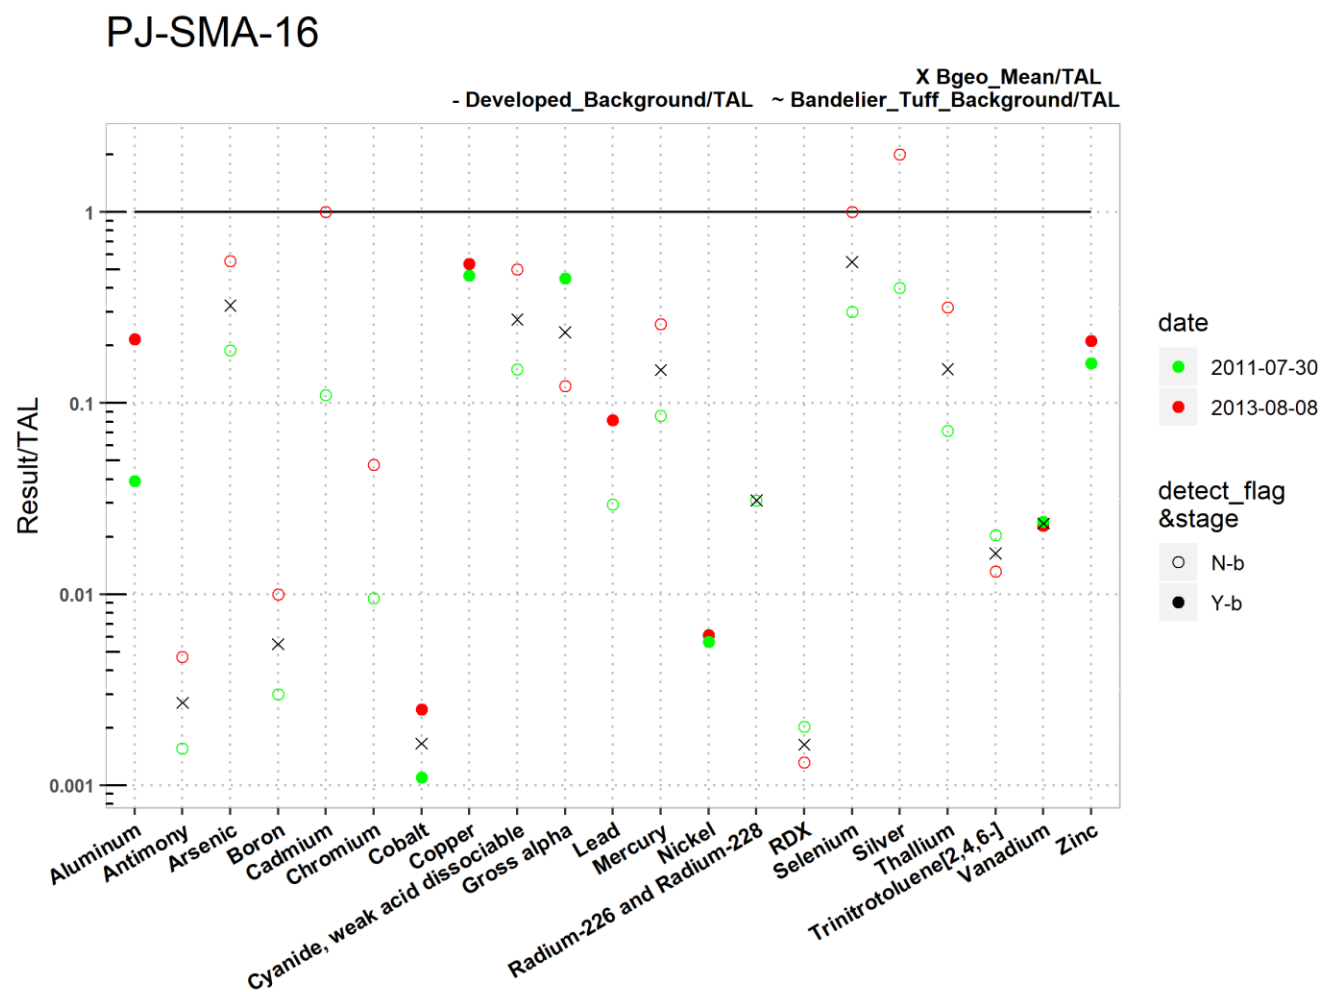
Figure 171-2 Analytical results summary for PJ-SMA-16

PJ-SMA-16																						
	Aluminum	Antimony	Arsenic	Boron	Cadmium	Chromium	Cobalt	Copper	Cyanide, weak acid dissociable	Gross alpha	Lead	Mercury	Nickel	Radium-226 and Radium-228	RDX	Selenium	Silver	Thallium	Trinitrotoluene [2,4,6-]	Vanadium	Zinc	
TAL	750	640	9	5000	1	210	1000	4.3	10	15	17	0.77	170	30	200	5	0.5	6.3	20	100	42	
MQL	2.5	60	0.5	100	1	10	50	0.5	10	NA	0.5	0.005	0.5	NA	NA	5	0.5	0.5	NA	50	20	
ATAL	NA	640	9	5000	NA	NA	1000	NA	10	15	NA	0.77	NA	30	200	5	NA	6.3	20	100	NA	
MTAL	750	NA	340	NA	0.6	210	NA	4.3	22	NA	17	1.4	170	NA	NA	20	0.4	NA	NA	NA	42	
unit	ug/L	ug/L	ug/L	ug/L	ug/L	ug/L	ug/L	ug/L	ug/L	pCi/L	ug/L	ug/L	ug/L	pCi/L	ug/L	ug/L	ug/L	ug/L	ug/L	ug/L	ug/L	
Bgeo_mean/ATAL	NA	0.0027	0.32	0.0055	NA	NA	0.0017	NA	0.27	0.23	NA	0.15	NA	0.031	0.0016	0.55	NA	0.15	0.016	0.023	NA	
2011-07-30 d	0.039	NA	NA	NA	NA	NA	0.0011	0.47	NA	0.45	NA	NA	0.0056	NA	NA	NA	NA	NA	NA	0.024	0.16	
2011-07-30 nd	NA	0.0016	0.19	0.003	0.11	0.0095	NA	NA	0.15	NA	0.029	0.086	NA	0.031	0.002	0.3	0.4	0.071	0.02	NA	NA

SWMU 27-002 is monitored within PJ-SMA-16. Following the installation of baseline control measures, baseline storm water samples were collected on July 30, 2011, and August 8, 2013 (Figure 171-2). In Figure 171-2, cadmium, selenium, and silver are reported as nondetected results greater than their respective TALs. These values are reported at the PQL, the MDL for these analytes are below the TAL. The values are nondetects and thus not considered TAL exceedances. Analytical results from these samples yielded no TAL exceedances. Baseline confirmation is complete for PJ-SMA-16 and the associated SWMU 27-002 because all applicable sampling results are below the applicable MTAL or ATAL. No further sampling is required for PJ-SMA-16 for the duration of the IP.
