# **2020 Update to the Site Discharge Pollution Prevention Plan, Revision 1**

NPDES Permit No. NM0030759  
May 1, 2021

## **Pajarito Watershed**

### **Volume 3**

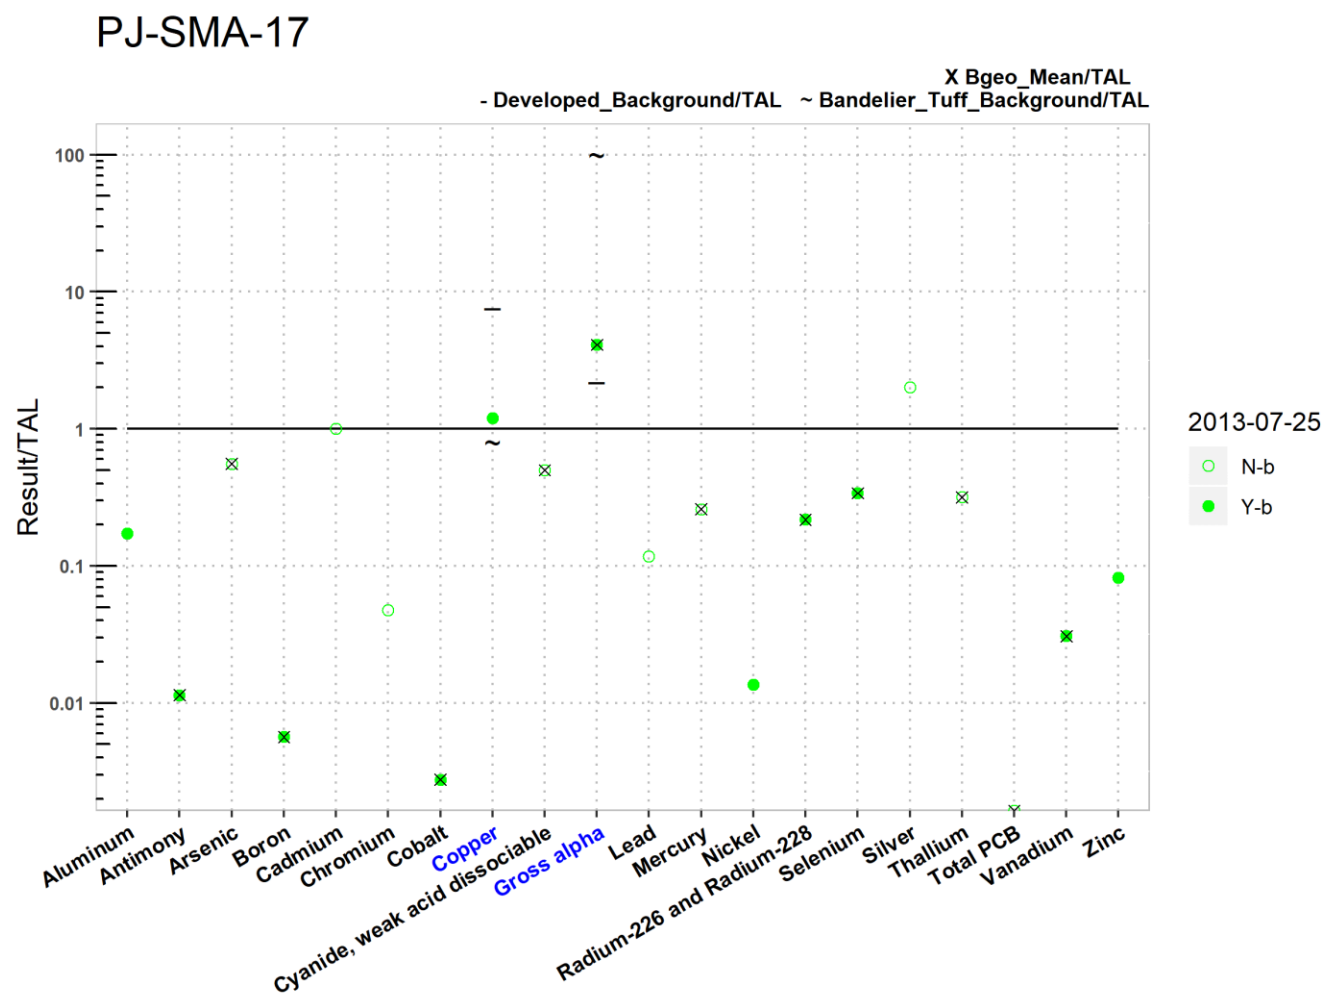
**Figure 172-2 Analytical results summary for PJ-SMA-17**

PJ-SMA-17																				
	Aluminum	Antimony	Arsenic	Boron	Cadmium	Chromium	Cobalt	Copper	Cyanide, weak acid dissociable	Gross alpha	Lead	Mercury	Nickel	Radium-226 and Radium-228	Selenium	Silver	Thallium	Total PCB	Vanadium	Zinc
TAL	750	640	9	5000	1	210	1000	4.3	10	15	17	0.77	170	30	5	0.5	6.3	0.00064	100	42
MQL	2.5	60	0.5	100	1	10	50	0.5	10	NA	0.5	0.005	0.5	NA	5	0.5	0.5	NA	50	20
ATAL	NA	640	9	5000	NA	NA	1000	NA	10	15	NA	0.77	NA	30	5	NA	6.3	0.00064	100	NA
MTAL	750	NA	340	NA	0.6	210	NA	4.3	22	NA	17	1.4	170	NA	20	0.4	NA	NA	NA	42
unit	ug/L	ug/L	ug/L	ug/L	ug/L	ug/L	ug/L	ug/L	ug/L	pCi/L	ug/L	ug/L	ug/L	pCi/L	ug/L	ug/L	ug/L	ug/L	ug/L	ug/L
Bgeo_mean/ATAL	NA	0.011	0.56	0.0057	NA	NA	0.0028	NA	0.5	<b>4.1</b>	NA	0.26	NA	0.22	0.34	NA	0.32	0	0.031	NA
2013-07-25 d	0.17	0.011	NA	0.0057	NA	NA	0.0028	<b>1.2</b>	NA	<b>4.1</b>	NA	NA	0.014	0.22	0.34	NA	NA	NA	0.031	0.082
2013-07-25 nd	NA	NA	0.56	NA	1	0.048	NA	NA	0.5	NA	0.12	0.26	NA	NA	NA	2	0.32	0	NA	NA

SWMU 54-018 was monitored within PJ-SMA-17. Following the installation of baseline control measures, a baseline storm water sample was collected on July 25, 2013 (Figure 172-2). In Figure 172-2, cadmium and silver are reported as nondetected results greater than their respective TALs. These values are reported at the PQL, the MDL for these analytes are below the TAL. The values are nondetects and thus not considered TAL exceedances. Analytical results from this sample yielded TAL exceedances for copper (5.13 µg/L) and gross-alpha activity (61.6 pCi/L) and are presented in Figure 172-2.

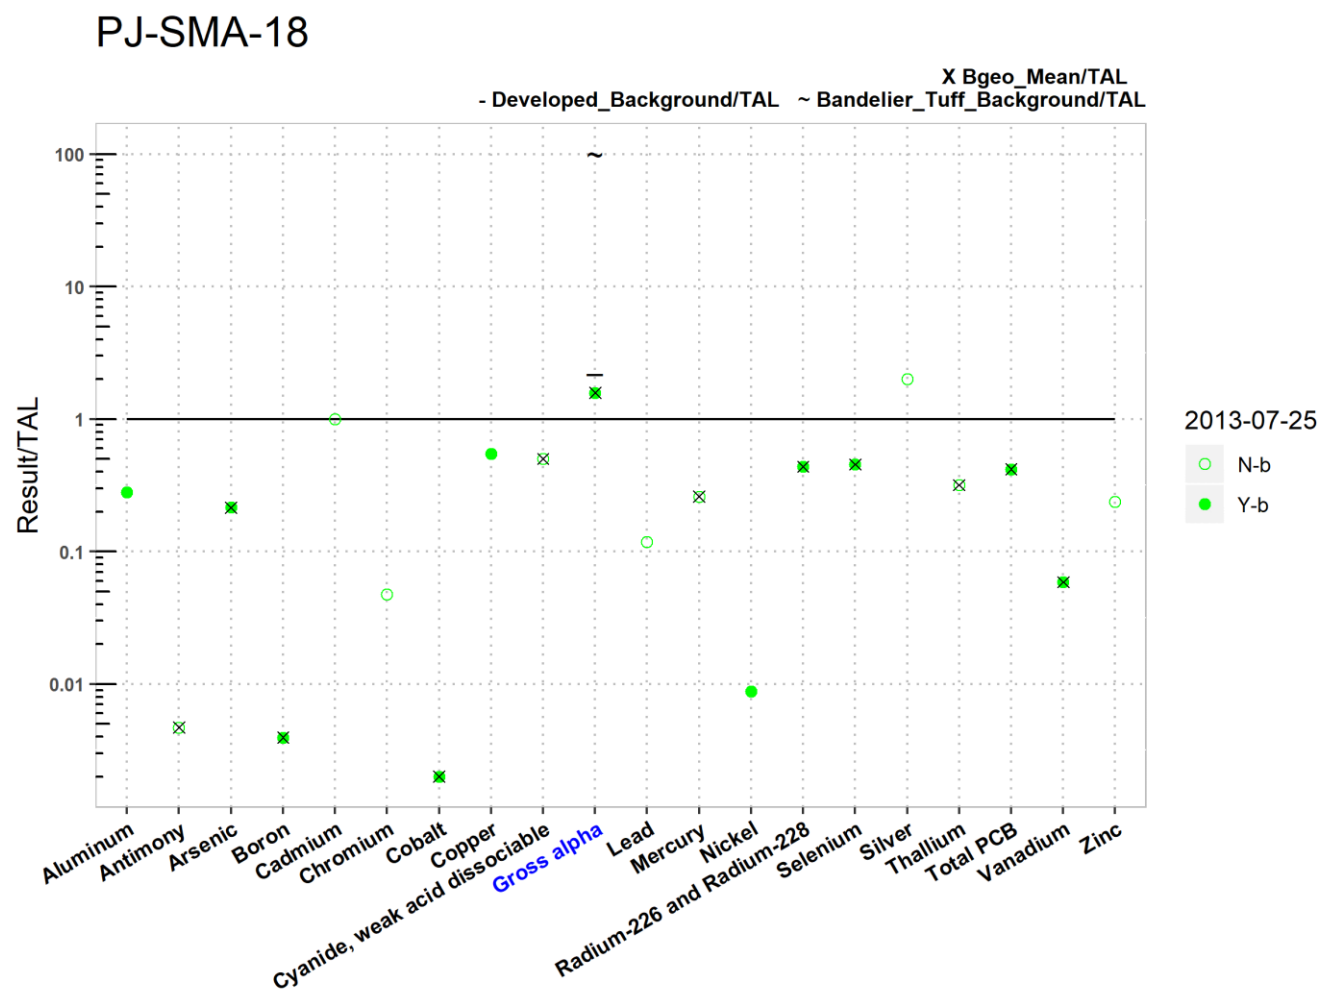
**Figure 173-2 Analytical results summary for PJ-SMA-18**

PJ-SMA-18																				
	Aluminum	Antimony	Arsenic	Boron	Cadmium	Chromium	Cobalt	Copper	Cyanide, weak acid dissociable	Gross alpha	Lead	Mercury	Nickel	Radium-226 and Radium-228	Selenium	Silver	Thallium	Total PCB	Vanadium	Zinc
TAL	750	640	9	5000	1	210	1000	4.3	10	15	17	0.77	170	30	5	0.5	6.3	0.00064	100	42
MQL	2.5	60	0.5	100	1	10	50	0.5	10	NA	0.5	0.005	0.5	NA	5	0.5	0.5	NA	50	20
ATAL	NA	640	9	5000	NA	NA	1000	NA	10	15	NA	0.77	NA	30	5	NA	6.3	0.00064	100	NA
MTAL	750	NA	340	NA	0.6	210	NA	4.3	22	NA	17	1.4	170	NA	20	0.4	NA	NA	NA	42
unit	ug/L	ug/L	ug/L	ug/L	ug/L	ug/L	ug/L	ug/L	ug/L	pCi/L	ug/L	ug/L	ug/L	pCi/L	ug/L	ug/L	ug/L	ug/L	ug/L	ug/L
Bgeo_mean/ATAL	NA	0.0047	0.21	0.0039	NA	NA	0.002	NA	0.5	<b>1.6</b>	NA	0.26	NA	0.44	0.45	NA	0.32	0.42	0.059	NA
2013-07-25 d	0.28	NA	0.21	0.0039	NA	NA	0.002	0.55	NA	<b>1.6</b>	NA	NA	0.0088	0.44	0.45	NA	NA	0.42	0.059	NA
2013-07-25 nd	NA	0.0047	NA	NA	1	0.048	NA	NA	0.5	NA	0.12	0.26	NA	NA	NA	2	0.32	NA	NA	0.24

SWMUs 54-014(d) and 54-017 were monitored within PJ-SMA-18. Following the installation of baseline control measures, a baseline storm water sample was collected on July 25, 2013 (Figure 173-2). In Figure 173-2, cadmium and silver are reported as nondetected results greater than their respective TALs. These values are reported at the PQL, the MDL for these analytes are below the TAL. The values are nondetects and thus not considered TAL exceedances. Analytical results from this sample yielded a TAL exceedance for gross alpha (23.6 pCi/L) and are presented in Figure 173-2.

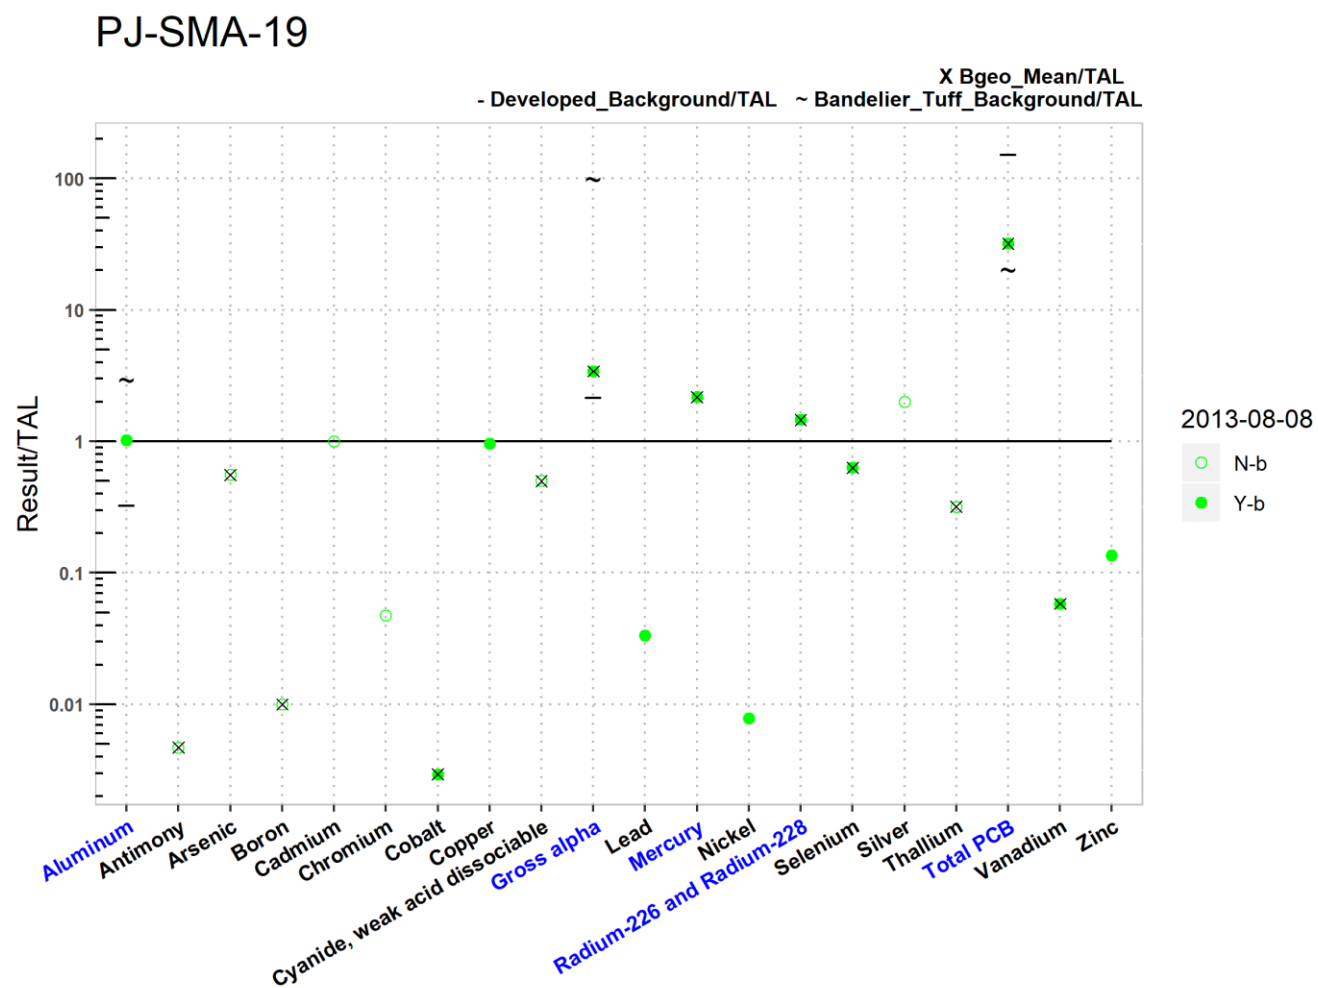
**Figure 174-2 Analytical results summary for PJ-SMA-19**

PJ-SMA-19																				
	Aluminum	Antimony	Arsenic	Boron	Cadmium	Chromium	Cobalt	Copper	Cyanide, weak acid dissociable	Gross alpha	Lead	Mercury	Nickel	Radium-226 and Radium-228	Selenium	Silver	Thallium	Total PCB	Vanadium	Zinc
TAL	750	640	9	5000	1	210	1000	4.3	10	15	17	0.77	170	30	5	0.5	6.3	0.00064	100	42
MQL	2.5	60	0.5	100	1	10	50	0.5	10	NA	0.5	0.005	0.5	NA	5	0.5	0.5	NA	50	20
ATAL	NA	640	9	5000	NA	NA	1000	NA	10	15	NA	0.77	NA	30	5	NA	6.3	0.00064	100	NA
MTAL	750	NA	340	NA	0.6	210	NA	4.3	22	NA	17	1.4	170	NA	20	0.4	NA	NA	NA	42
unit	ug/L	ug/L	ug/L	ug/L	ug/L	ug/L	ug/L	ug/L	ug/L	pCi/L	ug/L	ug/L	ug/L	pCi/L	ug/L	ug/L	ug/L	ug/L	ug/L	ug/L
Bgeo_mean/ATAL	NA	0.0047	0.56	0.01	NA	NA	0.0029	NA	0.5	<b>3.4</b>	NA	<b>2.2</b>	NA	<b>1.5</b>	0.63	NA	0.32	<b>32</b>	0.058	NA
2013-08-08 d	<b>1</b>	NA	NA	NA	NA	NA	0.0029	0.96	NA	<b>3.4</b>	0.033	<b>2.2</b>	0.0078	<b>1.5</b>	0.63	NA	NA	<b>32</b>	0.058	0.14
2013-08-08 nd	NA	0.0047	0.56	0.01	1	0.048	NA	NA	0.5	NA	NA	NA	NA	NA	NA	2	0.32	NA	NA	NA

SWMUs 54-013(b), 54-017, and 54-020 were monitored within PJ-SMA-19. Following the installation of baseline control measures, a baseline storm water sample was collected on August 8, 2013 (Figure 174-2). In Figure 174-2, cadmium and silver are reported as nondetected results greater than their respective TALs. These values are reported at the PQL, the MDL for these analytes are below the TAL. The values are nondetects and thus not considered TAL exceedances. Analytical results from this sample yielded TAL exceedances for aluminum (761 µg/L), gross-alpha activity (51.2 pCi/L), mercury (1.67 µg/L), radium-226 and radium-228 activity (43.7 pCi/L), and PCB concentration (20 ng/L) and are presented in Figure 174-2.

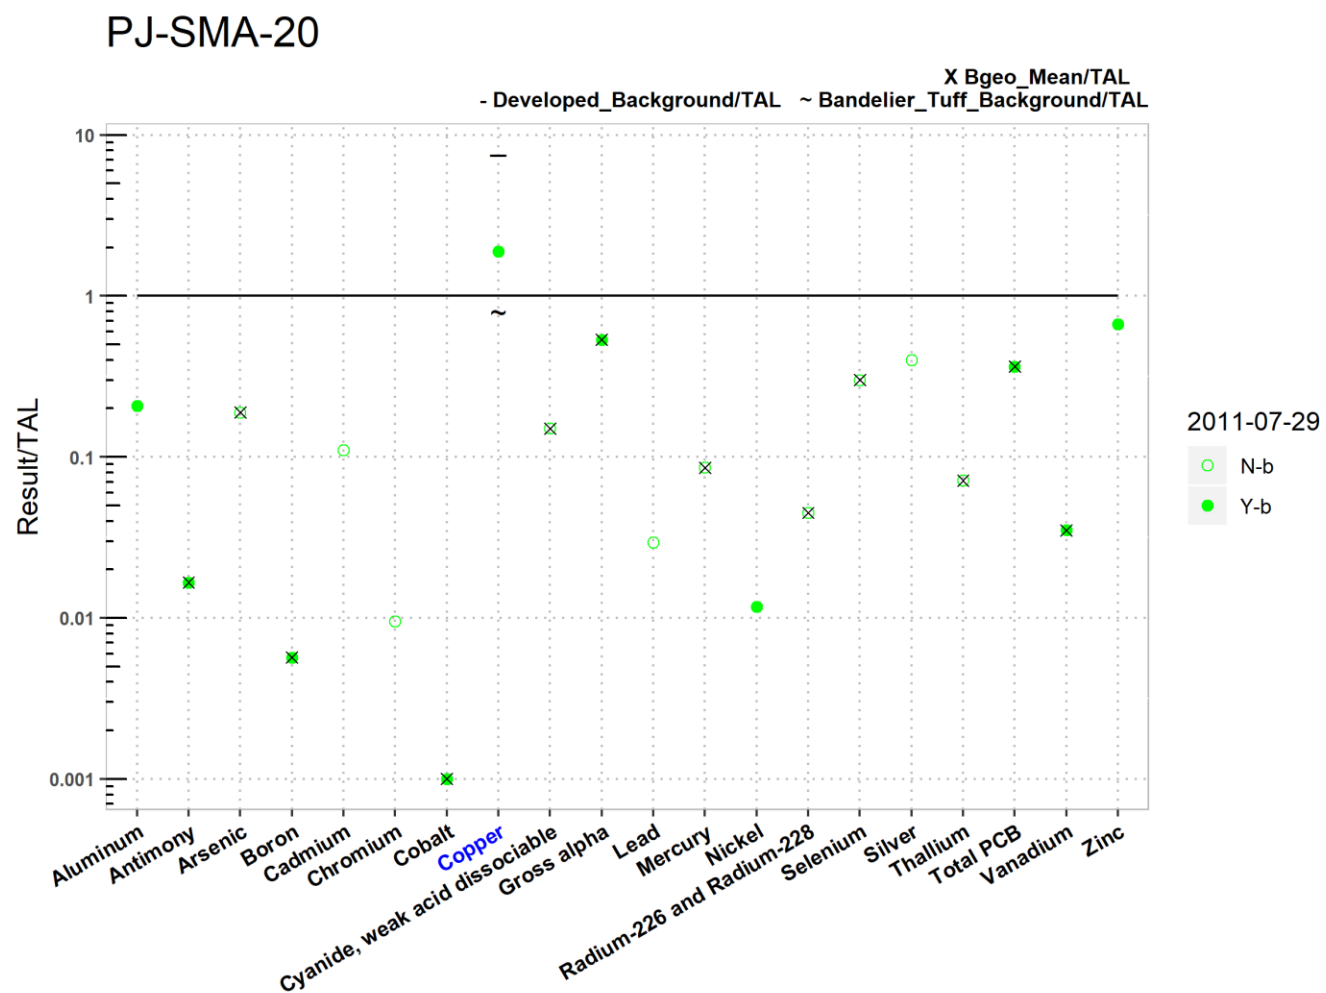
Figure 175-2 Analytical results summary for PJ-SMA-20

PJ-SMA-20																				
	Aluminum	Antimony	Arsenic	Boron	Cadmium	Chromium	Cobalt	Copper	Cyanide, weak acid dissociable	Gross alpha	Lead	Mercury	Nickel	Radium-226 and Radium-228	Selenium	Silver	Thallium	Total PCB	Vanadium	Zinc
TAL	750	640	9	5000	1	210	1000	4.3	10	15	17	0.77	170	30	5	0.5	6.3	0.00064	100	42
MDL	2.5	60	0.5	100	1	10	50	0.5	10	NA	0.5	0.005	0.5	NA	5	0.5	0.5	NA	50	20
ATL	NA	640	9	5000	NA	NA	1000	NA	10	15	NA	0.77	NA	30	5	NA	6.3	0.00064	100	NA
MTL	750	NA	340	NA	0.6	210	NA	4.3	22	NA	17	1.4	170	NA	20	0.4	NA	NA	NA	42
unit	ug/L	ug/L	ug/L	ug/L	ug/L	ug/L	ug/L	ug/L	ug/L	pCi/L	ug/L	ug/L	ug/L	pCi/L	ug/L	ug/L	ug/L	ug/L	ug/L	ug/L
Bgeo_mean/ATL	NA	0.017	0.19	0.0057	NA	NA	0.001	NA	0.15	0.53	NA	0.086	NA	0.045	0.3	NA	0.071	0.36	0.035	NA
2011-07-29 d	0.21	0.017	NA	0.0057	NA	NA	0.001	<b>1.9</b>	NA	0.53	NA	NA	0.012	NA	NA	NA	NA	0.36	0.035	0.66
2011-07-29 nd	NA	NA	0.19	NA	0.11	0.0095	NA	NA	0.15	NA	0.029	0.086	NA	0.045	0.3	0.4	0.071	NA	NA	NA

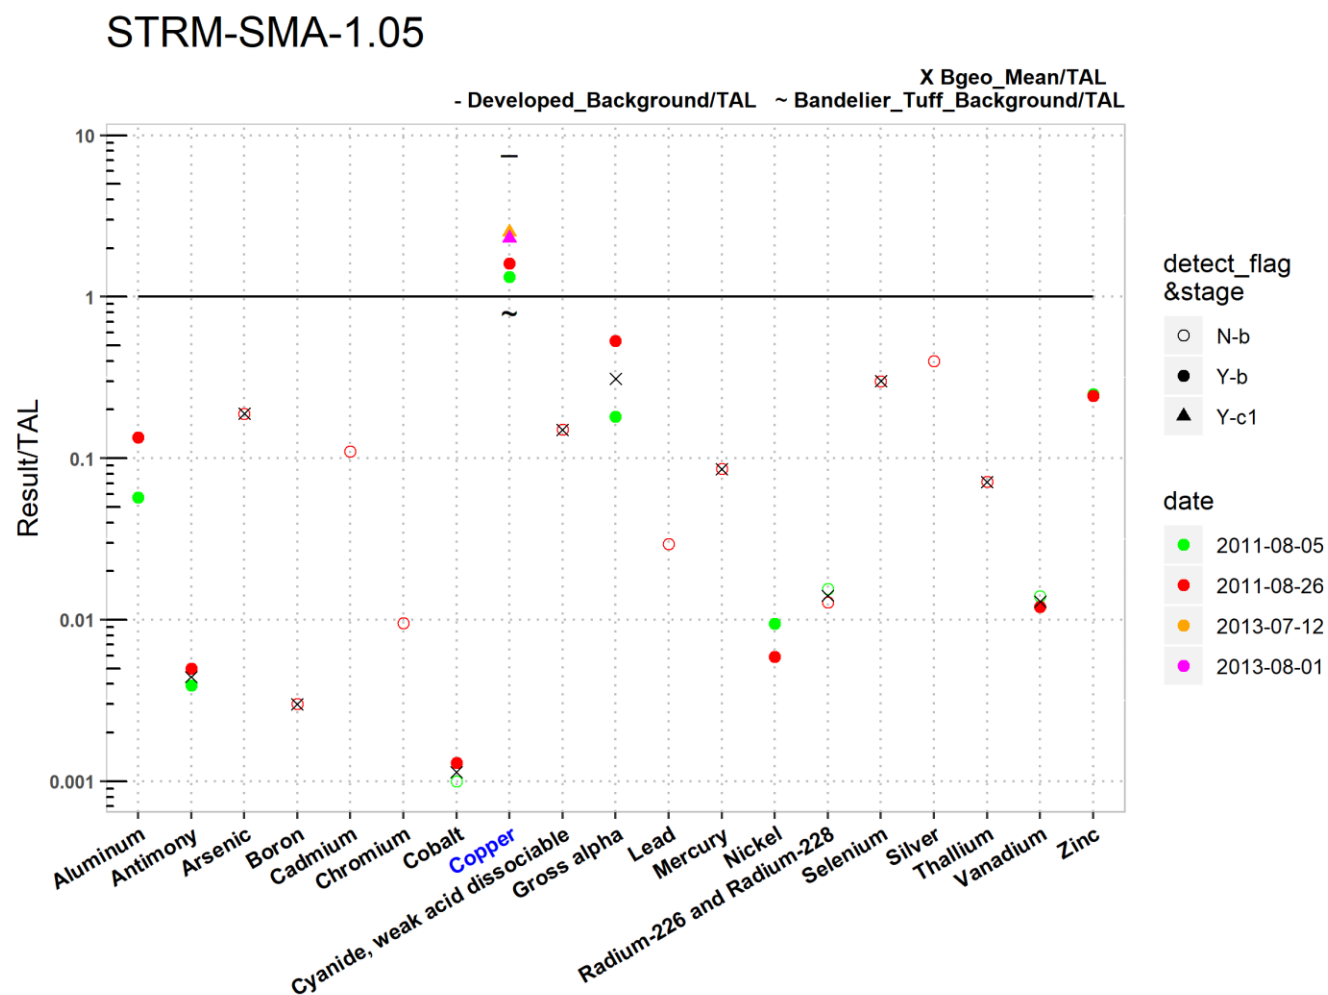
Figure 176-2 Analytical results summary for STRM-SMA-1.05

STRM-SMA-1.05																		
		Aluminum	Antimony	Arsenic	Boron	Cadmium	Chromium	Cobalt	Copper	Cyanide, weak acid dissociable	Gross alpha	Lead	Mercury	Nickel	Radium-226 and Radium-228	Selenium	Silver	Thallium	Vanadium	Zinc
	TAL	750	640	9	5000	1	210	1000	4.3	10	15	17	0.77	170	30	5	0.5	6.3	100	42
	MQL	2.5	60	0.5	100	1	10	50	0.5	10	NA	0.5	0.005	0.5	NA	5	0.5	0.5	50	20
	ATAL	NA	640	9	5000	NA	NA	1000	NA	10	15	NA	0.77	NA	30	5	NA	6.3	100	NA
	MTAL	750	NA	340	NA	0.6	210	NA	4.3	22	NA	17	1.4	170	NA	20	0.4	NA	NA	42
	unit	ug/L	ug/L	ug/L	ug/L	ug/L	ug/L	ug/L	ug/L	ug/L	pCi/L	ug/L	ug/L	ug/L	pCi/L	ug/L	ug/L	ug/L	ug/L	ug/L
Bgeo_mean/	ATAL	NA	0.0044	0.19	0.0030	NA	NA	0.0011	NA	0.150	0.31	NA	0.086	NA	0.0141	0.30	NA	0.07	0.013	NA
	2011-08-05 d	0.0572	0.0039	NA	NA	NA	NA	NA	<b>1.33</b>	NA	0.18	NA	NA	0.00941	NA	NA	NA	NA	NA	0.250
	2011-08-05 nd	NA	NA	0.19	0.0030	0.1	0.00952	0.0010	NA	0.150	NA	0.0294	0.086	NA	0.0155	0.30	0.4	0.07	0.014	NA

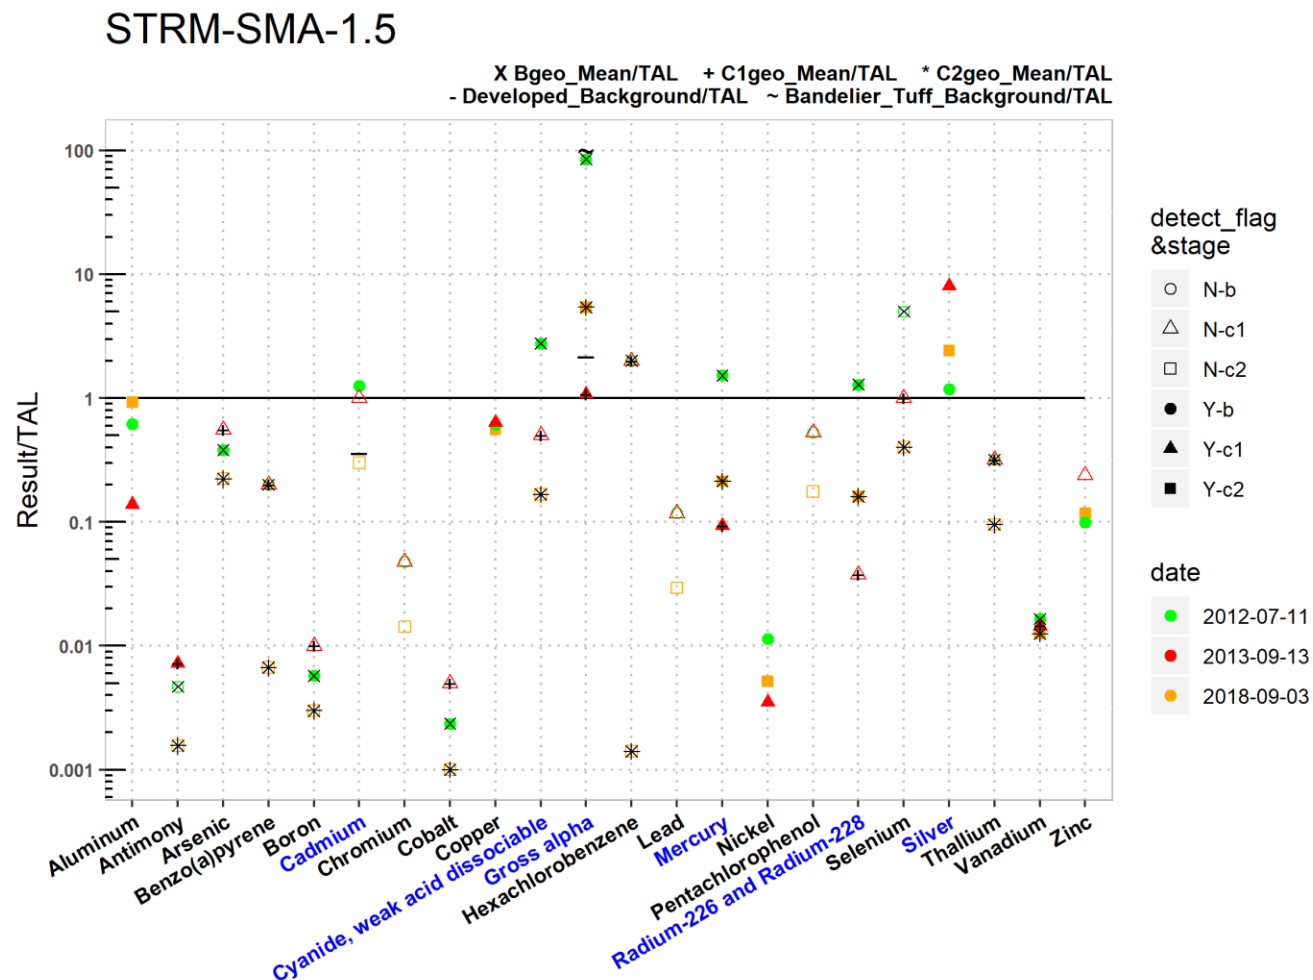
Figure 177-2 Analytical results summary for STRM-SMA-1.5

STRM-SMA-1.5																					
	Aluminum	Antimony	Arsenic	Benzo(a)pyrene	Boron	Cadmium	Chromium	Cobalt	Copper	Cyanide, weak acid dissociable	Gross alpha	Hexachlorobenzene	Lead	Mercury	Nickel	Pentachlorophenol	Radium-226 and Radium-228	Selenium	Silver	Thallium	Vanadium	Zinc
TAL	750	640	9	5	5000	1	210	1000	4.3	10	15	5	17	0.77	170	19	30	5	0.5	6.3	100	42
MQL	2.5	60	0.5	5	100	1	10	50	0.5	10	NA	5	0.5	0.005	0.5	5	NA	5	0.5	0.5	50	20
ATAL	NA	640	9	5	5000	NA	NA	1000	NA	10	15	5	NA	0.77	NA	NA	30	5	NA	6.3	100	NA
MTAL	750	NA	340	NA	NA	0.6	210	NA	4.3	22	NA	NA	17	1.4	170	19	NA	20	0.4	NA	NA	42
unit	ug/L	ug/L	ug/L	ug/L	ug/L	ug/L	ug/L	ug/L	ug/L	ug/L	pCi/L	ug/L	ug/L	ug/L	ug/L	ug/L	pCi/L	ug/L	ug/L	ug/L	ug/L	ug/L
Bgeo_mean/ATAL	NA	0.0047	0.38	0.2	0.0057	NA	NA	0.0024	NA	<b>2.8</b>	<b>85</b>	<b>2</b>	NA	<b>1.5</b>	NA	NA	<b>1.3</b>	<b>5</b>	NA	0.32	0.016	NA
C1geo_mean/ATAL	NA	0.0072	0.56	0.2	0.01	NA	NA	0.005	NA	0.5	<b>1.1</b>	<b>2</b>	NA	0.094	NA	NA	0.038	1	NA	0.32	0.014	NA

SWMU 08-009(d) is monitored within STRM-SMA-1.5. Following the installation of baseline control measures, a baseline storm water sample was collected on July 11, 2012 (Figure 177-2). In Figure 177-2, hexachlorobenzene and selenium are reported as nondetected results greater than their respective TALs. These values are reported at the PQL, the MDL for these analytes are below the TAL. The values are nondetects and thus not considered TAL exceedances. Analytical results from this sample yielded TAL exceedances for cadmium (1.26 µg/L), cyanide (0.02 mg/L), gross-alpha activity (1270 pCi/L), mercury (1.17 µg/L), radium-226 and radium-228 activity (38.5 pCi/L), and silver (0.58 µg/L) and are presented in Figure 177-2.

Following the 2013 installation of enhanced control measures at STRM-SMA-1.5, a corrective action storm water sample was collected on September 13, 2013 (Figure 177-2). In Figure 177-2, cadmium, hexachlorobenzene, and selenium are reported as a nondetected results greater than their respective TALs. These value are reported at the PQL, the MDL for these analytes are below the TAL. The values are nondetects and thus not considered TAL exceedances. Analytical results from this corrective action monitoring sample yielded TAL exceedances for gross-alpha activity (16.1 pCi/L) and silver (4.02 µg/L) and are presented in Figure 177-2.

Following the 2015 installation of enhanced control measures at STRM-SMA-1.5, a corrective action storm water sample was collected on September 3, 2018 (Figure 177-2). Analytical results from this corrective action monitoring sample yielded TAL exceedances for gross-alpha activity (81.3 pCi/L) and silver (1.21 µg/L) and are presented in Figure 177-2.

TAL exceedances were also evaluated against the appropriate storm water BV, that is, “Bandelier Tuff background” for undisturbed SMAs or “developed background” for urban settings. BVs are expressed as UTLs using the approved EPA method for calculating BVs. UTLs for undisturbed SMAs were derived from storm water runoff containing entrained sediments derived from Bandelier Tuff and are labeled “Bandelier Tuff Background” in Figure 177-2. UTLs developed for urban settings were derived from runoff from developed landscapes on the Pajarito Plateau, including buildings, parking lots, roads, and associated features, and are labeled “Developed Background” in Figure 177-2.

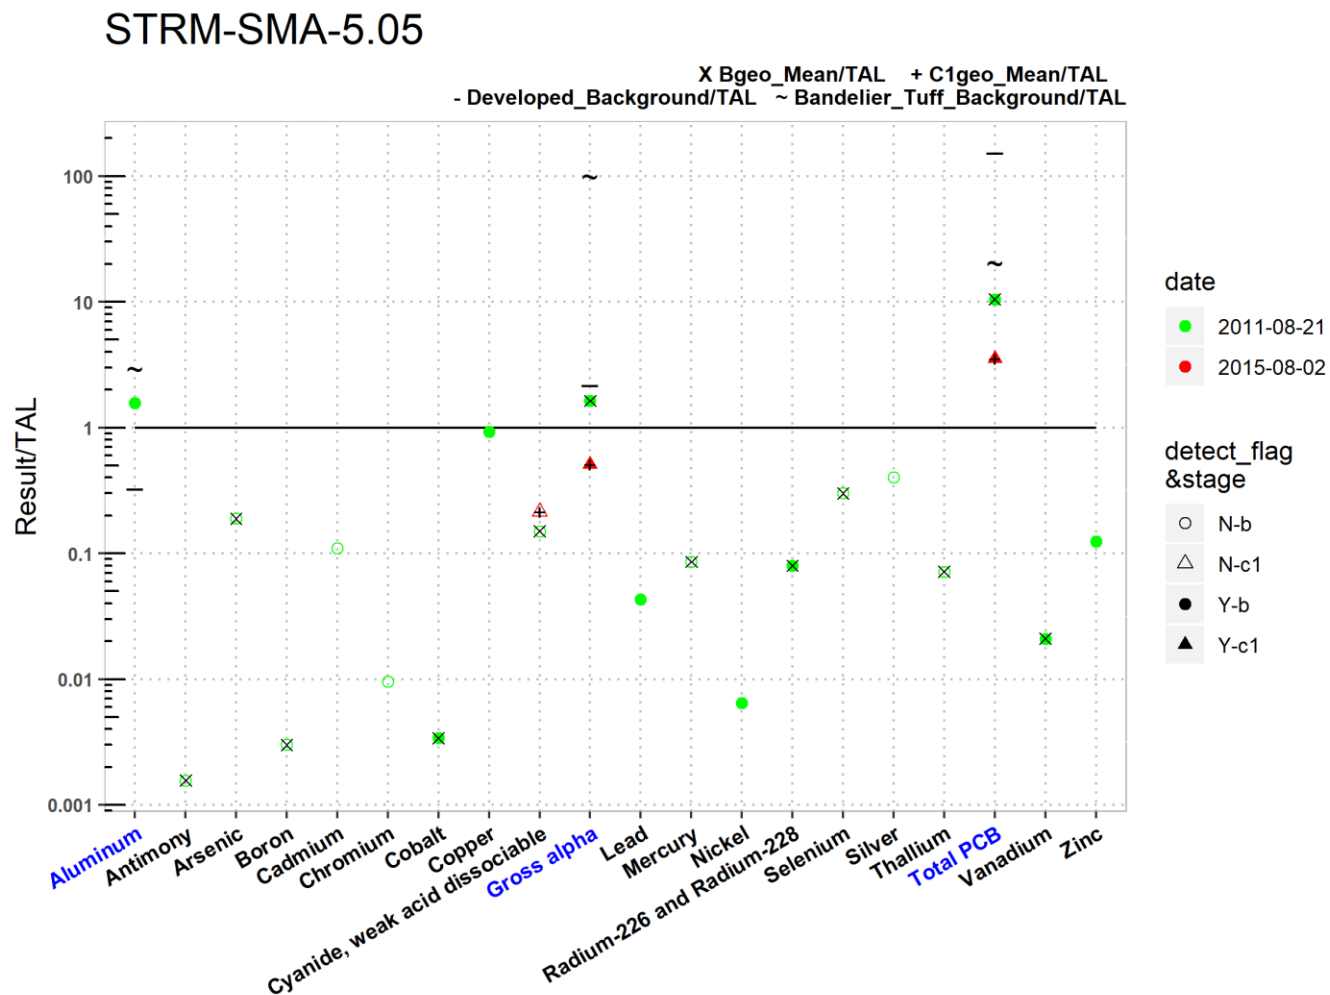
**Figure 179-2 Analytical results summary for STRM-SMA-5.05**

STRM-SMA-5.05																				
	Aluminum	Antimony	Arsenic	Boron	Cadmium	Chromium	Cobalt	Copper	Cyanide, weak acid dissociable	Gross alpha	Lead	Mercury	Nickel	Radium-226 and Radium-228	Selenium	Silver	Thallium	Total PCB	Vanadium	Zinc
<i>TAL</i>	750	640	9	5000	1	210	1000	4.3	10	15	17	0.77	170	30	5	0.5	6.3	0.00064	100	42
<i>MQL</i>	2.5	60	0.5	100	1	10	50	0.5	10	NA	0.5	0.005	0.5	NA	5	0.5	0.5	NA	50	20
<i>ATAL</i>	NA	640	9	5000	NA	NA	1000	NA	10	15	NA	0.77	NA	30	5	NA	6.3	0.00064	100	NA
<i>MTAL</i>	750	NA	340	NA	0.6	210	NA	4.3	22	NA	17	1.4	170	NA	20	0.4	NA	NA	NA	42
<i>unit</i>	ug/L	ug/L	ug/L	ug/L	ug/L	ug/L	ug/L	ug/L	ug/L	pCi/L	ug/L	ug/L	ug/L	pCi/L	ug/L	ug/L	ug/L	ug/L	ug/L	ug/L
<i>Bgeo_mean/ATAL</i>	NA	0.0016	0.19	0.003	NA	NA	0.0034	NA	0.15	<b>1.6</b>	NA	0.086	NA	0.08	0.3	NA	0.071	<b>10</b>	0.021	NA
<i>C1geo_mean/ATAL</i>	NA	NA	NA	NA	NA	NA	NA	NA	0.21	0.51	NA	NA	NA	NA	NA	NA	NA	<b>3.5</b>	NA	NA
<i>2011-08-21 d</i>	<b>1.6</b>	NA	NA	NA	NA	NA	0.0034	0.93	NA	<b>1.6</b>	0.043	NA	0.0065	0.08	NA	NA	NA	<b>10</b>	0.021	0.12

SWMU 09-013 is monitored within STRM-SMA-5.05. Following the installation of baseline control measures, a baseline storm water sample was collected on August 21, 2011 (Figure 179-2). Analytical results from this sample yielded TAL exceedances for aluminum (1170 µg/L), gross-alpha activity (24.5 pCi/L), and PCB concentration (7 ng/L) and are presented in Figure 179-2.

Following the installation of enhanced control measures at STRM-SMA-5.05, a corrective action storm water sample was collected on August 2, 2015 (Figure 179-2). Analytical results from this corrective action monitoring sample yielded a TAL exceedance for PCB concentration (2.26 ng/L) and are presented in Figure 179-2.

TAL exceedances were also evaluated against the appropriate storm water BV, that is, “Bandelier Tuff background” for undisturbed SMAs or “developed background” for urban settings. BVs are expressed as UTLs using the approved EPA method for calculating BVs. UTLs for undisturbed SMAs were derived from storm water runoff containing entrained sediments derived from Bandelier Tuff and are labeled “Bandelier Tuff Background” in Figure 179-2. UTLs developed for urban settings were derived from runoff from developed landscapes on the Pajarito Plateau, including buildings, parking lots, roads, and associated features, and are labeled “Developed Background” in Figure 179-2.
