Subject: Submittal of Starmer/Upper Pajarito Canyon Aggregate Area Progress Report

September 2023 EM2023-0582

Starmer/Upper Pajarito Canyon Aggregate Area Progress Report

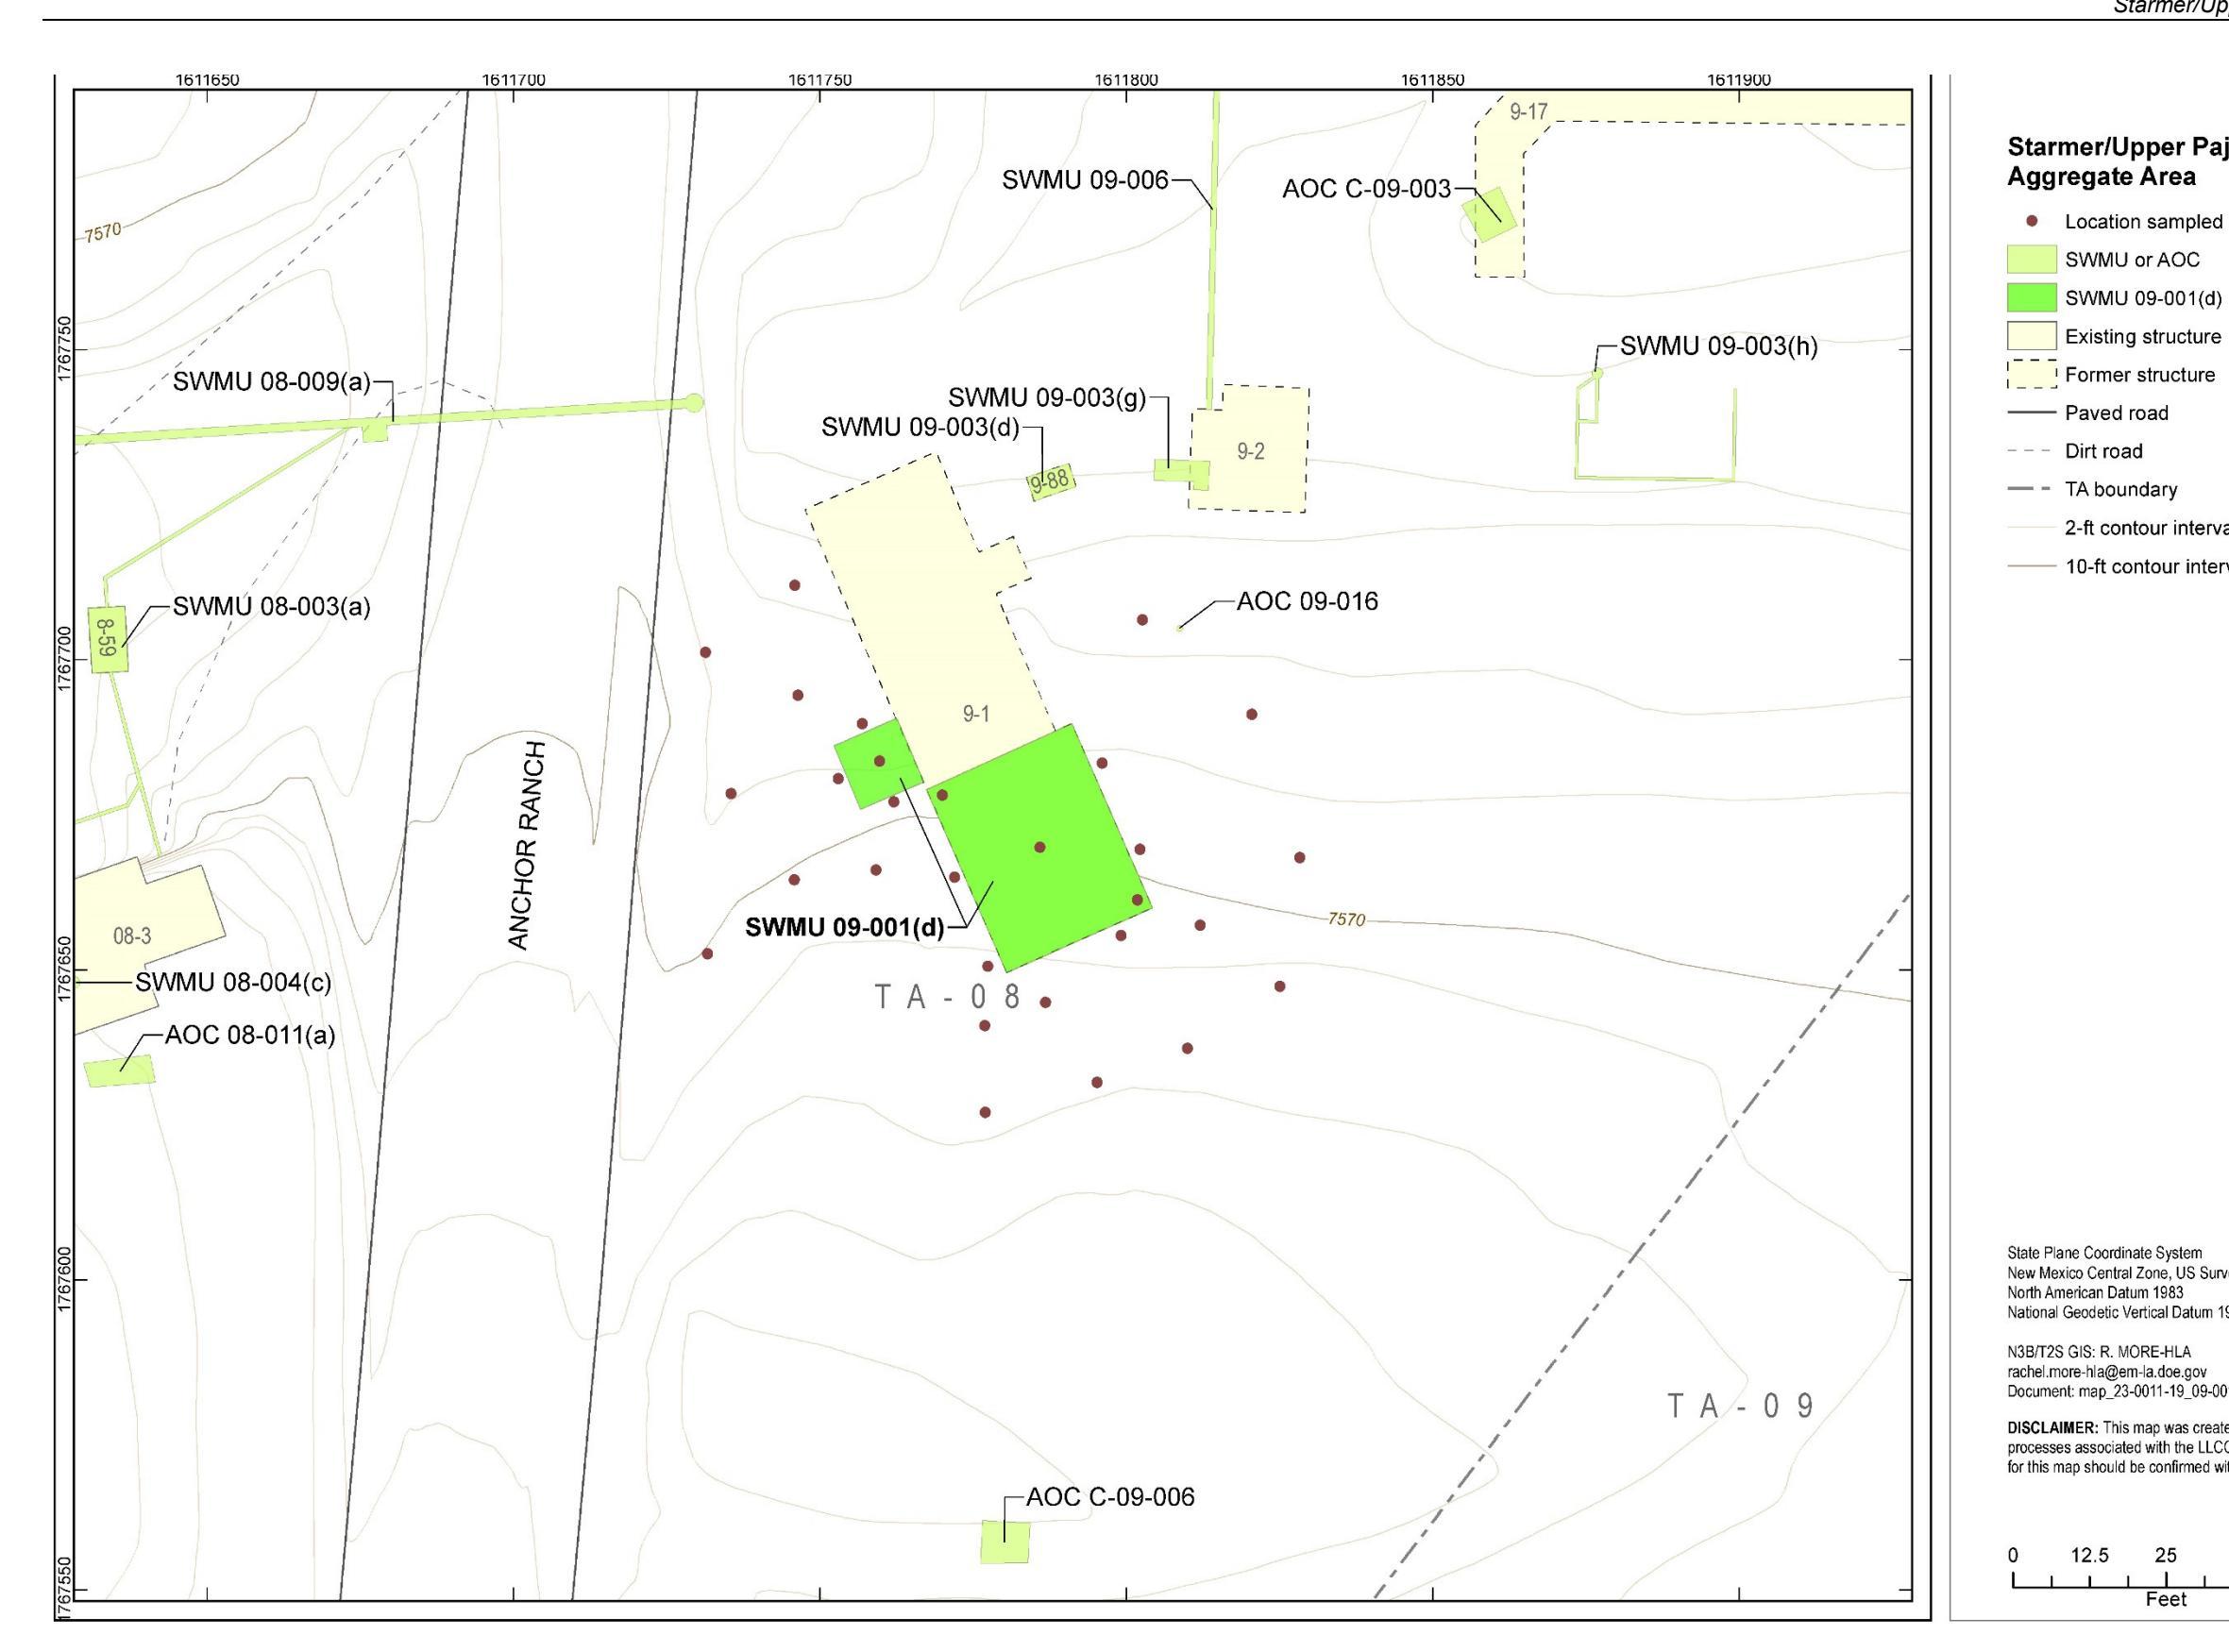
Figure 2.2-1 Locations sampled at SWMU 09-001(d) in FY 2022

Following the submittal of the FY 2022 progress report, 25 samples from 10 locations were collected. Fieldwork was completed on September 29, 2022. Samples were collected from 0–1 ft, 2–3 ft, and 4–5 ft bgs. Three samples from 2 locations were unable to be collected due to auger refusal at approximately 2.5 and 4.5 ft bgs. Samples were analyzed for TAL metals, nitrate, perchlorate, total cyanide, explosive compounds, SVOCs, volatile organic compounds (VOCs) (except in surface samples), dioxins/furans, americium-241, gamma spectroscopy, isotopic plutonium, isotopic uranium, and pH. Twenty percent of samples were analyzed for polychlorinated biphenyls (PCBs). Figure 2.2-1 shows locations sampled at SWMU 09-001(d) in FY 2022.

The primary objective of the investigation at SWMU 09-001(d) is to implement the approved "Investigation Work Plan for Starmer/Upper Pajarito Canyon Aggregate Area, Revision 1" and collect 26 samples from 13 locations (LANL 2011, 111794; NMED 2011, 201465). A secondary objective is to ensure a sufficient number of samples are collected to define nature and extent of contamination at SWMU 09-001(d) and to determine if the site poses a potential unacceptable risk to human health or the environment. To meet both objectives, a total of 87 samples from 29 locations are planned to be collected at SWMU 09-001(d). At each location, samples will be collected from 0–1 ft, 2–3 ft, and 4–5 ft below ground surface (bgs). The samples locations are shown in Figure 2.2-1.

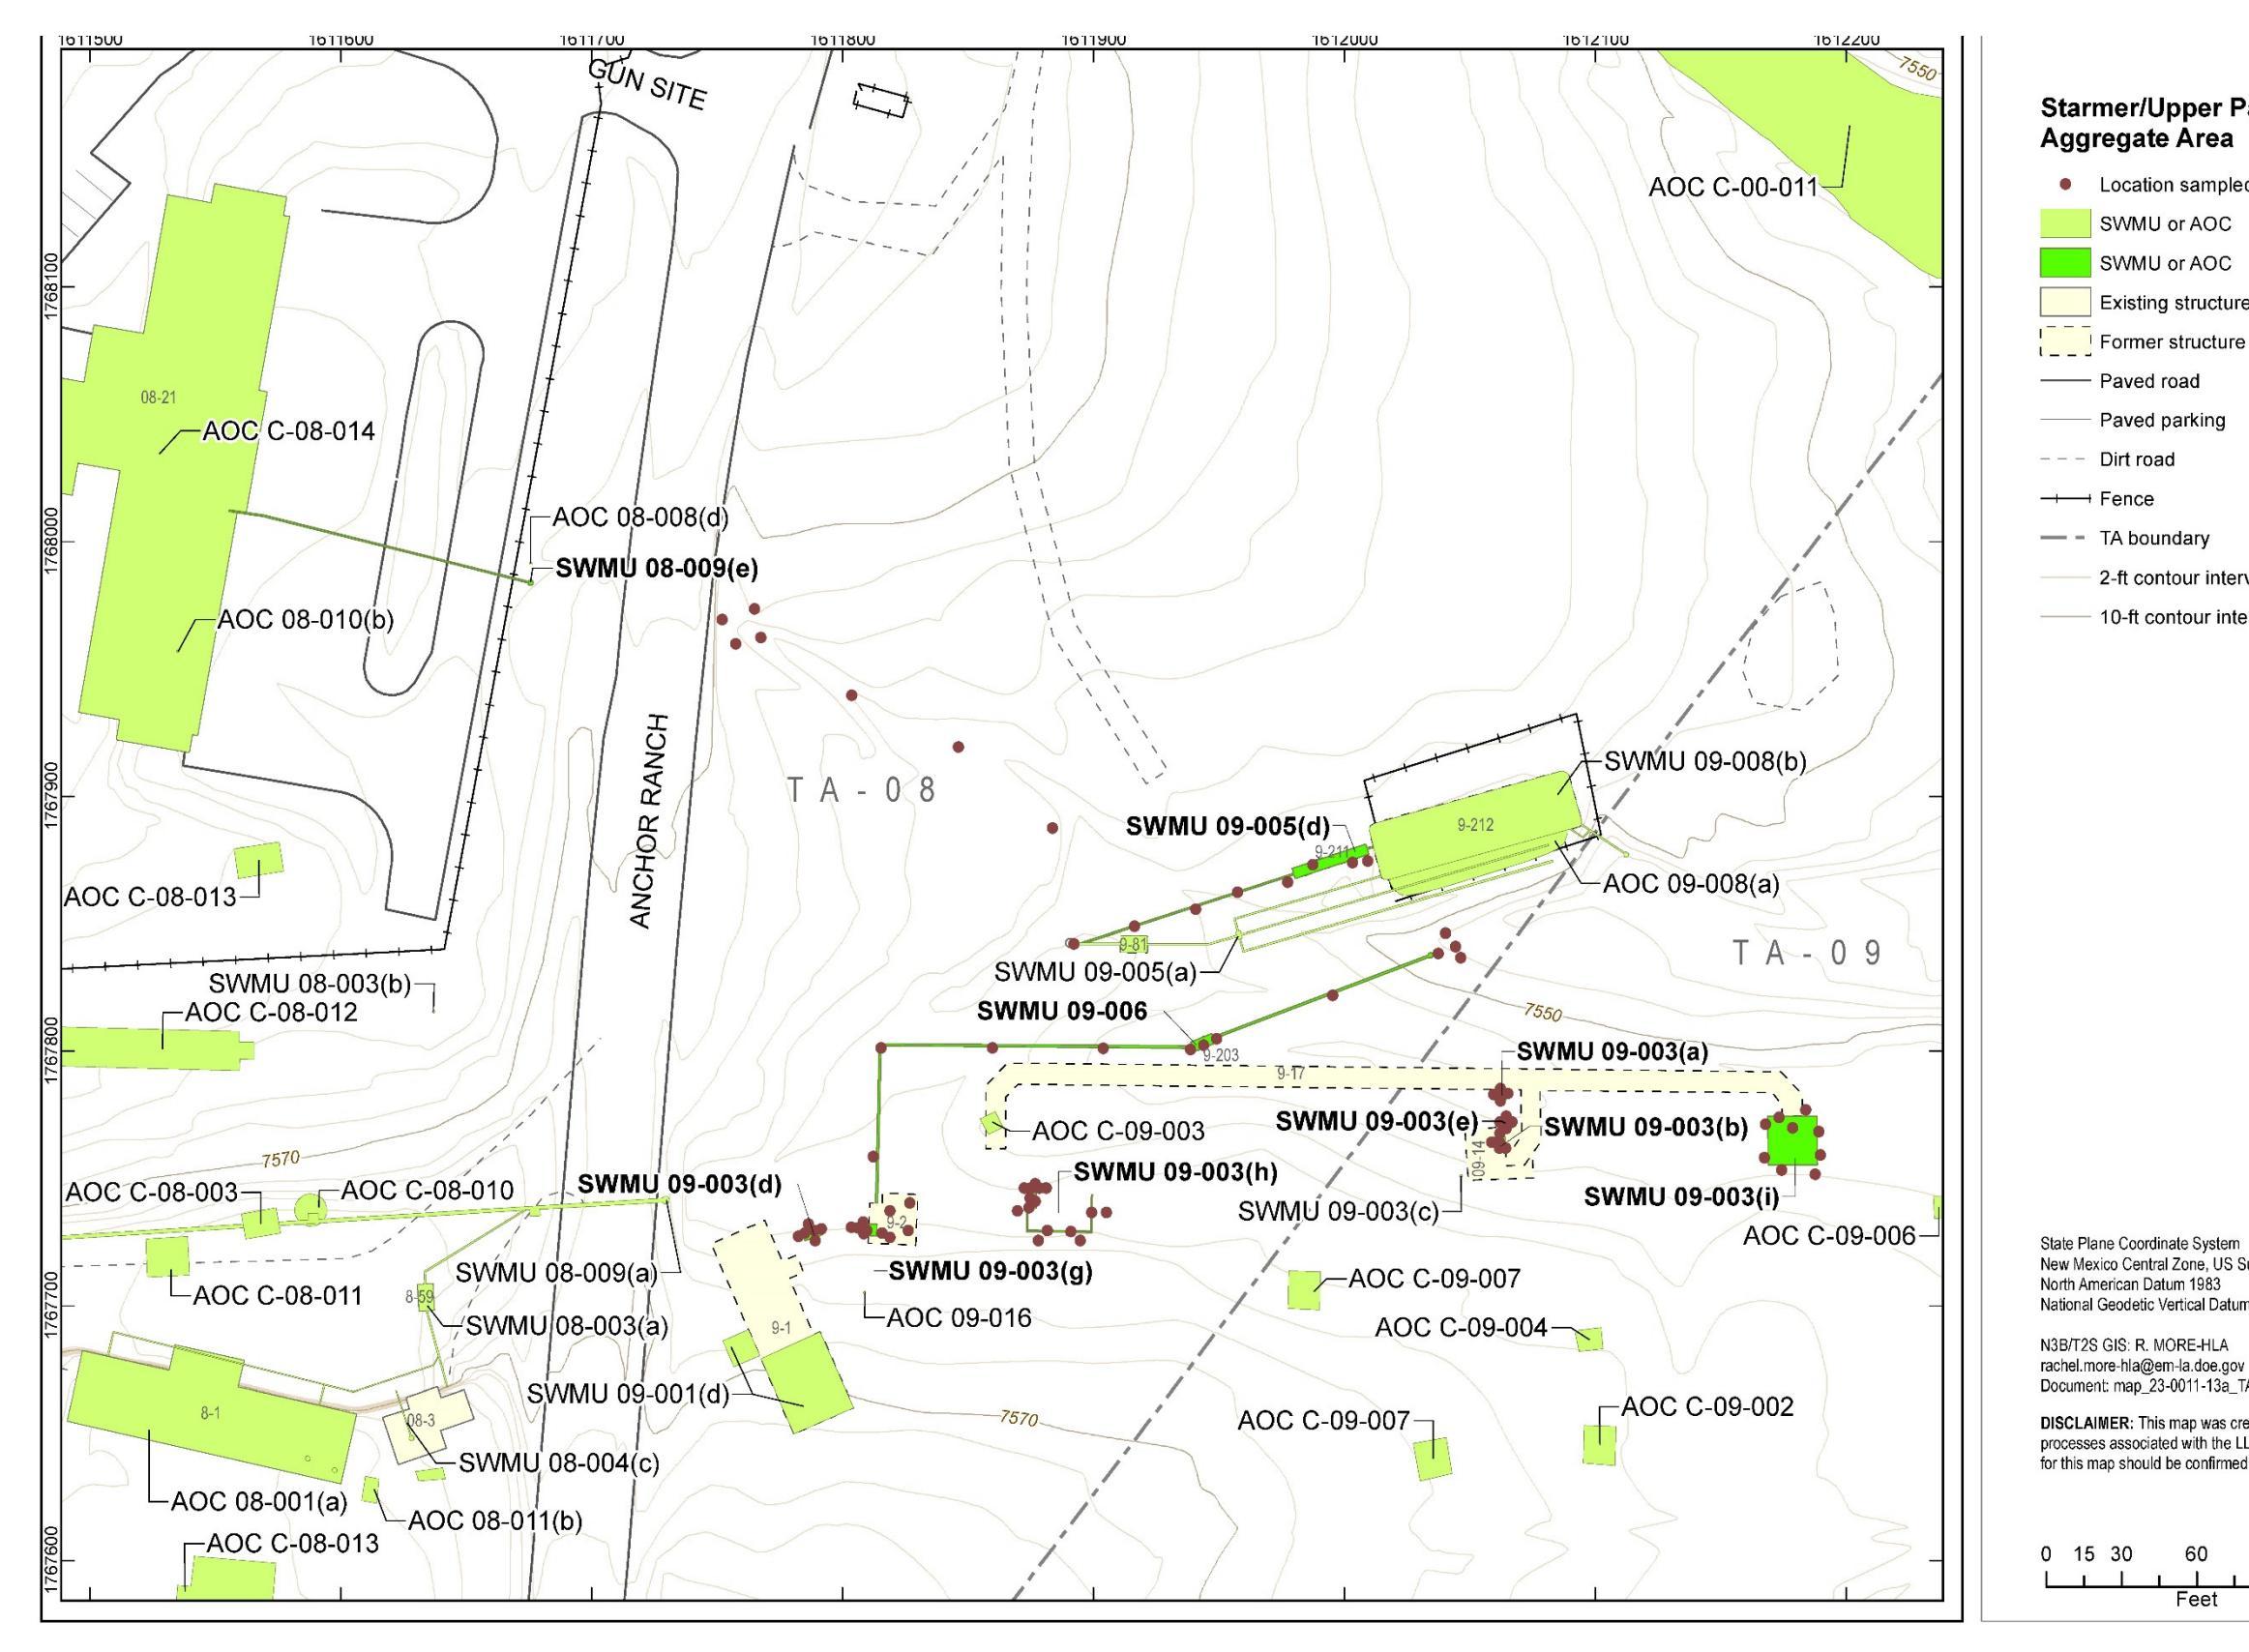
Figure 3.1-1 Locations sampled at TA-08 and TA-09 west in FY 2023

Sampling was initiated on January 31, 2023. A total of 21 samples were collected from 7 locations. Three samples were collected from 1 location from 0–1 ft, 2–3 ft, and 5–6 ft below the drainlines. A total of 18 samples were collected from 6 locations from 0–1 ft, 2–3 ft, and 4–5 ft bgs in the outfall and downgradient of the outfall. Samples were analyzed for TAL metals, nitrate, perchlorate, total cyanide, explosive compounds, VOCs (except in surface samples), SVOCs, americium-241, gamma spectroscopy, isotopic plutonium, isotopic uranium, and pH. Twenty percent of all samples were analyzed for PCBs. Remaining fieldwork includes collecting 24 samples from 8 locations. Figure 3.1-1 shows locations sampled at SWMU 08-009(e) in FY 2023.

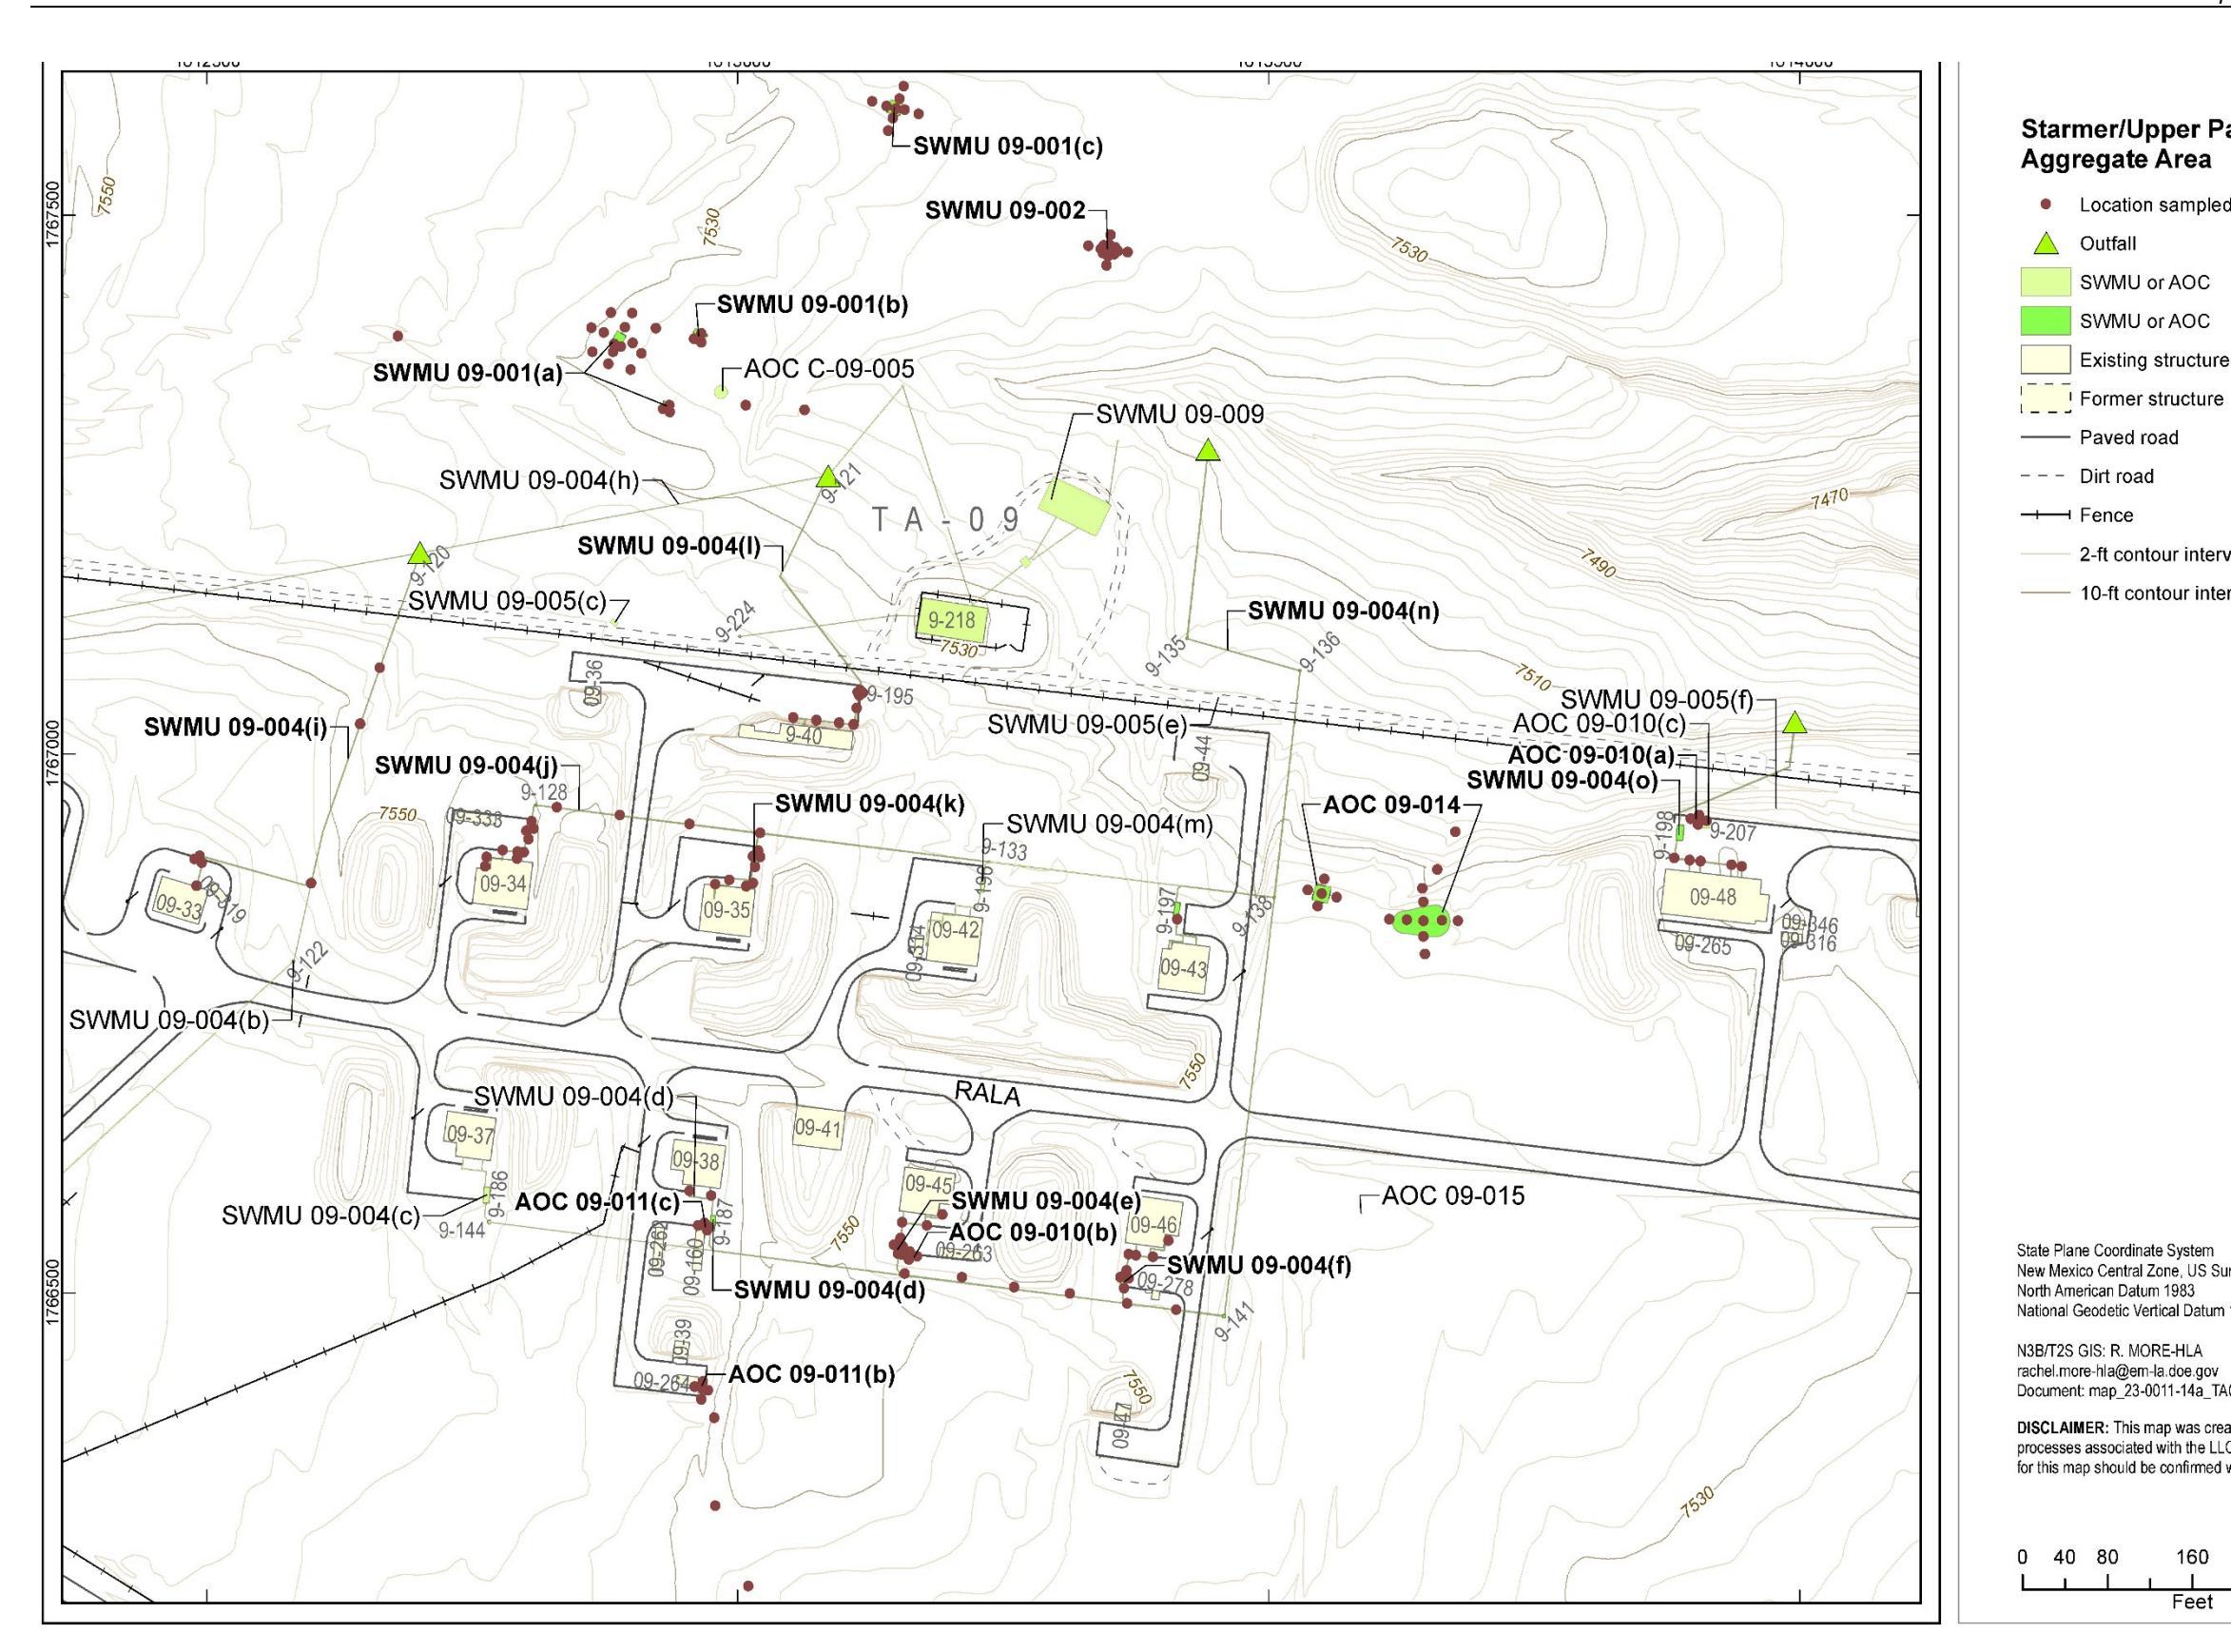
Figure 4.1-1 Locations sampled at TA-09 east in FY 2023

Sampling was conducted between January 6 and January 10, 2023. A total of 60 samples were collected from 20 locations. At 14 locations within and around the concrete firing pad, samples were collected from 0–1 ft, 2–3 ft, and 4–5 ft bgs. An additional 6 locations were sampled downgradient of the firing pad from 0–1 ft, 2–3 ft, and 4–5 ft bgs. Samples were analyzed for TAL metals, nitrate, perchlorate, total cyanide, explosive compounds, VOCs (except in surface samples), SVOCs, dioxins/furans, americium-241, gamma spectroscopy, isotopic plutonium, isotopic uranium, and pH. Twenty percent of all samples were analyzed for PCBs. Figure 4.1-1 shows locations sampled at SWMU 09-001(a) in FY 2023.

Sampling was conducted on January 6, 2023. A total of six samples were collected from three locations, from 0–1 ft, 2–3 ft, and 4–5 ft bgs. Samples were analyzed for TAL metals, nitrate, perchlorate, total cyanide, explosive compounds, VOCs (except in surface samples), SVOCs, PCBs, dioxins/furans, americium-241, gamma spectroscopy, isotopic plutonium, isotopic uranium, and pH. Figure 4.1-1 shows locations sampled at SWMU 09-001(b) in FY 2023.

Sampling was conducted between November 17 and December 16, 2022. A total of 39 samples were collected from 13 locations. Samples were collected from 5 locations within and surrounding the former burn pit from 0–1 ft, 3–4 ft, and 5–6 ft bgs. An additional 4 locations were positioned 10 ft from the burn pit and were sampled from 0–1 ft, 3–4 ft, and 5–6 ft bgs. Samples were analyzed for TAL metals, nitrate, perchlorate, total cyanide, explosive compounds, VOCs (except in surface samples), SVOCs, dioxins/furans, americium-241, gamma spectroscopy, isotopic plutonium, isotopic uranium, and pH. Twenty percent of samples were analyzed for PCBs. Figure 4.1-1 shows locations sampled at SWMU 09-002 in FY 2023.

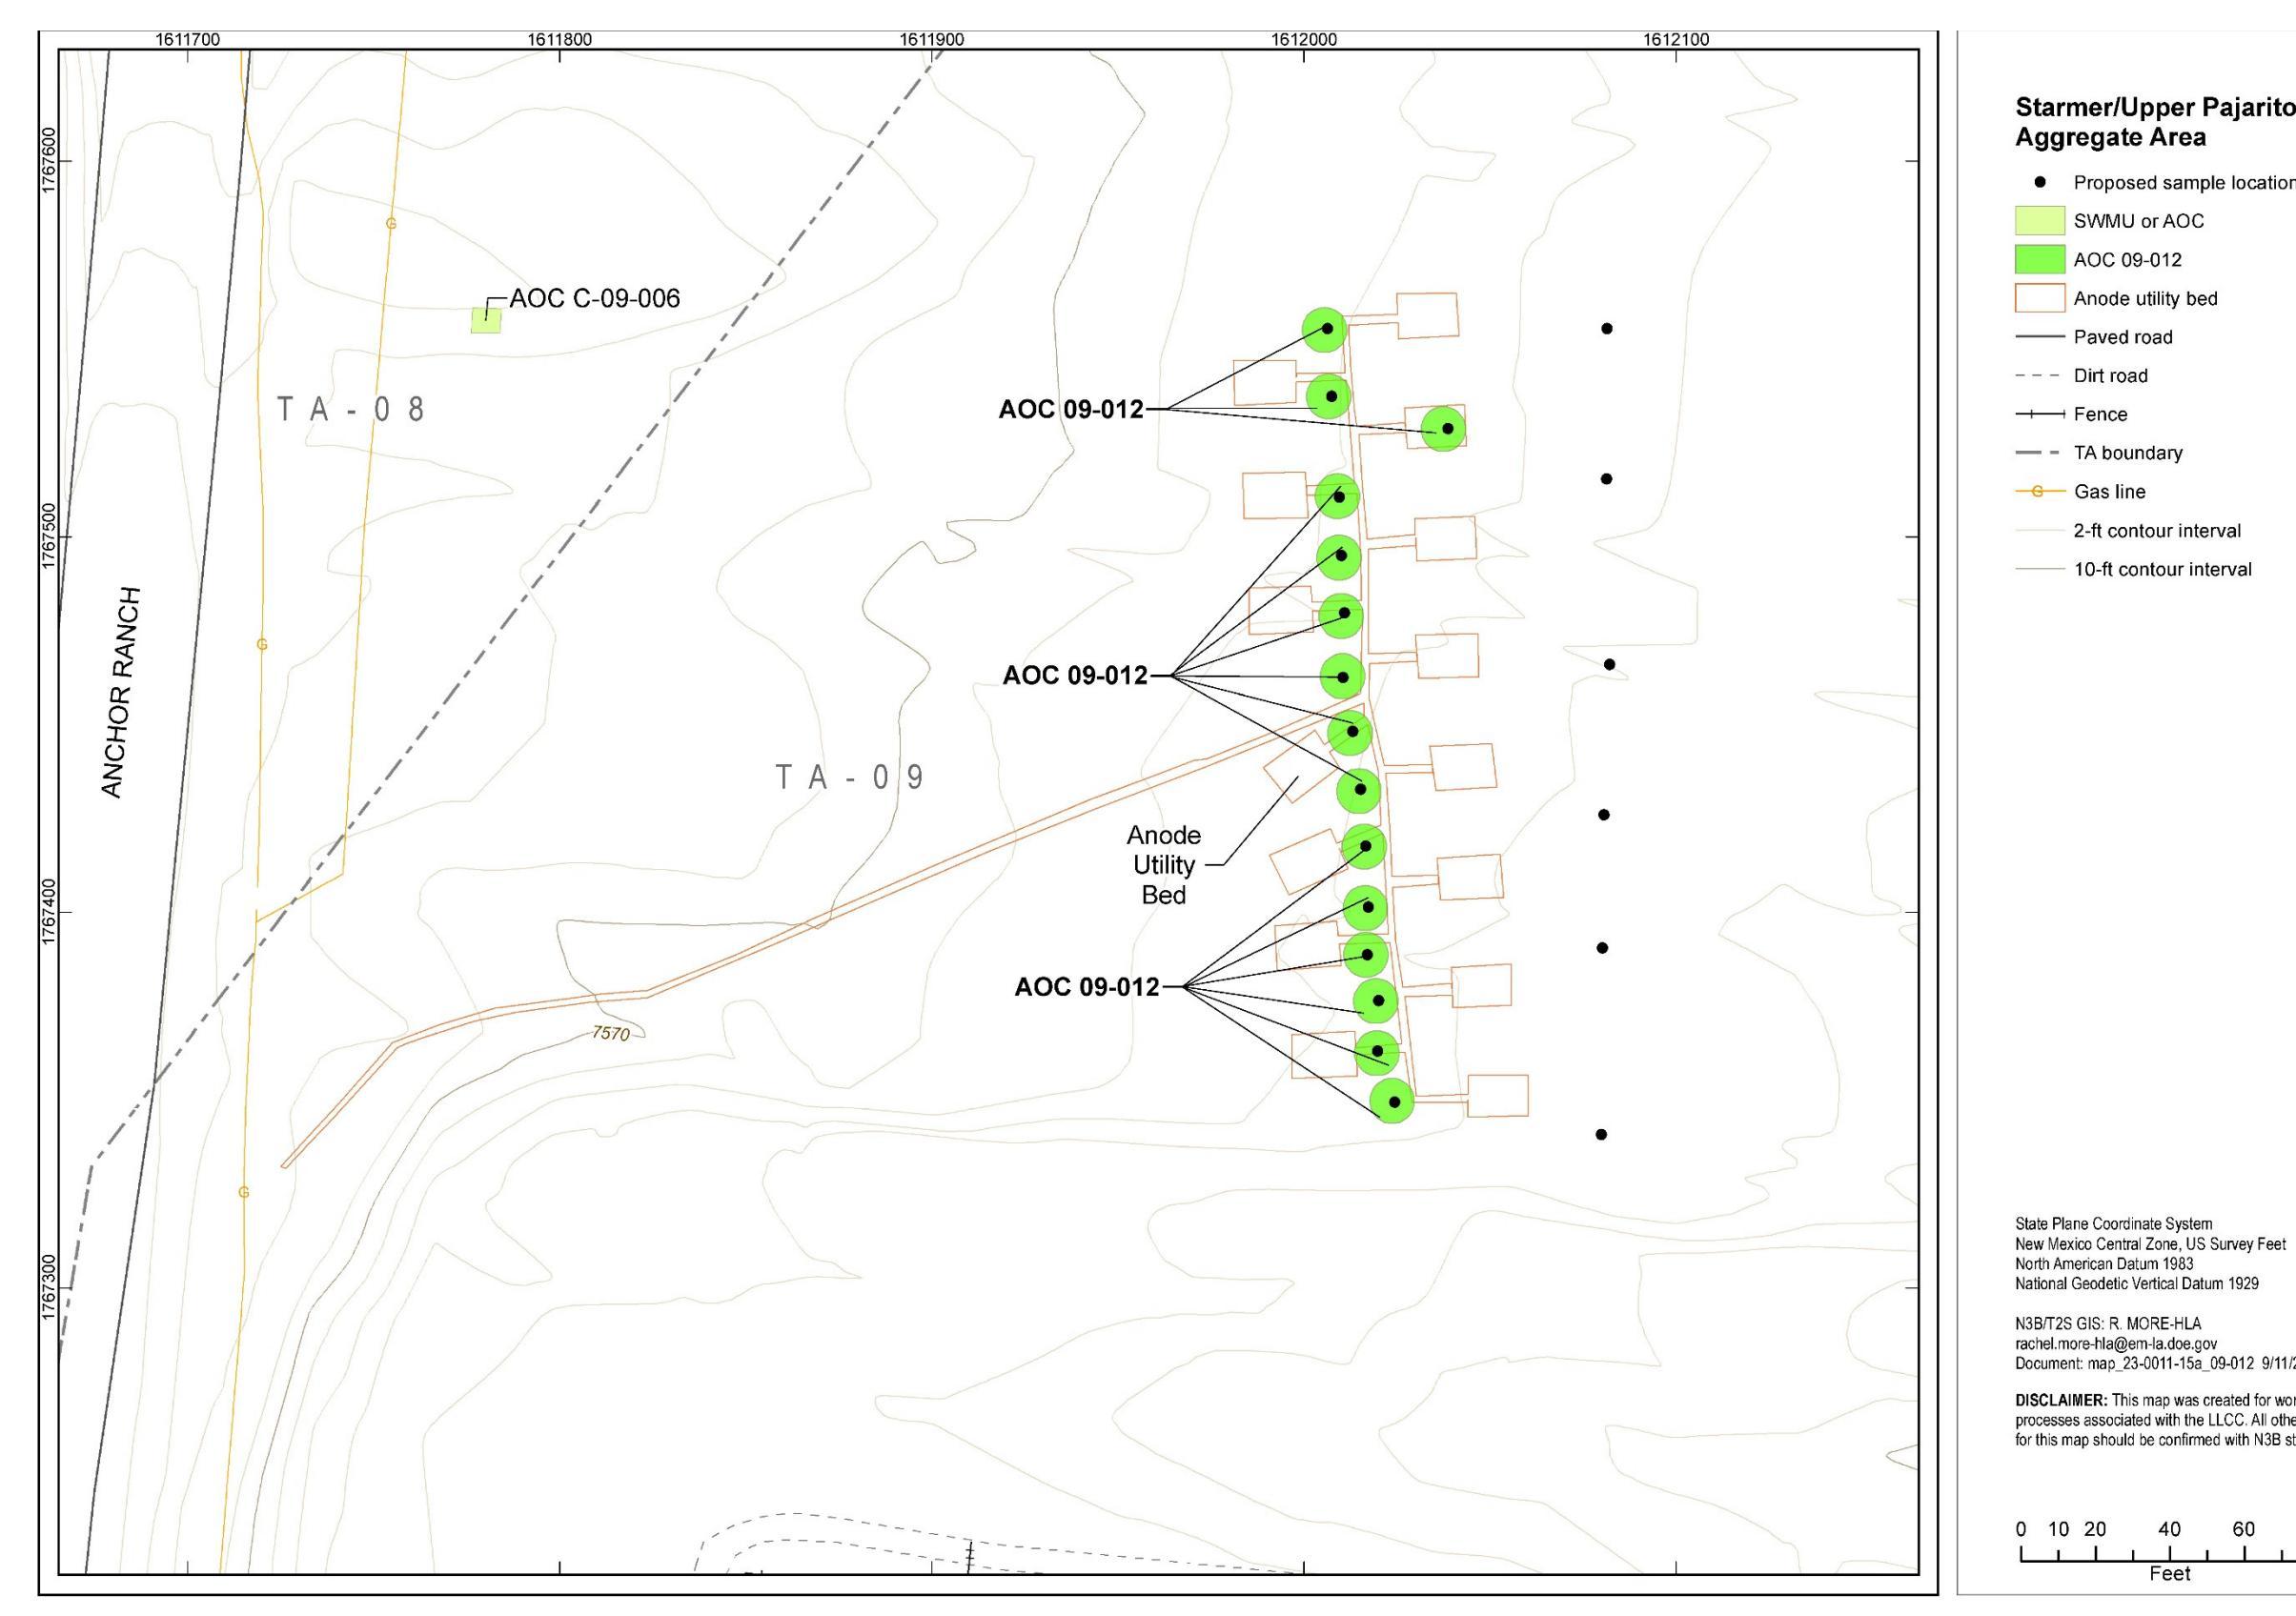
Figure 4.27-1 AOC 09-012, proposed sample locations, and anode bed utility layer showing spatial relationship

AOC 09-012 is described by the 1990 SWMU Report as a possible waste pit identified in Engineering File 1757 at TA-09 (LANL 1990, 007511). The SWMU Report further states that it is unknown whether the pit was located in the old TA-09 or the new TA-09, or even if the disposal area existed. It had not been found during previous field surveys. Based on this information, the RFI work plan for Operable Unit 1157 proposed the possible location of the AOC 09-012 disposal pit is an area where 15 circular, nonvegetated sites were identified within the Old Anchor East site (old TA-09) (LANL 1993, 020949). The circles begin 200 ft north of building 09-31 and continue north in a basically straight line. The circles are each approximately 6 ft in diameter and are spaced approximately 5 ft apart (LANL 1993, 020949).
