NPDES Individual Permit NM0030759
Storm Water Permitted Feature
E009: 2M-SMA-1.7

TYPE: REGULAR
GIS: Jeffrey Lyon
DATE: 08-May-2024
REVISION NUMBER: 13

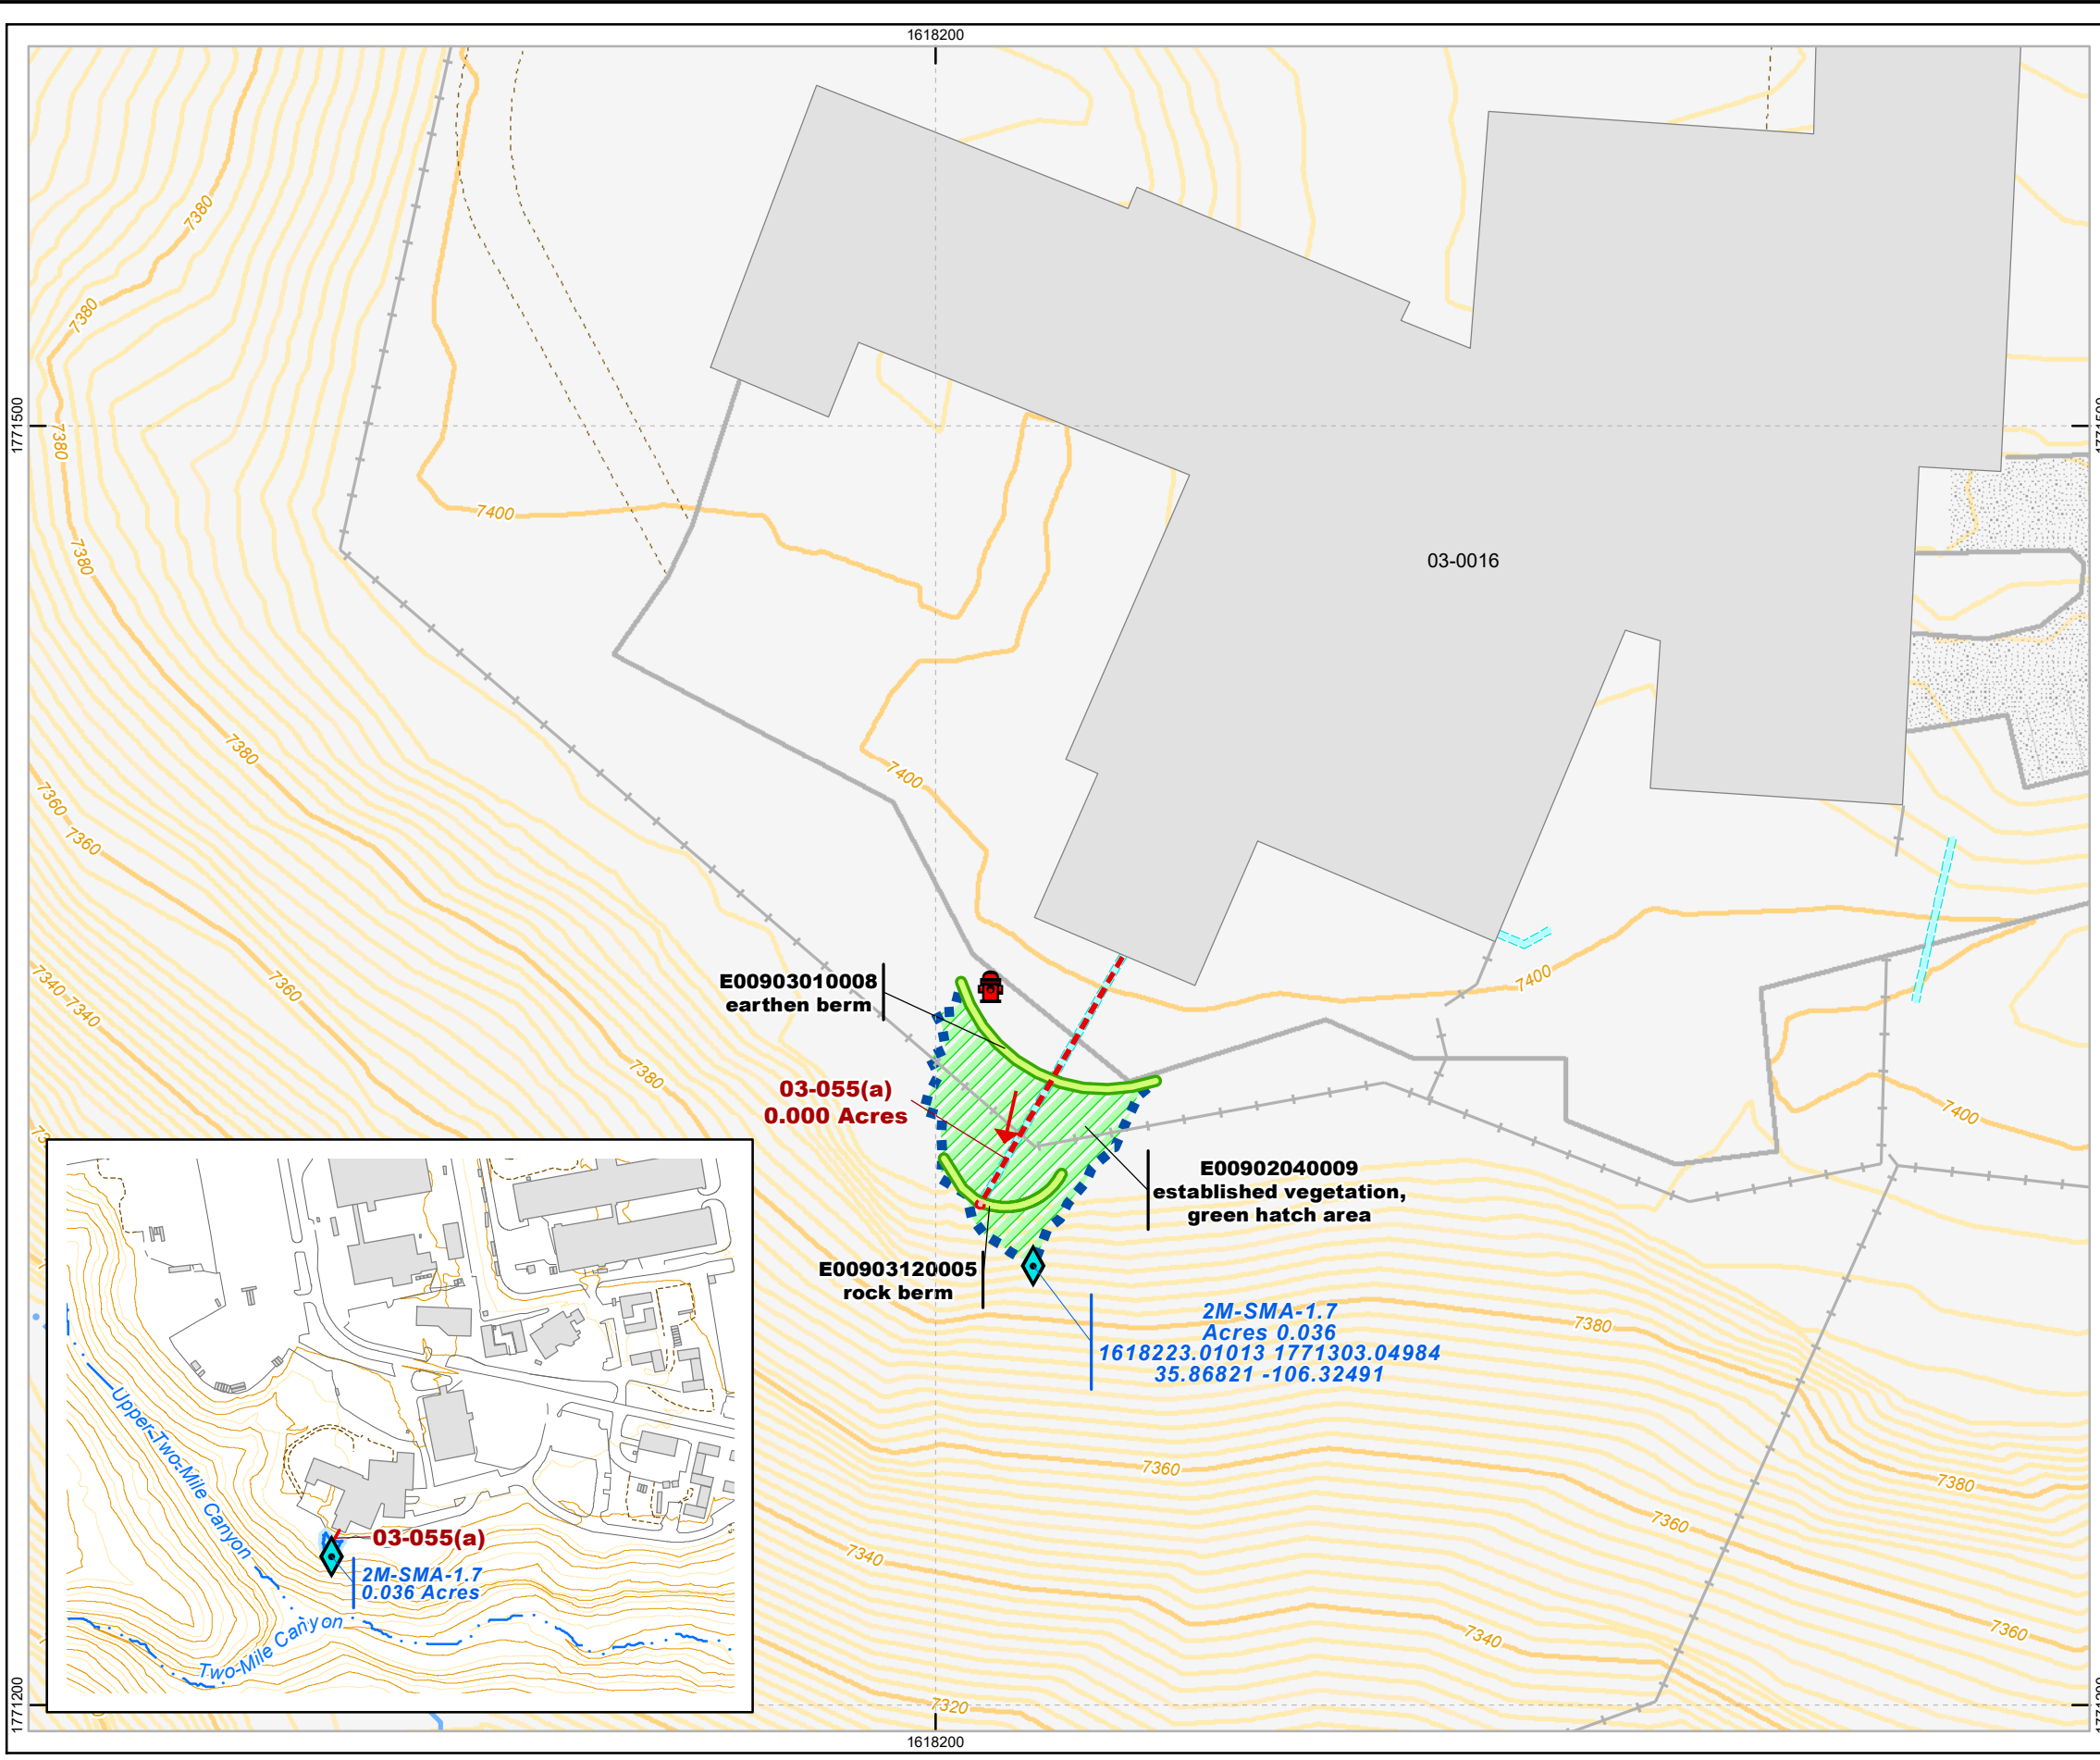
E00903010008
earthen berm

E00902040009
established vegetation,
green hatch area

E00903120005
rock berm

2M-SMA-1.7
Acres 0.036
1618223.01013 1771303.04984
35.86821 -106.32491
