NPDES Individual Permit NM0030759
Storm Water Permitted Feature
P004: P-SMA-0.3

MAP: P004-13-0006-193-P0.3
TYPE: REGULAR

GIS: Jeffrey Lyon
DATE: 26-January-2023
REVISION NUMBER: 19

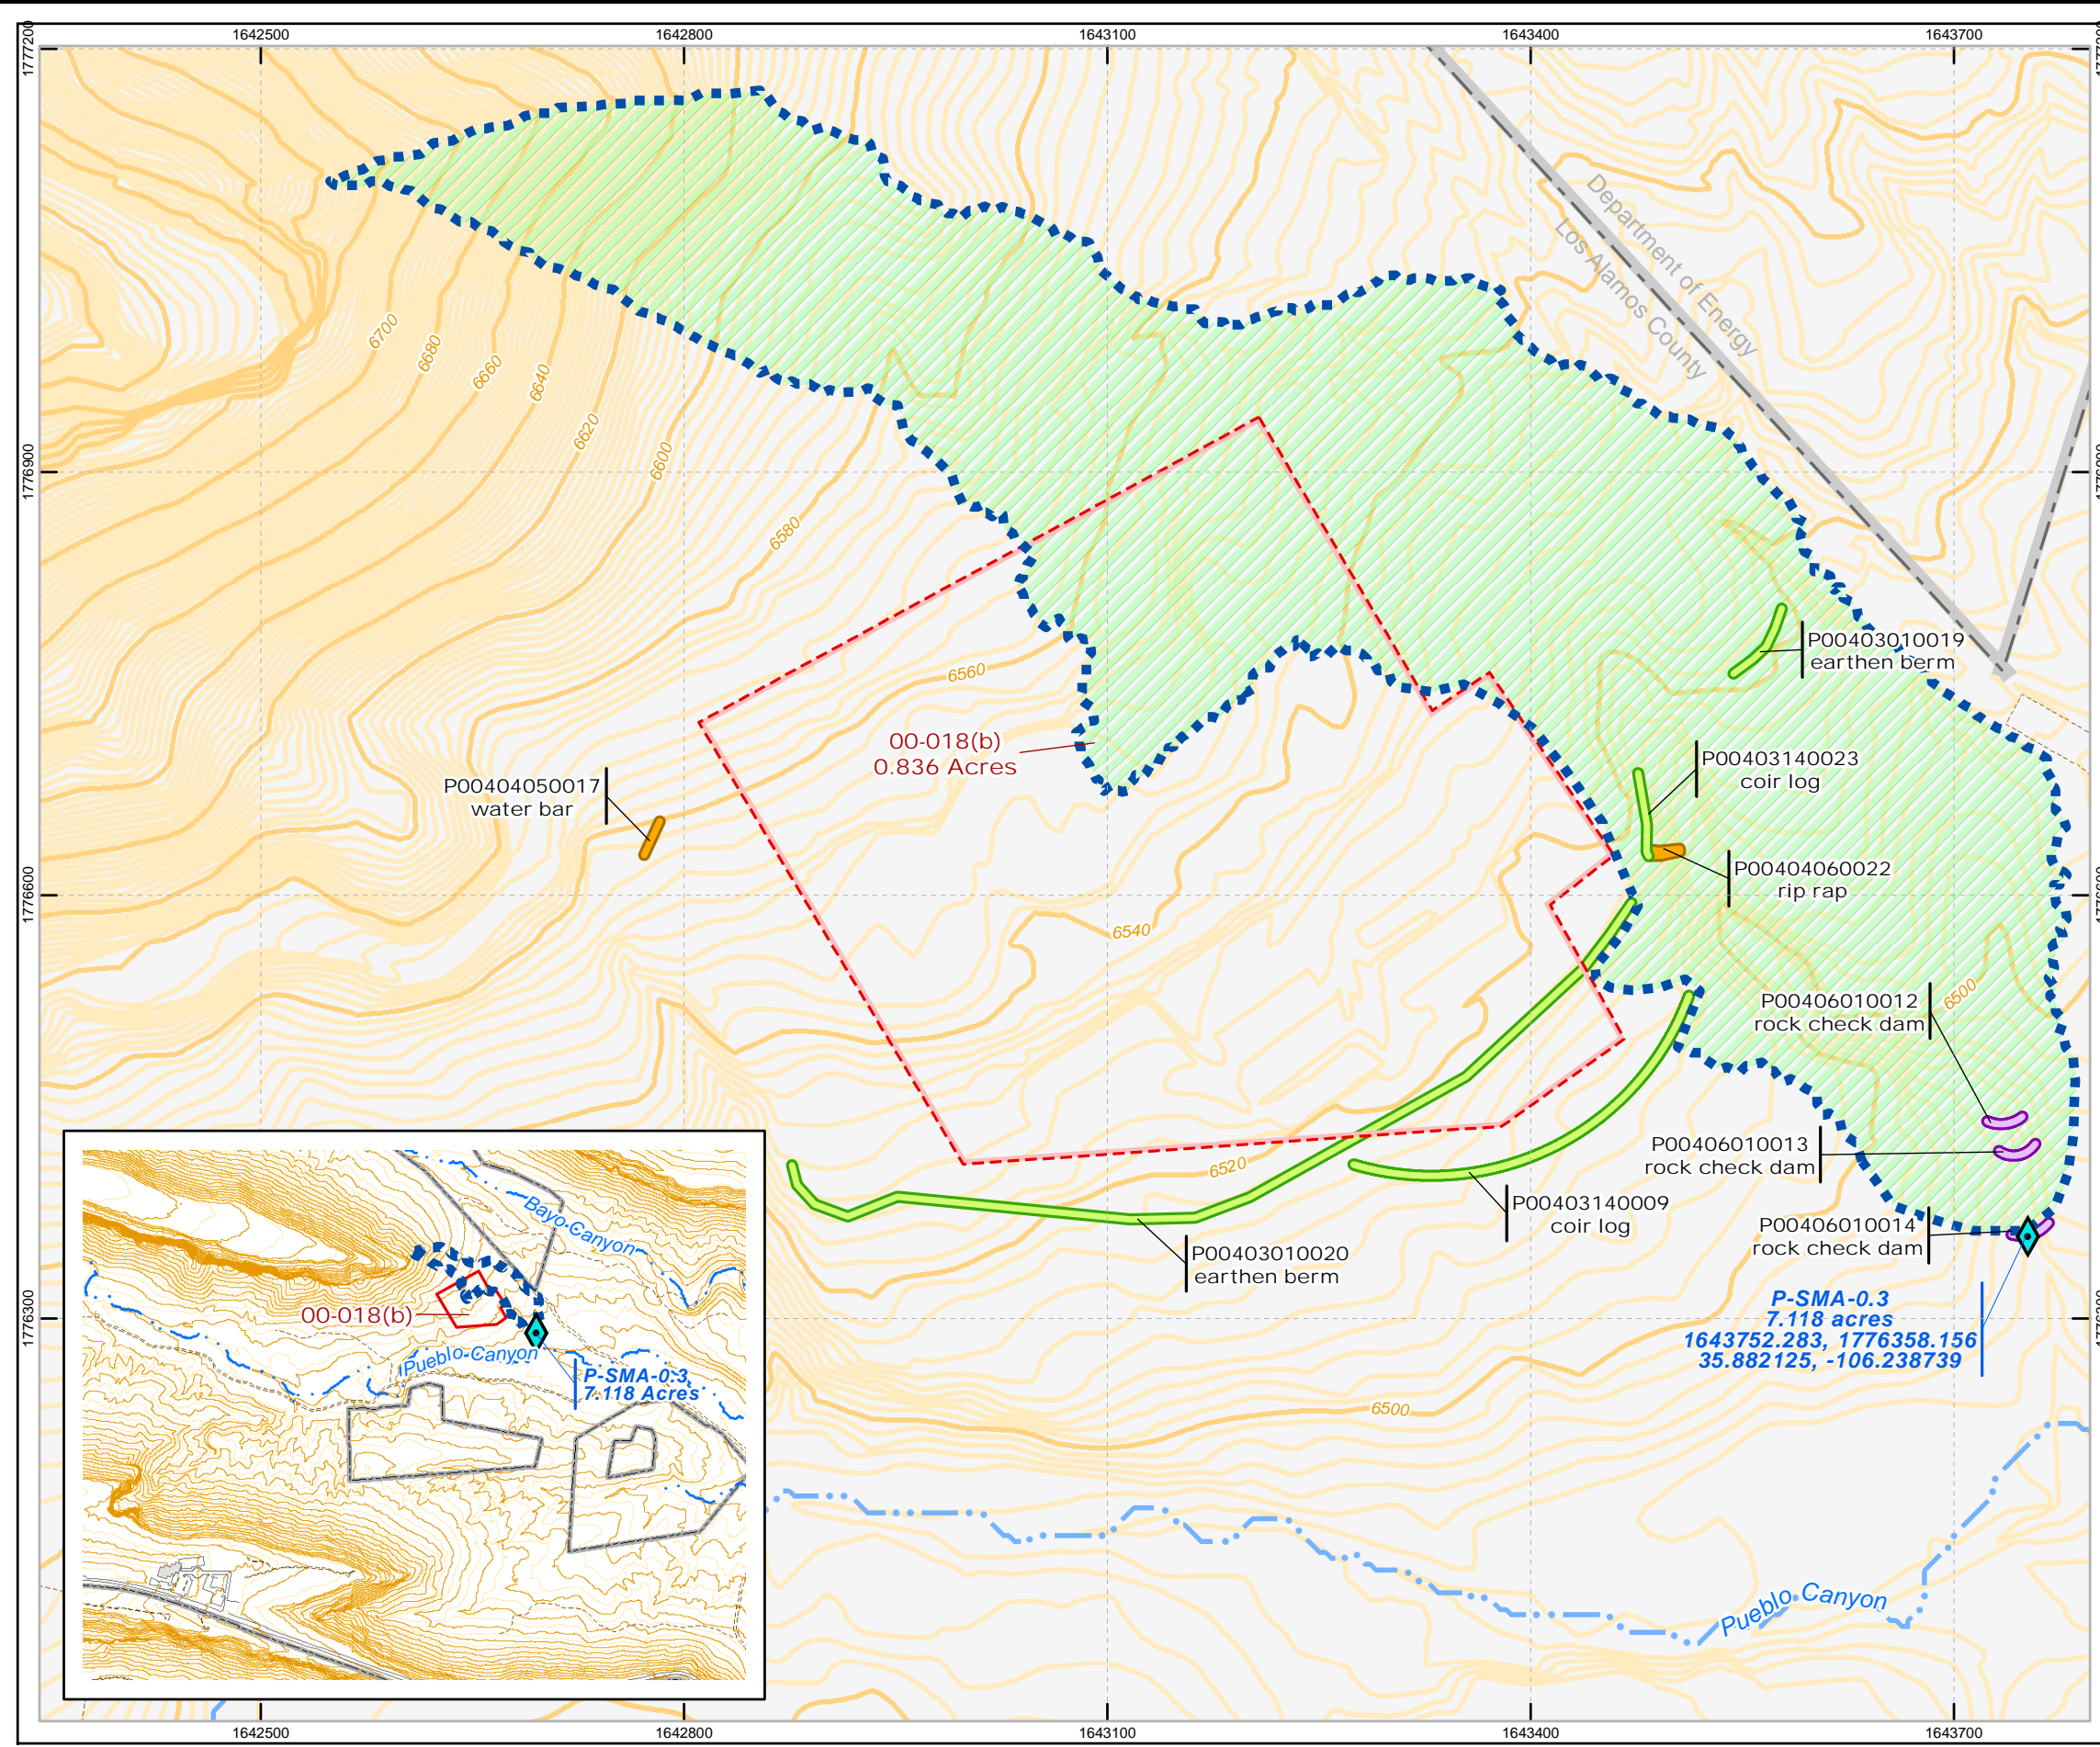
P-SMA-0.3
7.118 acres
1643752.283, 1776358.156
35.882125, -106.238739

00-018(b)
0.836 Acres

P00404050017
 water bar

P00403010019
 earthen berm

P00403140023
 coir log

P00404060022
 rip rap

P00406010012
 rock check dam

P00406010013
 rock check dam

P00406010014
 rock check dam

P00403010020
 earthen berm

P00403140009
 coir log
