NPDES Individual Permit NM0030759
Storm Water Permitted Feature
V006: CDV-SMA-2

MAP: V006-13-0006-177-CDV2
TYPE: REGULAR

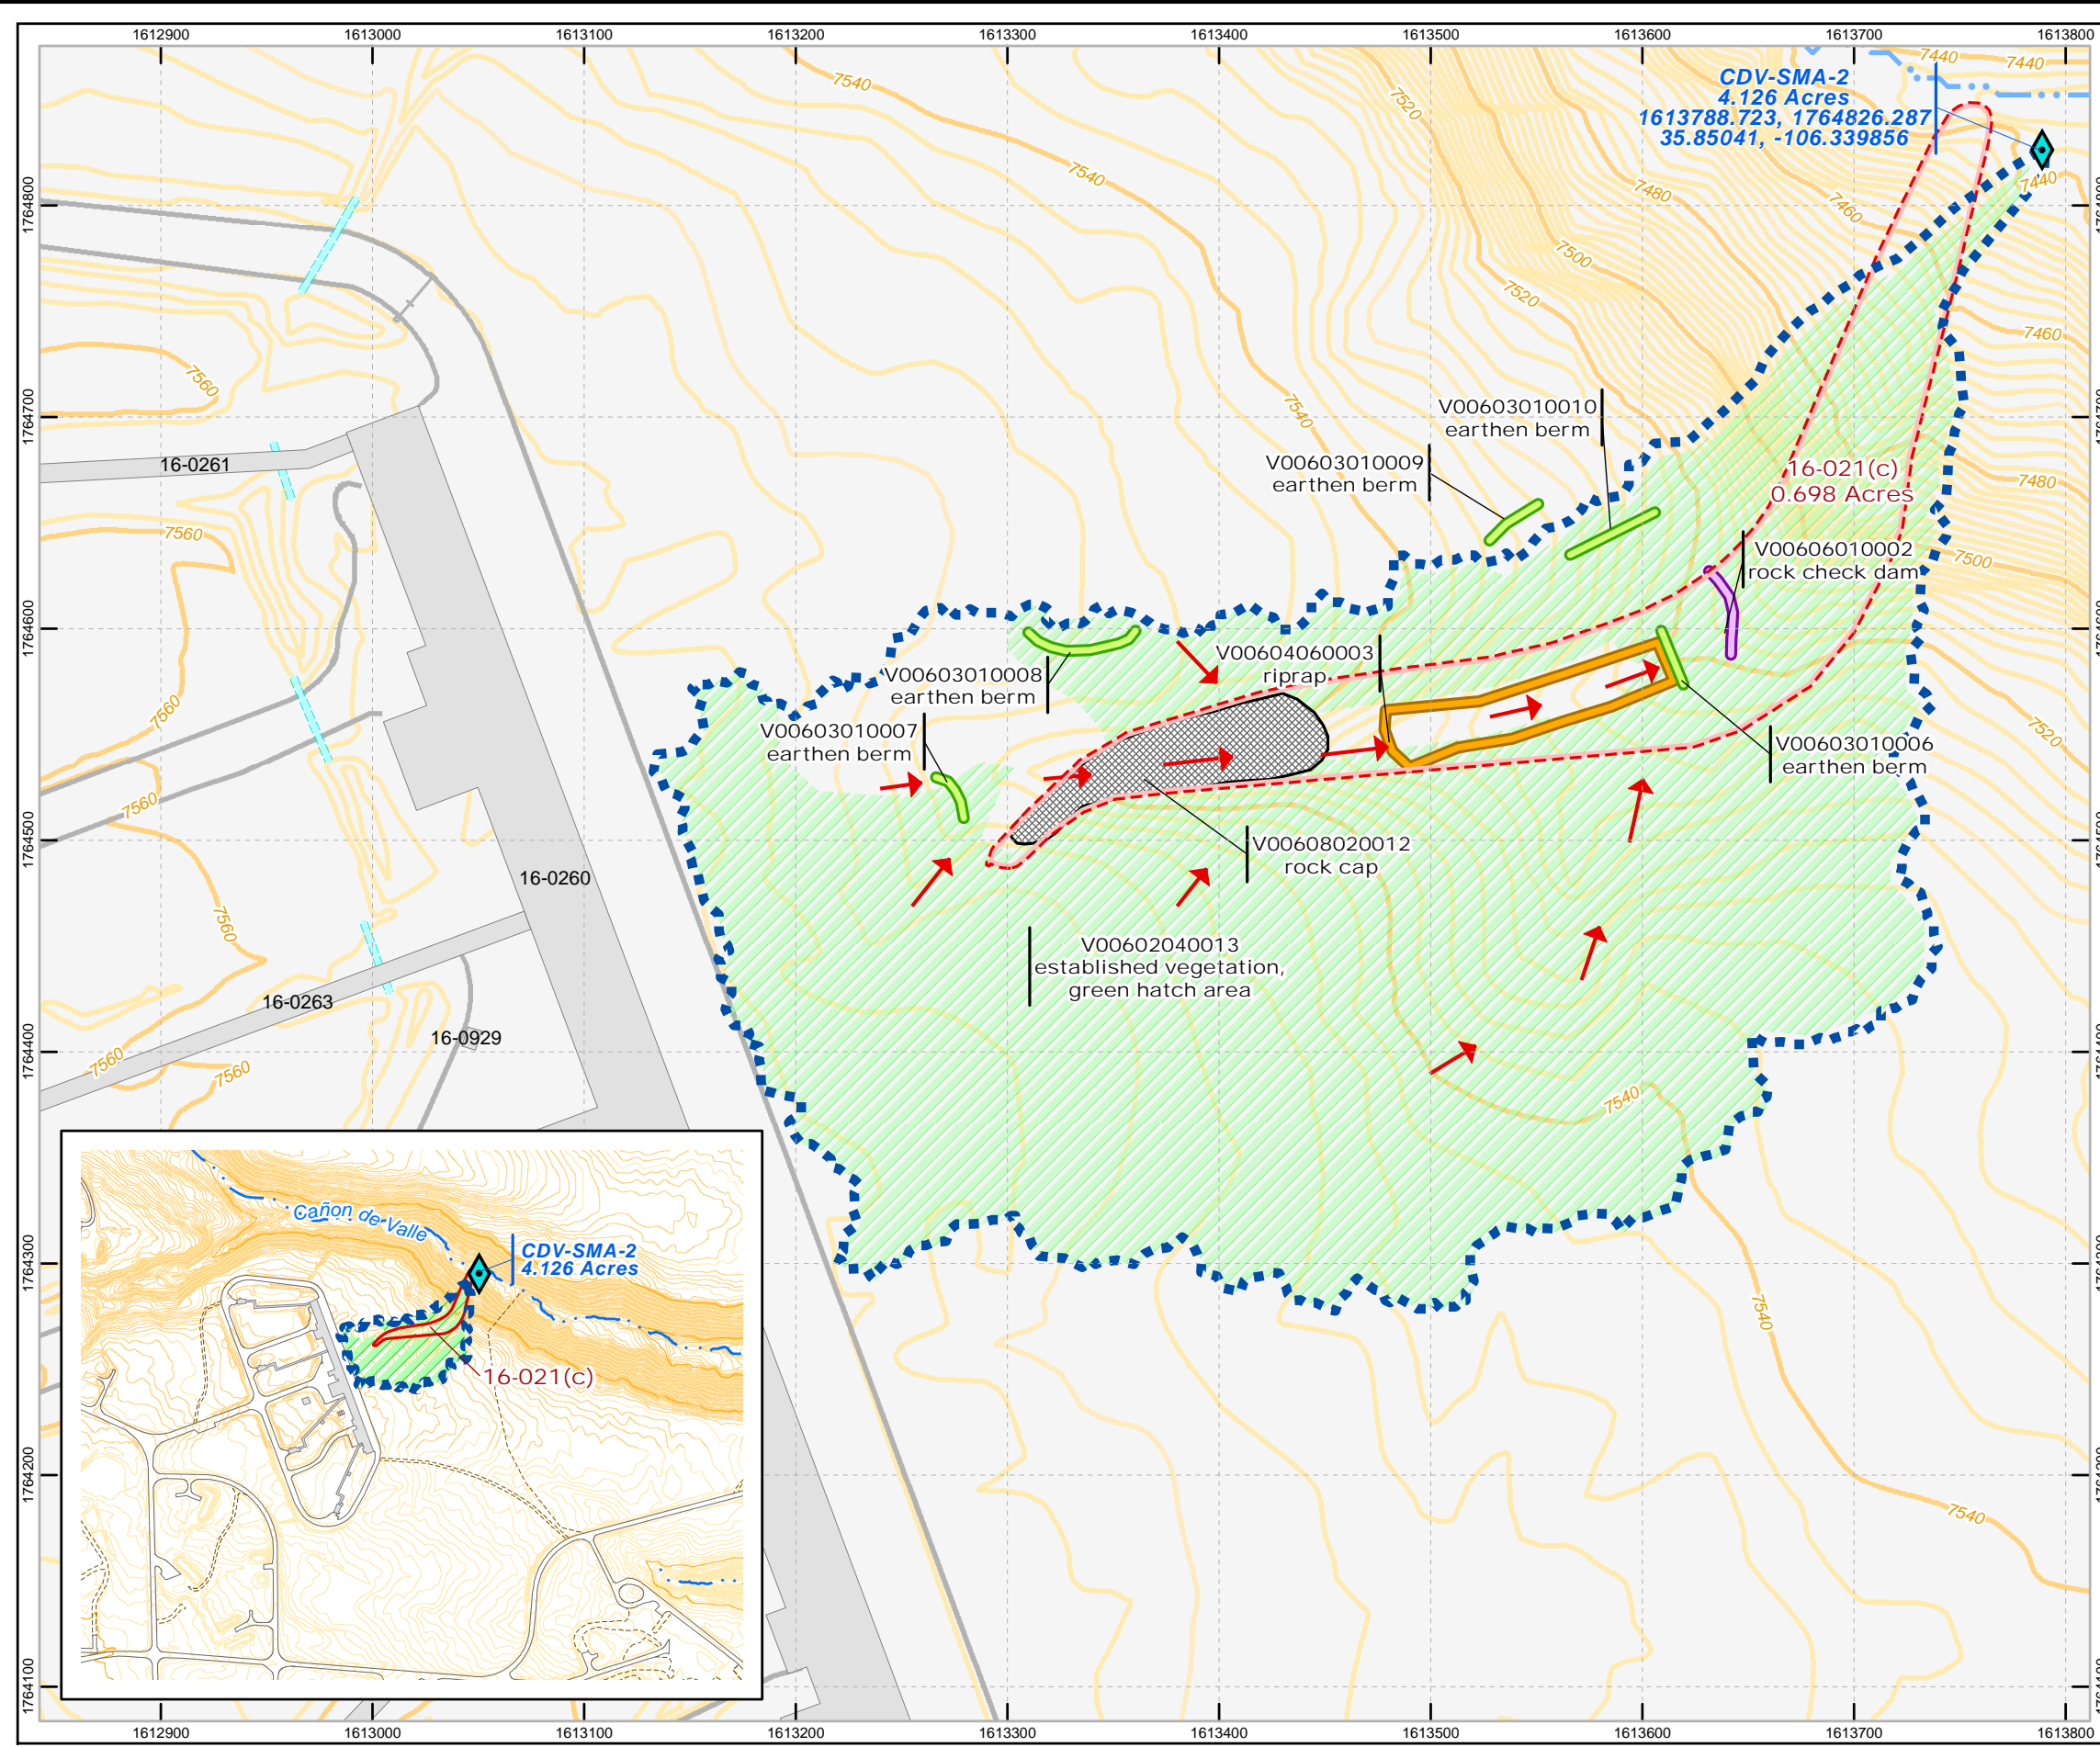
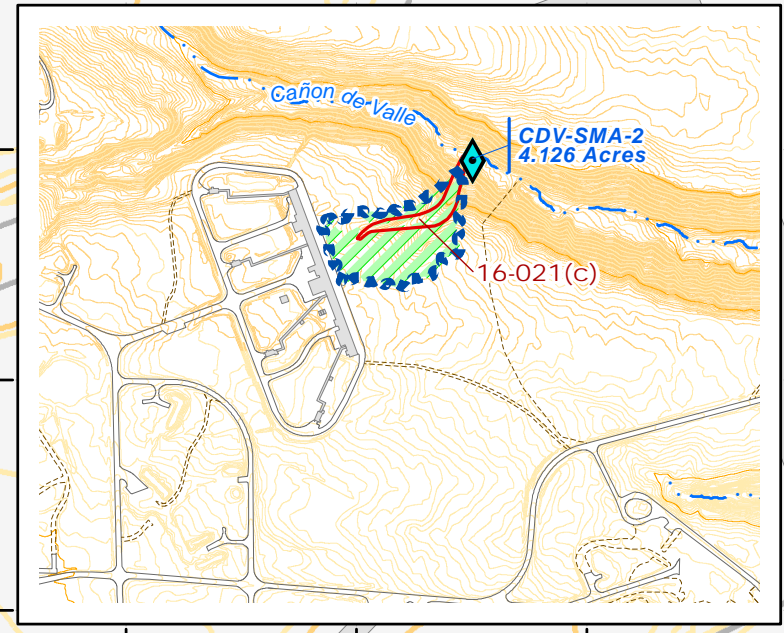
CDV-SMA-2
4.126 Acres
1613788.723, 1764826.287
35.85041, -106.339856

16-021(c)
0.698 Acres

V00603010007 earthen berm
 V00603010008 earthen berm
 V00603010009 earthen berm
 V00603010010 earthen berm

V00604060003 riprap

V00608020012 rock cap

V00602040013 established vegetation, green hatch area

V00606010002 rock check dam

V00603010006 earthen berm
