EMLA-2020-1602-02-001

Subject: Submittal of the Delta Prime Site Aggregate Area Progress Report

Delta Prime Site Aggregate Area Progress Report for Fiscal Year 2020

September 2020

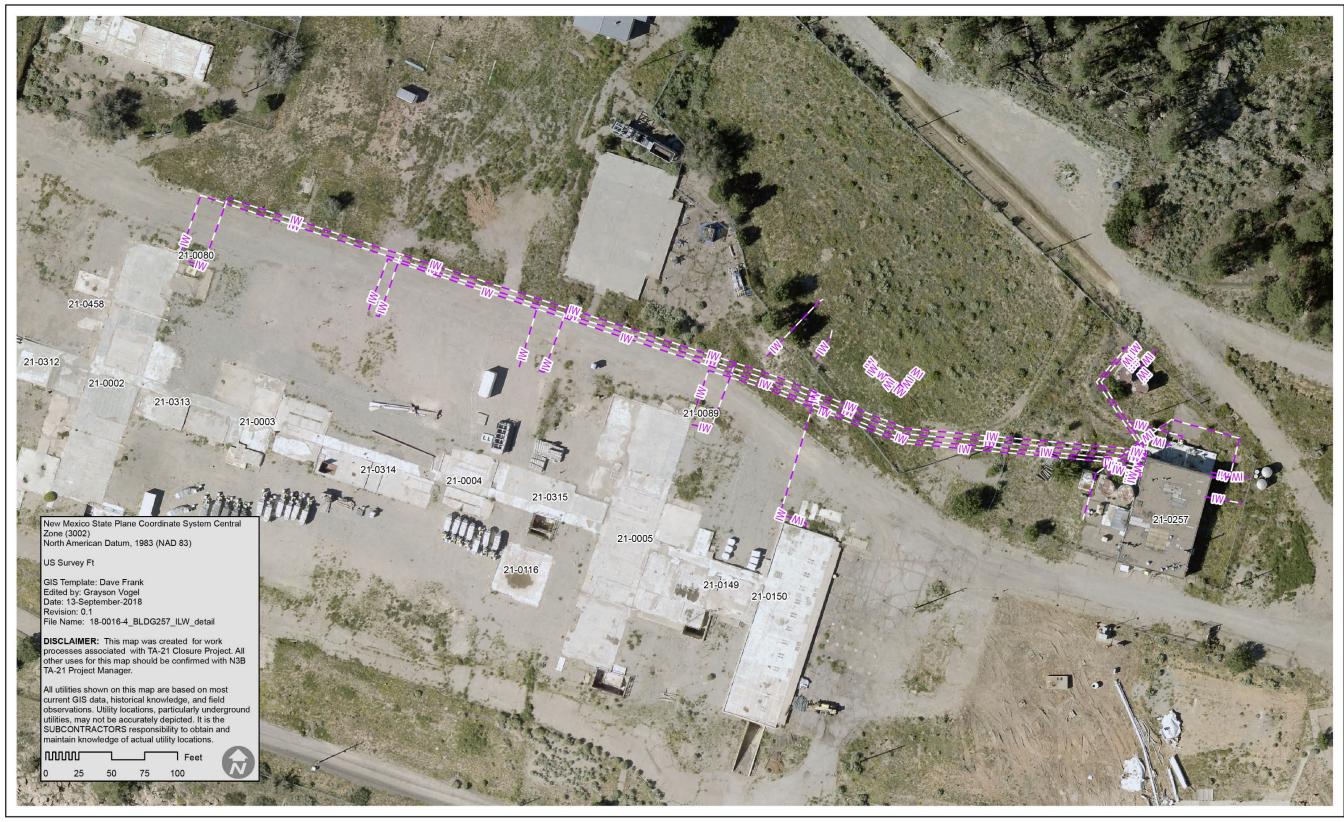
Figure 2.0-1 Aerial view of the DP Site Aggregate Area and IWLs

Note: The IWLs are shown as dashed lines.

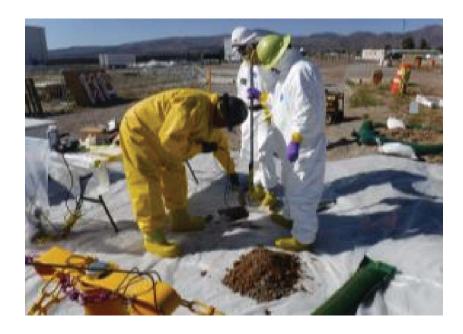
- Date: August 5, 2019
- Direction: Southwest
- Description: RCT performing field scan of overburden soil at OB1

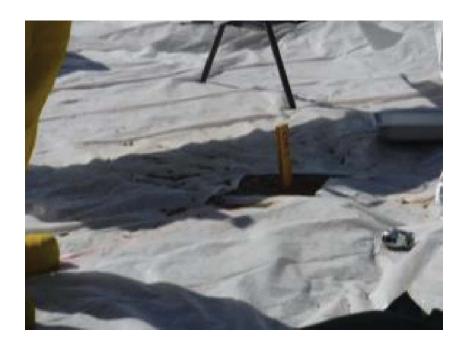
- Date: August 5, 2019
- Direction: n/a
- Description: OB1 backfilled and staked

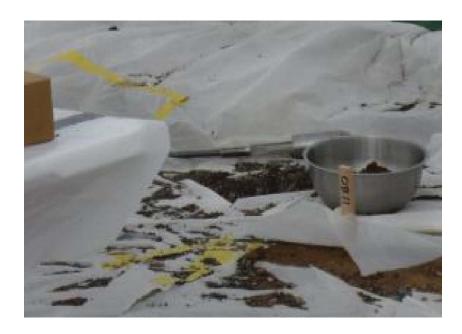
- Date: November 15, 2019
- Direction: n/a
- Description:
 OB11 backfilled
 and staked

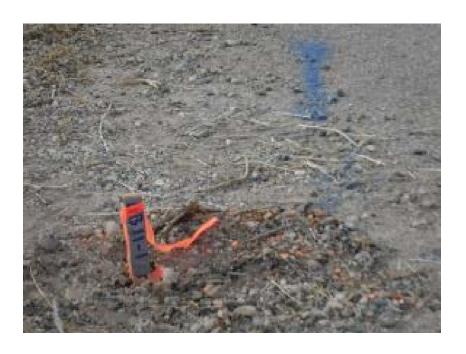
- Date: November 15, 2019
- Direction: West
- Description: OB

11-1 backfilled and staked. Utility
 markings for water line to the north.

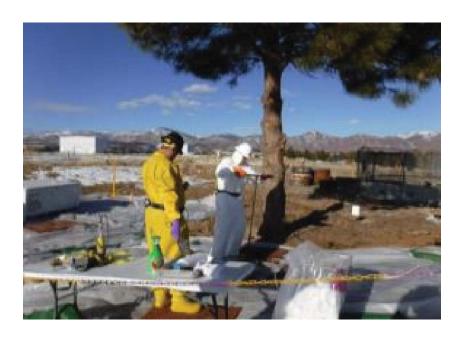
- Date: December 19, 2019
- Direction: Northwest
- Description: Using hand auger to sample OB21

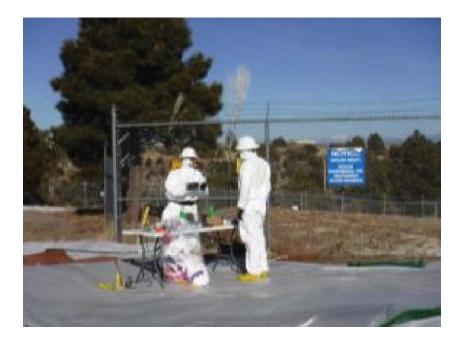
- Date: January, 14 2020
- Direction: North
- Description: Preparing full-suite samples at OB25

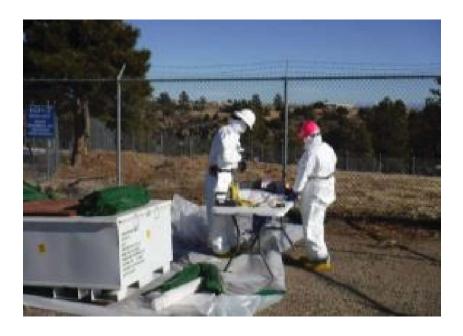
- Date: January 14, 2020
- Direction: North
- Description: Preparing full-suite samples at OB26

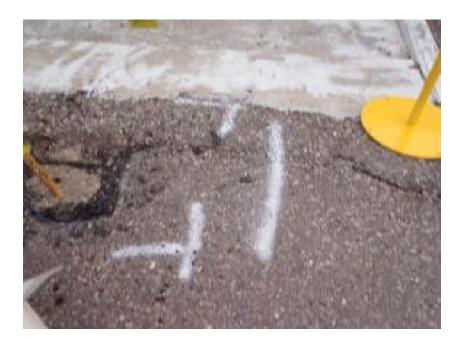
- Date: January 8, 2020
- Direction: n/a
- Description: OB27 backfilled and staked

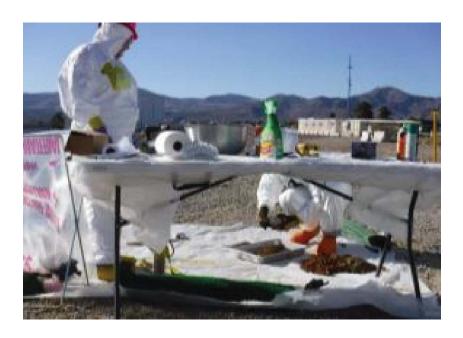
- Date: November 5, 2019
- Direction: West
- Description: Field crew overburden sampling at location OB36

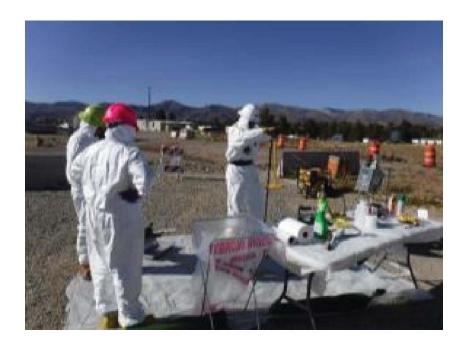
- Date: November 4, 2019
- Direction: West
- Description:

Overburden
 sampling at
 location OB37

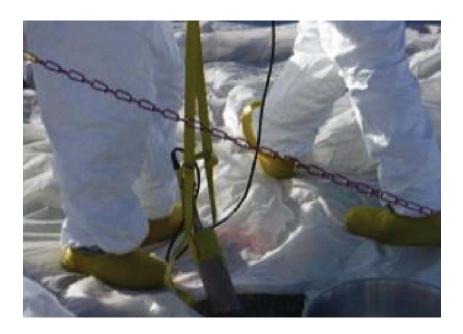
Description: Nal probe used to collect field measurements

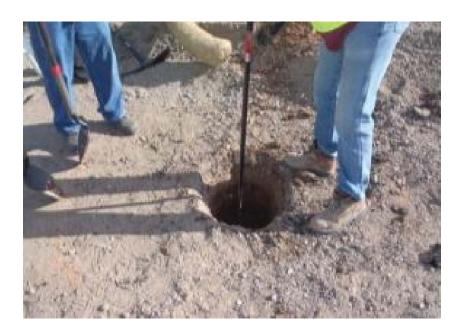
- Date: August 5, 2019
- Direction: North
- Description: Potholing performed on August 05, 2019

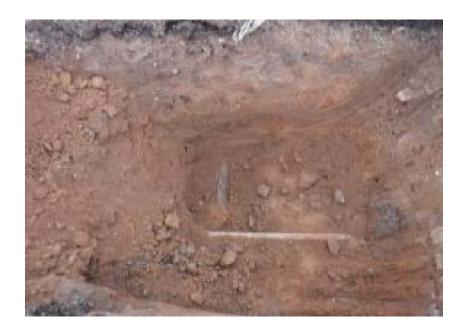
Location ID ^a	Size (in.)	Material	Origin	Approximate Depth (ft bgs)	Comment
1	1.5	Stainless steel	Building 21-02	3.5	NA ^b
	1.5	Unknown	Unknown	2.5	Suspected secondary electrical conduit
	4	Cast iron	Building 21-02	4.55	North/south section of common 4-in. IWL. Appeared plugged with cement.
2	1.5	Stainless steel	Building 21-02	5.1	NA

- Date: January 30, 2020
- Direction: Top of image is North
- Description: Location 1,4Cl and (1) 1.5SS

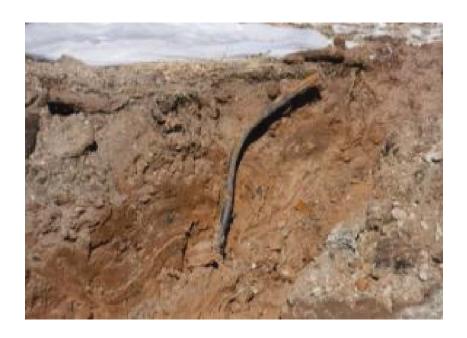
- Date: January 30, 2020
- Direction: Northwest
- Description: Location 1, 1.5SS Unknown removed by excavator

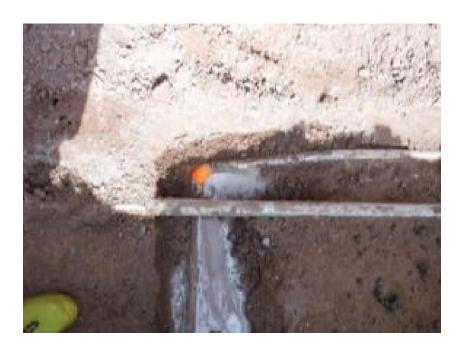
1.5	Stainless steel	Building 21-03	5.7	North/south section of IWL runs under 1.5-in. IWL from building 21-02 and elbows to the east.
3	1.5	Stainless steel	Building 21-02	5.65	NA

- Date: February 12, 2020
- Direction: Top of image is North
- Description: Location 2, (2)
 1.5SS, elbow of
 1.5SS from
 Building 3

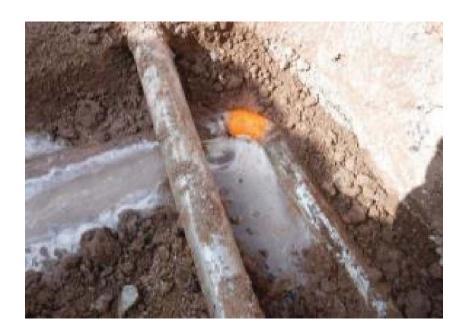
- Date: February 12, 2020
- Direction: Northwest
- Description: Location 2, Close-up view

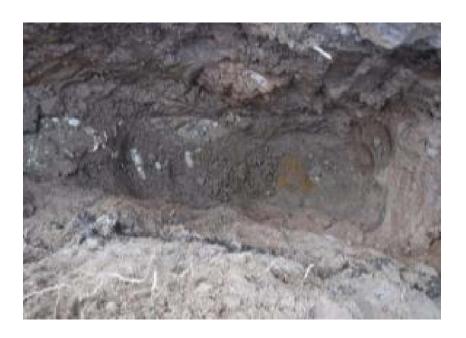
- Date: January 22, 2020
- Direction: Top of image is West
- Description: Location 6, 4CI, (3) 1.5SS

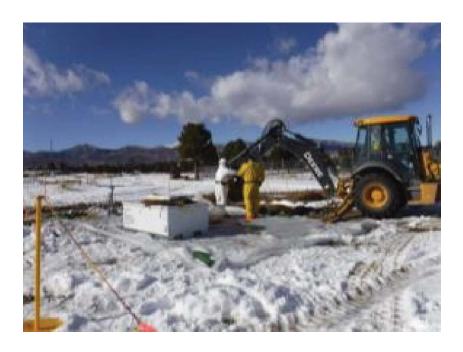
- Date: January 22, 2020
- Direction: Northwest
- Description: Scanning excavated soil for Radiological levels and VOCs at Location 6

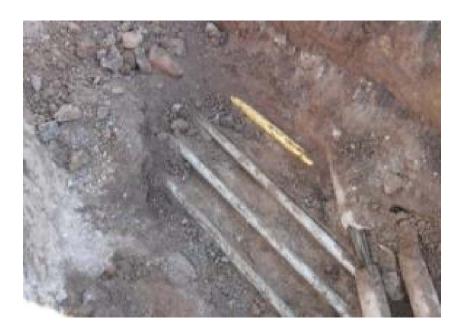
1.5	Stainless steel	Building 21-03	3.6	NA
	1.5	Stainless steel	Building 21-05	3.6	NA
	1.5	Stainless steel	Unknown	3.8	Coated in yellow PVC ^c
	4	Cast iron	Unknown	3.9	Common 4-in. IWL, north of three 1.5-in. IWLs
	4	Transite	Unknown	3.4	Electrical conduit was found inside of 4-in. transite.
	4	Transite	Unknown	3.4	Electrical conduit was found inside of 4-in. transite.
7	4	Cast iron	Unknown	3.1	Common 4-in. IWL, north of three 1.5-in. IWLs

- Date: January 30, 2020
- Direction: Southeast
- Description: Location 6, 4CI, (3) 1.5SS, 1.5SS Unknown yellow, (2) 4transite

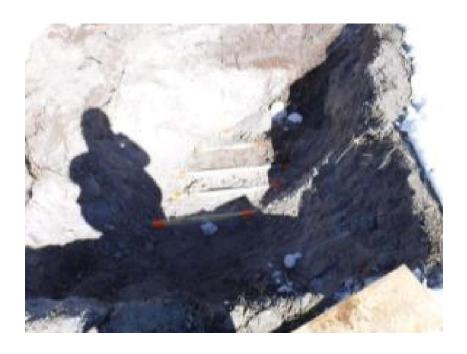
- Date: January 24, 2020
- Direction: North
- Description: Location 7,4Cl, (3) 1.5SS, 1.5SS Unknown yellow

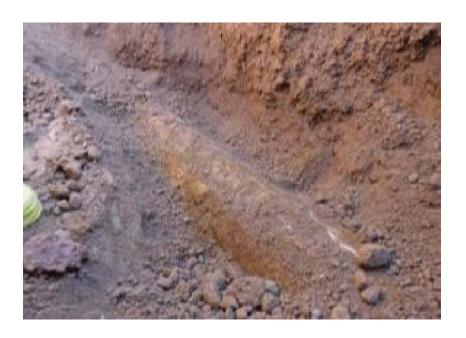
- Date: February 24, 2020
- Direction: Southeast
- Description: Location 8,6Cl

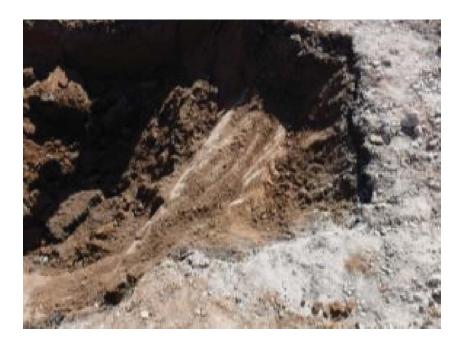
- Date: February 24, 2020
- Direction: Top of image is South
- Description: Location 8, Storm Drain

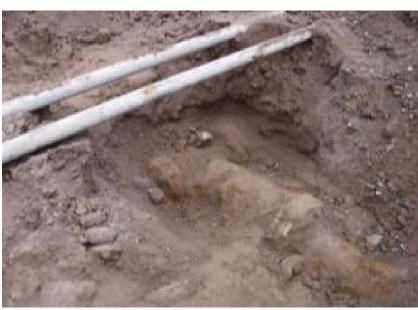
- Date: February 26, 2020
- Direction: Northeast
- Description: Location 10, (2) 1.5SS, 4Cl from Building 4

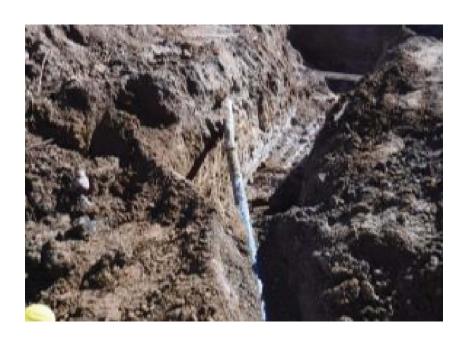
- Date: February 26,2020
- Direction: South
- Description: Location 10, Unknown 2SS

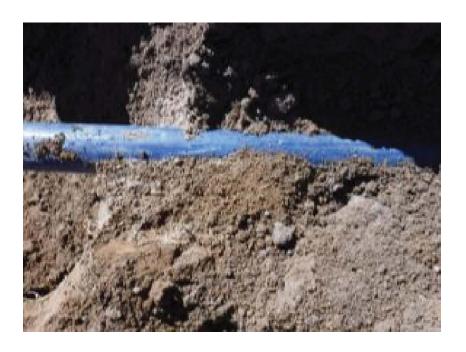
- Date: February 26, 2020
- Direction: Top view
- Description: Location 10, close-up view of Unknown 2SS

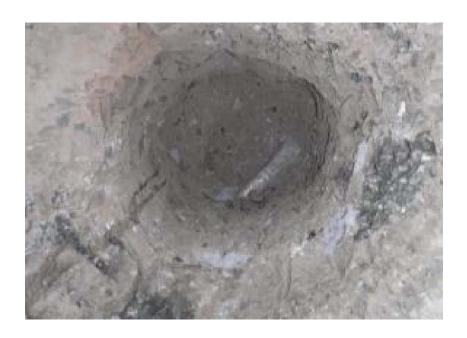
- Date: March 5, 2020
- Direction: top of image is Northwest
- Description: Location 11, 1.5SS from Building 5

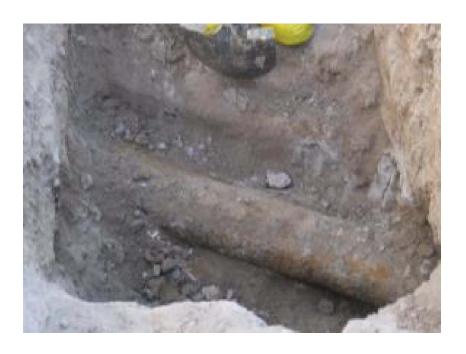
- Date: March 5, 2020
- Direction: West
- Description: Location 34,4Cl from Building 5

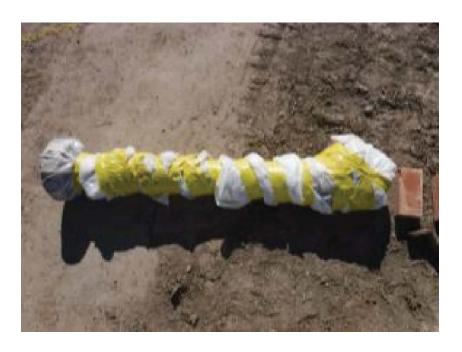
- Date: March 11, 2020
- Direction: n/a
- Description: Location 48, Standpipe removed during mechanical potholing

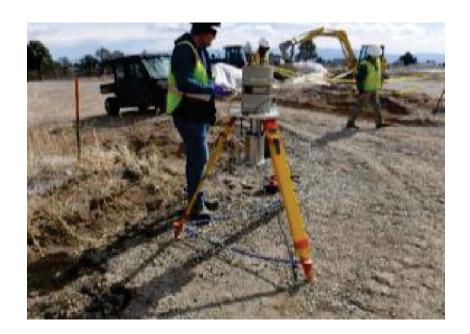
Description: Background of instrument being measured

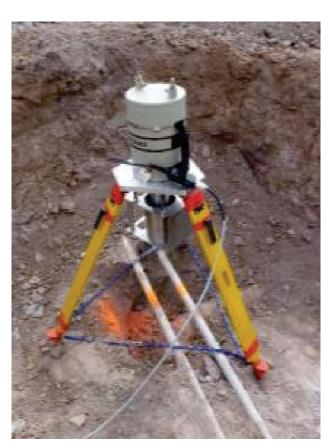
Description: Location 10, (2)
 1.5SS from Building 2 and 3

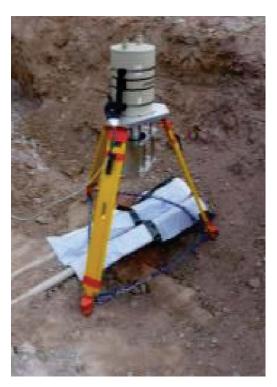
Description: Location 10,4Cl "T" from Building 4

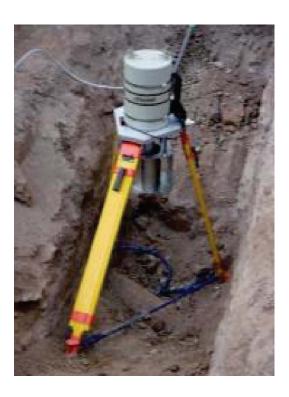
Description: Location 34,4Cl from Building 5

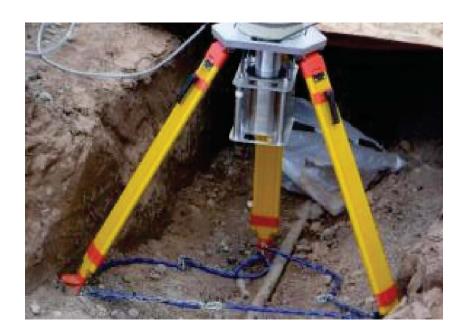
Description: Location 11, 1.5SS from Building 5

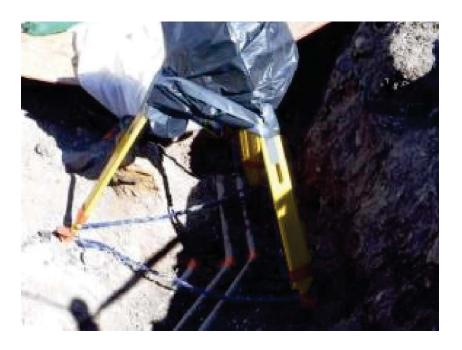
Description: Location 6, (3)
 1.5SS from Buildings 2,3, and 5 at bend

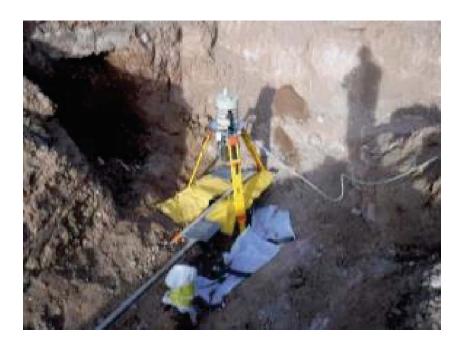
Description: Location 48,4CI

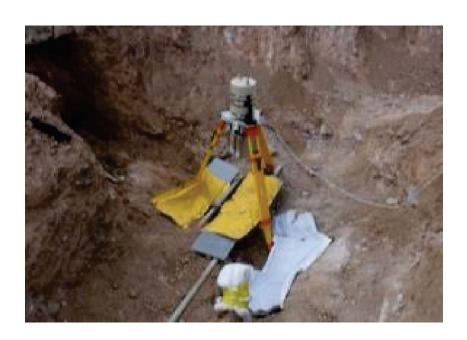
Description: Location 48, 1.5SS from Building 3

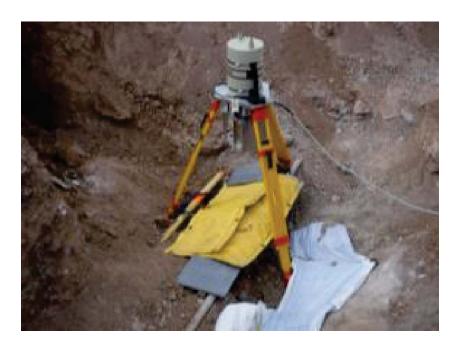
Description: Location 48, 1.5SS from Building 2

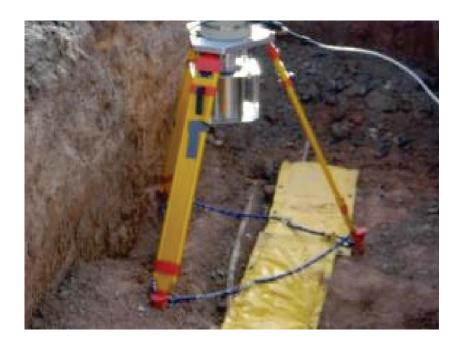
Description: Location 48, 1.5SS Unk Yellow

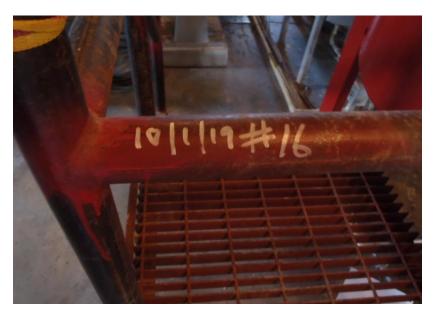
Red paint located on a handrail at XRF location #16, and coupon sample ID WST21-20-188178.

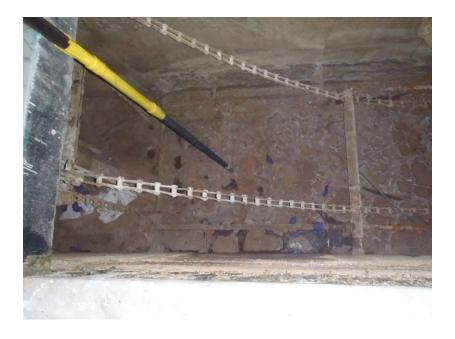
Settling tank, minimum aliquot location sample ID WST21-20-188235

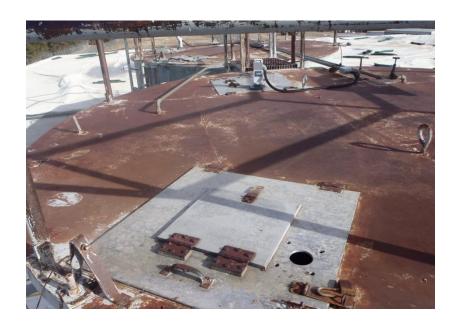
Tops of tanks 21-110 and 21-111, building 21-257 roof in background

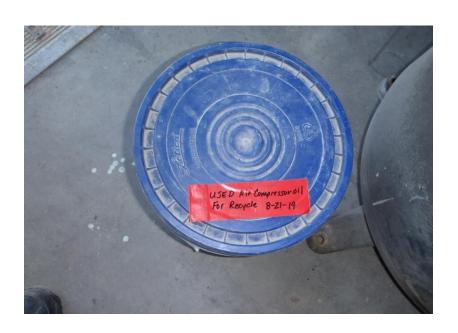
Oil from air compressors staged for final packaging for recycling

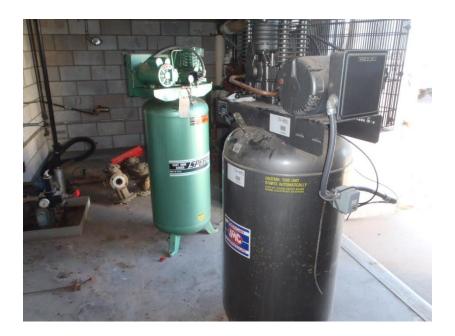
Two air compressors disconnected and ready for pickup by N3B for re-use

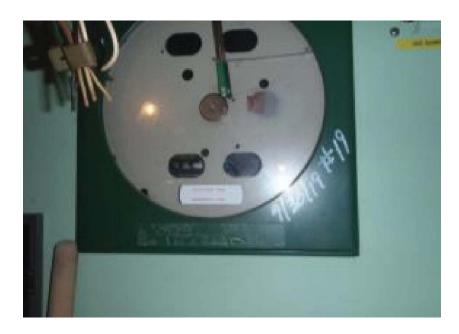
Description: #19

Dark green paint on a Honeywell south metal graph door cover XRF location #19 and coupon sample ID WST21-20-188178. This location failed for TCLP lead in the dark green paint. Packaged as mixed waste.
