Subject:Submittal of the 2022–2023 Annual Long-Term Monitoring Status Report (July 2022
through June 2023) for the Los Alamos County Airport Landfill Cover System
Replacement, Solid Waste Management Units 73-001(a,d) in Technical Area 73

July 2023 EM2023-0423

2022–2023 Annual Long-Term Monitoring Status Report (July 2022 through June 2023) for the Los Alamos County Airport Landfill Cover System Replacement, Solid Waste Management Units 73-001(a,d) in Technical Area 73

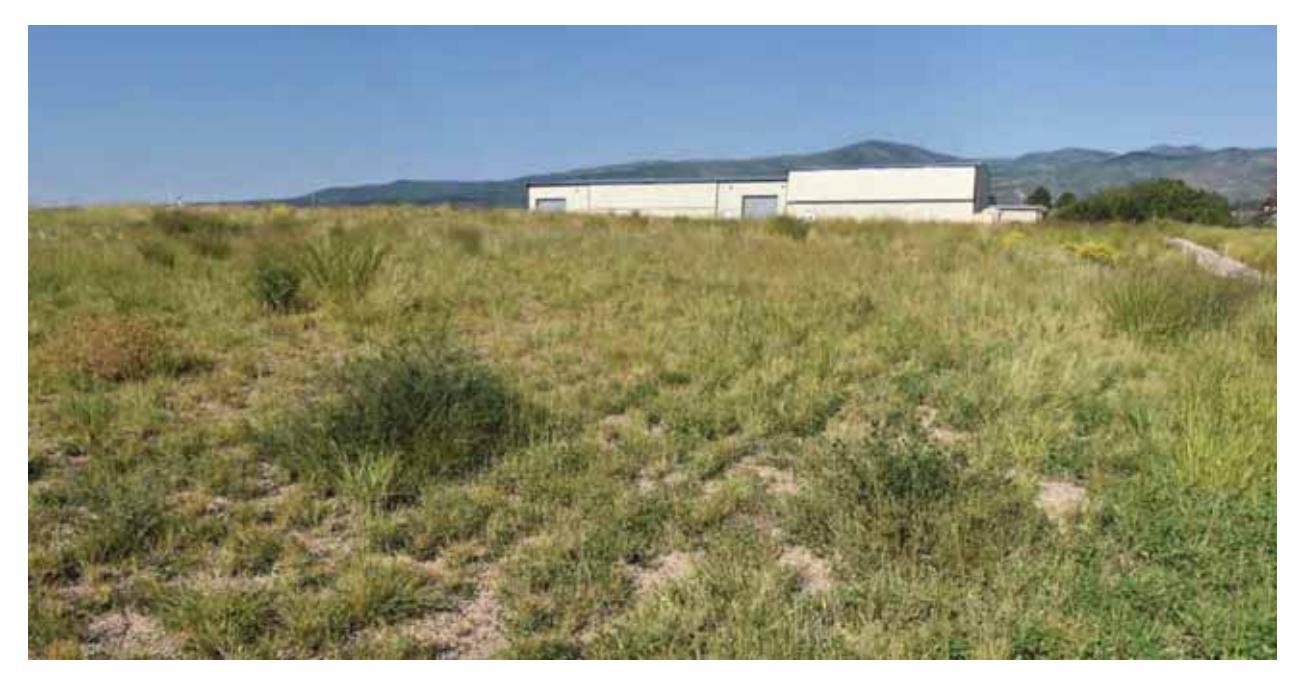
Vegetation Condition	Pamarka	
General Condition progressing as expected: ☑ Yes □ No If no, explain: Repairs necessary: □ Yes ⊠ No If yes, explain:	Vegetation has full coverage on the cover system. The vegetation is predominantly native grasses, alfalfa, and clover. The summer monsoon season has been very active; the vegetation has recovered from the dry spring conditions and is thriving (Photos 3 to 6).	
	The side slope of the older prescriptive cover appears to be well established and is dominated by grasses mixed with forbs. This area is not mowed because of the steepness of the slope. (Photo 7).	
	The vegetation on the Debris Disposal Area (DDA) is active and has good coverage following the summer rains (Photos 8 and 9).

Photo 3 Vegetation on the north-western section of the ET cover, looking west

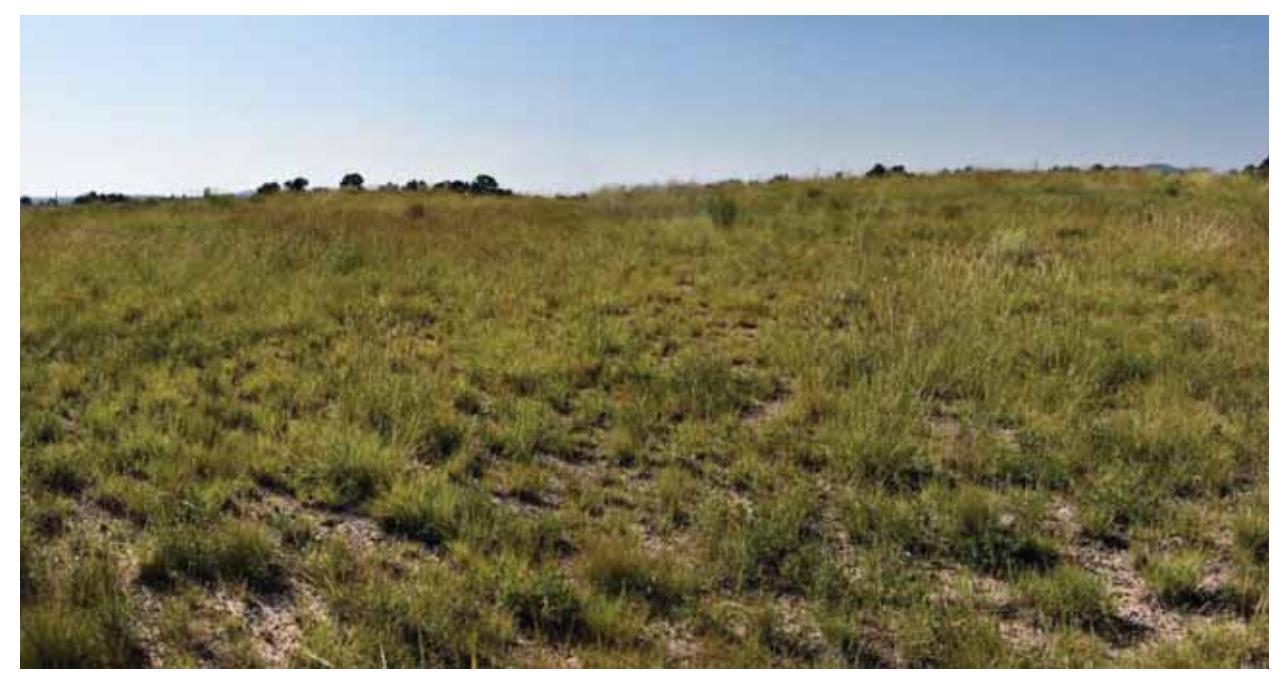
Photo 4 Vegetation on the central section of the ET cover, looking south

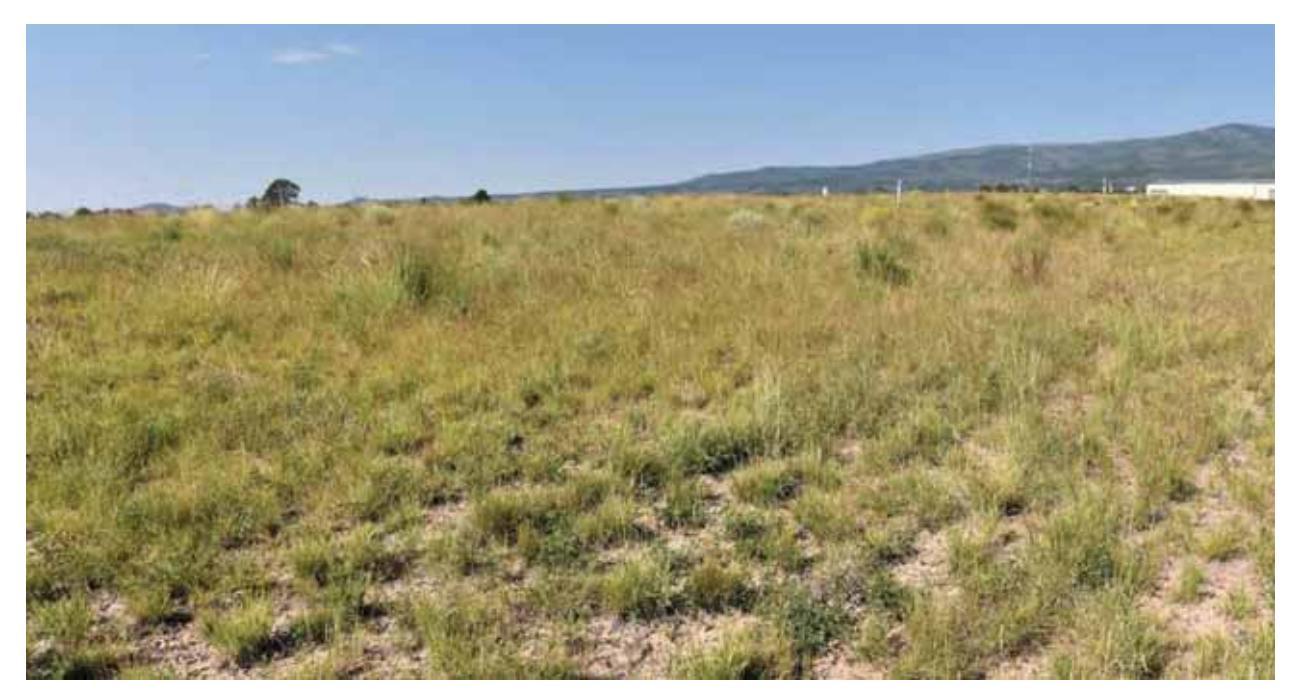
Photo 5 Vegetation on the north-central section of the ET cover, looking west

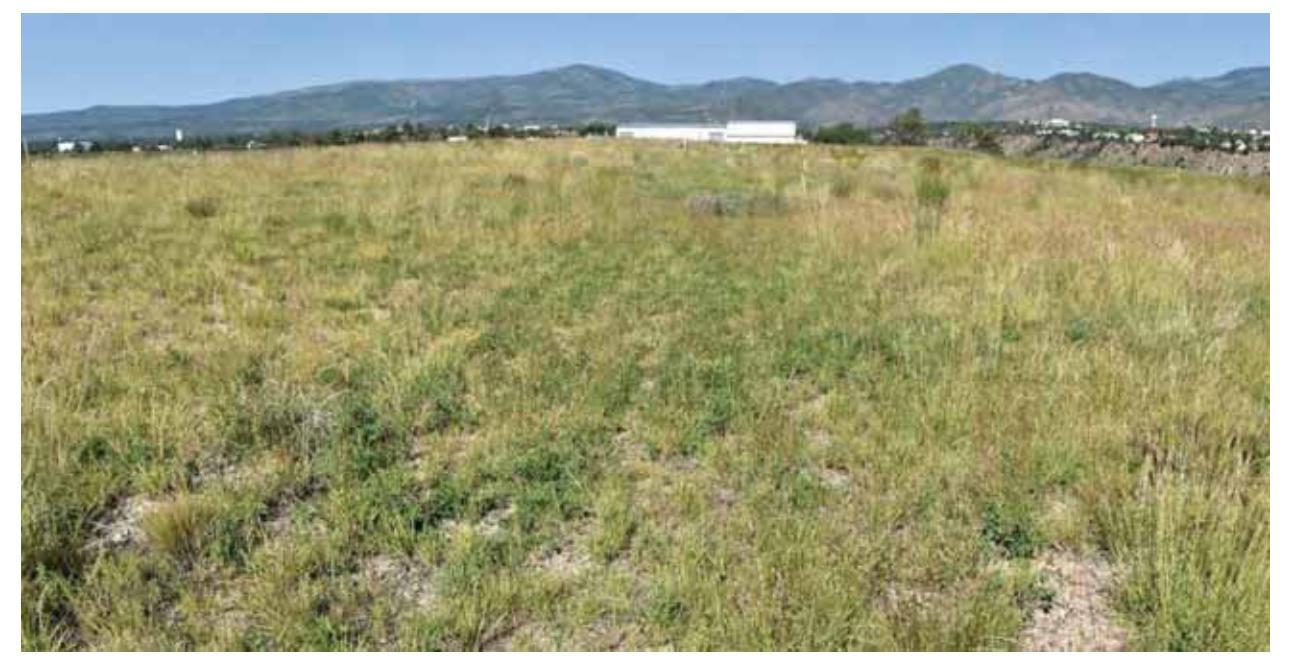
Photo 6 Vegetation on the east-central section of the ET cover, looking west

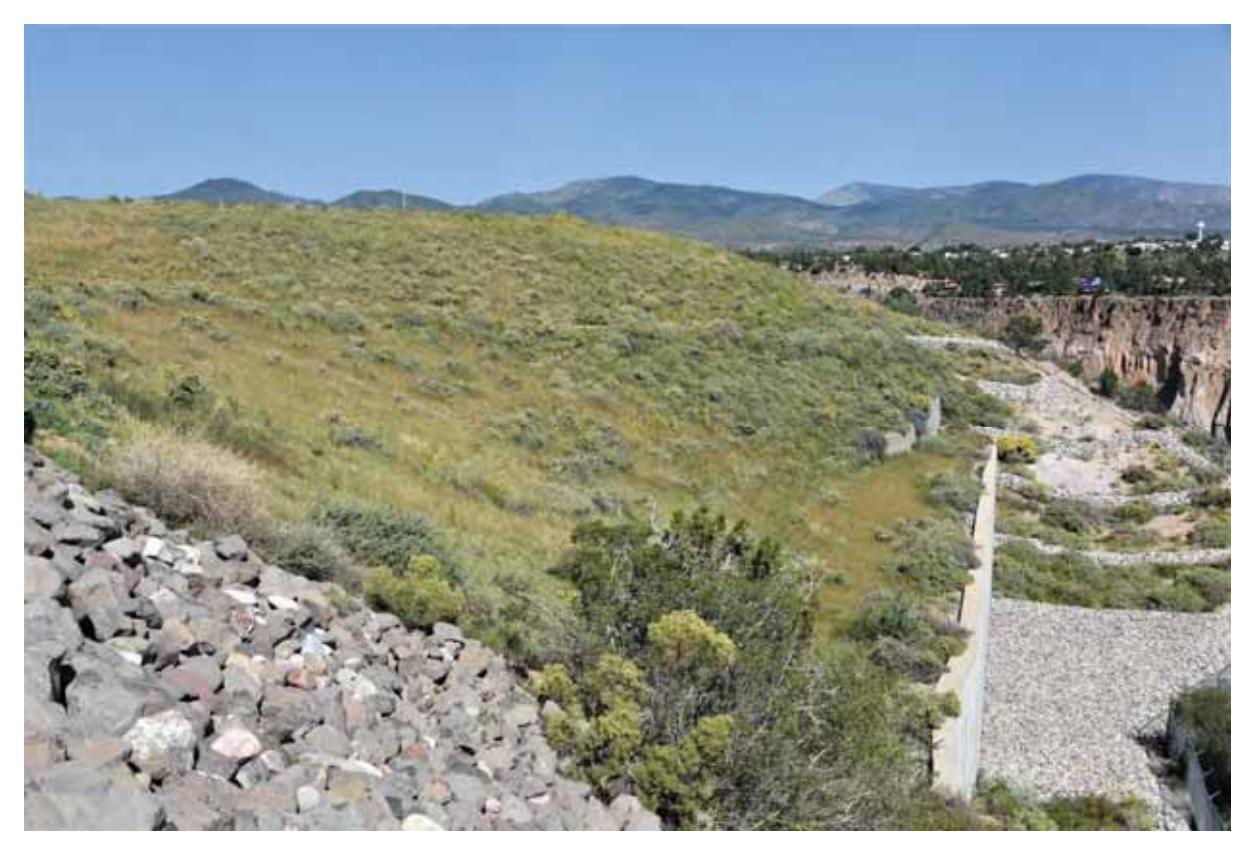
Photo 7 Vegetation on the eastern side slope, looking northwest

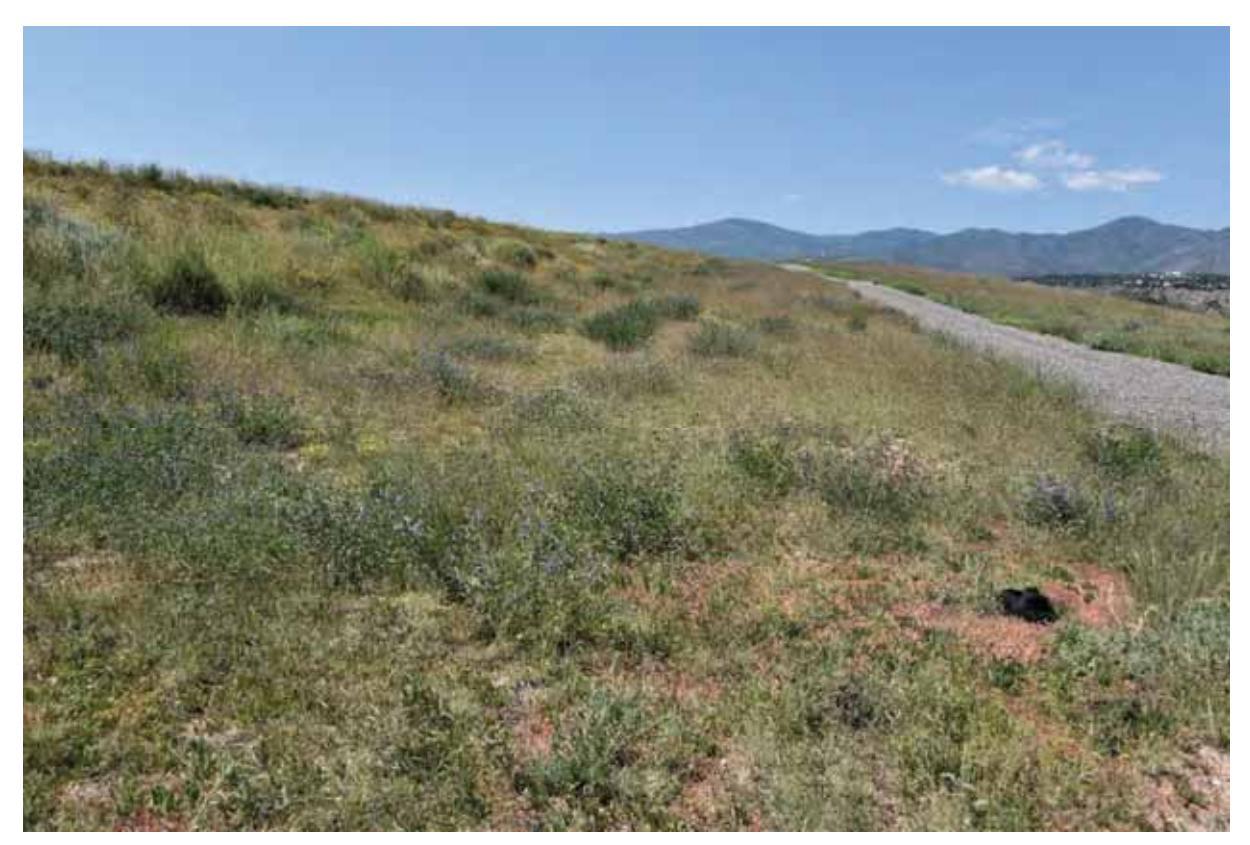
Debris Disposal Area (DDA)	
Debris Disposal Area Condition: ⊠ Good Condition □ Poor Condition Repairs necessary: □ Yes ⊠ No If yes, explain:	Remarks: The surface of the DDA cover system is in good condition (Photos 8 and 9). There is no observed degradation of the site.
General	
Vandalism:⊠ Yes□ NoDescription of damage: Steel grates missing (see "Concrete Culvert" section, above).Repairs necessary:⊠ Yes□ NoIf yes, explain:Grates will require replacement	Remarks: Concrete culvert steel grates are missing and presumed stolen.
Land Use Change: Ves No	Remarks:
Description:	No land use changes.
Repairs necessary: □ Yes ⊠ No If yes, explain:	
Summary of Recommended Maintenance and/or Repair	rs
Maintenance/Repairs Necessary: ☑ Yes □ No If yes, explain: Metal grates missing from the concrete culvert need to be replaced. One heat dissipation probe in the northwest instrument	Remarks:
Other	
Continue monitoring erosion control devices (wattles) on th	e east slope of the old landfill cover.

Photo 8 Southern side of Debris Disposal Area, looking west

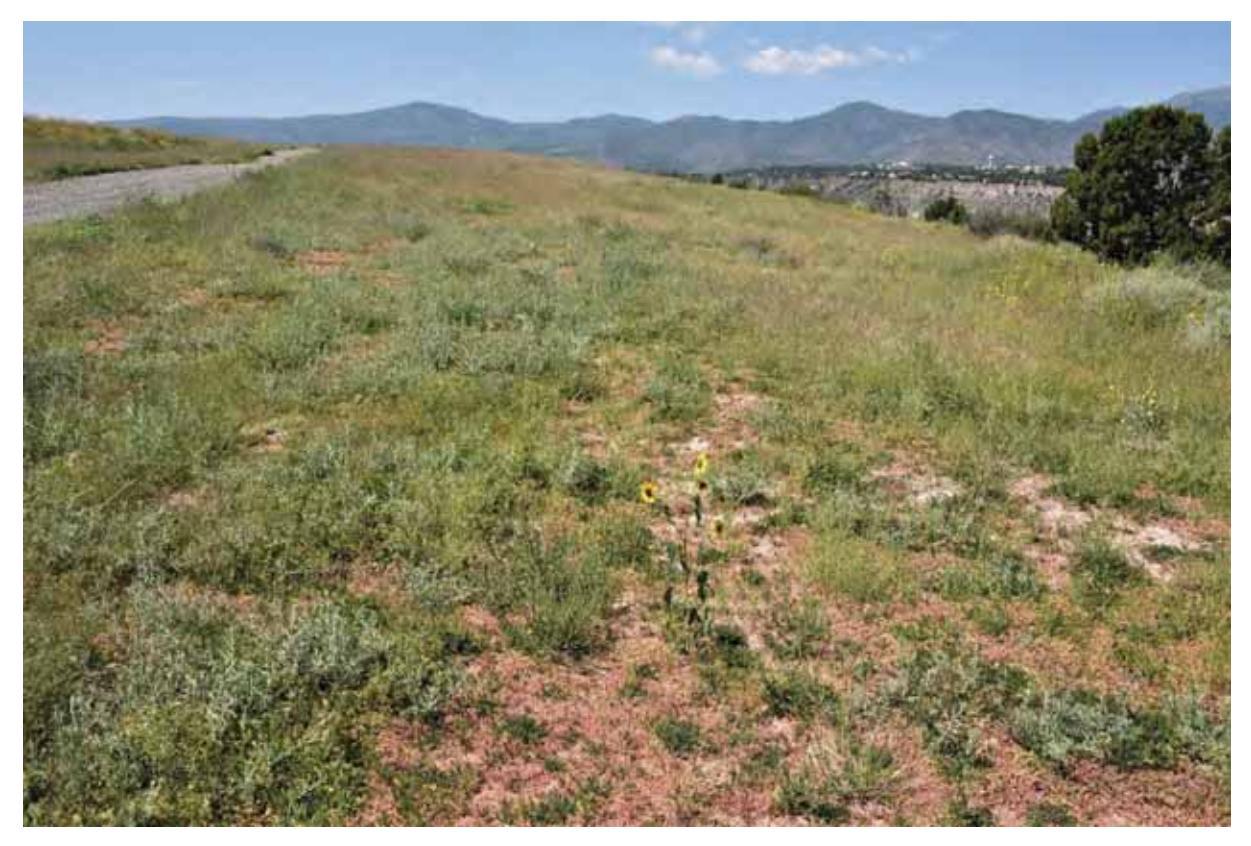
Photo 9 Northern side of Debris Disposal Area, looking west

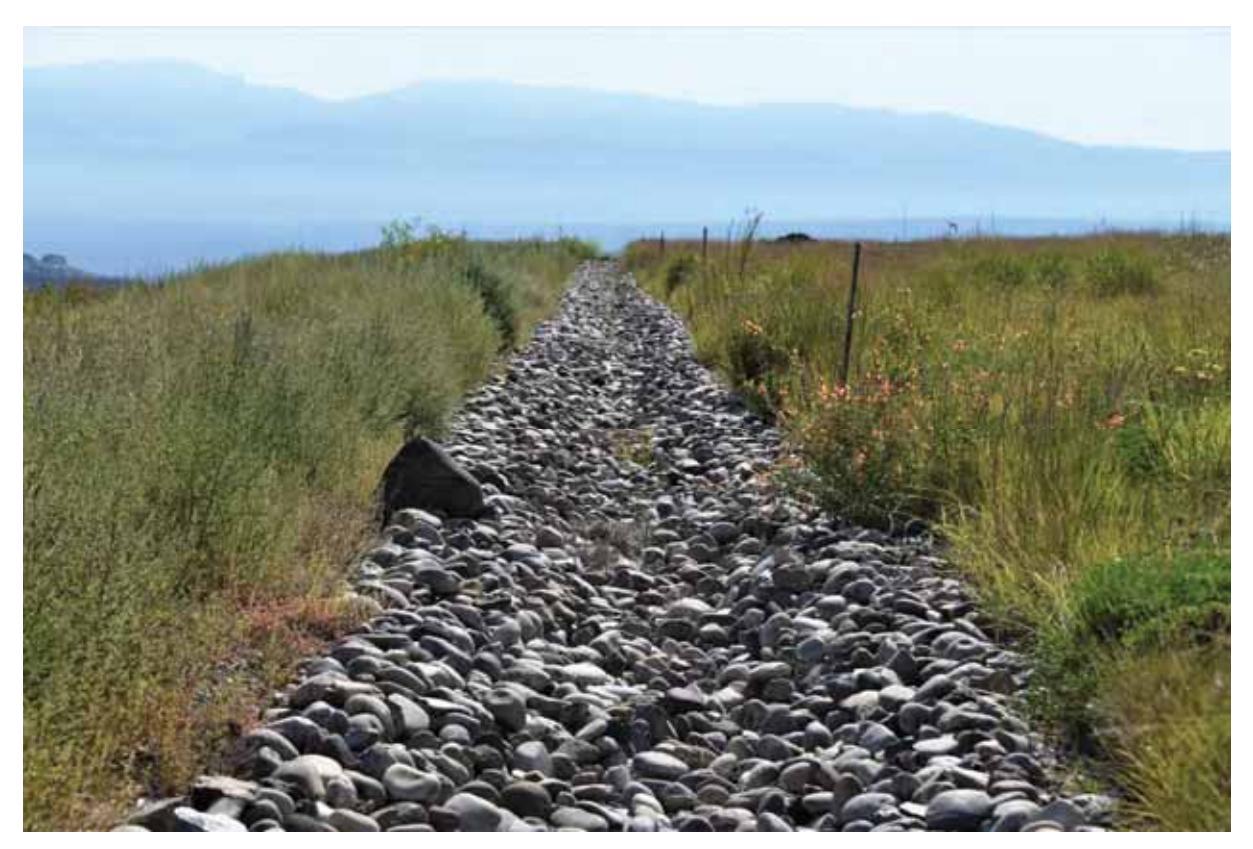
Photo 10 Northern drainage channel, looking east

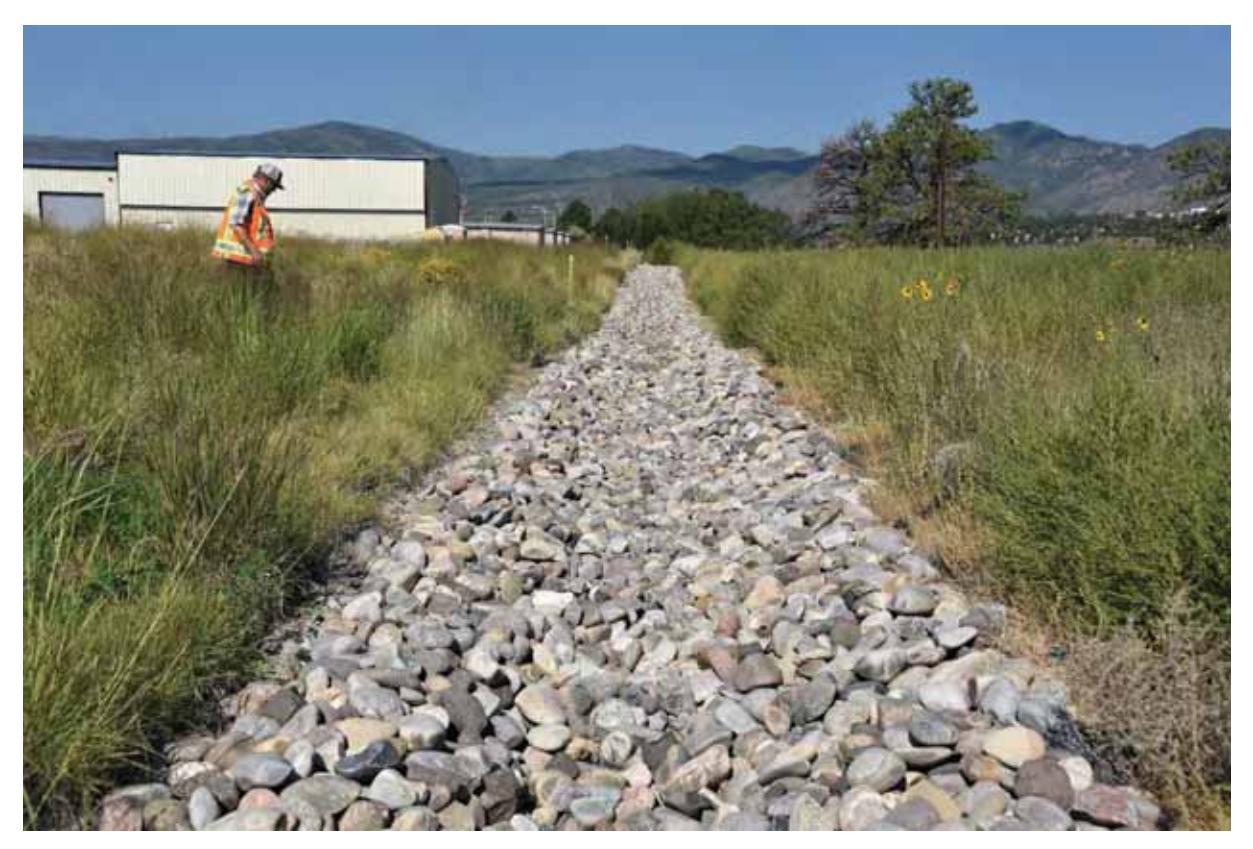
Photo 11 Northern drainage channel, looking west

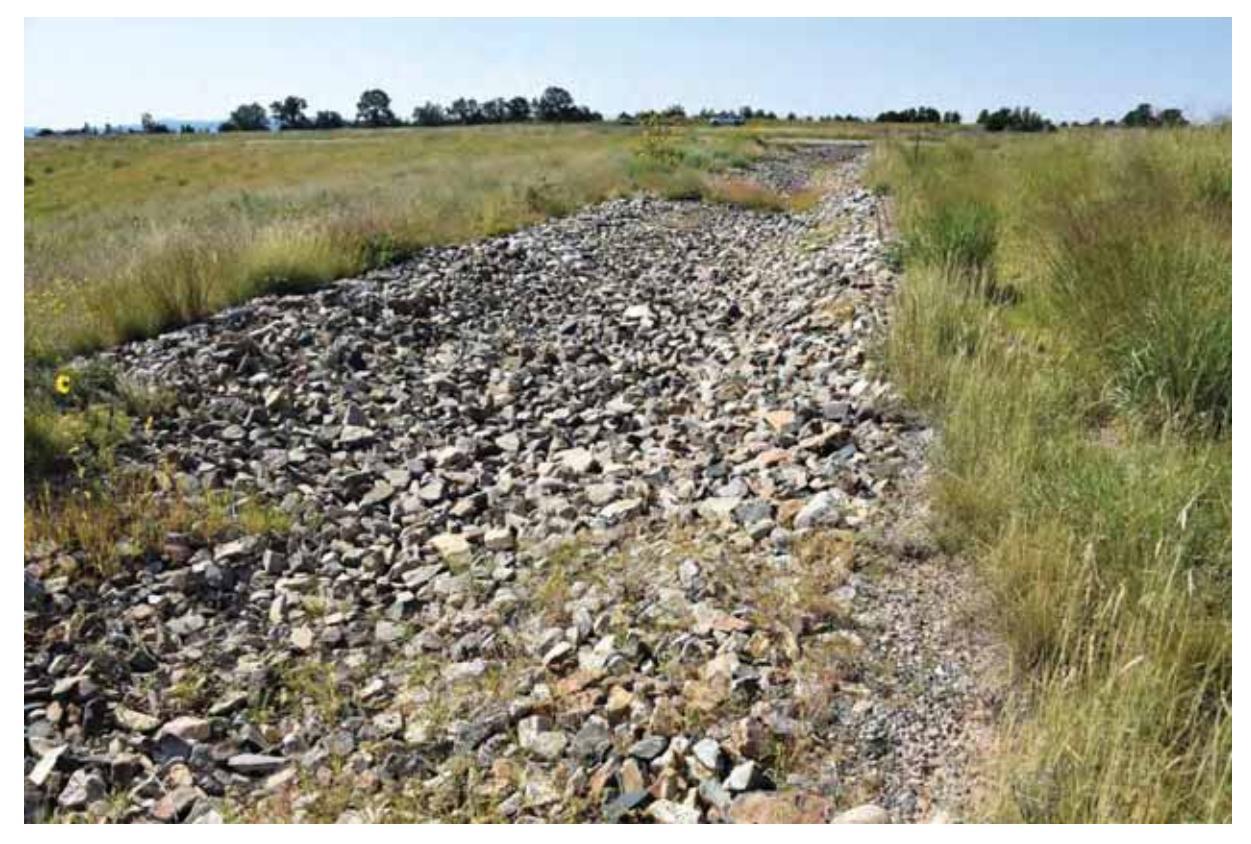
Photo 12 Eastern drainage channel, looking south

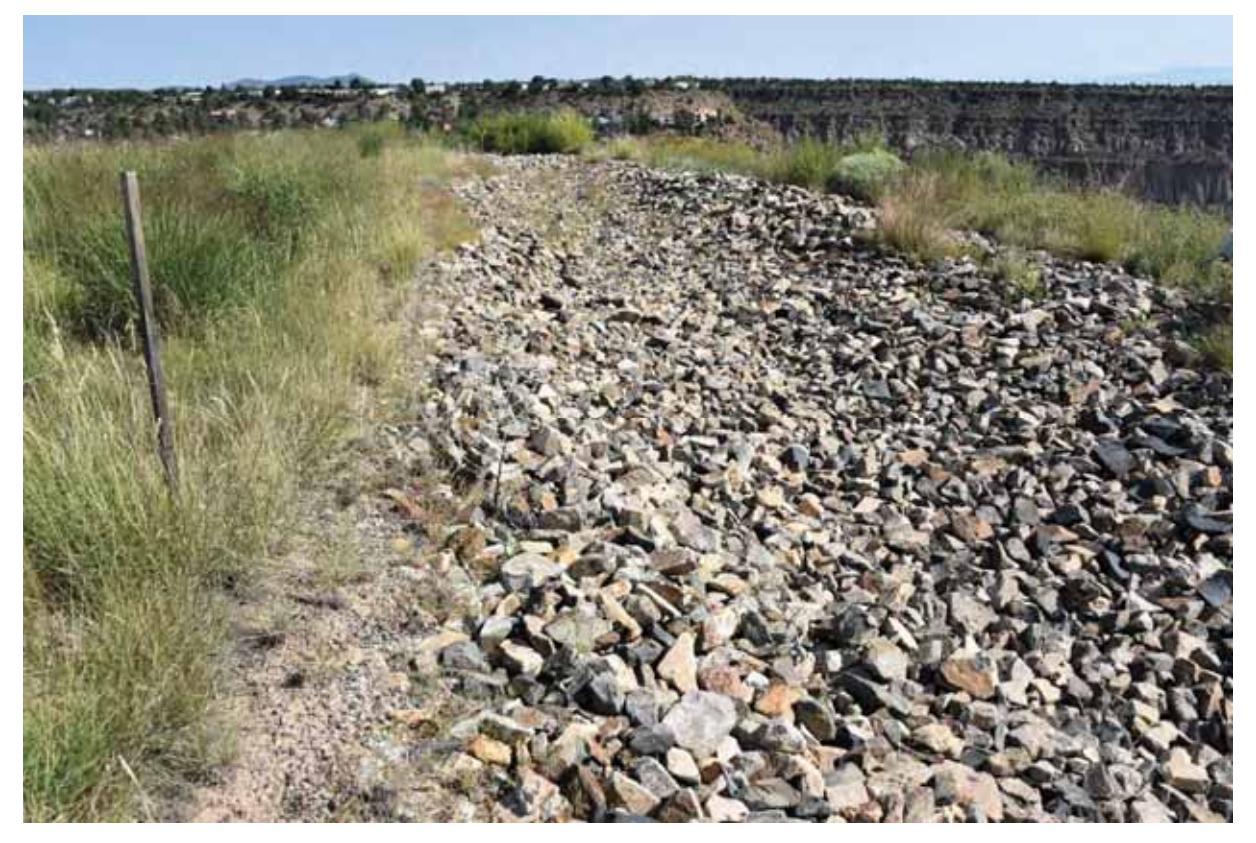
Photo 13 Eastern drainage channel, looking north

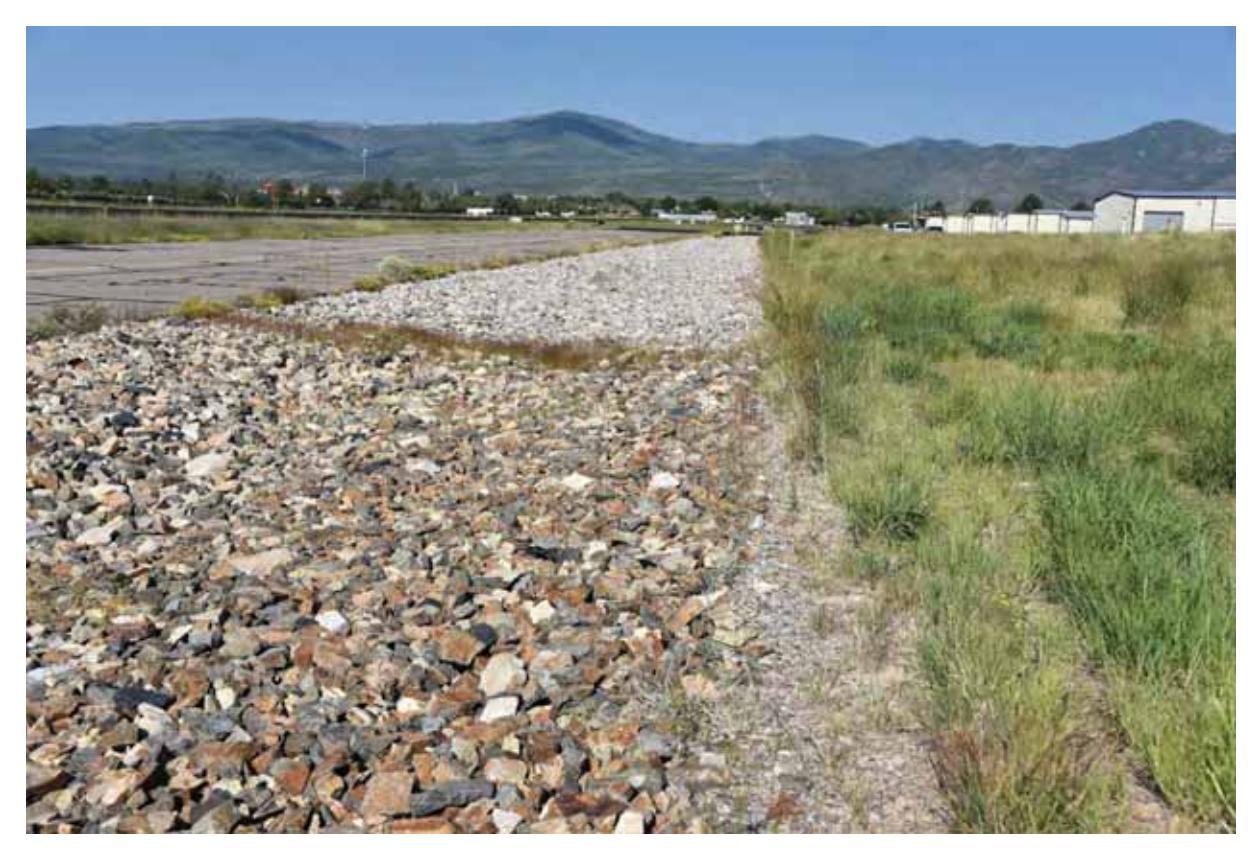
Photo 14 Southern drainage channel, looking west

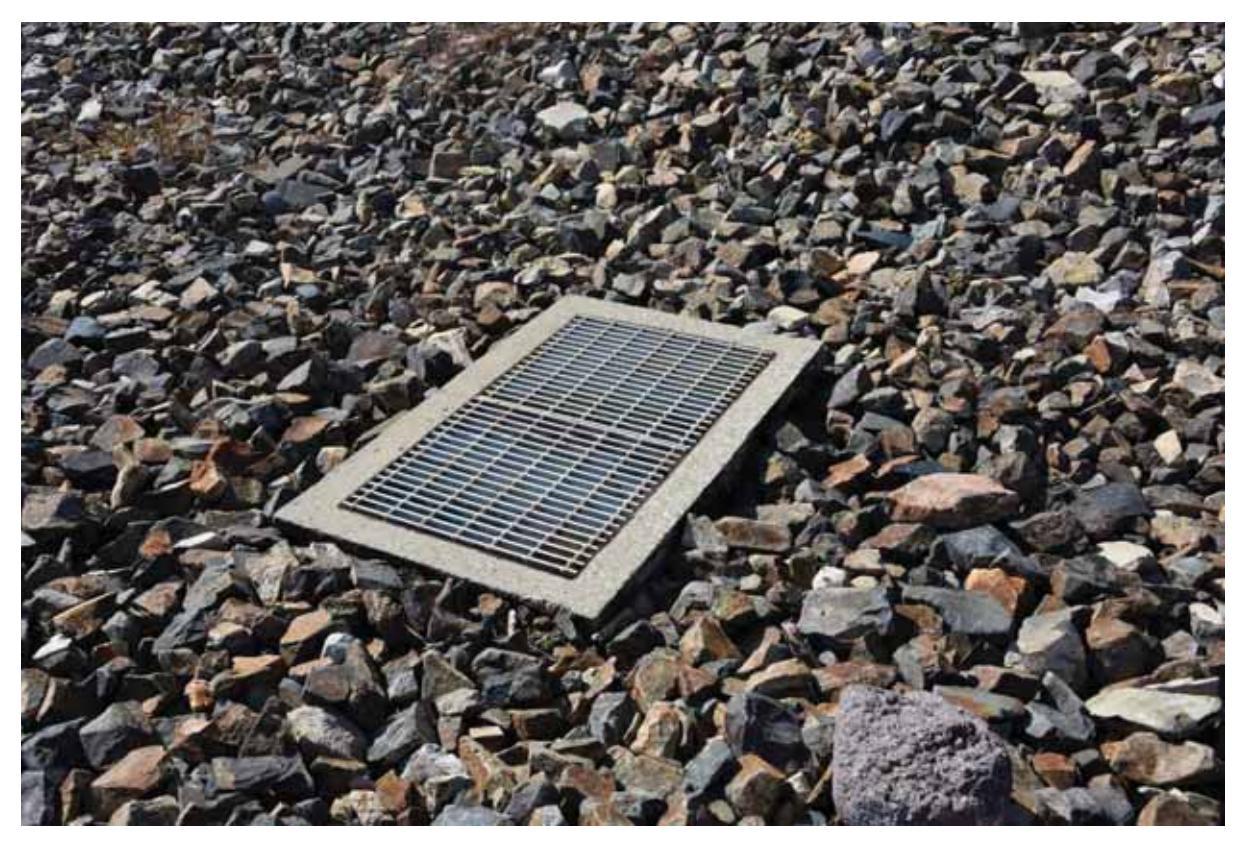
Photo 15 Southern drainage channel drop inlet structure

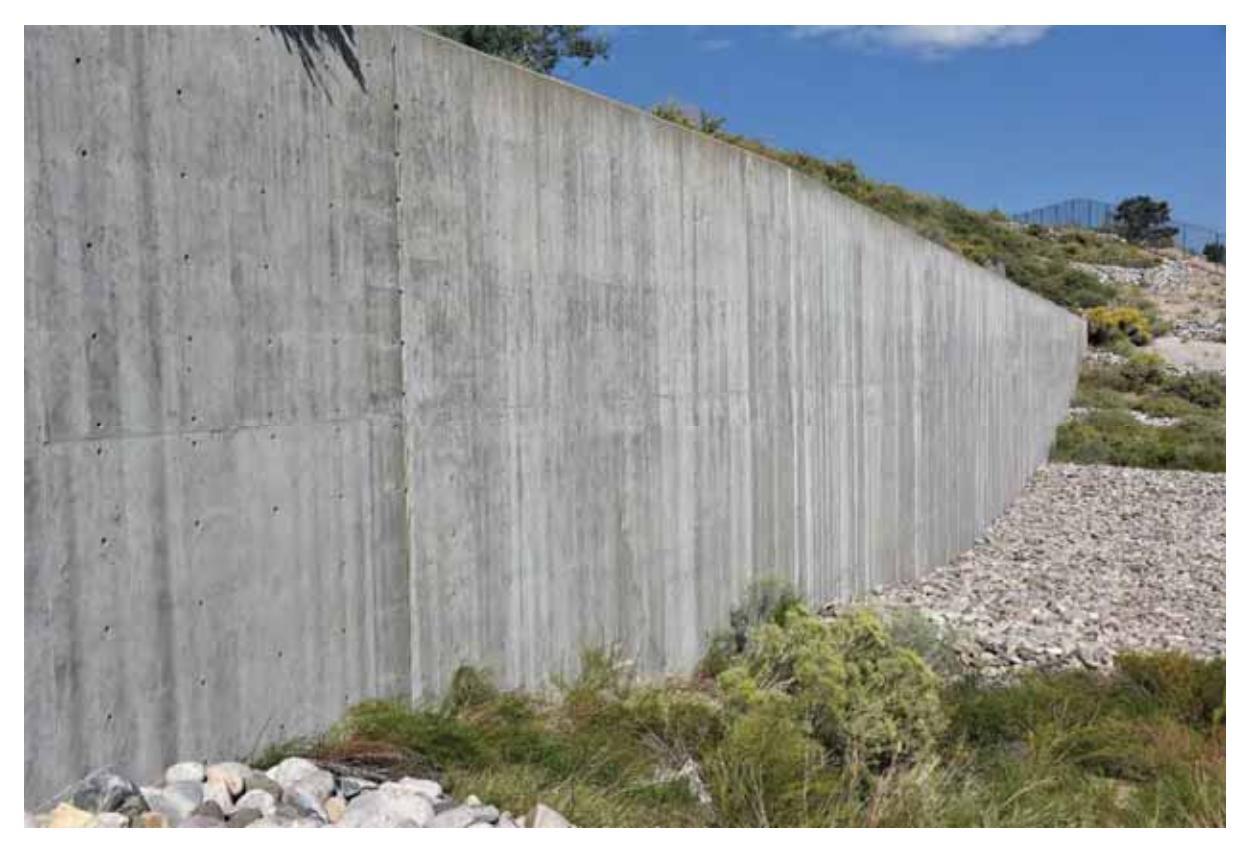
Photo 16 Concrete retaining wall, looking northwest

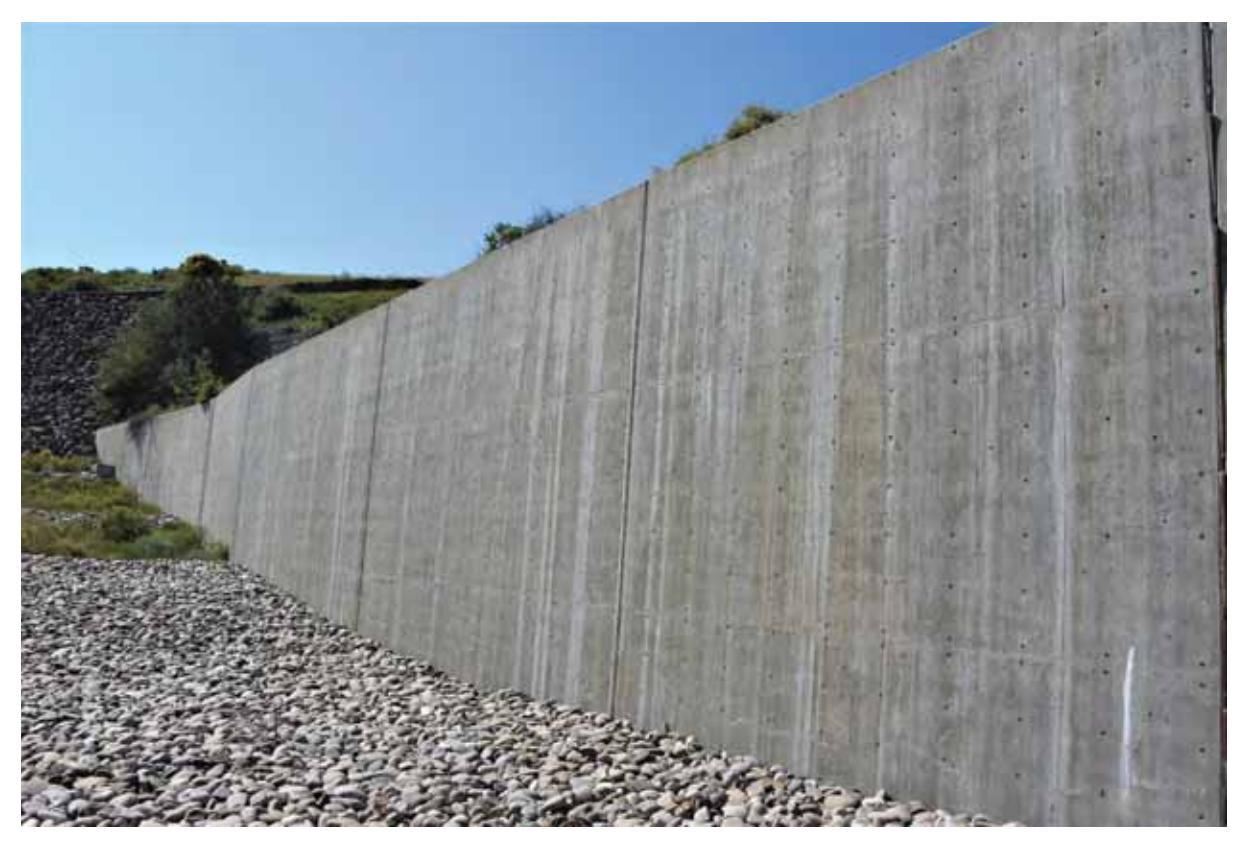
Photo 17 Concrete retaining wall, looking southeast

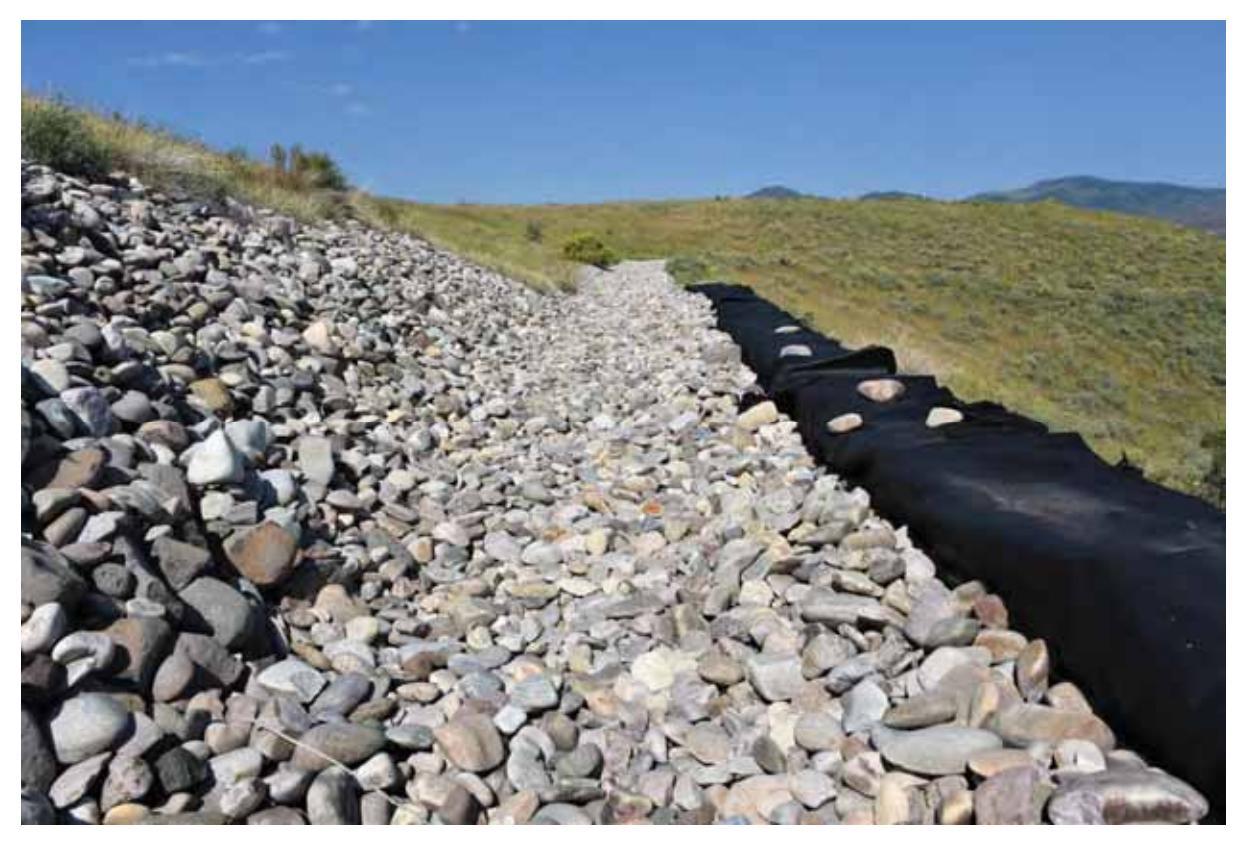
Site Element	Remarks
Fencing	
Airport Fence Adjacent to Landfill: Bent posts: □ Yes ℕ No Loose posts: □ Yes ℕ No Broken links or wire: □ Yes ℕ No Damaged gates: □ Yes ℕ No Description of damage: ℝepairs necessary: □ Yes ℕ No	Remarks: Airport fencing is in good condition and securing the site. This fencing is maintained by the County of Los Alamos.
Retaining Wall	
Retaining Wall Condition: General Condition progressing as expected: Image: Second structure Image: Second structur	Remarks: Retaining walls are in good condition. No damage or issues were noted (Photos 16, 17, 20, and 23).
Description (if any): Issues Observed: □ Yes ⊠ No If yes, explain:	None
Repairs Necessary: □ Yes ⊠ No If yes, explain:	Remarks: None
Permanent Erosion & Sedimentation Control Measures	
Rip Rap Berm near Retaining Wall:Functional:⊠ Yes□ NoIf no, describe locations:□Damage or degradation:□ Yes⊠ NoDescription of damage:Repairs necessary:□ Yes⊠ NoIf yes, explain:	Remarks: The rip-rap drainage on the side slope is in good condition (Photos 18 and 19).

Photo 19 Rip-rap berm (side-slope berm) above retaining wall, looking west

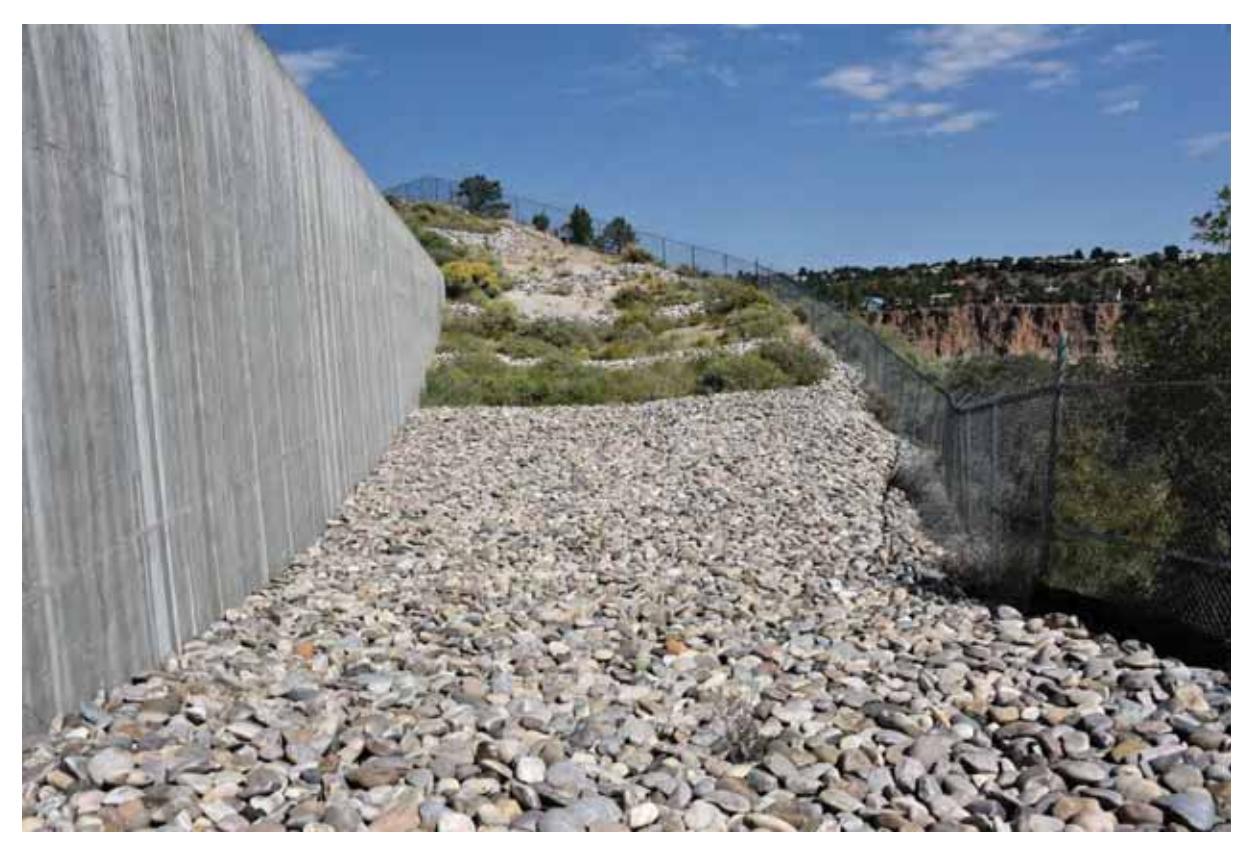
Rock Check Dams near Retaining Wall: Functional: ⊠ Yes □ No If no, describe locations: □ □ Damage, displaced rock, or other damage: □ Yes ⊠ No □ Yes ⊠ No □ □ □ Description of damage: N/A □ Yes ⊠ No If yes, explain:	Remarks: The rock check dams are in good condition (Photos 20 and 21).
Landfill Terrace above Retaining Wall:	Remarks:
Functional: ⊠ Yes □ No If no, describe locations: Damage, adjunct erosion, slope problem, or other damage/degradation: □ Yes ⊠ No Description of damage: Repairs necessary: □ Yes ⊠ No If yes, explain:	The landfill terrace above the retaining walls is in good condition (Photo 22).

Photo 20 Drainage channel, concrete retaining wall, and rock check dams, looking northwest

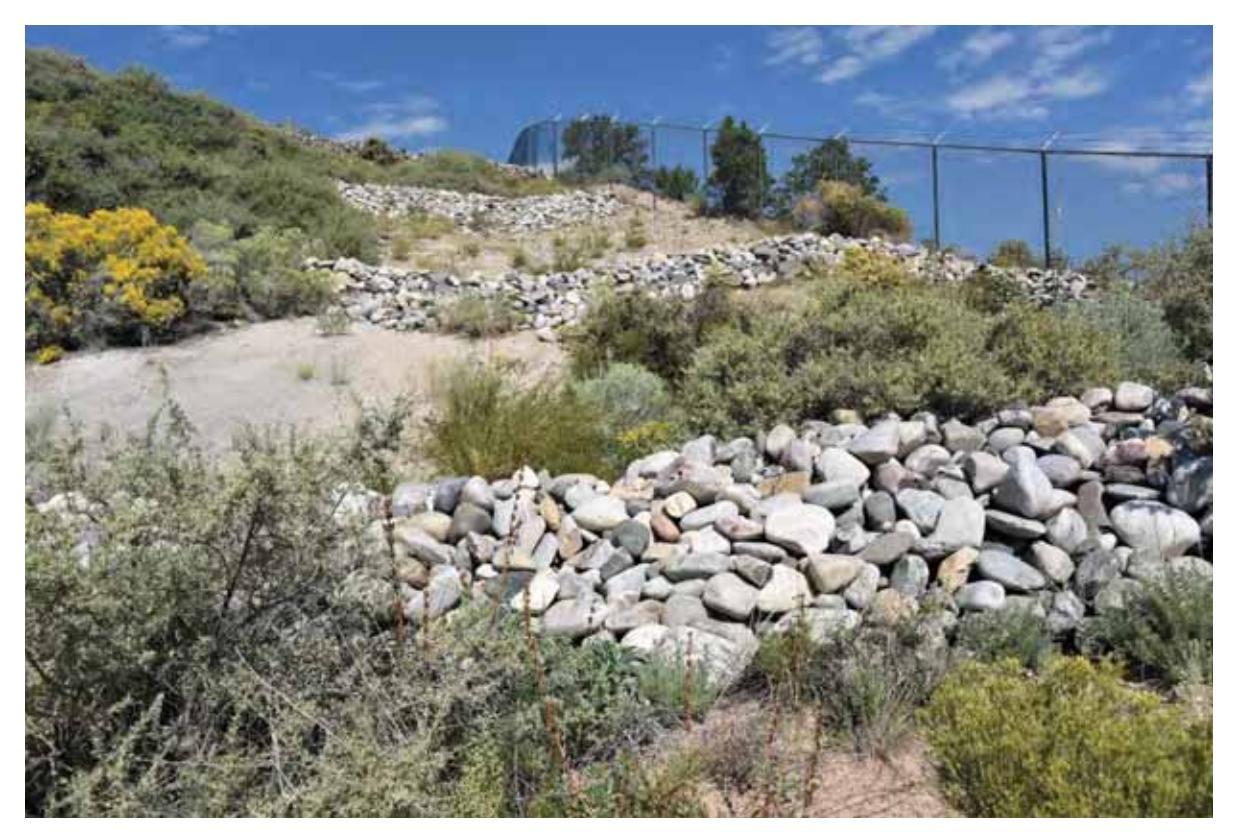
Photo 21 Rock check dams, looking northwest

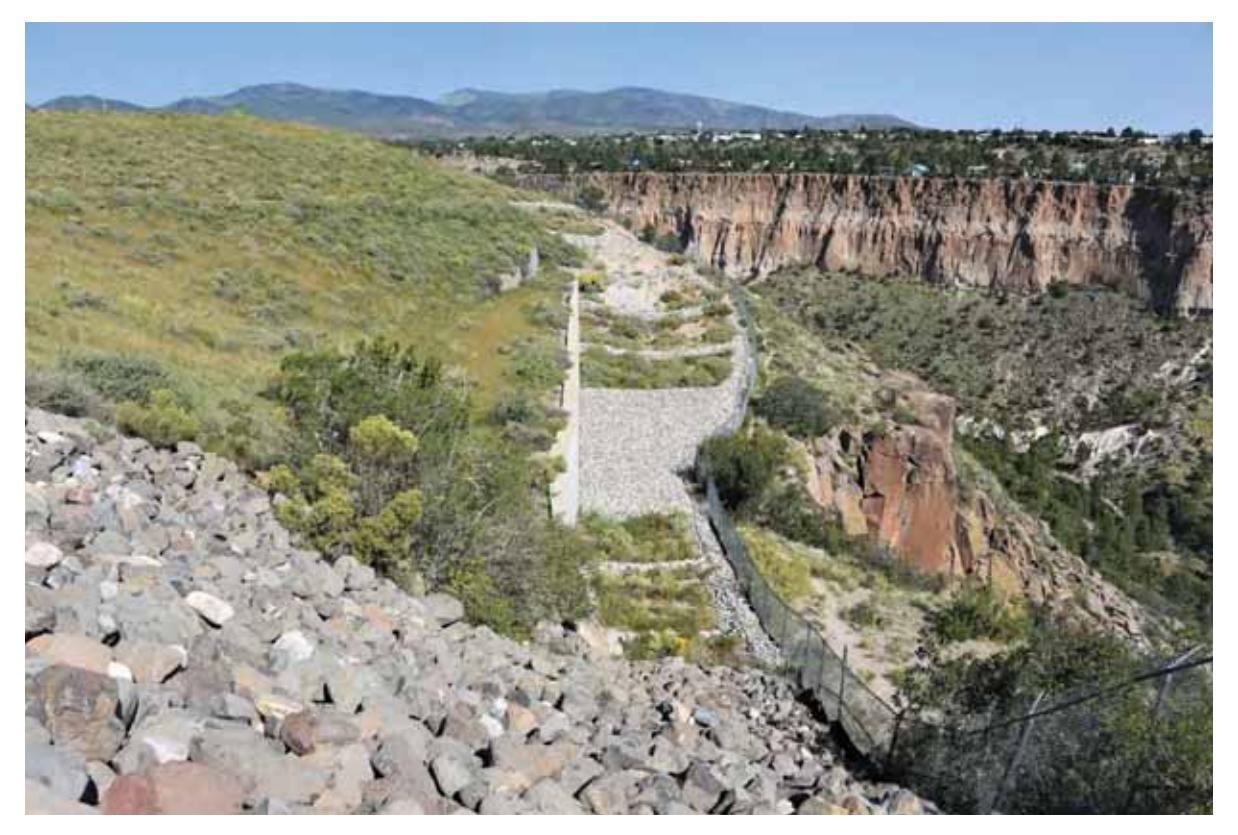
Photo 22 Eastern terrace and drainage channels, looking northwest

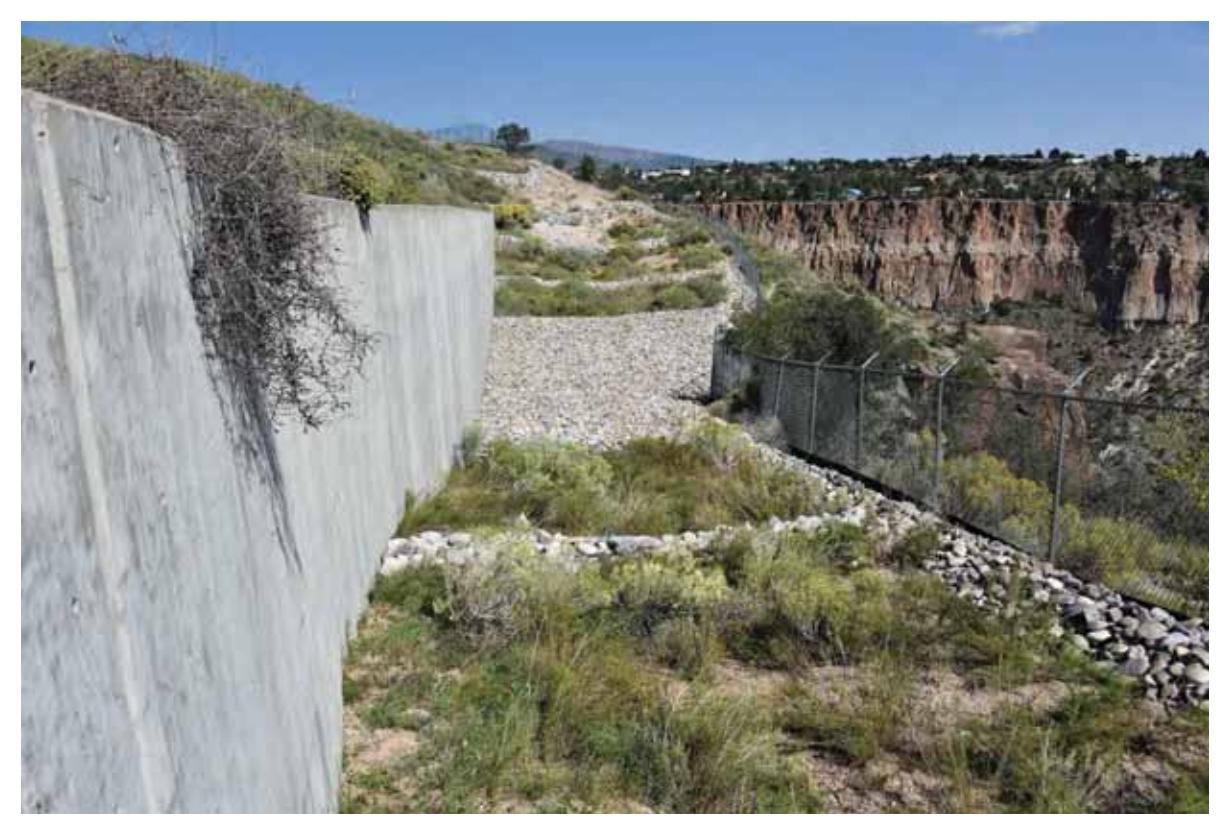
Site Element	Remarks
Drainage Channels adjacent to Retaining Wall:	Remarks:
Functional: ⊠ Yes □ No If no, describe locations: Damage, adjunct erosion, slope problem, or other damage/degradation: □ Yes ⊠ No Description of damage:	The drainage channels adjacent to the retaining wall appear to be in good condition and working properly (Photos 20, 22, and 23).
Repairs necessary: \Box Yes \boxtimes No If yes, explain:	
Gabion above Drainage Channels adjacent to Retaining Wall: Functioning: ⊠ Yes Functioning: ⊠ Yes If no, describe locations: Damage or degradation: □ Yes Description of damage: Repairs necessary: □ Yes Provide the second	Remarks: The gabions above the drainage channels adjacent to the retaining walls are in good condition (Photos 24 and 25).
Access Restrictions: 🛛 Yes 🗆 No	Remarks:
Description: Secured fence with keyed lock Repairs necessary: \Box Yes \boxtimes No If yes, explain:	The site has controlled access with a security fence and locked gates.

Photo 23 Drainage channels adjacent to retaining wall, looking northwest

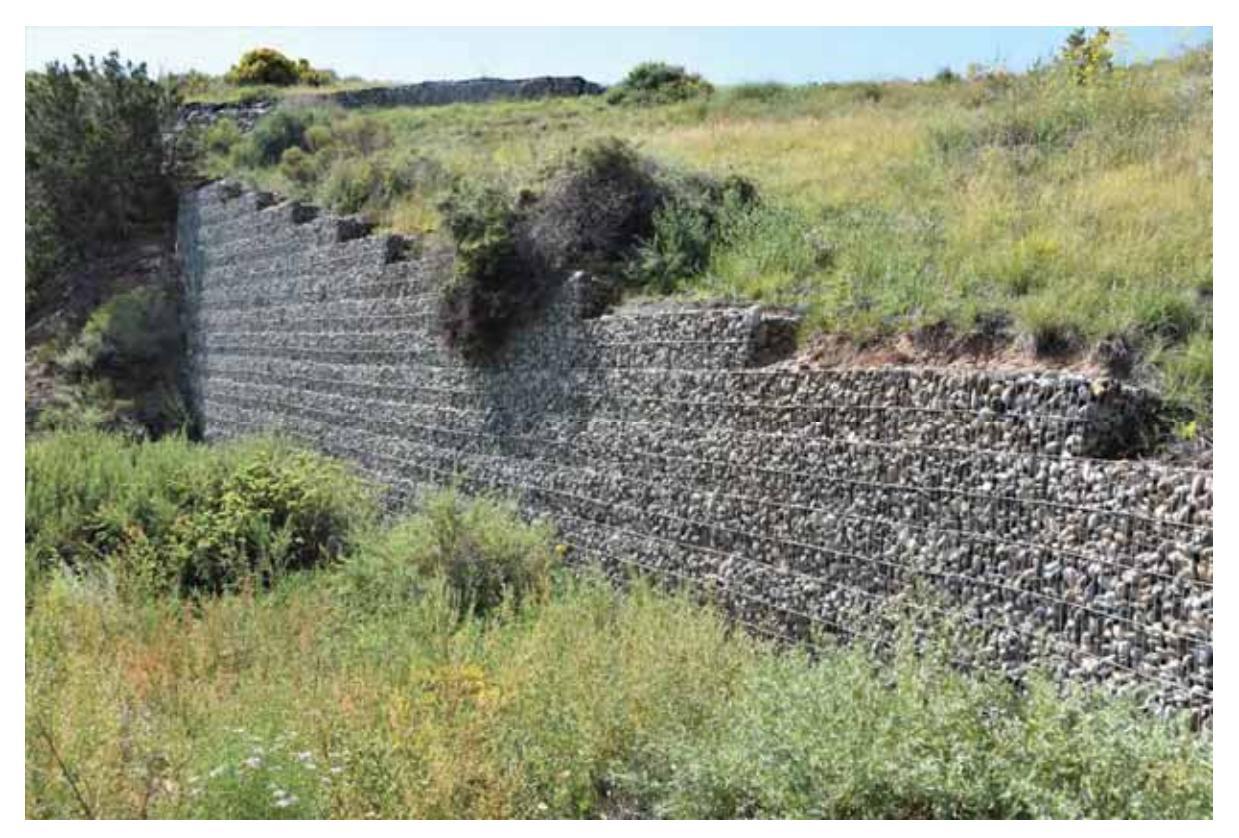
Photo 24 Southern gabion wall, looking south
