Subject:Submittal of the 2022–2023 Annual Long-Term Monitoring Status Report (July 2022
through June 2023) for the Los Alamos County Airport Landfill Cover System
Replacement, Solid Waste Management Units 73-001(a,d) in Technical Area 73

July 2023 EM2023-0423

2022–2023 Annual Long-Term Monitoring Status Report (July 2022 through June 2023) for the Los Alamos County Airport Landfill Cover System Replacement, Solid Waste Management Units 73-001(a,d) in Technical Area 73

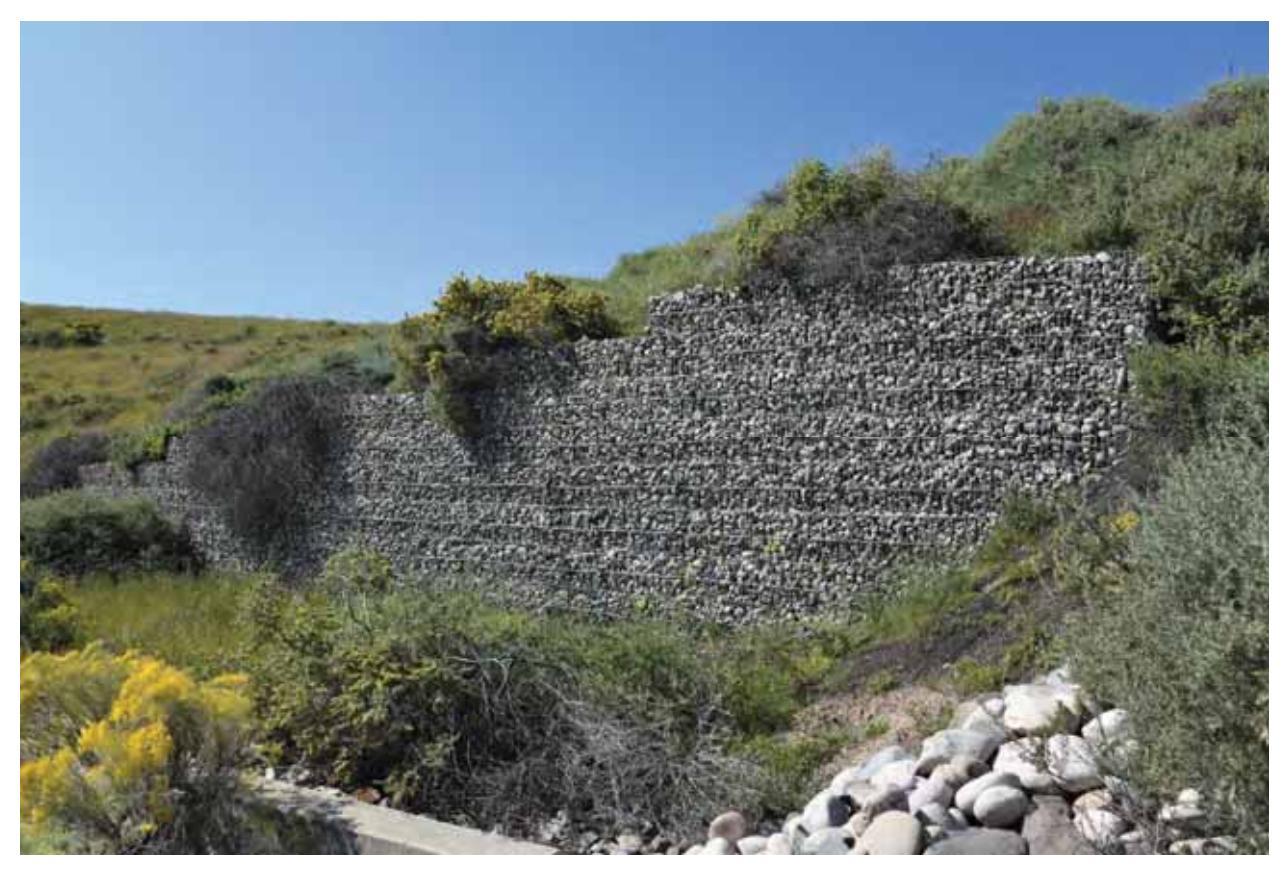
Photo 25 Northern gabion wall, looking south

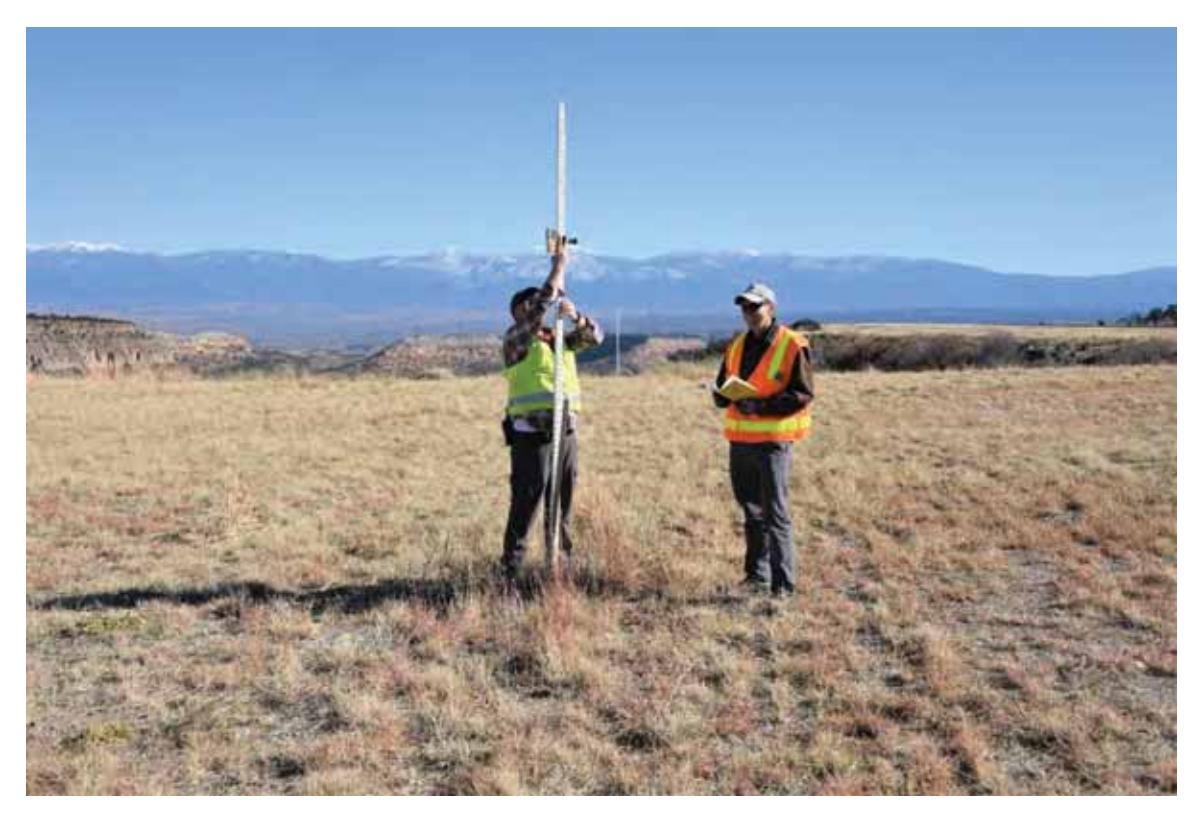
Photo 1 Survey crew recording elevation of settlement survey grid point

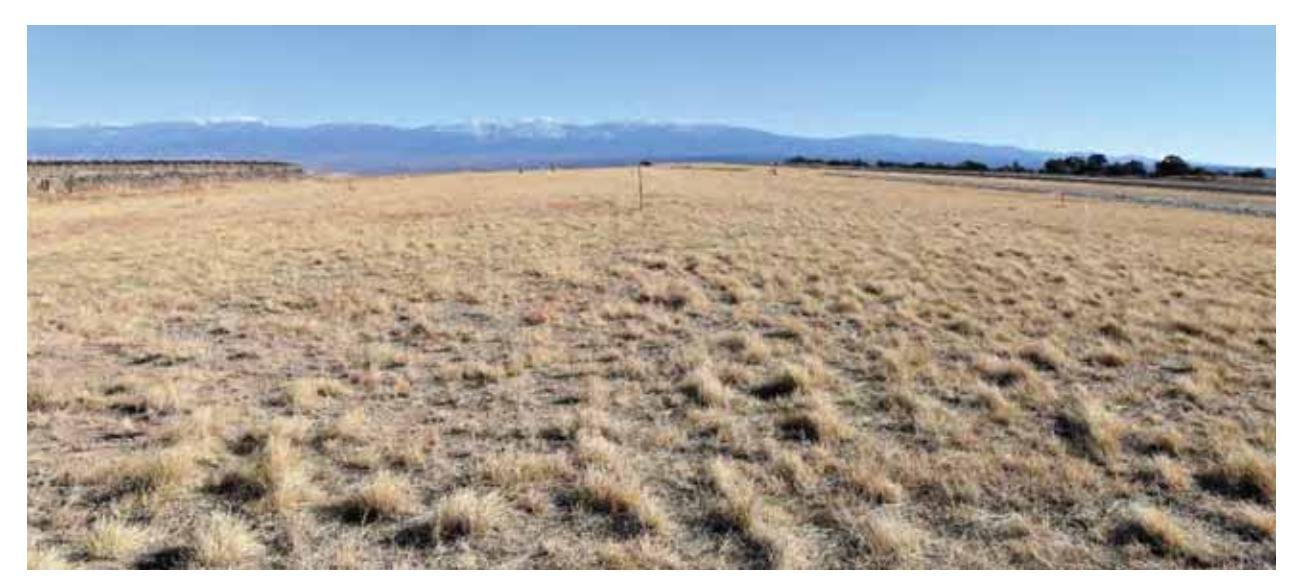
Photo 3 Vegetation on the central section of the ET cover, looking east

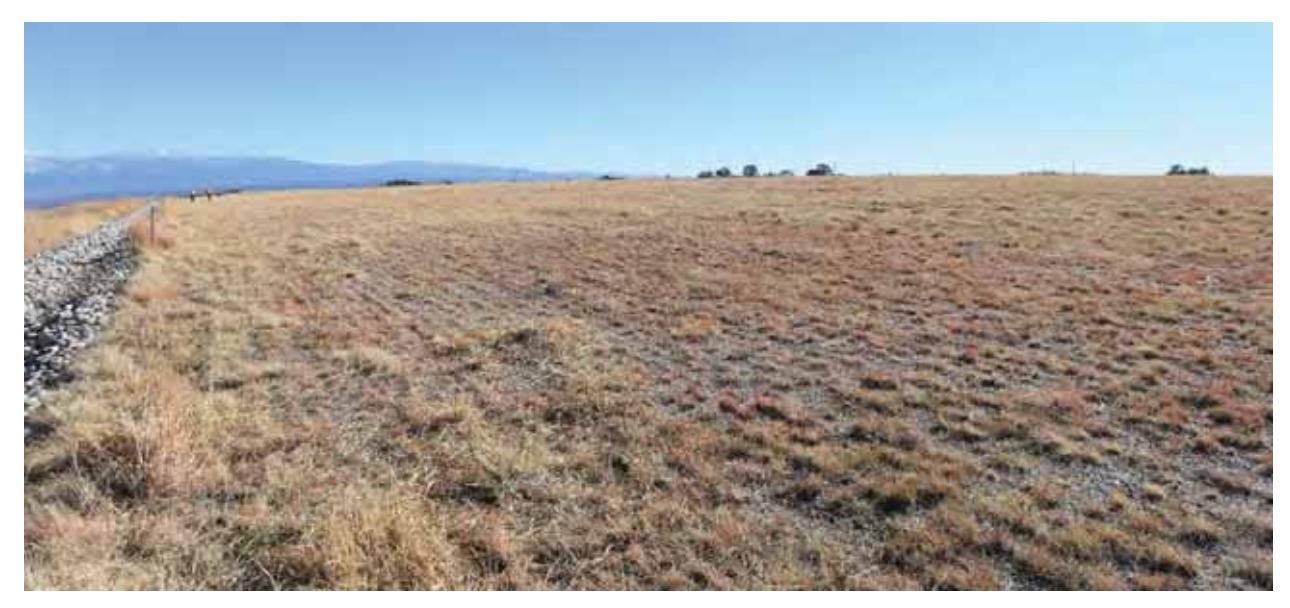
Photo 4 Vegetation on the northern section of the ET cover, looking east

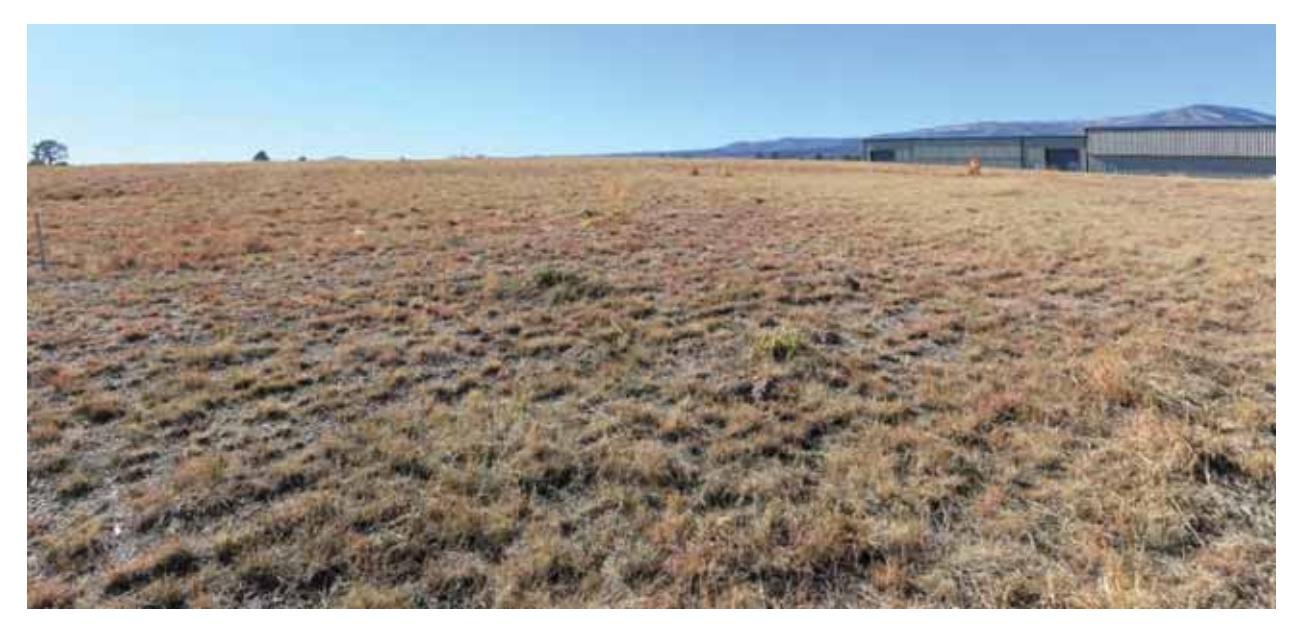
Photo 5 Vegetation on the northern and central sections of the ET cover, looking southwest

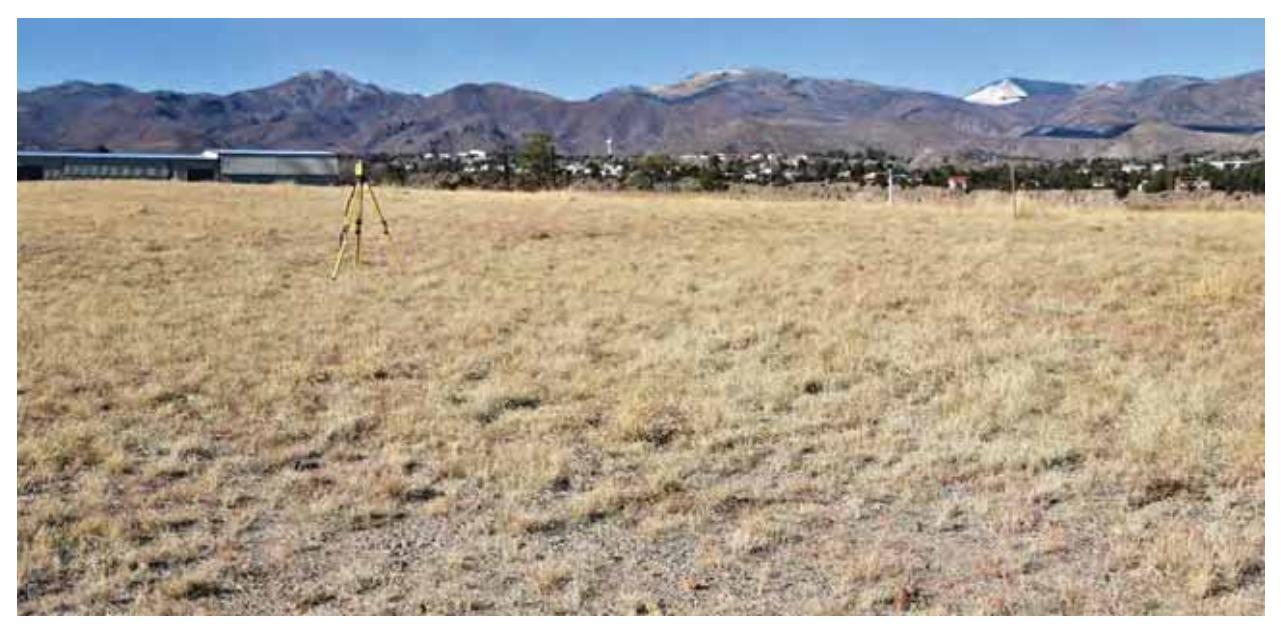
Photo 6 Vegetation on the southern and central sections of the ET cover, looking west

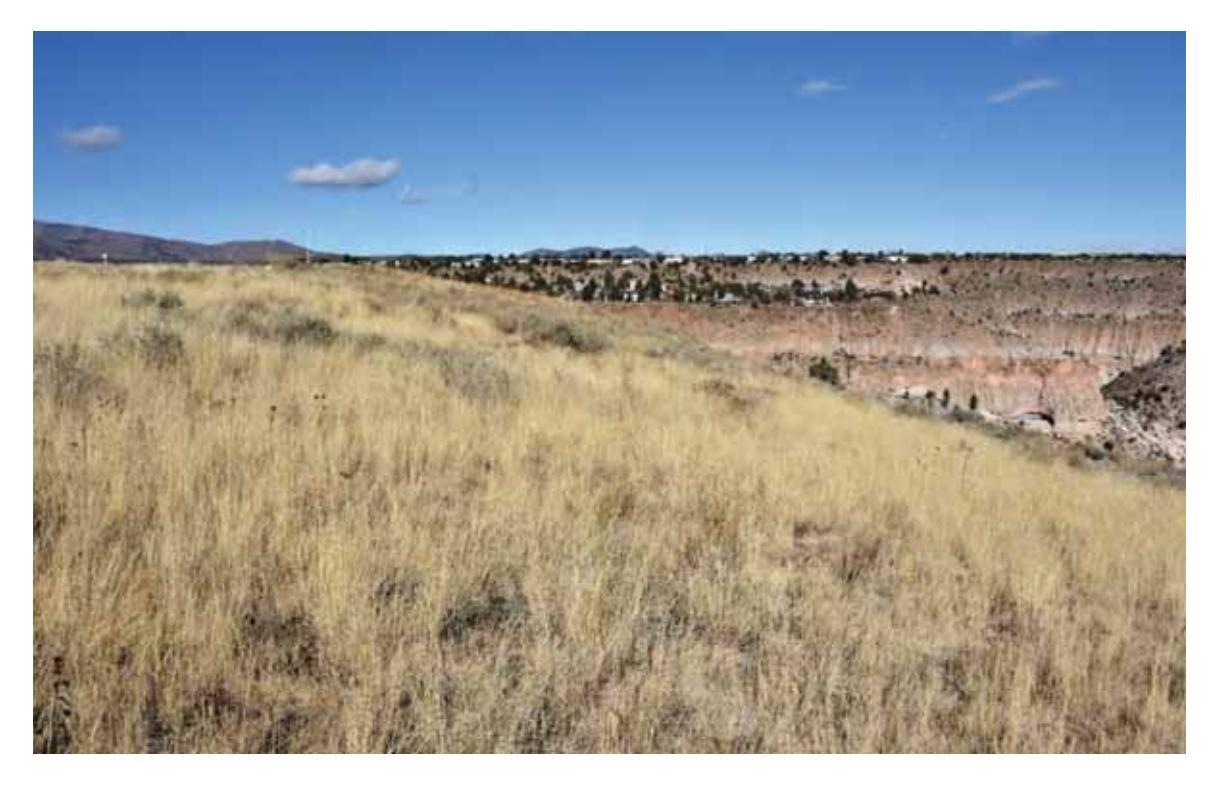
Photo 7 Vegetation on the upper section of the eastern side slope, looking north

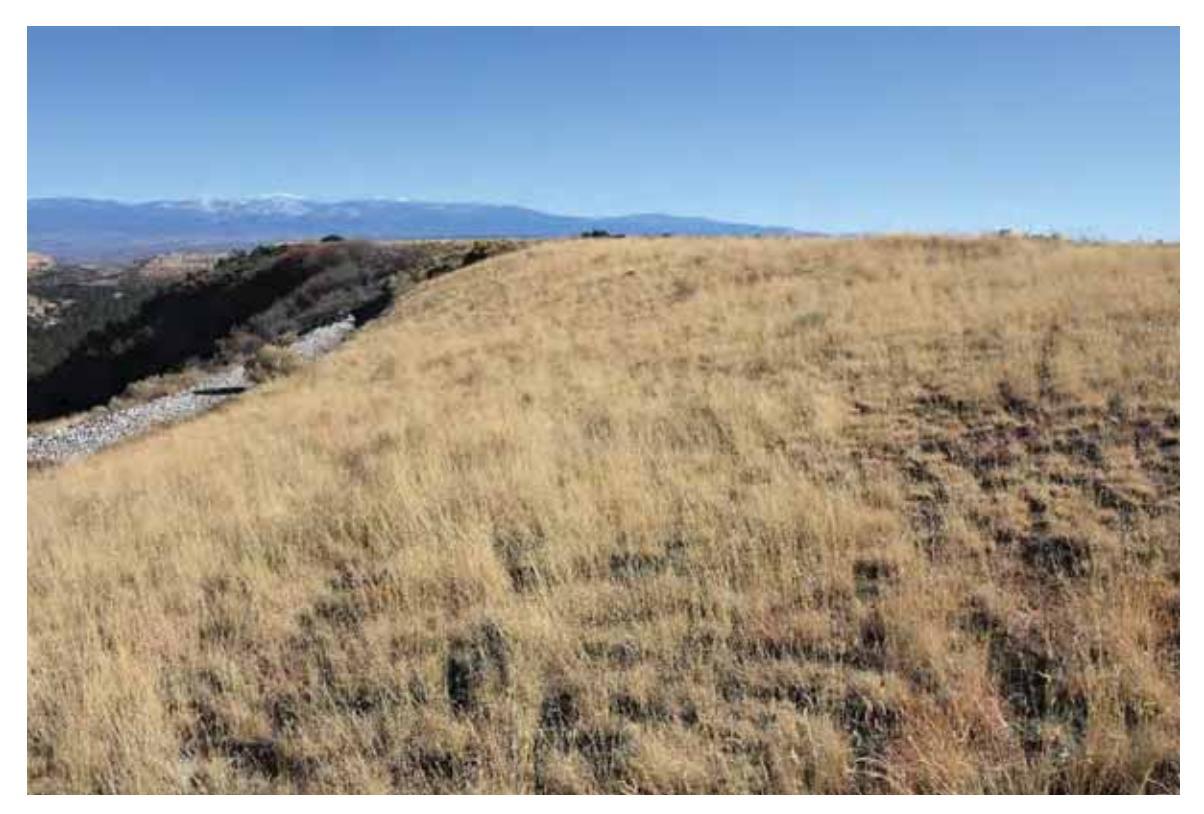
Photo 8 Vegetation on the upper section of the eastern side slope, looking east

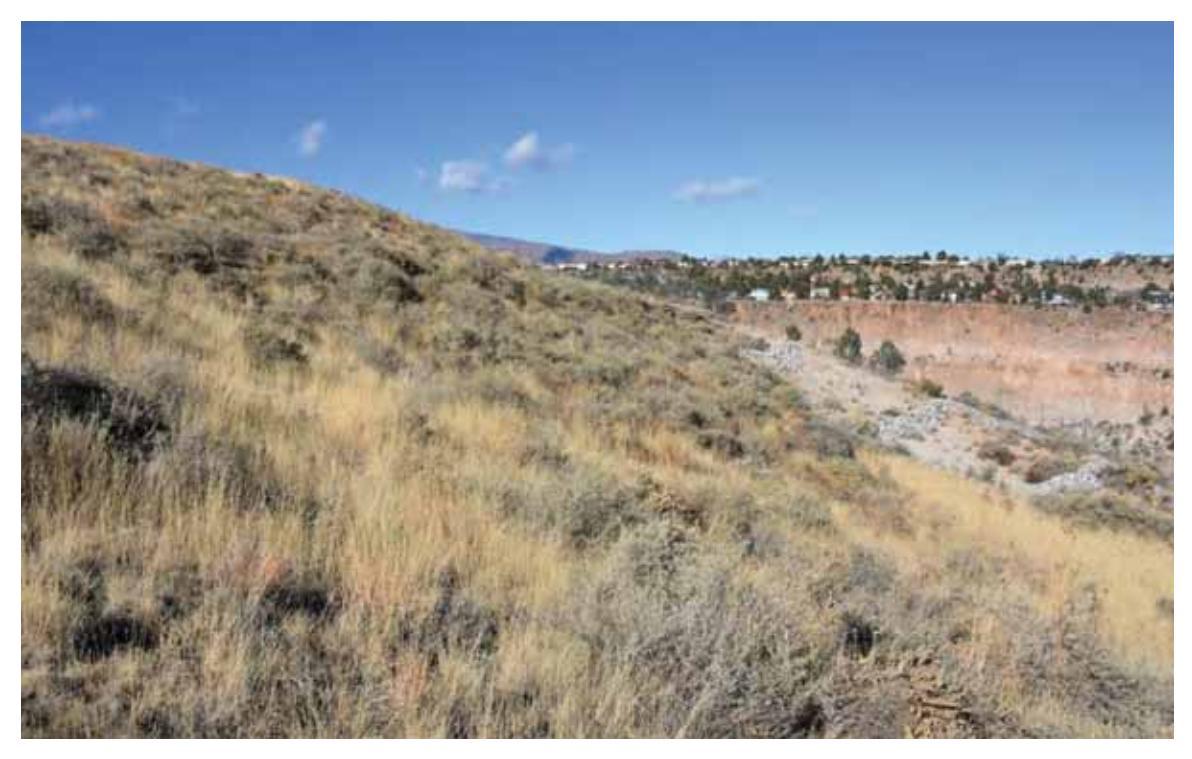
Photo 9 Vegetation on the lower section of the eastern side slope, looking north

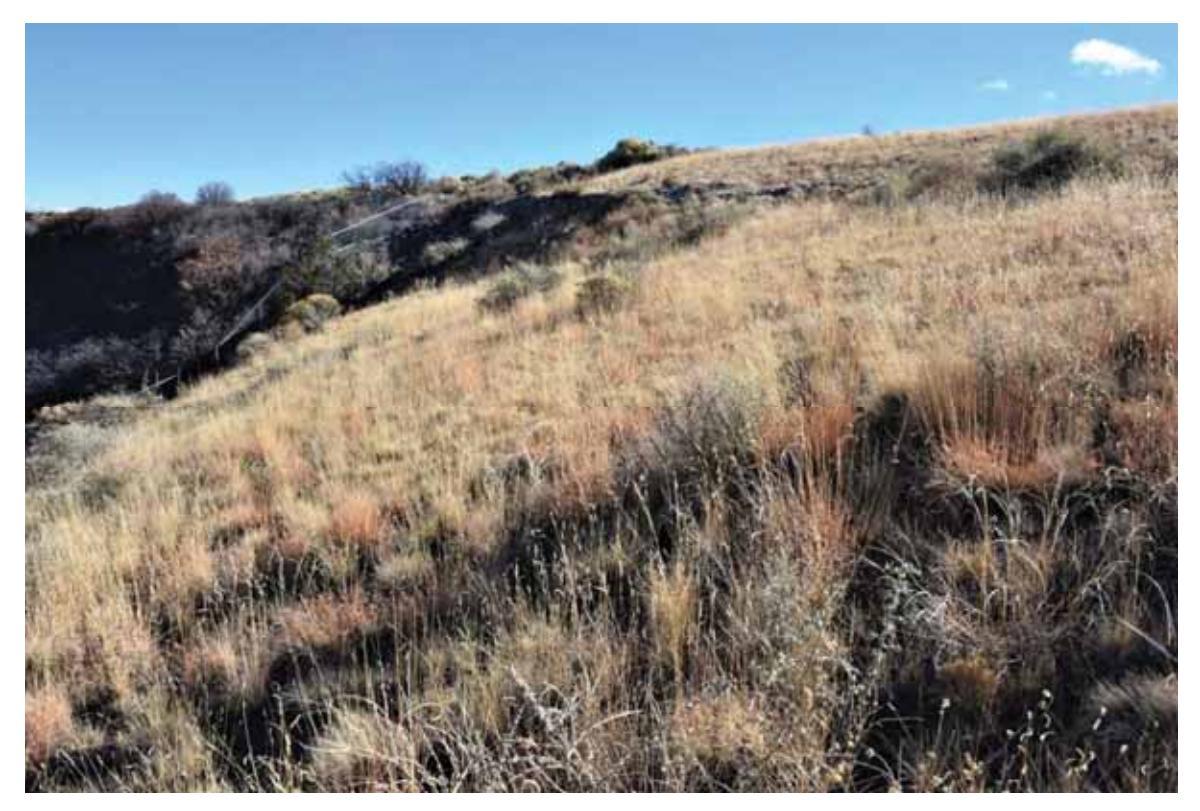
Photo 10 Vegetation on the lower section of the eastern side slope, looking east

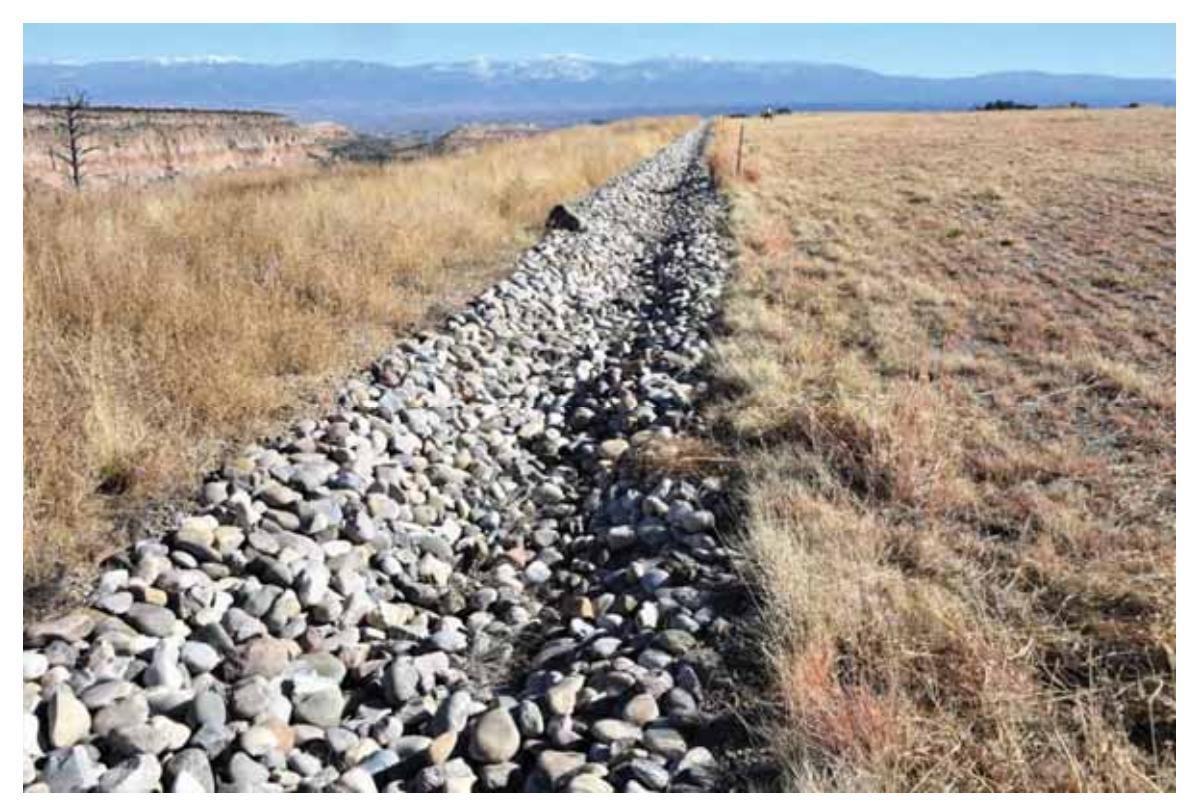
Photo 12 Northern drainage channel, looking east

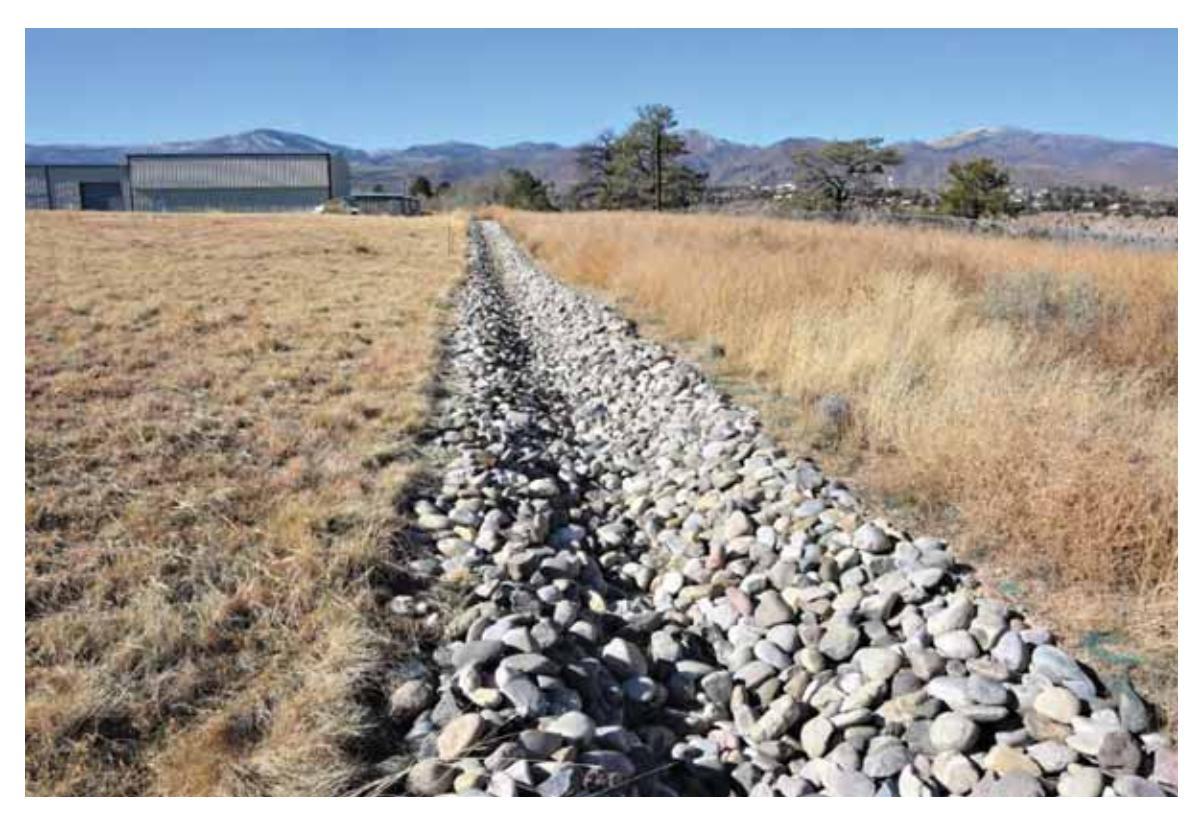
Photo 13 Northern drainage channel, looking west

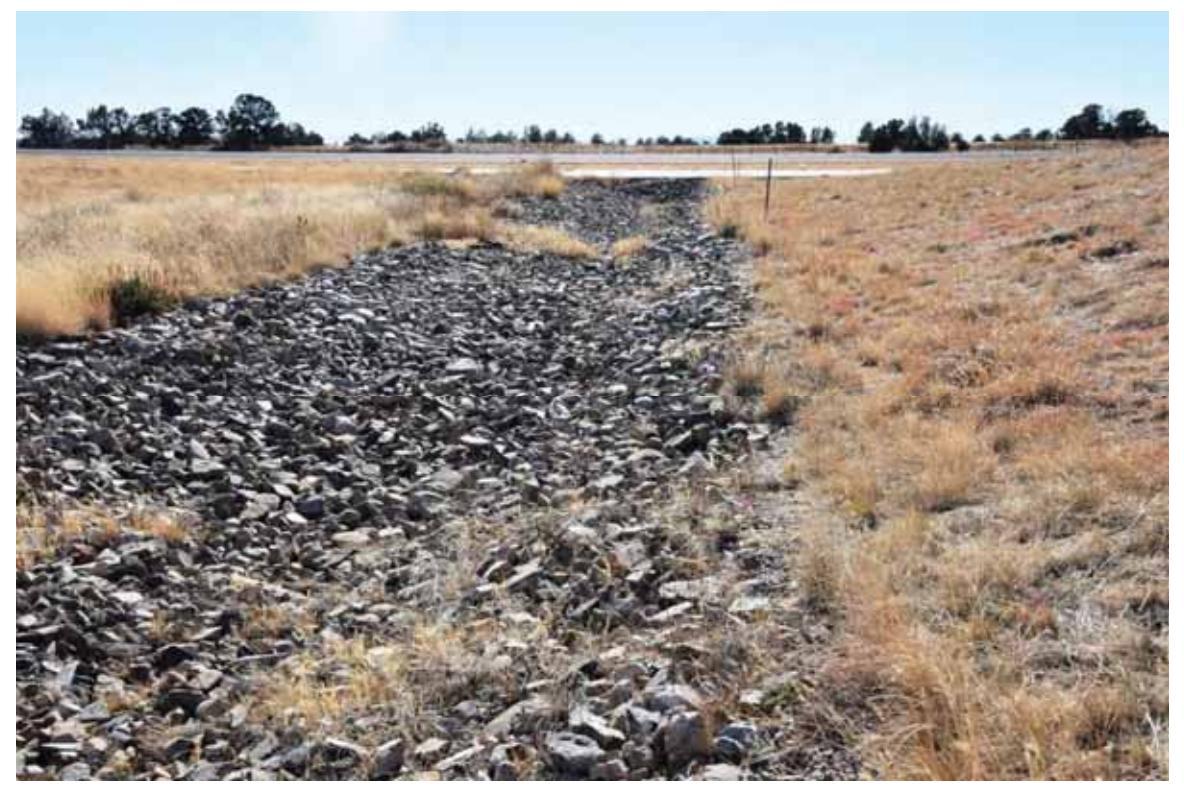
Photo 14 Eastern drainage channel, looking south

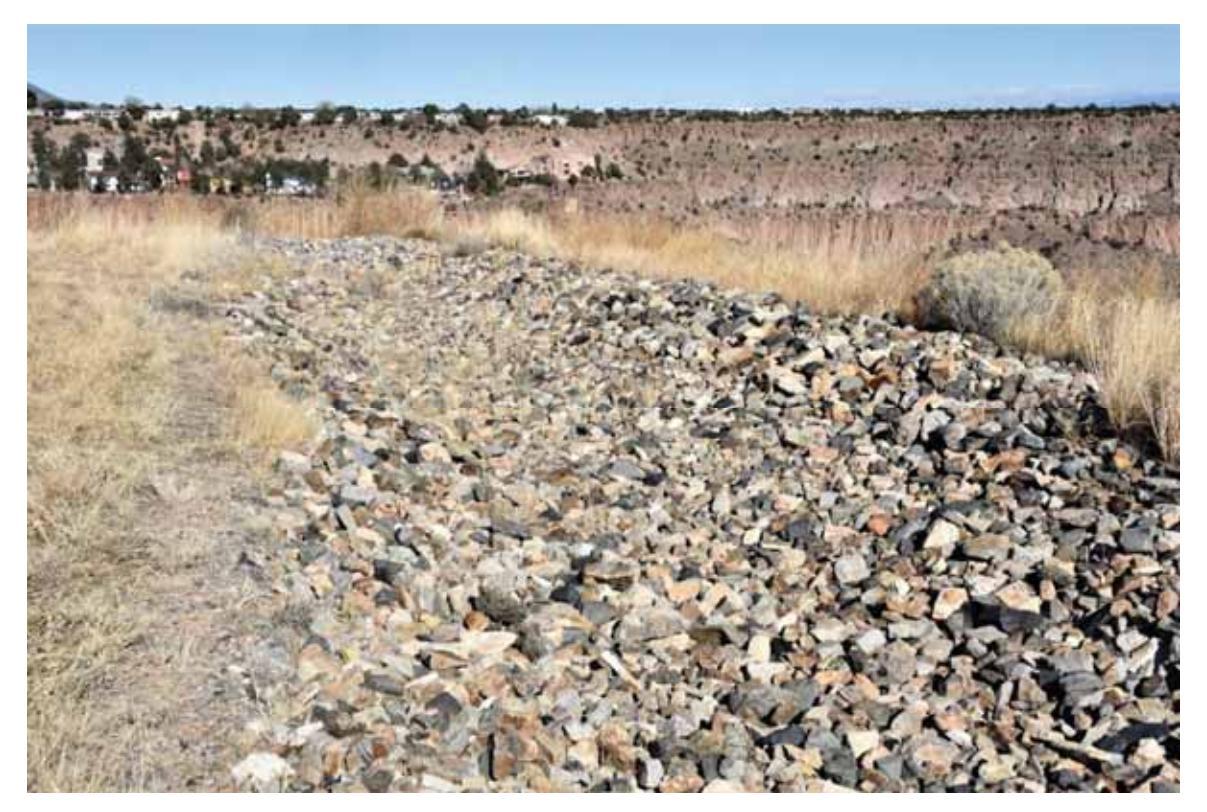
Photo 15 Eastern drainage channel, looking north

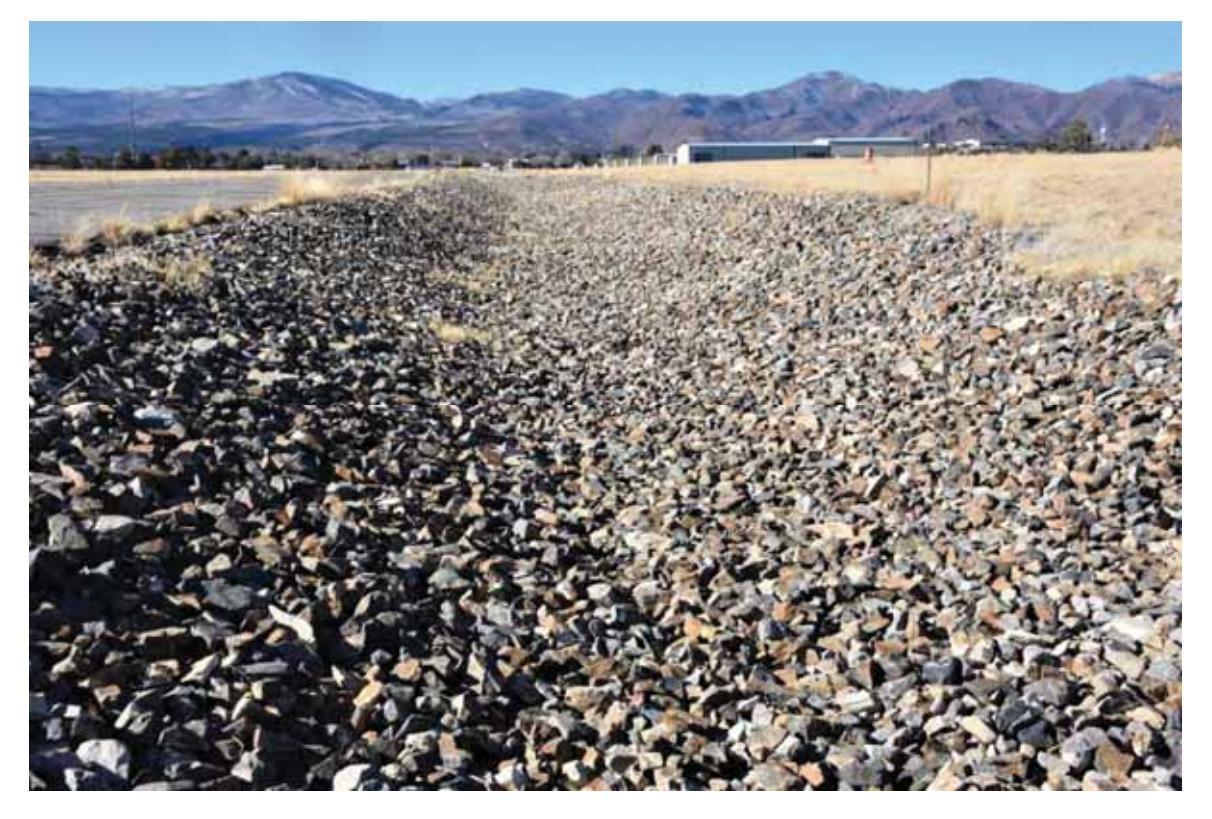
Photo 16 Southern drainage channel, looking west

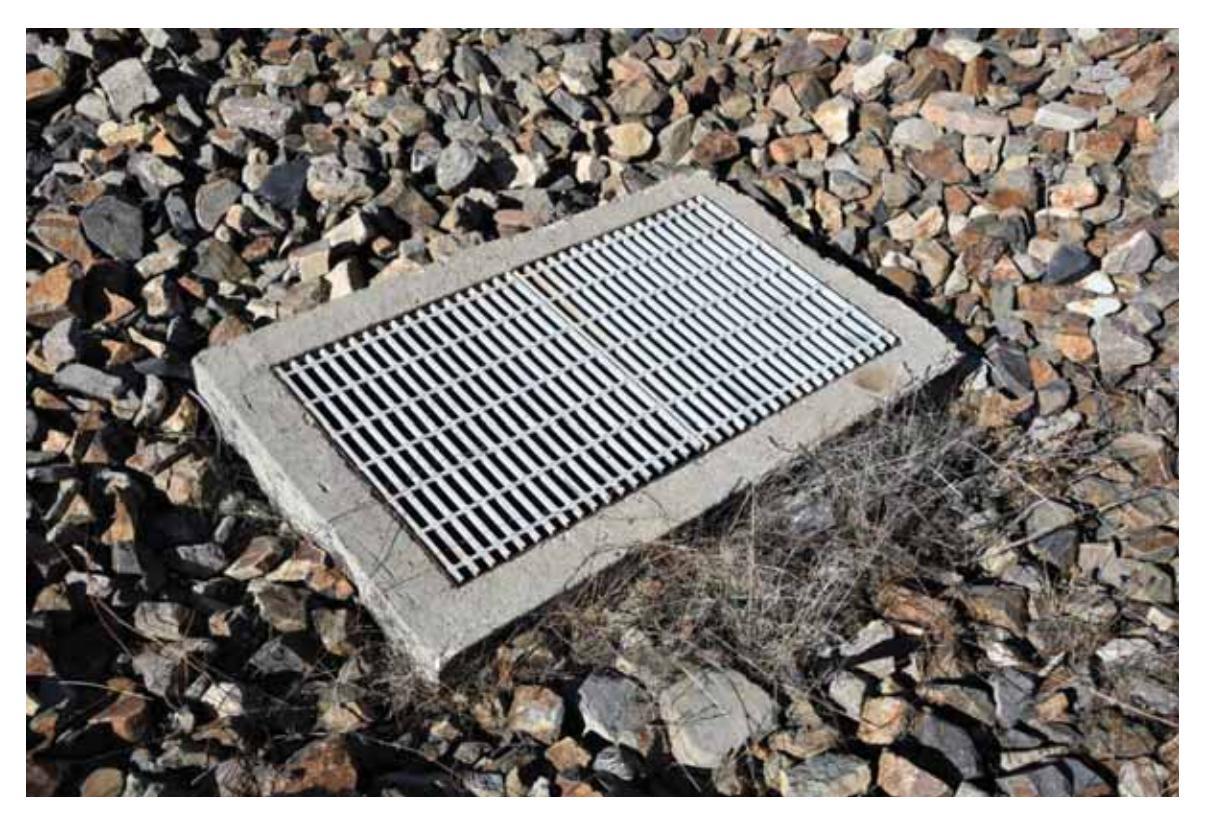
Photo 17 Southern drainage channel inlet structure

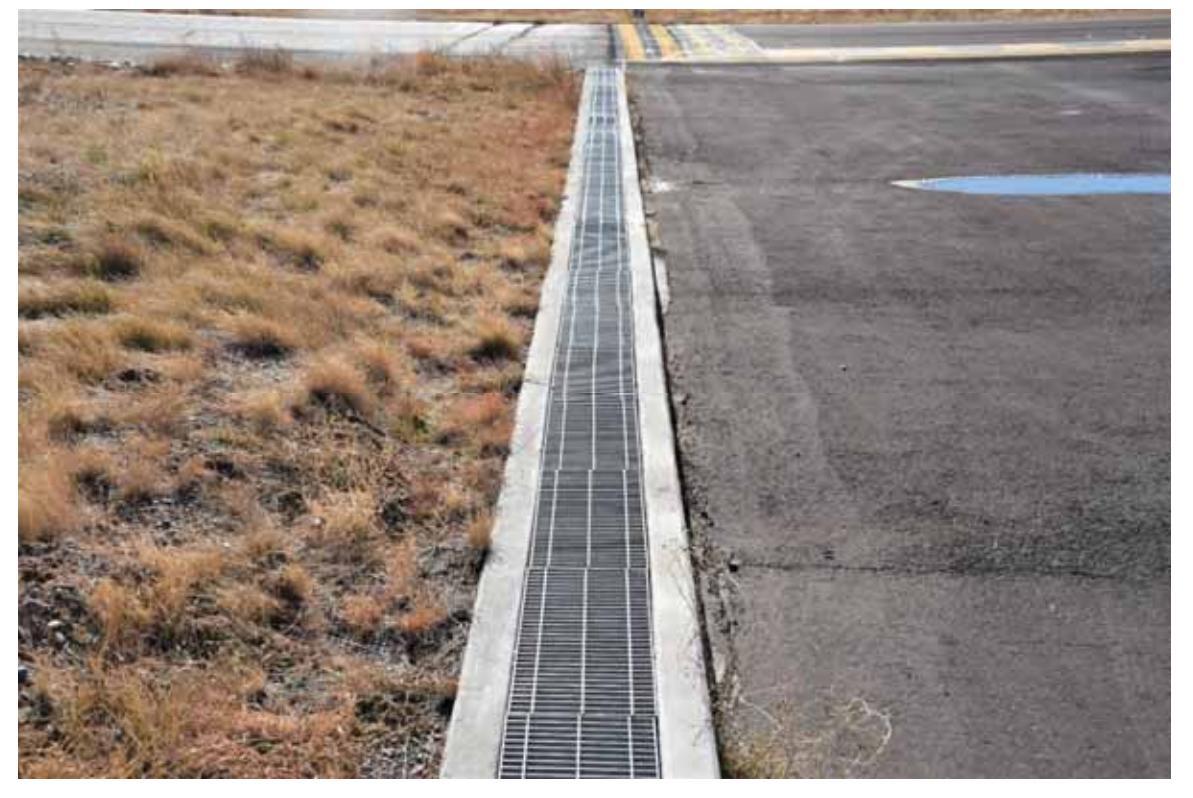
Photo 18 Concrete culvert, looking south

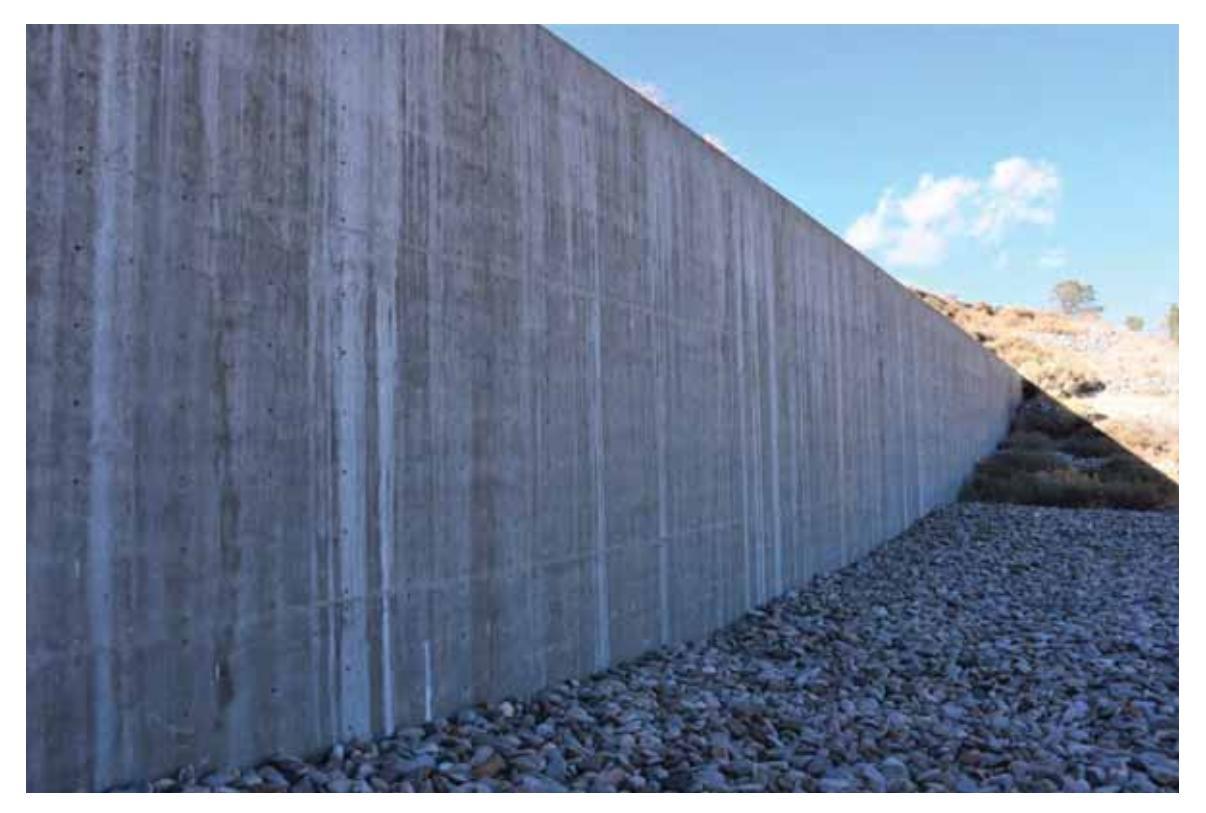
Photo 19 Concrete retaining wall, looking northwest

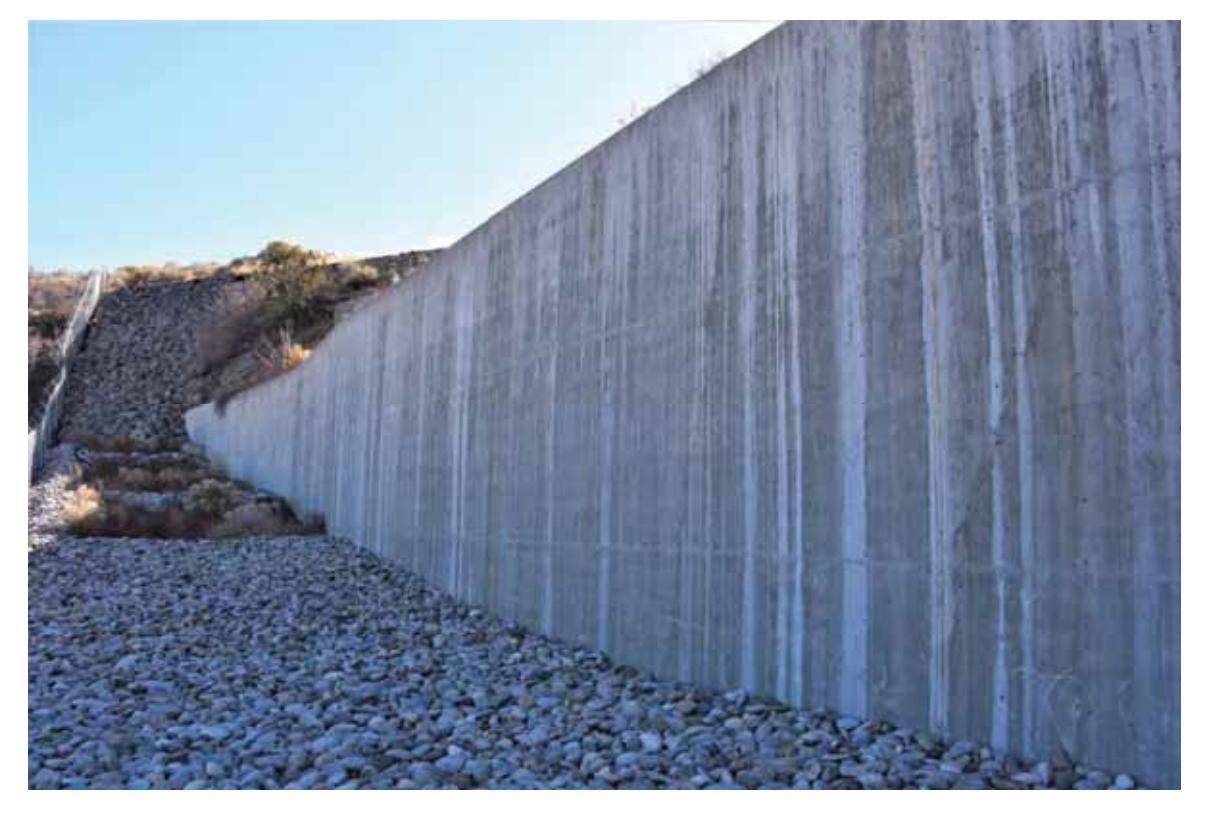
Photo 20 Concrete retaining wall, looking southeast

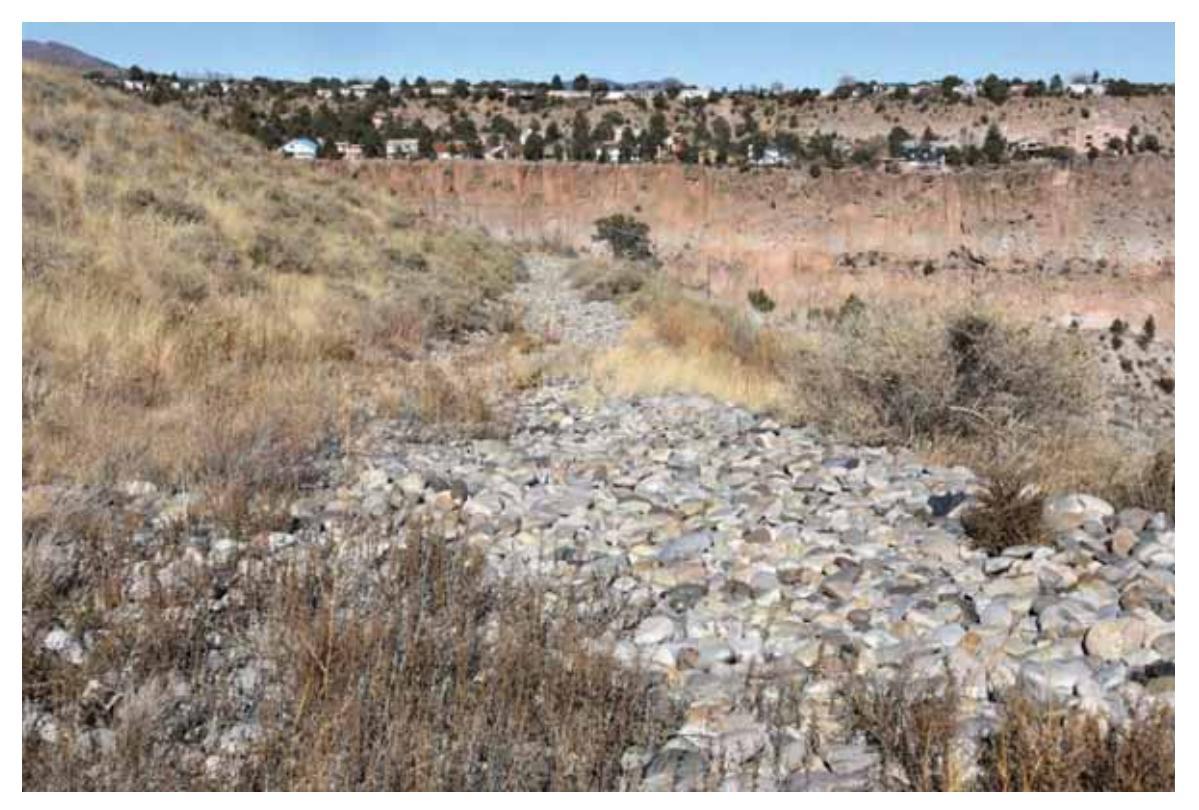
Photo 21 Rip-rap berm (side-slope berm) above retaining wall, looking north

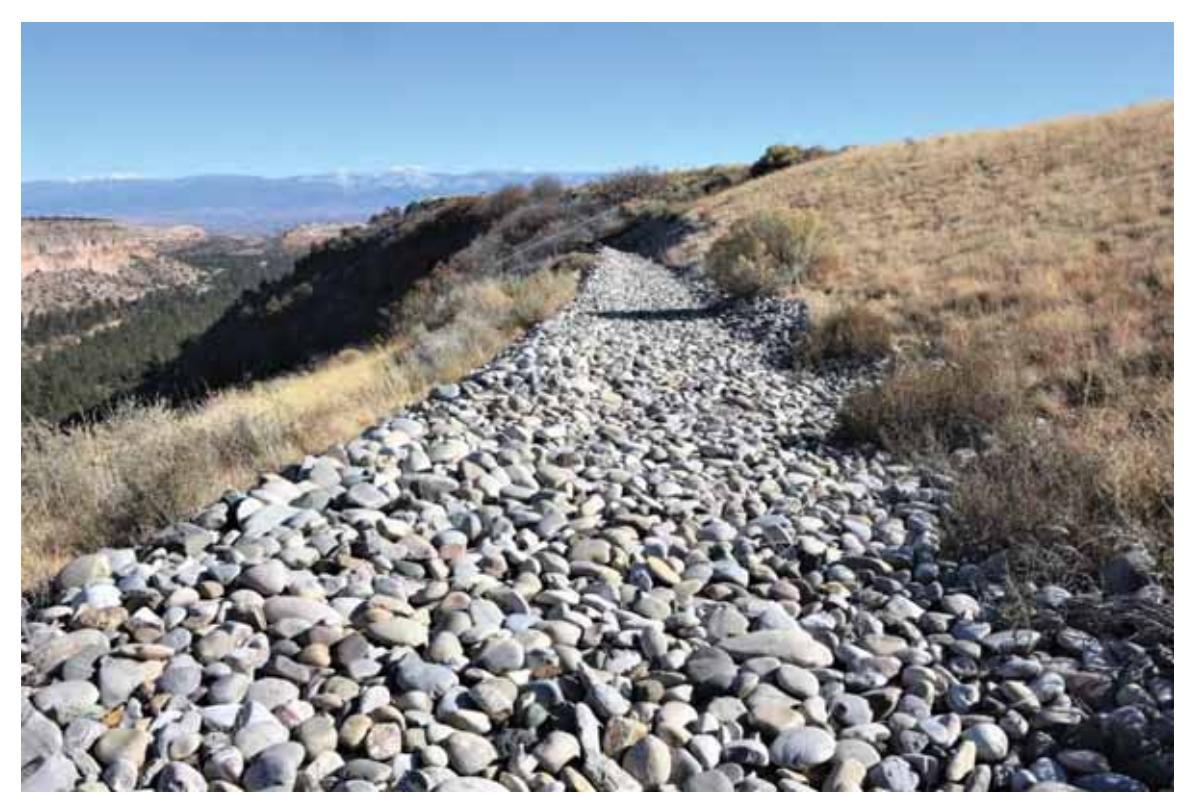
Photo 22 Rip-rap berm (side-slope berm) above retaining wall, looking east

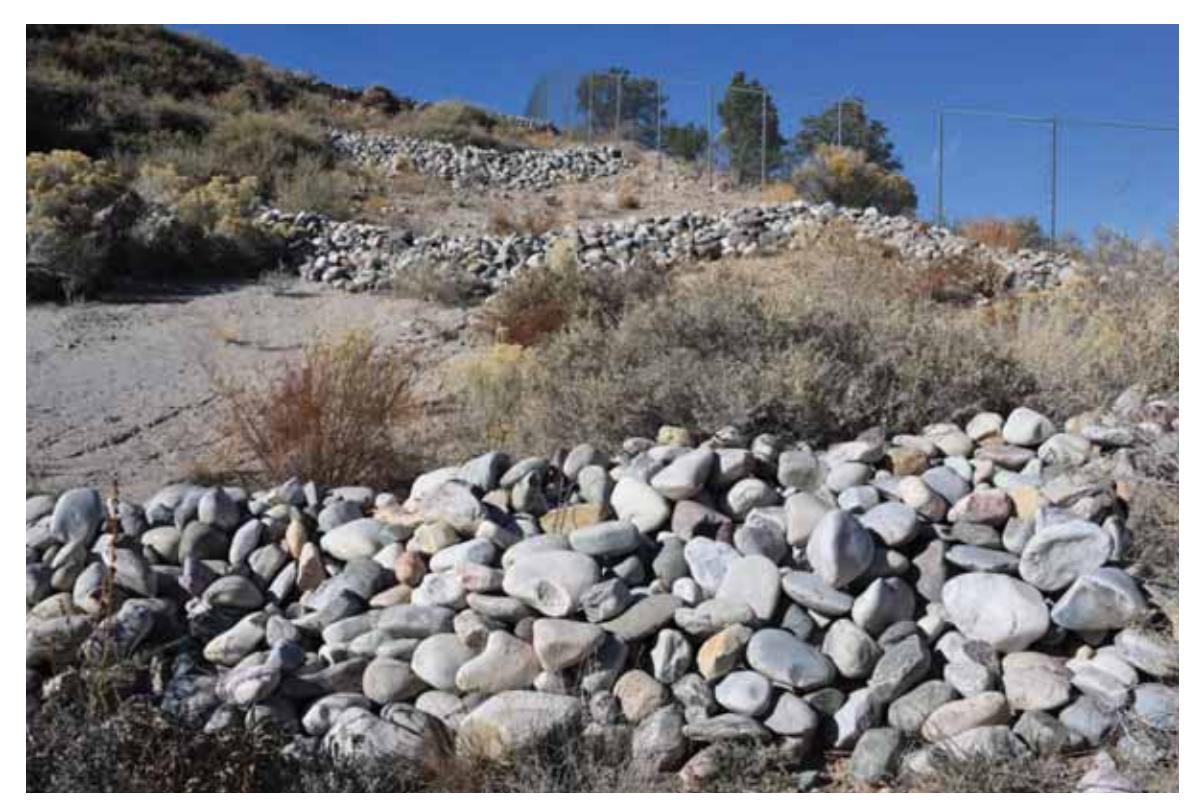
Photo 23 Rock check dams, looking northwest

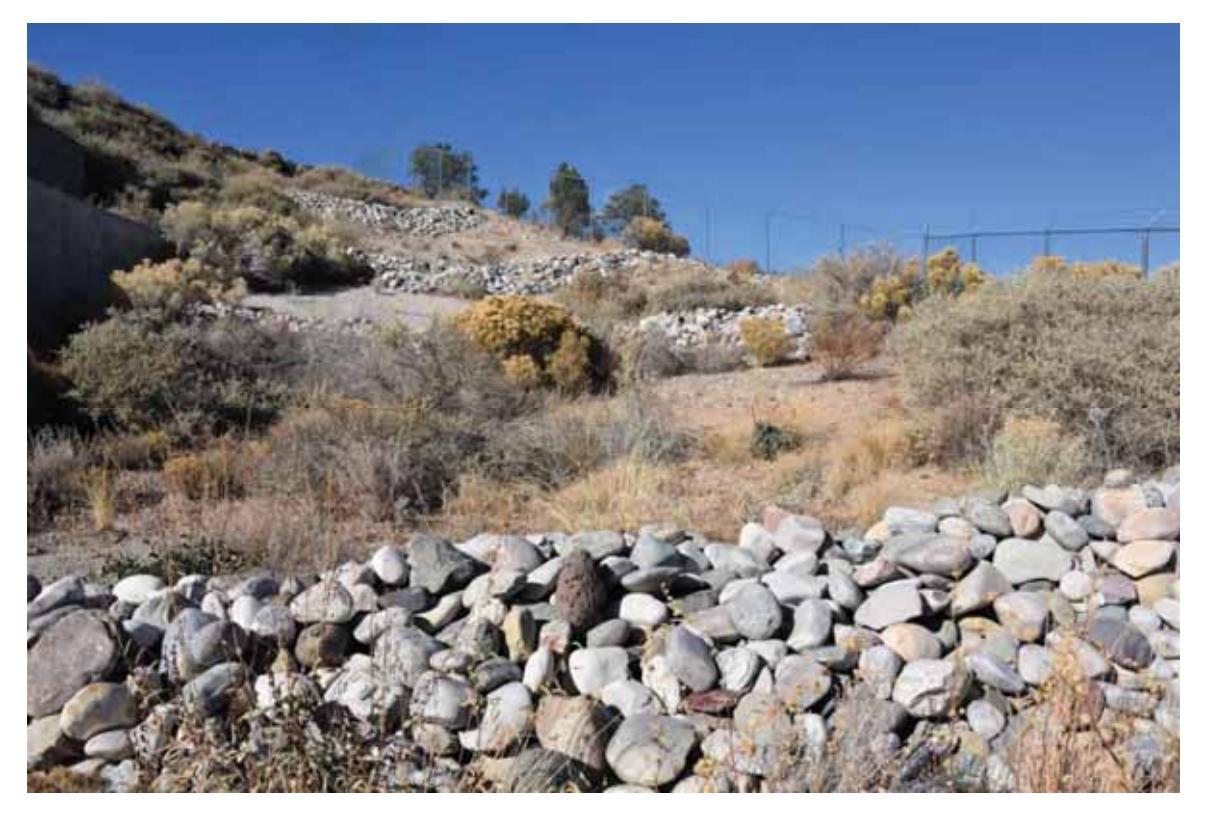
Photo 24 Rock check dams, looking northwest

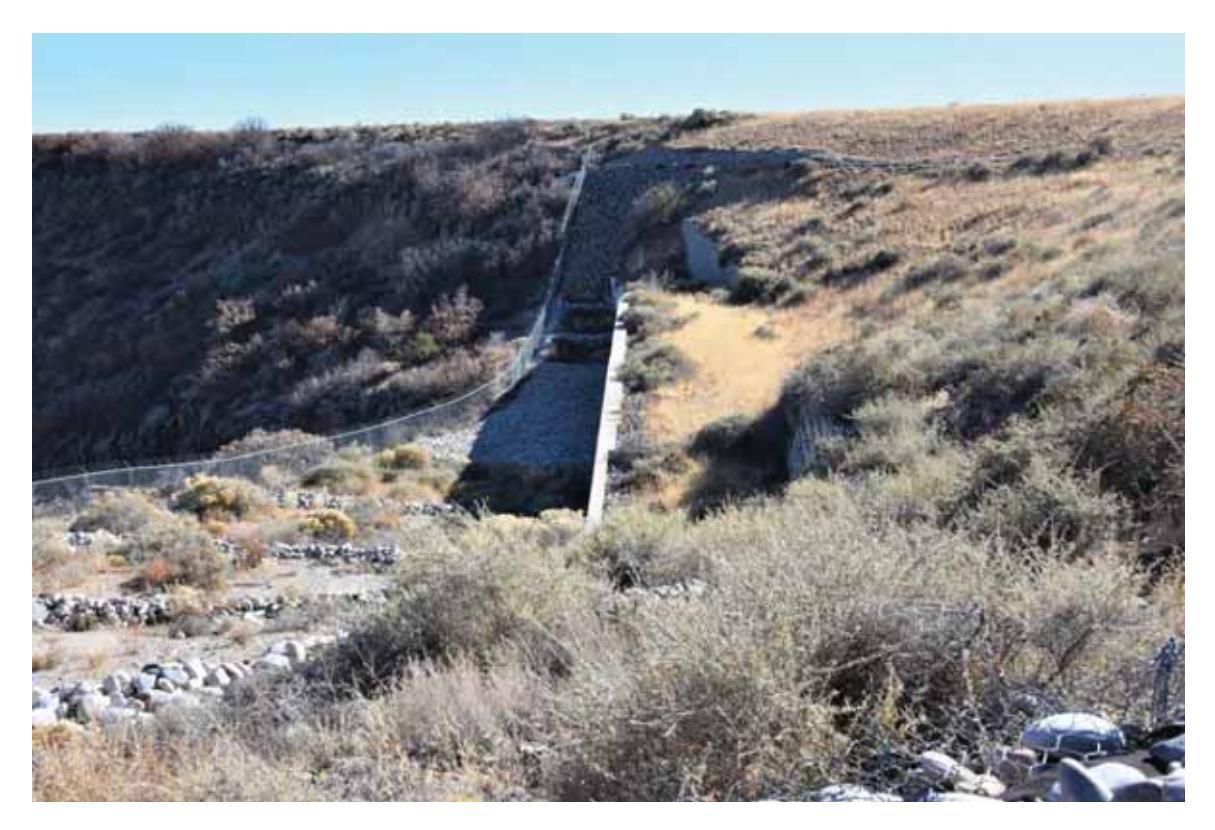
Photo 25 Eastern terrace, rock check dams, and retaining wall, looking southeast
