Subject:Submittal of the 2022–2023 Annual Long-Term Monitoring Status Report (July 2022
through June 2023) for the Los Alamos County Airport Landfill Cover System
Replacement, Solid Waste Management Units 73-001(a,d) in Technical Area 73

July 2023 EM2023-0423

2022–2023 Annual Long-Term Monitoring Status Report (July 2022 through June 2023) for the Los Alamos County Airport Landfill Cover System Replacement, Solid Waste Management Units 73-001(a,d) in Technical Area 73

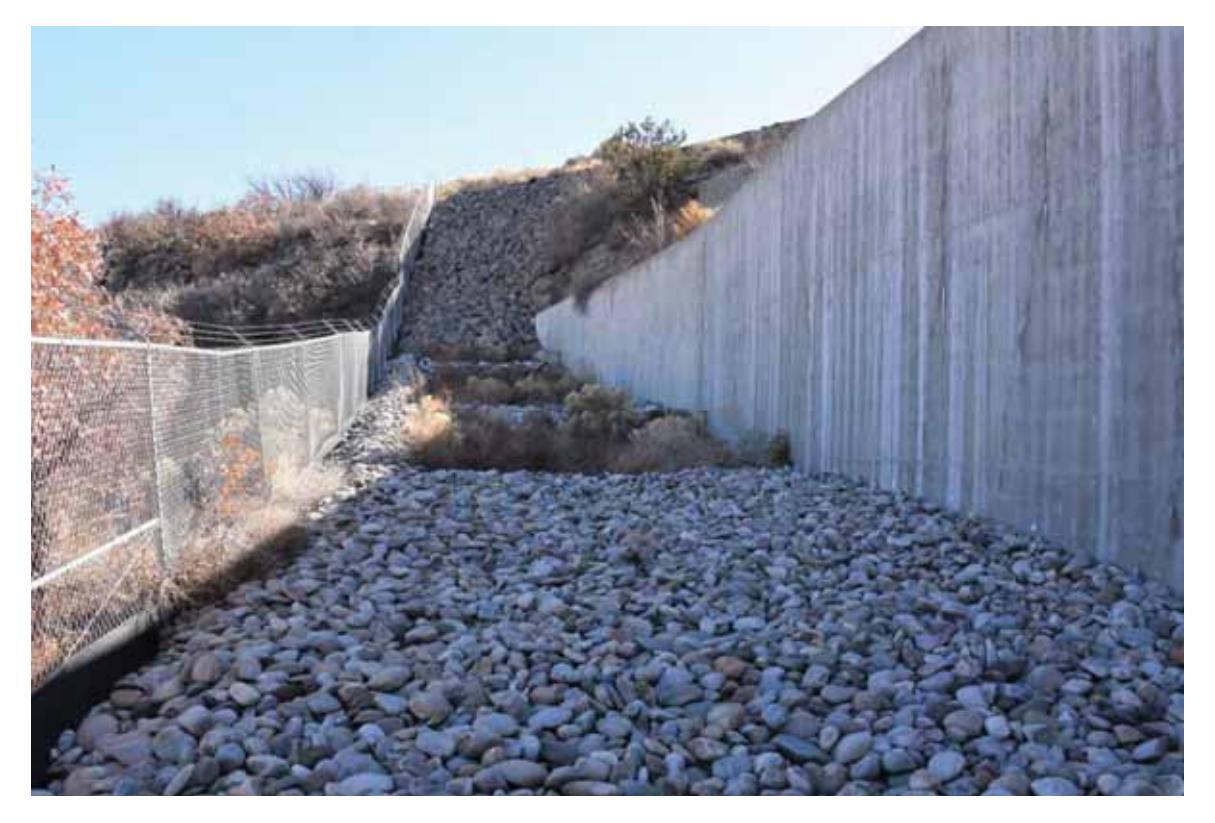
Photo 26 Drainage channel adjacent to concrete retaining wall, looking southeast

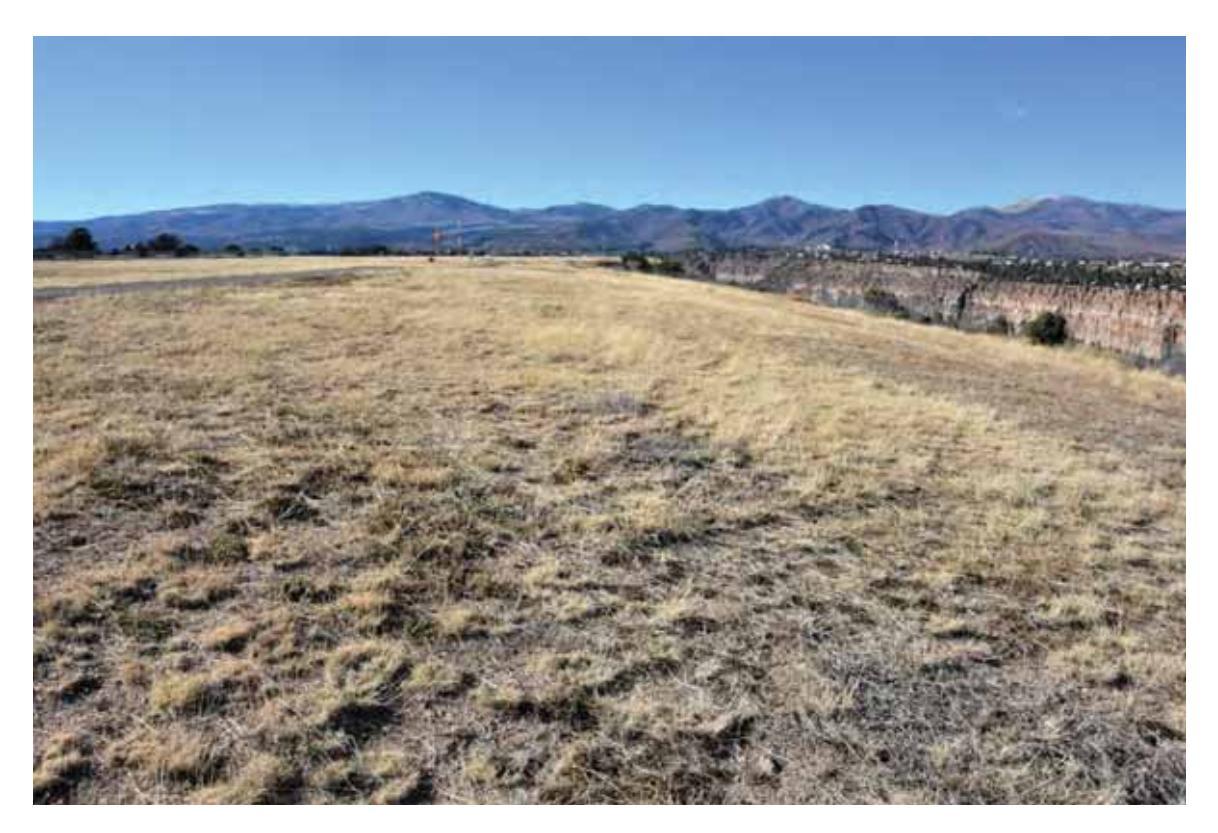
Photo 27 Northern side of the western end of the Debris Disposal Area, looking west

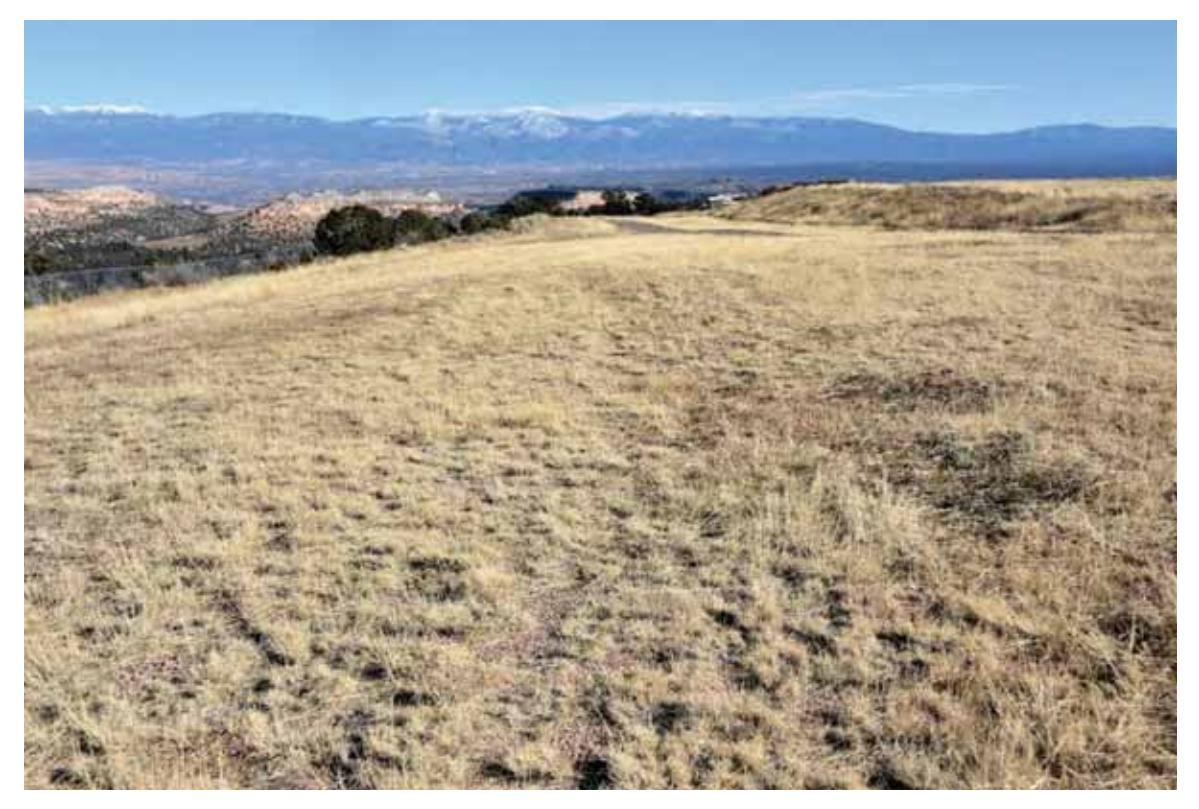
Photo 28 Northern side of the western end of the Debris Disposal Area, looking east

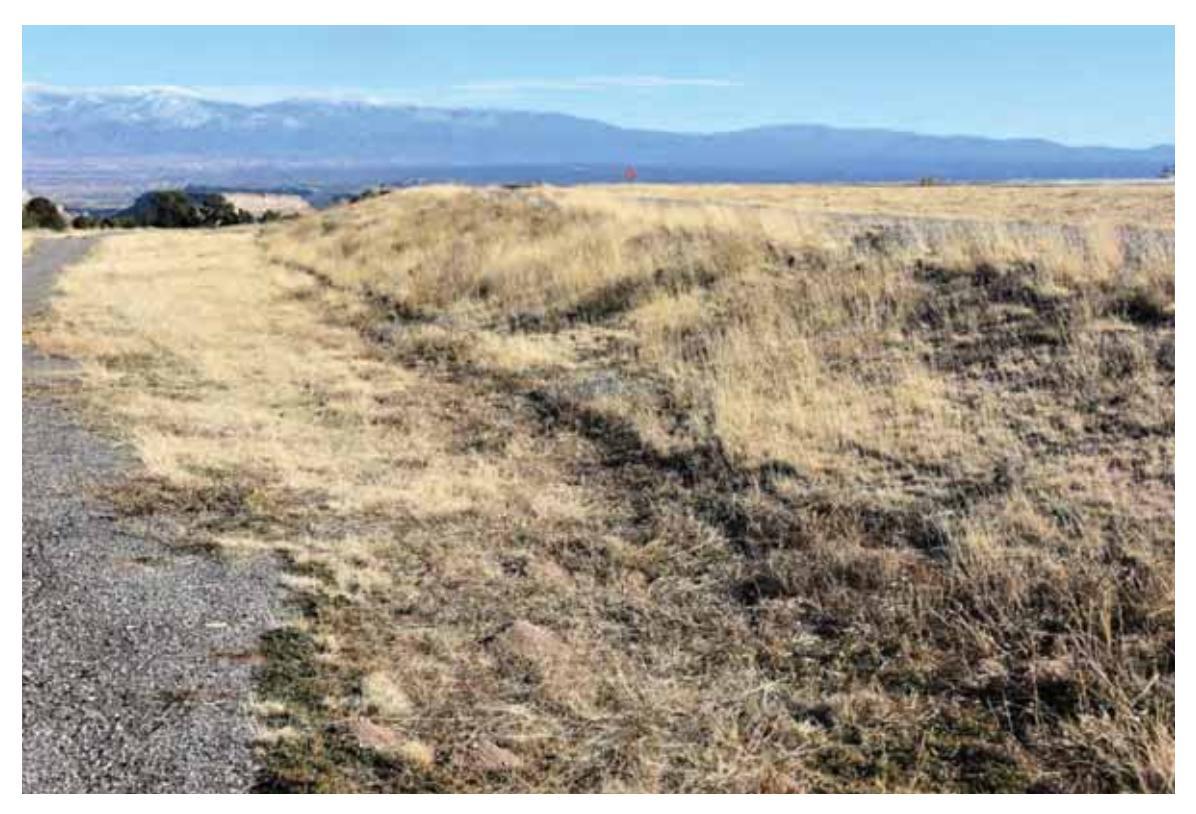
Photo 29 Southern side of the eastern end of the Debris Disposal Area, looking east.

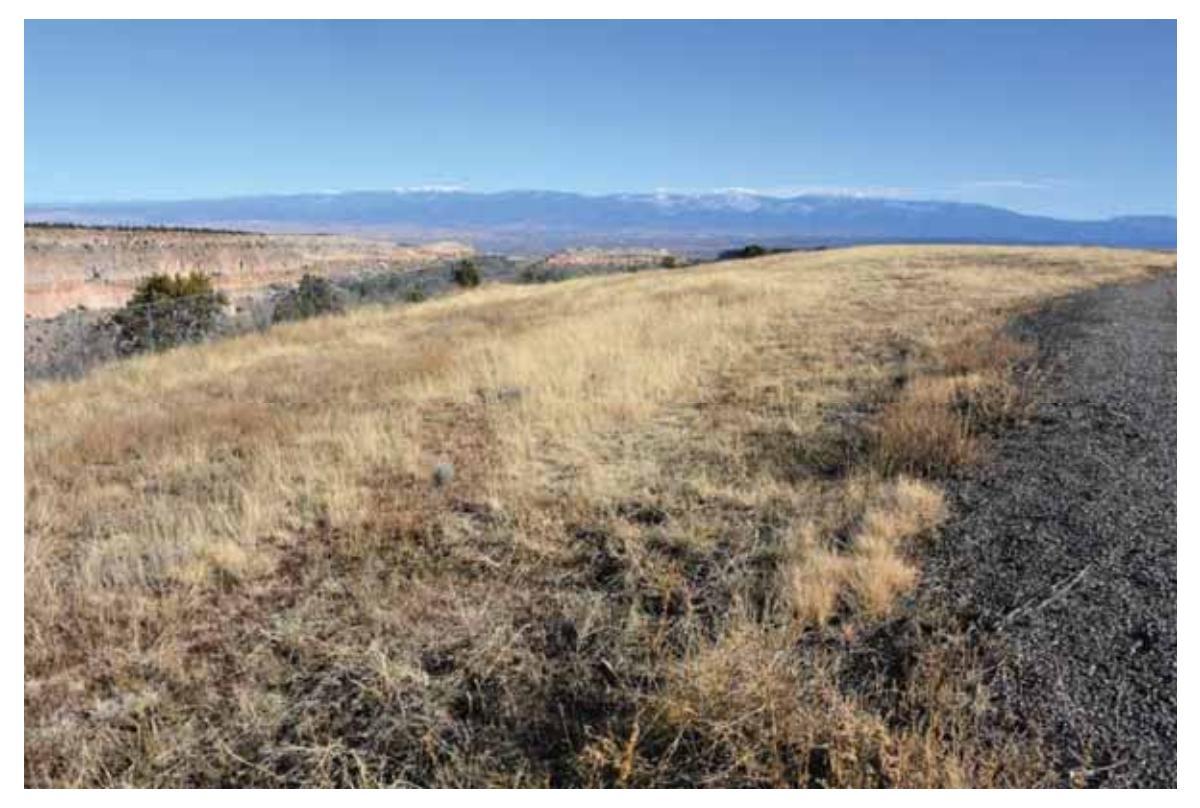
Photo 30 Northern side of the eastern end of the Debris Disposal Area, looking northeast

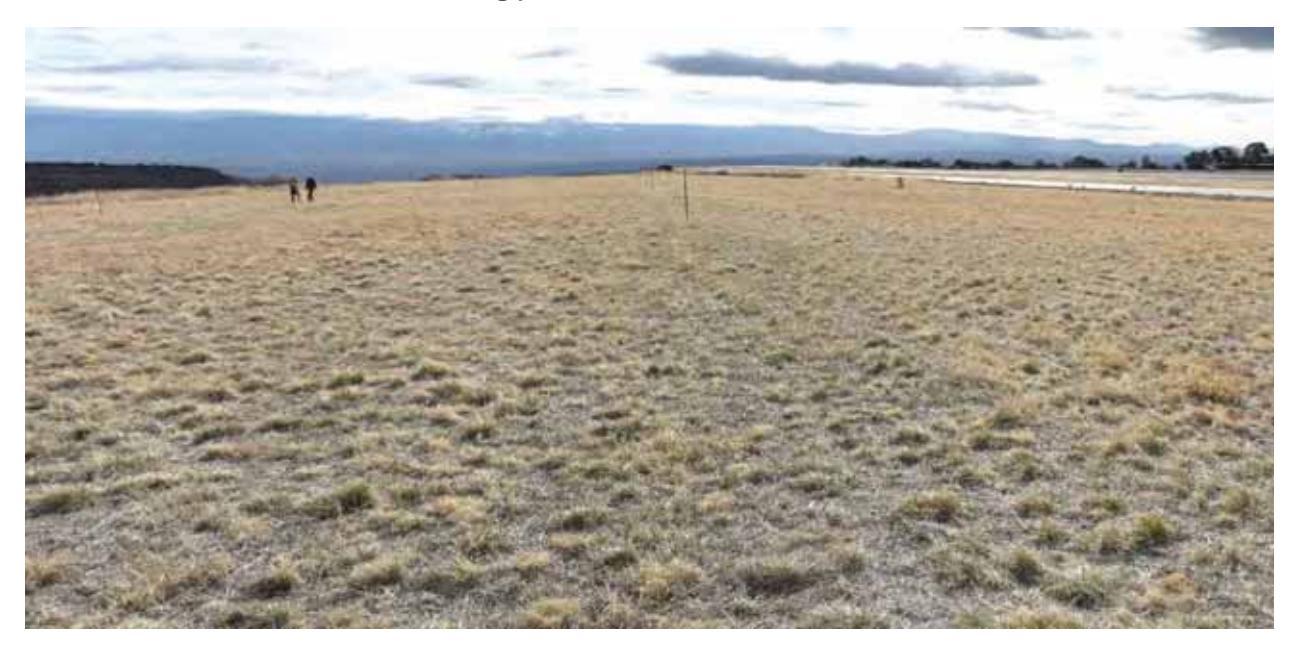
Site Element	Remarks
Vegetation Condition:	Remarks:
General Condition progressing as expected: ☑ Yes □ No If no, explain:	The vegetation was mowed in the fall and is dormant. Overall the vegetation cover is dense ~50–70%. The vegetation is well established and is expected to return in spring (Photos 2 to 4).
Repairs necessary: Yes No If yes, explain:.	
Rill/Gully: □ Yes ⊠ No	Remarks:
Areal Extent: N/A	No evidence of rills or gullies was observed on the
Depth: N/A	landfill cover.
Suspected Cause: N/A	
Repairs necessary: □ Yes ⊠ No If yes, explain:	
Wet Areas:	Remarks:
Ponding: Yes No	No wet areas were observed.
Areal Extent:	
Seeps: 🗆 Yes 🖾 No	
Areal Extent:	
Estimated Flow Rate:	
Soft Subgrade:	
Areal Extent:	
Repairs necessary: \Box Yes \boxtimes No If yes, explain:	
North and East Slopes Instability: Ves No	Remarks:
Areal Extent: N/A	The slopes were observed to be in stable condition with
Suspected Cause:	no evidence of erosion, slumping, or cracking (Photos 5

Photo 2 Vegetation on the west-central section of the ET cover, looking east

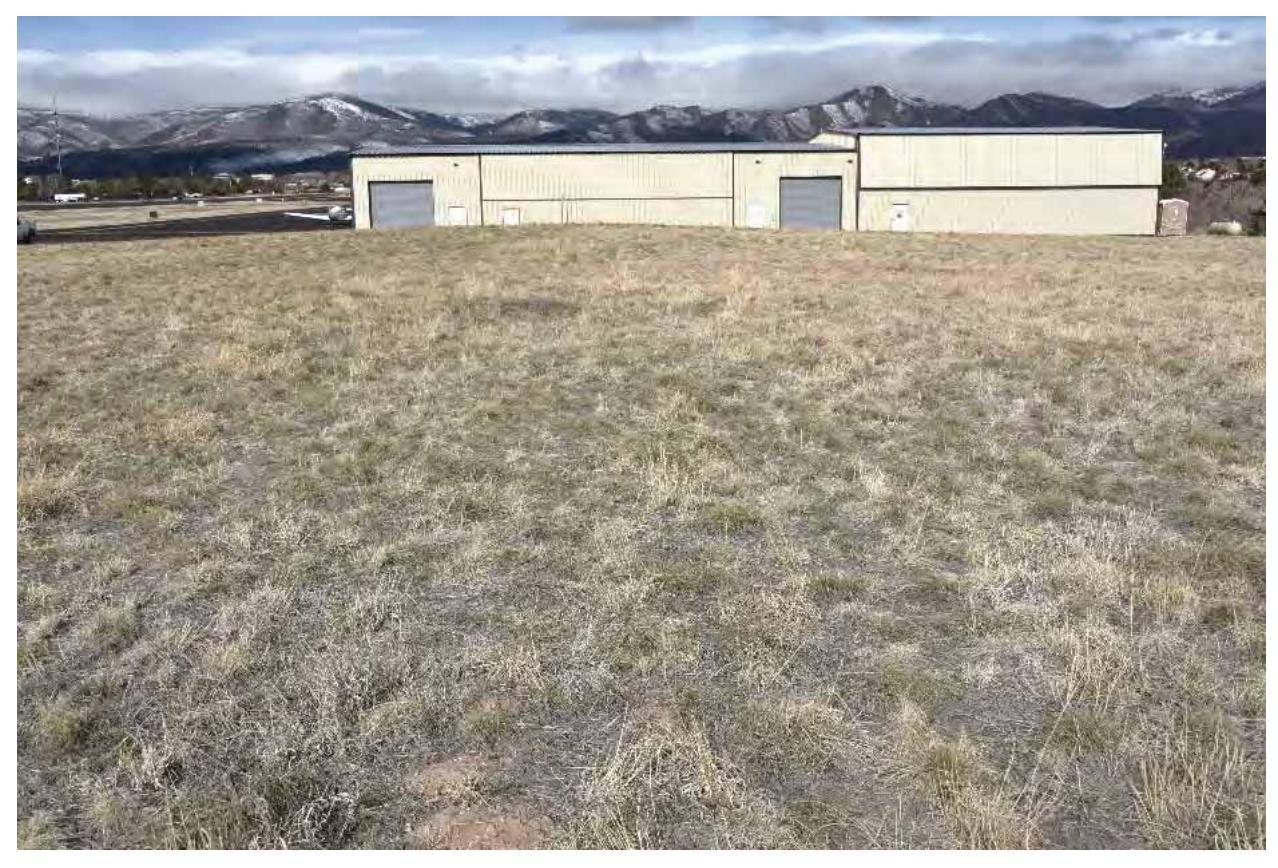
Photo 3 Vegetation on the western end of the ET cover, looking west

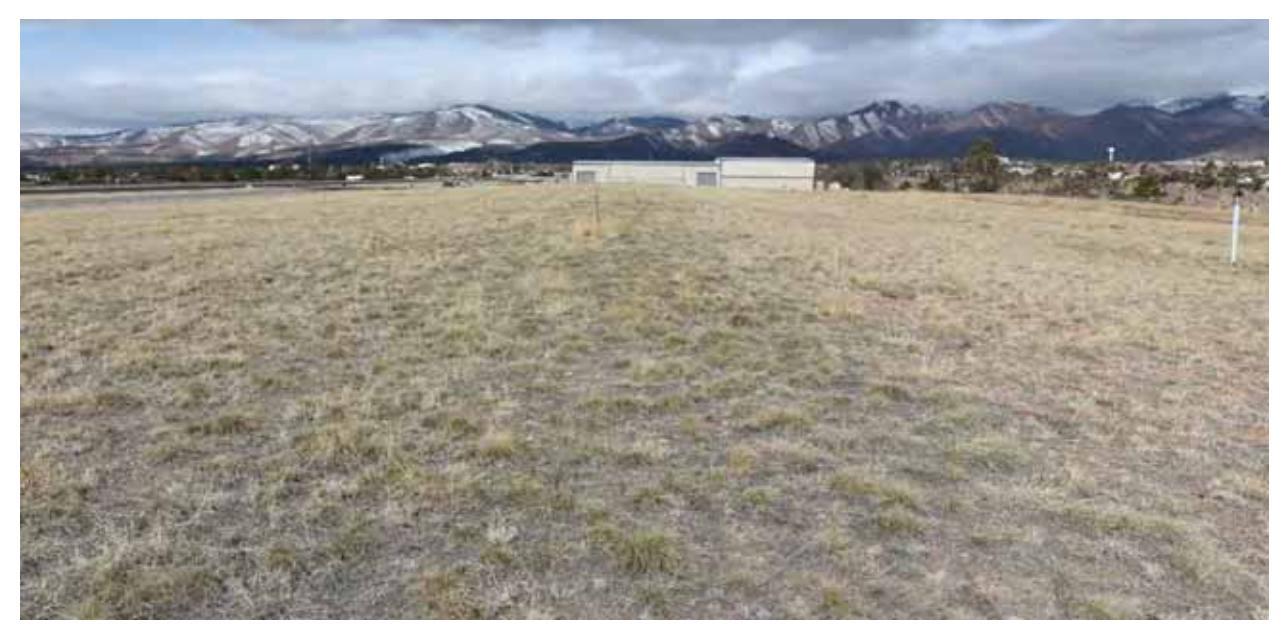
Photo 4 Vegetation on the eastern end of the ET cover, looking west

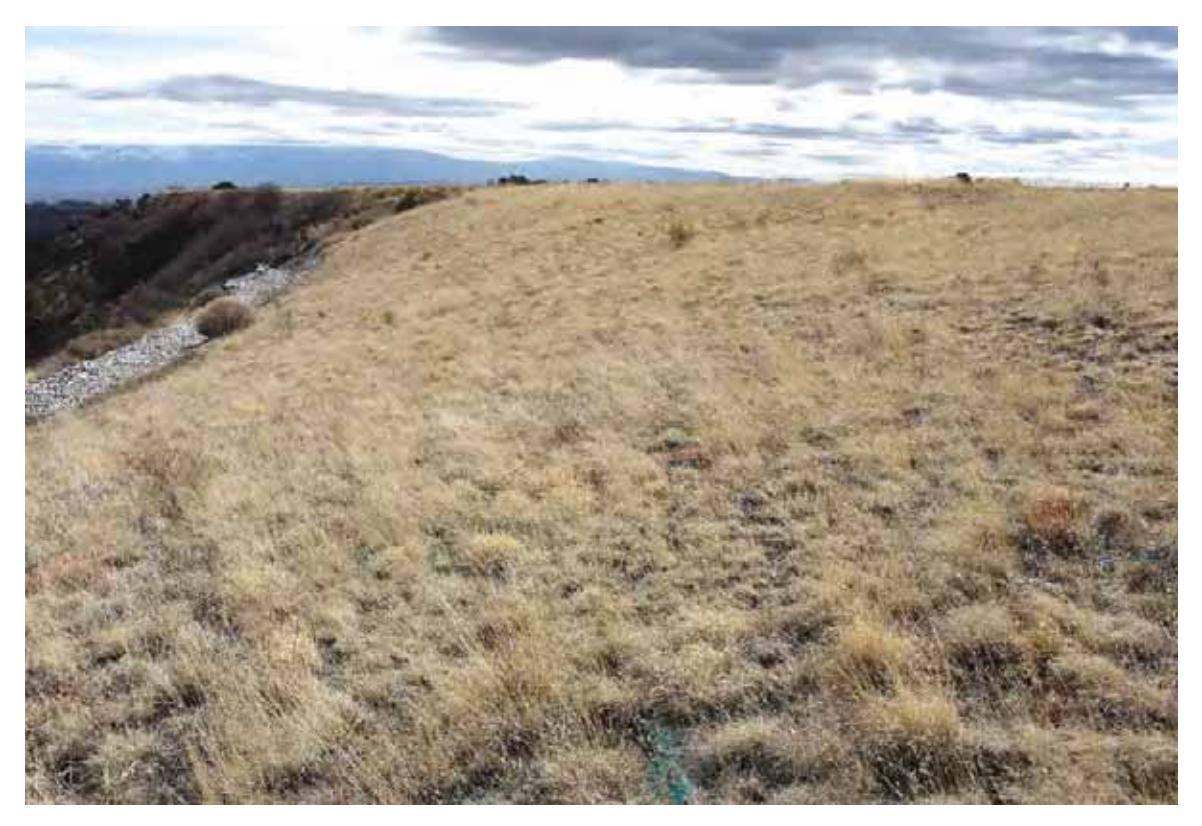
Photo 5 Vegetation on the upper section of the eastern side slope, looking east

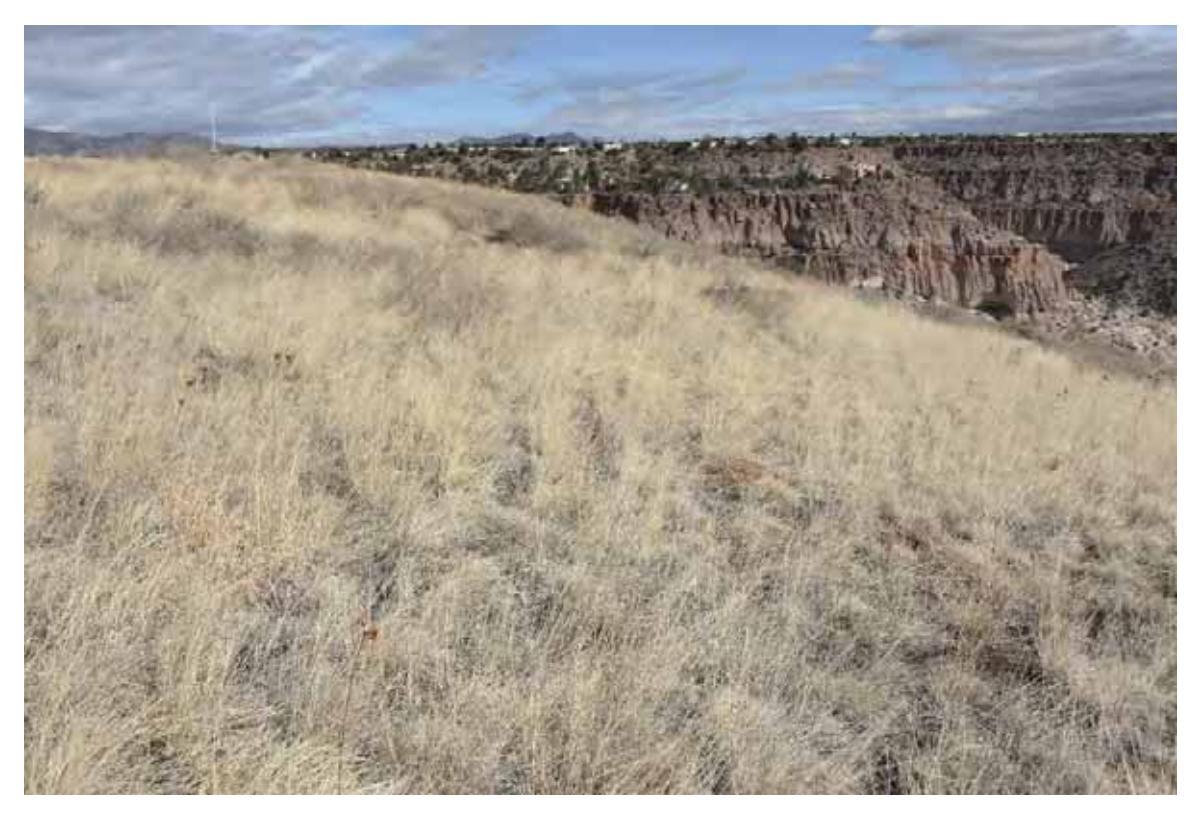
Photo 6 Vegetation on the upper section of the eastern side slope, looking north

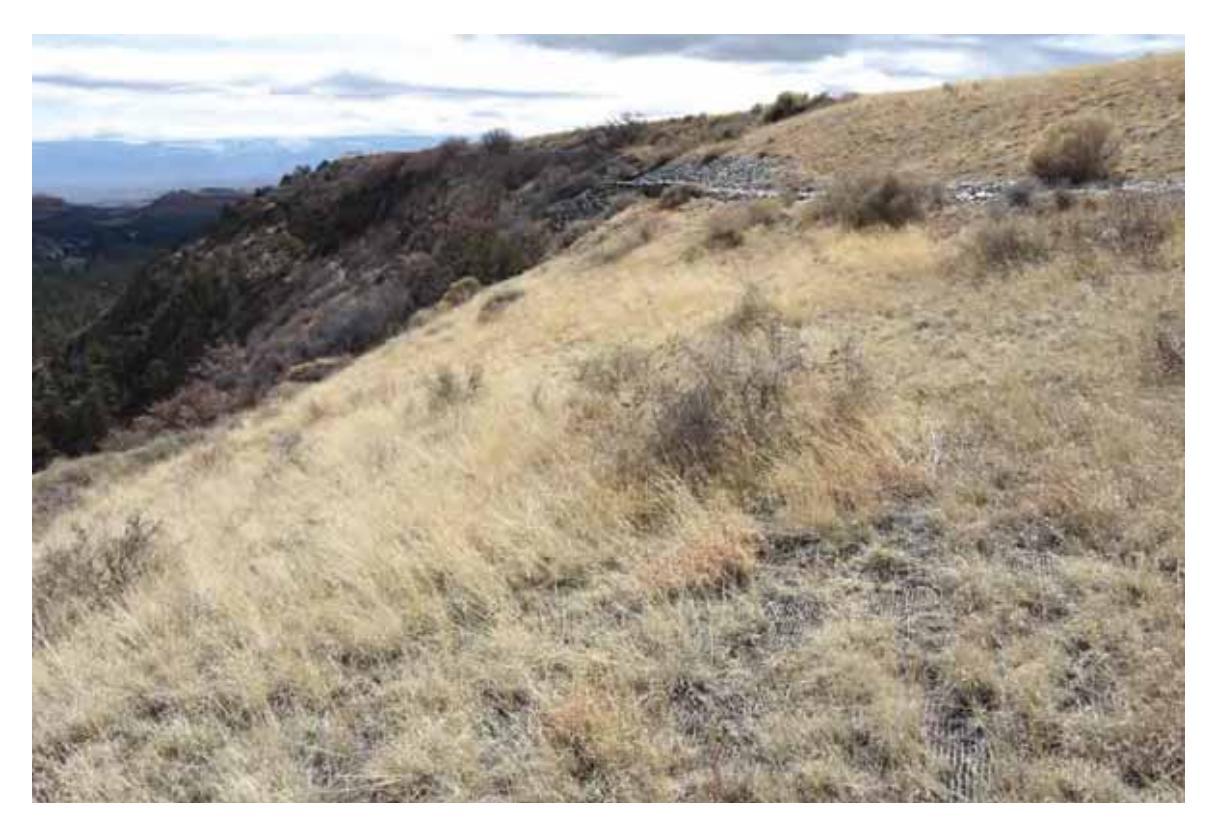
Photo 7 Vegetation on the lower section of the eastern side slope, looking east

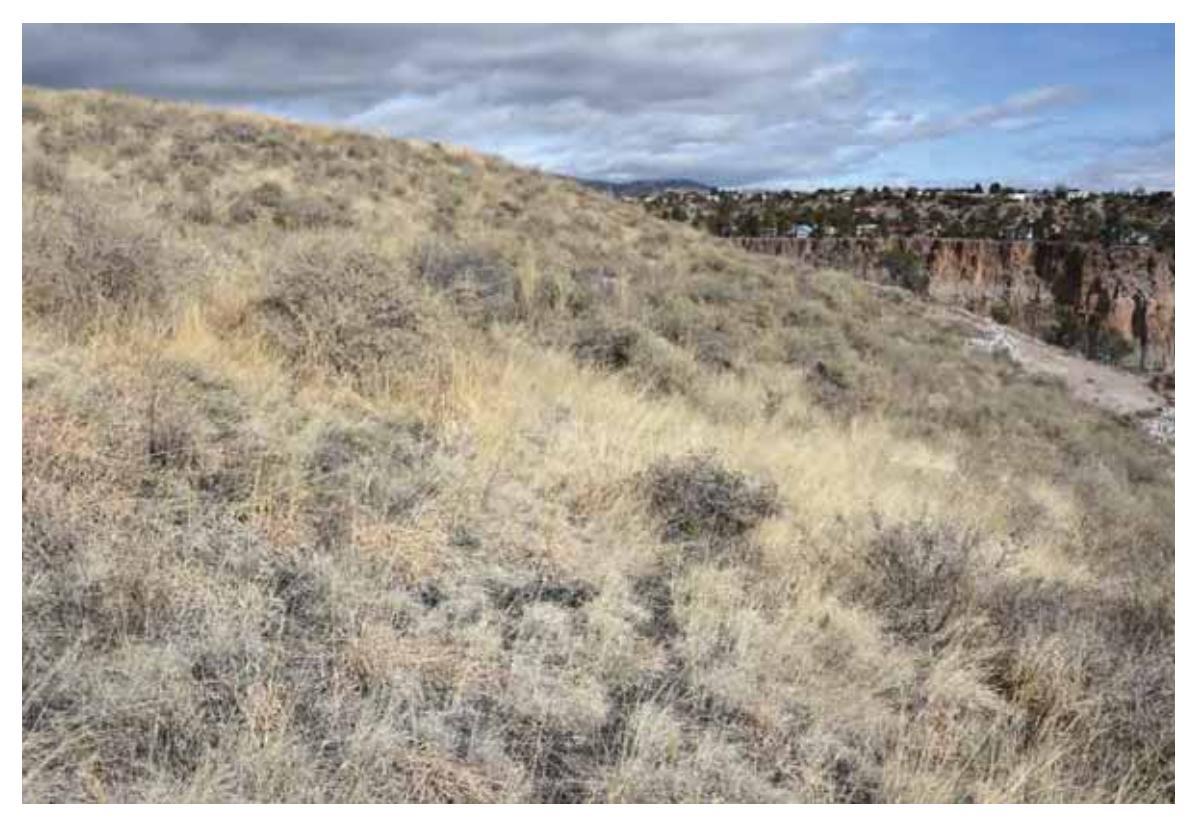
Photo 8 Vegetation on the lower section of the eastern side slope, looking north

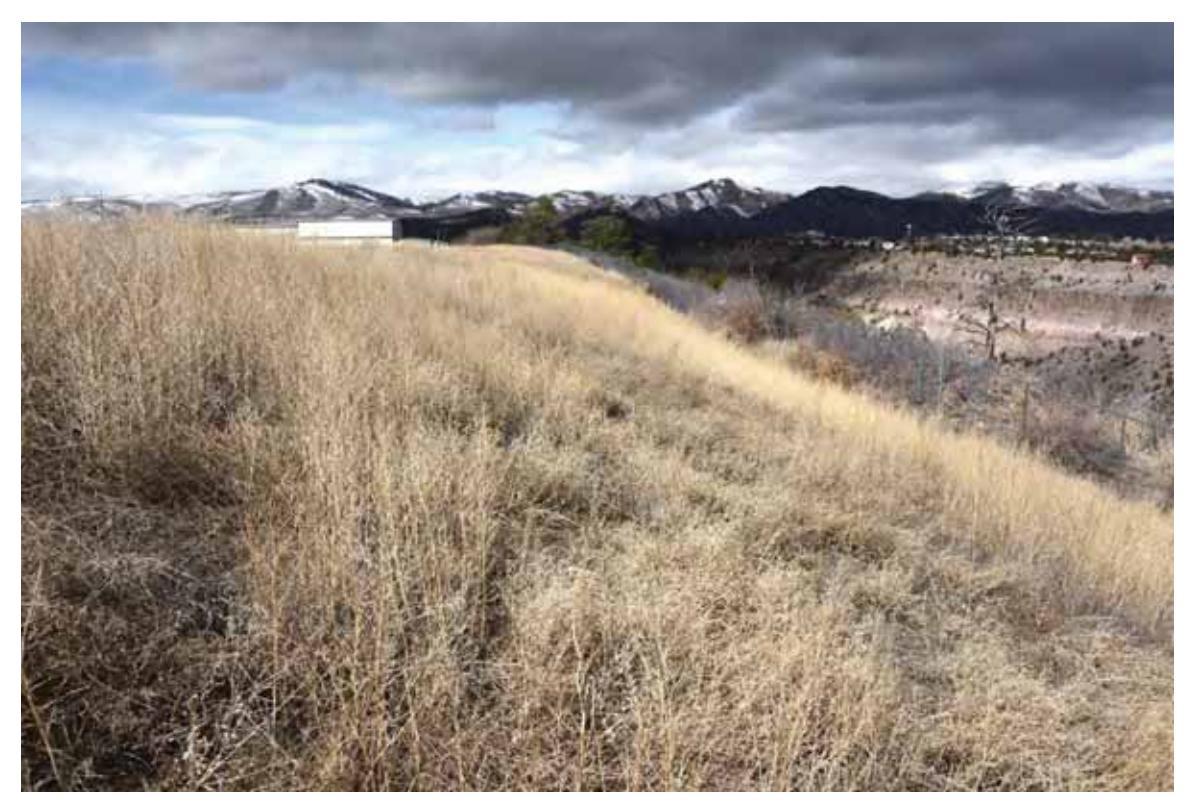
Photo 9 Vegetation on the northern side slope, looking west

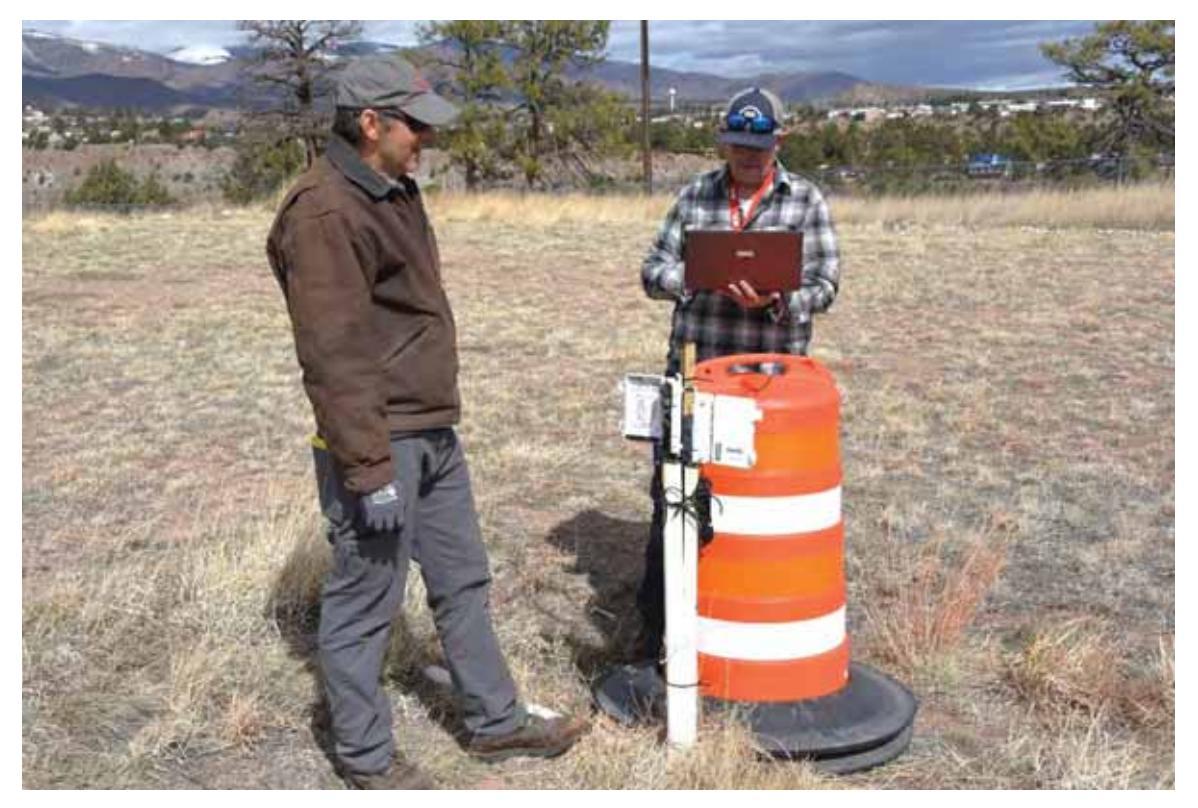
Photo 10 Inspection crew downloading moisture monitoring data from northern data logger

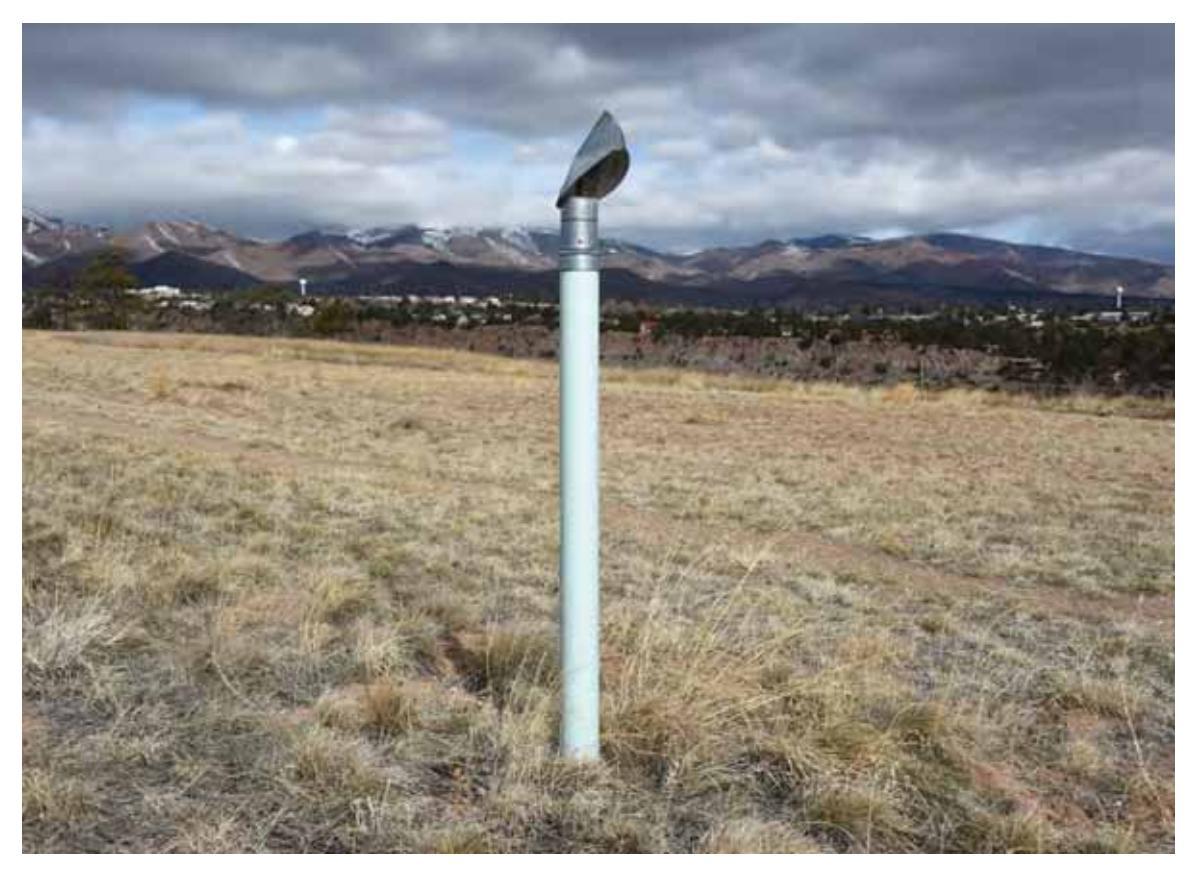
Site Element	Remarks
Methane Monitoring Instrumentation: Functioning Properly: ☑ Yes ☐ No Damage: ☐ Yes ☑ No Repairs necessary: □ Yes ☑ No	Remarks: Methane monitoring was performed during this inspection and no methane was detected in any of the methane vents. The vents were inspected and are in good condition (Photo 11).
Rip Rap Lined Drainage Channels	
Settlement (Low Spots): □ Yes ⊠ No Areal Extent: □ □ Depth: Repairs necessary: □ Yes ⊠ No If yes, explain:	Remarks: The riprap-lined channels were in excellent condition and there was no observable sedimentation within the channels (Photos 12 to 14).
Material Degradation:□ Yes⊠ NoMaterial Type:Areal Extent:Degree of DegradationRepairs necessary:□ Yes⊠ NoIf yes, explain:	Remarks: No material degradation was noted.
Erosion: □ Yes ⊠ No Areal Extent: □ Depth: Repairs necessary: □ Yes ⊠ No If yes, explain:	Remarks: No erosion was noted.
Undercutting: □ Yes ⊠ No Areal Extent: Depth: Repairs necessary: □ Yes ⊠ No If yes, explain:	Remarks: No undercutting was noted.

Photo 11 Eastern methane monitoring vent, looking north

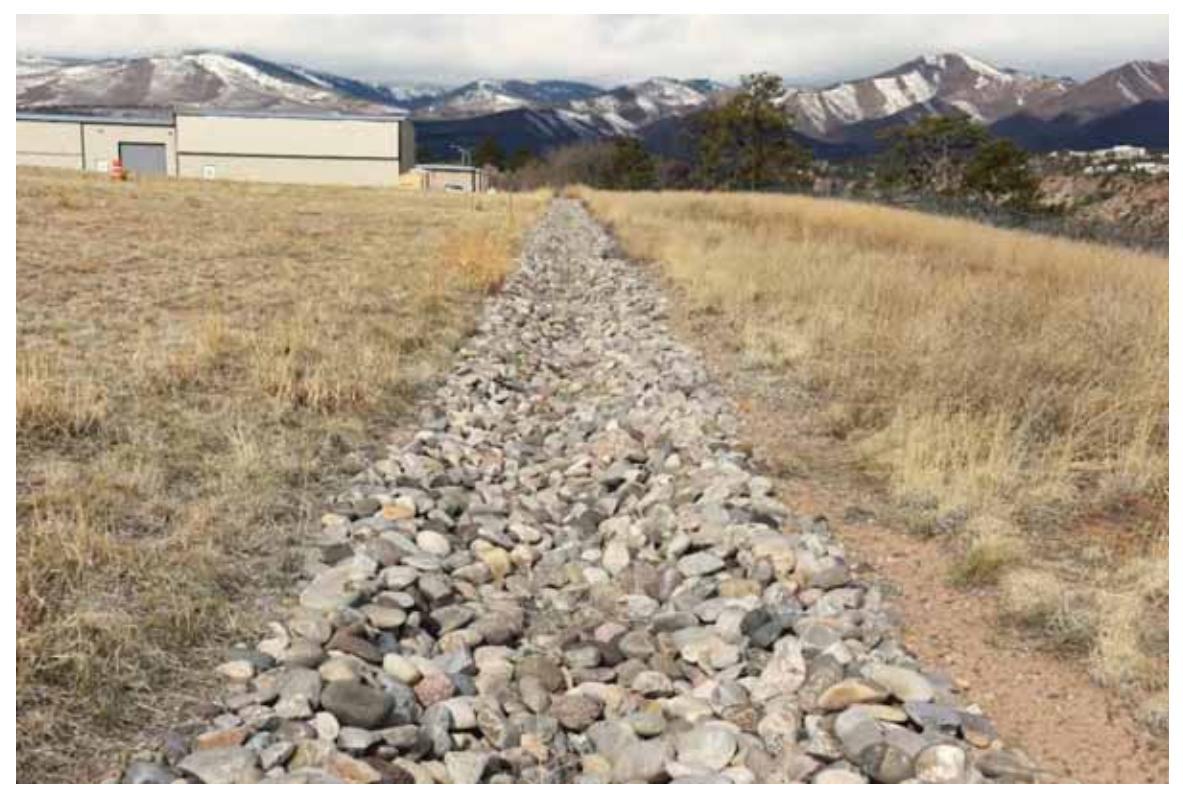
Photo 12 Northern drainage channel, looking west

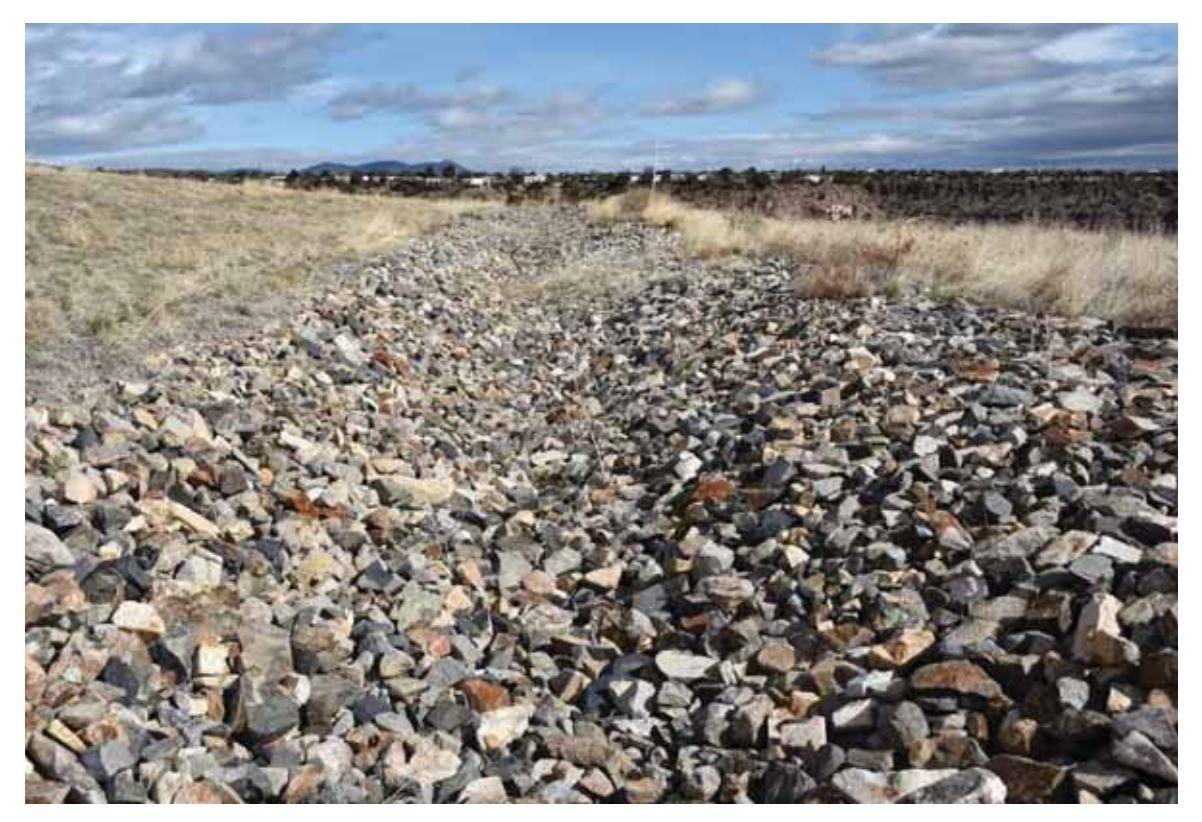
Photo 13 Eastern drainage channel, looking north

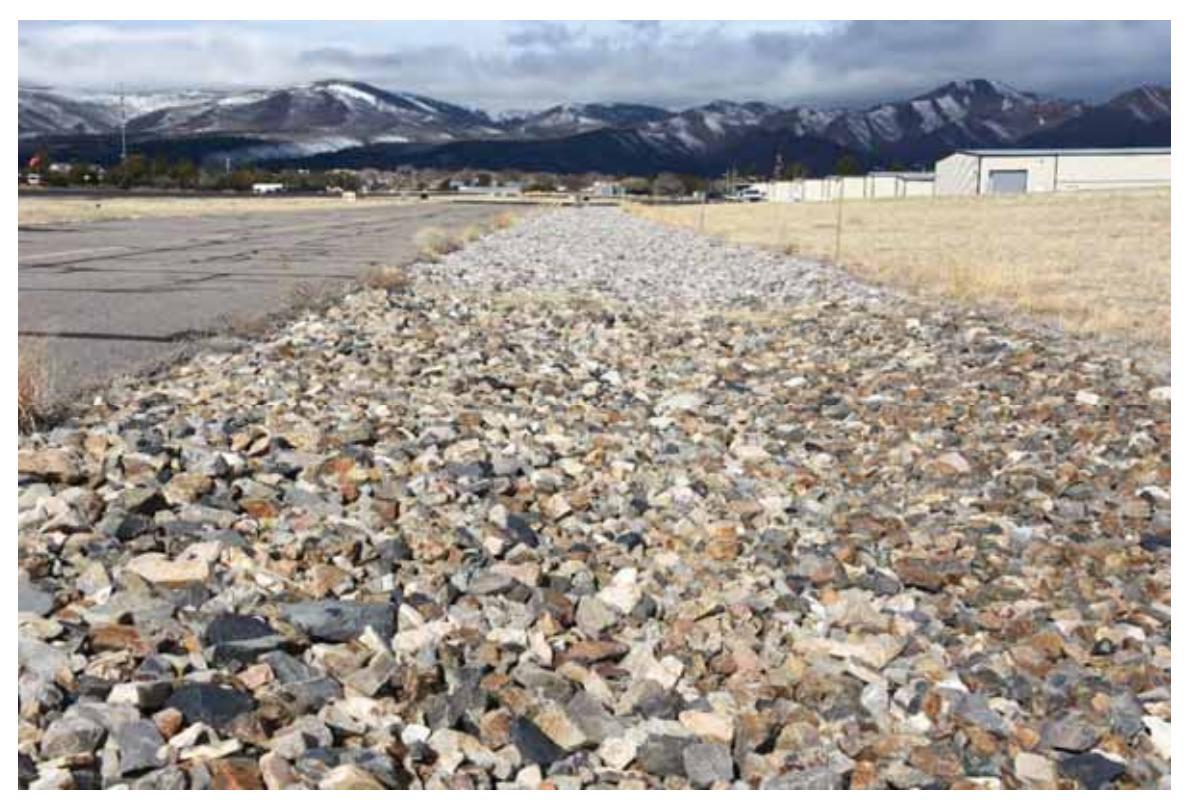
Photo 14 Southern drainage channel, looking west

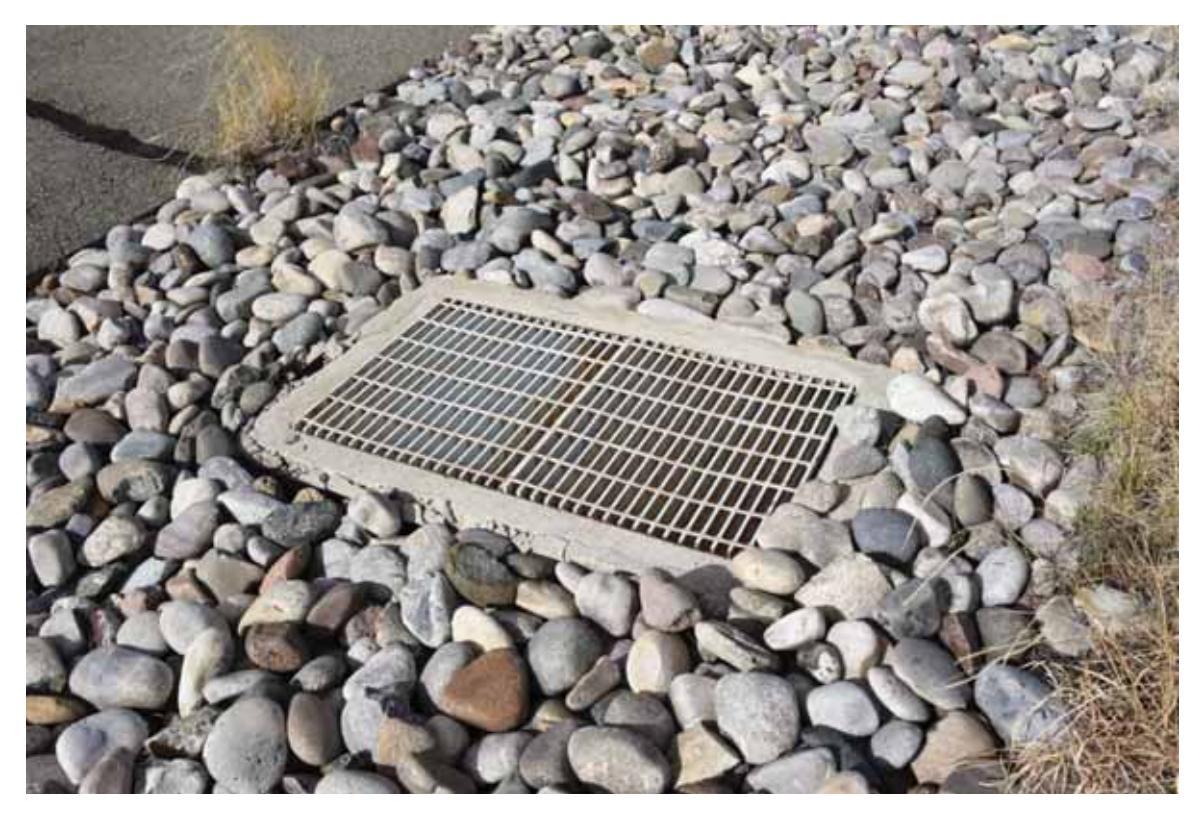
Site Element	Remarks
Drop Inlet Structures: Working Properly: ⊠ Yes □ No Condition:	Remarks: Structures are clear of debris and in good condition (Photo 15).
Extent of Damage: Repairs necessary: □ Yes ⊠ No If yes, explain:	
Concrete Culvert	
Siltation: □ Yes ⊠ No Areal Extent: Depth: Banairs necessary: □ Yes ⊠ No	Remarks: No siltation was observed.
Concrete Condition and Joints: General Condition progressing as expected: ☑ Yes □ No If no, explain: Issues Observed: □ Yes ☑ Yes □ No If no, explain: Repairs necessary: □ Yes ☑ No If yes, explain:	Remarks: Concrete is in good condition (Photo 16).
Grating Condition: General Condition progressing as expected: ☑ Yes □ No If no, explain: Issues Observed: ☑ Yes □ No If yes, explain: 33 ft of grating is missing at the north end of the culvert. Grates were stolen. Repairs necessary: ☑ Yes □ No If yes, explain: Grates will require replacement. □ □ □	Remarks: With the exception of grating sections that were removed from the site, grating is in good condition (Photo 16).

Photo 15 Western drop inlet structure along the southern drainage channel

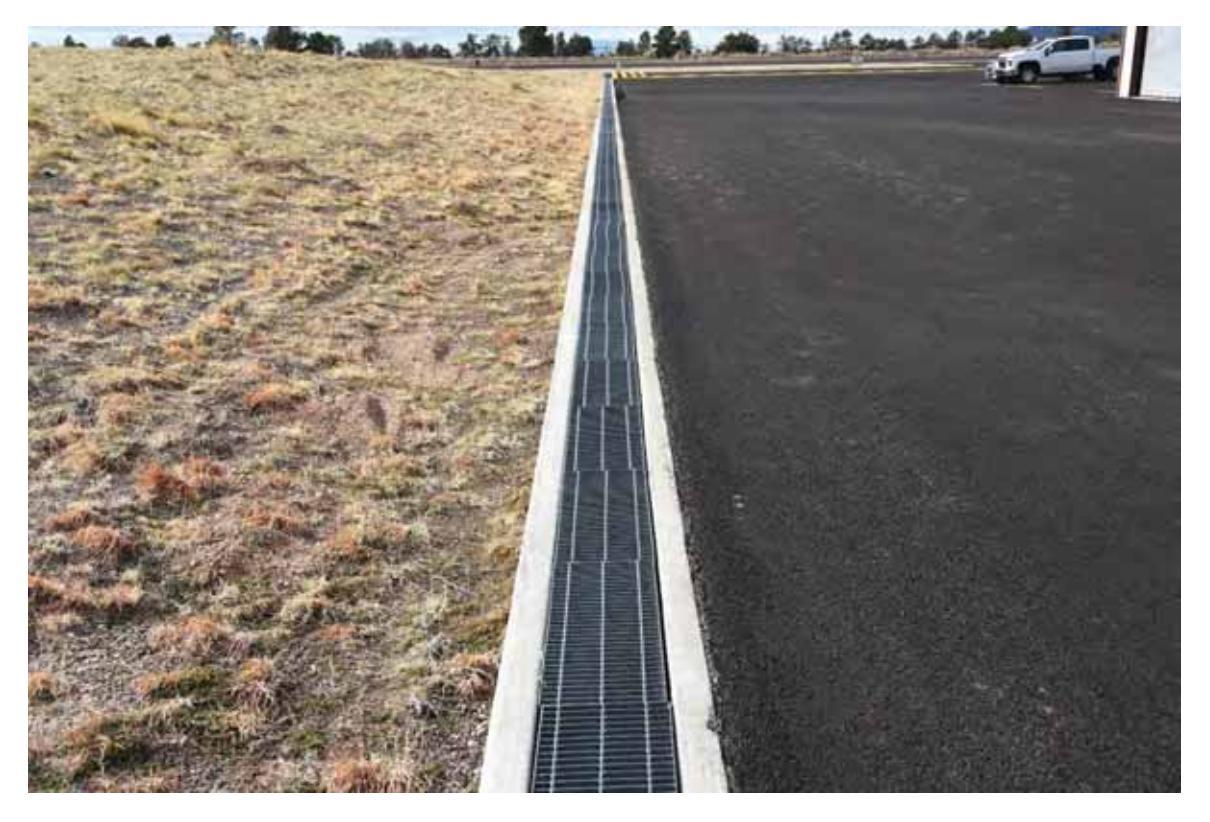
Photo 16 Concrete culvert, looking south

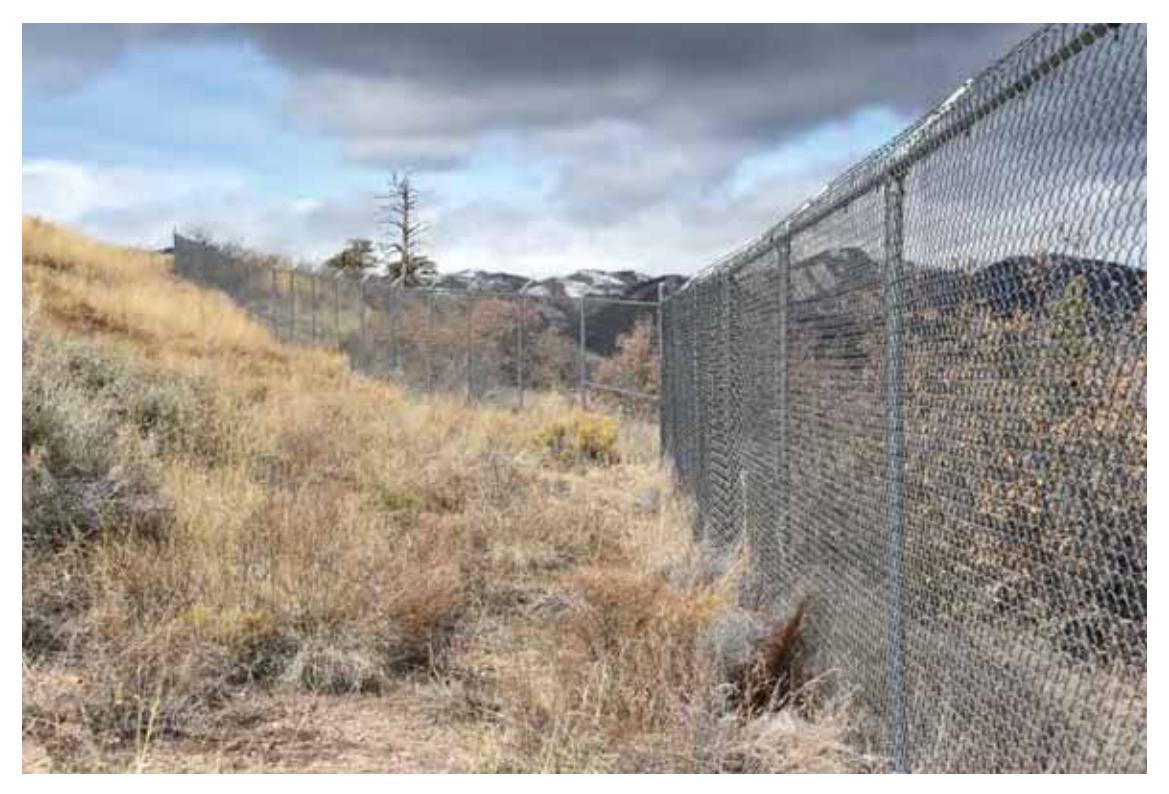
Fencing	
Airport Fence Adjacent to Landfill: Bent posts: □ Yes No Loose posts: □ Yes No Broken links or wire: □ Yes ⊠ No Damaged gates: □ Yes ⊠ No Description of damage: Repairs necessary: □ Yes ⊠ No	Remarks: Airport fencing is in good condition and securing the site (Photo 17). This fencing is maintained by the County of Los Alamos.
Retaining Wall	
Retaining Wall Condition: General Condition progressing as expected: Image: Second state of the second stat	Remarks: Retaining walls are in good condition. No damage or issues were noted (Photos 18 to 20 and Photo 24).
Retaining Wall DamageDescription (if any):Issues Observed:□ Yes□ Yes□ No	Remarks: None

Photo 17 Security fencing along the north side of the landfill, looking west

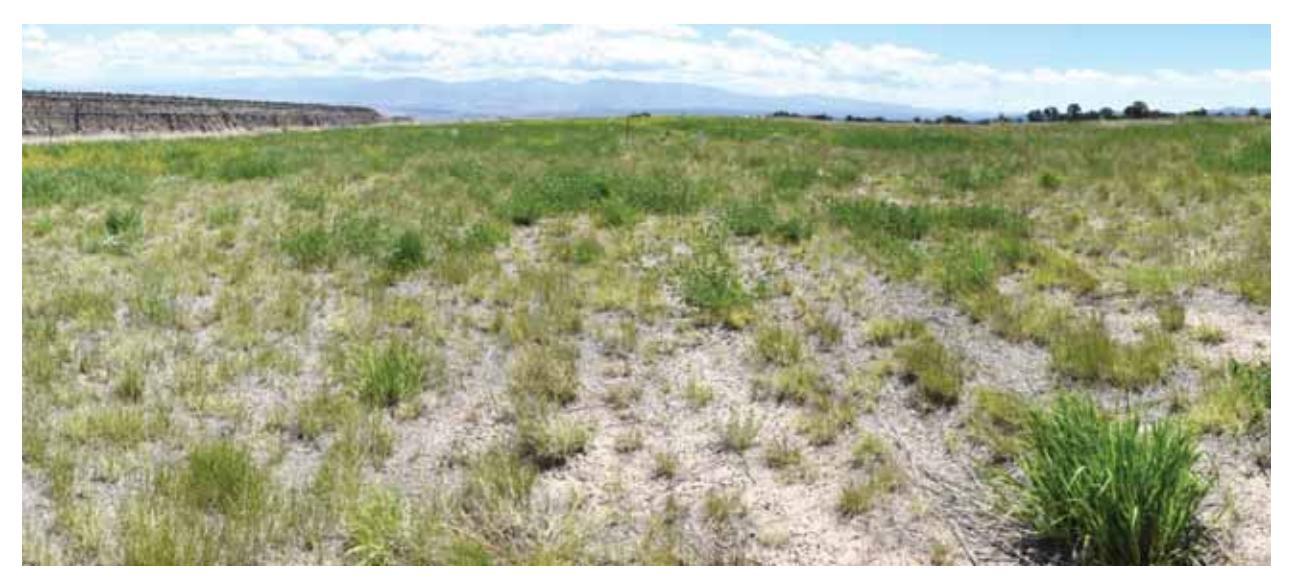
Erosion: □ Yes ⊠ No Areal Extent: □ Depth: □ Repairs necessary: □ Yes ⊠ No If yes, explain:	Remarks: No evidence of erosion from the landfill cover was observed. No rills, pedestals, or incision points were observed in the cover. No depositional packages of eroded material observed.	
Biointrusion Holes: 🛛 Yes 🗌 No	Remarks:	
Areal Extent: discrete locations scattered across the landfill cover Depth: unknown Suspected Cause (Rodent/Other): rodent, possibly gopher Repairs necessary:	There was minor evidence of animal burrows on the landfill cover. A couple of new mounds were noted in the west-central area of the cover. A few anthills were observed. The activity will continue to be monitored but, at this point, it is insignificant and not in need of repair.	
Vegetation Condition: General Condition progressing as expected: ☑ Yes □ No If no, explain: Repairs necessary: ☑ Yes □ No If yes, explain: Vegetation is approximately 1ft tall and recommended to be mowed. □ □	Remarks: Overall the vegetation cover is dense approximately 50%–70%. The vegetation is well established and the dominant species were alfalfa and clover. Other minor cover types were grasses, shrubs, and wildflowers (Photos 4 to 6). Vegetation in some areas was approximately 1 ft tall and it is recommended to be mowed.

Photo 4 Vegetation on the western end of the ET cover, looking east
