Subject:Submittal of the 2022–2023 Annual Long-Term Monitoring Status Report (July 2022
through June 2023) for the Los Alamos County Airport Landfill Cover System
Replacement, Solid Waste Management Units 73-001(a,d) in Technical Area 73

July 2023 EM2023-0423

2022–2023 Annual Long-Term Monitoring Status Report (July 2022 through June 2023) for the Los Alamos County Airport Landfill Cover System Replacement, Solid Waste Management Units 73-001(a,d) in Technical Area 73

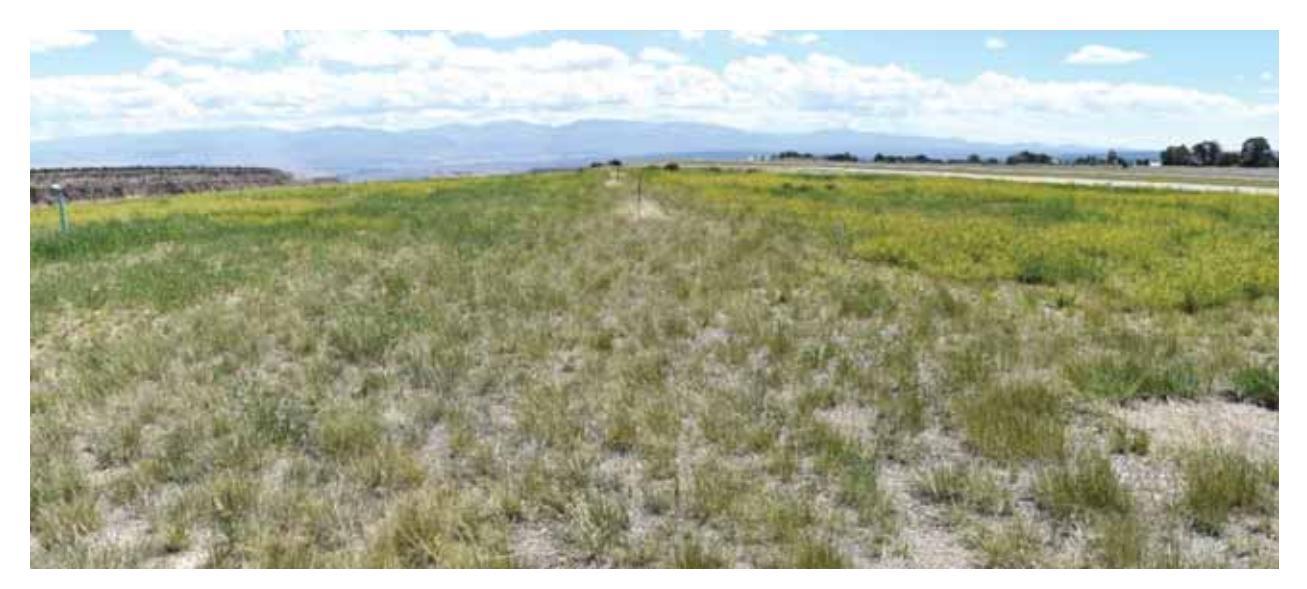
Erosion: □ Yes ⊠ No Areal Extent: □ Depth: □ Repairs necessary: □ Yes ⊠ No If yes, explain:	Remarks: No evidence of erosion from the landfill cover was observed. No rills, pedestals, or incision points were observed in the cover. No depositional packages of eroded material observed.	
Biointrusion Holes: 🛛 Yes 🗌 No	Remarks:	
Areal Extent: discrete locations scattered across the landfill cover Depth: unknown Suspected Cause (Rodent/Other): rodent, possibly gopher Repairs necessary:	There was minor evidence of animal burrows on the landfill cover. A couple of new mounds were noted in the west-central area of the cover. A few anthills were observed. The activity will continue to be monitored but, at this point, it is insignificant and not in need of repair.	
Vegetation Condition: General Condition progressing as expected: ☑ Yes □ No If no, explain: Repairs necessary: ☑ Yes □ No If yes, explain: Vegetation is approximately 1ft tall and recommended to be mowed. □ □	Remarks: Overall the vegetation cover is dense approximately 50%–70%. The vegetation is well established and the dominant species were alfalfa and clover. Other minor cover types were grasses, shrubs, and wildflowers (Photos 4 to 6). Vegetation in some areas was approximately 1 ft tall and it is recommended to be mowed.

Photo 5 Vegetation on the center section of the ET cover, looking east

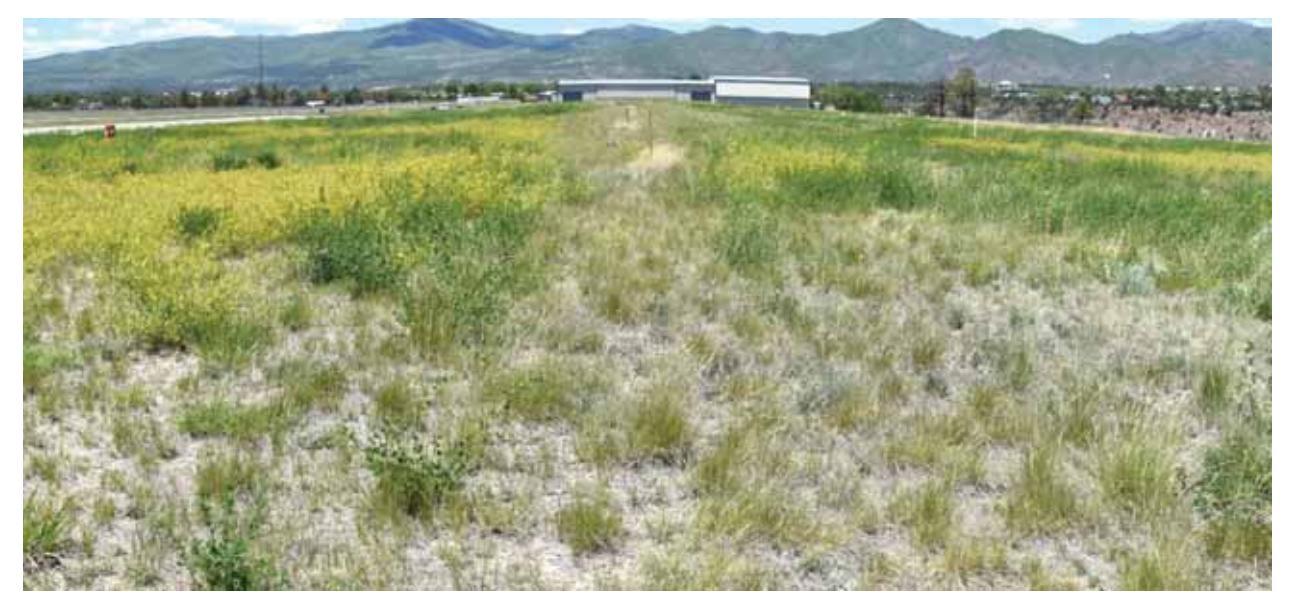
Photo 6 Vegetation on the eastern end of the ET cover, looking west

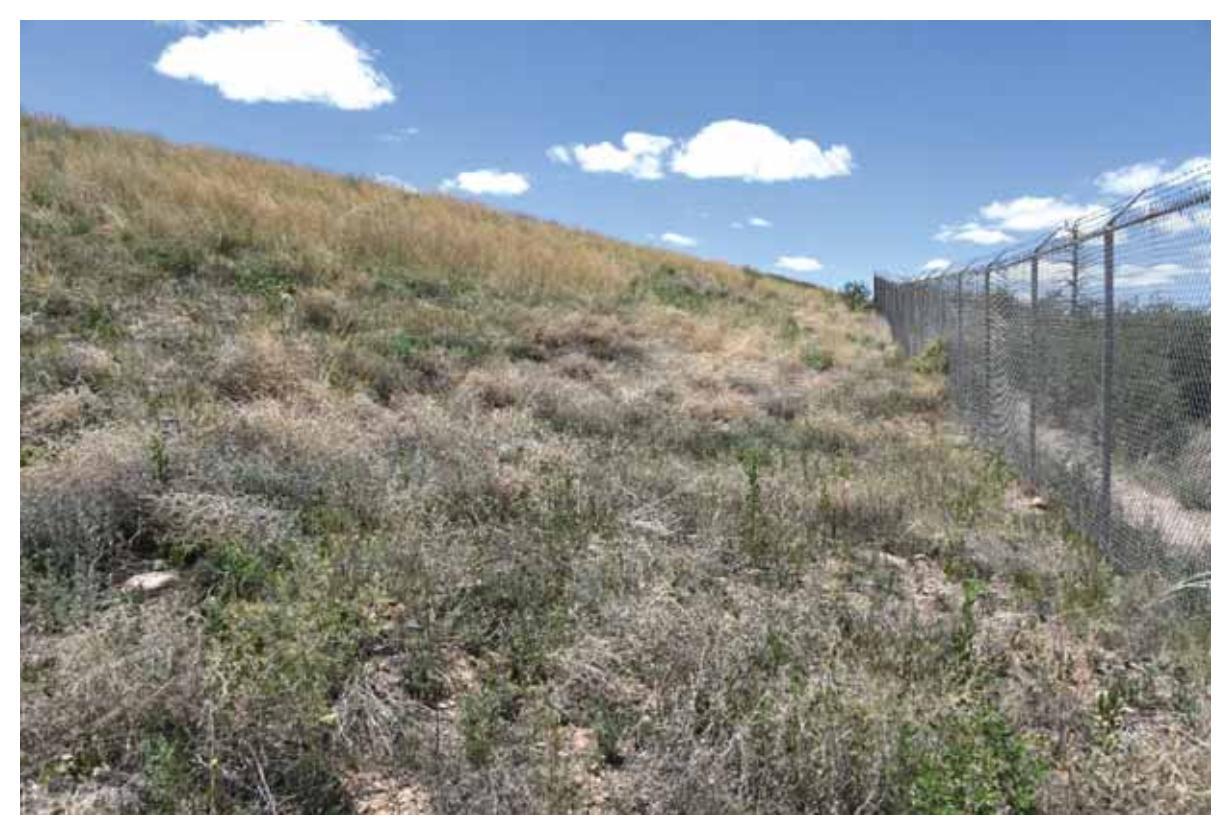
Bent posts: Yes No	Airport fencing is in good condition and securing the site			
Loose posts: 🗆 Yes 🛛 No	(Photo 7). This fencing is maintained by the County			
Broken links or wire: Yes No	of Los Alamos.			
Damaged gates:				
Description of damage:				
Repairs necessary: □ Yes ⊠ No If yes, explain:				
Retaining Wall	L			
Retaining Wall Condition:	Remarks:			
General Condition progressing as expected:	Retaining walls are in good condition. No damage or			
⊠ Yes □ No If no, explain:	issues were noted (Photos 18 and 19).			
Retaining Wall Damage	Remarks:			
Description (if any):	None			
Issues Observed: □ Yes ⊠ No If yes, explain:				
Repairs Necessary:	Remarks:			
□ Yes ⊠ No If yes, explain:	None

Photo 7 Vegetation and security fencing on the northern side slope, looking southwest

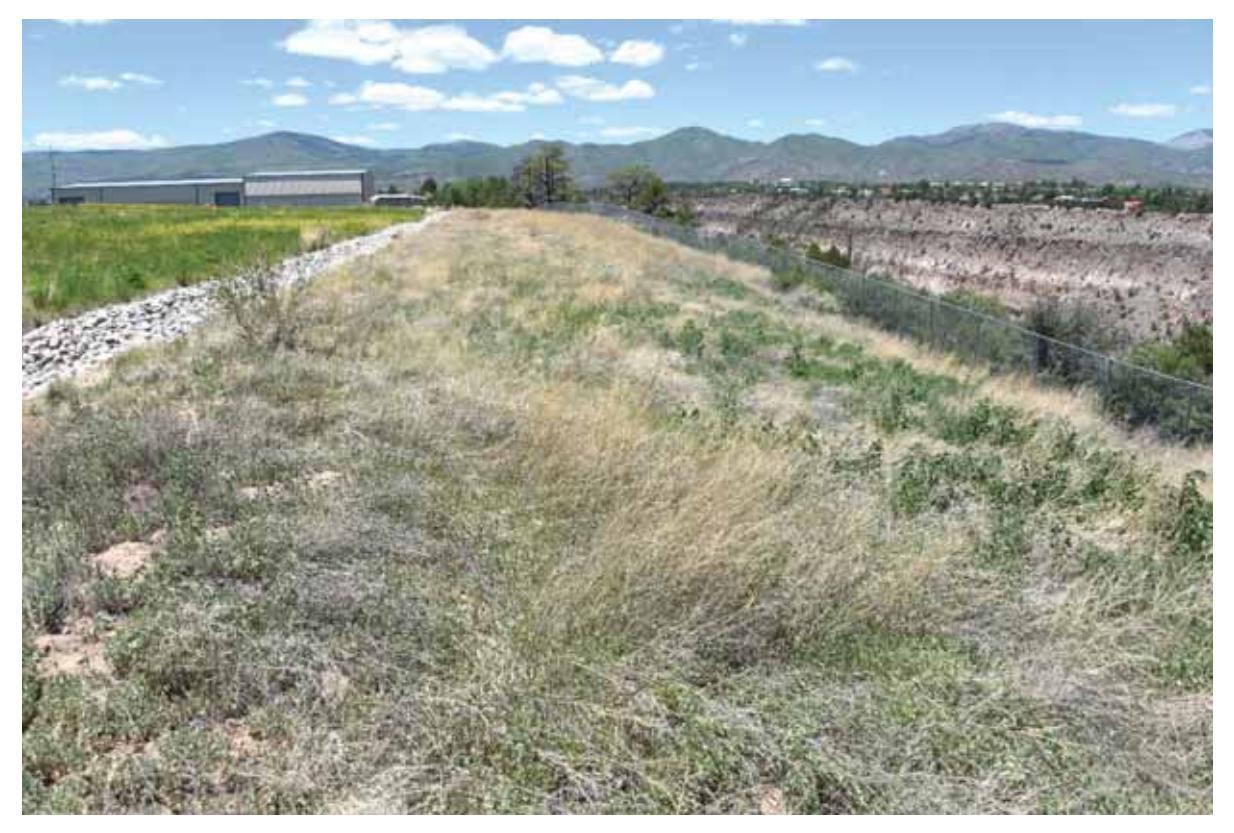
Photo 8 Vegetation on the northern side slope, looking west

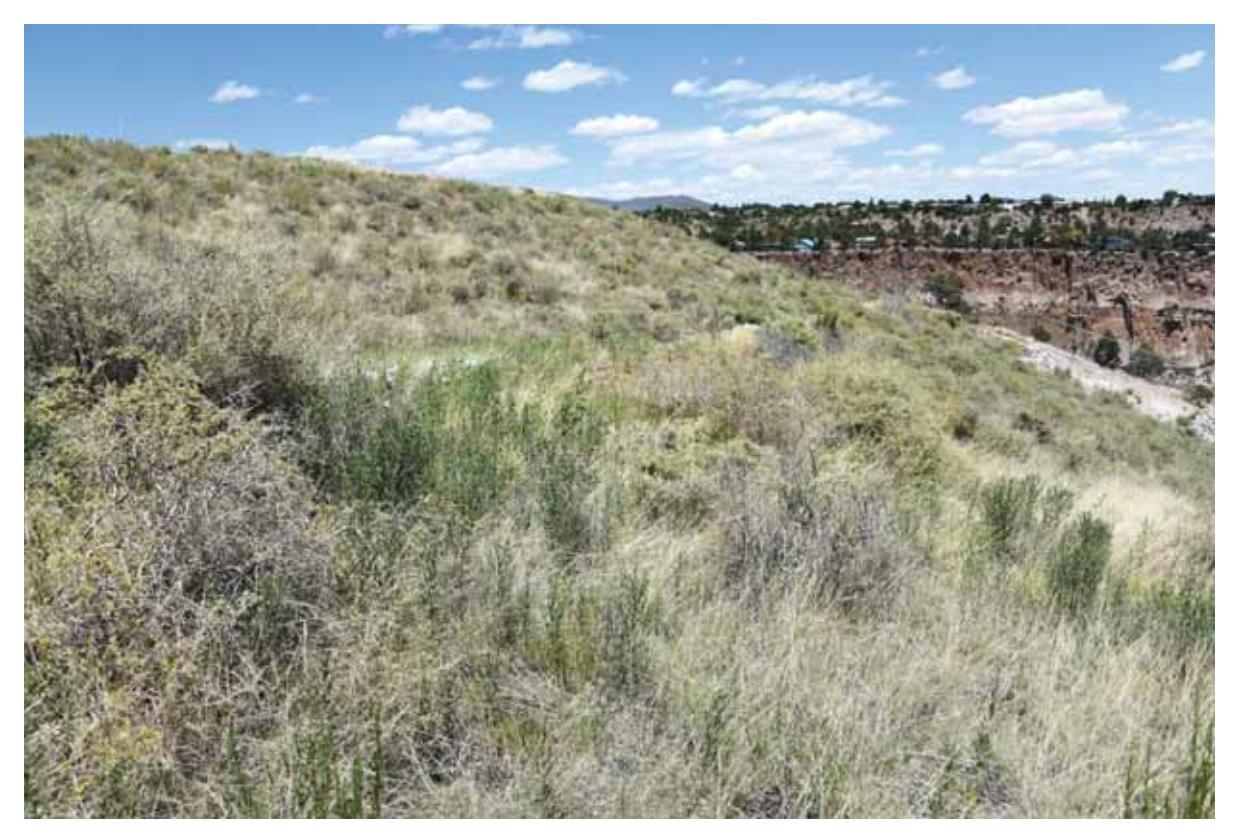
Photo 9 Vegetation on the eastern side slope, looking north

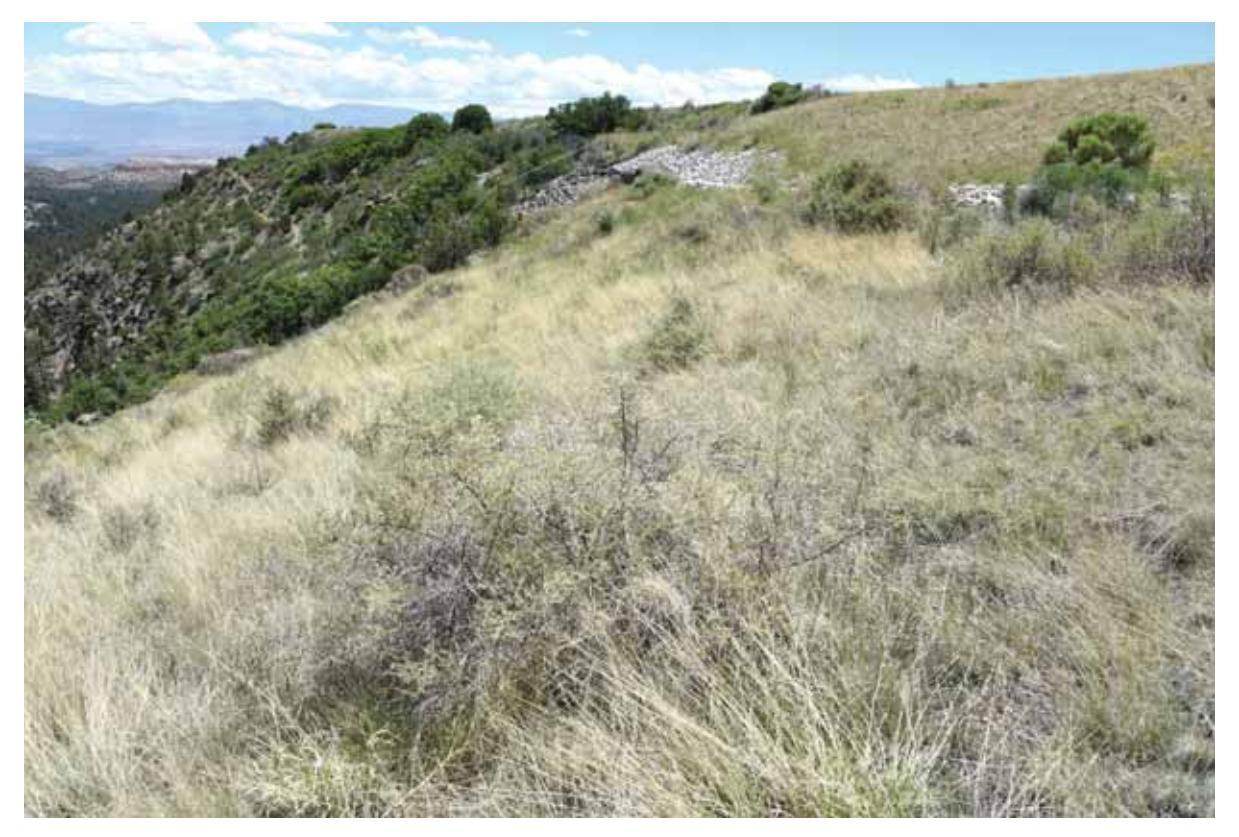
Photo 10 Vegetation on the eastern side slope, looking east

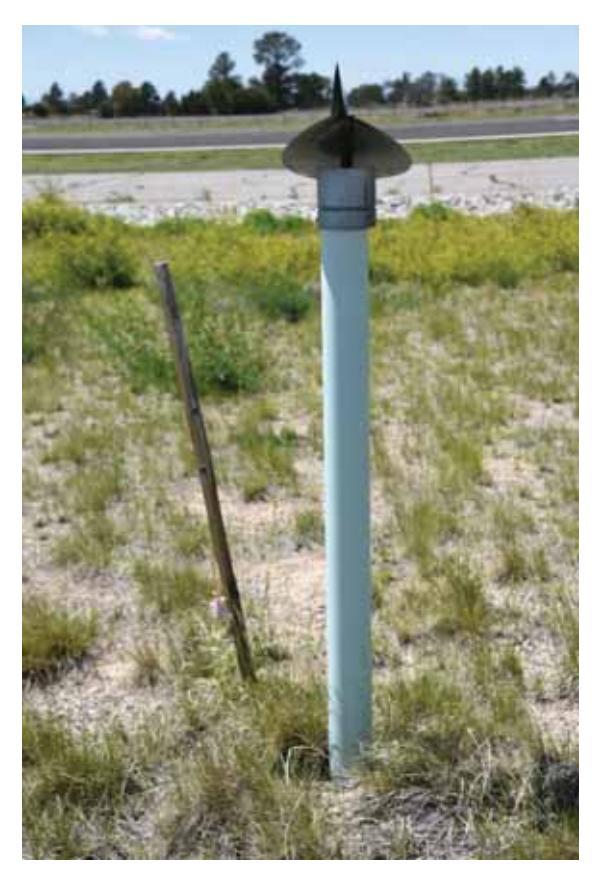
Methane Monitoring Instrumentation:Functioning Properly:⊠ Yes□ NoDamage:□ Yes⊠ NoRepairs necessary:□ Yes⊠ NoIf yes, explain	Remarks: Methane monitoring was not performed during this inspection. The vents were inspected and are in good condition (Photo 11).

Photo 11 Western methane monitoring vent, looking south

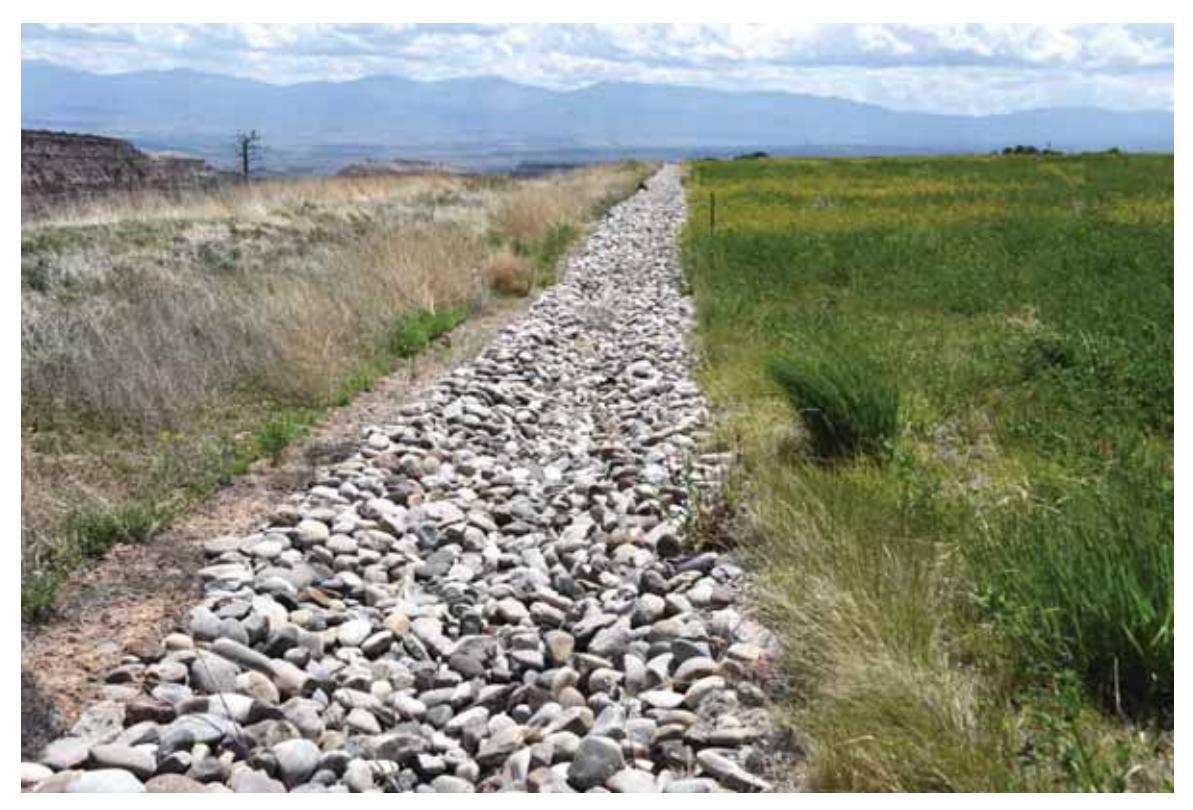
Site Element	Remarks			
Rip Rap Lined Drainage Channels				
Settlement (Low Spots): □ Yes ⊠ No Areal Extent: □ □ Depth: □ Yes ⊠ No Repairs necessary: □ Yes ⊠ No If yes, explain:	Remarks: The riprap lined channels were in excellent condition and there was no observable sedimentation within the channels (Photos 12–15).			
Material Degradation:□ Yes⊠ NoMaterial Type:Areal Extent:Degree of DegradationRepairs necessary:□ Yes⊠ NoIf yes, explain:	Remarks: No material degradation was noted.			
Erosion: □ Yes ⊠ No Areal Extent: Depth: Repairs necessary: □ Yes ⊠ No If yes, explain:	Remarks: No erosion was noted.			
Undercutting: □ Yes ⊠ No Areal Extent: Depth: Repairs necessary: □ Yes ⊠ No If yes, explain:	Remarks: No undercutting was noted.			
Obstructions: □ Yes ⊠ No Type:	Remarks: No obstructions were noted.			
Slope Instability: □ Yes ⊠ No Type:	Remarks: No slope instability was noted.			
Siltation: □ Yes ⊠ No Areal Extent: □ Depth: Repairs necessary: □ Yes ⊠ No If yes, explain:	Remarks: No siltation was noted.

Photo 12 Northern drainage channel, looking east

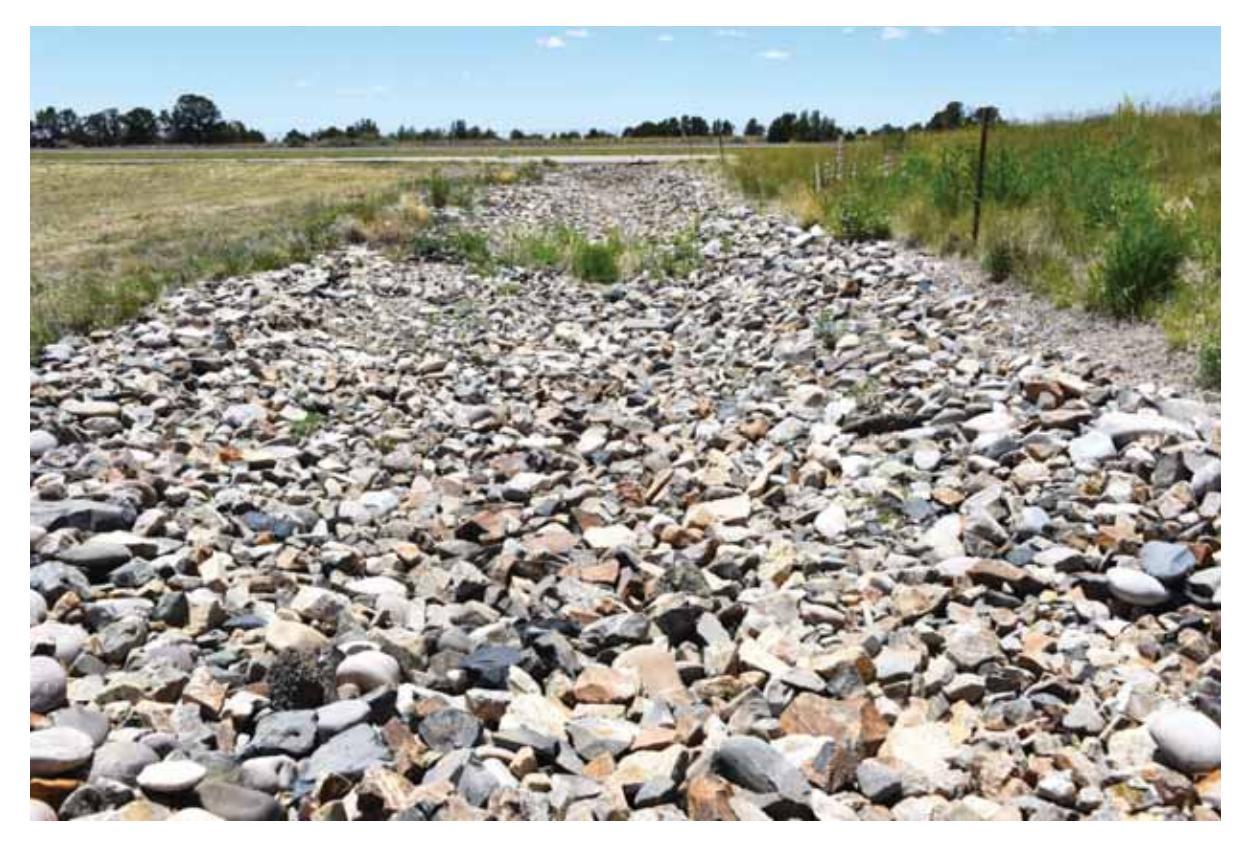
Photo 13 Eastern drainage channel, looking south

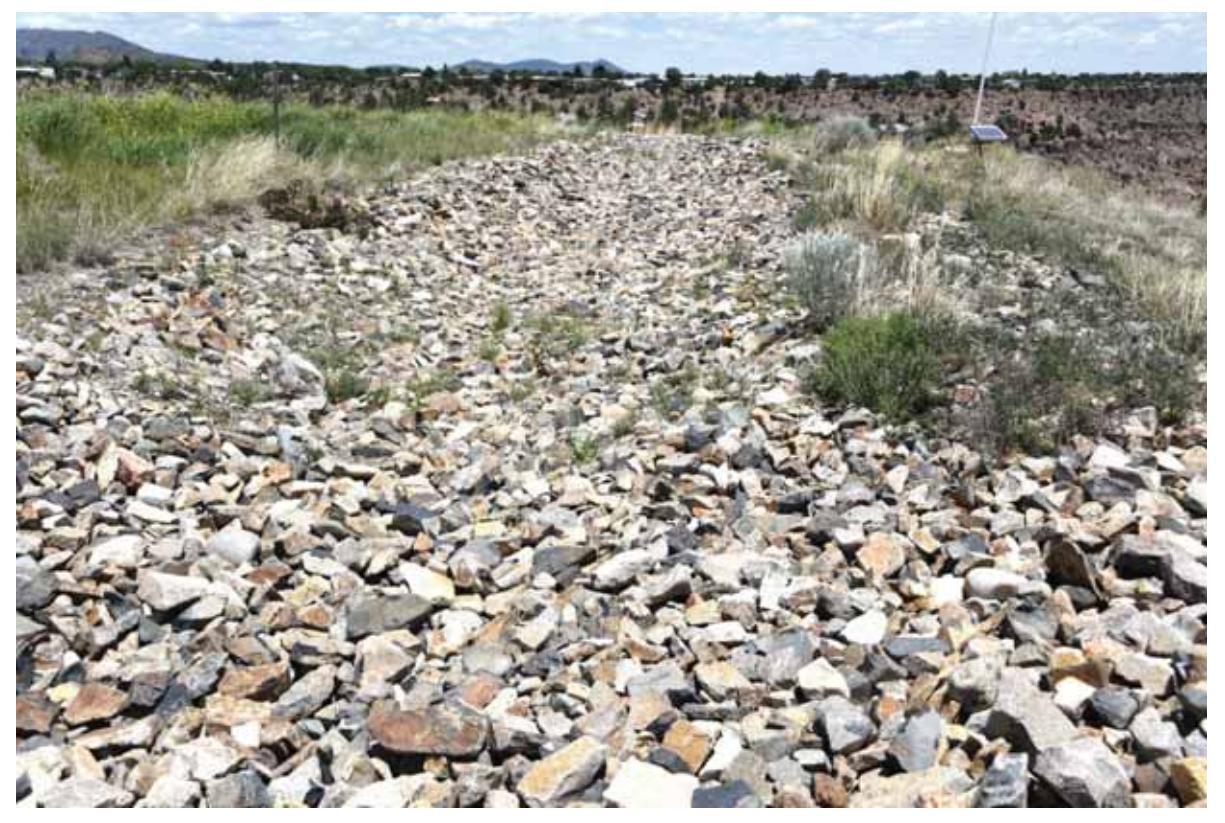
Photo 14 Eastern drainage channel, looking north

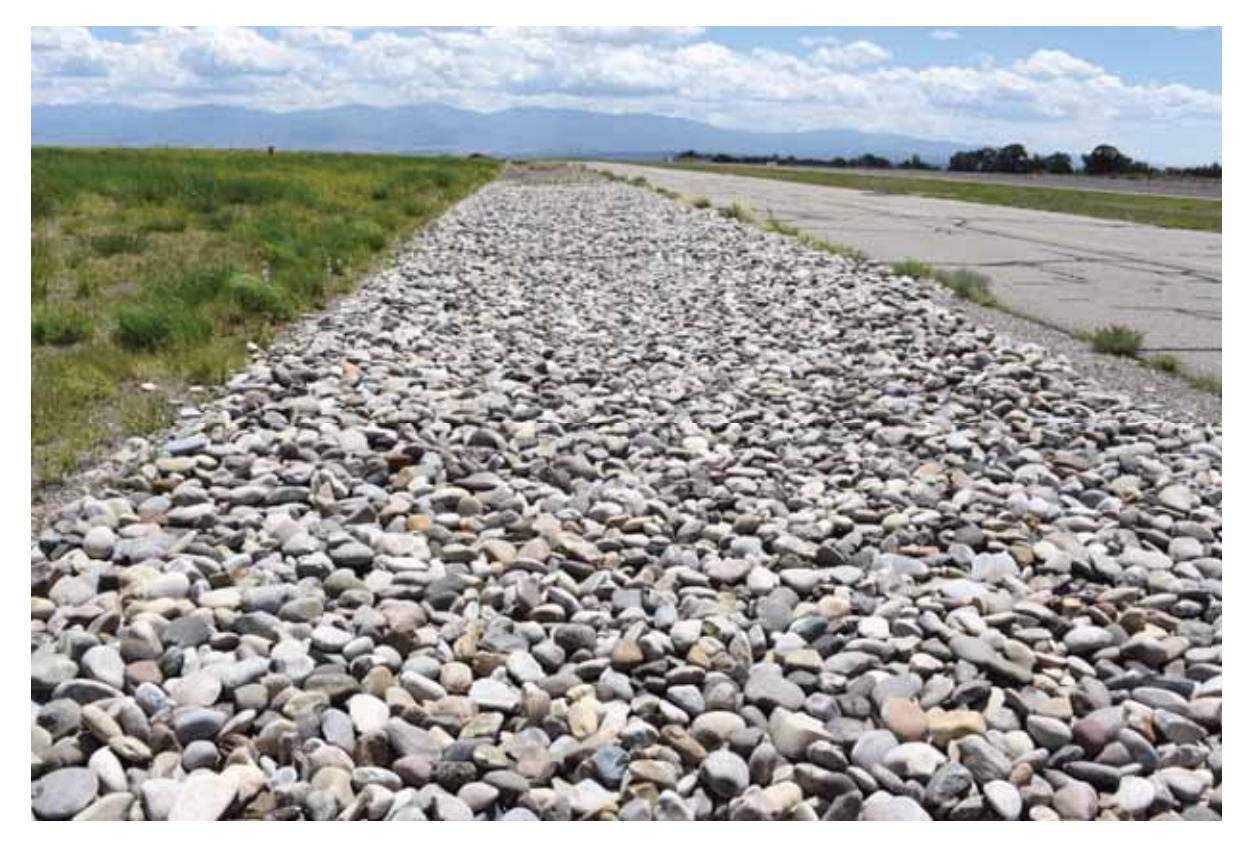
Photo 15 Southern drainage channel, looking east

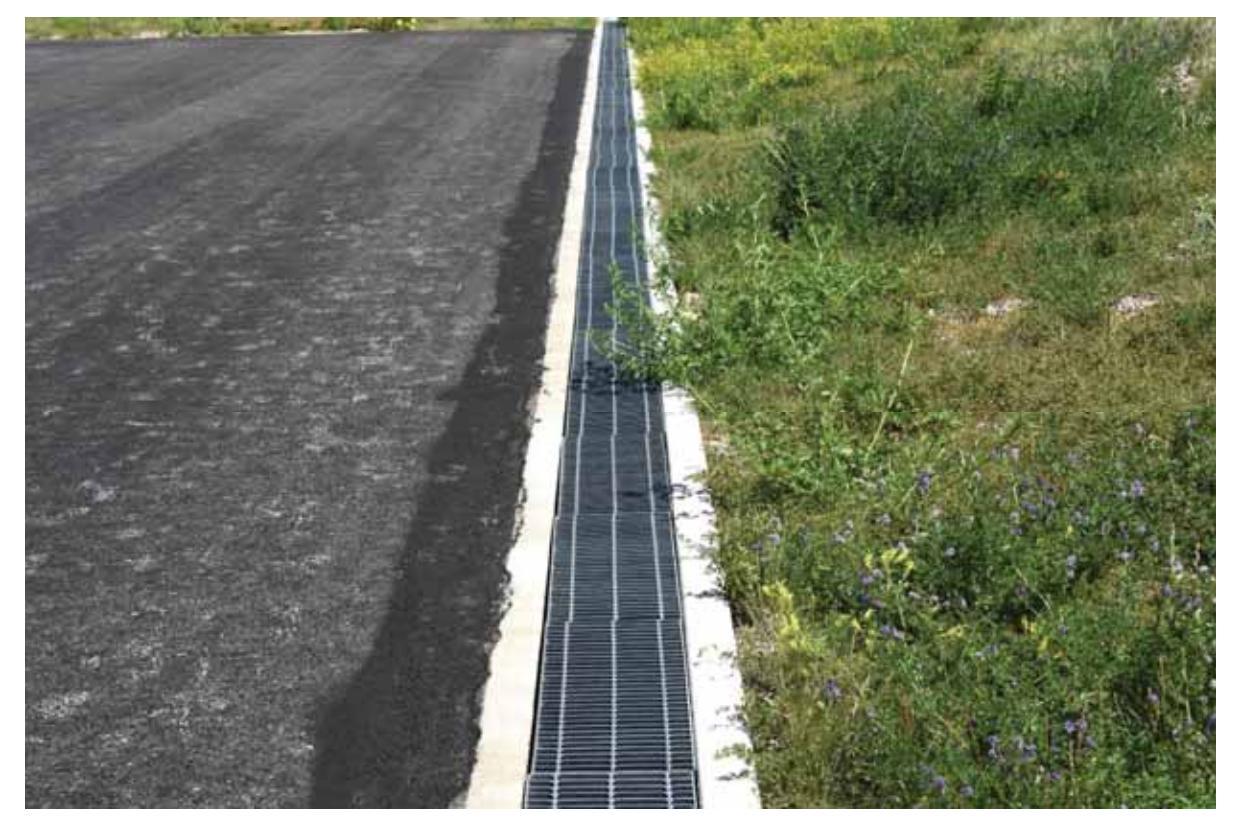
Site Element	Remarks			
Concrete Culvert				
Siltation: □ Yes ⊠ No Areal Extent: Depth:	Remarks: No siltation was observed.			
Repairs necessary: □ Yes ⊠ No If yes, explain:				
Concrete Condition and Joints:	Remarks:			
General Condition progressing as expected:	Concrete is in good condition (Photos 16 and 17).			
⊠ Yes □ No If no, explain:				
Issues Observed: \Box Yes \boxtimes No If yes, explain:				
Repairs necessary: □ Yes ⊠ No If yes, explain:				
Grating Condition:	Remarks:			
General Condition progressing as expected:	Grating is in good condition (Photos 16 and 17).			
🛛 Yes 🗆 No If no, explain:				
Issues Observed: \boxtimes Yes \square No If yes, explain: 33 ft of grating are missing at the north end of the culvert. Grates were stolen.				
Repairs necessary: \boxtimes Yes \square No If yes, explain: grates will require replacement.				
Fencing				
Airport Fence Adjacent to Landfill:	Remarks:

Photo 16 Concrete culvert, looking north

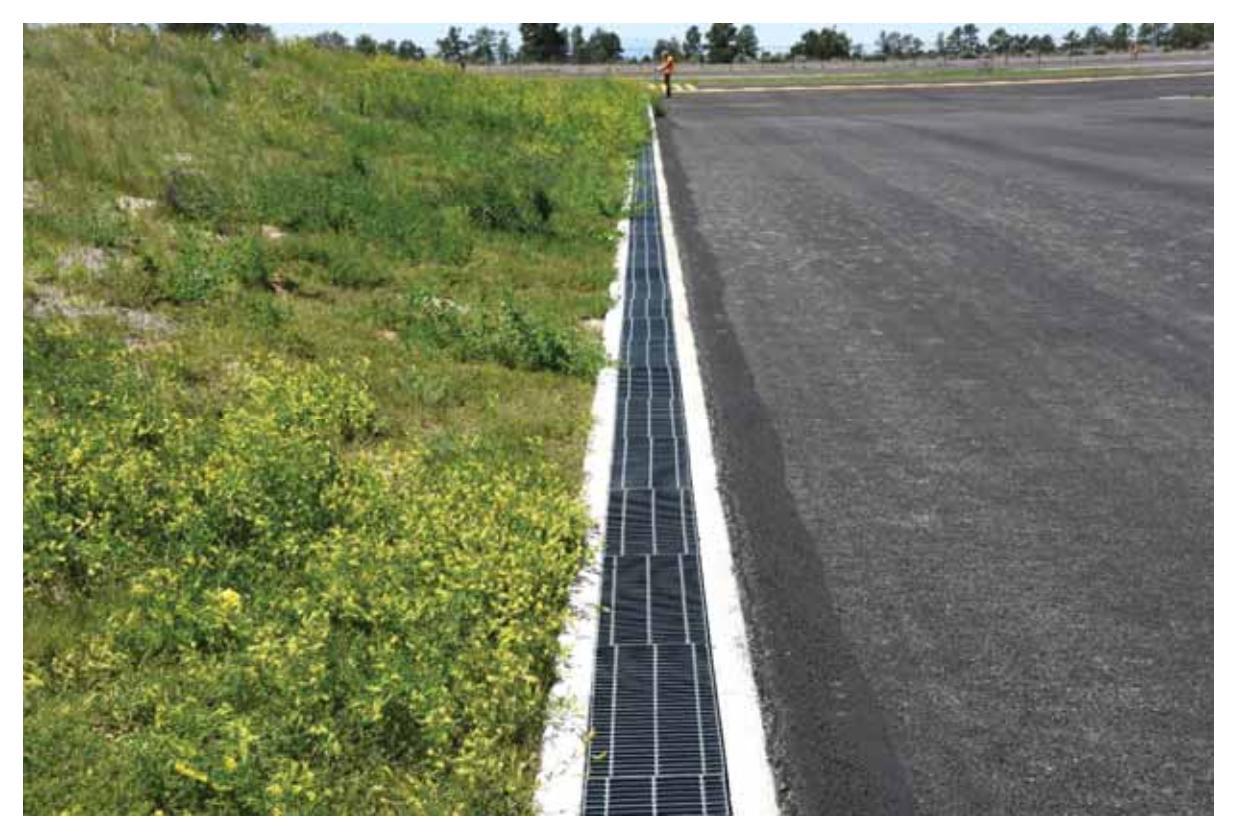
Photo 17 Concrete culvert, looking south

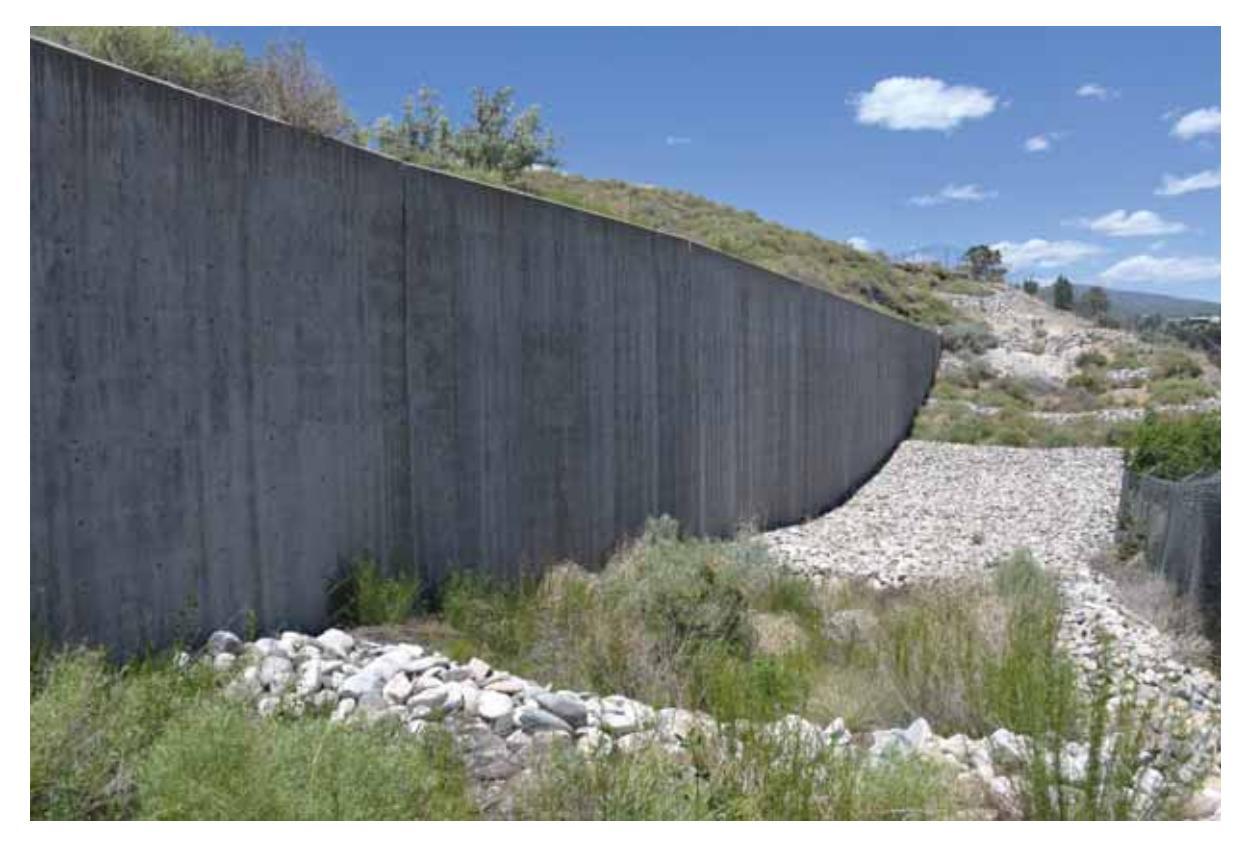
Photo 18 Concrete retaining wall and drainage channel, looking northwest

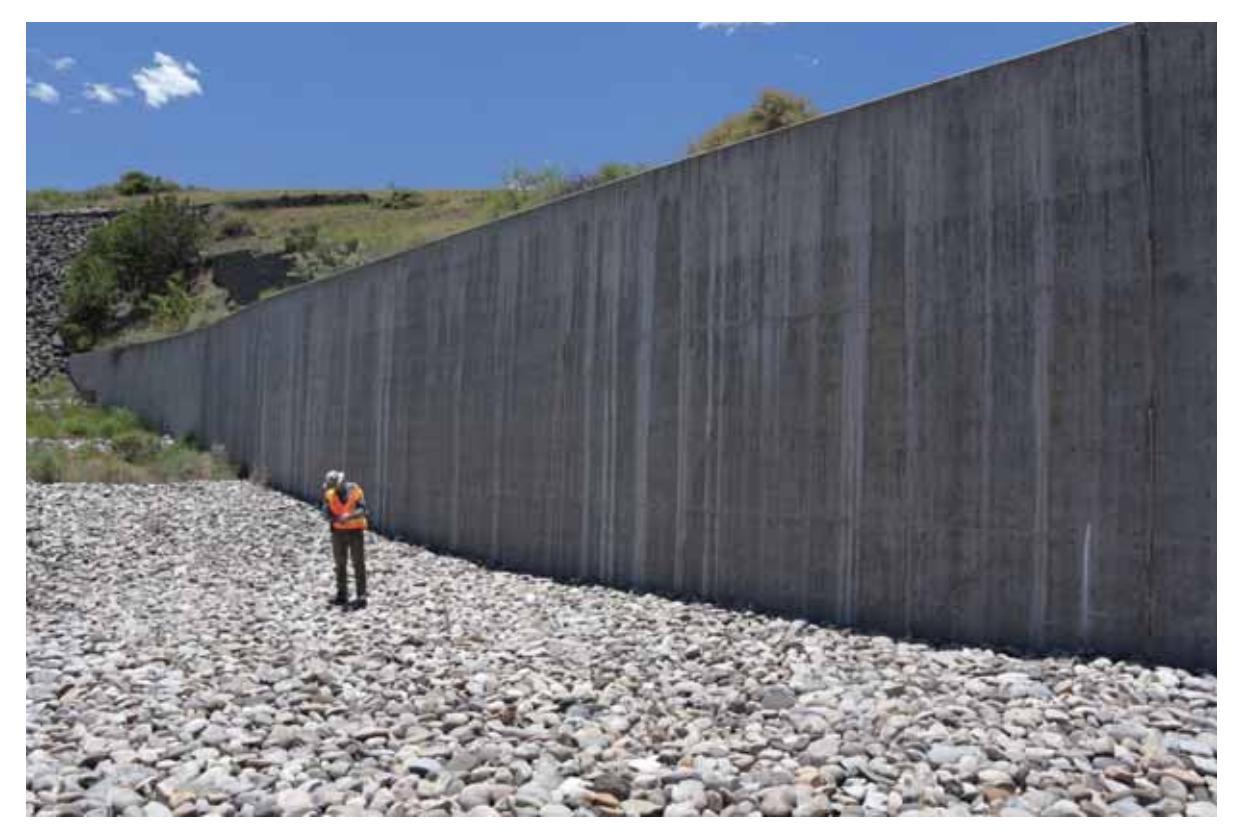
Photo 19 Concrete retaining wall, looking south

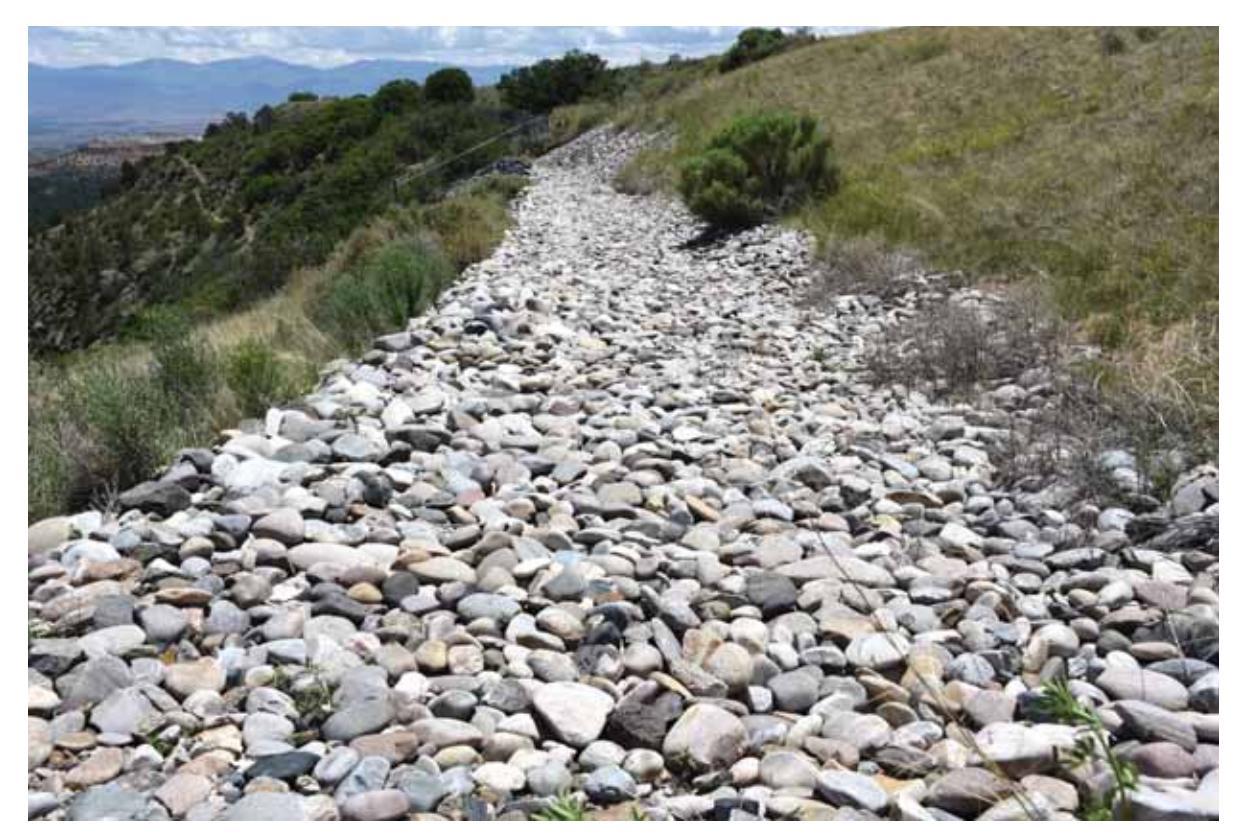
Site Element	Remarks
Permanent Erosion & Sedimentation Control Measures	
Rip Rap Berm above Retaining Wall:Functional:⊠ Yes□ NoIf no, describe locations:□Damage or degradation:□ Yes⊠ NoDescription of damage:□Repairs necessary:□ Yes⊠ NoIf yes, explain:	Remarks: The riprap drainage on the side slope is in good condition (Photos 20 and 21).
Rock Check Dams near Retaining Wall: Functional: ⊠ Yes □ No If no, describe locations: □ Damage, displaced rock, or other damage: □ Yes ⊠ No Description of damage: N/A Repairs necessary: □ Yes ⊠ No	Remarks: The rock check dams are in good condition (Photo 22). No maintenance or repairs are necessary.
Landfill Terrace above Retaining Wall: Functional: ☑ Yes □ No If no, describe locations: □ Damage, adjunct erosion, slope problem, or other damage/degradation: □ Yes ☑ No Description of damage: Repairs necessary: □ Yes ☑ No If yes, explain:	Remarks: The landfill terrace above the retaining walls is in good condition.

Photo 21 Riprap berm (side-slope berm) above retaining wall, looking east

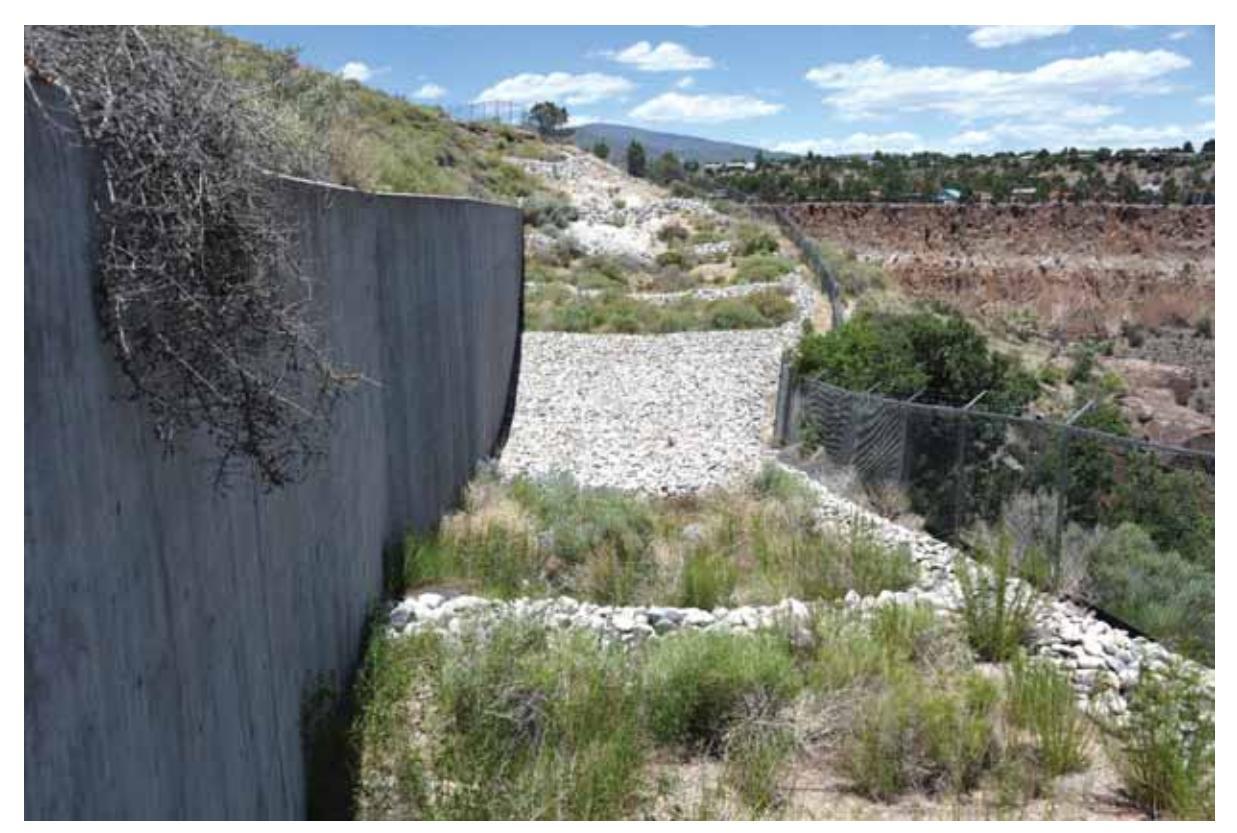
Photo 22 Retaining wall drainage channel and rock check dams, looking northwest

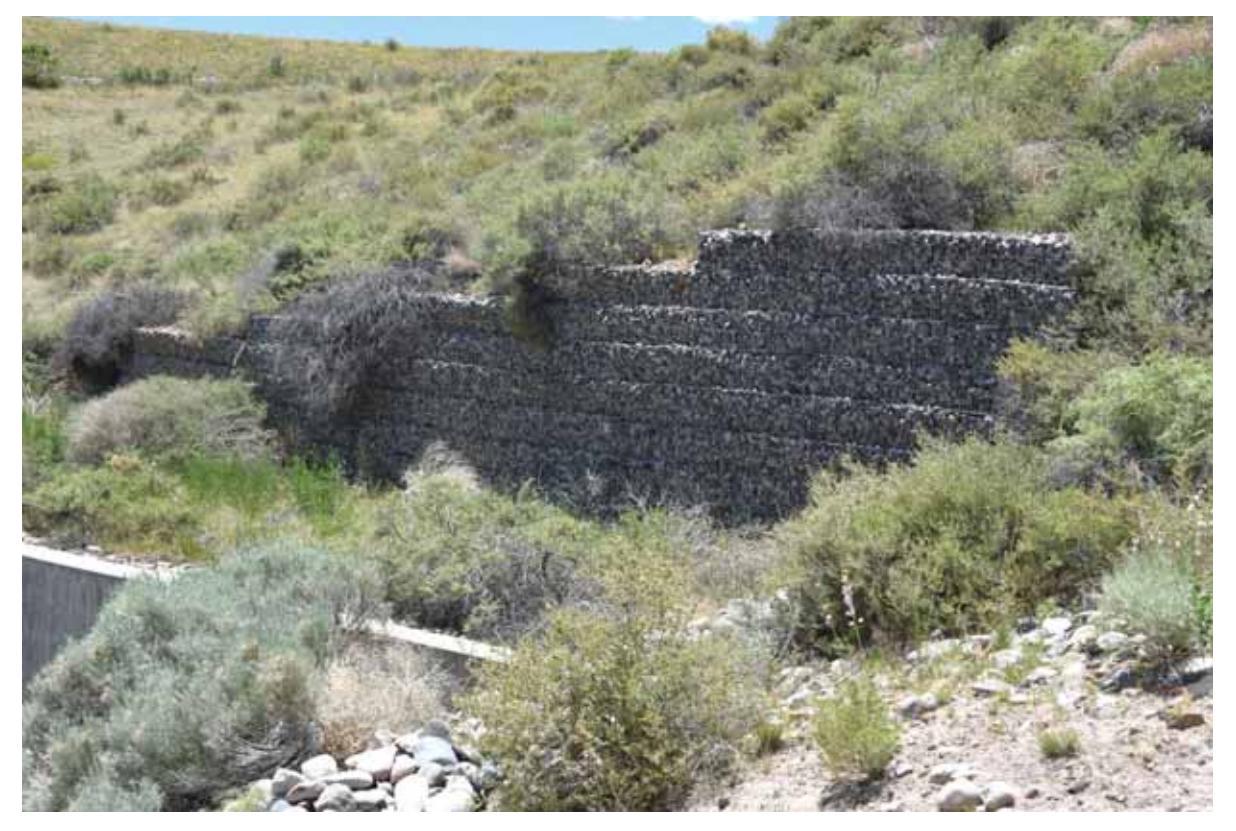
Photo 24 Northern gabion wall, looking south

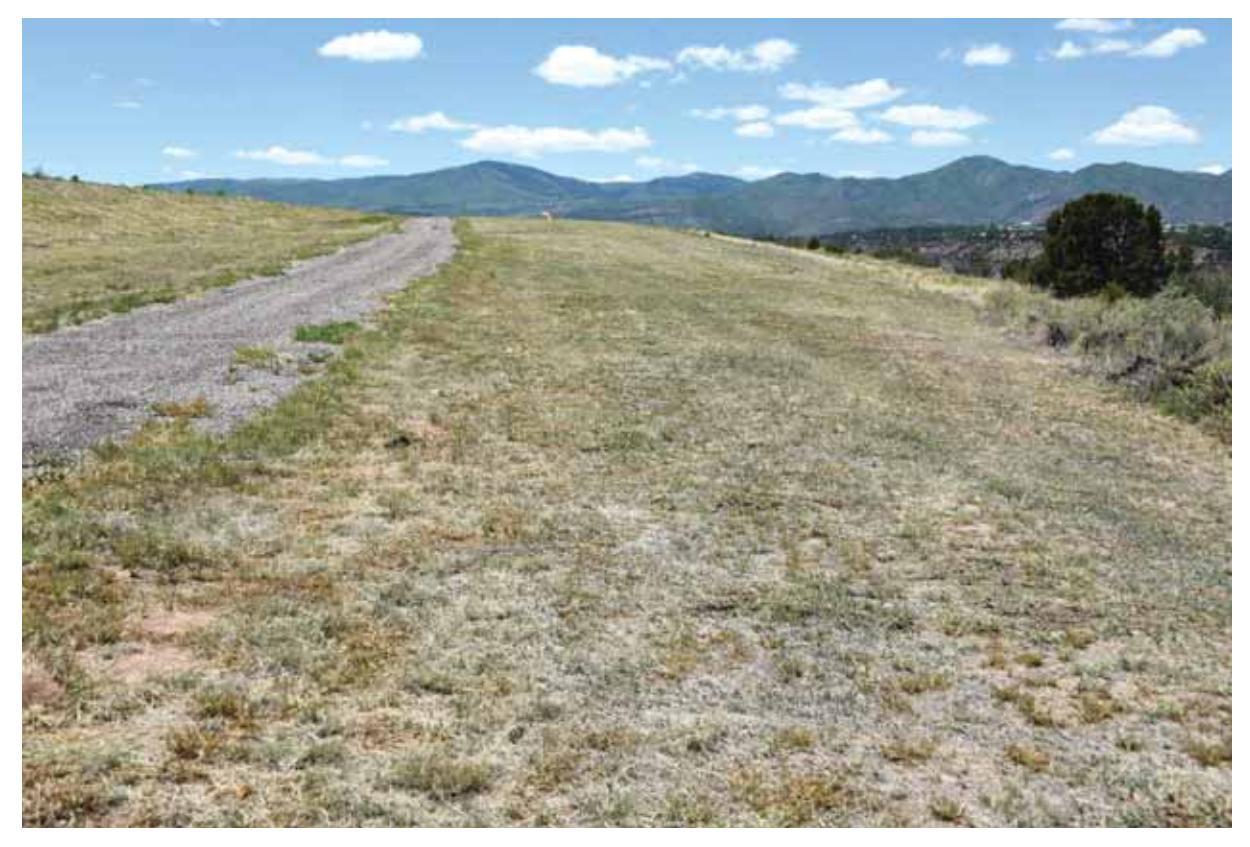
Site Element	Remarks			
Debris Disposal Area (DDA)				
Debris Disposal Area Condition: ⊠ Good Condition □ Poor Condition Repairs necessary: □ Yes ⊠ No If yes, explain:	Remarks: The surface of the DDA cover system is in good condition. The vegetation on the DDA had recently been mowed by the airport staff. (Photos 25 to 27). No degradation of the site was observed.			
General				
Vandalism: □ Yes ⋈ No Description of damage: Repairs necessary: ⋈ Yes □ No If yes, explain: Grates will require replacement If yes ⋈ No If yes, explain: Land Use Change: □ Yes ⋈ No ⋈ Description: Repairs necessary: □ Yes ⋈ No If yes, explain: □ □ □	Remarks: Concrete culvert steel grates are missing and presumed stolen. Remarks: No land use changes.			
Summary of Recommended Maintenance and/or Repairs				
Maintenance/Repairs Necessary: □ Yes ⊠ No If yes, explain:	Remarks: None			
Other				
None

Photo 25 Northwestern section of the debris disposal area, looking west

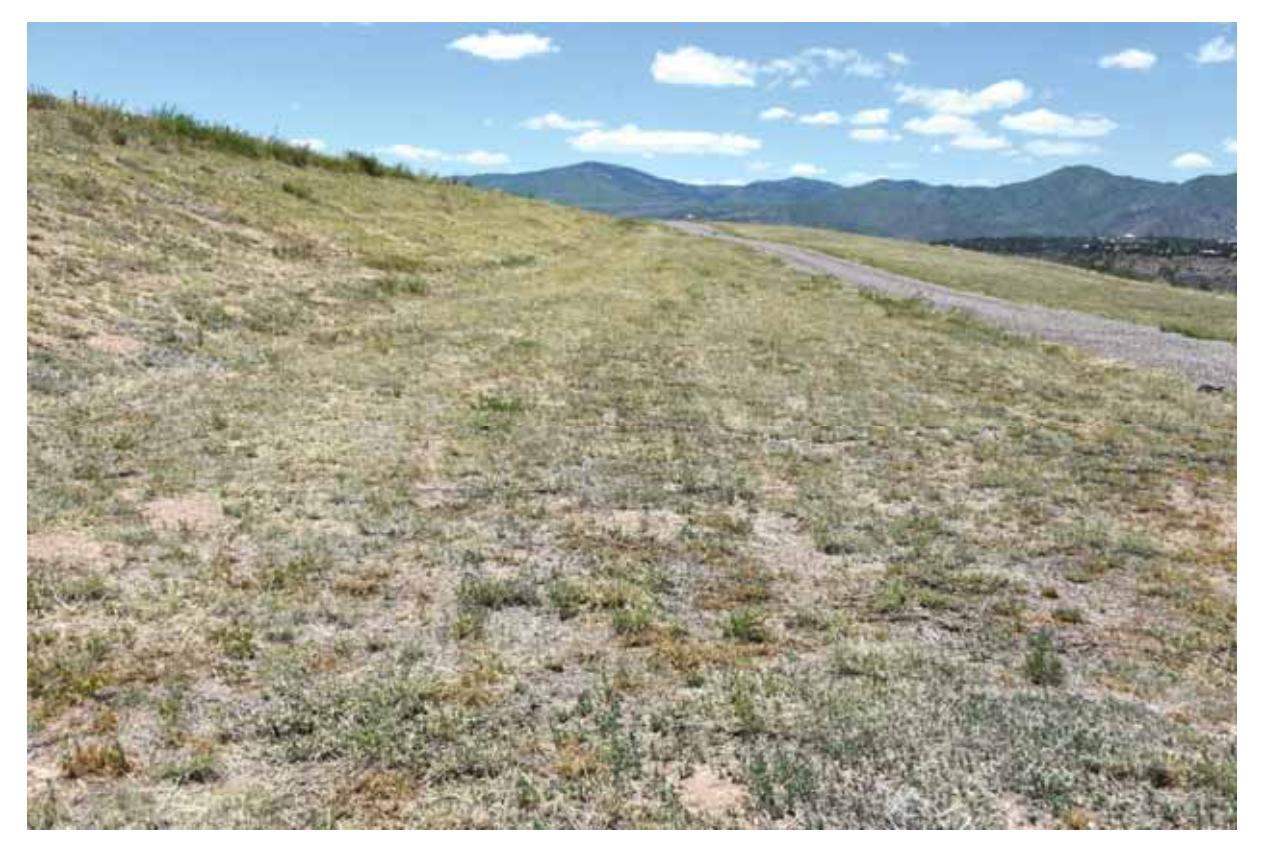
Photo 26 Southcentral section of the debris disposal area, looking west

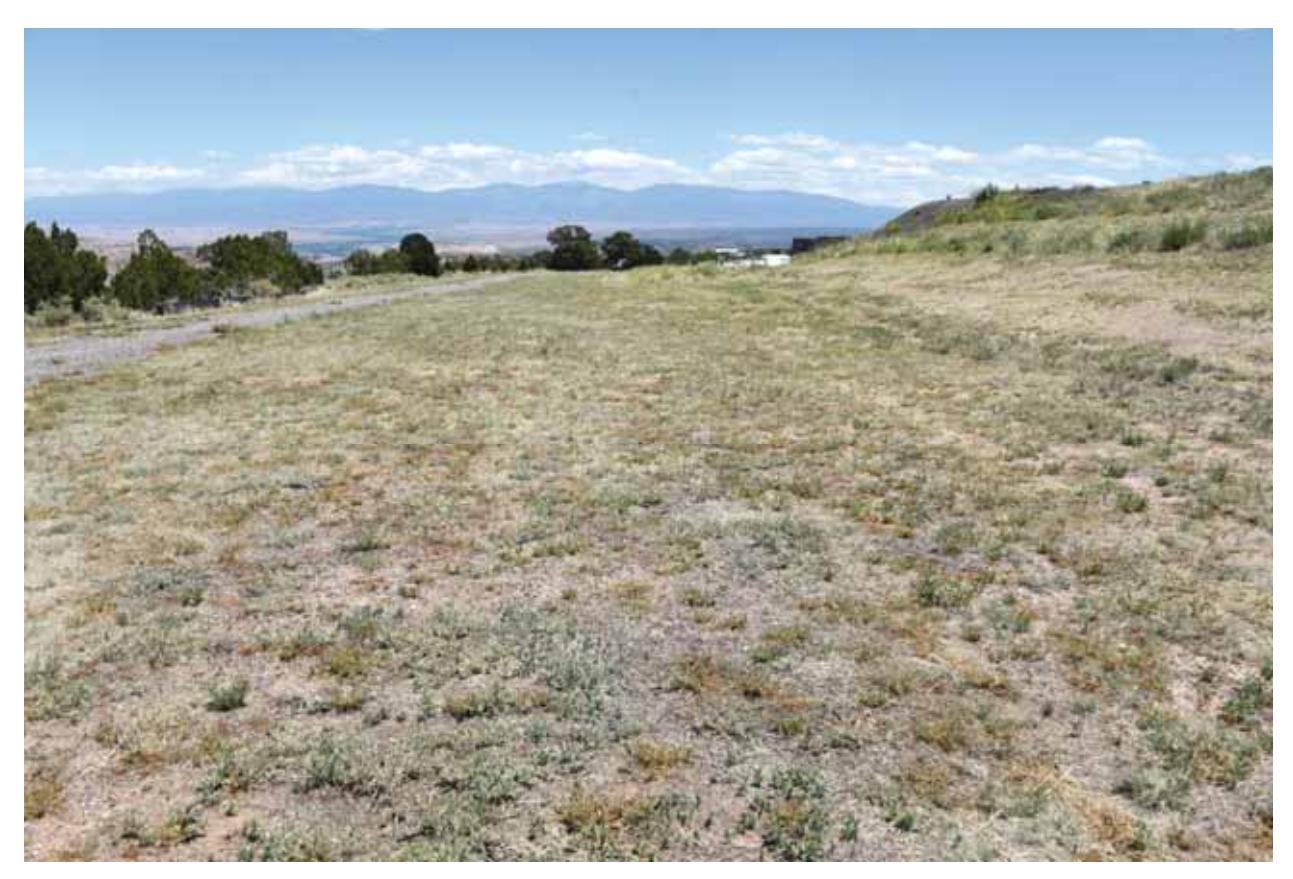
Photo 27 Southeastern section of the debris disposal area, looking east
