Subject:Submittal of the 2022–2023 Annual Long-Term Monitoring Status Report (July 2022
through June 2023) for the Los Alamos County Airport Landfill Cover System
Replacement, Solid Waste Management Units 73-001(a,d) in Technical Area 73

July 2023 EM2023-0423

2022–2023 Annual Long-Term Monitoring Status Report (July 2022 through June 2023) for the Los Alamos County Airport Landfill Cover System Replacement, Solid Waste Management Units 73-001(a,d) in Technical Area 73

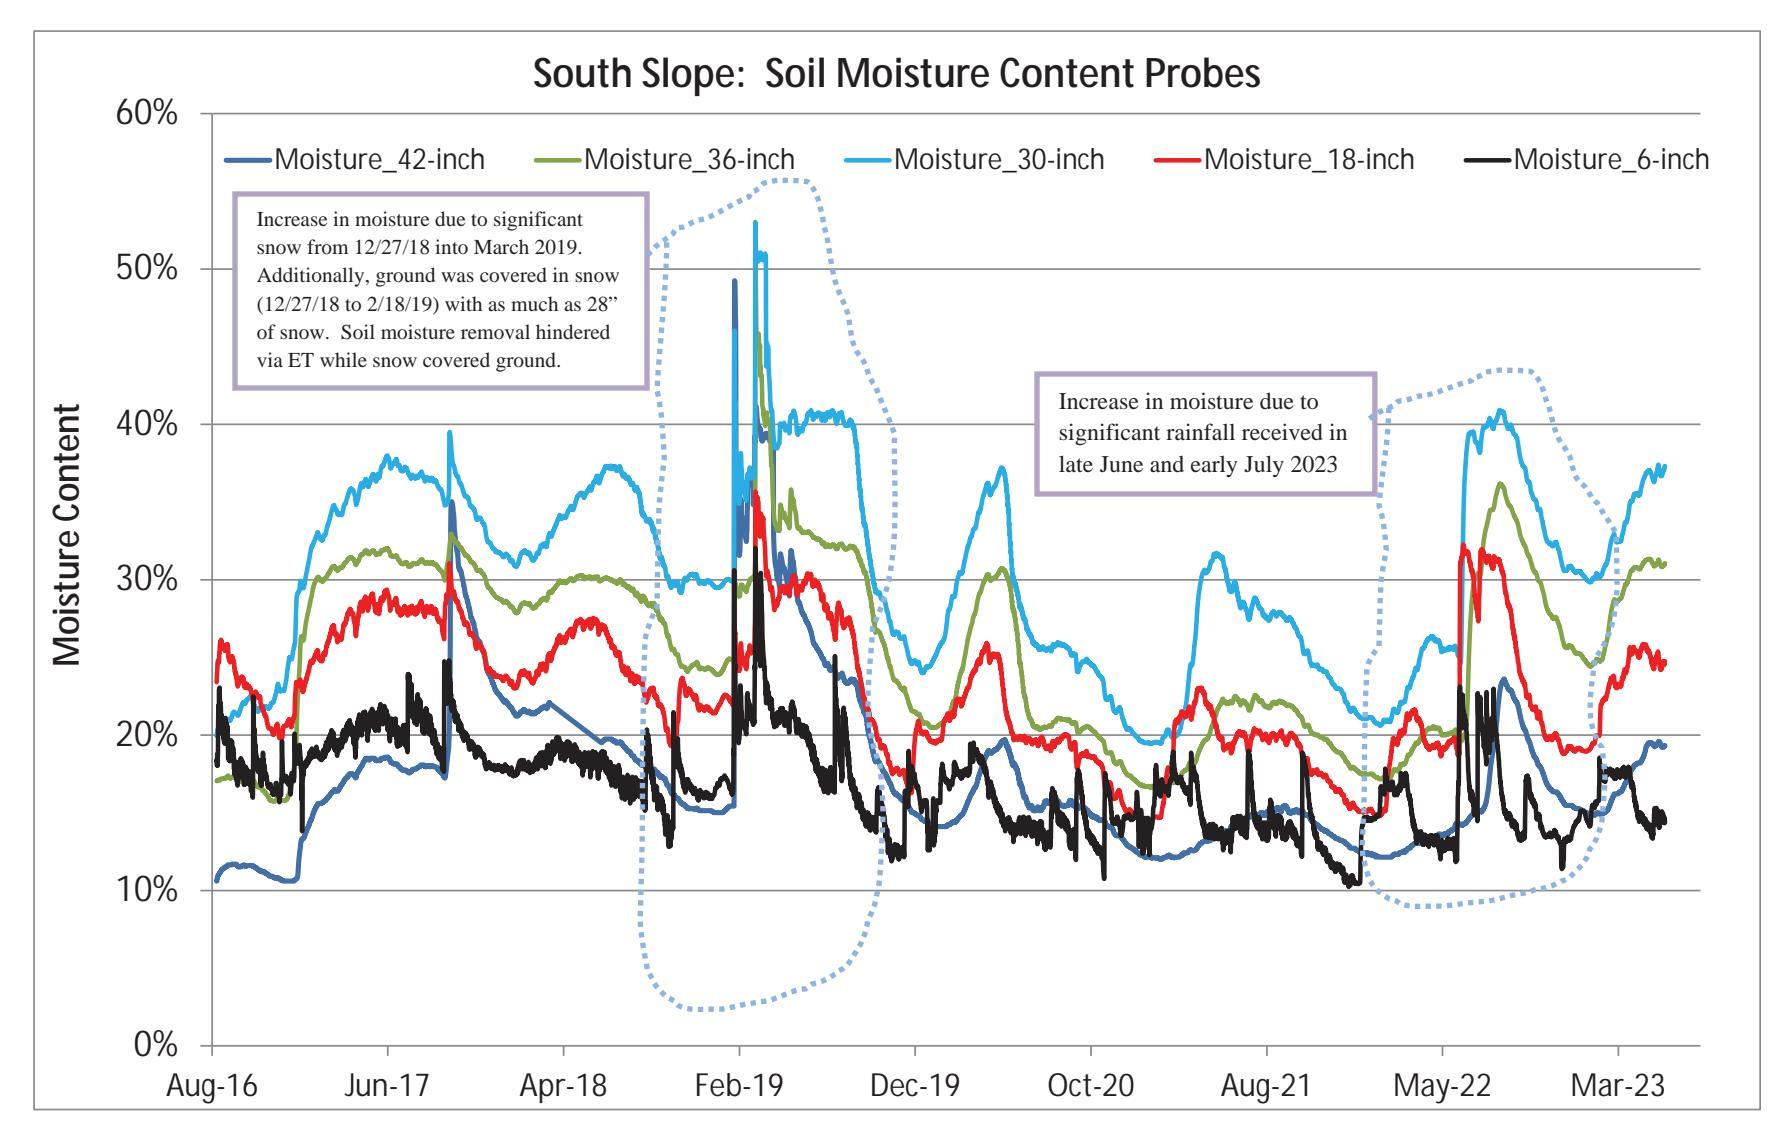
Figure B-1. Moisture Probe Data (September 2016 to June 2023) - ET Cover South Slope

The moisture content probes reveal that infiltrated moisture due to precipitation quickly dries shortly after (Figures B-1 and B-2). There also appears to be some sensitivity of the moisture content measurements to soil temperature (especially noted in variation of winter and summer months). This data will take multiple seasons to analyze and better understand the water balance trends in the cover system.

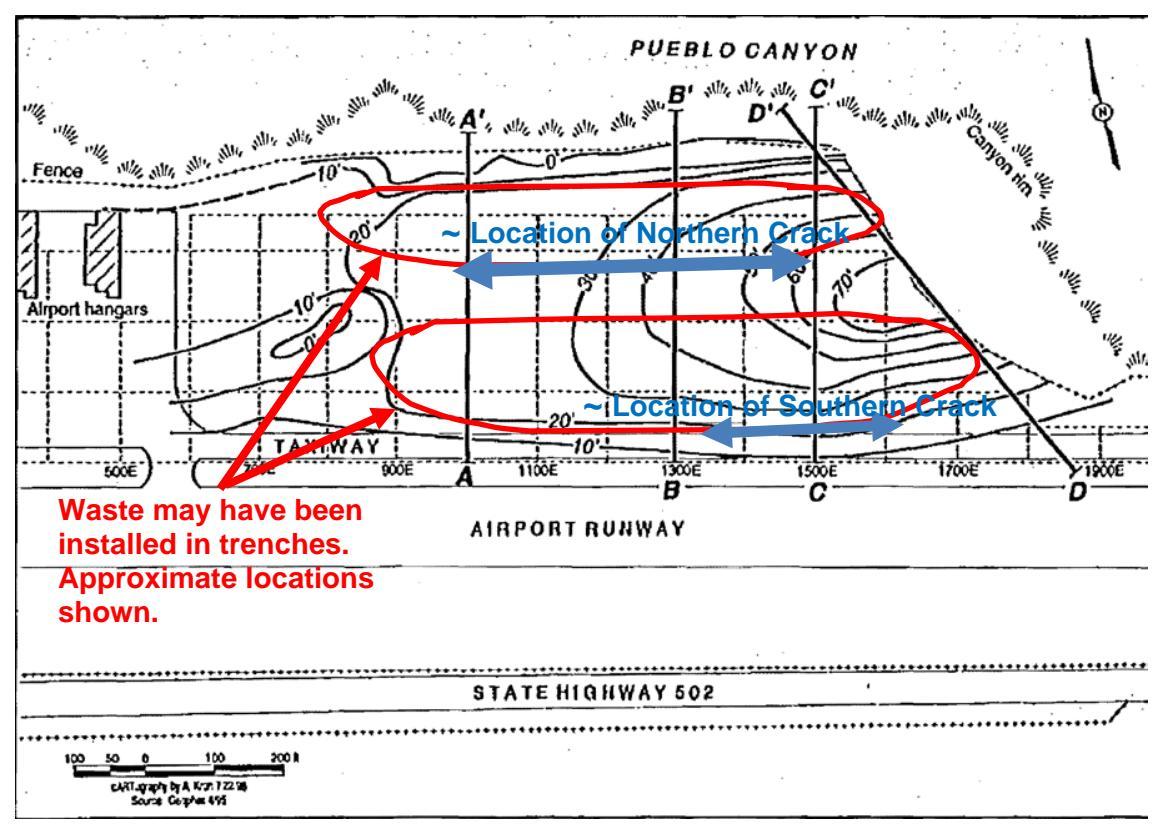
Figure 3. Estimated Waste Depths from LANL (1998)

Based on observations of settlement prior to the cover placement and again after its placement, it is possible the waste was installed in trenches running east/west (Figure 3). The northern crack (Figure 1) appears to be running parallel with the estimated boundary of the northern waste trench (Figure 3). Thus, the continued settlement likely caused a tension crack along this boundary. There was significant infiltration of meteoric water into the waste prior to the installation of the initial asphalt/concrete cover and while it was in place. This moisture is still causing biodegradation in the waste although it is has slowed significantly. Thus, settlement continues – albeit much slower than when the asphalt/concrete cover was in place. The infiltration into the waste ceased after the Evapotranspiration (ET) Cover was installed based on ongoing monitoring documented in inspection reports.

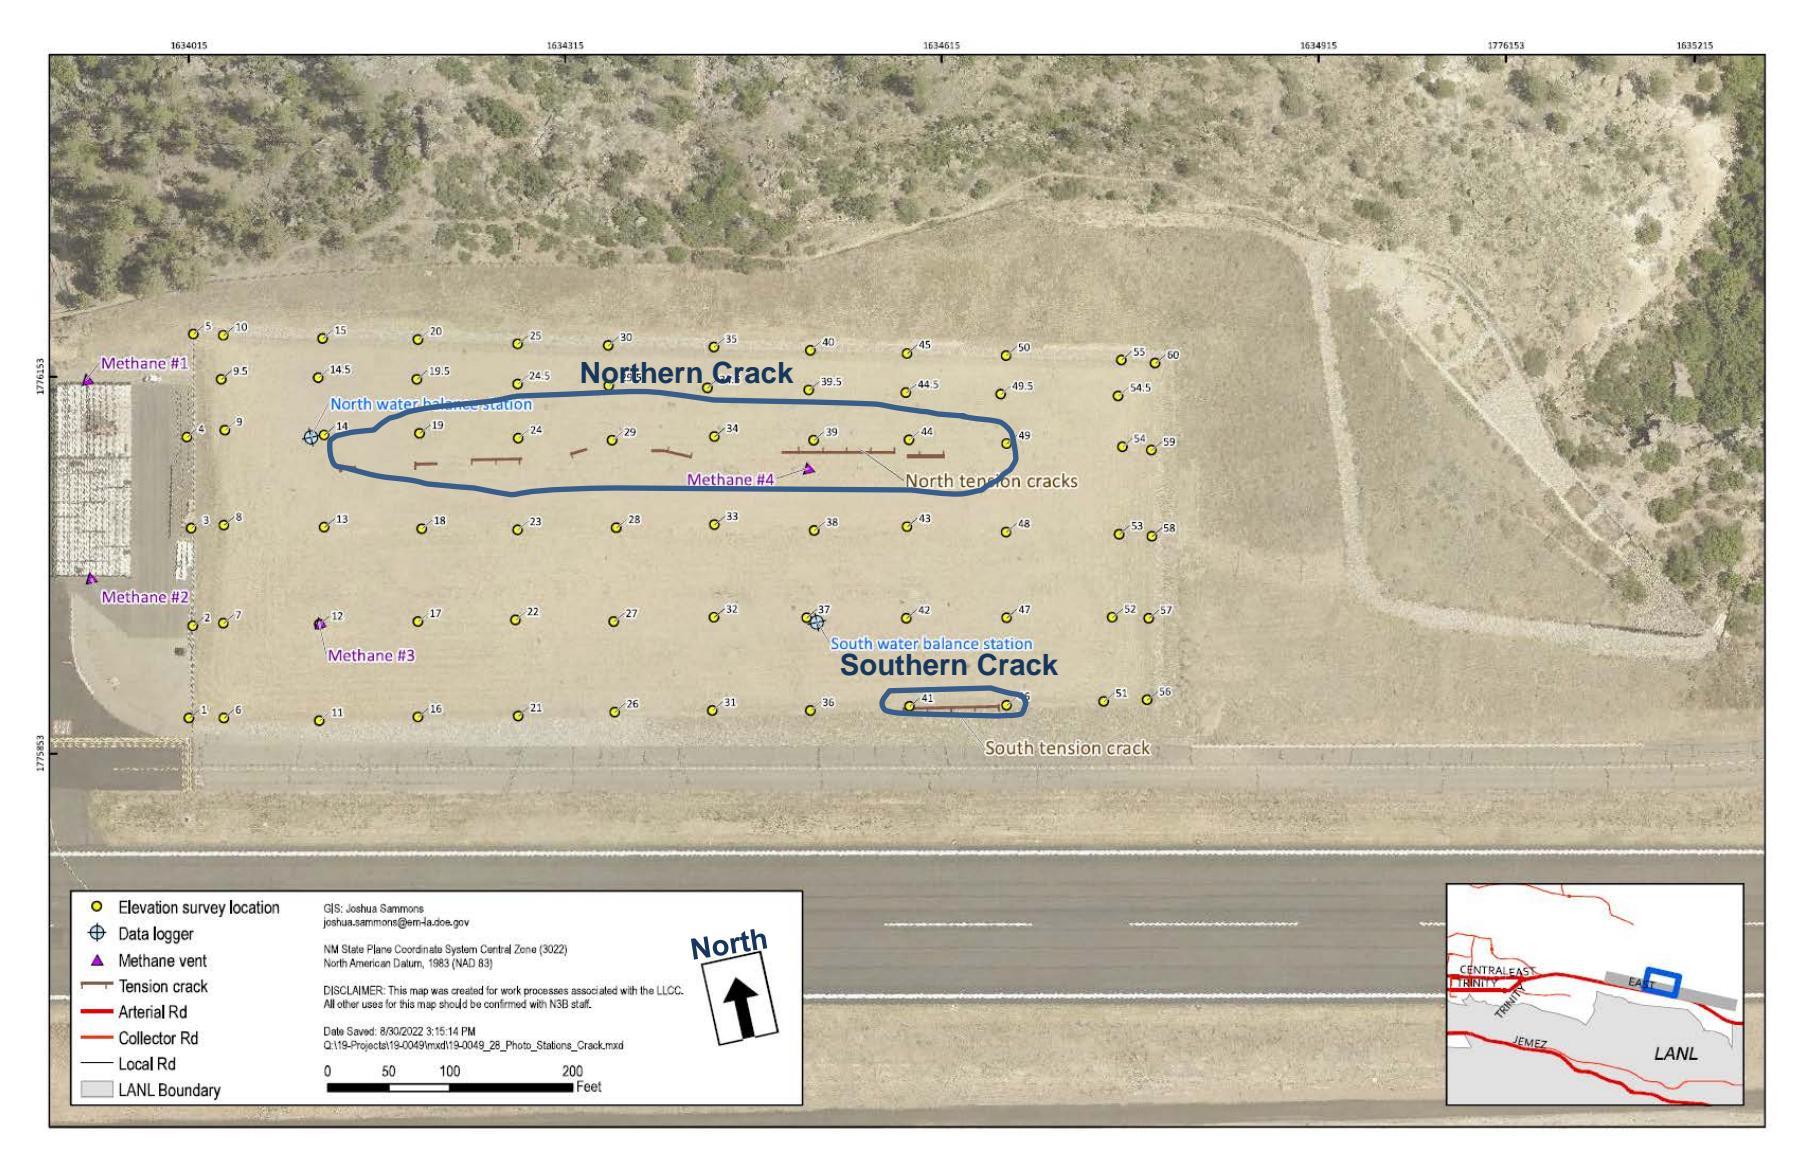
Figure 1. Crack Repair Locations

The northern crack ran intermittently as shown in Figure 1. Repairs included filling the opening with similar soil mixed with gravel to match the original cover design and compacting. The filled areas were then seeded. The compacted fill soil matches the adjacent cover soil (Figure 3). Vegetation has begun to emerge in the seeded areas (Figure 4).
